BRANDYWINE INDUSTRIAL TRACK:**Structure # 1, Augustine Road Overpass**

Structure # 2, CSX Railroad Bridge Overpass

Structure # 3, Interstate-95 Overpass

Structure # 4, Washington Street Bridge Overpass

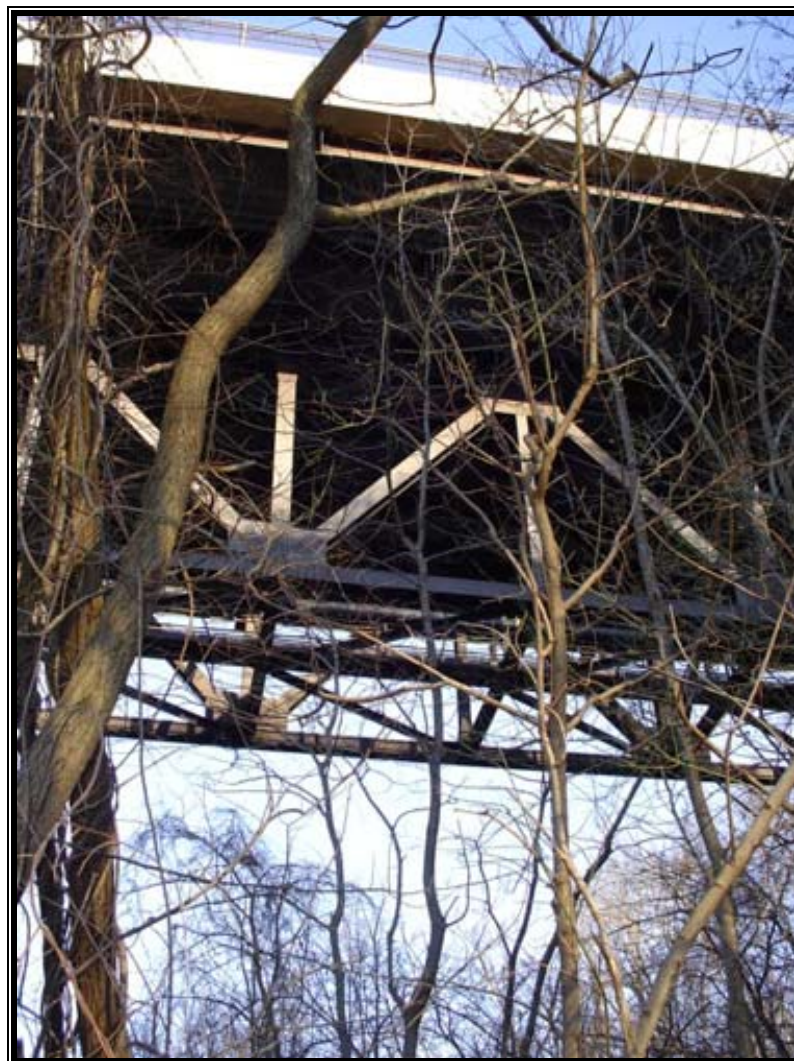
The bridge appears to be in good condition. A cursory inspection of the bridge did not reveal any immediate dangers to the placement of the proposed trail. The inspection was performed from ground level, which is 75 to 125 feet below the bridge (Fig. 1.1).

Fig. 1.1- View from below at the northern terminus of the existing trail

It is recommended, if this corridor progresses into a Planning Study, to perform a comprehensive bridge inspection to determine the condition of the trusses and concrete deck slab for the bridge section that is above the proposed trail alignment.

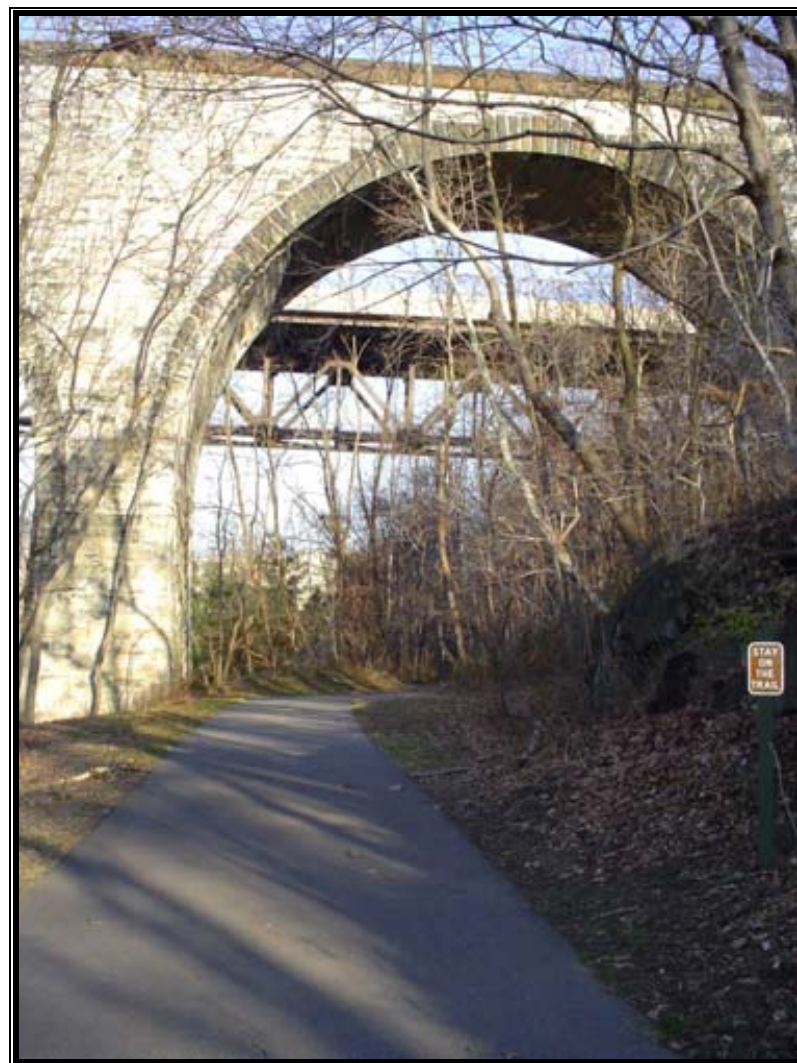
A cursory inspection was performed on December 17th 2004 of a multi-span stone arched railroad bridge over the Brandywine Creek (Fig. 2.1). The existing trail segment within Brandywine Park currently terminates under this bridge.

Fig. 2.1- View of stone railroad bridge over the northern terminus of the existing trail

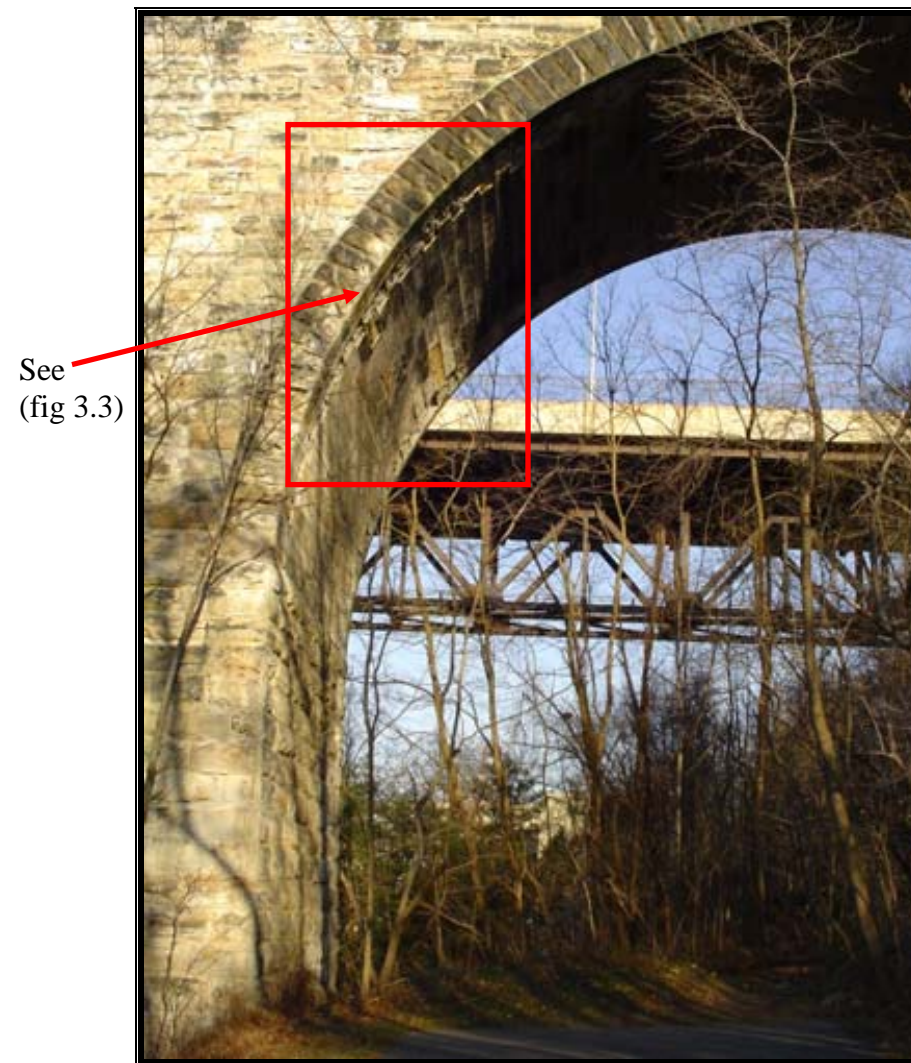
The inspection did not reveal any immediate dangers to the placement of the proposed trail under this bridge. The inspection was performed from ground level, which is some 75 to 100 feet below the bridge. Minor cracking and recent repairs to the stone (Fig. 2.2 & 2.3) are located at various locations throughout the structure. The approximate width between the piers (outside face to outside face) is approximately 61' -0" ±.

Fig. 2.2- View of arch condition
View from northern terminus of the existing trail

It is recommended, if this corridor progresses into a Planning Study, to perform a comprehensive bridge inspection to determine the condition of the stone and its mortar joints for the arched bridge section that is above the proposed trail alignment.

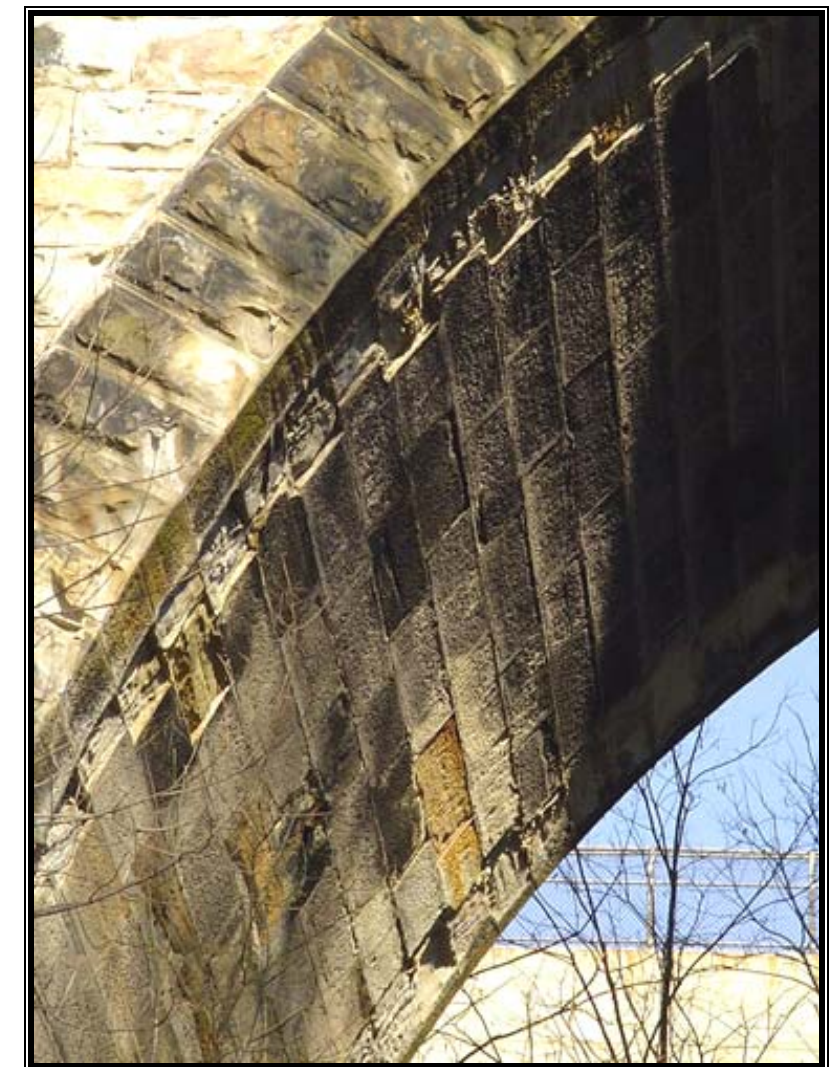
Fig. 2.3- Typical deterioration of stone and repair work

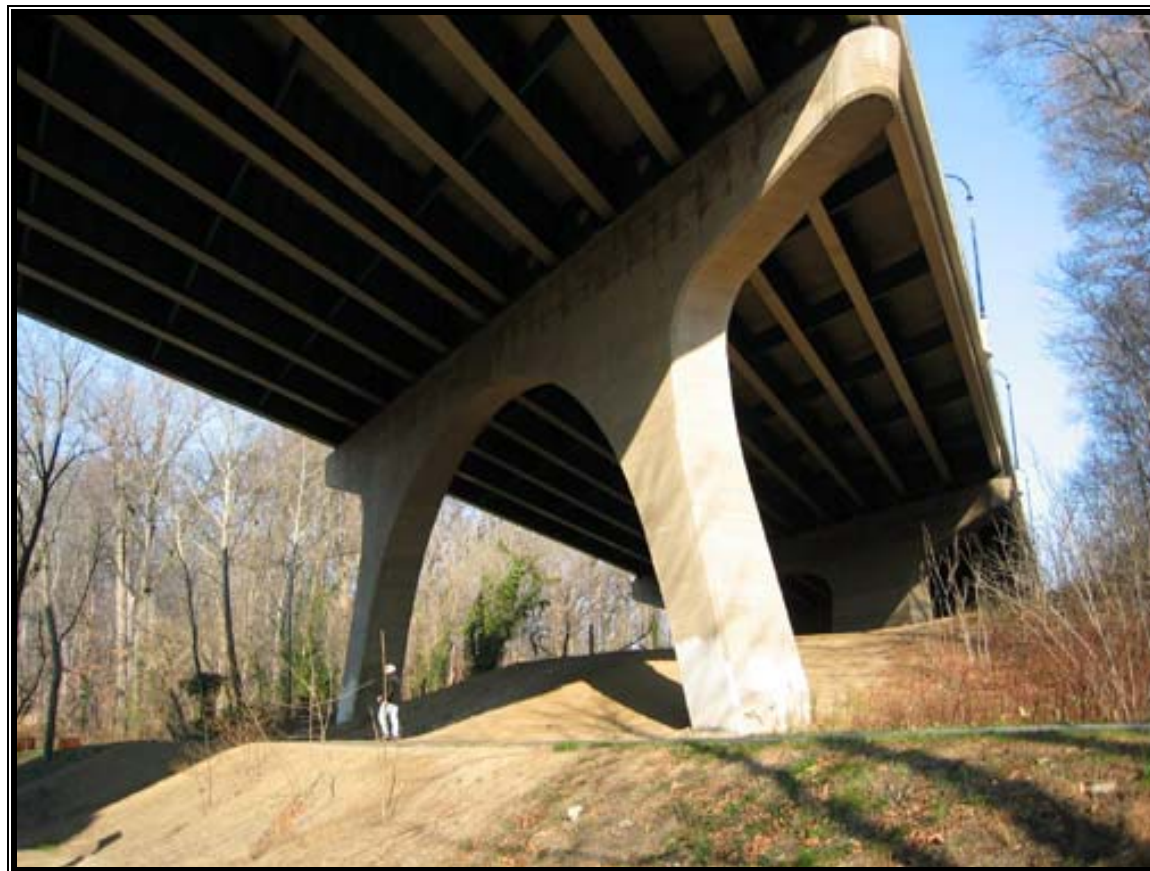
A visual inspection of the structure did not reveal any immediate dangers to the placement of the proposed trail under this bridge. The visual inspection was from ground level, which is some 75 to 100 feet below the bridge. It appears as if the bridge is relatively new or has been recently rehabilitated (Fig. 3.1).

Fig. 3.1- View of I-95 over existing RTT segment within Brandywine Park

It is recommended, if this corridor progresses into a Planning Study, to perform a comprehensive bridge inspection to determine the condition of the beams, concrete deck slab, and the concrete surface of the pier for the bridge section that is above the proposed trail alignment.

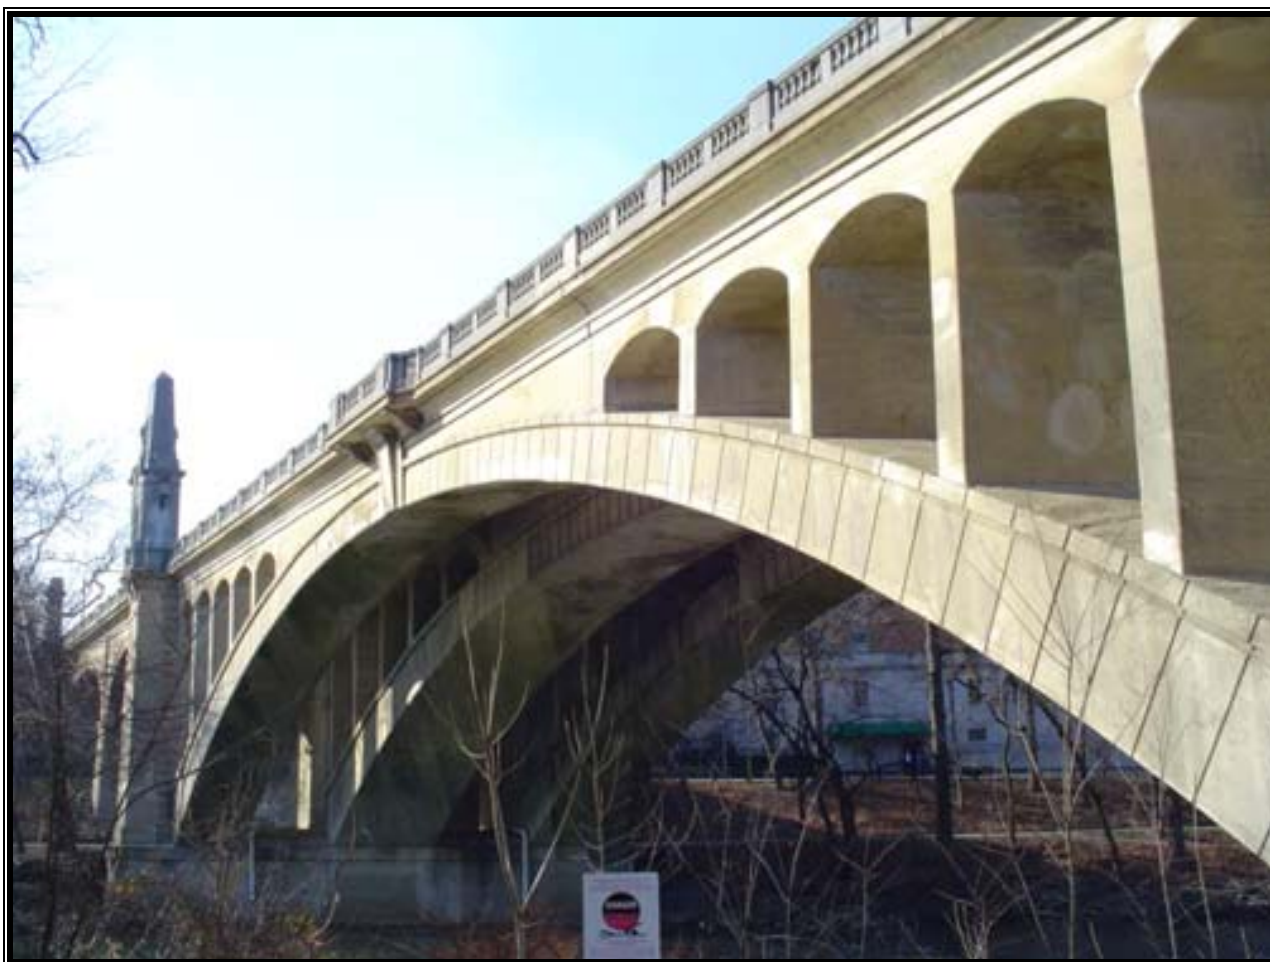
Fig. 4.1- General view of bridge over the Brandywine Creek from rail corridor

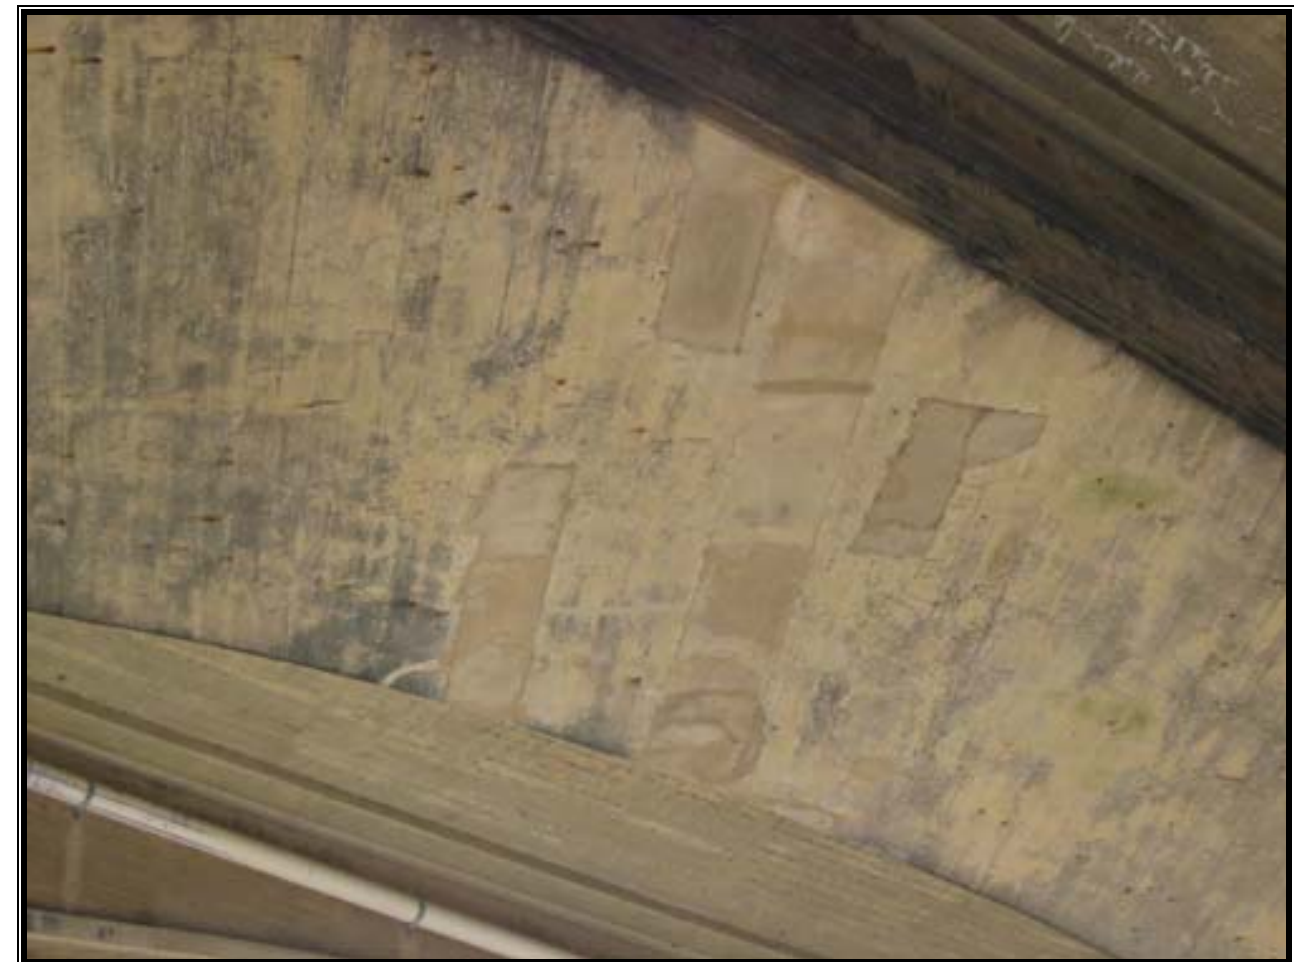
The bridge is in fair condition, despite signs of minor deterioration. The concrete has patchwork in various areas and exposed rebar (Fig. 4.2). The exposed rebar is evident from the staining of the concrete (Fig. 4.3). In many places, cracking extends the entire length of the concrete member accompanied by efflorescence (Fig. 4.4). The cracked concrete and evidence of compromised rebar is of concern.

Fig. 4.2- Evidence of concrete repair directly over area of proposed trail

It is recommended, if this corridor progresses into a Planning Study, to perform a comprehensive bridge inspection to determine the condition and repair of the concrete and rebar for the bridge section that is above the proposed trail alignment.

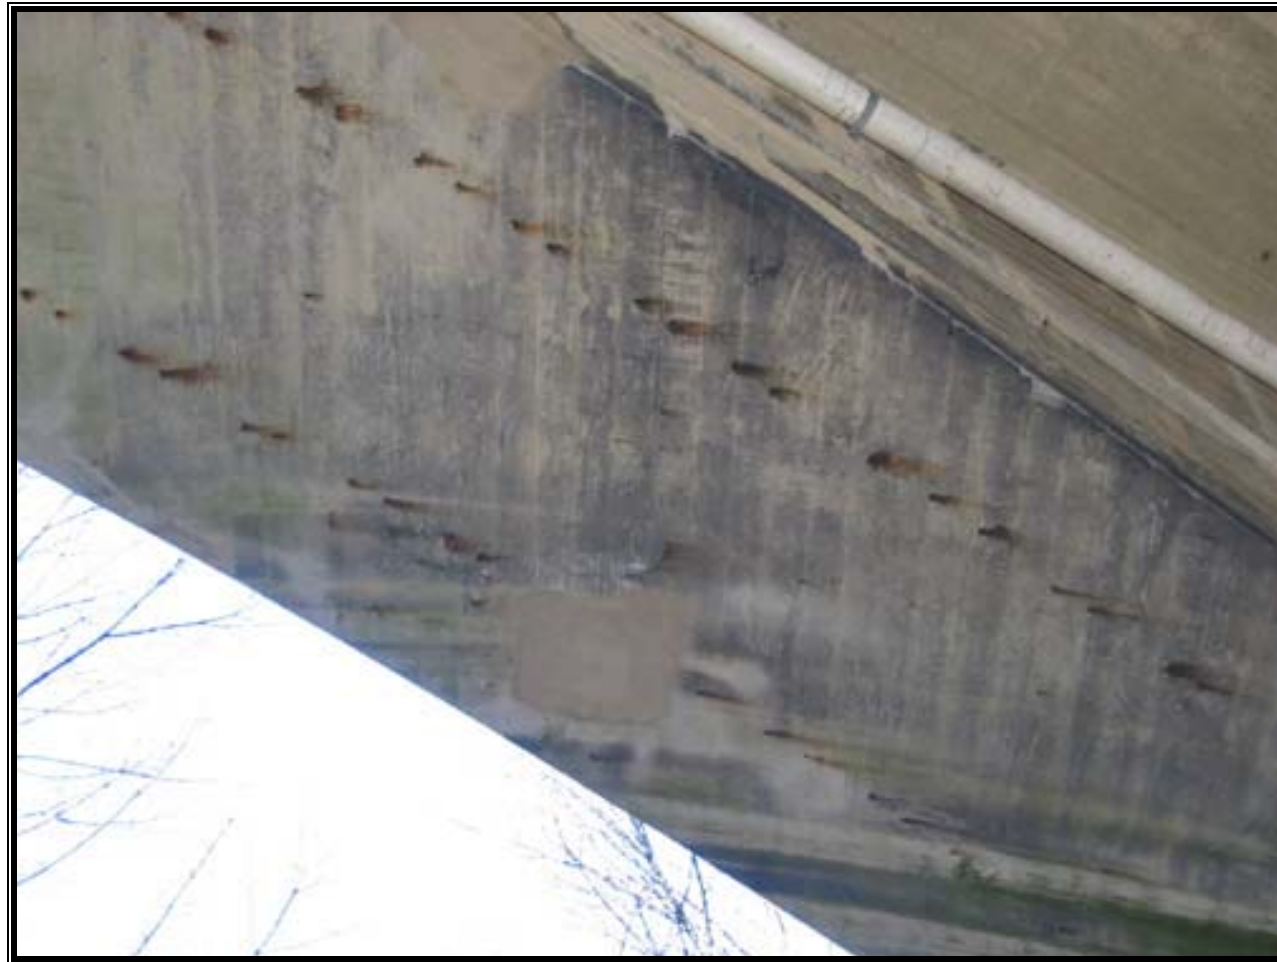
Fig. 4.3- Staining of rebar directly over area of proposed trail

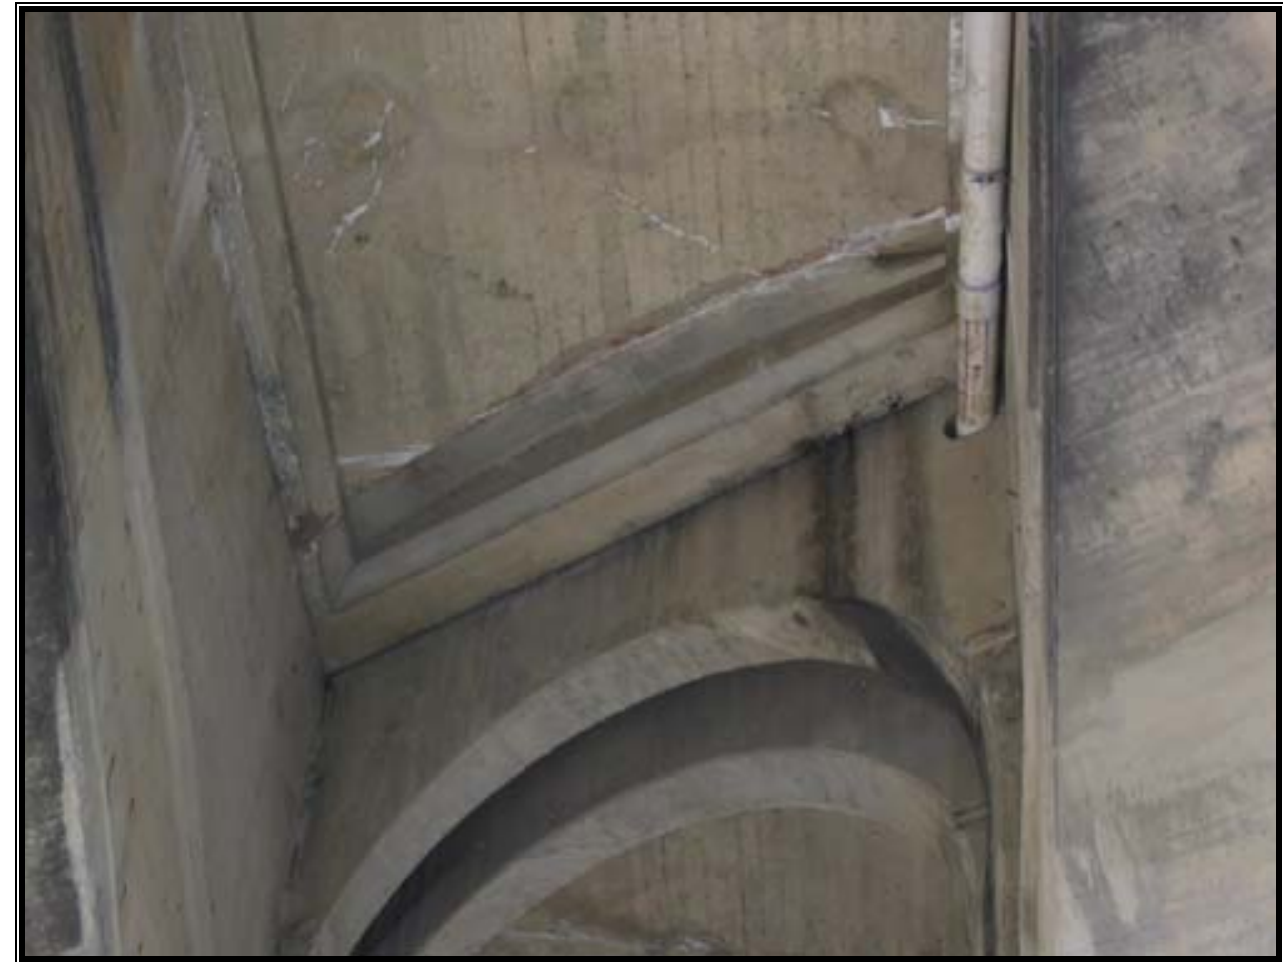
Fig. 4.4- Concrete repair with efflorescence

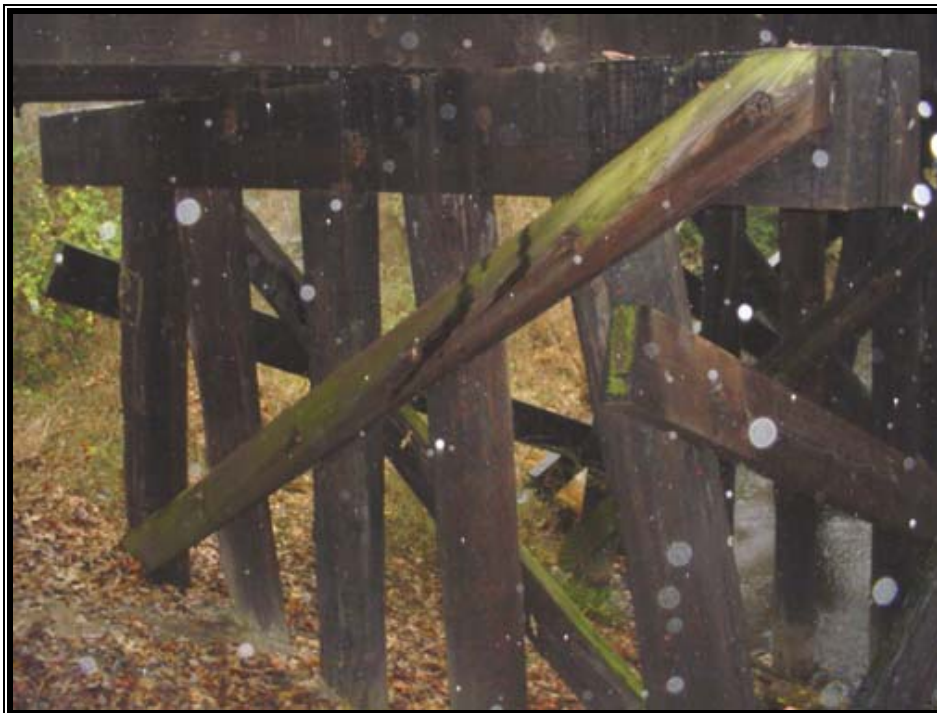
The girders and piers are in fair condition. The substructure consists of six girders, consisting of three timbers each measuring 0'-10" wide by 1'-4" deep, evenly distributed over the abutments and piers. The piers consist of timber caps above five timber piles, two battered and three straight (Fig. 5.1). The substructure shows signs of wear, due to weathering of timber members. The piers have various repairs to the piles. Pile repairs consisted of fiberglass jacketing and steel banding (Fig. 5.2 and 5.3). The piers are supported by typical cross bracing (Fig. 5.4). Additionally, the cross bracing has been repaired in several locations using banding at the ends (Fig. 5.5).

Fig. 5.1- Typical pier arrangement

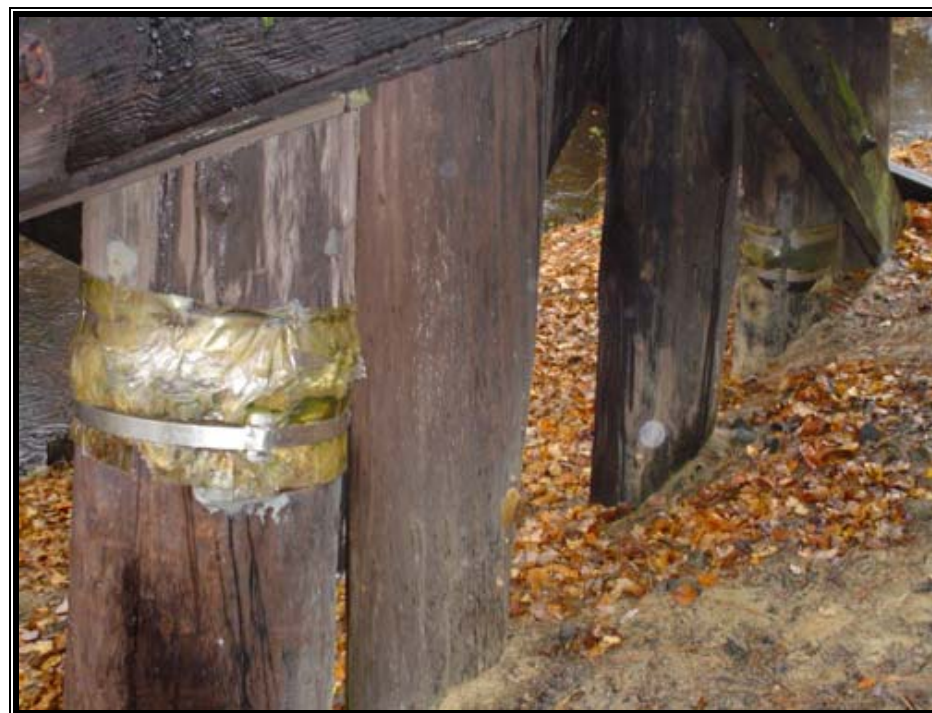
Fig. 5.2- Jacketing around pile 1 at pier 5

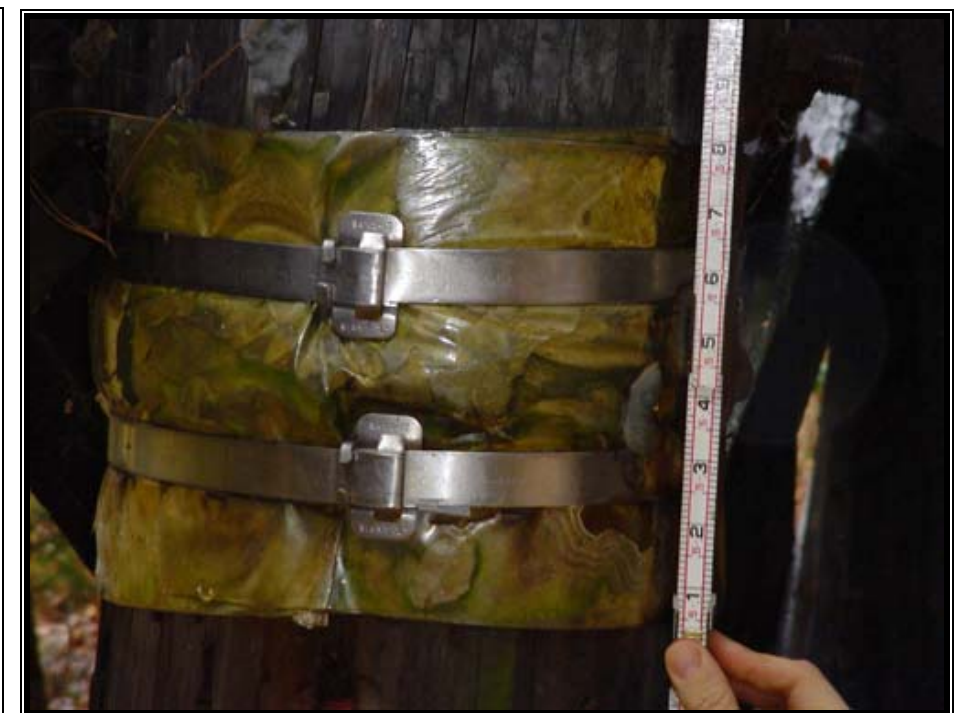
Fig. 5.3- Jacketing at pier 2

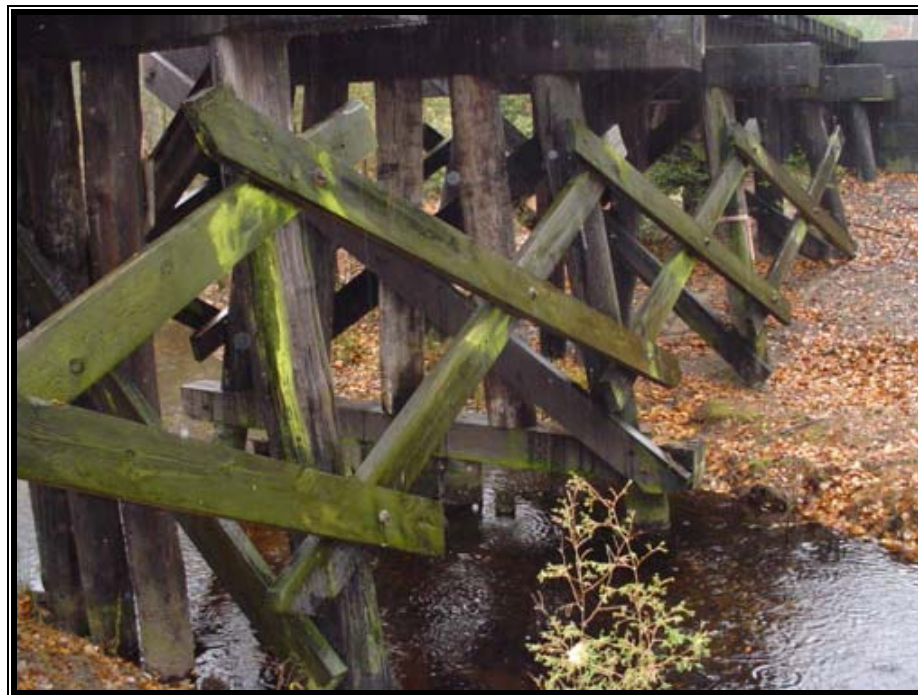
Fig. 5.4- Typical cross bracing between piers

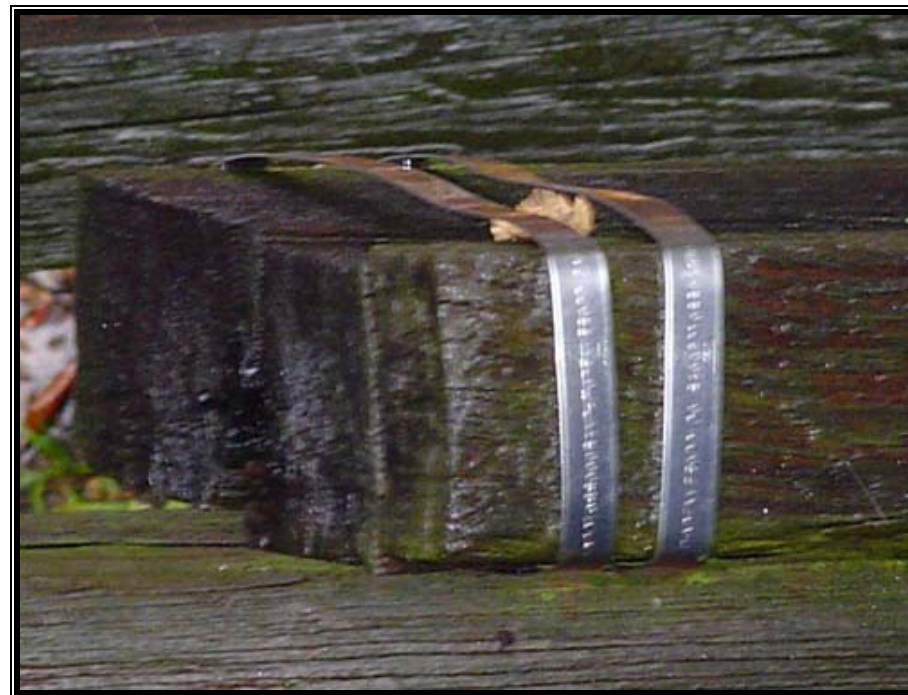
Fig. 5.5- Banding on cross bracing at pier 4

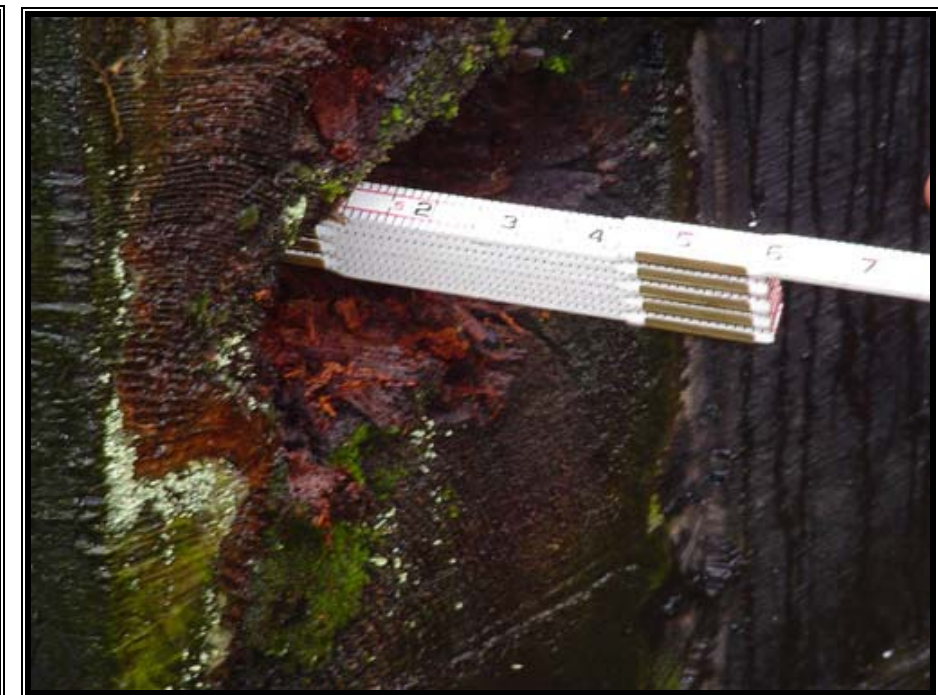
The abutments are in poor condition. The abutments are made of large timber lagging against piles. There is evidence of moderate to severe rot in the abutments. The wing walls have severe rot, including holes 5 inches in diameter and 2.5 deep into lagging (Fig. 5.6 and 5.7). Evidence on insect infestation is present in the form of "mud tubes" which are common to Termites.

Fig. 5.6- Rot in wing wall 2'6" deep

It is recommended, if this corridor progresses into a Planning Study, to perform a comprehensive bridge inspection to determine the condition and extent of the required repairs. This cursory inspection and evaluation yields that many of the wood beams need to be treated and conditioned and several of the large timbers, at the bridge abutments, should be replaced. Additionally, further investigation should be conducted to determine the condition of the piles, piers, pile jacketing/ banding, and to determine the capability of supporting the vehicular load of an emergency vehicle after bridge improvements and bridge/ trail modifications have been made to accommodate a RTT facility.

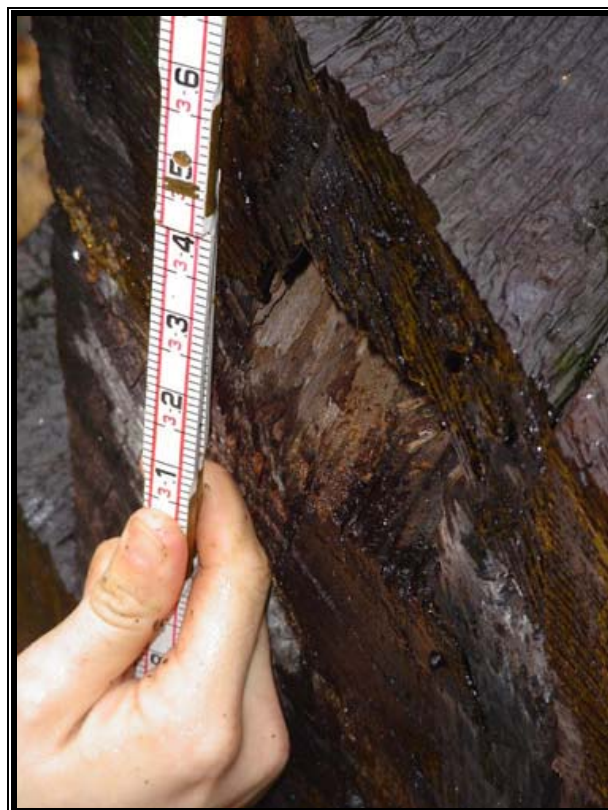
Fig. 5.7- Rot in wing wall 5 inches

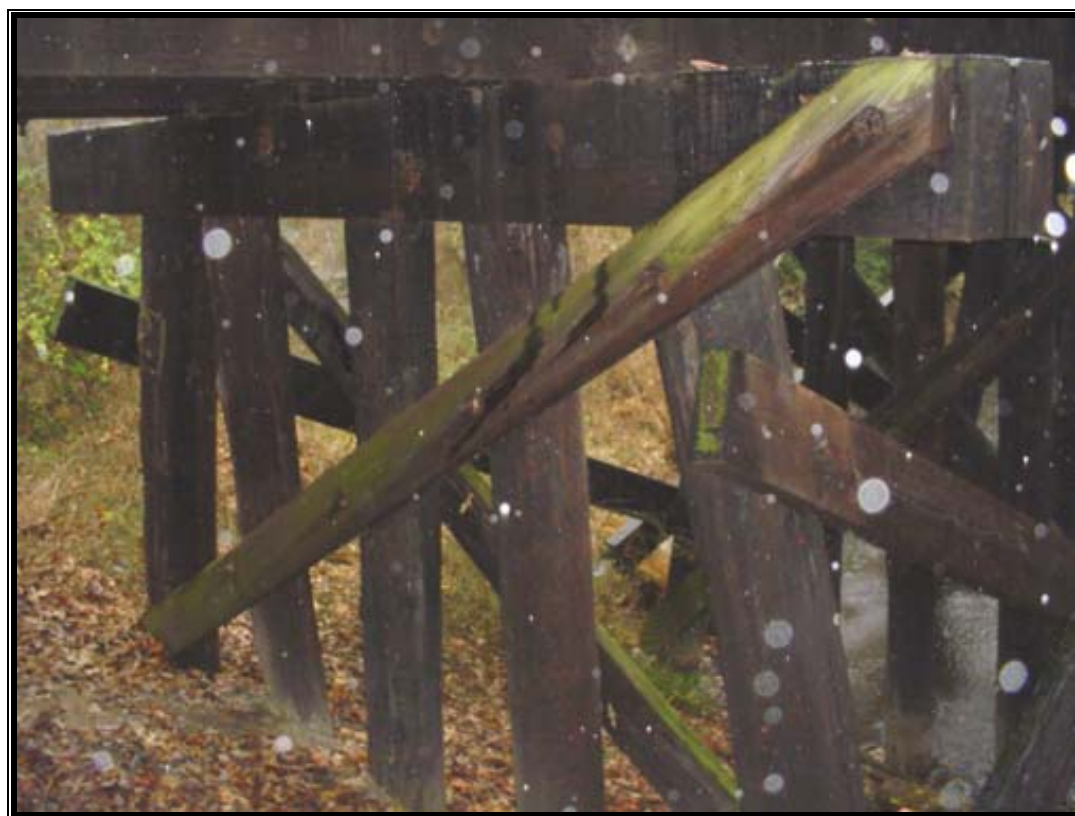
The girders and piers are in fair condition. The substructure consists of six girders, consisting of three timbers each measuring 0'-10" wide by 1'-4" deep, evenly distributed over the abutments and piers. The piers consist of timber caps above five timber piles, two battered and three straight (Fig. 6.1). The substructure shows signs of wear, due to weathering of timber members. The piers seem to be in good shape and show no visual signs of deterioration.

Fig. 6.1- Typical Pier

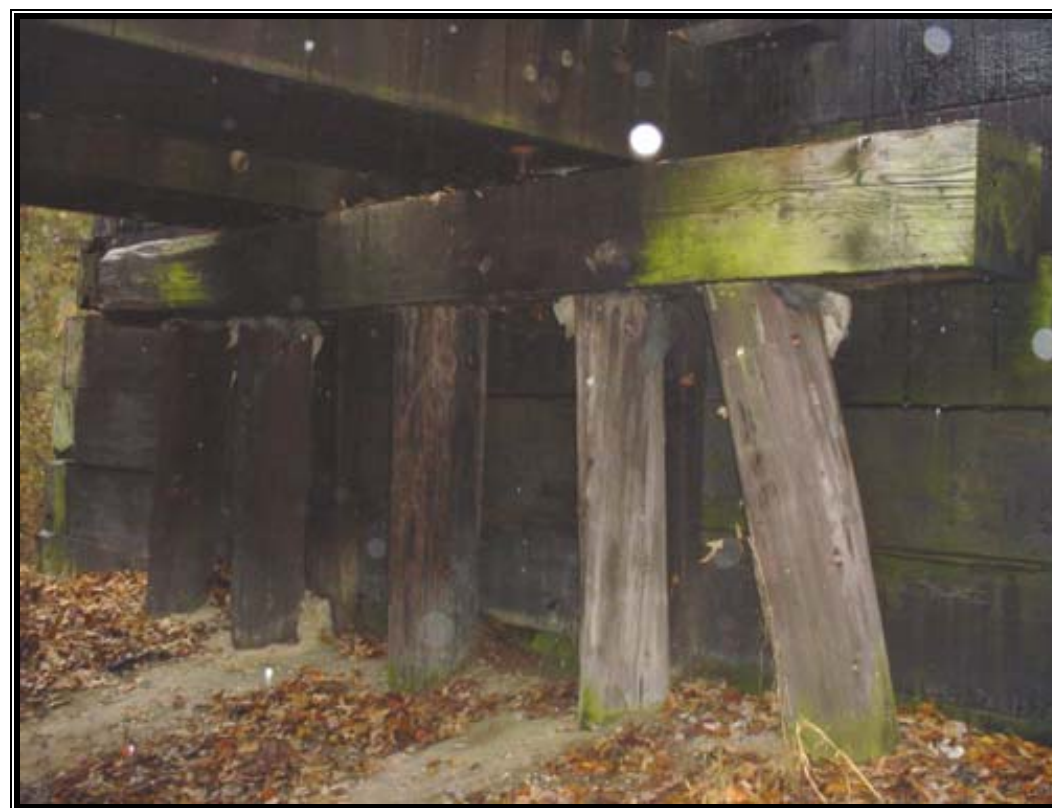
The abutments are in poor condition. The abutments are made of large timber lagging against piles (Fig. 6.2). There is evidence of moderate to severe rot in the abutments (Fig.6.3). The wing walls show evidence of past repairs (Fig. 6.4). Some lagging will need to be replaced, due to significant rot. There is evidence on insect infestation, in the form of "mud tubes" which are common to Termites (Fig. 6.5). In addition, the west abutment has an exposed timber aiding the slope protection. This timber has been undermined with moderate erosion (Fig. 6.6). A metal tag on pier 7 indicates that the structure had been rebuilt in 1988 by Osmose (Fig. 6.7).

Fig. 6.2- Typical abutment

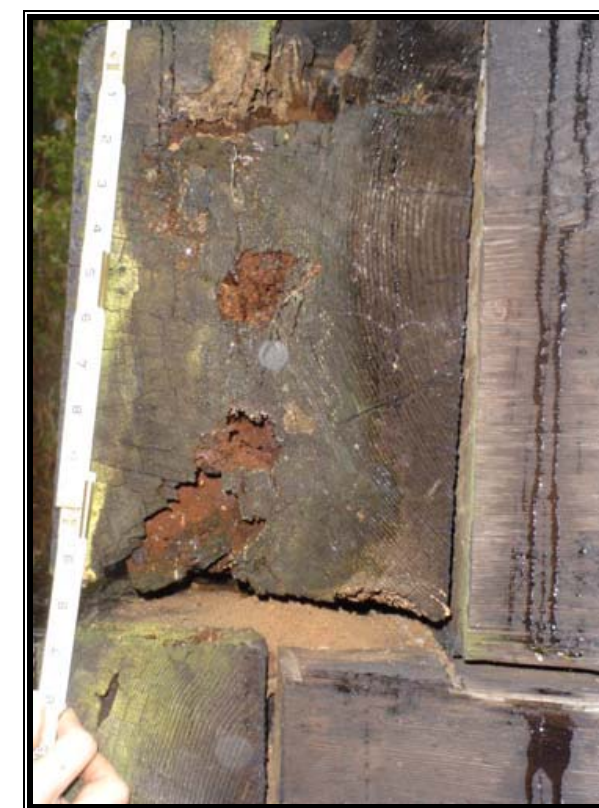
Fig. 6.3- Typical wing wall timber deterioration

It is recommended, if this corridor progresses into a Planning Study, to perform a comprehensive bridge inspection to determine the condition and extent of the required repairs. This cursory inspection and evaluation yields that many of the wood beams need to be treated and conditioned and several of the large timbers, at the bridge abutments, should be replaced. Additionally, further investigation should be conducted to determine the condition of the piles, piers, and to determine the capability of supporting the vehicular load of an emergency vehicle after bridge improvements and bridge modifications have been made to accommodate a RTT facility.

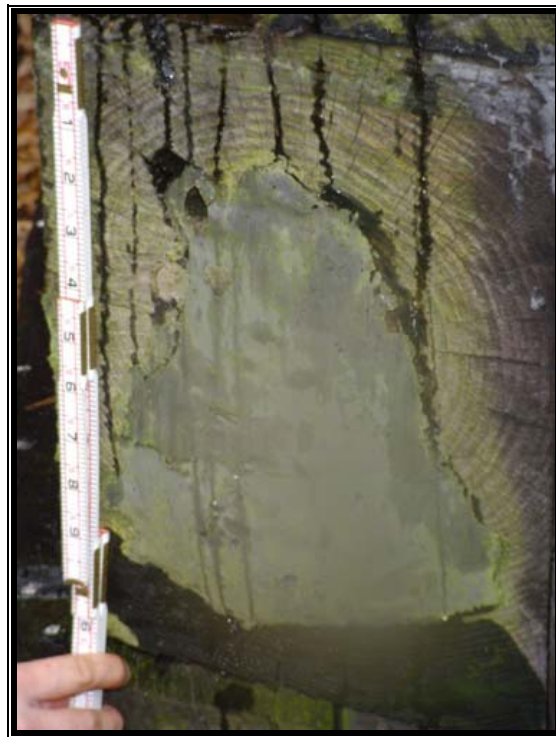
Fig. 6.4- Typical repair on abutment

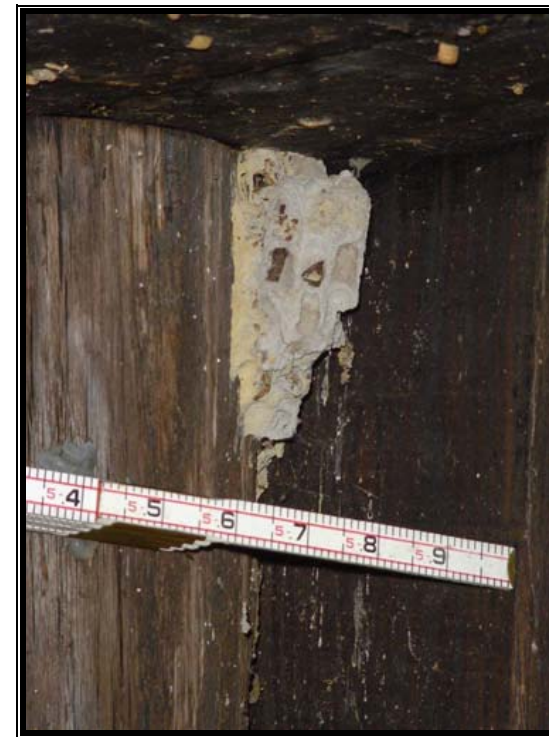
Fig. 6.5- Evidence of insect infestation

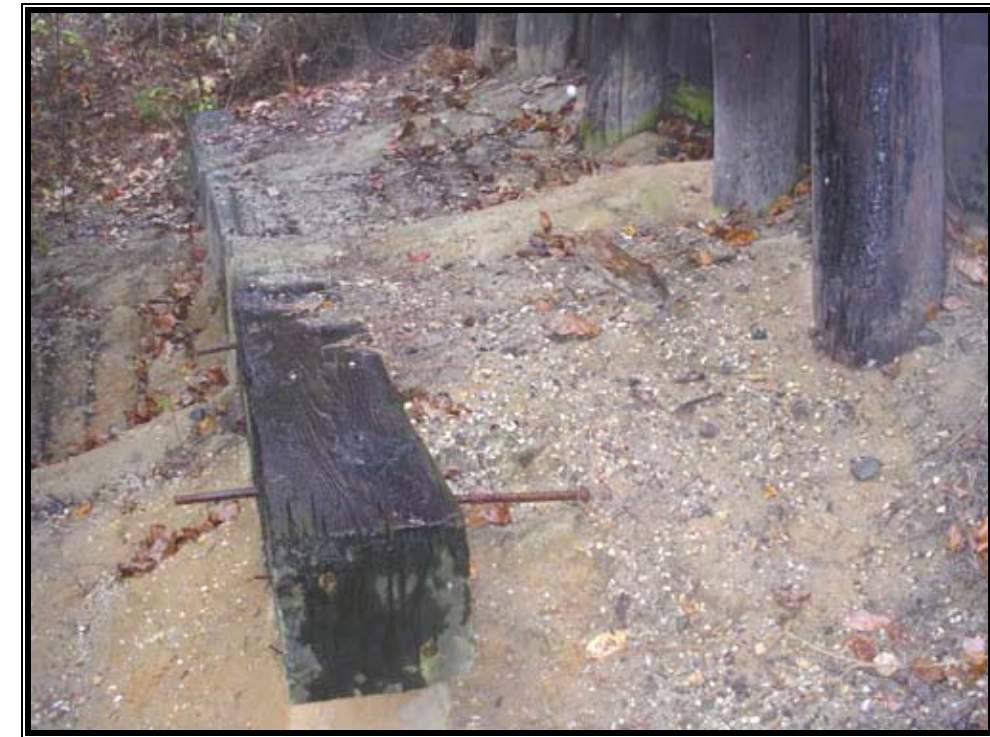
Fig. 6.6- Timber used for slope protection

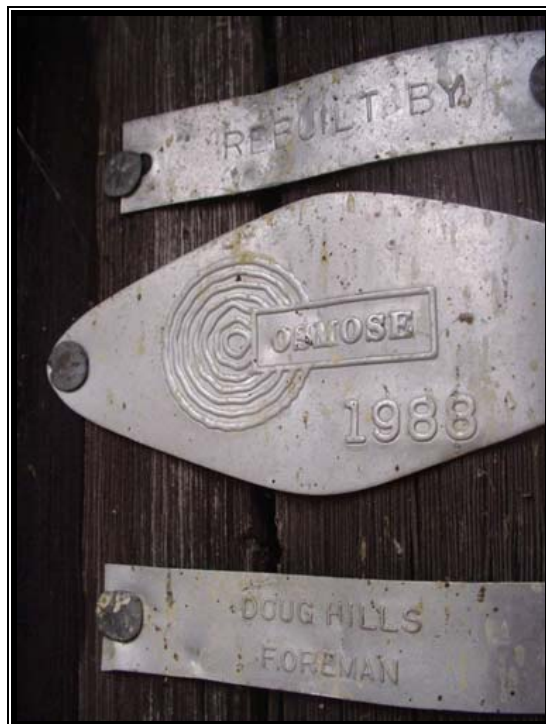
Fig. 6.7- Metal tag on pier 7, indicating when the structure was rebuilt

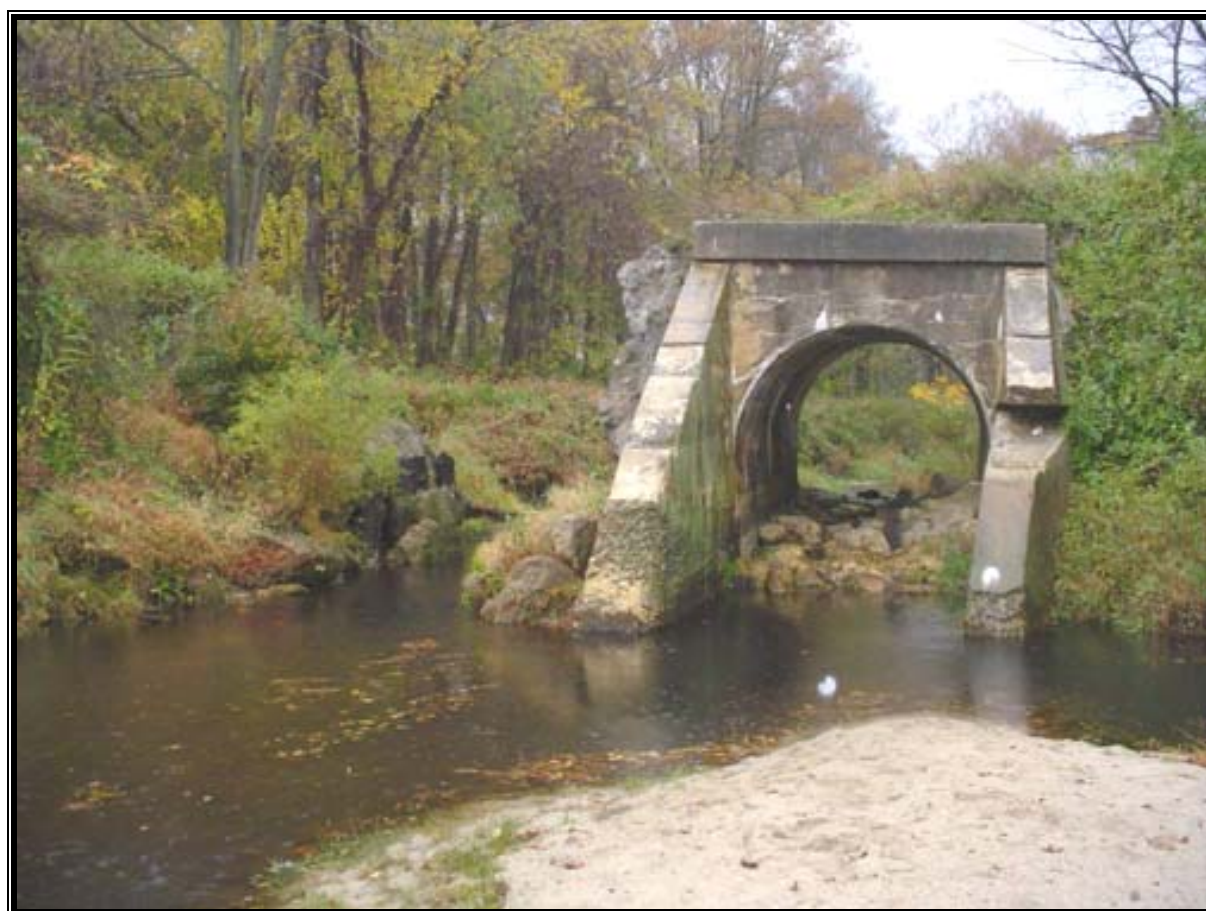
The location and orientation of the culvert suggests the stream ran through this structure at one time. Today, the stream runs west of the culvert, with the top of water below the elevation of the riprap in the culvert (Fig. 7.1). Many structural defects such as major cracking, differential footing settlement, major spalling of concrete, efflorescence in concrete, and scoured out foundation, have rendered this structure unusable.

Fig. 7.1- South elevation

The structure is unusable in its present state, due to the deterioration and missing span over the stream. It is recommended, if this corridor progresses into a Planning Study, that this structure be removed and a new and independent RTT bridge structure be provided.

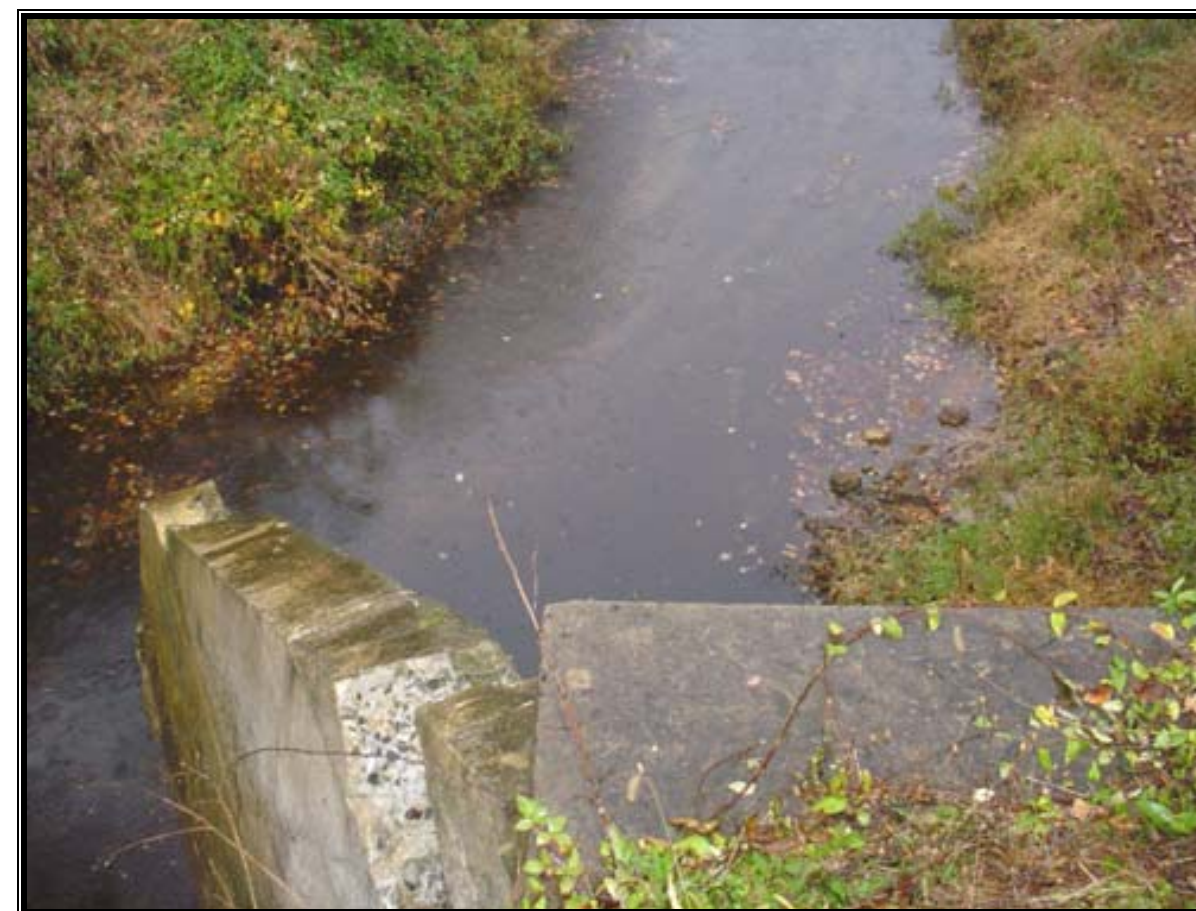
The north face west wing wall is directly in the path of the stream flow, which has lead to significant scour (Fig. 7.2). Differential settlement at the south face east wing wall (Fig. 7.3) has cracked and separated the wing wall (Fig. 7.4). The site contains remnants of timber piles, located along the west bank of the stream and inside the culvert.

Fig. 7.2- North face –west wing wall directly in path of steam
