BRANDYWINE INDUSTRIAL TRACK:**Structure # 1, Augustine Road Overpass**

Structure # 2, CSX Railroad Bridge Overpass

Structure # 3, Interstate-95 Overpass

Structure # 4, Washington Street Bridge Overpass

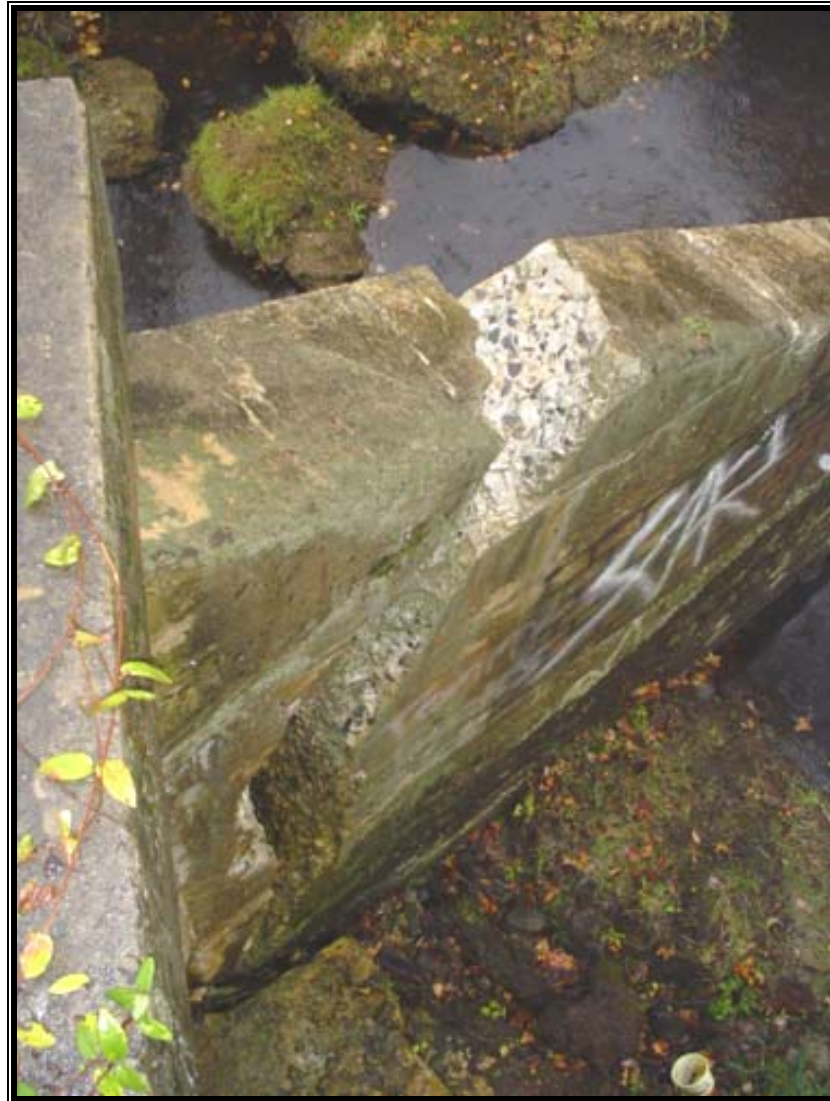
The north face west wing wall is directly in the path of the stream flow, which has lead to significant scour (Fig. 7.2). Differential settlement at the south face east wing wall (Fig. 7.3) has cracked and separated the wing wall (Fig. 7.4). The site contains remnants of timber piles, located along the west bank of the stream and inside the culvert.

Fig. 7.3- Cracked south face – east wing wall

The structure is unusable in its present state, due to the deterioration and missing span over the stream. It is recommended, if this corridor progresses into a Planning Study, that this structure be removed and a new and independent RTT bridge structure be provided.

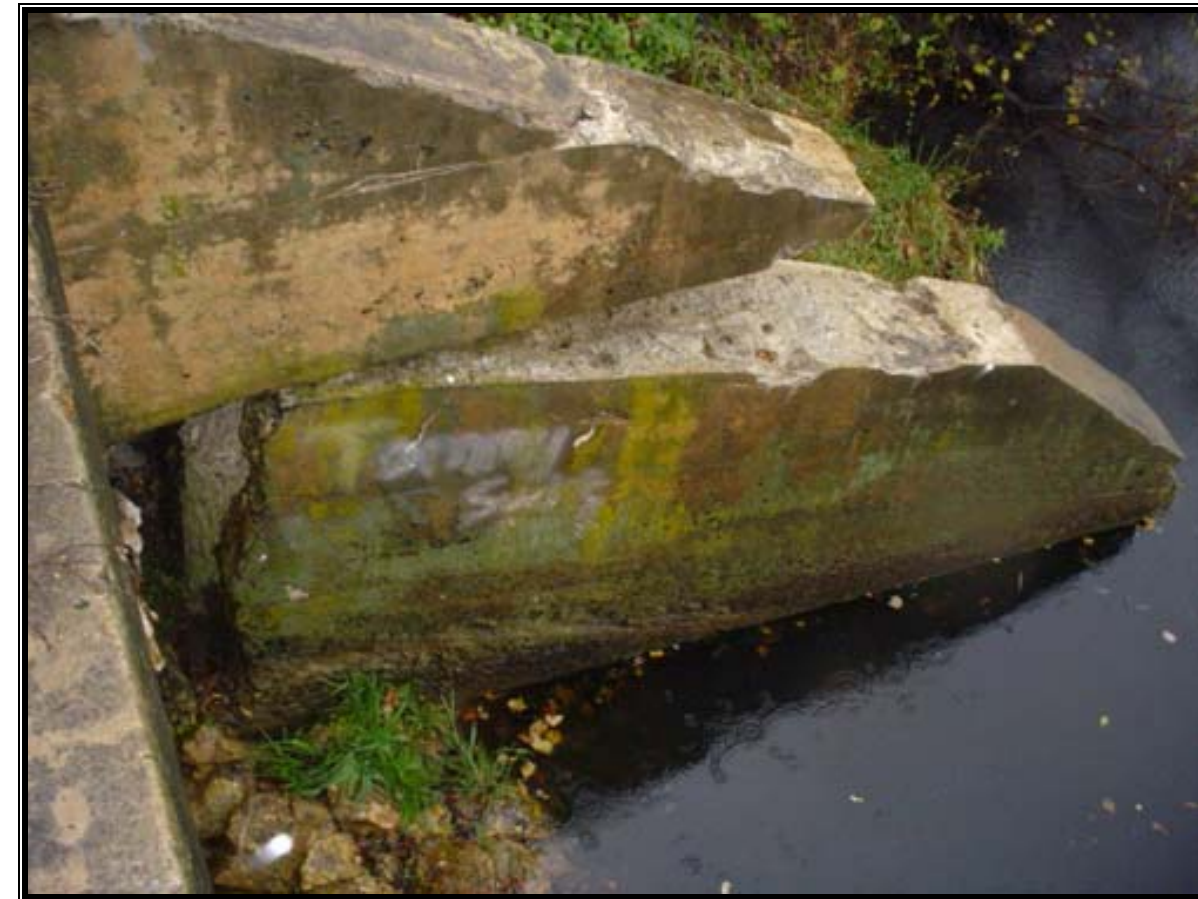
Fig. 7.4- Differential settlement at south face – east wing wall

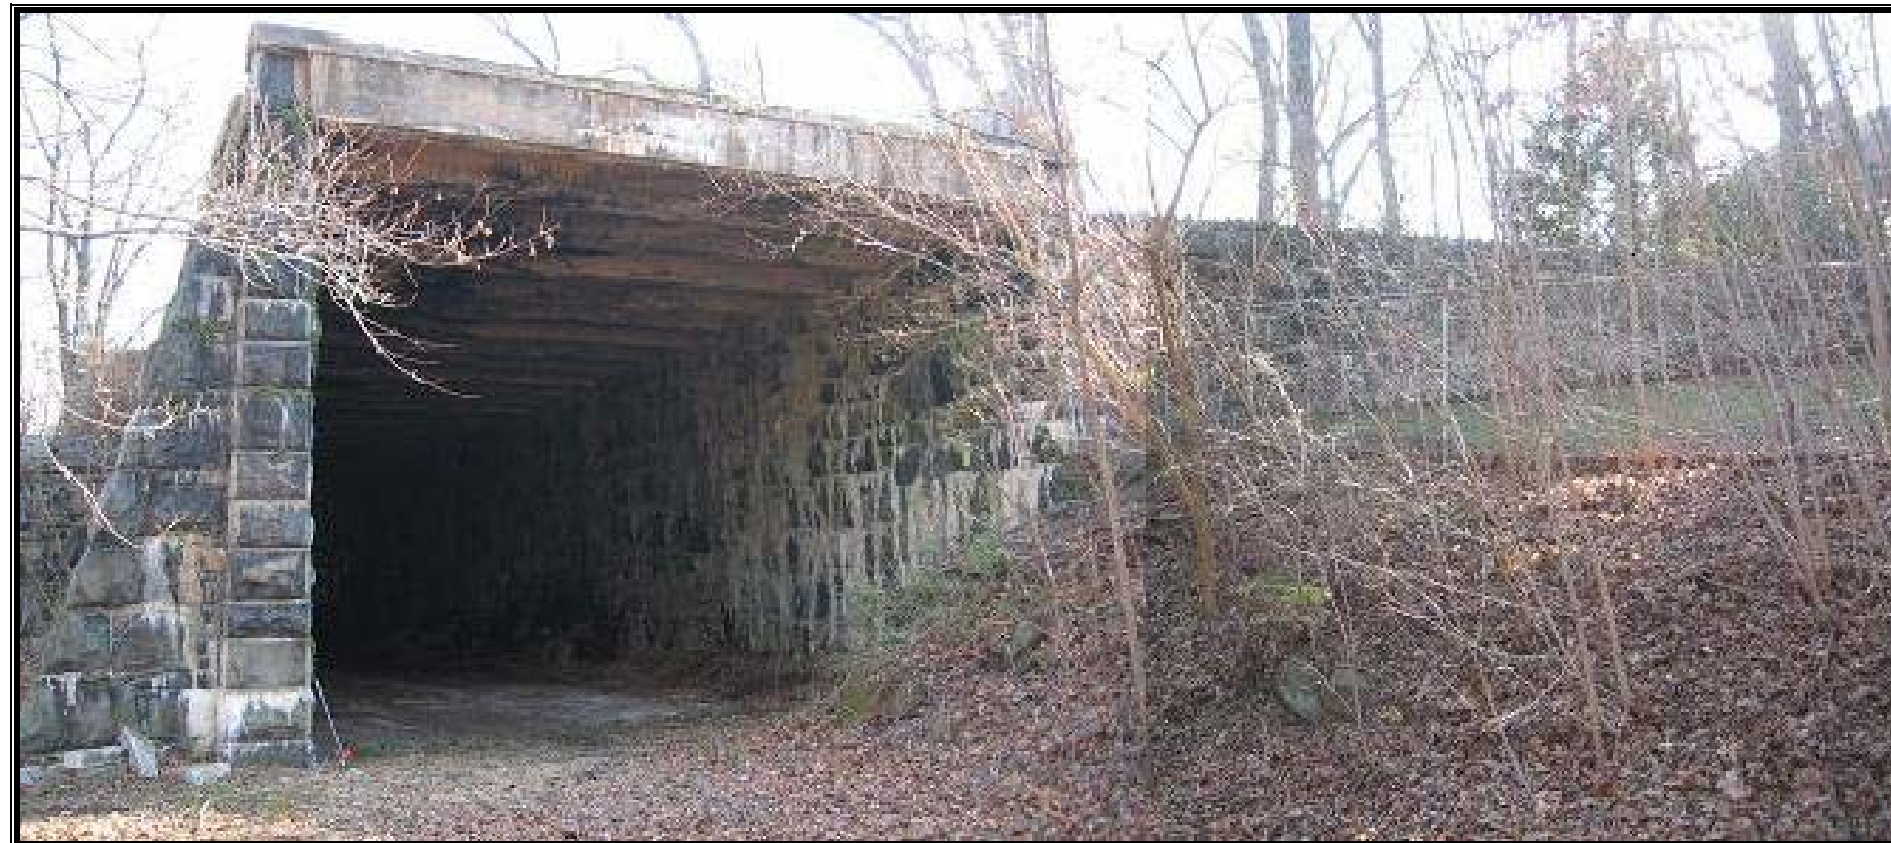
A cursory inspection was performed on December 17th 2004 of a simply supported concrete and stone railroad tunnel. The length is approximately 241'- 0" ± in length and 32'- 0" ± in width spanning north to south. The height is approximately 27'- 0" ± tall from ground to bottom of concrete girders. The concrete girders are approximately 3'- 0" ± in depth with approximately a 0'- 9" ± of earth on the top of the structure (Fig. 8.1).

Fig. 8.1- West end of tunnel

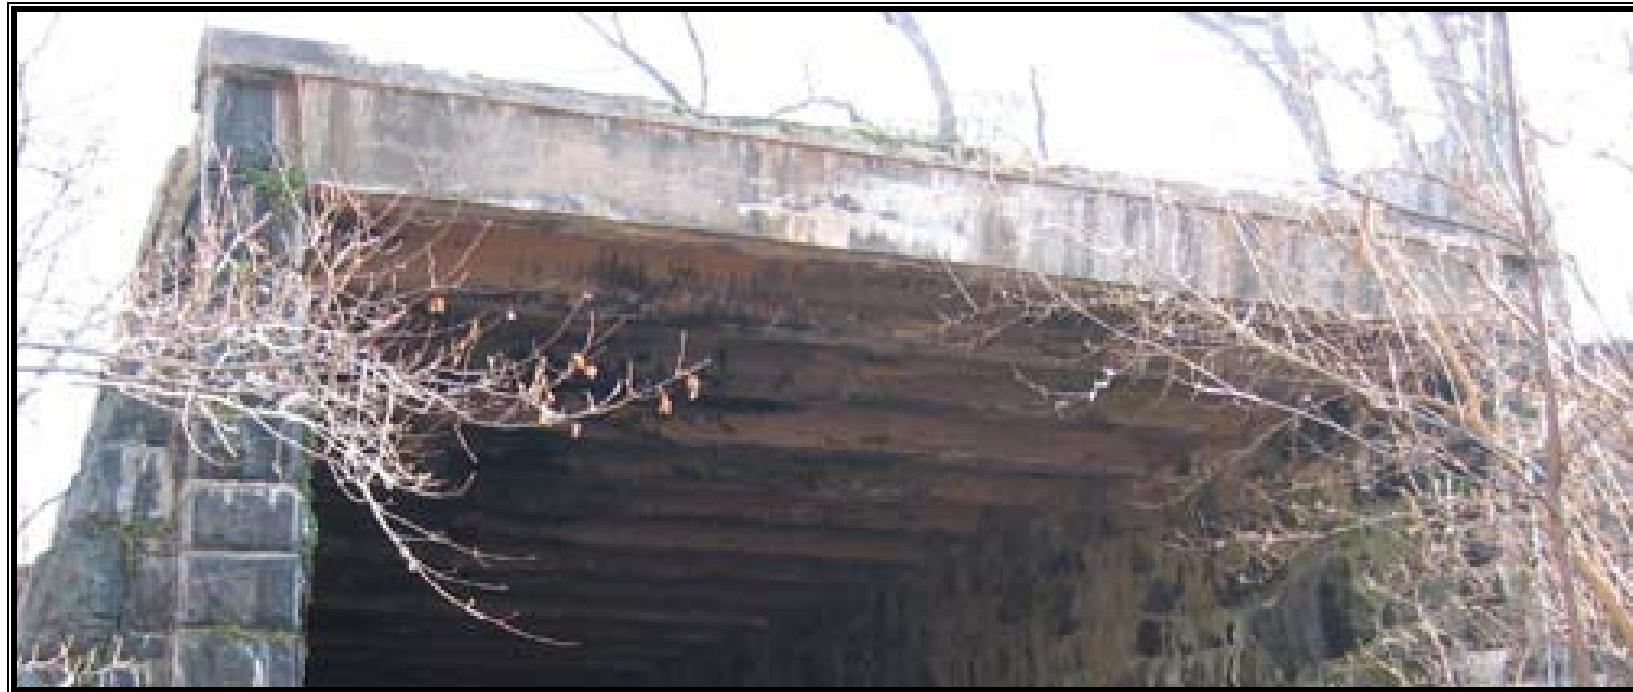
The superstructure is in fair condition. The superstructure consists of simply supported T-shaped concrete girders with a layer of earth above. The girders seem to be in fair condition despite cracking and efflorescence (Fig. 8.2). Located on the exterior of the north abutment, an existing staircase is deteriorated. The staircase is in poor condition and will need to be restricted from use, by trail users, or removed (Fig. 8.3). The top of the structure is an earthen covering with a well managed turf surface (Fig. 8.4), which appears to be maintained by the adjoining residence.

Fig. 8.2- Typical exterior beam cracking and efflorescence on west end

If this corridor progresses into a Planning Study then the following recommendations are: the abutments need to be repaired as needed which include crack and mortar repair; the staircase on the north abutment will need extensive repair or replacement if it is to function as a usable staircase; it is recommended that the staircase is to be closed off to public access if it is not to be repaired; additionally, it is necessary to conduct a more comprehensive inspection to provide a more accurate condition in determining the usability of this tunnel.

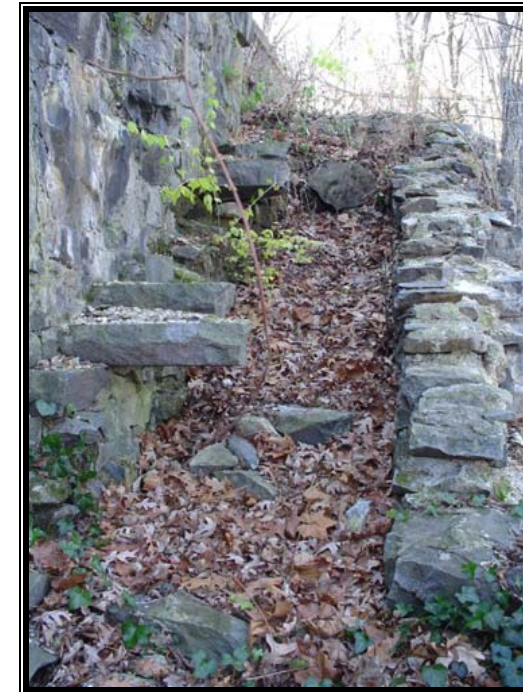
Fig. 8.3- Deteriorated stair case on north abutment

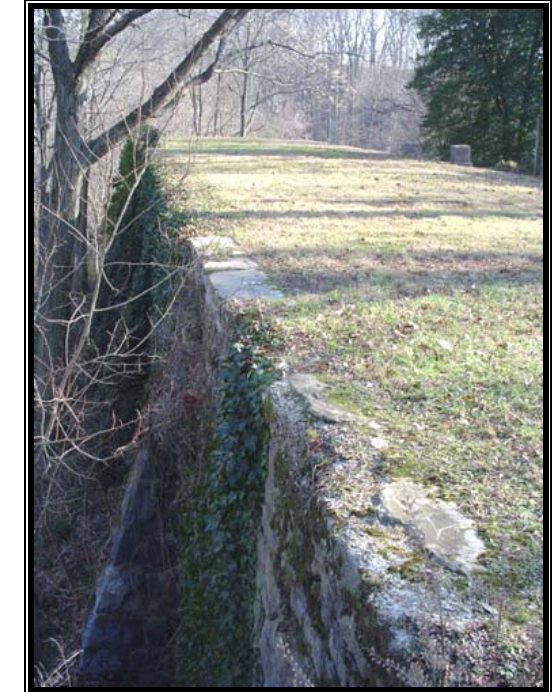
Fig. 8.4- Tunnel roof with maintained turf, view from west

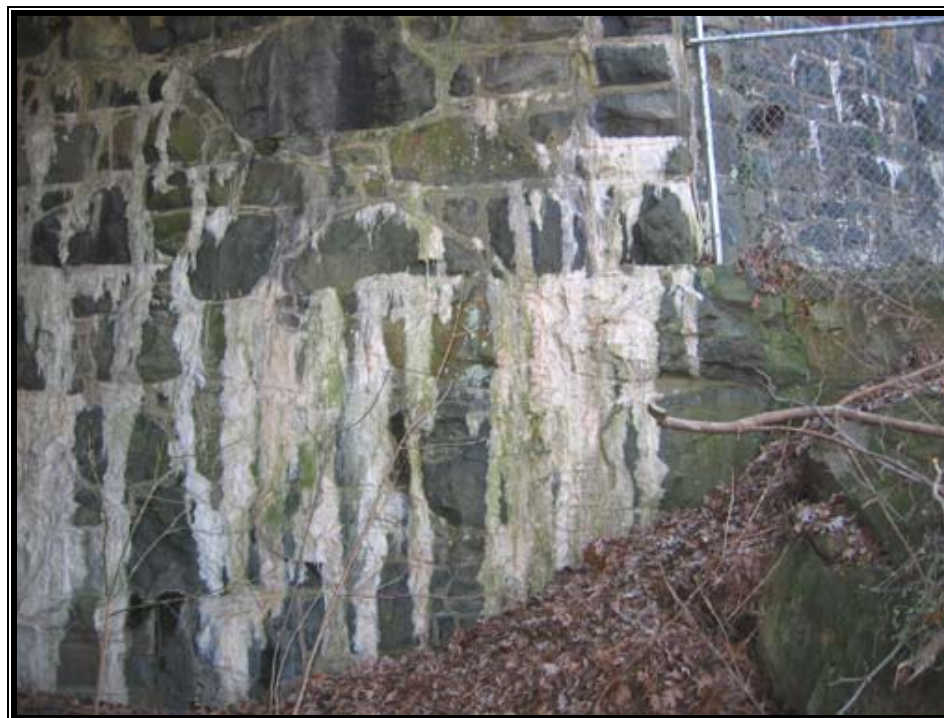
The abutments are in fair to poor condition. The abutments are made of large stone. The stone appears to be in fair condition despite large amounts of efflorescence (Fig. 8.5). The joints of the stone are in fair to poor condition with some evidence of repair. Vegetation is also growing, in locations, within the rock and joints of the abutments. A large amount of debris lines the south abutment. The abutments on the north side are stabilized with buttresses (Fig. 8.6). The bearings for this tunnel were not visible and condition is unknown.

Fig. 8.5- Heavy efflorescence on south abutment – west end

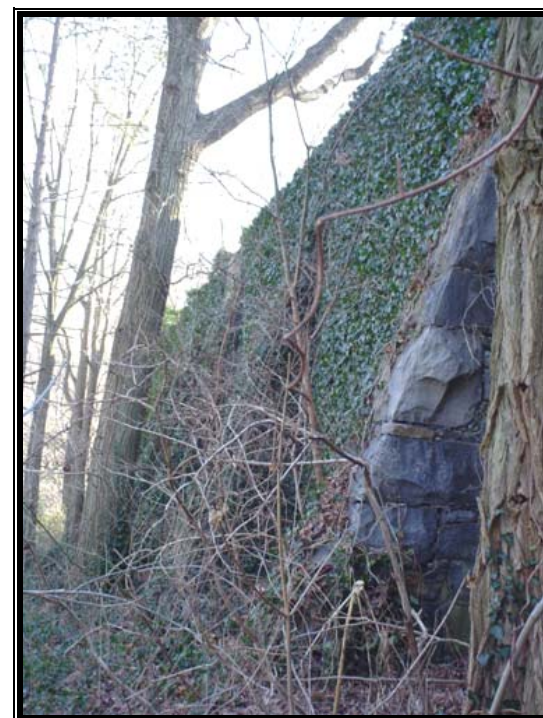
Fig. 8.6- North abutment with buttress

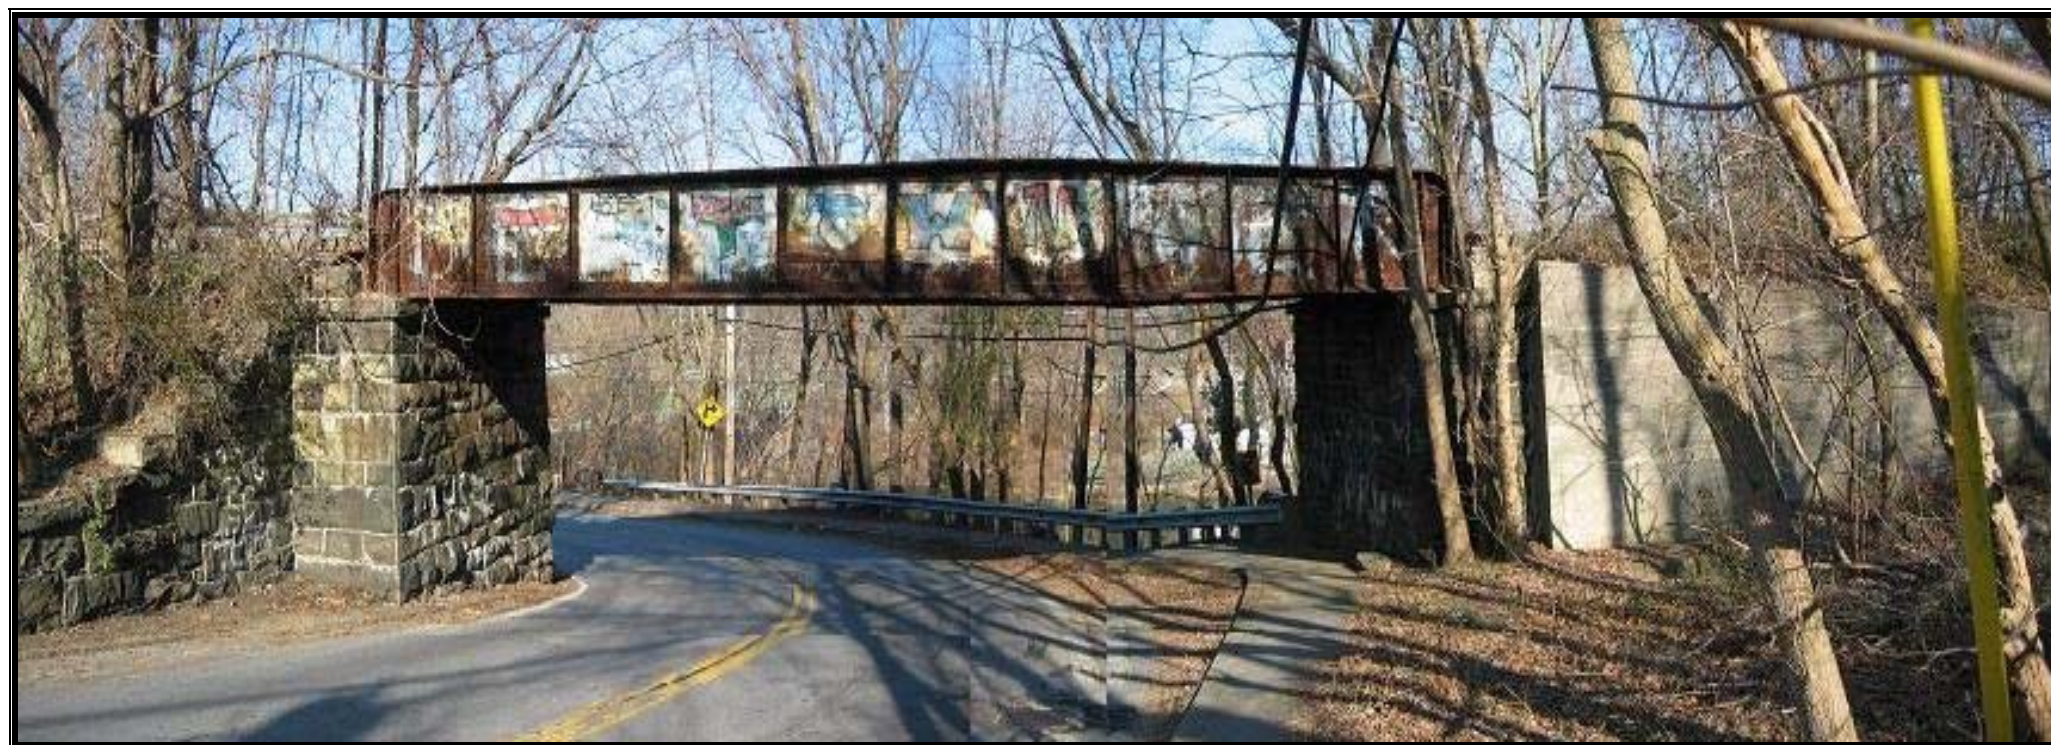
A cursory inspection was performed on December 17th 2004 of a single span steel railroad bridge along, the Kentmere Track, over Rising Sun Lane. The span is approximately 47'-0" in length and 18'-6" in width spanning east to west, respectively. The clearance under the bridge is of concern; the approximate existing minimum clearance is 15'-6" (Fig.9.1).

Fig. 9.1- South elevation

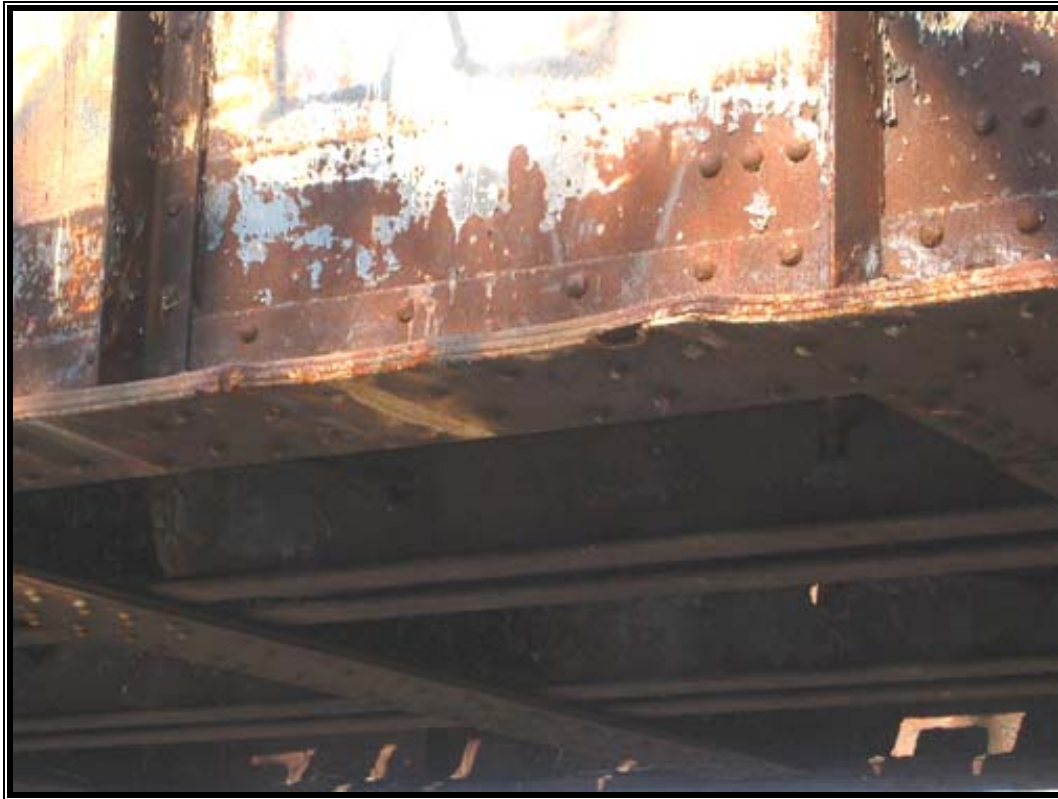
The superstructure is in fair to poor condition. The superstructure consists of simply supported steel girders on concrete and stone abutments. The girders seem to be in fair shape despite damage from vehicles and heavy rust. Vehicle damage is located on the south face of the exterior beam in the northbound lane (Fig. 9.2). The heavy rust is evident throughout the structure from the parapet to the beams and diaphragms (Fig. 9.3). There is flaking of what resembles lead based paint on all the steel components of the bridge. The deck is made from timbers approximately 0'-7" square. These timbers are rotted with vegetation growing within. In addition, there is a large amount of debris on the superstructure (Fig. 9.4).

Fig. 9.2- Evidence of vehicular damage on south exterior girder

If this corridor progresses into a Planning Study then the following recommendations are: evaluate and make necessary repairs to the abutments; the east wing walls will need extensive work if not replacement; the superstructure steel will need proper removal of potential lead paint chips and a proper determination of the condition of the steel; the deck requires complete replacement; additionally, it is necessary to conduct a comprehensive inspection to provide a more accurate condition and to determine the capacity to support the vehicular load of an emergency vehicle.

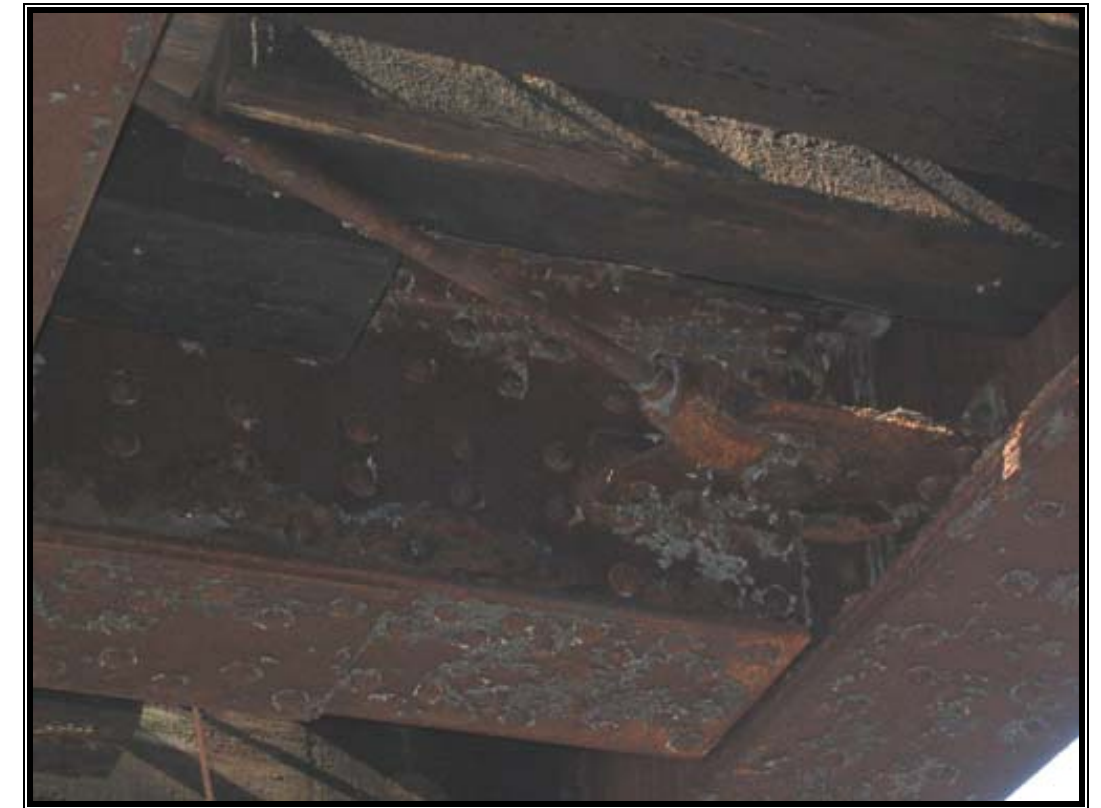
Fig. 9.3- Typical rust and paint flaking at strut and exterior beam

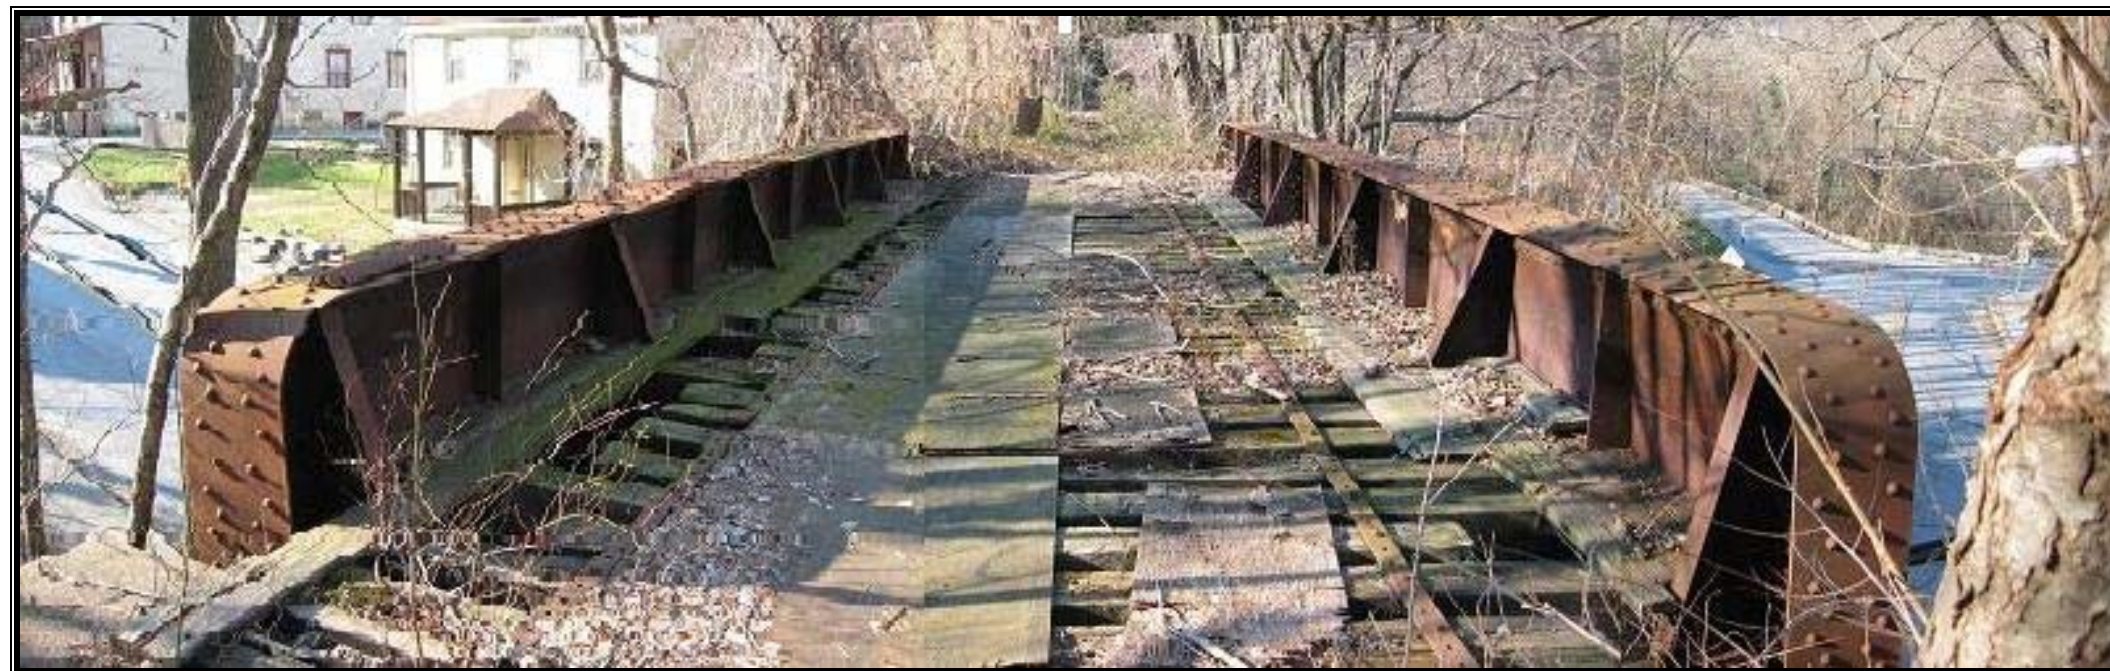
Fig. 9.4- View of superstructure from east

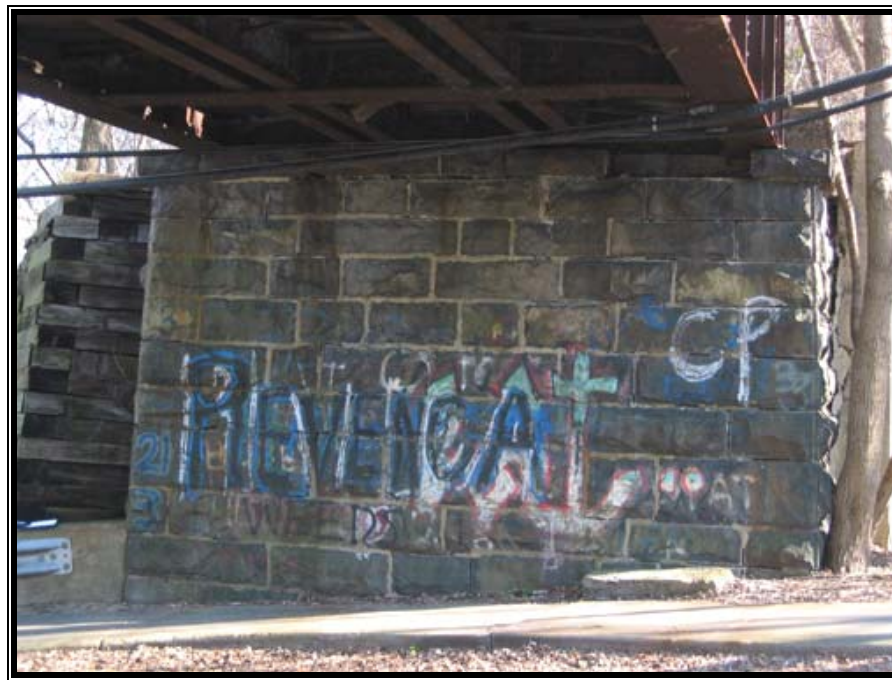
The abutments are in poor condition. The abutments are primarily made of large stone (Fig. 9.5 & 9.6). The stone appears to be in good condition; however the joinery of the stone is in poor condition. Many joints are non-existent, or have been repaired and again are compromised (Fig. 9.7). The abutment seat is cast in place concrete that has severe cracking. This raises a concern of the bearing of the girders on the present bearing seat.

Fig. 9.5- East abutment

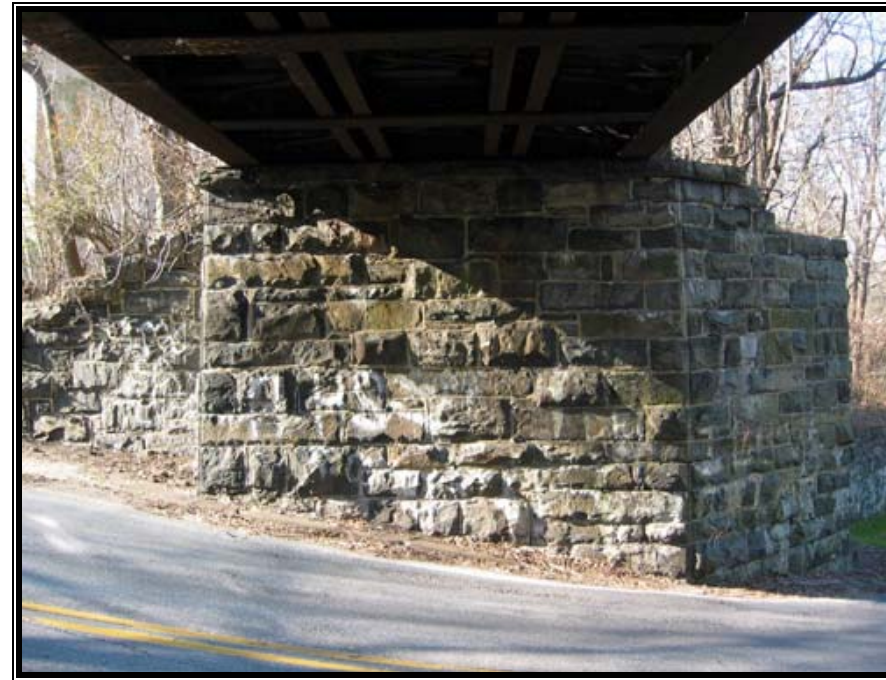
Fig. 9.6- West abutment

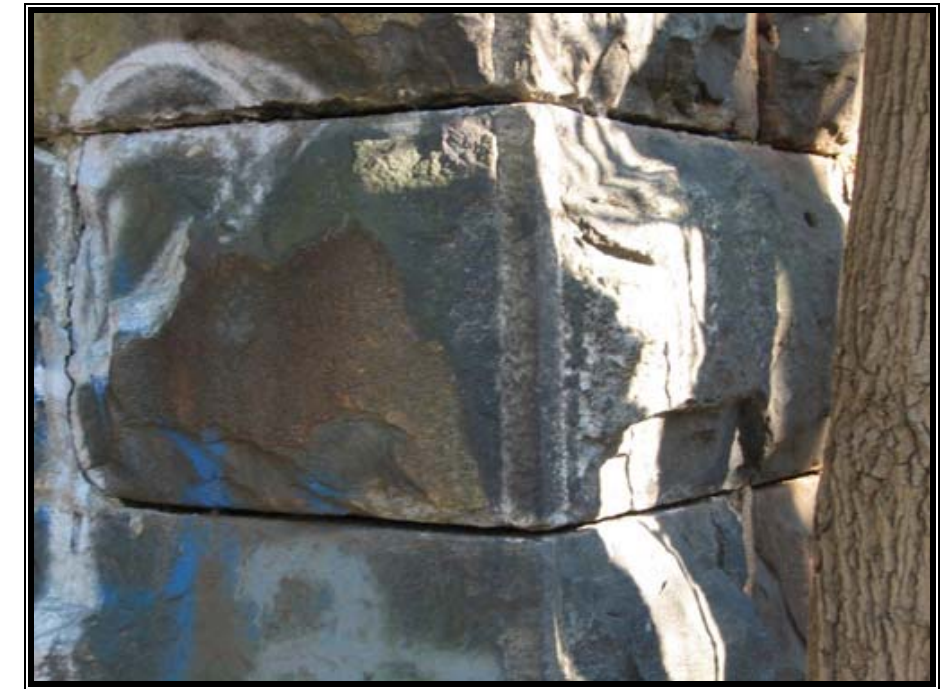
Fig. 9.7- Typical mortar joint damage

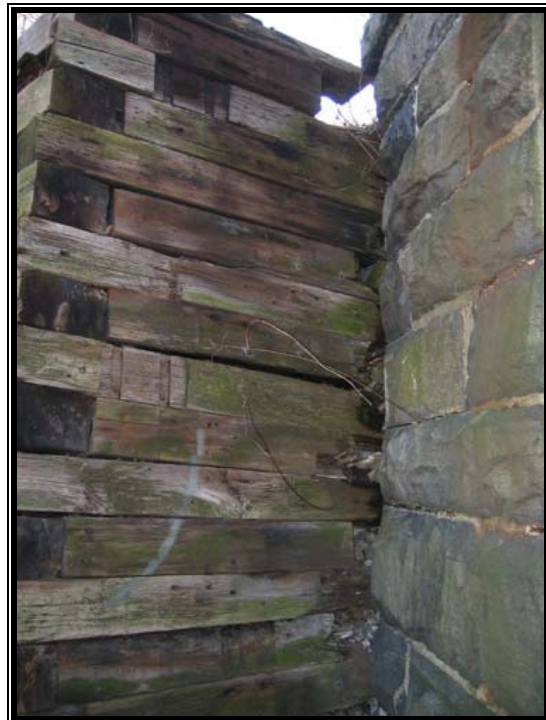
The wing walls on the East abutment are in poor condition. The north wing wall on the east abutment is made of heavy timber (Fig. 9.8). The timbers are severely rotted (Fig. 9.9) along with vegetation growing within. The South wing wall on the east abutment appears to have been replaced, due to the wing wall being constructed of cast in place concrete (Fig. 9.10) rather than heavy timber or stone. Repaired concrete at the joint of this wing wall and the east abutment is now failing (Fig. 9.11). The wing walls on the west side are made of the same large stone as the abutment and show signs of the same types deterioration. The bearings for this bridge were not visible and condition is unknown.

Fig. 9.8- North wing wall at east abutment

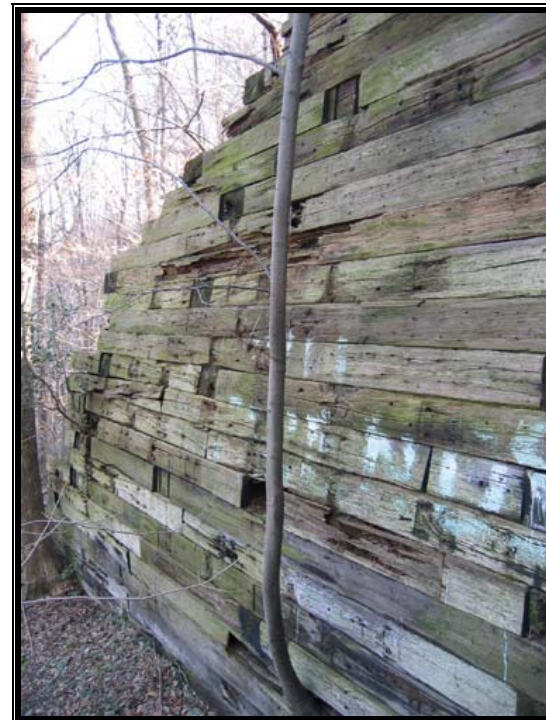
Fig. 9.9- Bowed north wing wall

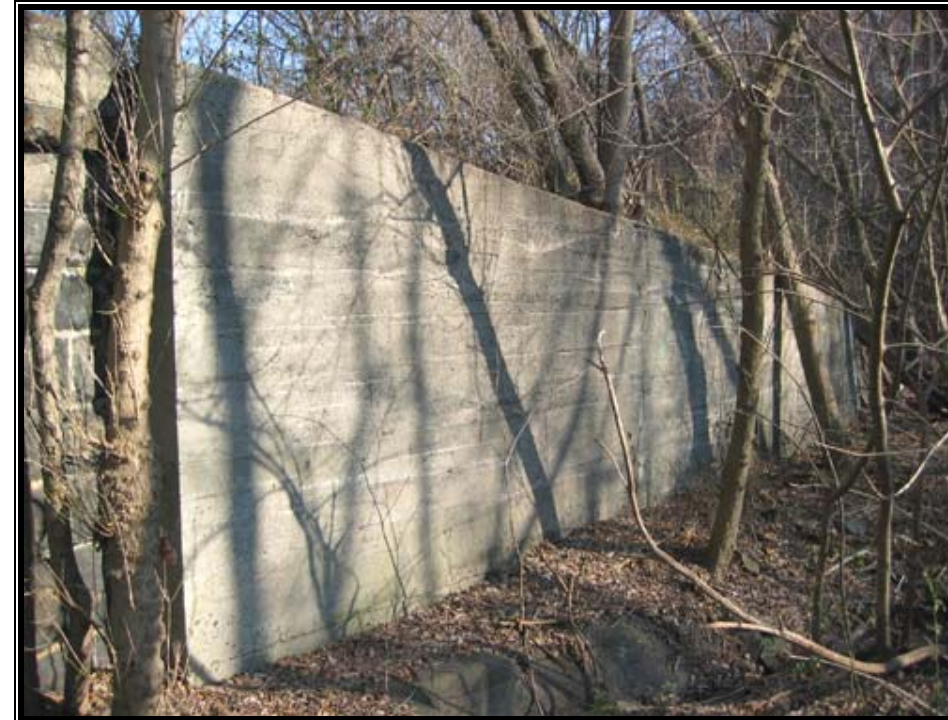
Fig. 9.10- South wing wall

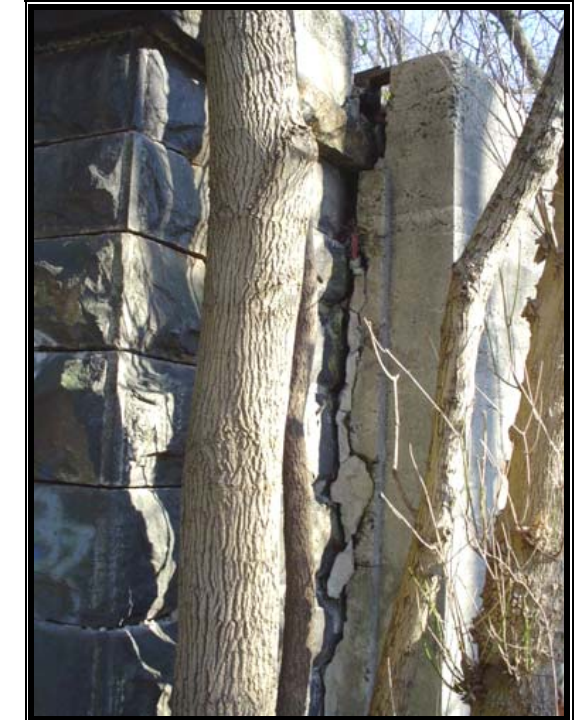
Fig. 9.11- Compromised repair at south wing wall - east abutment

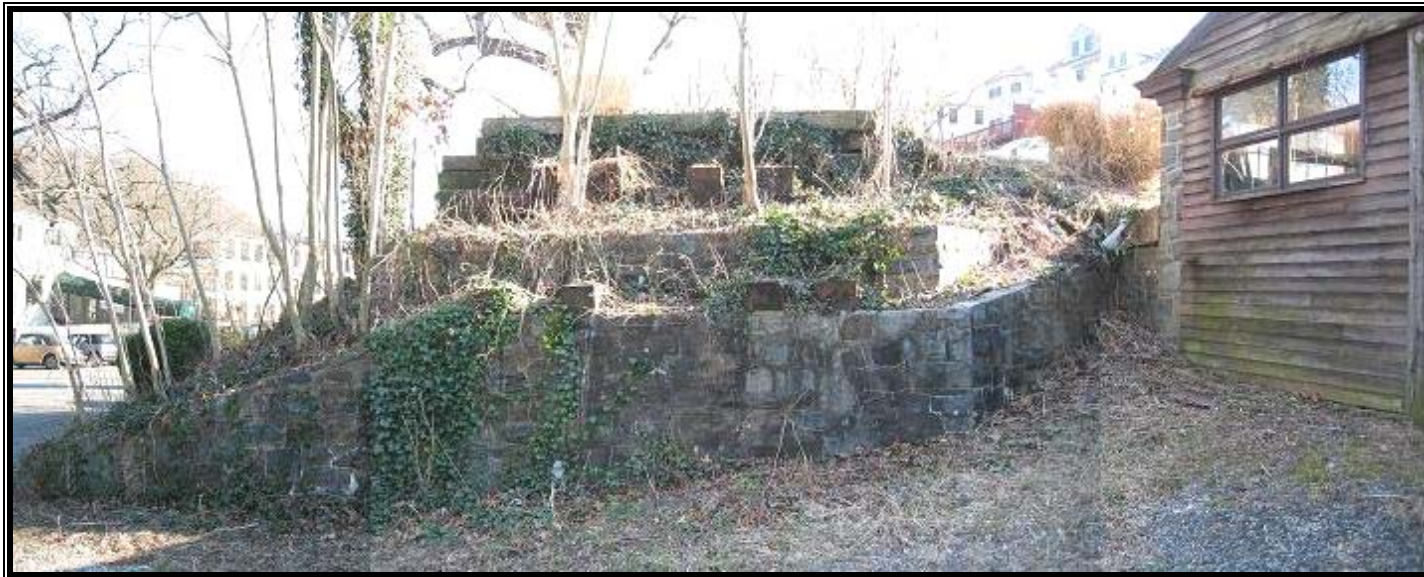
The abutments are in fair to poor condition (Fig. 10.1 & 10.2). The widths at the top of the abutments are approximately 8' - 6" ±. Due to neglect, the abutments are in need of repair. The timber wing walls on the east abutment are rotted. The joints of the west abutment are deteriorated and crumbling. However, the stone appears to be in good condition.

Fig. 10.1- East abutment

It is recommended, if this corridor progresses into a Planning Study, to perform a more comprehensive bridge inspection to more accurately assess the condition of mortar joints, stone, and load capacity. Additionally, in many locations the stone will have to be re-pointed and set to ensure proper fixity.

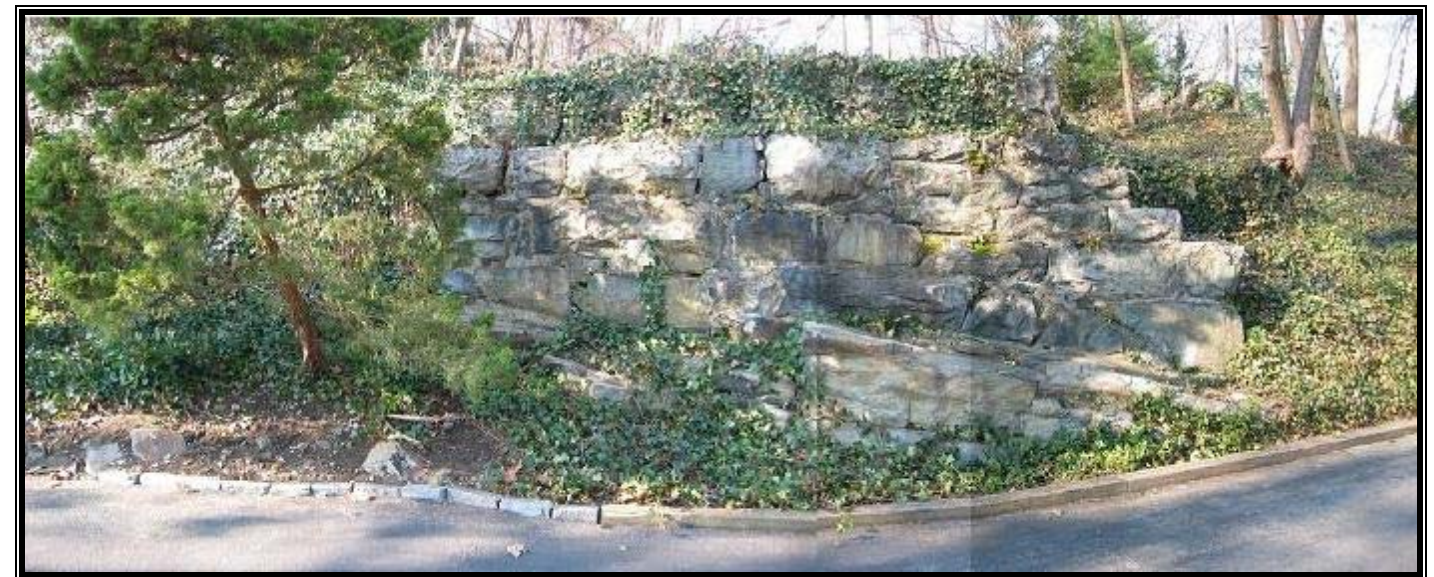
Fig. 10.2- West abutment
