CULTURAL RESOURCE SURVEY
SURVEY UPDATE FORM

CRS # K-02747

1. **HISTORIC NAME/FUNCTION:** Godwin Farm/Jones Agricultural Complex
2. **ADDRESS/LOCATION:** South side of Barratts Chapel Road/2,500 ft east of McGinnis Pond Road
3. **CURRENT CONDITION:** excellent good fair poor demolished
4. **INTEGRITY:** Many of the farmhouse windows are broken or missing, the brick chimney is gone, and only one of four outbuildings remains intact (but in poor condition).
-
5. **SETTING INTEGRITY:** All buildings are vacant. The property appears to have had recent agricultural activity in the surrounding fields. The property is to be cleared and the buildings demolished for a proposed subdivision.

Organization: Skelly and Loy, Inc. **Date:** 1/2008

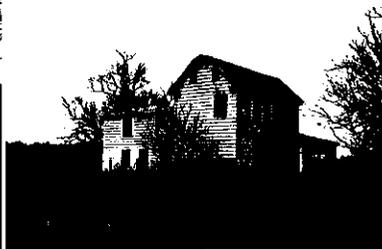
DX-24.JPG

a. Facade: Direction: North
1) Bays 3
2) Windows 5 (some broken)
fenestration Regular
type 1/1 wood sash
trim Simple wood surrounds
shutters 0

C-4867:23 Outbuilding (.002), N and W elevations, facing SE; C-4867:24 Farmhouse (.001), E and N (front) elevations, facing SW; C-4867:25 Farmhouse (.001) and outbuilding (.002), W and S elevations, facing N; C-4867:26 Outbuilding (.003), E and N elevations, facing SW; C-4867:27 Farmhouse (.001), N (front) and W elevations, facing SE
