CULTURAL RESOURCE SURVEY  
 PROPERTY IDENTIFICATION FORM

1. HISTORIC NAME/FUNCTION: Hearn & Rawlins Mill
2. ADDRESS/LOCATION: North of Seaford/west of 13A and Road 544 interseciton
3. TOWN/NEAREST NAMED PLACE: Seaford vicinity?
4. MAIN TYPE OF RESOURCE:

building	<input checked="" type="checkbox"/>	structure	<input type="checkbox"/>	site	<input type="checkbox"/>	object	<input type="checkbox"/>
landscape	<input type="checkbox"/>	district	<input type="checkbox"/>				
5. MAIN FUNCTION OF PROPERTY: water powered grist mill
6. PROJECT TITLE/ REASON FOR SURVEY (if applicable):  
T201207603, Hearn's Pond Dam Improvement - joint DNREC and DeIDOT project

CULTURAL RESOURCE SURVEY  
MAIN BUILDING FORM

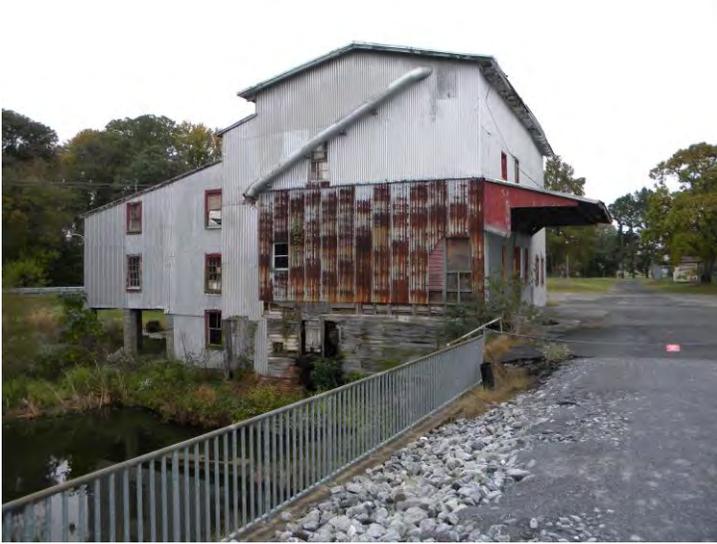
1: looking south: notice rusted ghost section

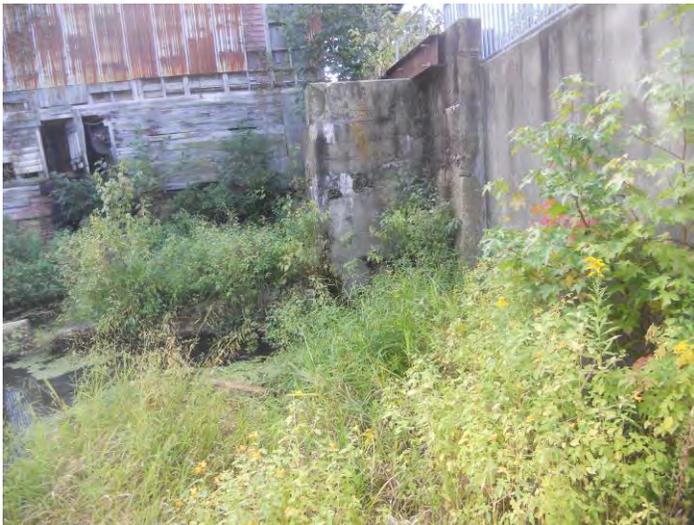
3: looking south at missing wheel section and sluice

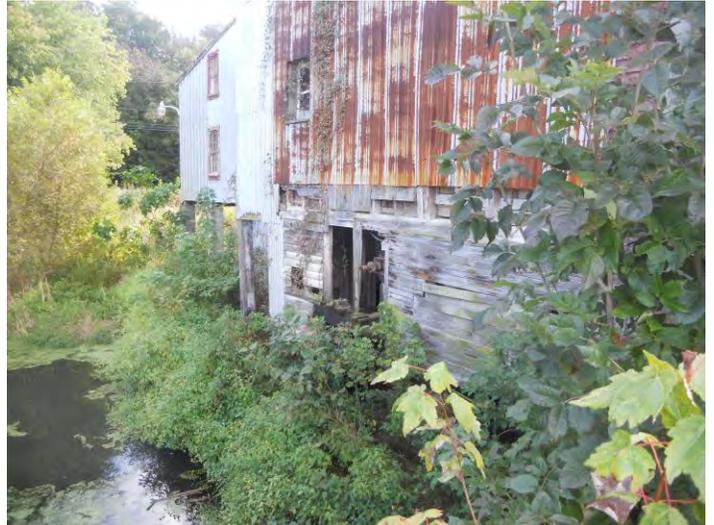
At the time of this survey, the sections of the earthen dam, spillway culvert, and mill building sections had been altered, washed away, damaged, or reconstructed to repair damage cause by storms in 2001 and 2006. An additional auxiliary overflow and boat ramp had also been added to the earthen dam in 2012. The same storms washed away a section of the water wheel house, which housed sections of the milling apparatus and water powered wheels, the pipe sluice (which was reset), and tail race. The mill building hosts an attached office/storage building on the south end and large rear addition resting on concrete block piles. The complex includes the barn/stable (.003) and granary/vehicle shed (.004). Additional research has established that the Marcellus Hearn House (S06138/S00213.005) was built at the time of the mill reconstruction and was home to the owners and operators of mill throughout the late 19<sup>th</sup> and 20<sup>th</sup> centuries. The mill as an operation is no longer functioning and without reproductions and replacements, it is likely beyond repair to operate as a working mill.

4: looking south at washout area

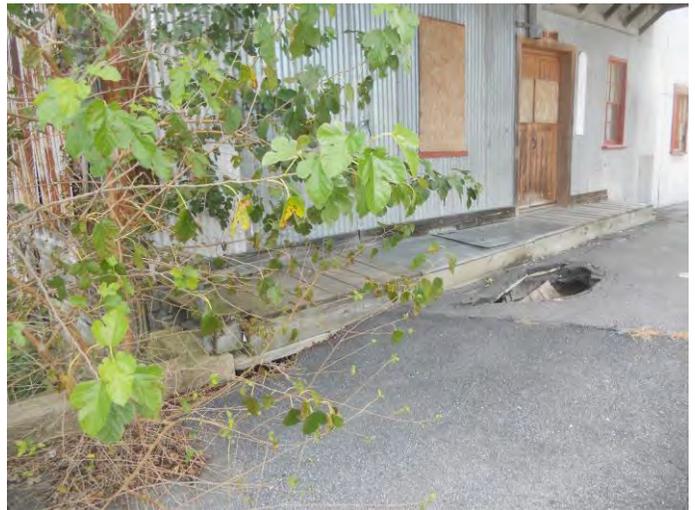
6. façade/entrance and sluice with undermining

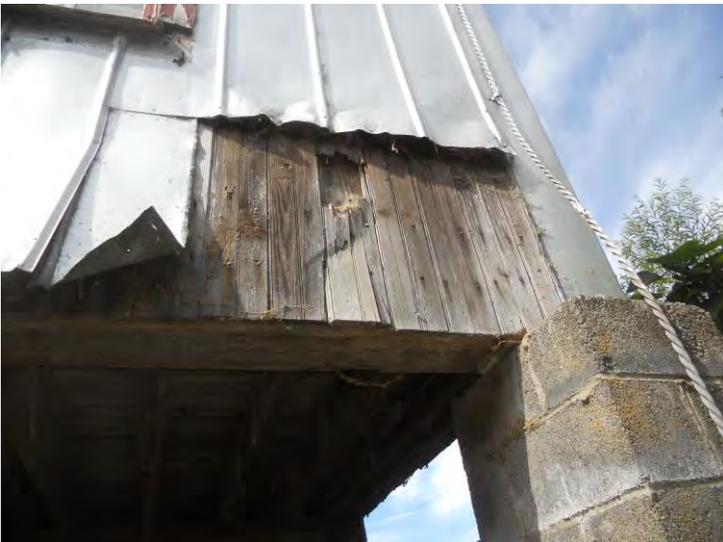
11. sheathing layers and modern block for piles

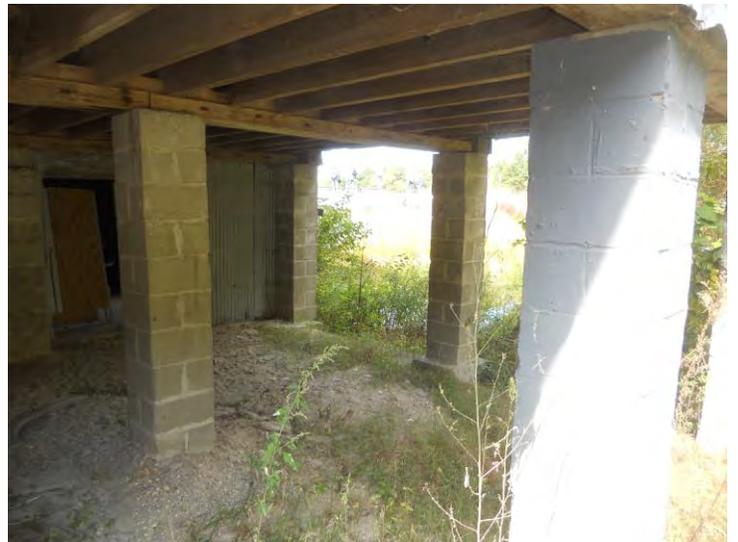
a. In 1912 two metal overshot wheels and a new dam were installed. The Monarch Mill was re-set on three pairs of steel rollers (circa 1930) with electric motor(s) added in a time series for backup power and regular use. Foundation replacements (at rear circa 2001). Most windows boarded.

12. detail on rear block piles and floorboards

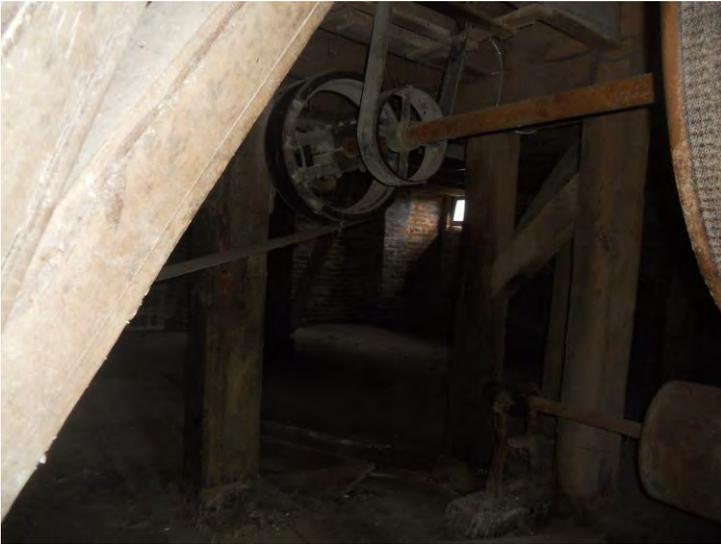
9. **INTERIOR:** wood frame; most of the milling equipment seems evident but not in working order.

13. on ground floor (gears and belts evident)

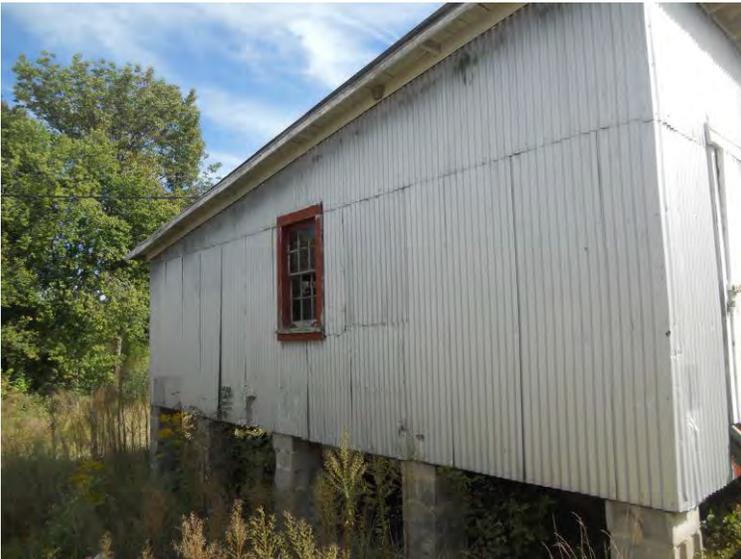
list major alterations and additions with years (if known) year  
a. metal sidings; foundation resting on concrete or new brick piles; floorboards ??  
b.

15. secondary buld (.002) west side on modern piles

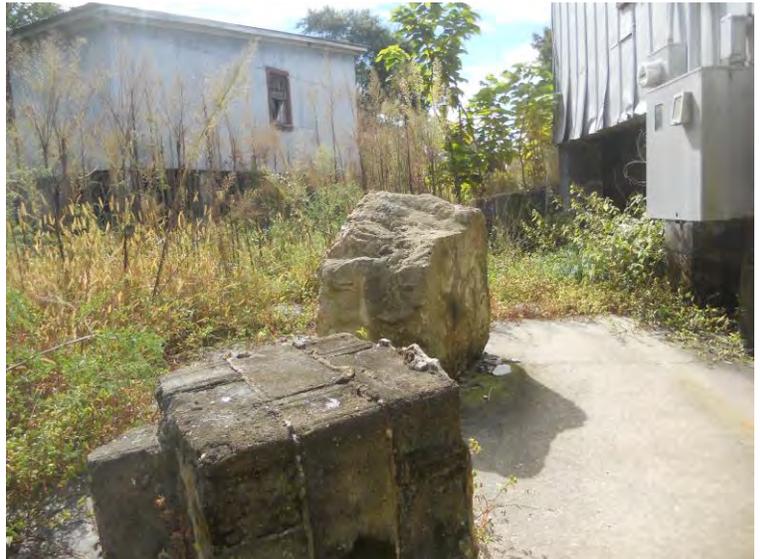
16. abandoned piles in ruins

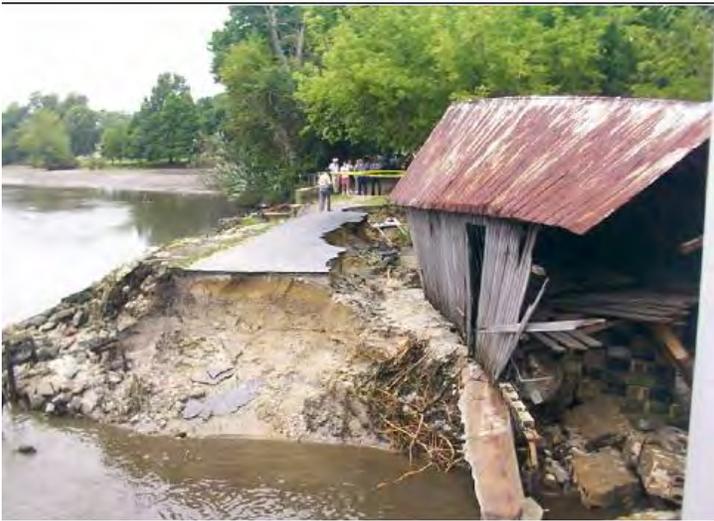
21. 2001 damage looking north – note corn crib

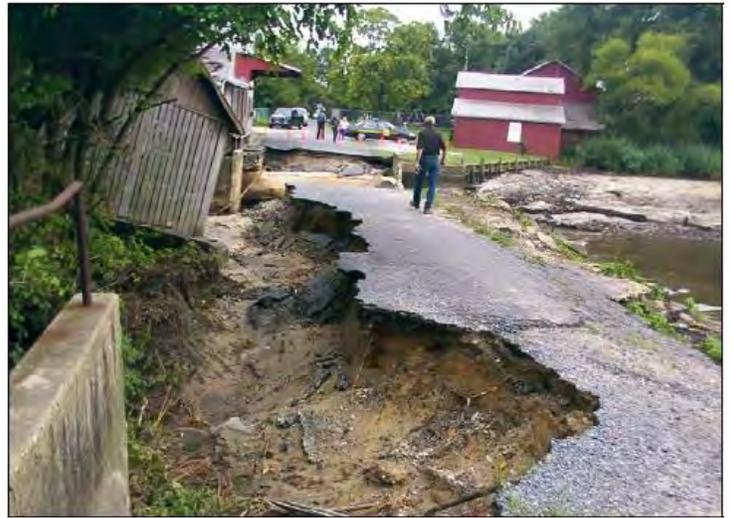
22. 2001 dam/road damage looking south

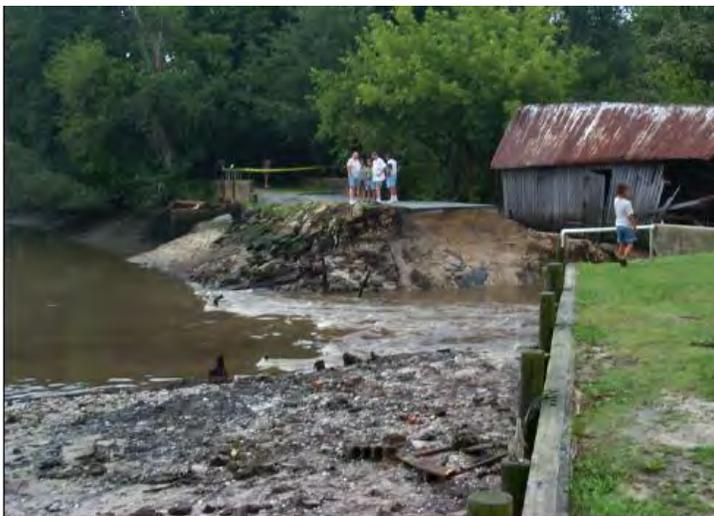
23. 2001 spillway damage blowout

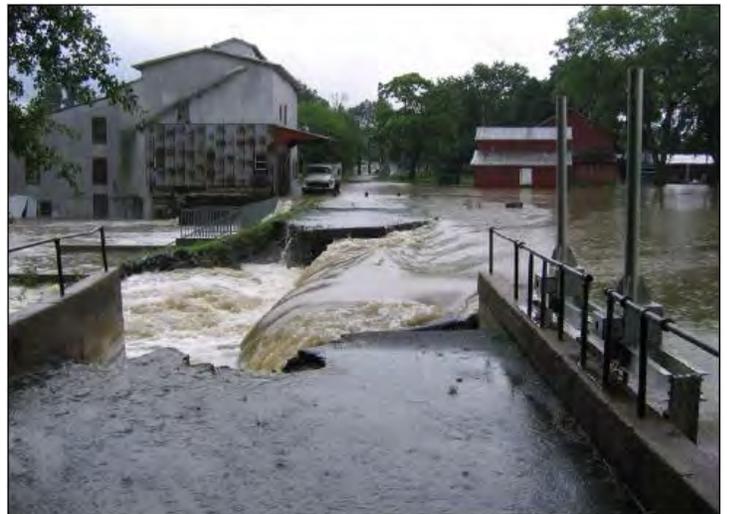
24. 2006 spillway damage (again) from culvert view

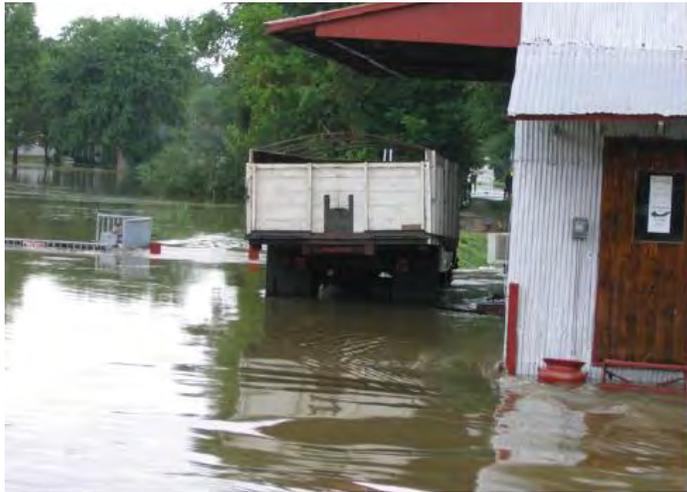
25. 2006 floods – damaged building
