Gutherie-Giacomelli House (Tweed's Tavern)
CRS-#N-1101, New Castle County, Delaware

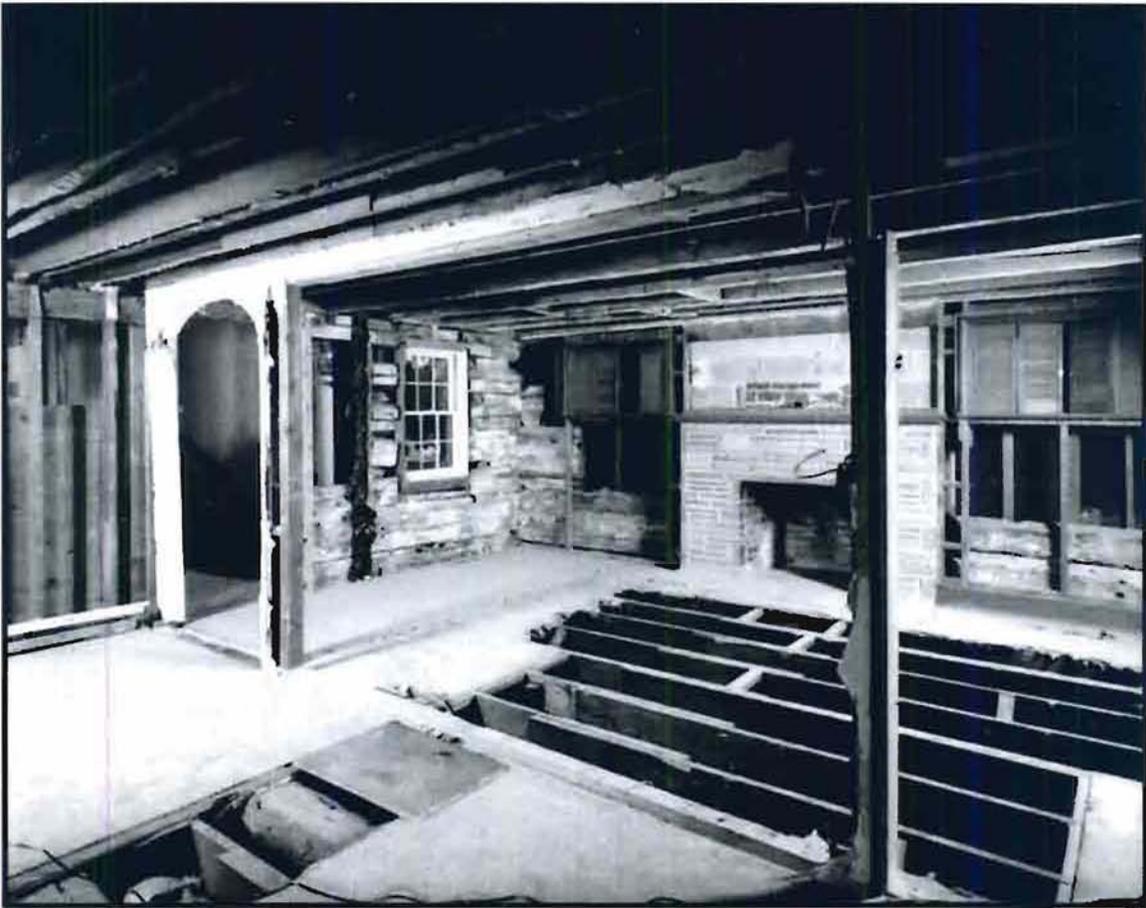
Plate 4.11. View of the interior face of the junction of southern and eastern walls, Room 101. Photograph taken from Room 102 looking through partially demolished 20th-century room partition wall (Photographer: Dawn Turner, December 1999)[HRI Neg.# 99037/31:5].

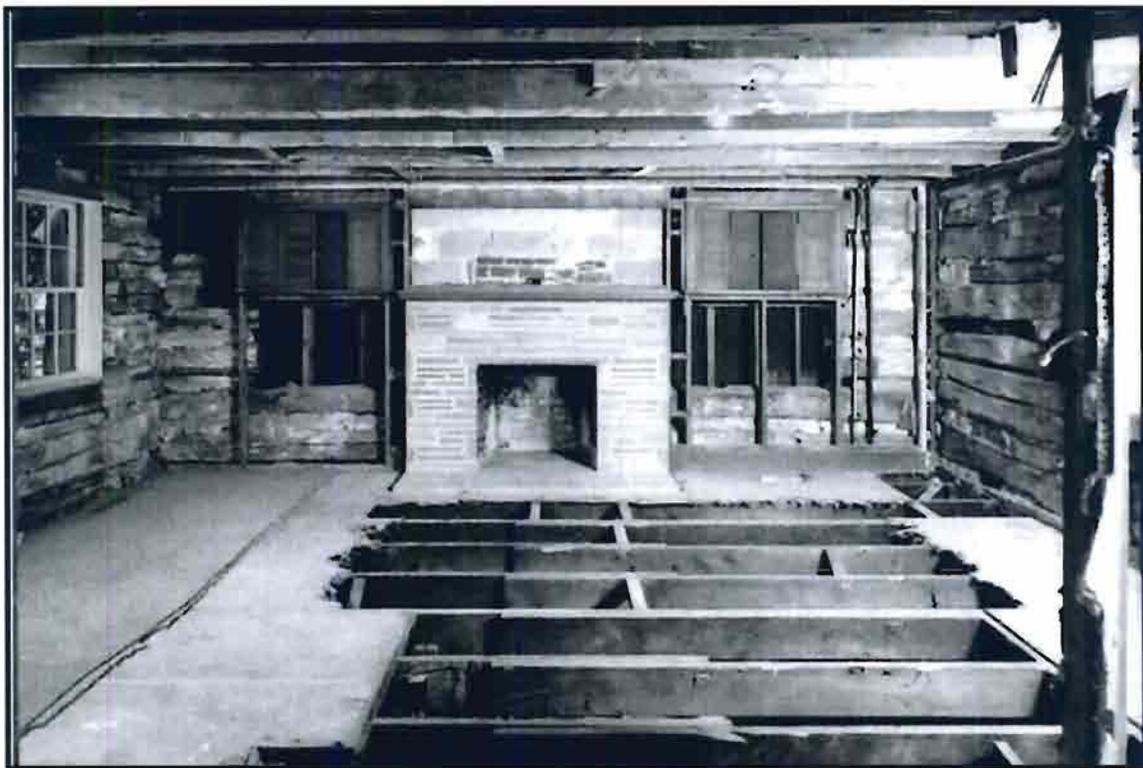
Plate 4.12. Interior of south wall, Room 101. Partially enclosed openings for Windows 101b and 101c flank fireplace. Modern plywood floor removed exposing 20th-century joists (Photographer: Dawn Turner, December 1999)[HRI Neg.# 99037/30:1].

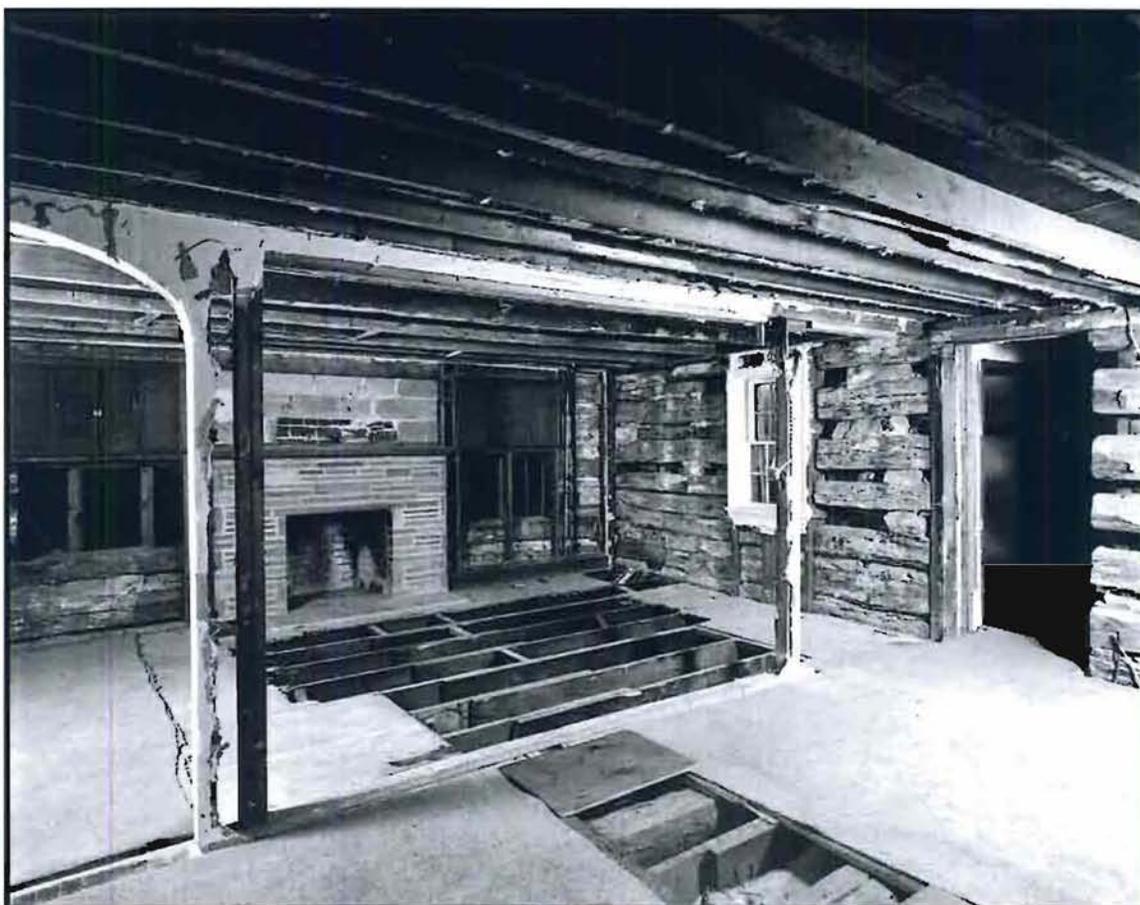
Plate 4.13. View of the interior face of the junction of southern and western walls, Room 101. Photograph taken from Room 102 looking through partially demolished 20th-century room partition wall (Photographer: Dawn Turner, December 1999)[HRI Neg.# 99037/31:9].

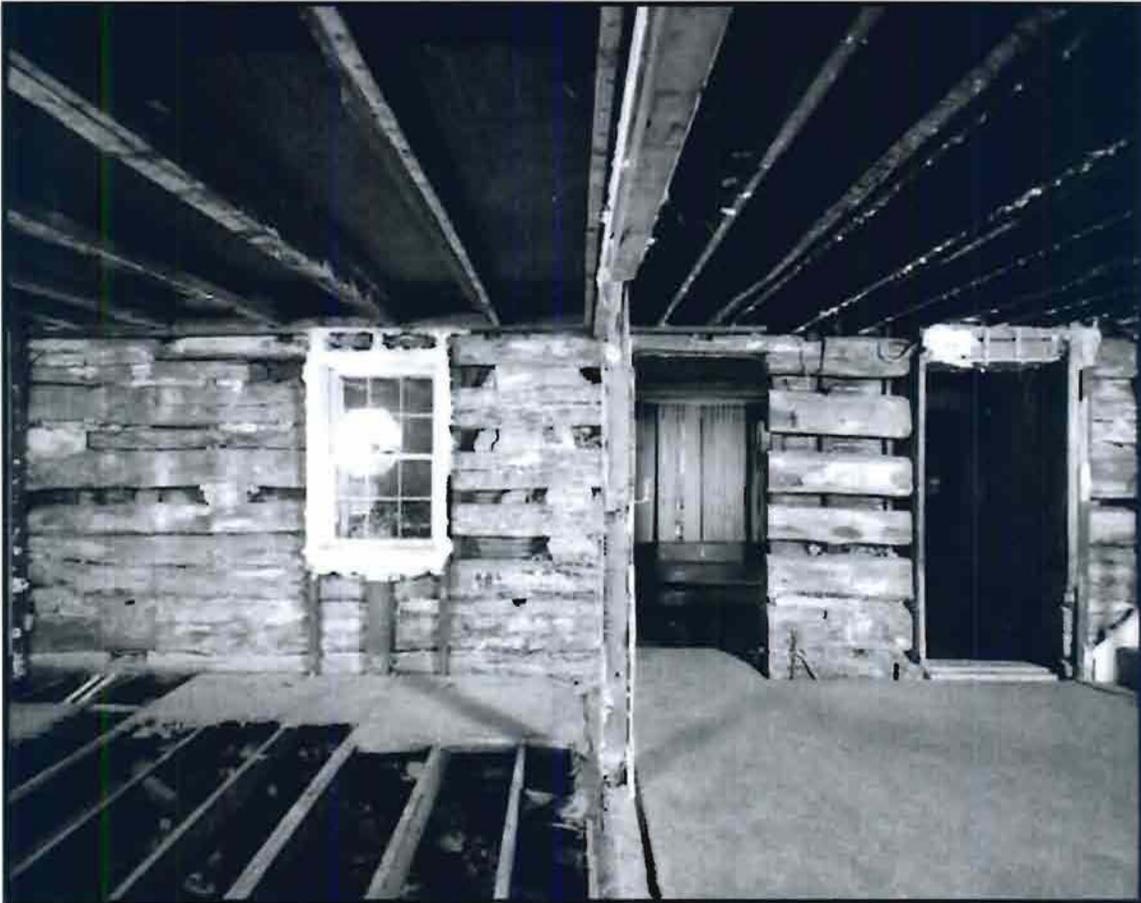
Plate 4.14. Interior of western wall, Rooms 101 and 102. Room 101 at left of view with 20th-century partition in center of view. Photograph shows (from left to right) Window 101b, Door 102b and Window 102a (Photographer: Dawn Turner, December 1999)[HRI Neg.# 99037/30:5].

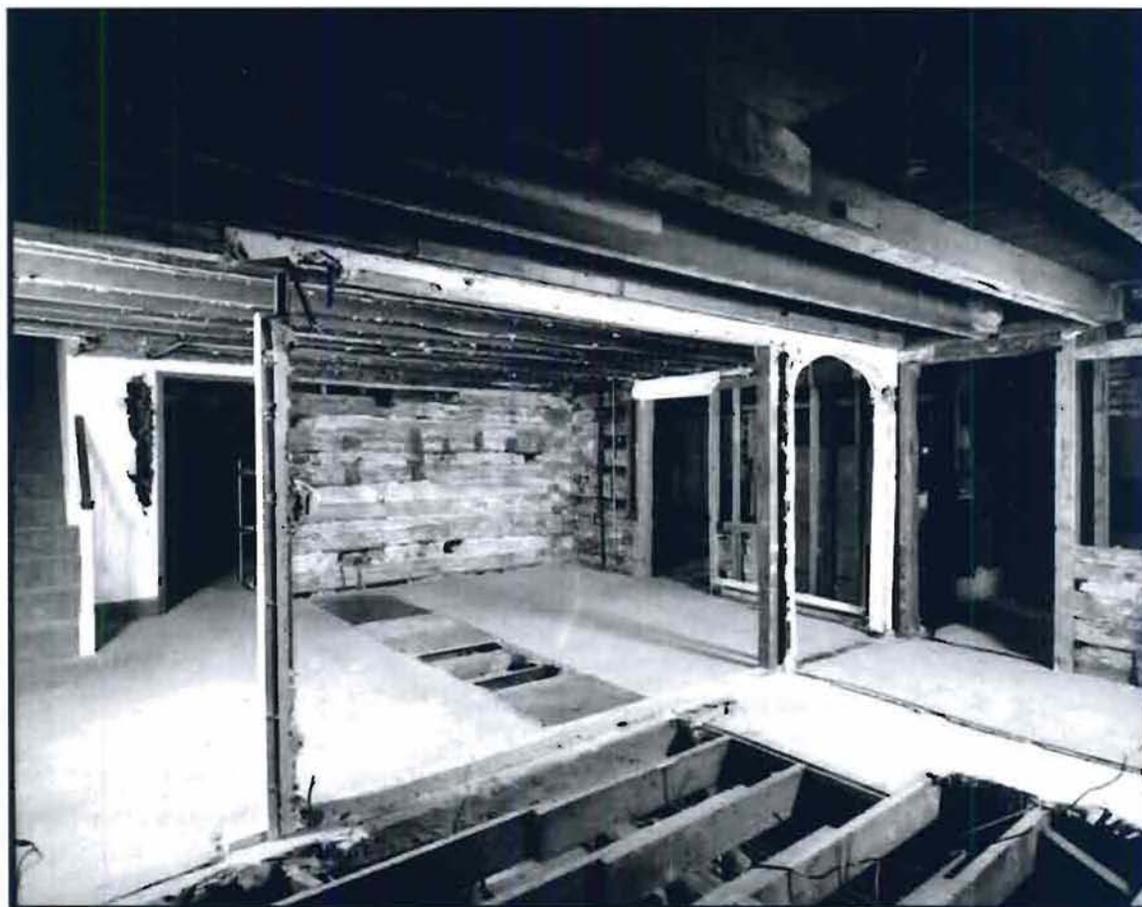
Plate 4.15. View of the interior face of the junction of the northern and eastern walls, Room 102 (Photographer: Dawn Turner, December 1999)[HRI Neg.# 99037/32:8].

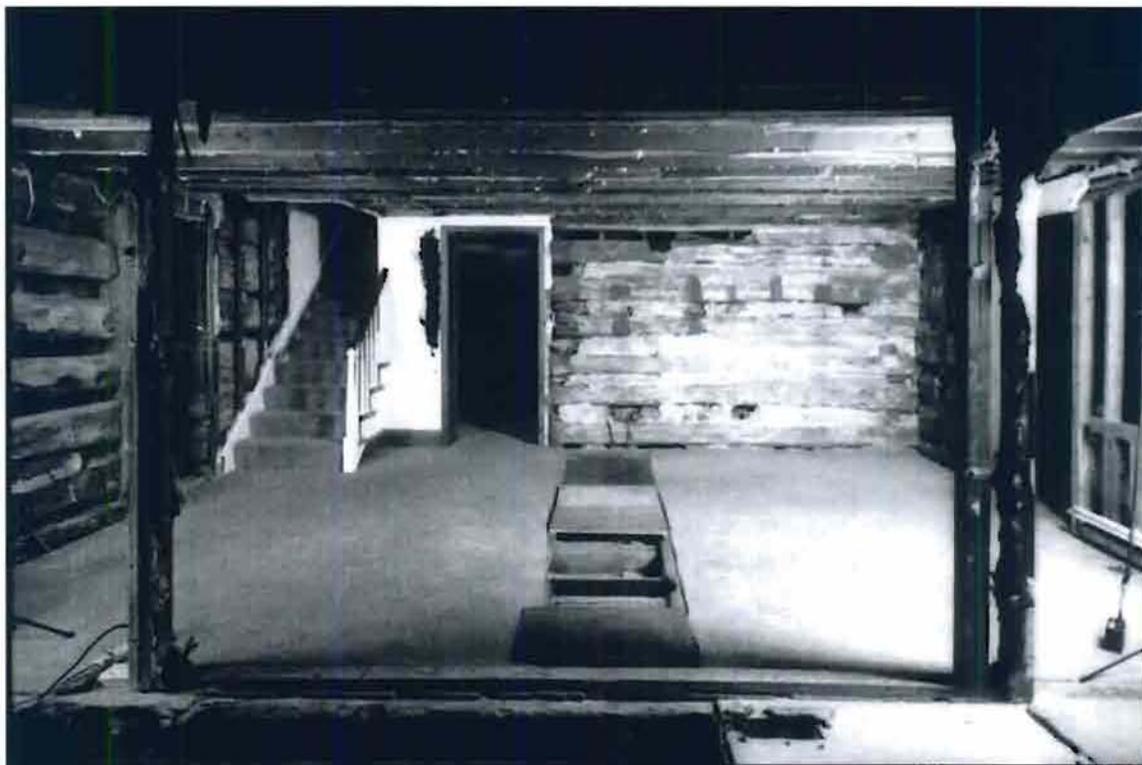
Plate 4.16. Interior face of the northern wall of Room 102. Door 102g visible at left. Niche in log matrix visible right of center. Photograph taken from Room 101 looking through partially demolished 20th-century room partition (Photographer: Dawn Turner, December 1999)[HRI Neg.# 99037/30:12].

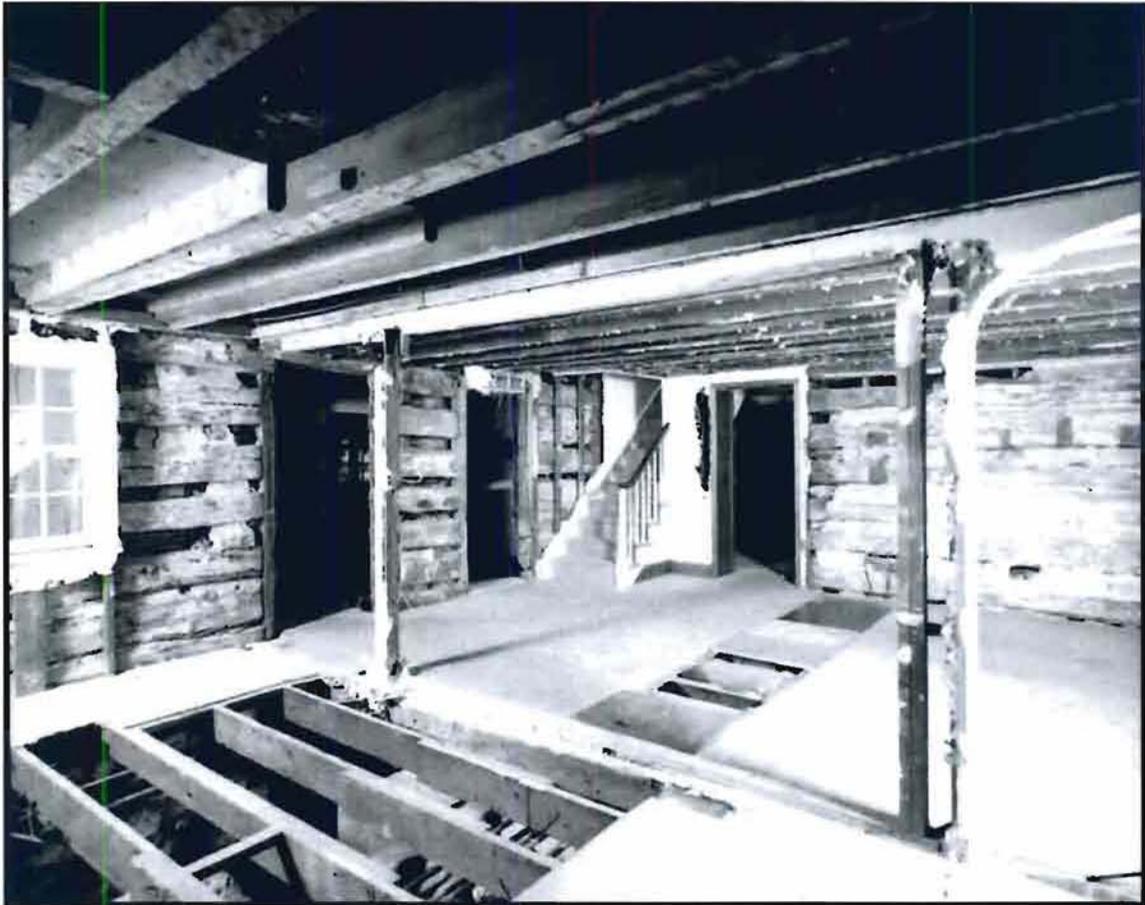
Plate 4.17. View of the interior face of the junction of the western and northern walls, Room 102. Photograph taken from Room 101 looking through partially demolished 20th-century room partition (Photographer: Dawn Turner, December 1999)[HRI Neg.# 99037/32:1].

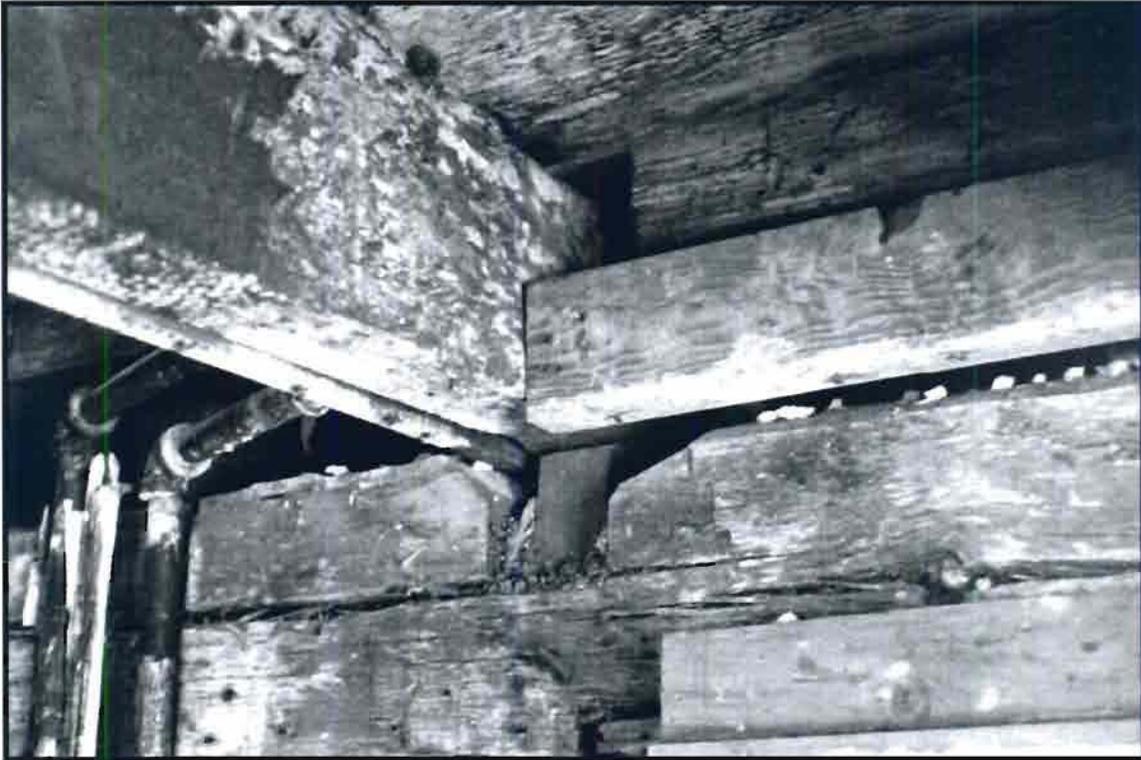
The ceiling of Room 102 consists of modern plaster board hung from the second floor joists. On the east side of the room blocks (Plate 4.18) have been inserted beneath the joists within the joist pockets to raise the height of the first floor ceiling. On the west wall of the room a beam has been inserted in the wall fabric above the log on which the joists formerly rested (and in which the lower half of the original joist pockets had been cut). New lower joist pockets were cut in the top of the inserted beam. Some alterations to joist location and joist spacing were apparently made at the time the floor was raised. The raising of the floor involved the lifting the entire structure of the building above the level of the second floor joists by approximately four inches.

Plate 4.18 View of second floor joist end (east wall) showing evidence of the raising of the first floor ceiling height. Wall above floor joist has been raised to permit the insertion of a block of wood in lower half of joist pocket (Photographer: Dawn Turner, December 1999)[HRI Neg.# 98039/18:1].

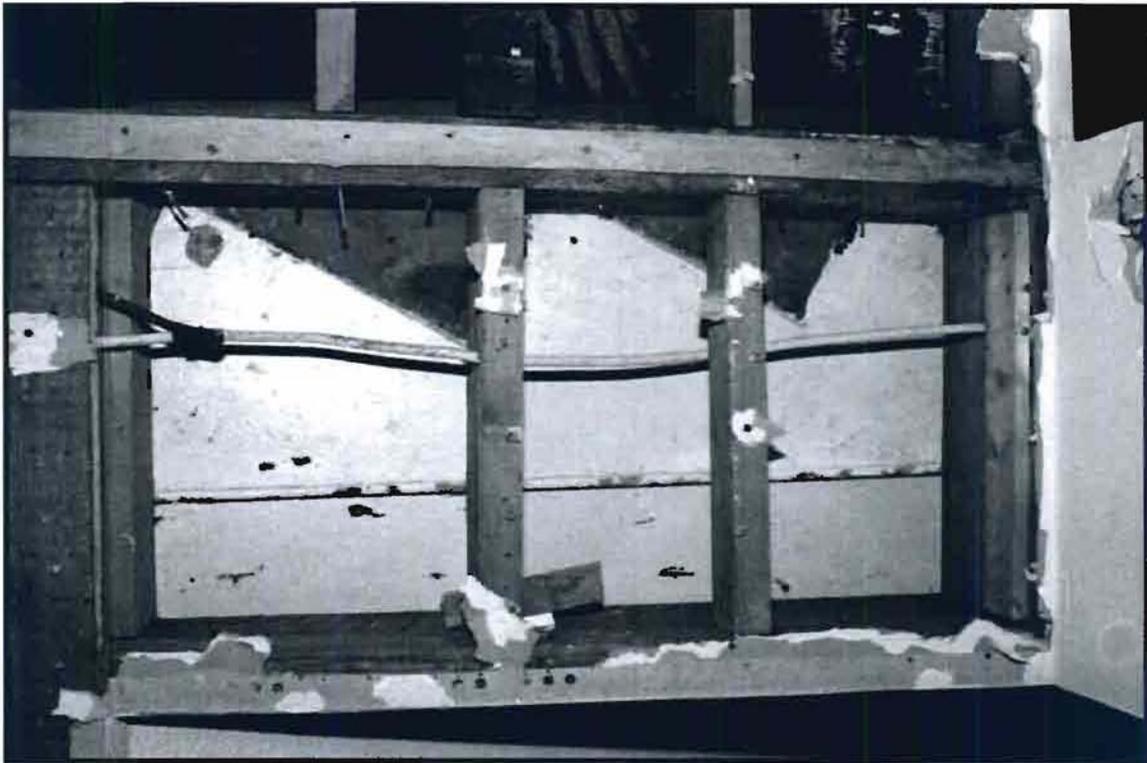
Plate 4.19. View of reused staircase stringer in ceiling above and in front of Door 102g (Photographer: Dawn Turner, December 1999)[HRI Neg.# 98039/18:9].

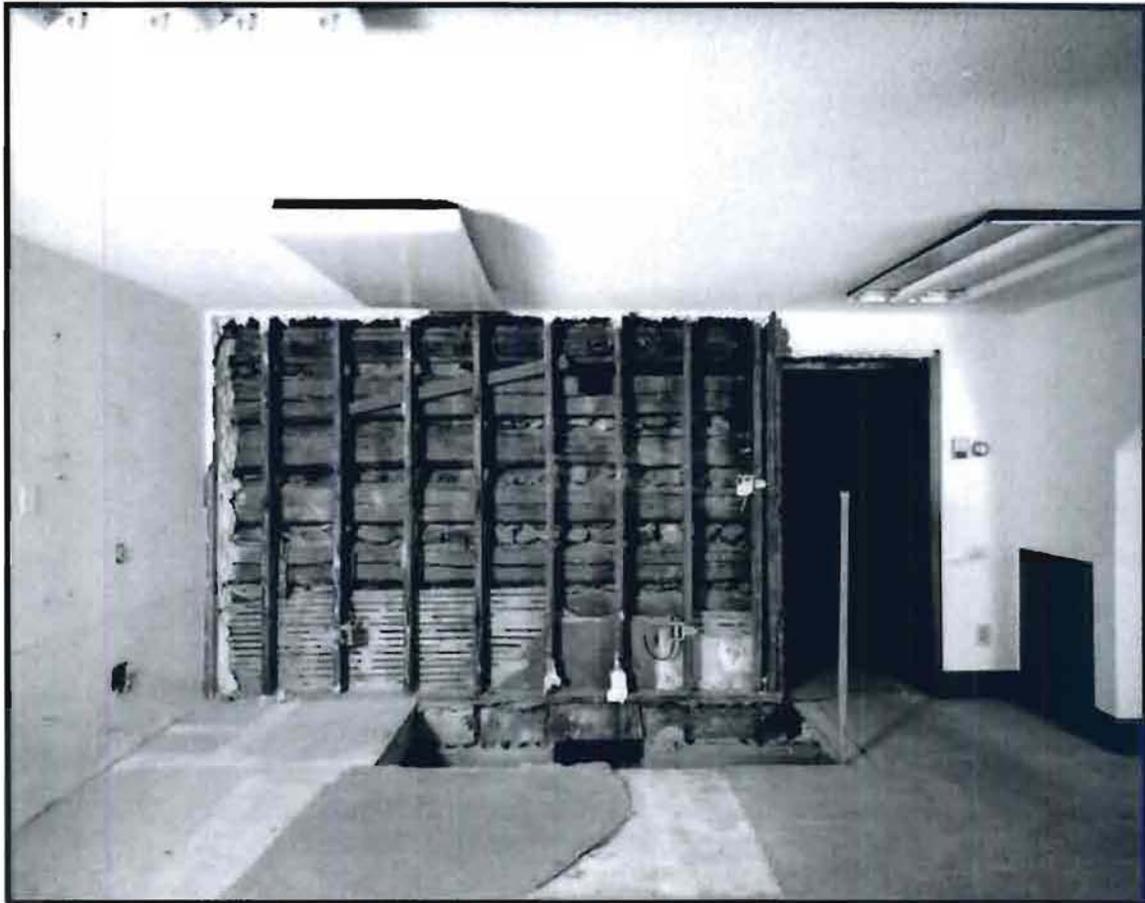
Plate 4.20. Northern face of southern wall of Room 103 showing intact log matrix beneath studs and a previous layer of stucco and lath. Notch visible at top of wall right of center. Hole in floor represents location of Excavation Unit 9 (Photographer: Dawn Turner, December 1999)[HRI Neg.# 99037/33:5].

The southern wall of Room 103 is composed of original log matrix. A notch in the upper portion of the wall near its center is situated directly above the footing described above under Crawl Space B2. This notch was likely associated with the brick chimney that was formerly located on the northern face of this wall within Room 103. The notch may either have been cut to tie the newly constructed chimney into the existing wall matrix or to accommodate passage for a flue pipe serving a heating stove in Room 102. The wall has been faced with plaster over wooden lath which has in turn been covered by plasterboard hung on studs.

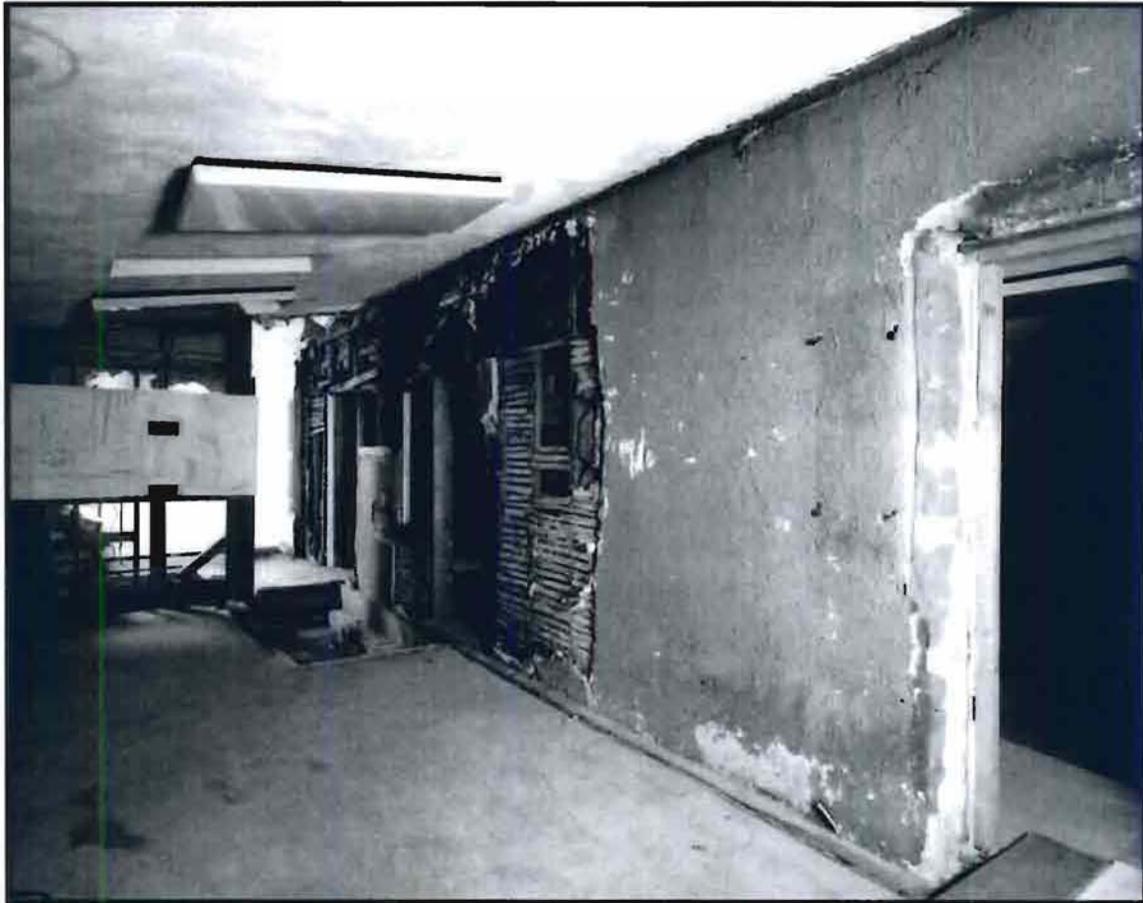
Plate 4.21. View of exposed original exterior wall surface in Room 105. View shows eastern face of western wall. Location of gabled porch roof visible at right. Blank wall to left of door opening at right represents the northern addition of the 1950s. Hole in floor at left was opened to accommodate Excavation Unit 8 (Photographer: Dawn Turner, December 1999)[HRI Neg.# 99037/33:12].

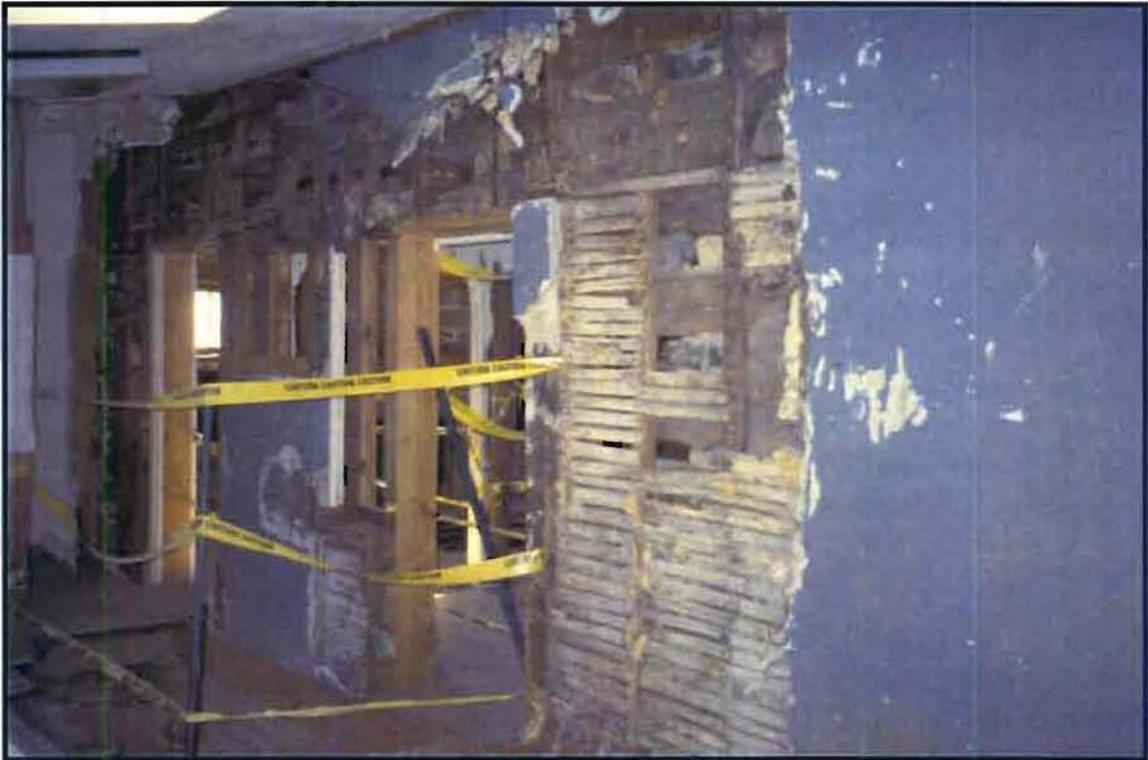
Plate 4.22. View of exposed original exterior wall surface in Room 105. View shows eastern face of western wall. Location of gabled porch roof visible at right (Photographer: Dawn Turner, December 1999)[HRI Neg.# 99037/19:12].

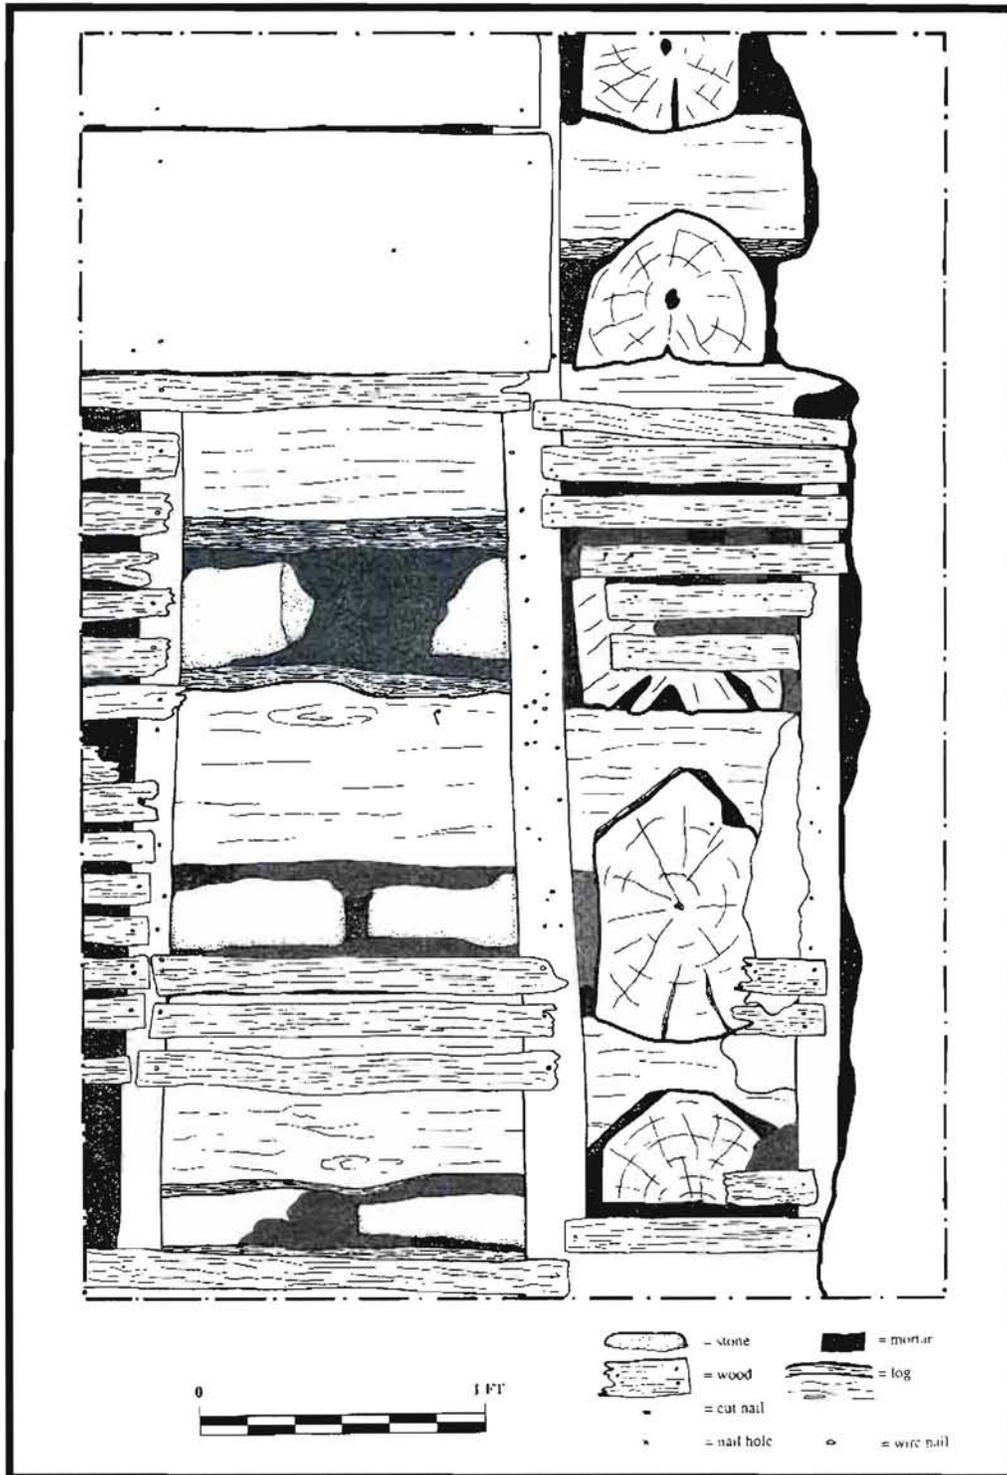
Removal of the stucco coat from the north face of the northeast corner of the building within Room 105 (Plate 4.24) revealed v-notch corner joinery (Figure 4.15 and Plate 4.25). The exterior surface of the logs was found to be covered on the lower levels by stucco over wire mesh over split lath attached to the logs by nailers. Cut nails were observed securing some, but not all, of the lath to the nailers. Wire nails affixed the rest. This fact along with vestigial nail holes suggest that the existing lath represents two separate phases. The stucco over lath treatment extends only part of the way up the wall. Approximately seven feet above the porch floor, the covering changes to stucco over wood plank. This change may represent evidence of the raising of the first floor ceiling.

Figure 4.15. Detail of V-notched Corner Joinery Showing Lath and Vestigial Nail Holes. Illustration documents a small section of the joinery visible on the eastern exterior face of the first floor northeast corner of "Tweed's Tavern". See also Plate 4.25.

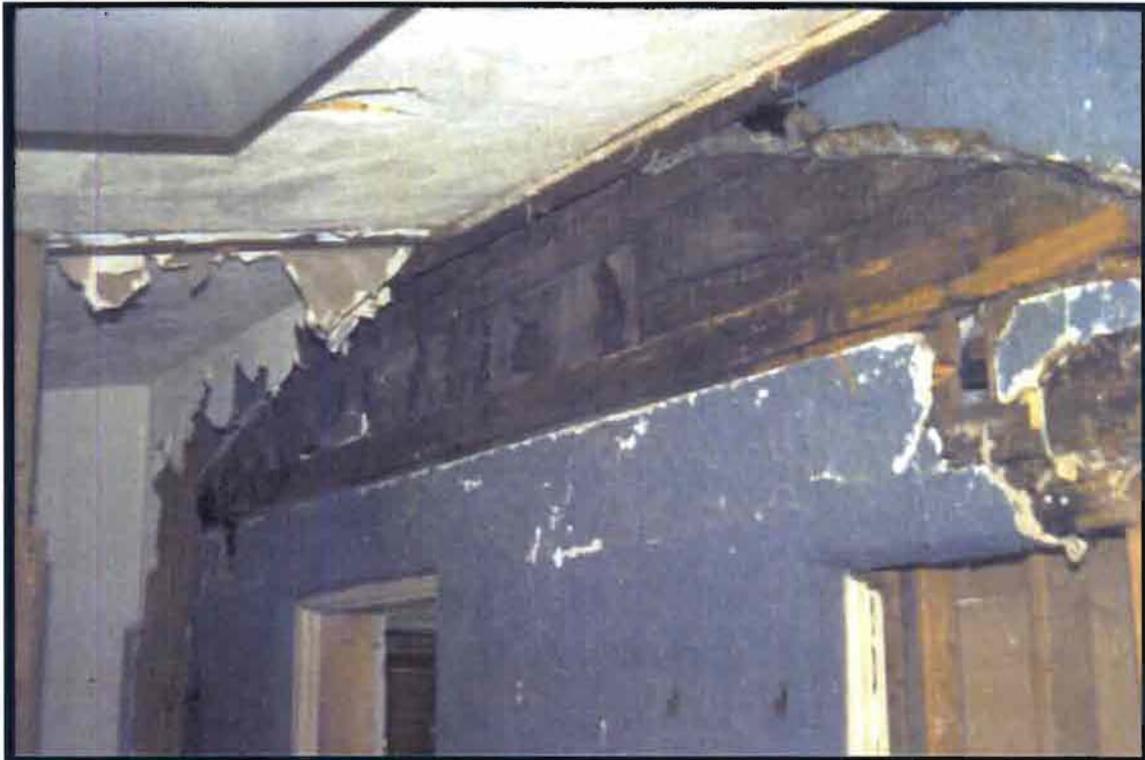
board" paneling revealed the former exterior face of the wall. A scar (Plate 4.23) was observed in the stucco from gabled porch roof that had covered the primary entrance prior to the construction of the enclosed full length porch in 1982. This porch is visible in several historic photographs of the building (Plates 3.1, 3.6, 3.7 and 3.9). Examination of the scar shows that the peak of the porch roof was centered over the space between paired Doors 101f and 102c suggesting that the gabled porch roof was constructed after the addition of the second door and the subdivision of the main tavern space in the 19th century.

Plate 4.23. View of former exterior (eastern) face of west wall of Room 105 showing profile of former gable front porch hood (Photographer: Dawn Turner, December 1999) [HRI Neg.# 98039/8:20].

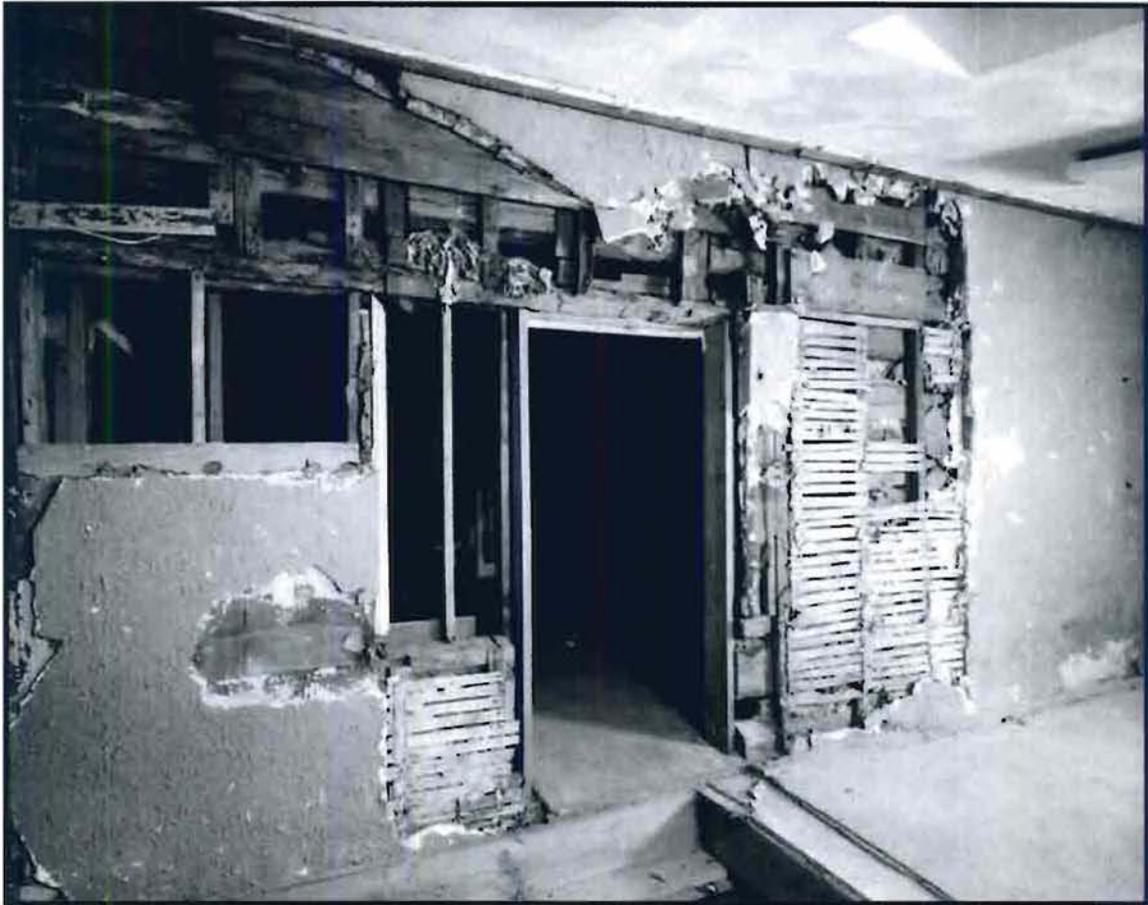
Plate 4.24. View of former exterior (eastern) face of west wall of Room 105 looking north west showing scars from former gable front porch roof (at left) and the former northeast corner of the building (at right) (Photographer: Dawn Turner, December 1999)[HRI Neg.# 99037/34:5].

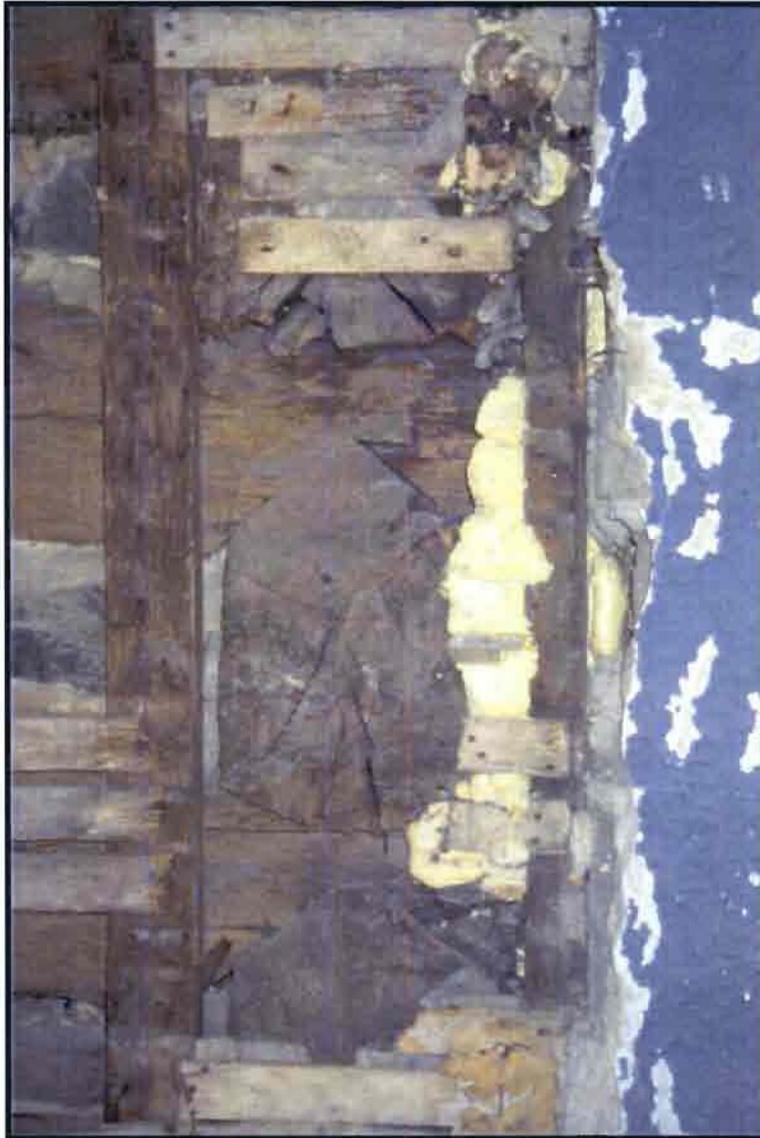
Plate 4.25. View of exposed corner v-notch joinery, west wall of Room 105, former northeast corner of log building (Photographer: Dawn Turner, December 1999)[HRI Neg.# 99037/19:23]. See also Figure 4.15.

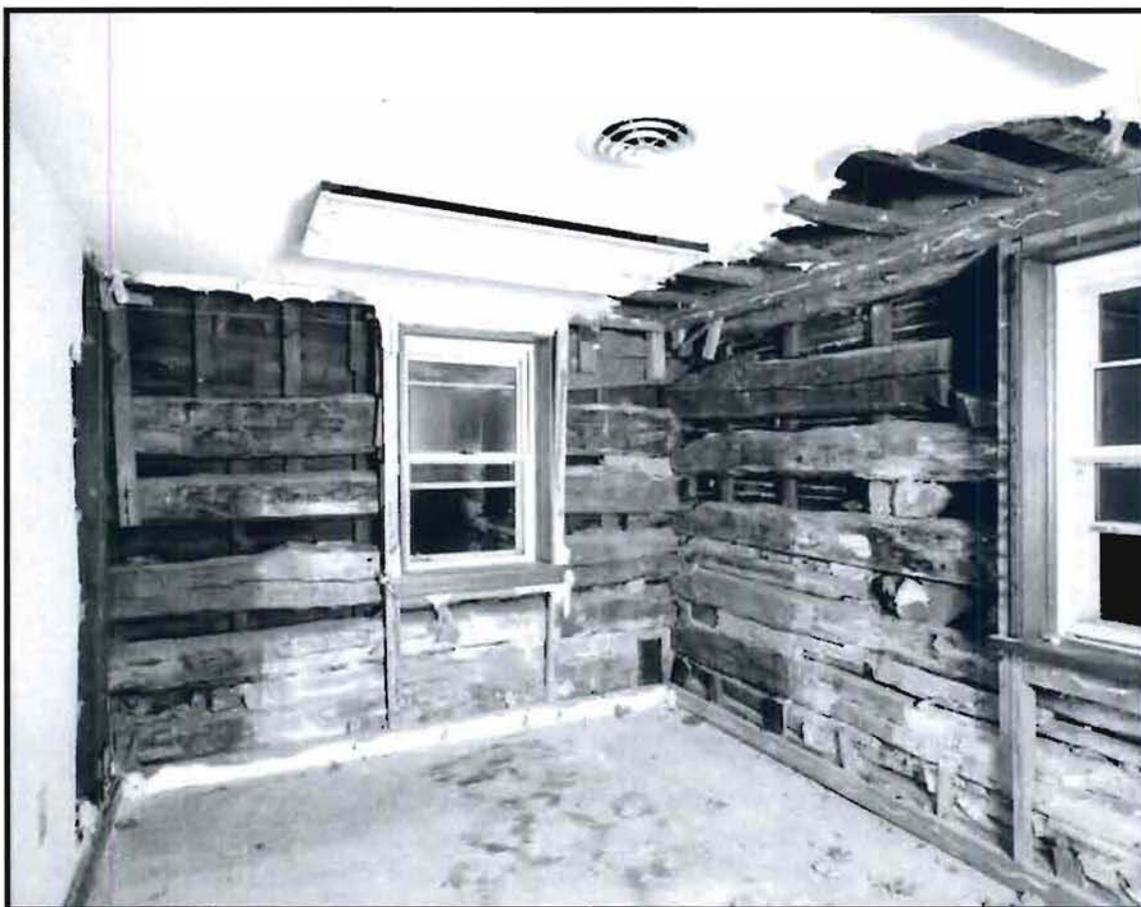
Plate 4.26. View of the junction of the southern and western walls, Room 201. Note absence of chinking at top of wall (Photographer: Dawn Turner, December 1999)[HRI Neg.# 99037/35:8].

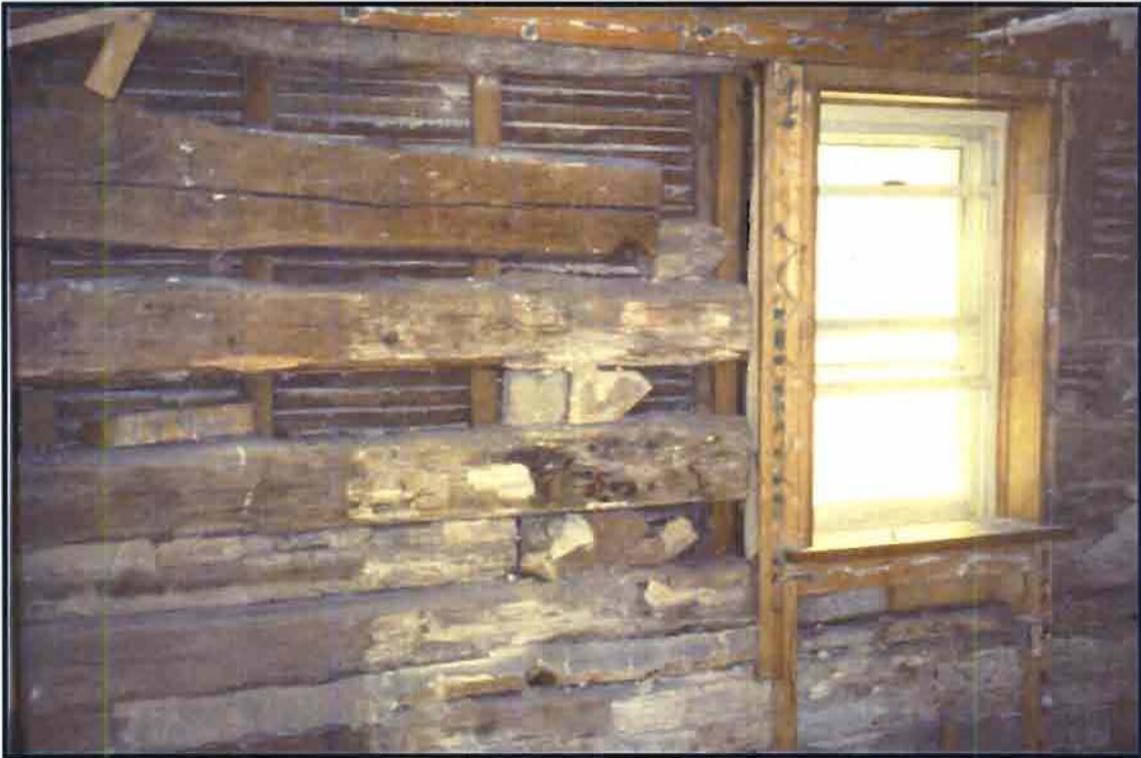
Plate 4.27. View of Western wall of Room 201 and Window 201a. Note second log from top of image displays evidence of reuse in the form of its insufficient length and the notch on the lower right end of log (Photographer: Dawn Turner, December 1999) [HRI Neg.# 99037/19:19].

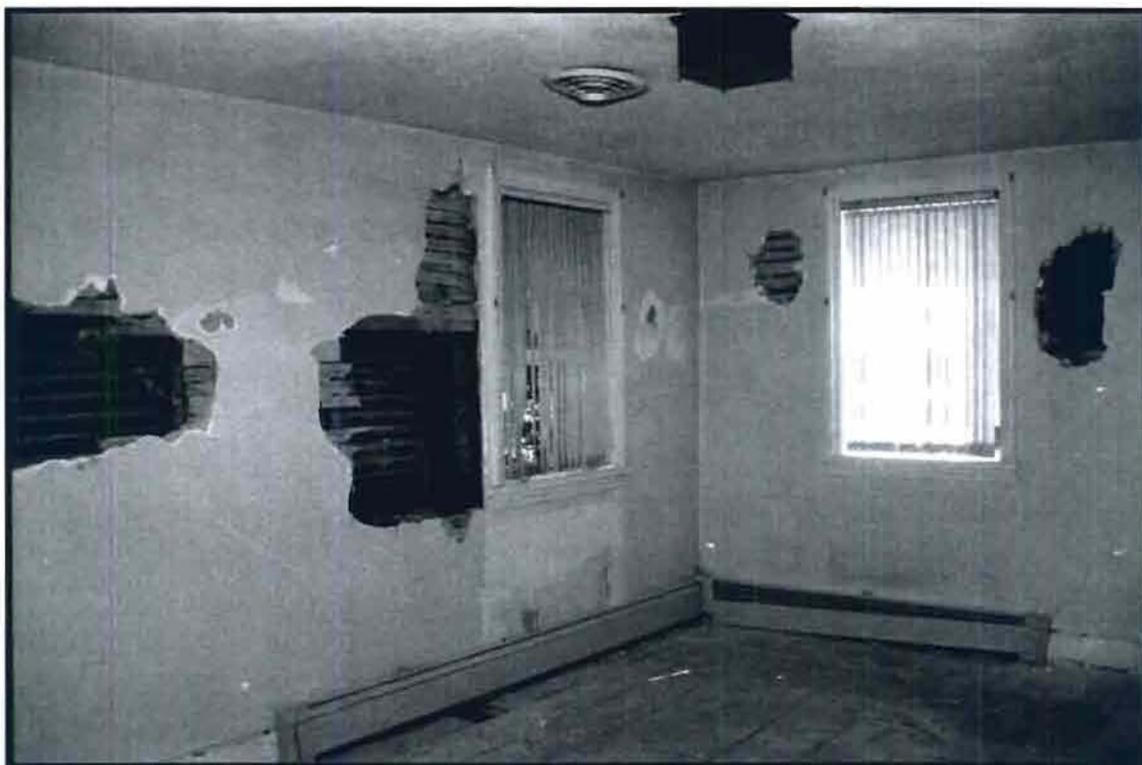
Plate 4.28. View showing eastern and southern walls of Room 202 prior to the removal of the majority of plaster and lath (Photographer: Dawn Turner, December 1999)[HRI Neg.# 98039/18:20].

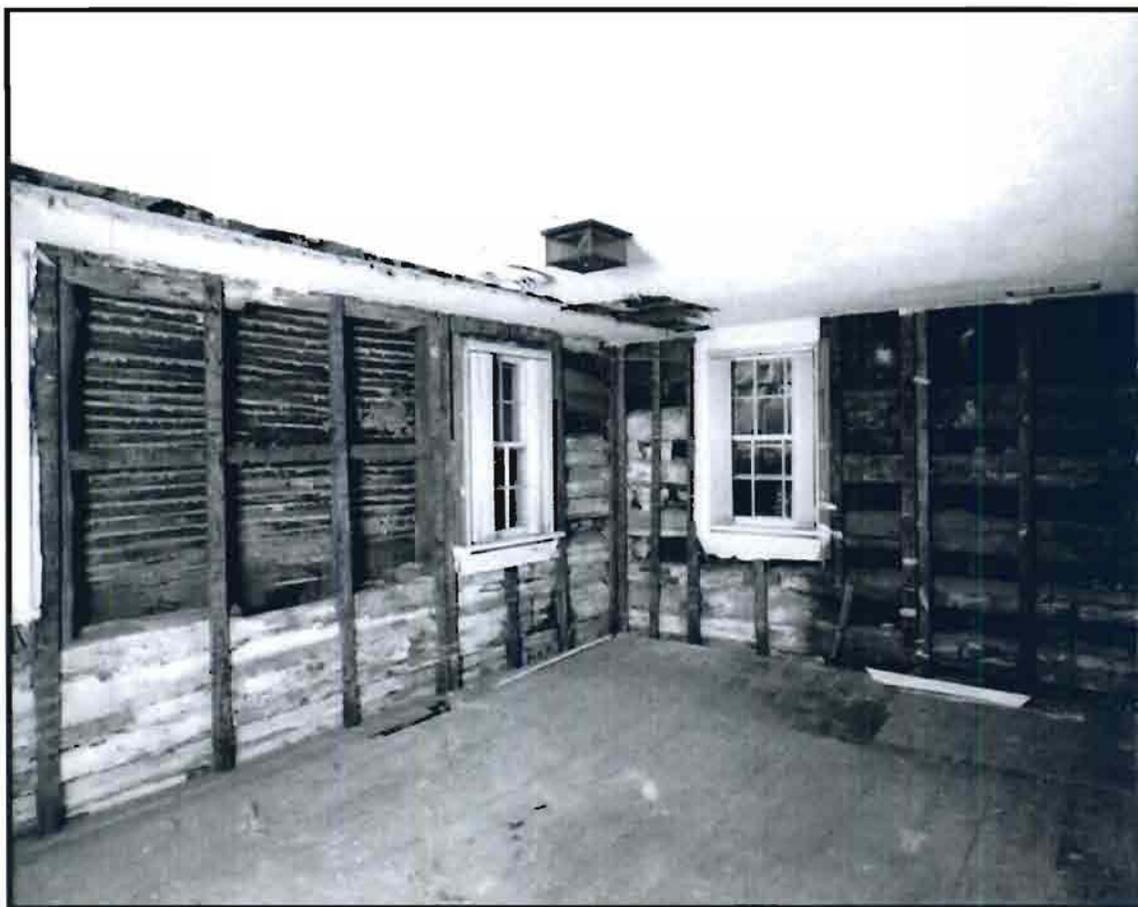
Plate 4.29. Junction of eastern and southern walls of Room 202 (Photographer: Dawn Turner, December 1999)[HRI Neg.# 99037/34:11].

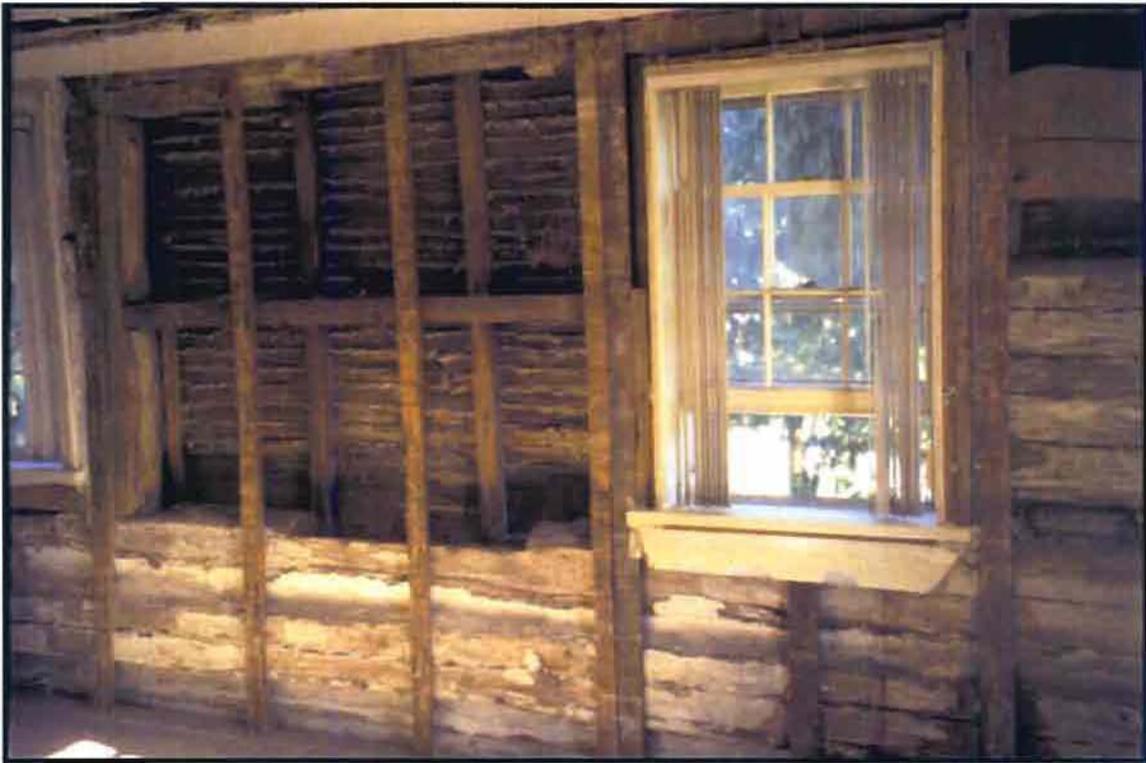
Plate 4.30. Interior of eastern wall of Room 202 looking northeast. Void former occupied by Window 202d visible at left. The modern double hung sash of Window 202c is visible at right (Photographer: Dawn Turner, December 1999)[HRI Neg.# 99037/19:17].
