Gutherie-Giacomelli House (Tweed's Tavern)
CRS-#N-1101, New Castle County, Delaware

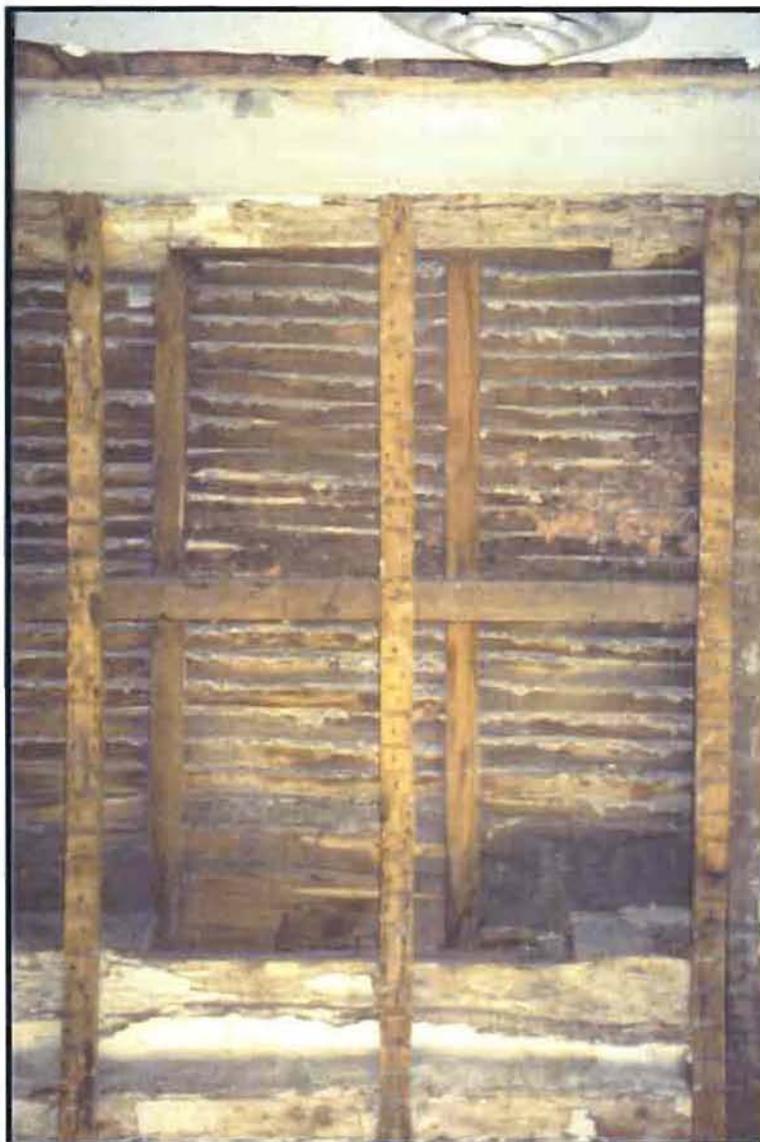
Prior to this reconfiguration, there was only one window in the section of the eastern wall encompassed by Room 202. This opening was Window 202d (Plate 4.31). With the reconfiguration, Window 202d was removed and covered over by plaster over split lath. It was at this time that openings for Windows 202c and 202e were cut. Six over six double hung fixtures are visible in these windows (202c and 202e) in historic photographs of the house (Plate 3.1).

Plate 4.31. View of inner (western) face of east wall of Room 202 showing the void in log matrix marking the former location of Window 202d. Note cut in upper log to accommodate window fixture (Photographer: Dawn Turner, December 1999)[HRI Neg.# 99037/19:21].

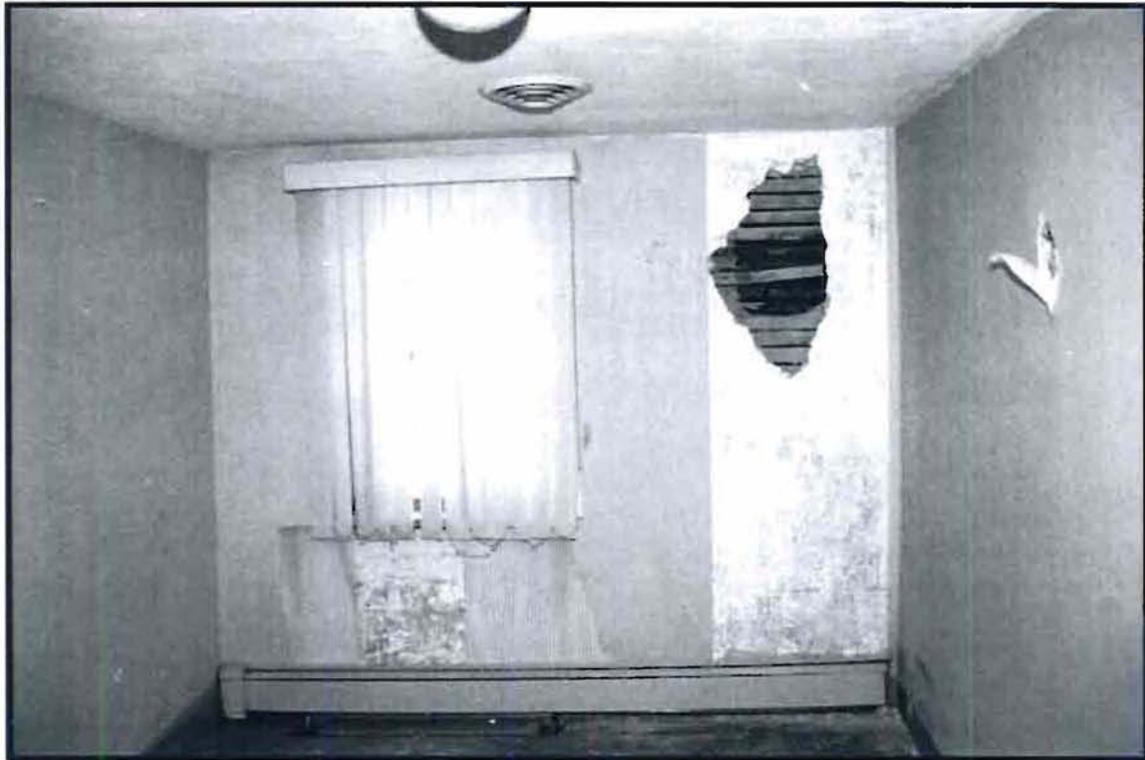
Plate 4.32. Interior of Room 203 before removal of plaster surfaces (Photographer: Dawn Turner, December 1999)[HRI Neg.# 99037/18:18].

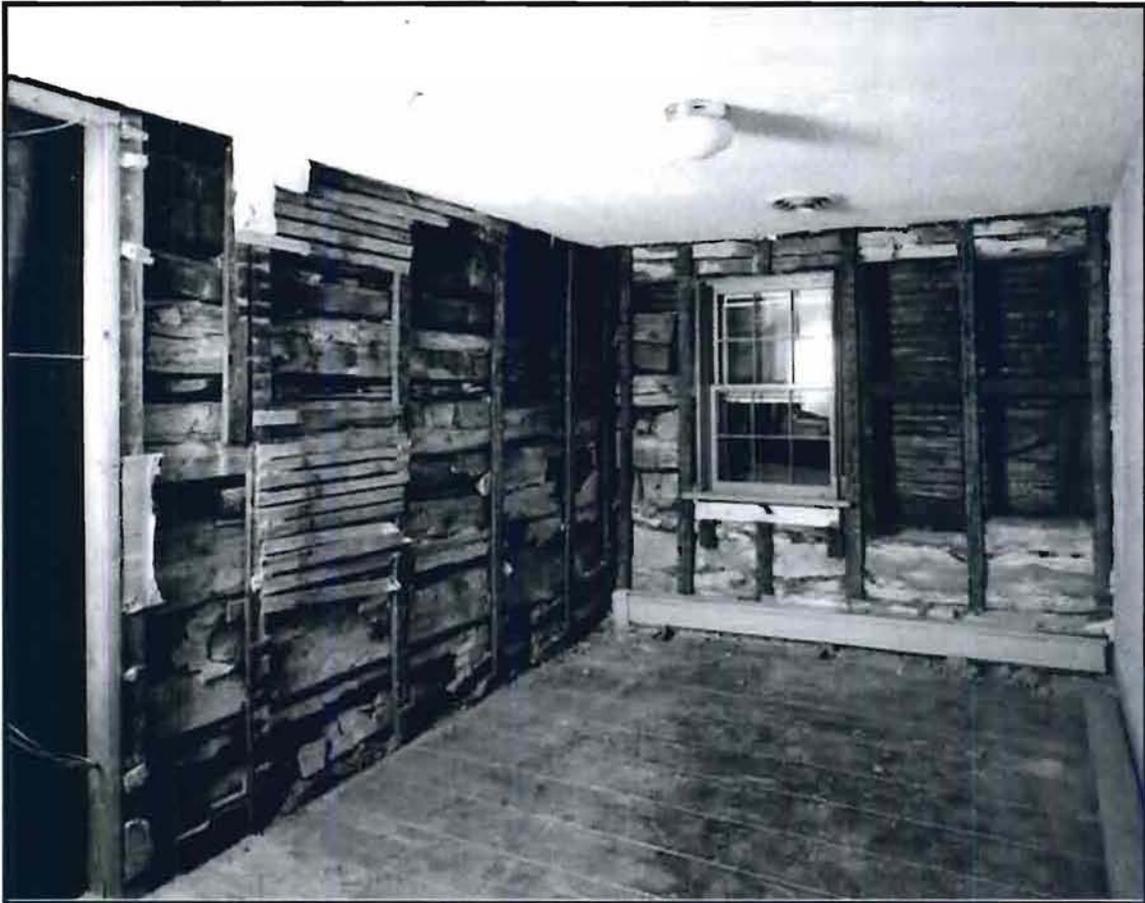
Plate 4.33. Junction of northern and eastern walls of Room 203 looking northeast. Scar from built in cabinet or closet visible on floor in foreground. Void in wall at left represents the former location of Window 203b (Photographer: Dawn Turner, December 1999)[HRI Neg.# 99037/34:8].

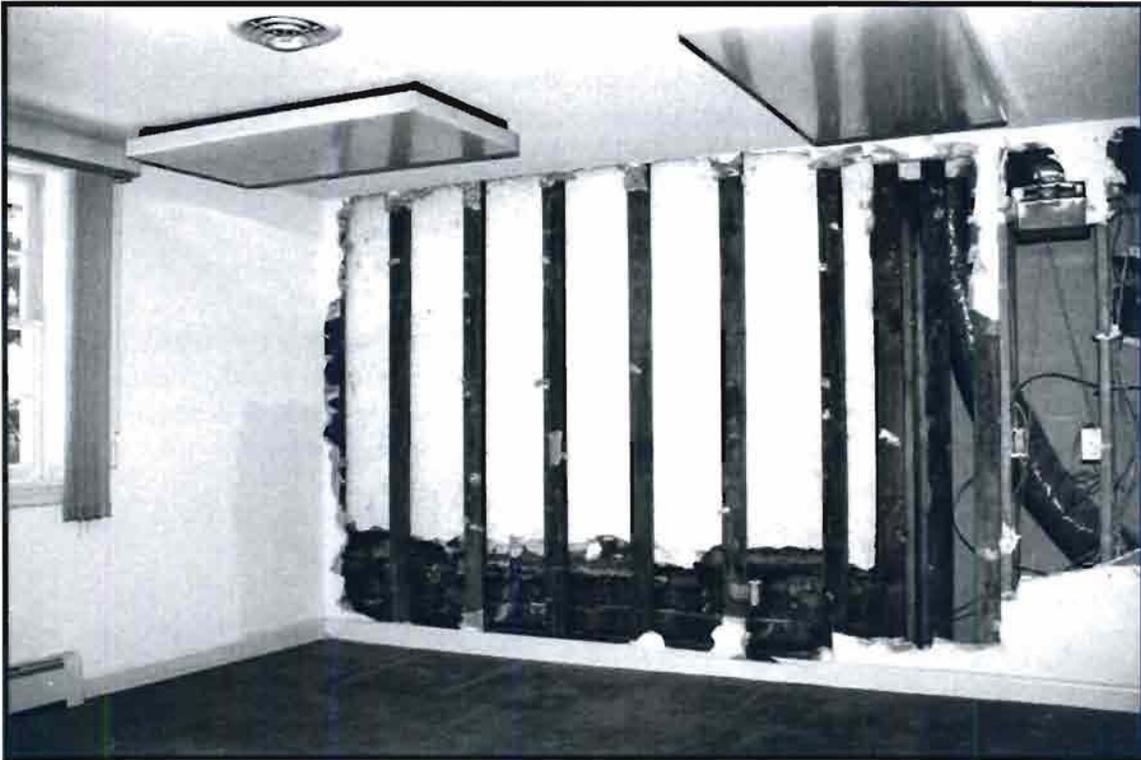
The southern wall of Room 203 represents its only historic feature. This is a log matrix wall. Removal of the modern plasterboard facing revealed the roof line of the one story lean-to appendage that formerly was situated in the location now occupied by the two story northern addition of the 1950s. This line is situated above the first full log above the room floor. Above this line is the original exterior northern face of the building. The wall treatment of the exterior surface consisted of clapboard applied on top of the log matrix. A coat of stucco on wire mesh was later applied to the clapboard surface.

Plate 4.34. View facing southeast showing northern face of southern wall of Room 205. Photograph shows the line of exposed broken stucco delimiting the former top edge of the roof of the shed roofed kitchen (Photographer: Dawn Turner, December 1999)[HRI Neg.# 98039/18:14].

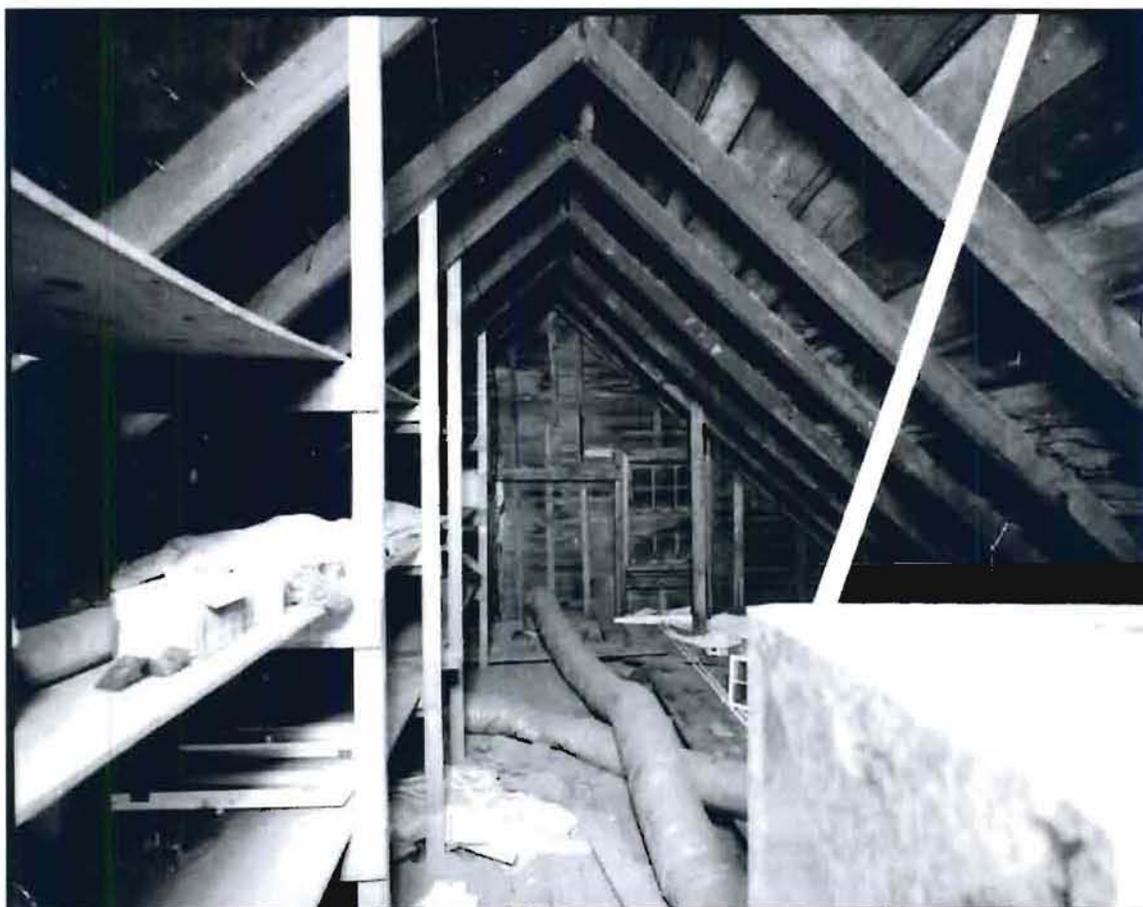
Plate 4.35. Interior of attic showing rafters, looking south (Photographer: Dawn Turner, December 1999)[HRI Neg.# 99037/35:5].

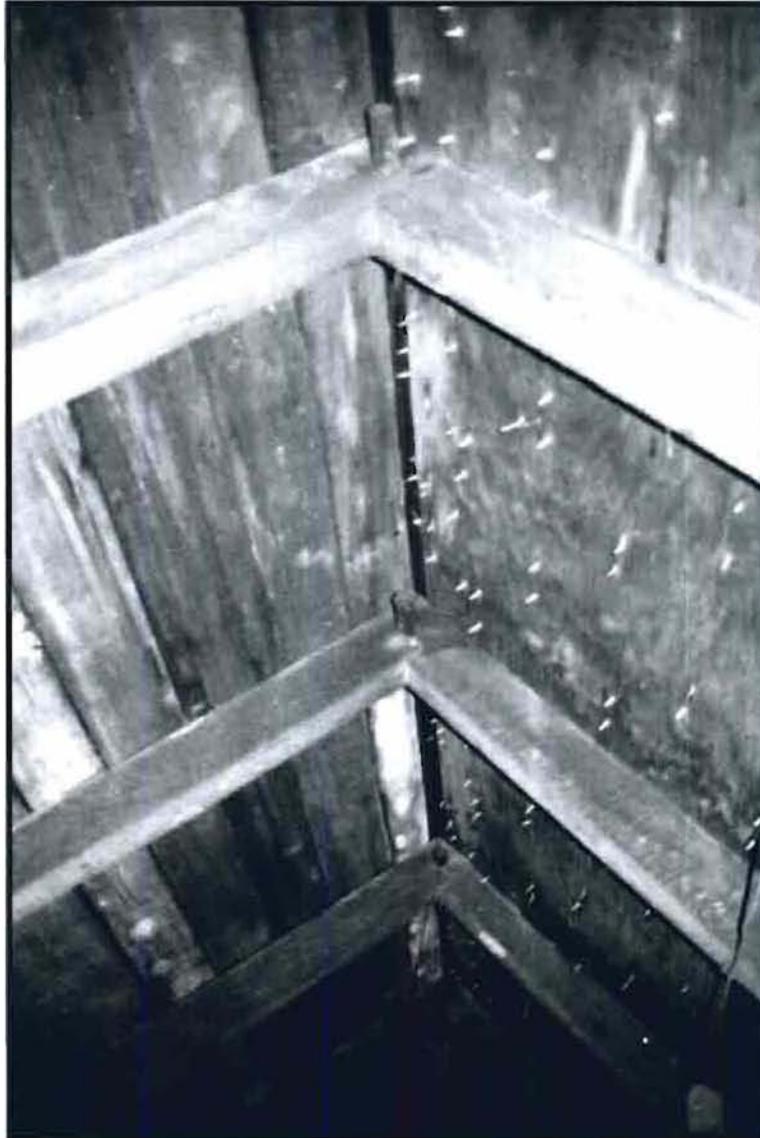
Plate 4.36. View of Rafters 3, 4 and 5, looking south
(Photographer: Dawn Turner, December 1999)[HRI Neg.#
98039/2:4].

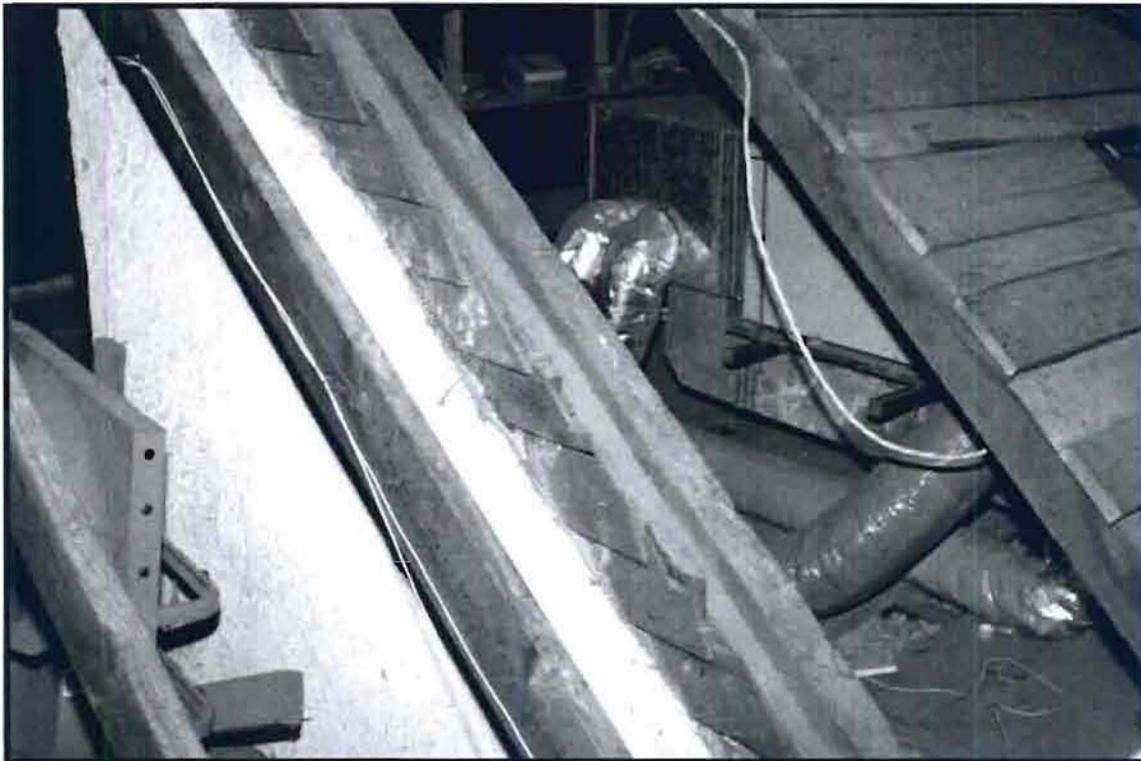
Plate 4.37. View facing southeast of the former exterior face of the former northwest corner of the building from within the attic of the western addition. Photograph shows opening cut through the roof of the historic core of the building to permit access from the attic of the western addition into the main attic space. Clapboard covered by stucco is visible on the once exterior now interior face of the northern gable (Photographer: Dawn Turner, December 1999)[HRI Neg.# 98039/18:30].

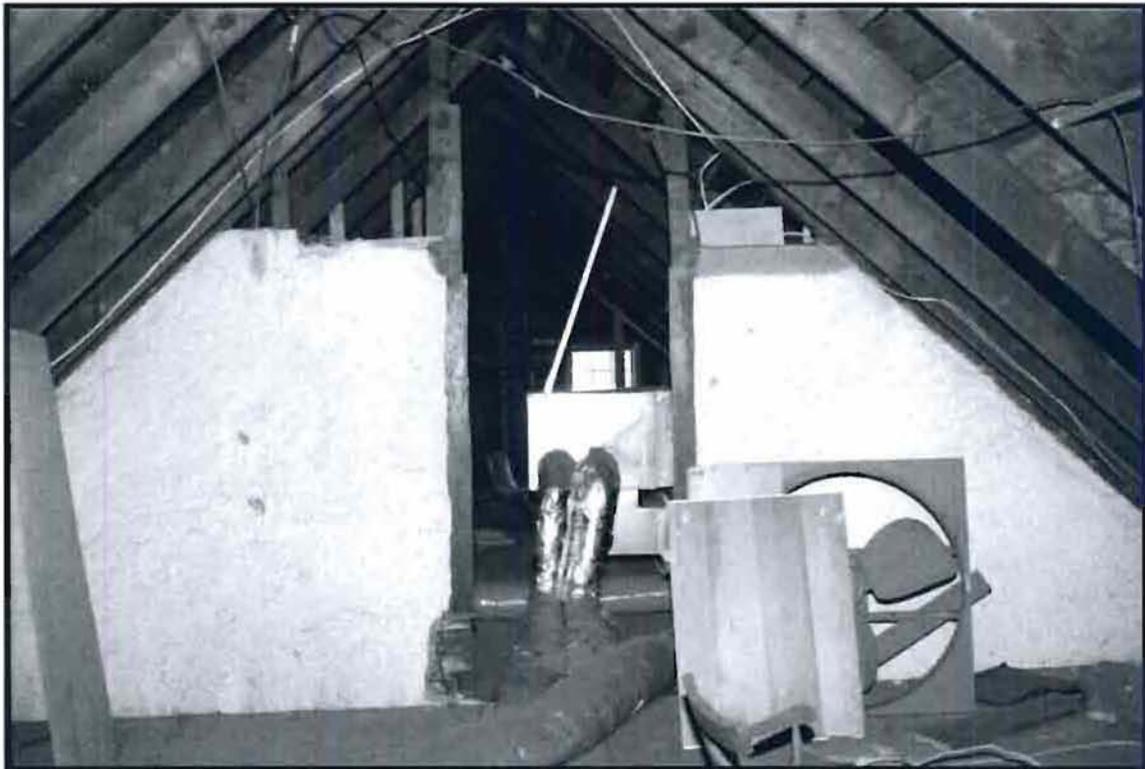
Plate 4.38. View facing south of the former exterior face of the top of the northern gable taken from within the attic of the northern addition. Photograph shows the former location of Window A3 (Photographer: Dawn Turner, December 1999)[HRI Neg.# 98039/18:29].
