**The Gutherie-Giacomelli House\Tweed's Tavern (CRS
#n-1101) and the Tweed's Tavern Archaeological
Site (7NC-A-18),
SR 7 and Valley Road, Hockessin, New Castle
County, Delaware**

Management Summary of Architectural Documentation,

**DELAWARE DEPARTMENT OF TRANSPORTATION
Parent Agreement 728, 728-1
Task 93-041-01**

RE: Structural Assessment, Tweeds Tavern, Valley Road/Route 7, New Castle County, DE.
Site Visits: 7 July 1999, 9 September 1999 and 8 November 1999
Delaware DOT Project 93-041-01
Ortega Consulting Project No. 99-14A

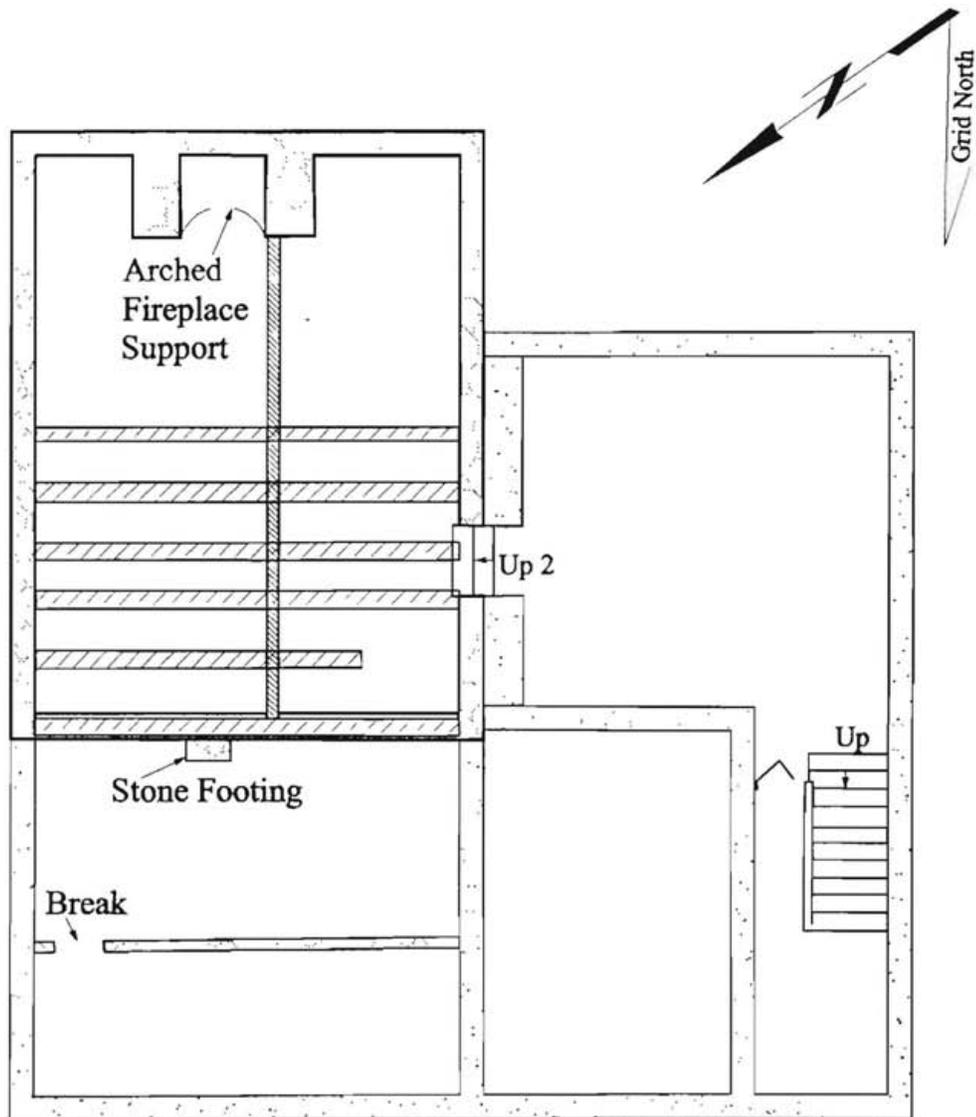
Figure 3. Plan of Basement Showing Location of Early First Floor Joists.

The north half of the first-floor framing consists of large timbers, irregularly sized but roughly 8" by 8", at about 30" on center, spanning east-west, and appears to be original to the building. The floor framing on the south half is modern dimensional lumber also spanning east-west. A timber summer beam bearing on the north foundation wall and supported on intermediate posts provides interior support to the floor joists.

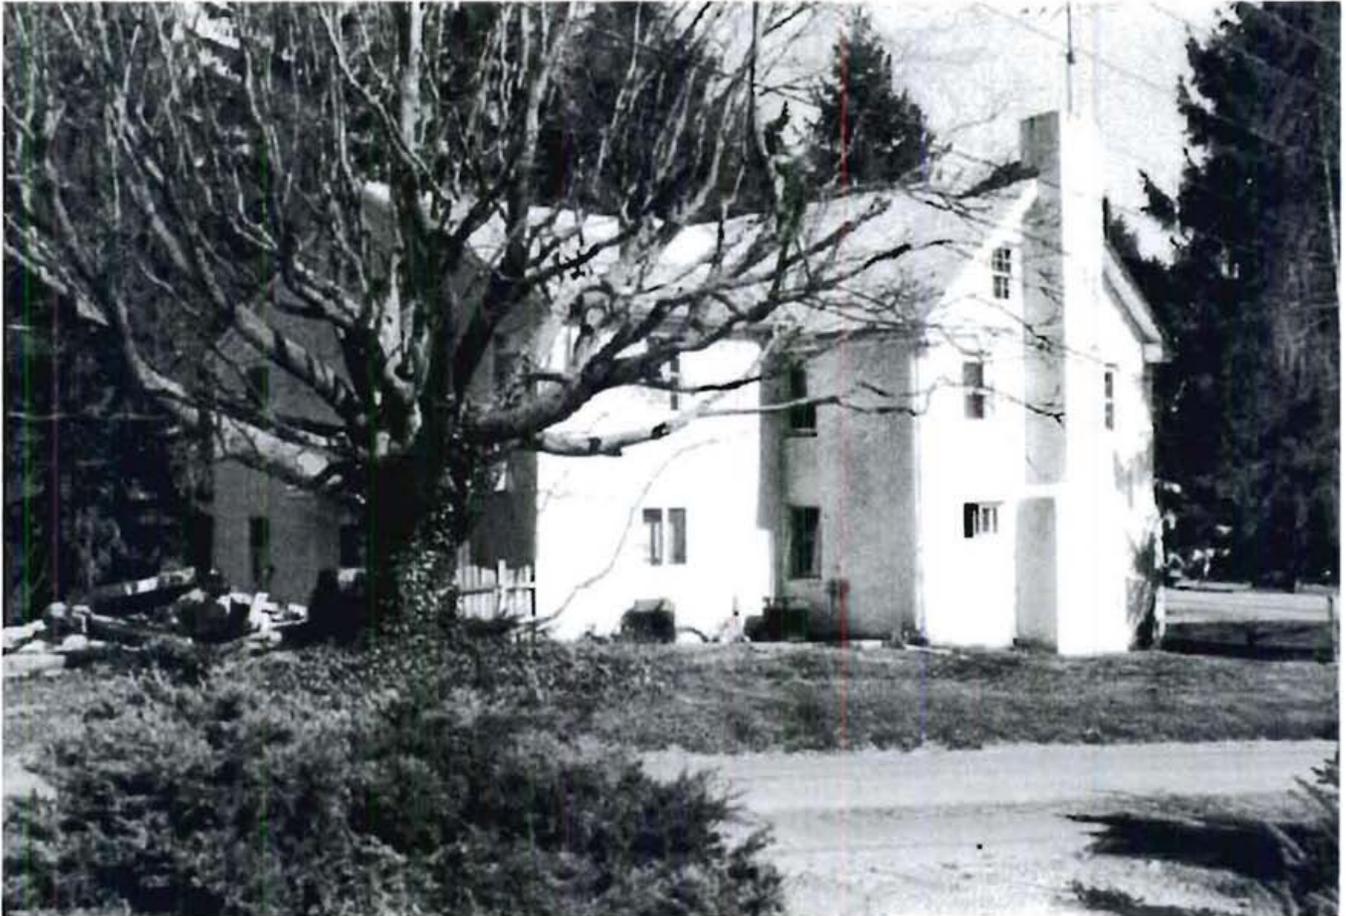
Plate 1. General view of the Gutherie-Giacomelli House/Tweed's Tavern, looking north from across Valley Road, showing a portion of the original core log structure on the right with a 20th-century addition on the left, behind the tree. The chimney attached to the core structure is a 20th-century rebuild (Photographer: Dawn Turner) [HRI Neg. #98039/17:1].

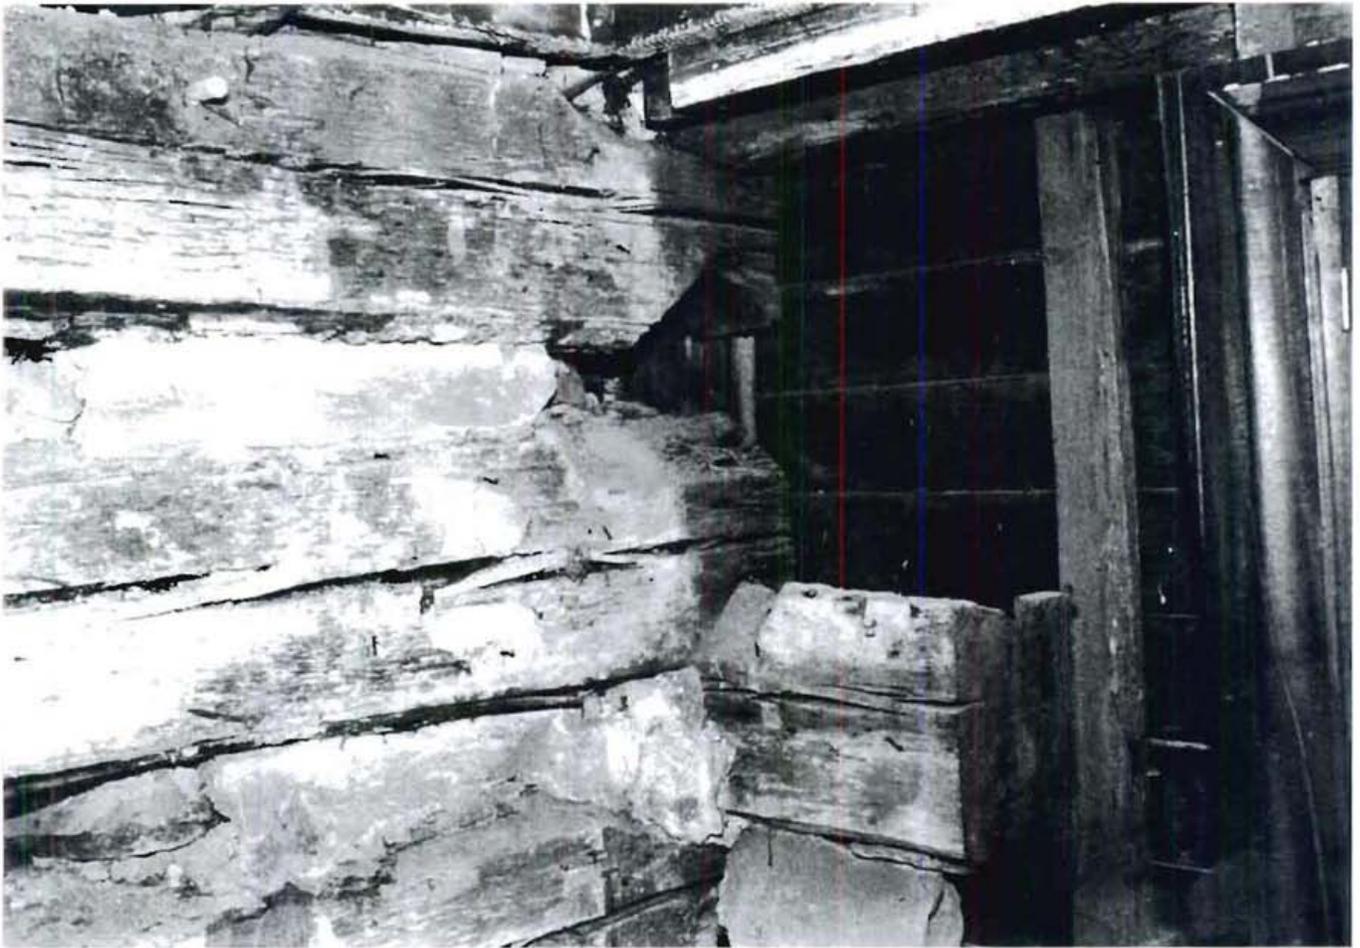
Plate 2. Detail view of the east interior of the first floor of the log structure in the Guthrie-Giacomelli House/Tweed's Tavern, showing V-notched corner joining (Photographer: Dawn Turner) [HRI Neg. #98039/18:8].

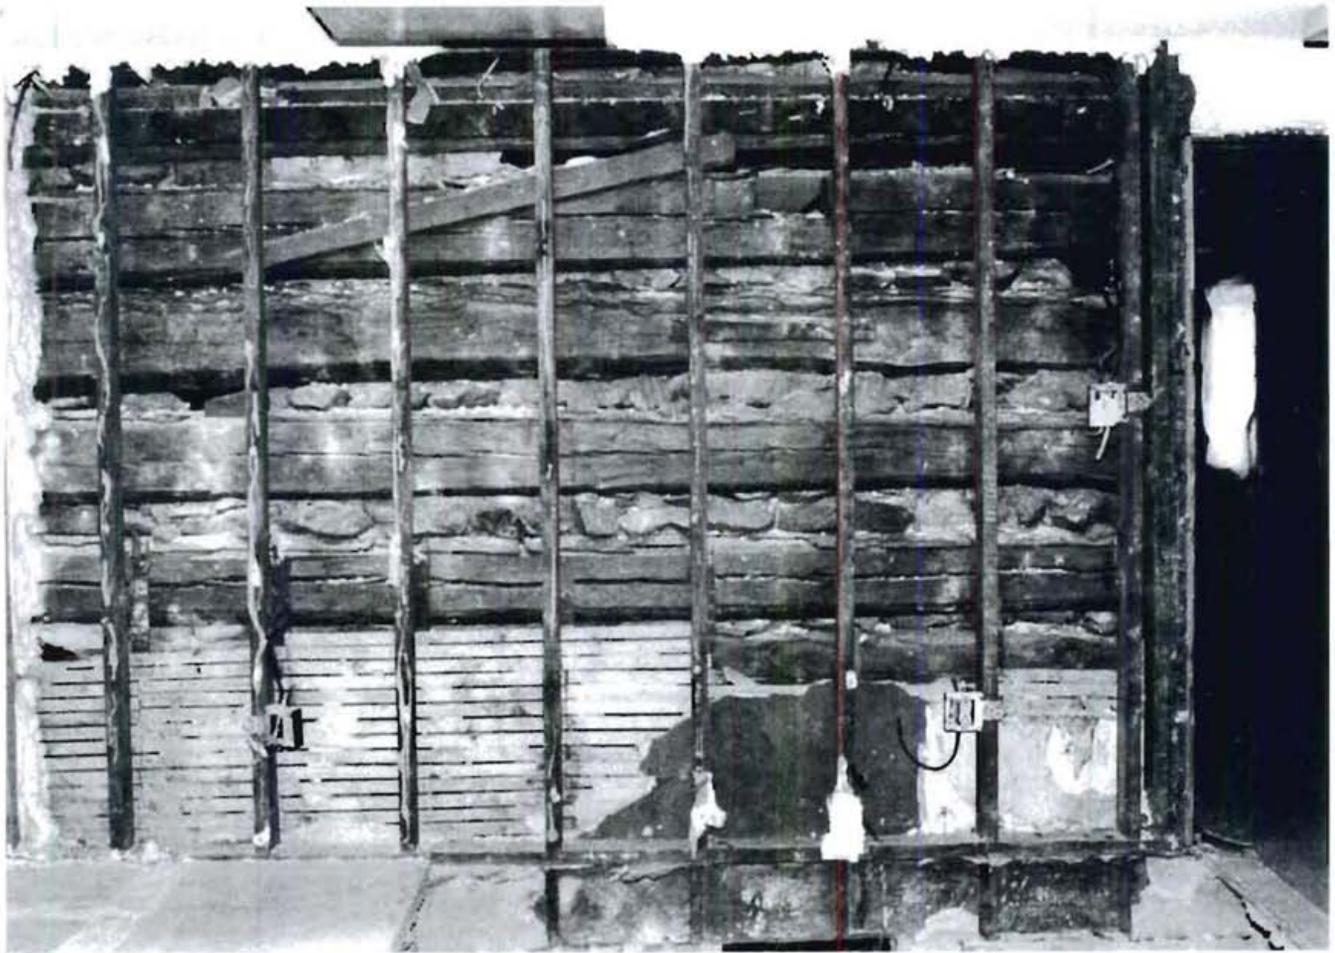
Plate 3. View of exterior face of the northwest wall of the log structure in the Guthrie-Giacomelli House/Tweed's Tavern, showing log construction and original exterior lath (Photographer: Dawn Turner) [HRI Neg. #98039/18:36].
