**S-03964. Erasmus Arnold Farmstead, Old Road, west of U.S. Route 113
(PIN: 230-31.00-8.00)
(Detail Map #2)**

**S-08151. Ellendale State Forest Picnic Facility, U.S. 113
(PIN: 230-31.00-48.00 and U.S. 113 ROW)
(Detail Map #3)**

**S-08384. Teddy's Tavern, DuPont Highway
(PIN: 230-26.00-35.10)
(Detail Map #1)**

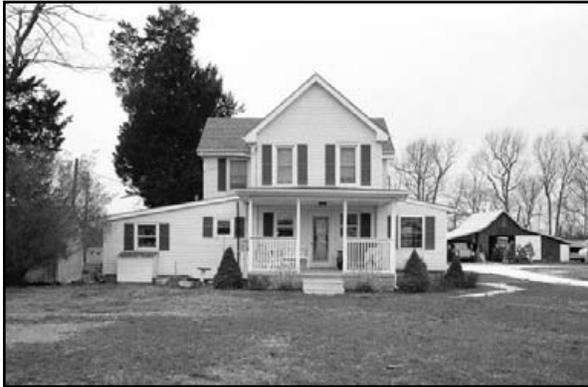
In basic form, the c. 1900 house is a three-bay, wood-framed, two-story, I-house with full height gabled rear ell. It has been substantially altered by construction of additions. A flat roofed, single-story block with side French doors and wood-framed steps adjoins the original façade wall. The outer wall of this addition is fenestrated with paired, eight-over-eight, double-hung vinyl clad sash windows. Additional fenestration consists of one-over-one, double-hung vinyl replacement windows. The rear ell is flanked by single story, shed-roofed additions. These recent additions have concrete-block foundations. A secondary entry is placed in the side wall of one addition; a hipped porch projects from the rear wall of the ell. This porch has a concrete deck and prefabricated stoop, modern posts and balustrade, and a vinyl-clad ceiling. It shelters what is currently the main entry, which consists of a 15-light, fiberglass door. The house sits on a concrete-block foundation and is sheathed in vinyl siding.

main building (.001) facade, view to W

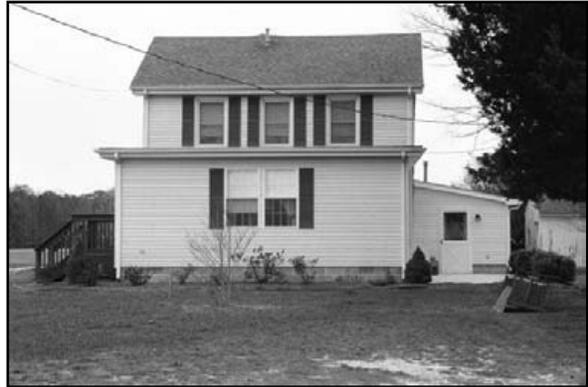
main building (.001) rear, view to E

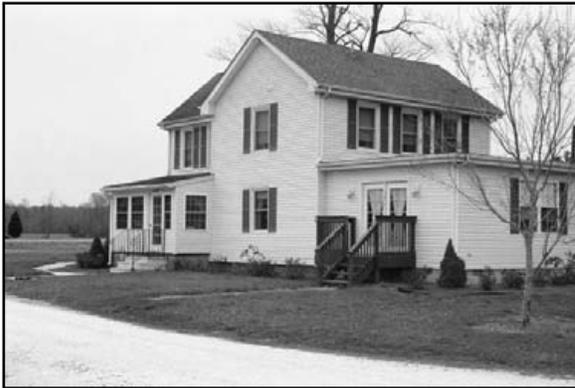
main building (.001) rear and north side,
view to S

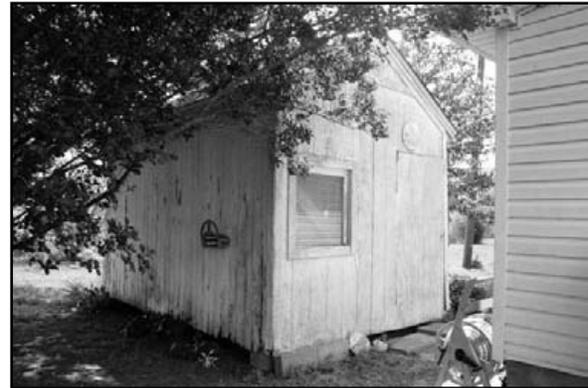
A toolshed (.002) is placed south of the house. This c. 1950, gabled front, wood-framed building has a single-light, fixed window in its north wall, and a plywood door at the northwest end of the wall. The side walls are blank as is the rear wall. The shed sits on concrete-block footers, and is sheathed in vertical wood siding and plywood. Its roof is sheathed in asphalt.

toolshed (.002), view to SW

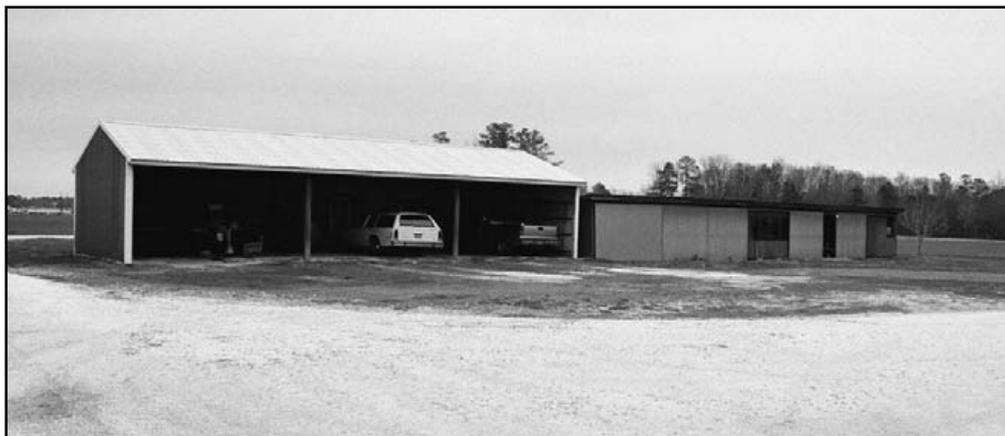
Built in about 1960, a chicken house is located on the opposite side of a gravel-shell driveway north of the house (.003). The façade faces south and contains two pairs of corrugated metal sliding doors and a plywood door, as well as single and grouped screened openings. The remaining sides are blank.

left to right: modern garage and chicken house (.003), view to NE

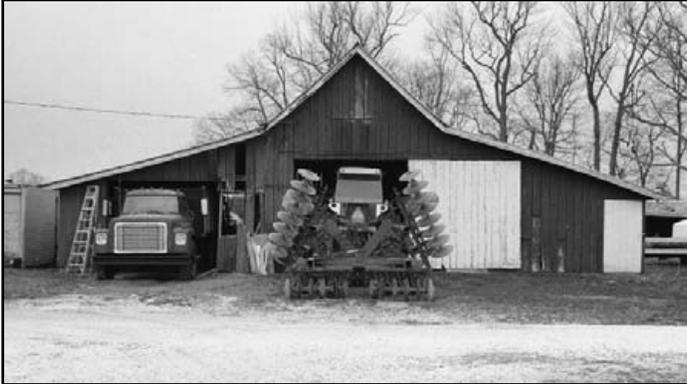
A c. 1900 barn (.004) is placed across New Road from the house. This gabled front barn with shed-roof side bays sits on a concrete-block foundation and is sheathed in vertical board wood siding. The east façade has three door openings. One contains a large sliding batten door, a second a plywood door, while a third, a vehicle door, is missing. The north wall contains five nine-light, fixed windows, and two Dutch doors, while the south wall contains five, single-light replacement windows and two boarded up doors. The rear wall contains two Dutch doors and one open bay.

barn (.004), view to W

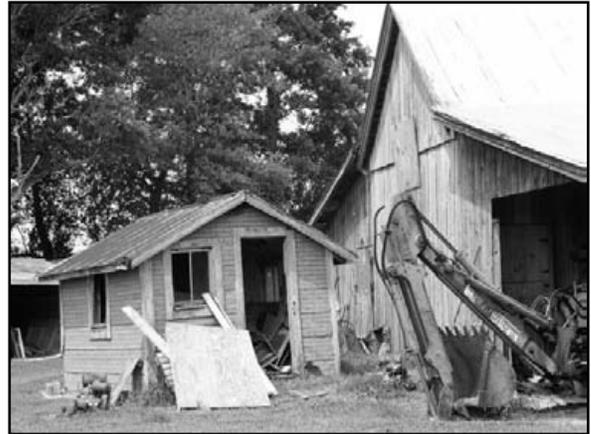
A c. 1920 shed (.005) is placed west of the barn. This gabled front building has its walls sheathed in bricktex and its roof sheathed in metal. Its southeast façade has a central door opening missing its door, and a two-light fixed window. The northeast wall has a single, two-light fixed window, while the southwest wall contains a two-light, fixed window. The rear wall is blank.

shed (.005), view to NE

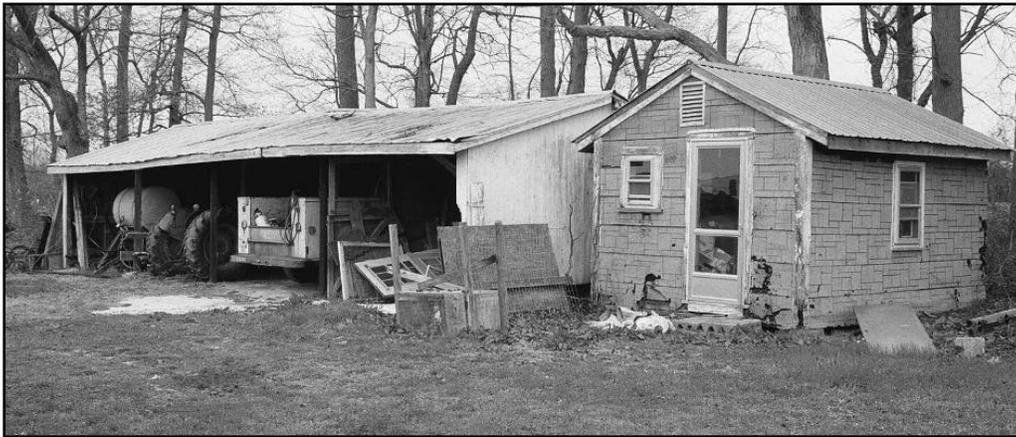
A 1960 equipment shed (.006) is placed northwest of the shed. This side-gabled, wood-framed building is sheathed in vertical boards and metal siding. Its roof is sheathed in ribbed metal. The southeast façade has four open bays, while the remaining sides are blank.

A c. 1950 tourist cabin or cottage (.007) is placed northeast of the equipment shed. The building sits on concrete-block footers and is sheathed in bricktex. The gabled front façade is pierced by a central aluminum storm door and a one-over-one, double-hung aluminum sash window. The side walls are fenestrated with single, two-over-two, double-hung wood sash windows with horizontal muntins, while the rear is blank. Its roof is sheathed in corrugated metal.

left to right: equipment shed (.006) and cabin (.007), view to NW

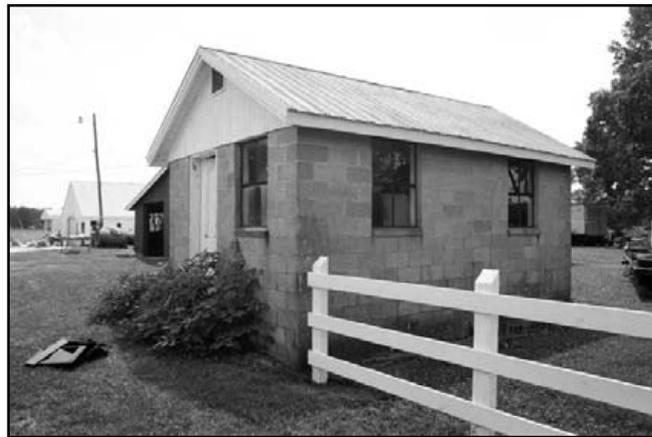
The last outbuilding, placed north of the barn, is the c. 1930 concrete-block milkhouse (.008) with gable peaks sheathed in clapboards. This gabled front building has a four-panel, salvaged Victorian door in the center of the east wall. The north and south walls are both pierced by two-over-two fixed windows. The south wall also is pierced by a salvaged four-panel Victorian door, while the rear wall is blank.

milkhouse (.008), view to SW

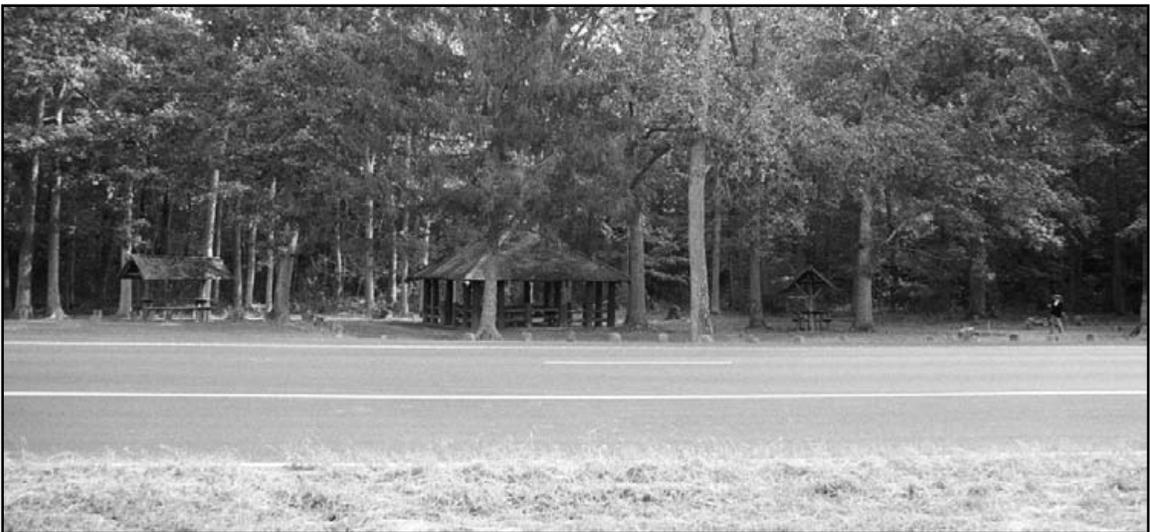
Minor changes have occurred to the property since it was listed in the National Register. The area along the roadway was originally lined and marked with two parking areas, one to the north and one to the south (Duhadaway et al. 1990:section 7). The small parking area to the south has been grassed over, while the northern lot is paved and is clearly meant to be the only parking area. The pavilion contains two built-in picnic tables with benches, which, in the nomination (Duhadaway et al. 1990:section 7), were described as half-logs. The current benches are constructed of wood planks. Lastly, the fieldstone fireplace hearth has been destroyed, with only a small pile of stone and mortar ruins remaining.

overview of picnic ground (.001) today, view to E

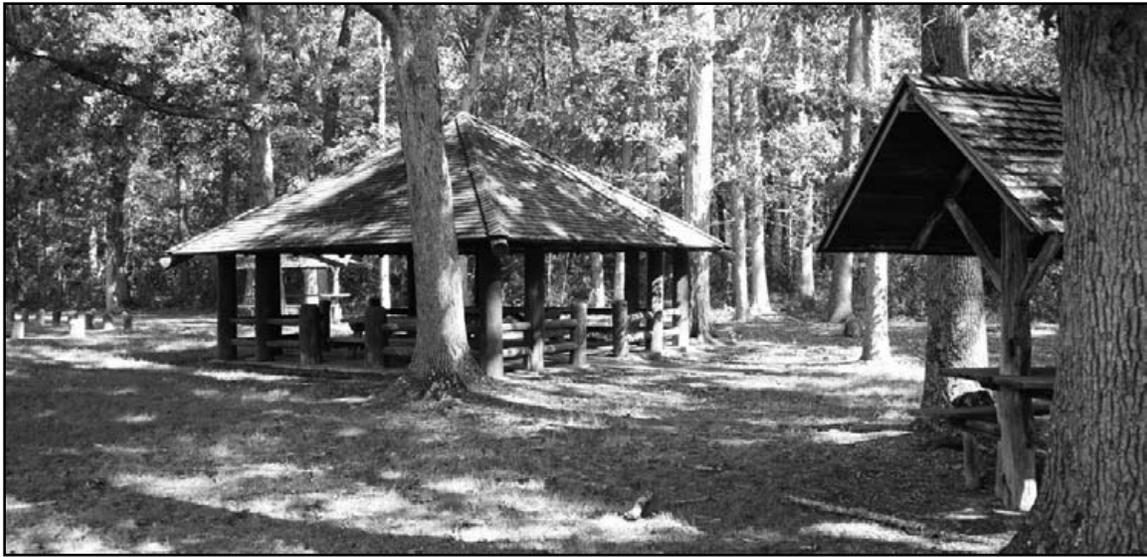
pavilion (.002) and south picnic shelter (.004), view to NE

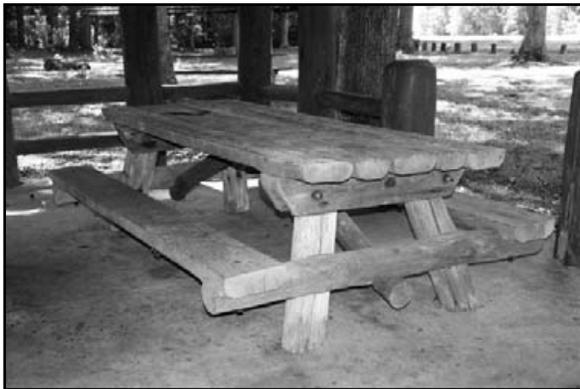
picnic table in pavilion (.002), view to SW

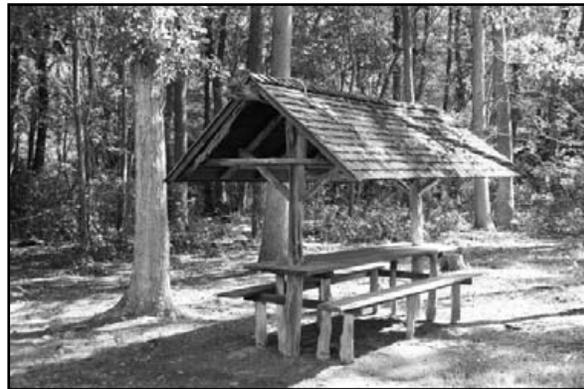
north picnic shelter (.003), view to E

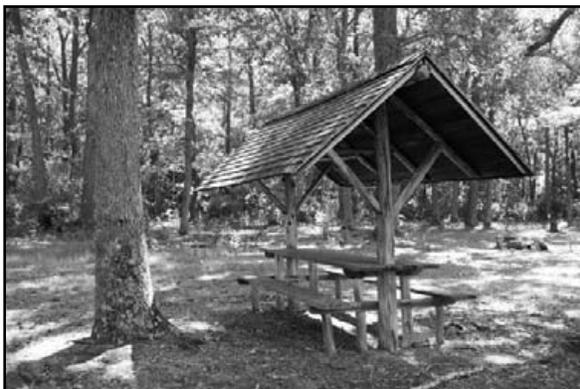
south picnic shelter (.004), view to SE

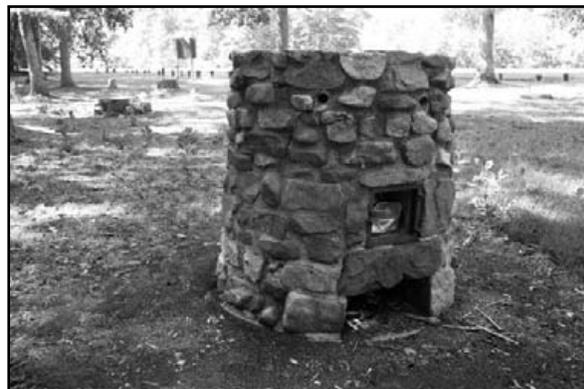
trash pit (.005) with firepit (.007) in background, view to SW

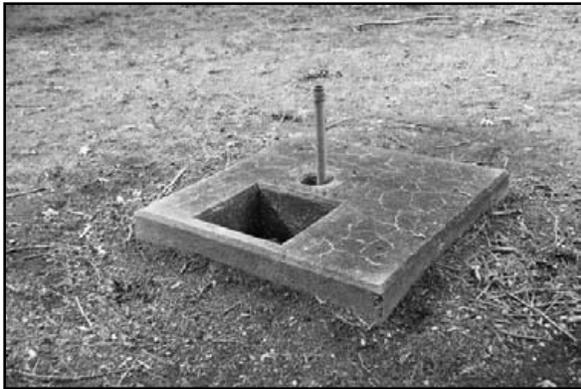
water fountain foundation (.006), view to SW

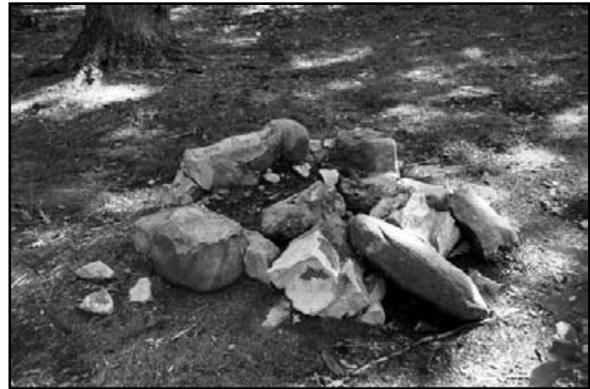
firepit (.007), view to NW

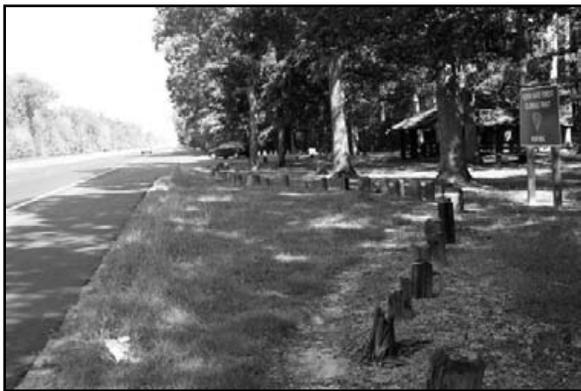
bollards (.008) and south parking area, view to N

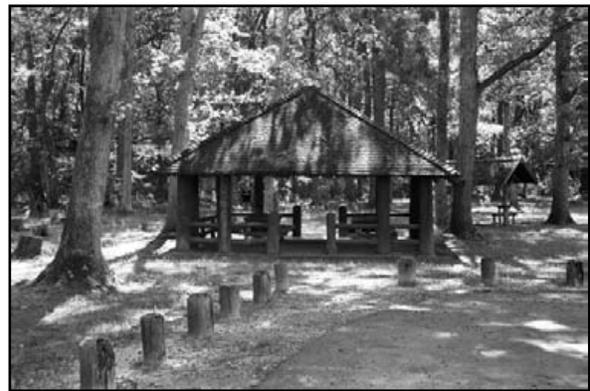
bollards (.008), pavilion (.002), and south picnic shelter (.004), view to S

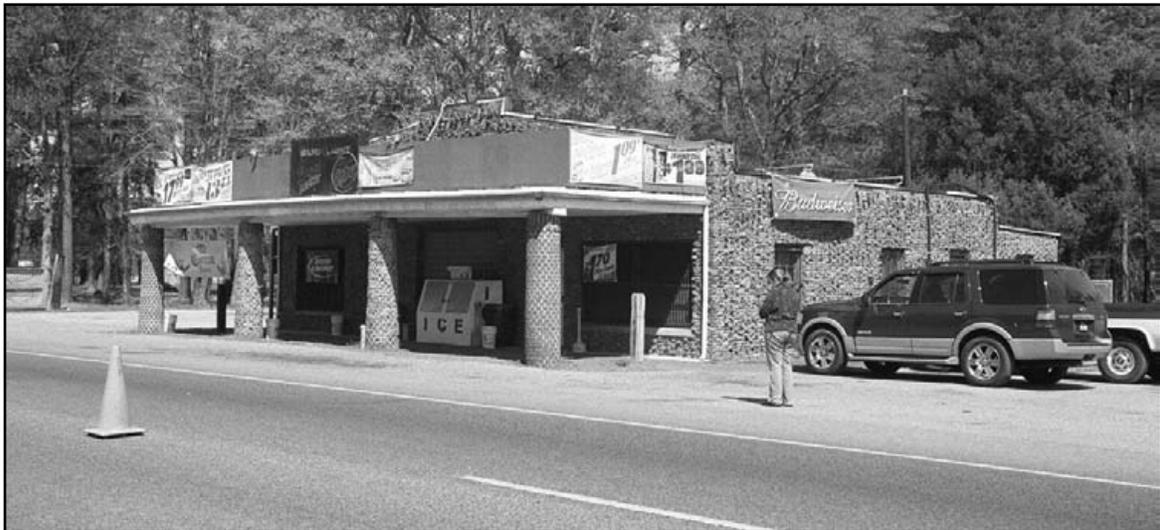
Several changes have occurred to the property since Teddy's Tavern was listed in the National Register. One of the distinguishing façade elements, the exposed rafter tails, have been removed and the cornice capped. The north and south columns have both been replaced using smooth, modern brick that does not exactly match the rusticated texture of the original columns. Other exterior changes include replacement of the signage on the front of the building. The interior has been altered by the reduction of the amount of space in the shop. Two notable interior elements, the unusual glass block bar and the pressed metal ceiling, remain.

Teddy's Tavern in 2008, view to NE

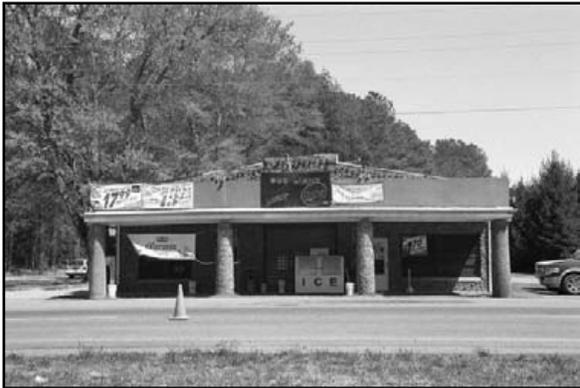
main building (.001) façade, view to E

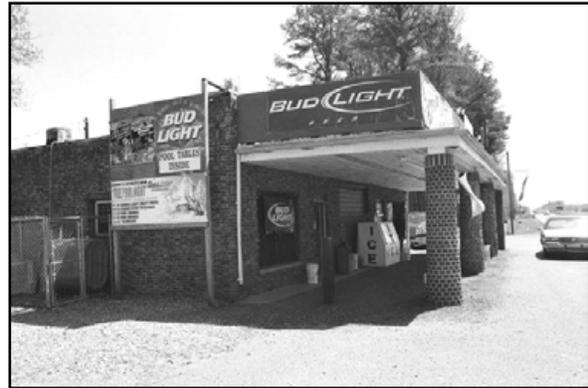
main building (.001) façade and north side, view to SE

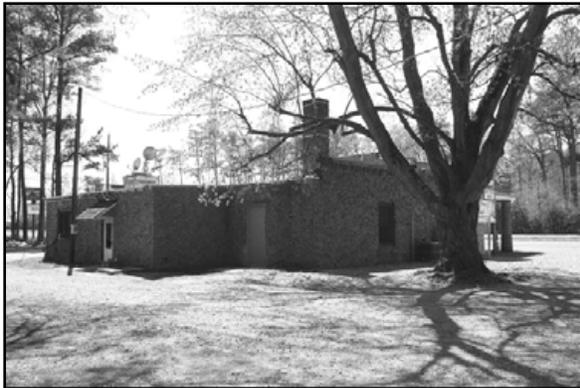
main building (.001) rear and north side, view to SW

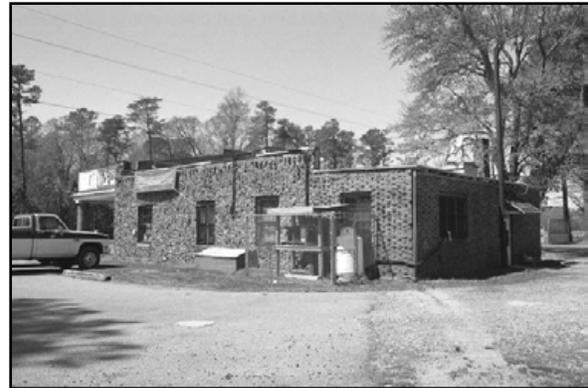
main building (.001) rear and south side, view to NW
