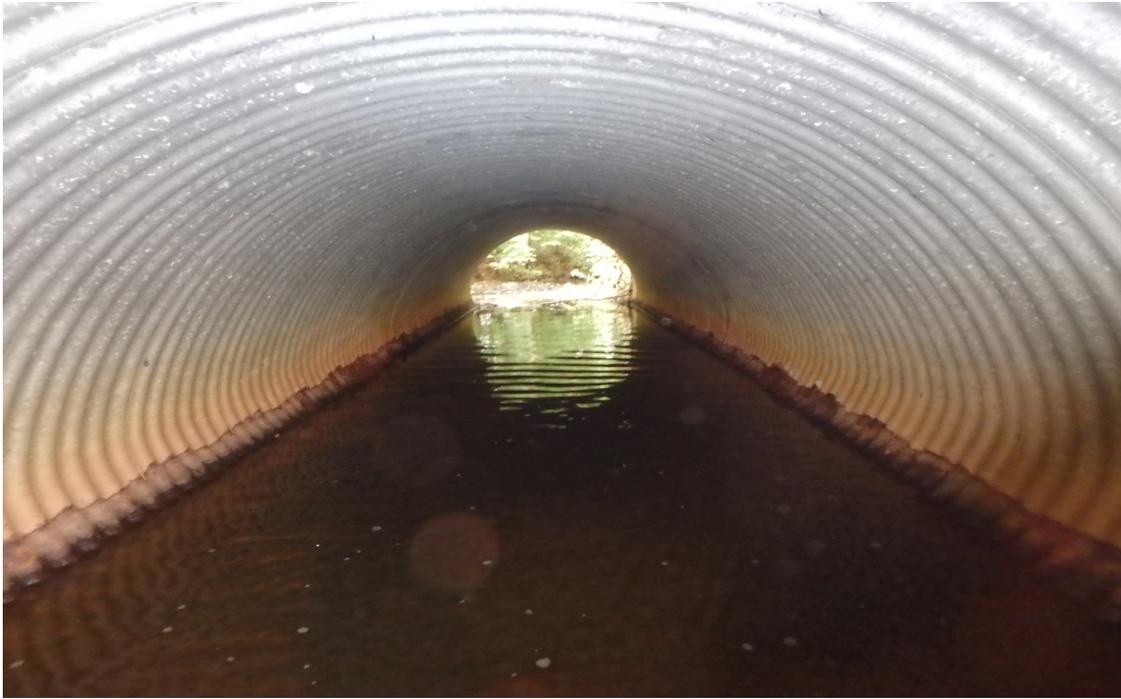
3. GENERAL VIEW SOUTH IS WEST SPAN

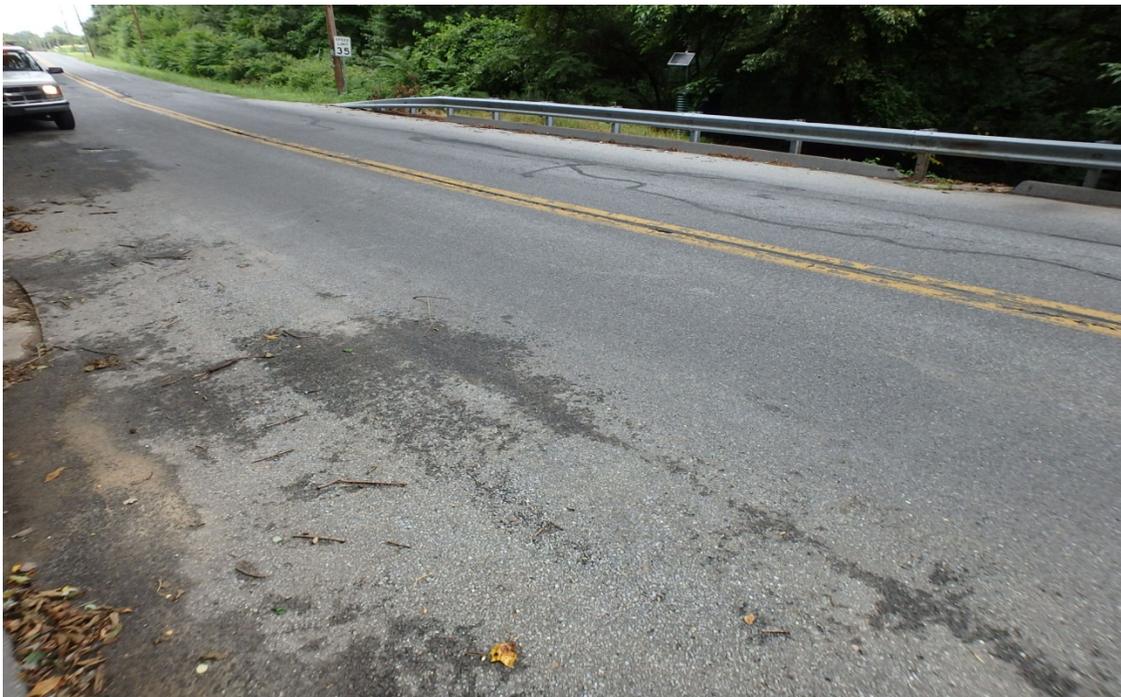
6. A/C OVERLAY LOOKING NORTH

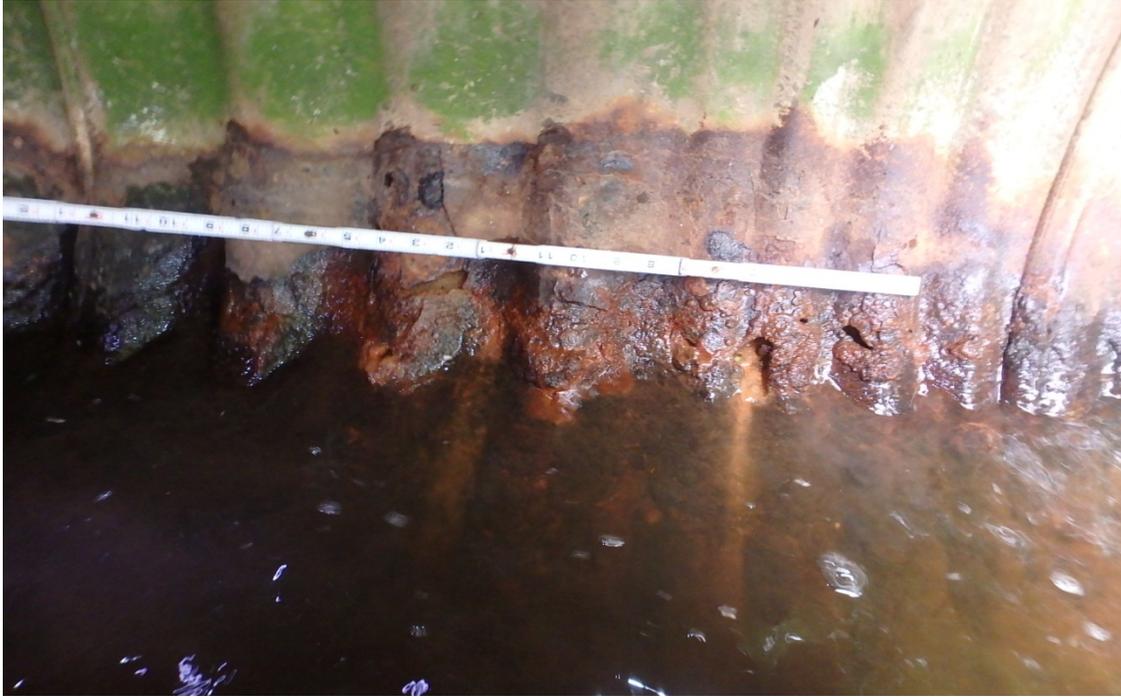
7. SPAN 1, EXISTING PERF. IN W. WALL @ N.
END.

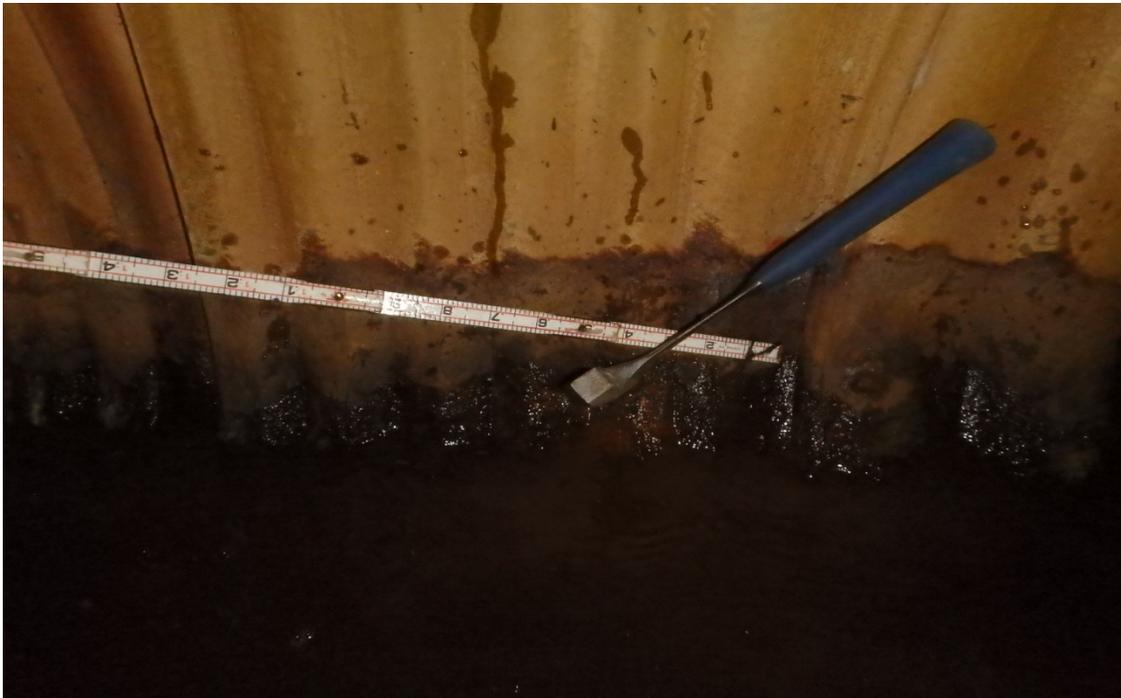
8. SPAN 1, ACT. COR. EASILY PERF. IN W.
WALL NEAR N. END.

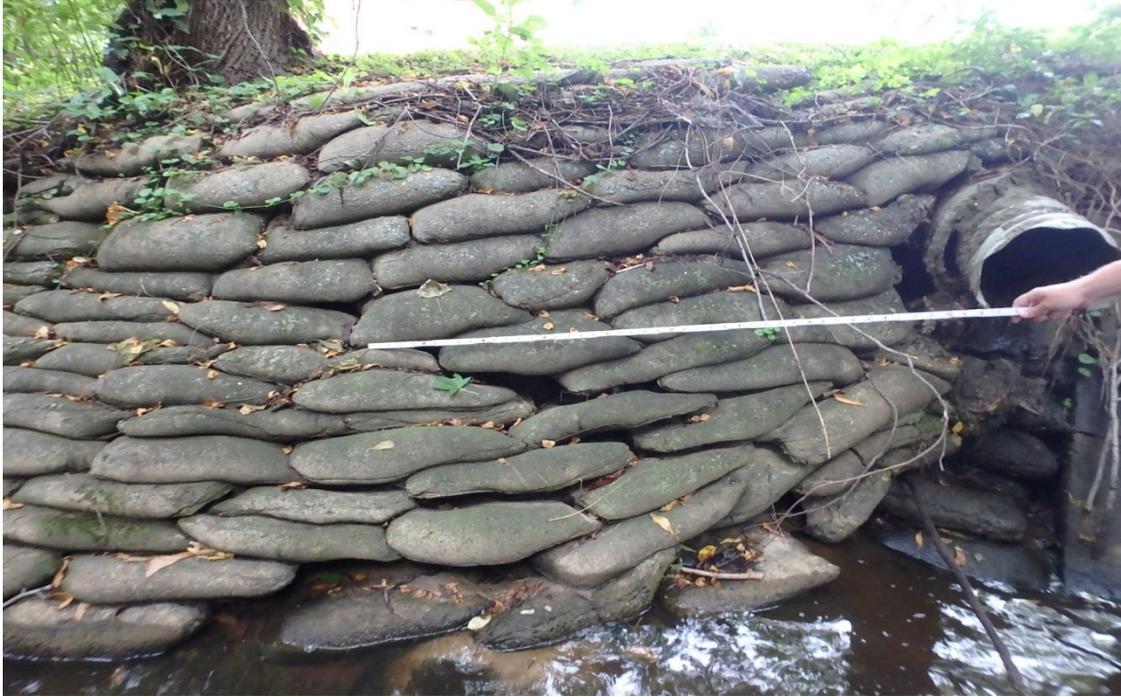
9. SPAN 2, SETTLED/UNDERMINED SACKED
RIP-RAP @ N/E CORNER DRAINAGE PIPE.

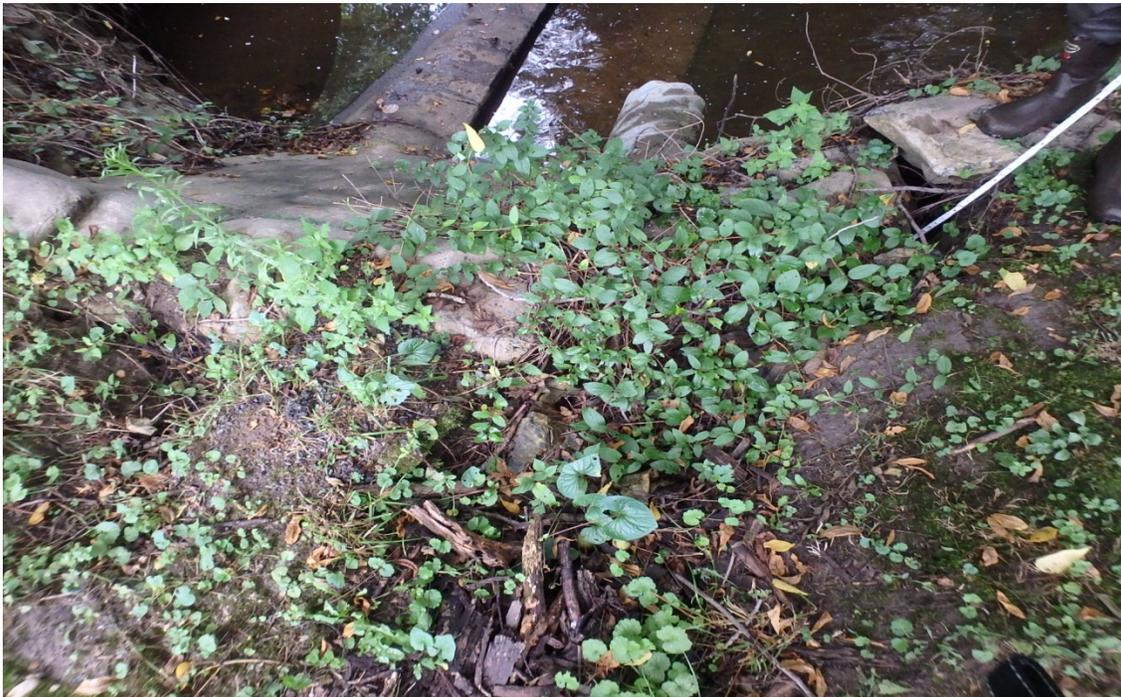
10. EROSION HOLE BEHIND SACKED RIP RAP
@ N/E CORNER DRAINAGE PIPE.
