November 30, 2007

Re: Management Summary
Boyd's Corner Intersection Improvements Project
Phase II Archaeological Evaluation Study
Boyd's Store and House [7NC-G-169; CRS N-12742]
Odessa, New Castle County, Delaware
Agreement 1275, Contract 25-041-04

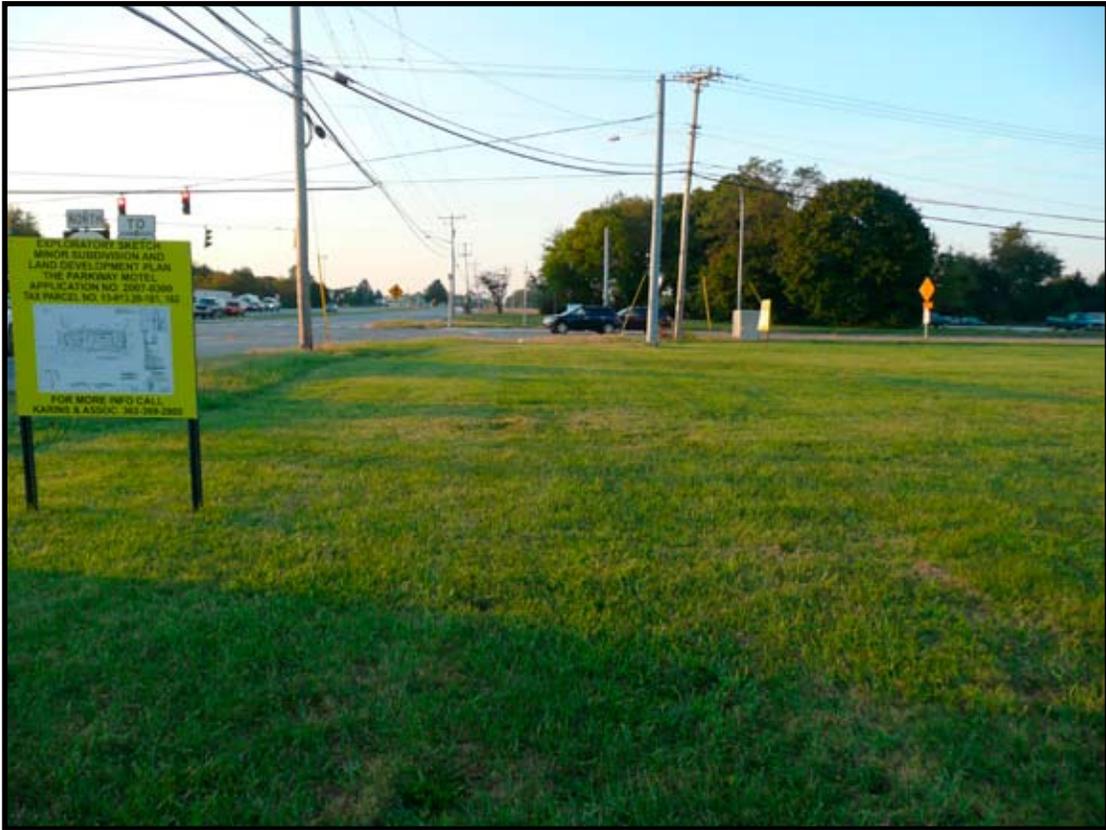
Plate 1. Boyd's Store and House site [7NC-G-169; CRS N-12742]: General view looking south of the southern portion of the project area south of the semi-circular motel driveway showing surface conditions prior to excavations (Photographer: William B. Liebeknecht, October 2007) [HRI Neg.# 07051/D2:43].

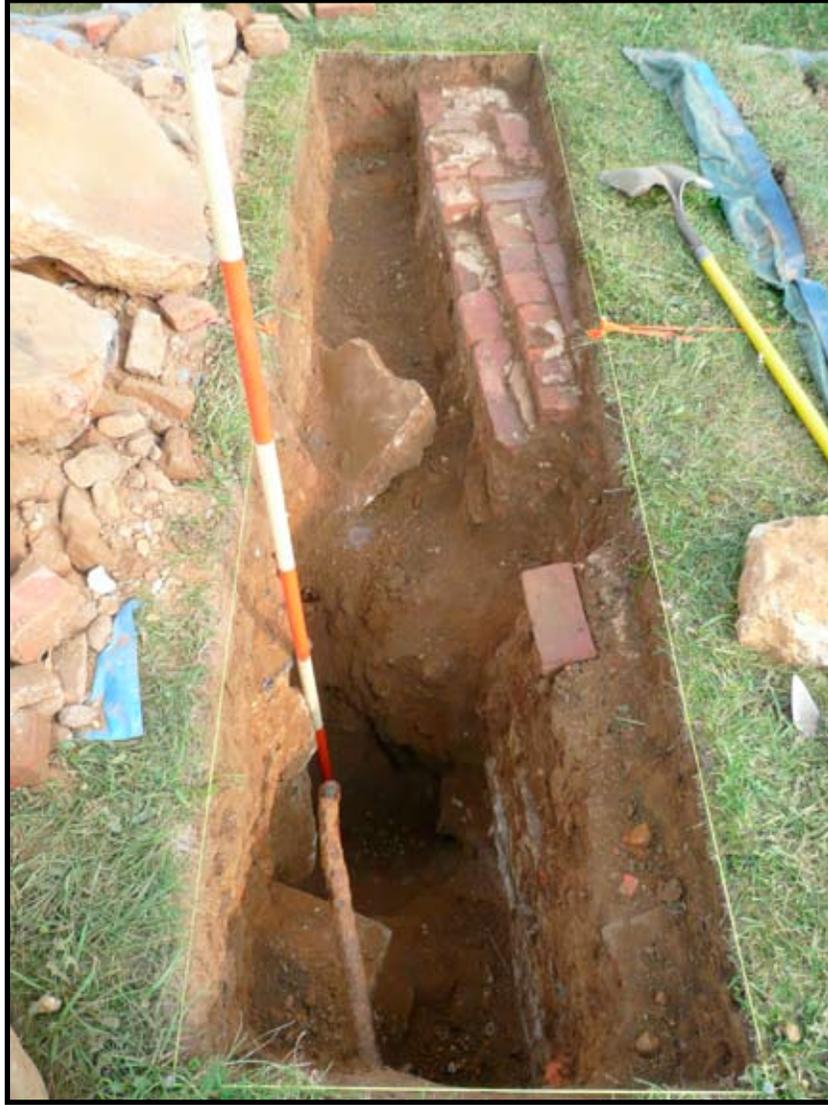
The location of the 1932 two-story frame structure, posited as Boyd's house/store, was plotted in the field from as-built maps so that units could be best positioned to locate the north and south walls. The first unit (EU 1) failed to locate any foundation walls but did recover over 300 artifacts, several dating to the early 19th century, but most dating to the mid- and late 19th century. Excavation Unit 2 encountered the foundation of Boyd's house/store immediately below the sod (Plate 2). From the historic map data this unit was expected to encounter the south wall of the foundation. The wall turned out to be the front or eastern foundation wall of the house/store. The wall is of stone construction with three courses of brick on the top. The west side of the wall exhibits a thick layer of whitewash down to at least four and a half feet below the top of the wall. The foundation wall was disturbed by a tapering circular hole, interpreted as a shovel test pit excavated during the phase I survey of the property. The exact bottom of the wall was not obtained due to massive amounts of debris in the form of concrete slabs that appear to be former bits of U.S. Route 13 pavement. The exposed depth, coupled with the presence of whitewash, suggest the structure had a full basement rather than a crawlspace.

Plate 2. Boyd's Store and House site [7NC-G-169; CRS N-12742]: View of Excavation Unit 2 looking north showing the front/eastern foundation wall of the house/store (Photographer: Sue Ferenbach, October 2007) [HRI Neg.# 07051/D2:26].

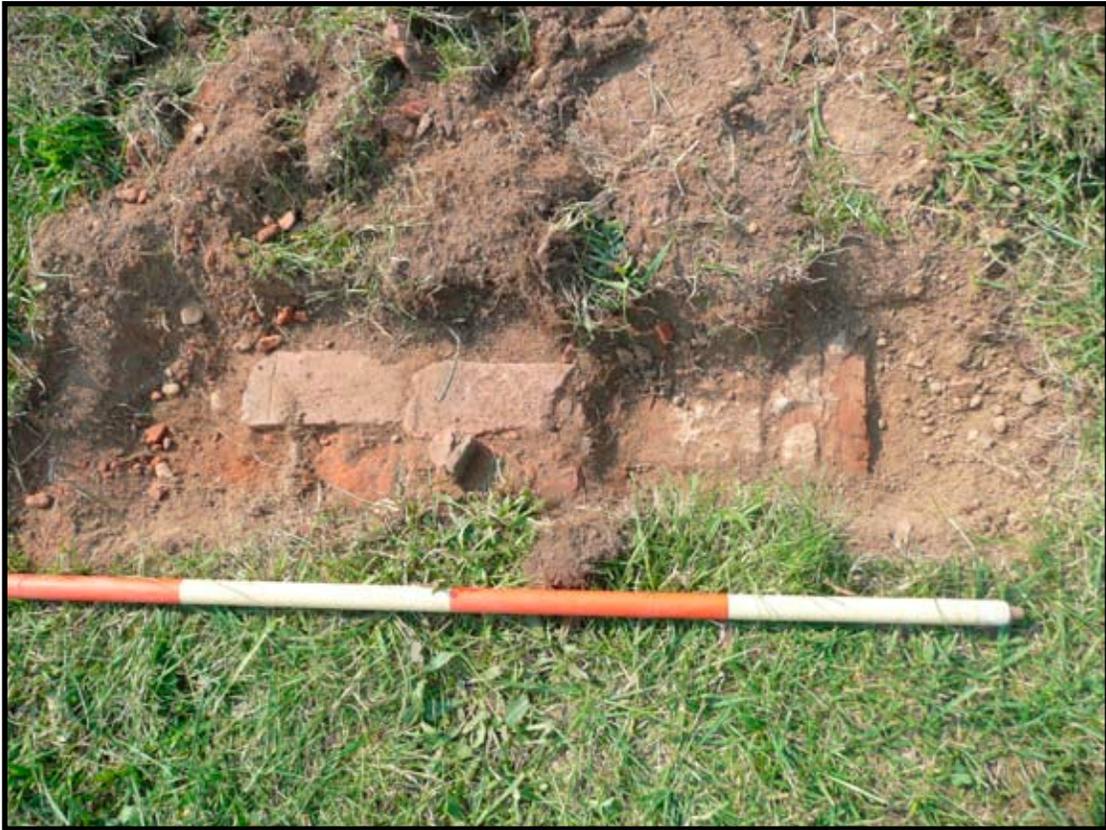
By following the foundation with a steel probe the eastern/front wall was found to be 37 feet in length. The northeastern corner was easily located by removing the sod (Plate 3). No formal excavation unit was deployed for further examination here. The southeastern corner proved more difficult to locate. A three-foot-square unit (EU 14) was initiated and was expanded south, following the wall an additional three feet until it became clear when the wall turned (Plate 4). This complex unit also successfully located the cut and foundation for the front porch.

Plate 3. Boyd's Store and House site [7NC-G-169; CRS N-12742]: View looking west of front/northeastern corner of foundation wall of the house/store (Photographer: Sue Ferenbach, October 2007) [HRI Neg.# 07051/D2:35].

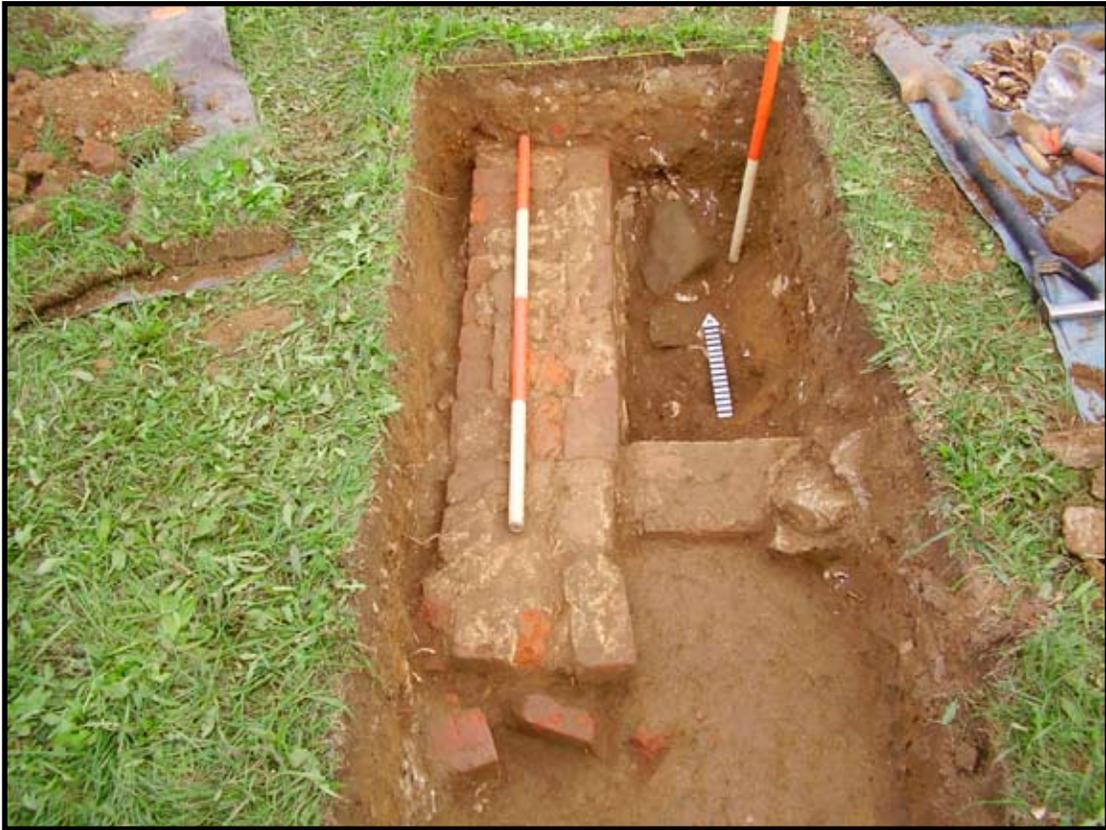
Plate 4. Boyd's Store and House site [7NC-G-169; CRS N-12742]: View of Excavation Unit 14 looking north showing the front/southeastern corner of foundation wall and porch of the house/store (Photographer: Sue Ferenbach, November 2007) [HRI Neg.# 07051/D4:9].

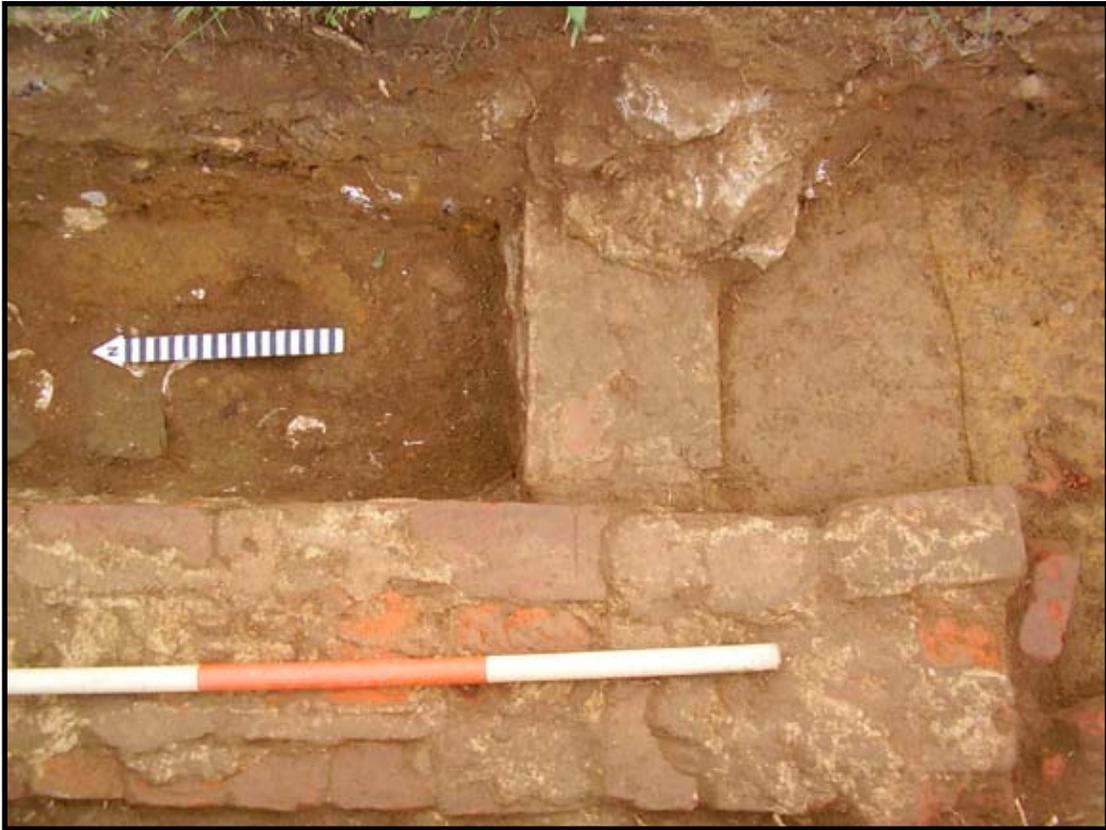
A brick drain was first located south of the house/store foundation in Excavation Unit 3 (Plate 5). The drain was constructed from brickbats, most half with some three quarters length. Several of the bricks exhibited “glazed” headers. None of the bricks exhibited any signs of mortar, implying they were left over or broken bricks not employed in the construction of the house/store and used specifically for the construction of the drain. The brick forming the sidewalls exhibit a slight angle inward with the bottom or floor of the drain formed by the shiner or bull stretcher surface of the brick. The top of the drain was not present and thus open to speculation (wood planks, brick, stone, or none). The drain was disturbed by a circular hole, interpreted as a shovel test pit excavated during the phase I survey of the property.

Plate 5. Boyd's Store and House site [7NC-G-169; CRS N-12742]: View of Excavation Units 3 and 5 looking west showing a brick drainage system located south of the house/store (Photographer: Sue Ferenbach, November 2007) [HRI Neg.# 07051/D4:13].

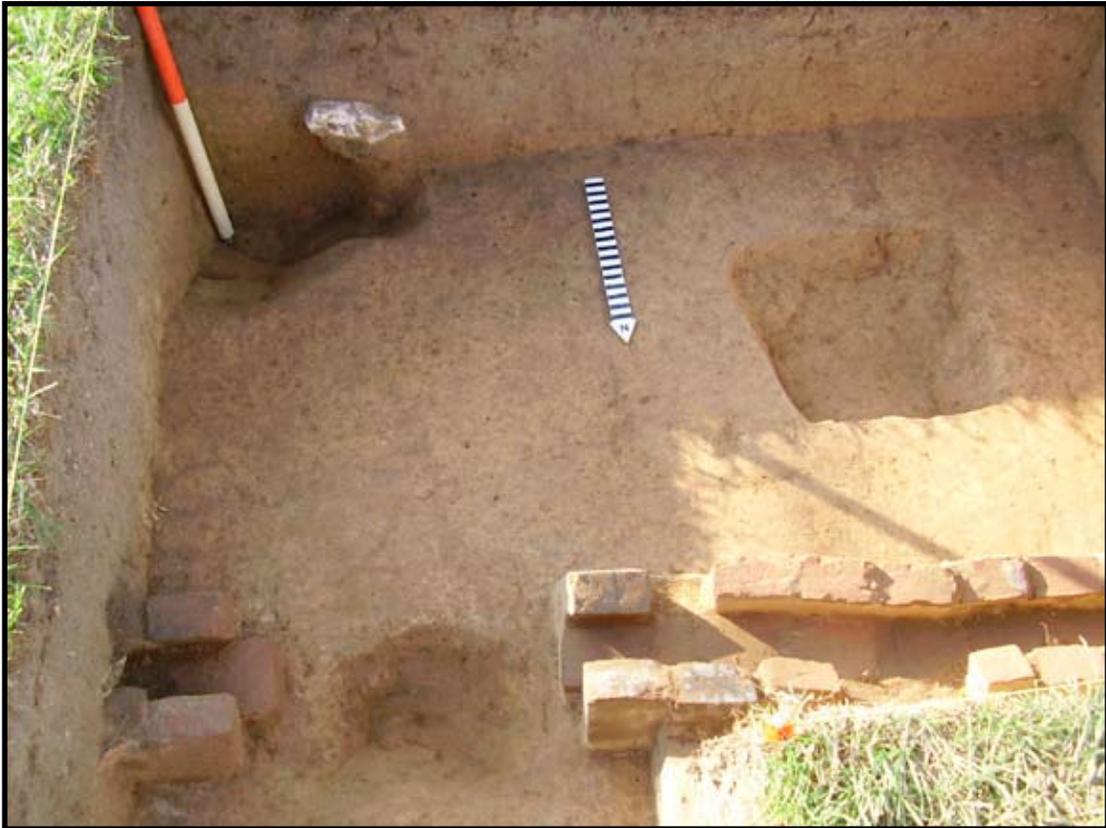
A possible pit or cut was observed near the drain (Plate 6). This circular feature was situated in the southeastern corner of the unit and contained two large pieces of lime. The majority of the feature extends south and east of the limits of the excavation unit. The function of this pit is indeterminate at this time, but the presence of lime may

indicate the feature could be a privy as lime was typically used to help break down organic matter in privies.

Plate 6. Boyd's Store and House site [7NC-G-169; CRS N-12742]: View of Excavation Units 3 looking south showing a cut of a possible privy pit (upper left) with a large chunk of lime in the side wall and a possible truncated posthole on the right with the brick drain in the foreground (Photographer: Sue Ferenbach, November 2007) [HRI Neg.# 07051/D4:59].

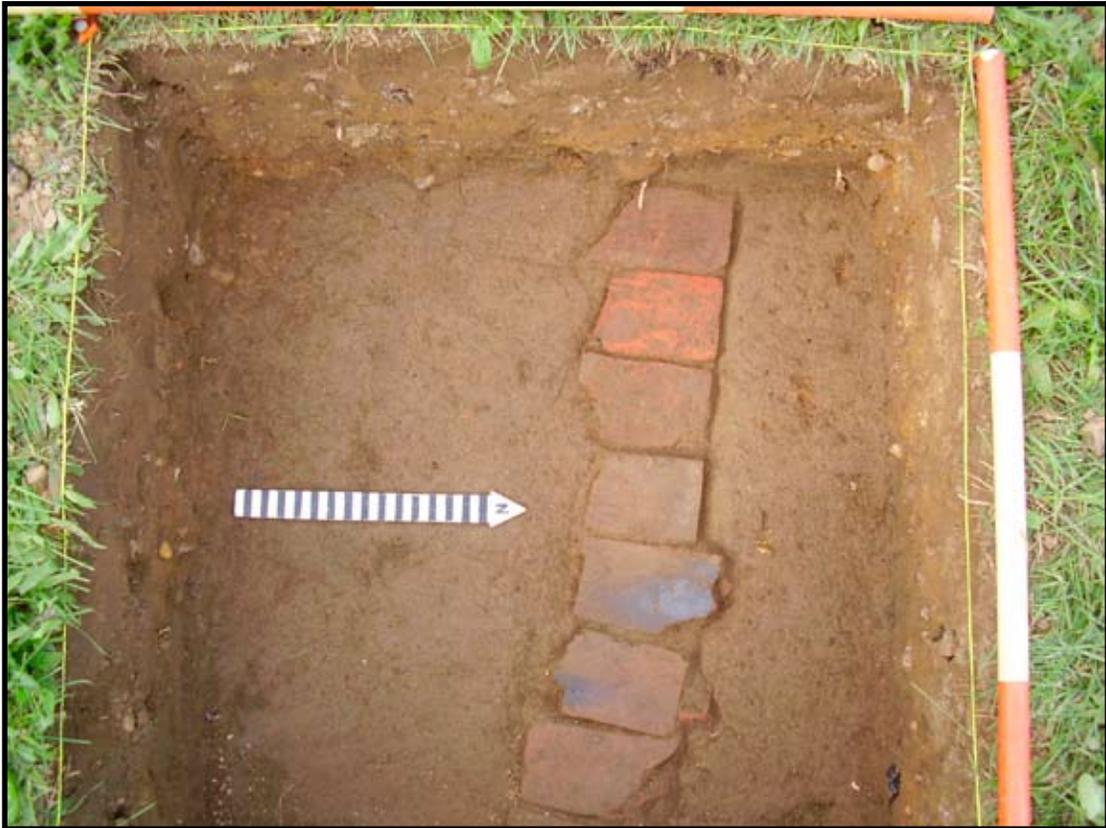
Plate 7. Boyd's Store and House site [7NC-G-169; CRS N-12742]: View of Excavation Unit 15 looking west showing intact, covered brick drainage system located south of the house/store (Photographer: Sue Ferenbach, November 2007) [HRI Neg.# 07051/D4:17].

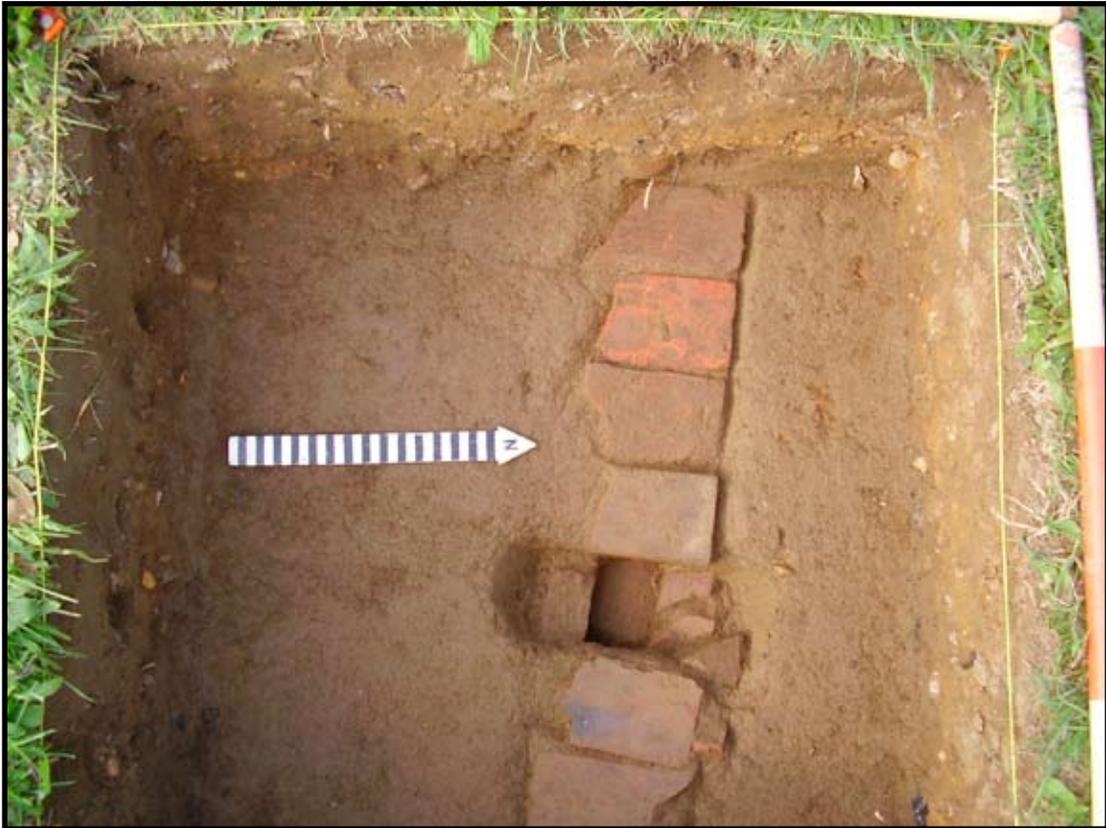
Plate 8. Boyd's Store and House site [7NC-G-169; CRS N-12742]: View of Excavation Unit 15 looking west showing intact, covered brick drainage system located south of the house/store with one brick removed from cover (Photographer: Sue Ferenbach, November 2007) [HRI Neg.# 07051/D4:19].

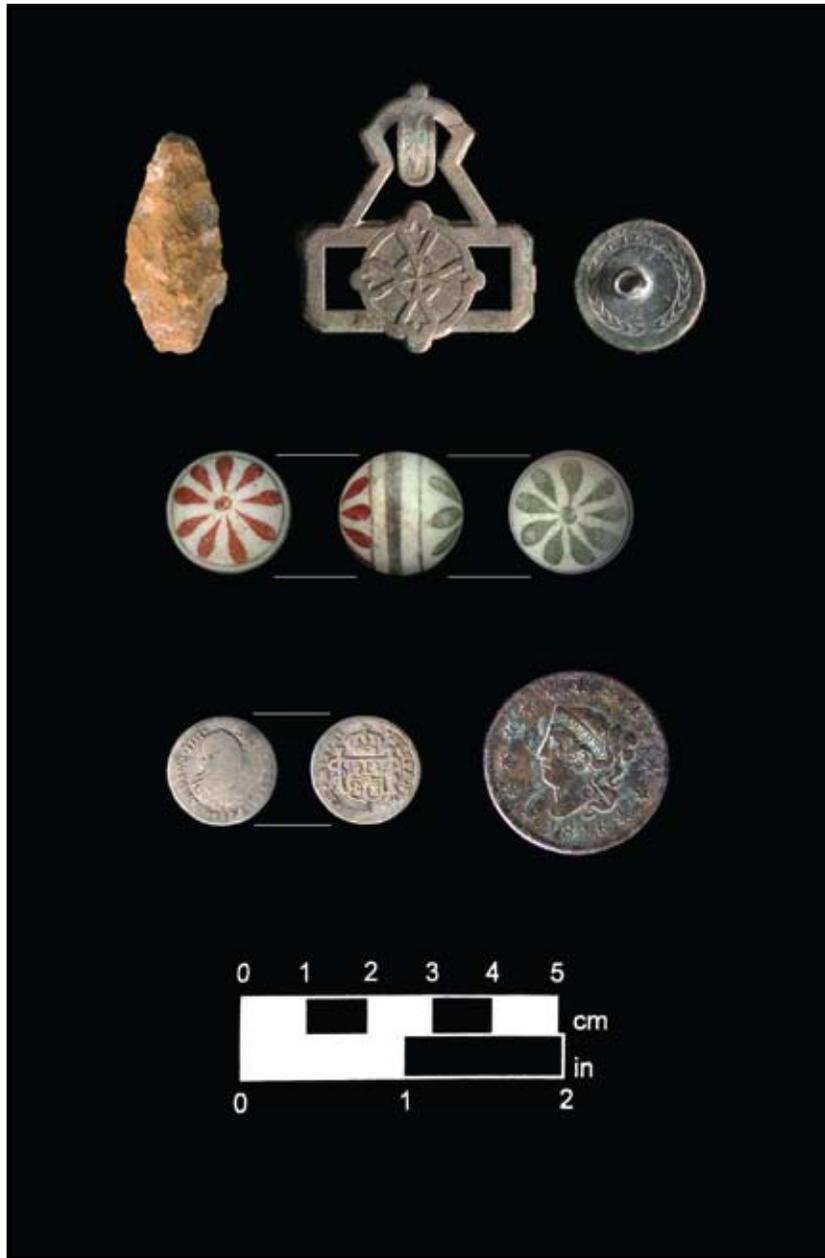
Of particular interest were two coins recovered from the level of the drain (Contexts 2 and 3) (Plate 9). The first was a Spanish silver half-real dated 1806. The front side exhibits a bust of King Carlos the IV and the reverse side exhibits the arms of Castile and León, between the Pillars of Hercules (the Straights of Gibraltar). The text on the coin, which was minted in Mexico City, Mexico, reads “DEI GRATIA. 1806. CAROLUS. IIII HISPAN. ET IND. R. M. T.H” which translates to By the Grace of God 1806 Charles IV King of the Spains and of the Indies, Mexico City Mint. This coin was considered legal tender in the United States until 1857. The second coin was a U.S. large cent, dated 1816 depicting a bust of Lady Liberty surround by 13 stars on the front. This type is known as the matron head variety of the coronet type first minted in 1816. Although not of course unknown on domestic sites, items of commerce are likely to be more common at stores or taverns where money would be changing hands on a more frequent basis.

Plate 9. Boyd's Store and House site [7NC-G-169; CRS N-12742]: Selected artifacts recovered from the southern portion of the project area, Top Row (left to right): small jasper stemmed projectile point [EU 17, context 3]; alloy buckle [EU 4, context 2], brass button stamped "GILT" [EU 16, context 2]. Middle Row: three views of a hand-painted porcelain marble [EU 4, context 2]. Bottom Row (Left to right): Spanish silver half real dated 1806 minted in Mexico City, Mexico. The front side exhibits a bust of King Carlos the IV and the reverse side exhibits the arms of Castile and León, between the Pillars of Hercules [EU 16, context 2], U.S. large cent, dated 1816 depicting a bust of Lady Liberty surround by 13 stars [EU 16, context 3] (Photographer: Marjan Osman, November 2007) [HRI Neg.# 07051/D5:01].

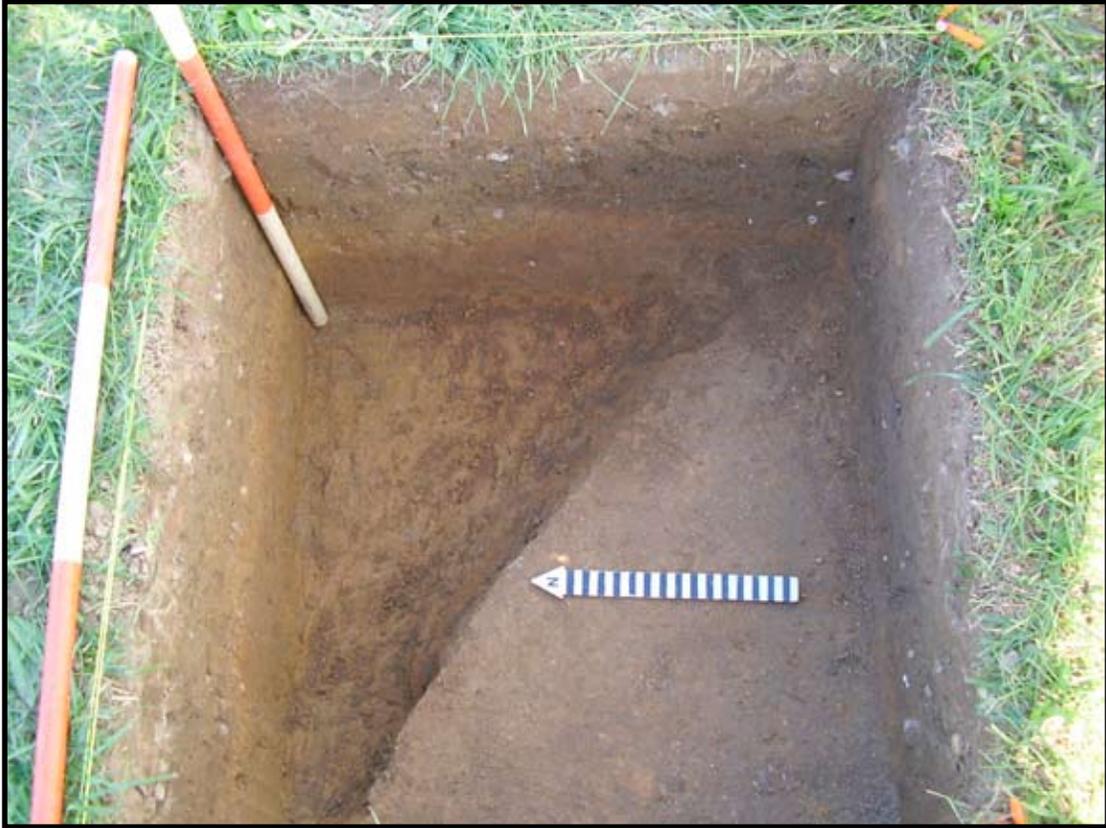
Two features were encountered in the field but were not positively identified as to their function. The first feature was observed in EU 17, this was a deep irregular cut with soils similar to the C horizon clays but slightly mottled. Initially it was thought to be an extremely old groundhog den but upon excavation appears to be a possible erosional gully naturally cut down into the subsoil (Plate 10). The feature extended beyond the limits of the unit to the north and east. The few artifacts recovered from the fill date to the 19th century. The second feature, located in EU 18, also exhibits soils similar to the C horizon but in this case the feature was circular similar to a tree planting (Plate 11). Once again only a few artifacts were recovered from this feature dating to the early 19th century. A small portion of this feature extends beyond the limits of the unit to the north.

Plate 10. Boyd's Store and House site [7NC-G-169; CRS N-12742]: View of Excavation Unit 17 looking east showing an unidentified historic feature, possibly a gully (Photographer: Sue Ferenbach, November 2007) [HRI Neg.# 07051/D4:05].

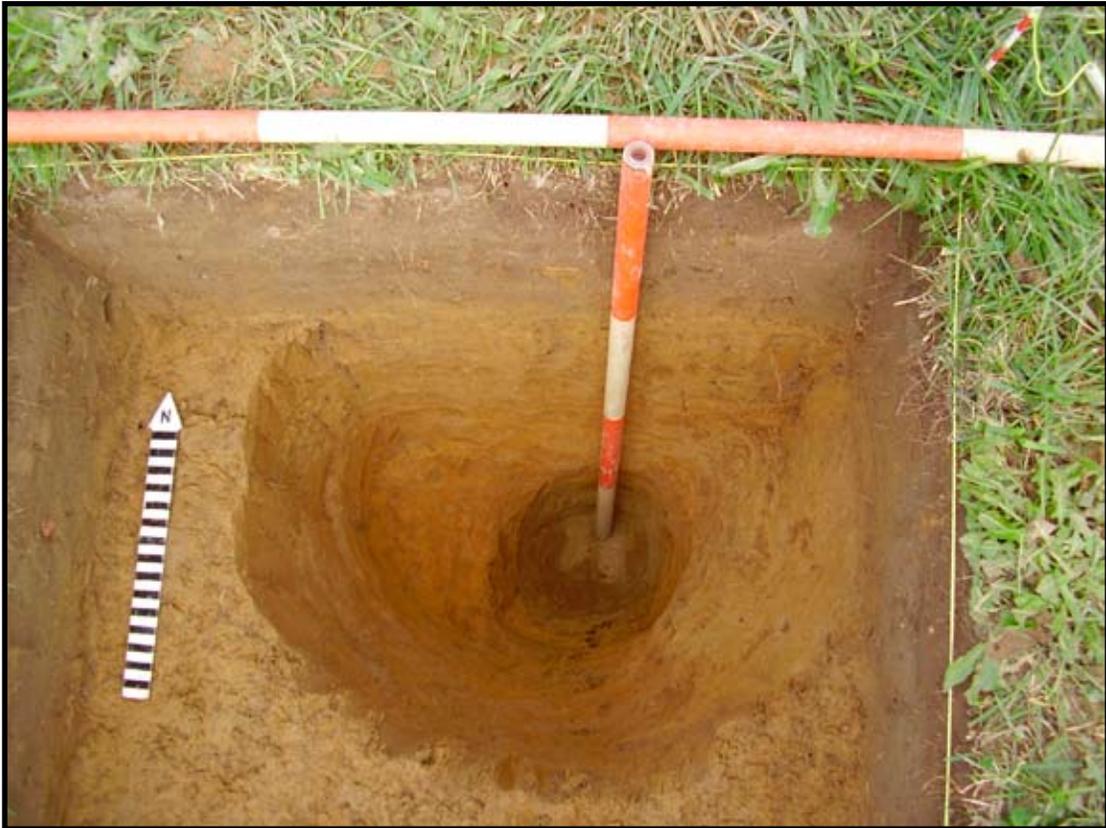
Plate 11. Boyd's Store and House site [7NC-G-169; CRS N-12742]: View of Excavation Unit 18 looking north showing and an unidentified feature, possibly a historic tree planting (Photographer: Sue Ferenbach, November 2007) [HRI Neg.# 07051/D3:06].

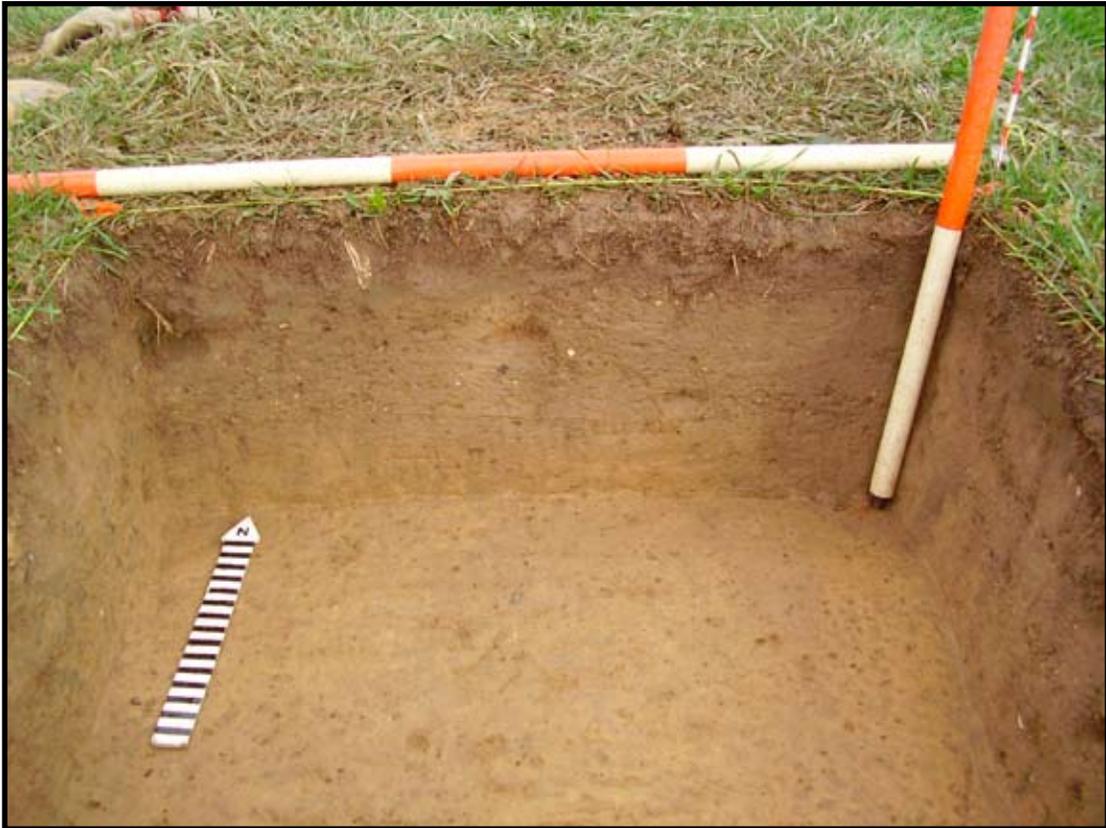
Units excavated within the semi-circular driveway east of the right-of-way line failed to locate any structural evidence of the farm complex shown on the as-built plans. Excavation Units 12 and 13 each exhibited postholes likely associated with a former fence line or an extension of the former stable. In both cases the upper stratigraphy of the postholes was truncated. In general the entire area within the semi-circular motel driveway appears to have had the A and B horizons stripped and then capped by a layer of topsoil (Plate 13). It is not certain when this occurred but it seems likely it may have happened when the motel was built or perhaps during one of the road widening events for U.S. Route 13. A metal anchor for a former utility pole encountered in EU 10 suggests utility poles may have been moved as a result road widening and possibly stripped to create a level grade (Plate 14). Three shovel tests placed along the western edge of the right-of-way exhibited a similar profile as the excavation units.

Plate 13. Boyd's Store and House site [7NC-G-169; CRS N-12742]: View of Excavation Unit 12 looking north showing the truncated northern soil profile (Photographer: Sue Ferenbach, October 2007) [HRI Neg.# 07051/D2:51].

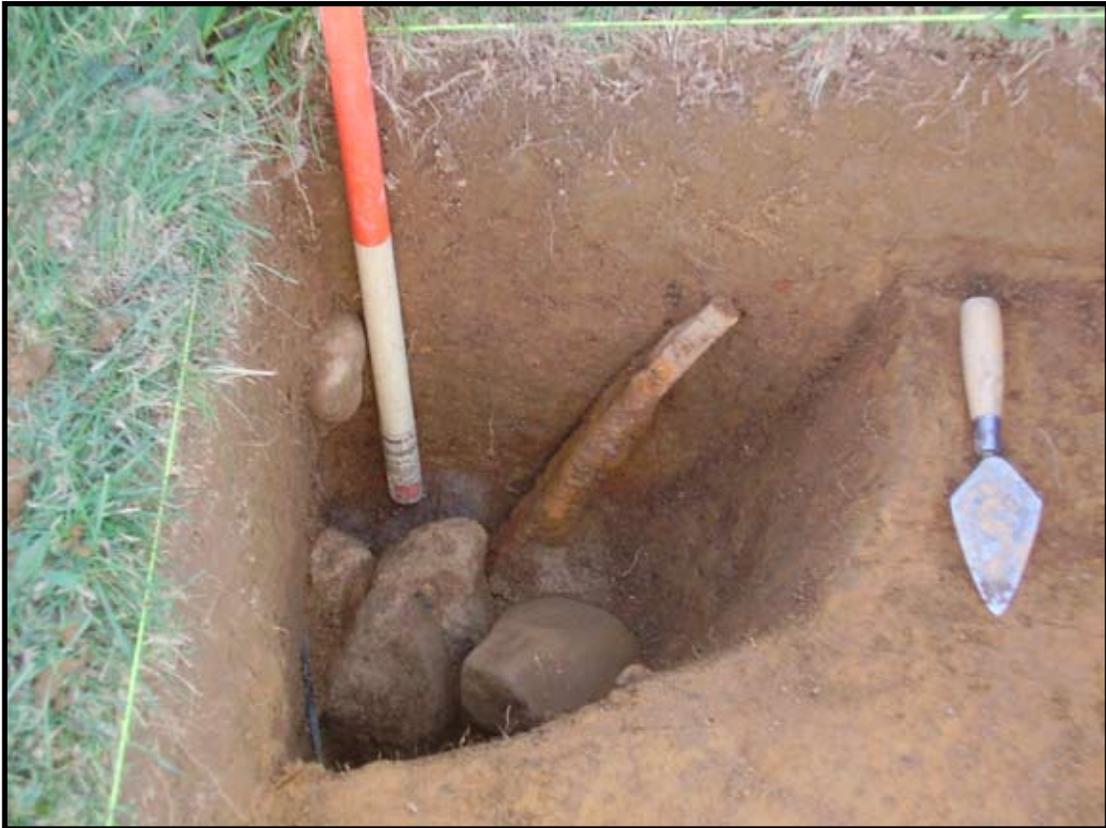
Plate 14. Boyd's Store and House site [7NC-G-169; CRS N-12742]: View of Excavation Unit 10 looking south showing a metal anchor surrounded by cobble and cement for a former utility pole (Photographer: Sue Ferenbach, October 2007) [HRI Neg.# 07051/D4:48].
