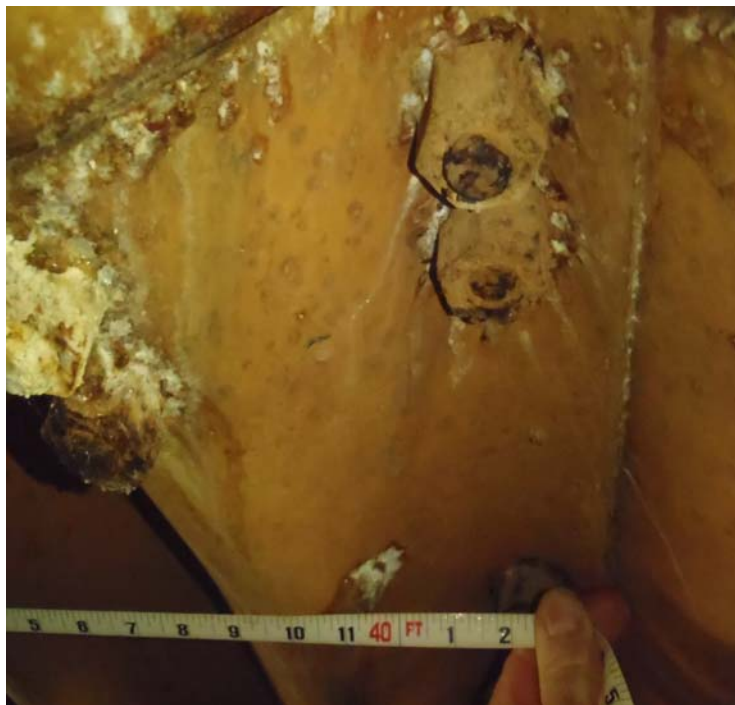
6. SPAN 1, W CELL, SMALL CORROSION BLISTERS & PITTING ON FASTENERS LOOK E

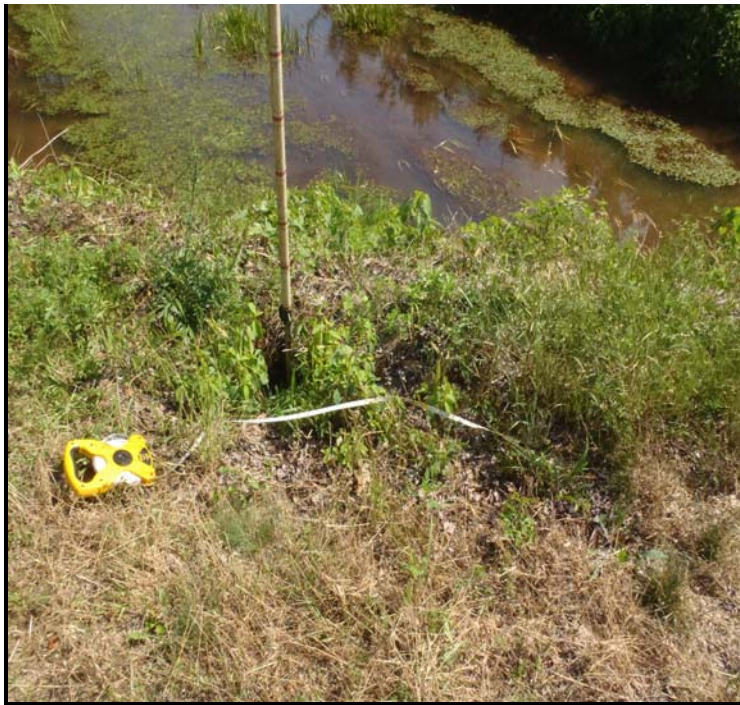
7. EROSION BETWEEN SPANS 1 & 2 IN THE NORTH SACK
RIPRAP HEADWALL LOOK NORTH

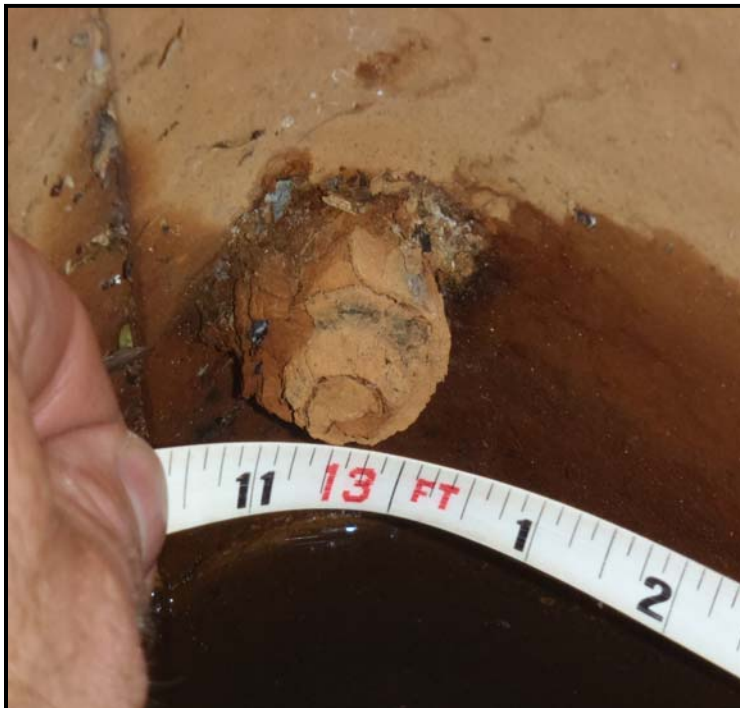
8. SPAN 2, E CELL, FASTENER SECTION LOSS AT 13 FEET FROM N END,
LOOKING EAST
