## **ARCHITECTURAL RESOURCE INVESTIGATIONS**

## **INVENTORY OF HISTORIC ARCHITECTURAL RESOURCES**

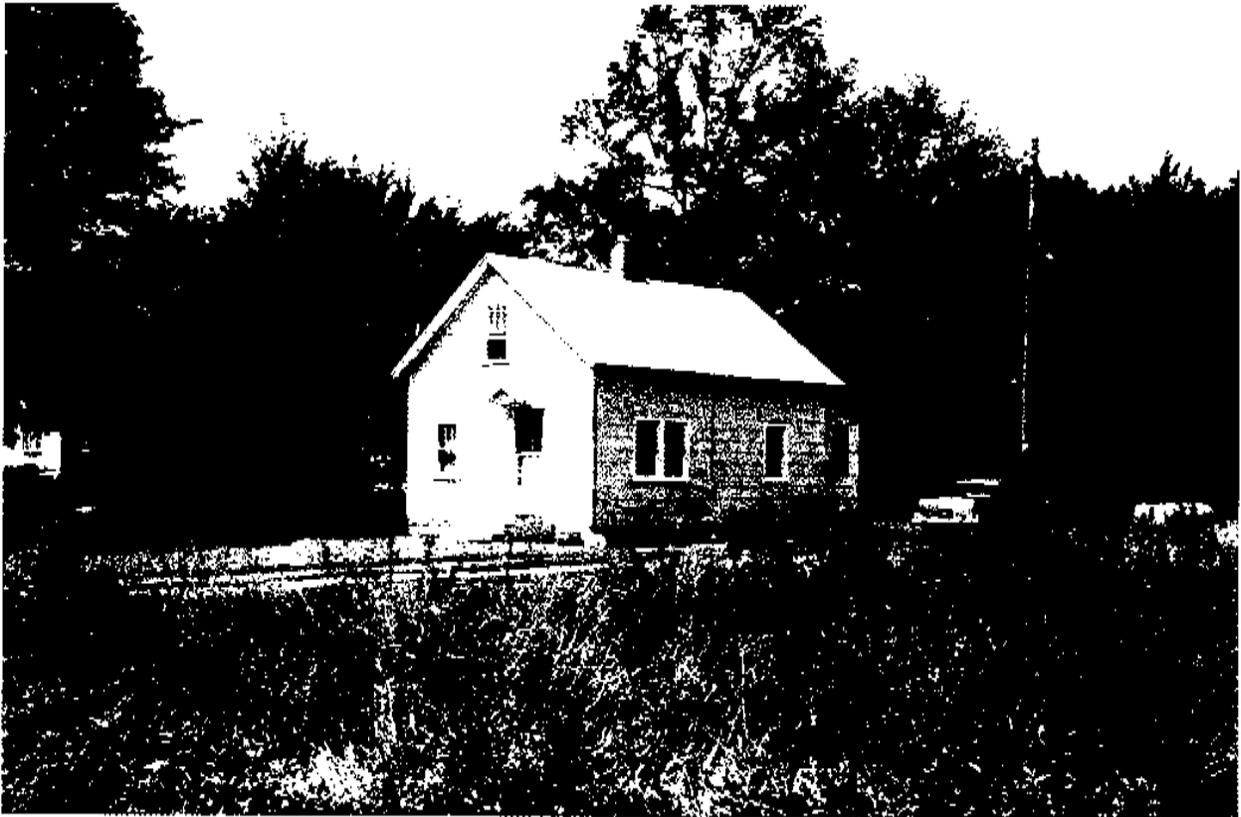
**PLATE 1: Building 1, Brenda Dantonio House, View to Northwest**

**Description:** This house, dated visually to the 1920s-30s period, is a very small 1 1/2-story frame dwelling with front gable orientation, set on a cast concrete block foundation. The exterior is clad with wide asbestos shingle siding, and the roof with composition shingles. A short brick chimney is centered on the roof ridge. The main (south) elevation is two bays wide, with entrance toward the west end, sheltered by a small gabled hood. Double-hung window sash, with 3/1 lights, are set in flat frames with narrow drip shelves.

**Evaluation:** This house does not constitute a significant representation of the small Craftsman house or "bungalow" type. No documentary basis for association with important persons or events has been identified. Integrity of materials is diminished by application of modern artificial siding. The house does not appear to meet National Register Criteria for Evaluation, and no further work is recommended.

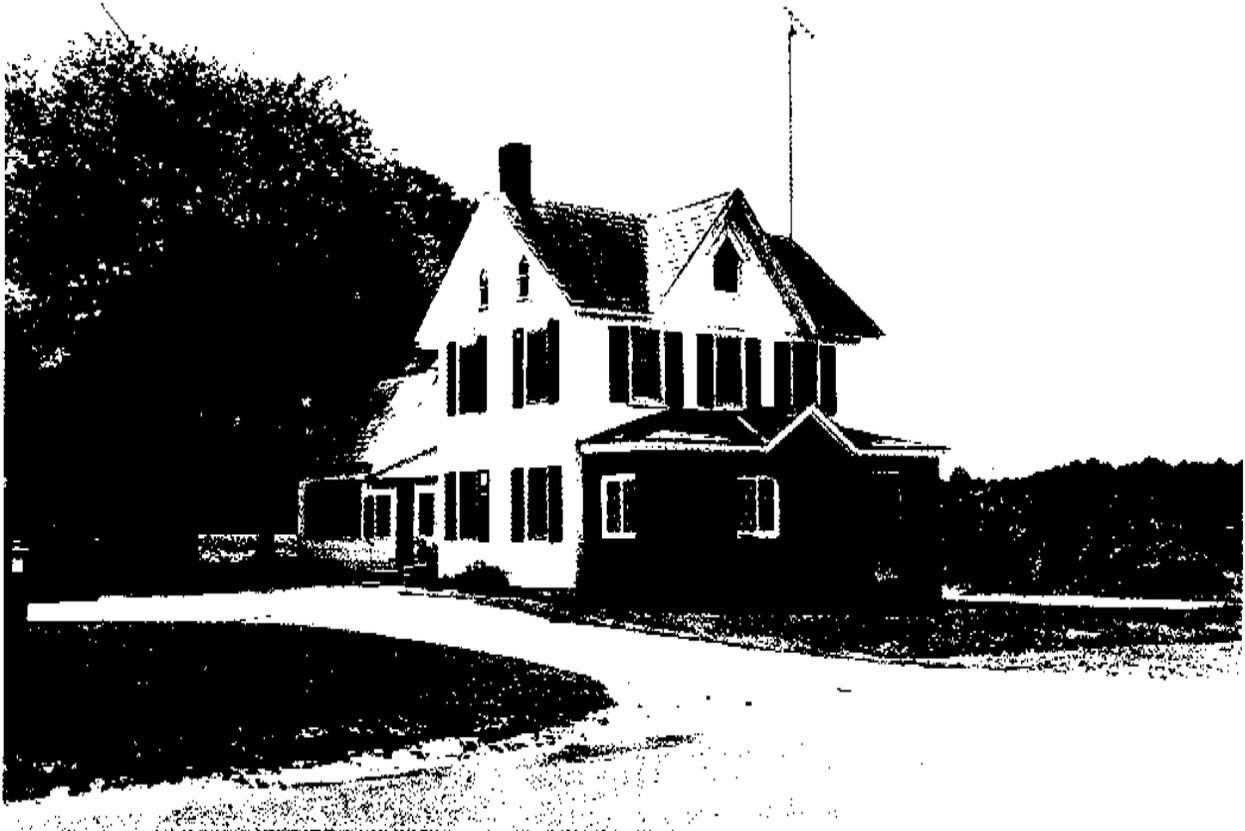
**PLATE 2: Building 2, Harry Swain House, View to Southwest**

**Description:** This late nineteenth-century house is a two-story side-gable dwelling of frame construction on a brick foundation. The main (north) elevation is divided into three bays, above which rises a centered gabled dormer. The house has a full-height rear ell, to which are attached a one-story gabled frame kitchen unit and a shed-roofed enclosed porch. The exterior of the house is covered with asbestos siding which obscures the trim of window openings fitted with 1/1 aluminum sash. Small triangular-headed windows are set within the east and west gable ends, and in the front dormer, to illuminate the attic. A full-length porch across the front has been completely enclosed with brick walls. To the rear of the house is a small side-gable barn, with wood-shingled exterior painted red, used as a garage.

**Evaluation:** This building is a representative example of a regional variation on the two-story, hall-parlor-plan house type, in which the basic side-gable, single-pile block is ornamented with a center front gable and (often but not always) triangular-headed attic windows. However, the house lacks integrity of design and materials as a result of installation of metal window elements and aluminum siding and the visually and historically inappropriate use of brick to enclose the front porch. No documentary basis for association with important persons or events has been identified. It does not appear to meet National Register Criteria for Evaluation, and no further work is recommended.

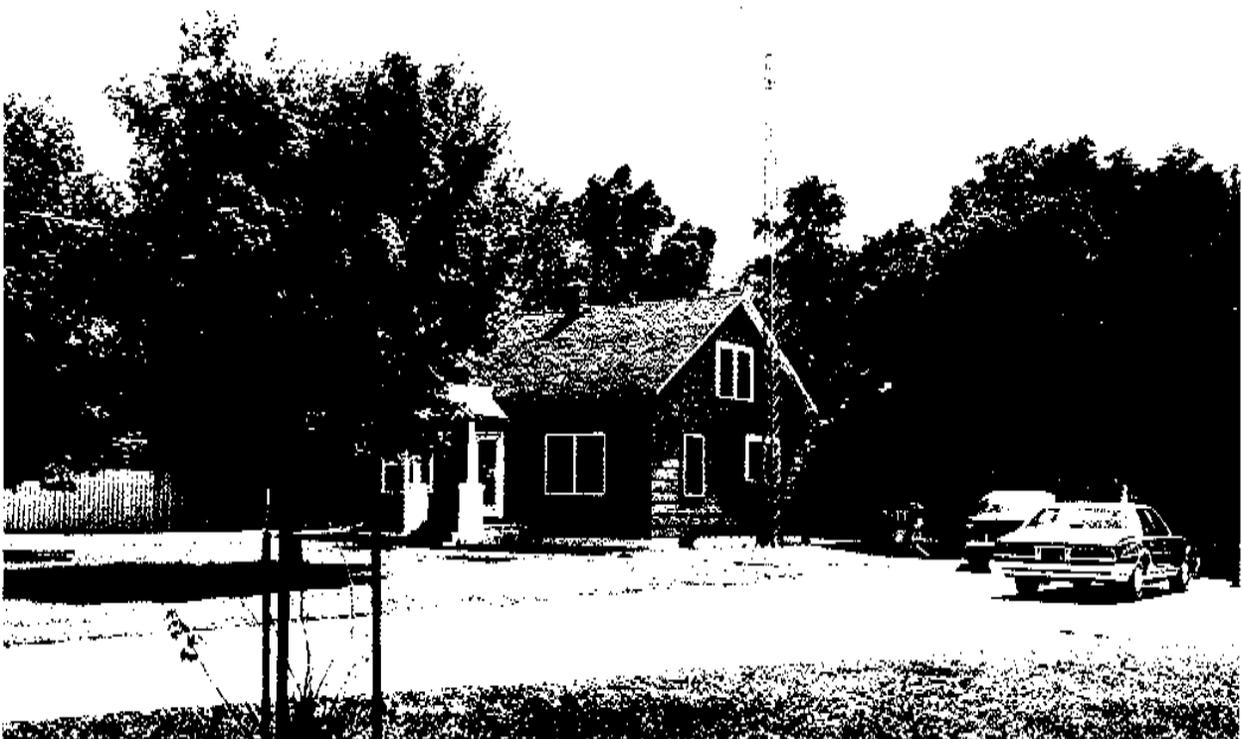
**PLATE 3: Building 3, John T. Fitzgerald House, View to Southeast**

**Description:** This house is a 1 1/2-story side-gable frame Craftsman "cottage" set on a low concrete basement. Exterior walls are clad with gray asbestos shingle siding, the roof with composition shingles. A short brick chimney is centered on the roof ridge. The main (north) elevation is symmetrically divided into three bays, with paired 1/1 windows flanking a center entrance sheltered by a gabled porch. The porch roof is supported on thin wood posts set on high concrete block piers. A one-room kitchen unit is projected off the rear.

**Evaluation:** This house is an example of early 20th century, Craftsman-derived residential architecture, but lacks qualities of clear architectural distinction as well as integrity of exterior materials. No documentary basis for association with important persons or events has been identified (although the present owner is a member of the Fitzgerald family associated with the auto salvage business across the road (see below)). It does not therefore appear to meet National Register Criteria for Evaluation, and no further work is recommended.

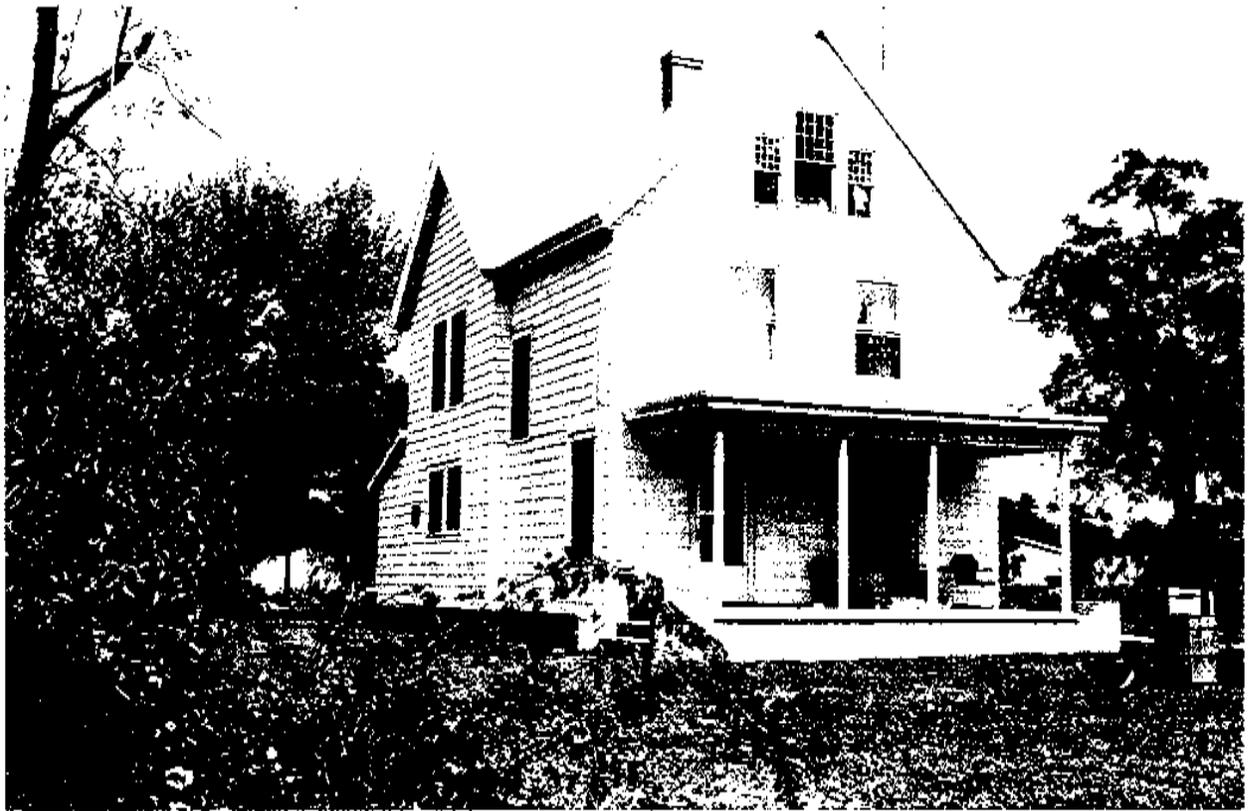
**PLATE 4: Building 4, John T. Fitzgerald, Sr., House, View to North**

**Description:** This property, located on a 1.1-acre lot, consists of an early twentieth-century, 2 1/2-story frame dwelling with front-gable orientation and side-hall plan. It is set on a brick foundation and sheathed with aluminum siding. At the rear, behind the short brick chimney projecting from the ridge, the roof forms a cross-gable to reflect the slight projection of the walls below. Window openings have flat surrounds and 1/1 sash. Three windows, the upper sash of which contain colored glass lights, are arranged in "Palladian" fashion in the front gable at attic level. The full-width front porch is raised on a concrete slab, and has a hipped-roofed porch supported on thin wood posts. An enclosed lean-to kitchen unit extends across the rear.

**Evaluation:** According to the present owner, Alvin Fitzgerald, this house was built between 1906 and 1908. It was the lifetime residence of John T. Fitzgerald, Sr., who founded Fitzgerald's Auto Salvage on adjacent property at the corner of Route 113 and Road 207 in 1935. The form, massing, and front-gable orientation of the house are more commonly found in more urbanized areas of lower Delaware (a number of similar examples can be found in Milford, for example). It is thus something of an architectural curiosity in the still relatively undeveloped Route 113 project area. Nonetheless, it lacks qualities of clear architectural distinction, and integrity of materials has been diminished by application of aluminum siding. The house thus does not appear to meet National Register criteria for architectural significance. However, it possesses direct association with the adjacent Fitzgerald's Auto Salvage complex and thus meets National Register Criterion C as a contributing element to that complex. See next entry for further elaboration.

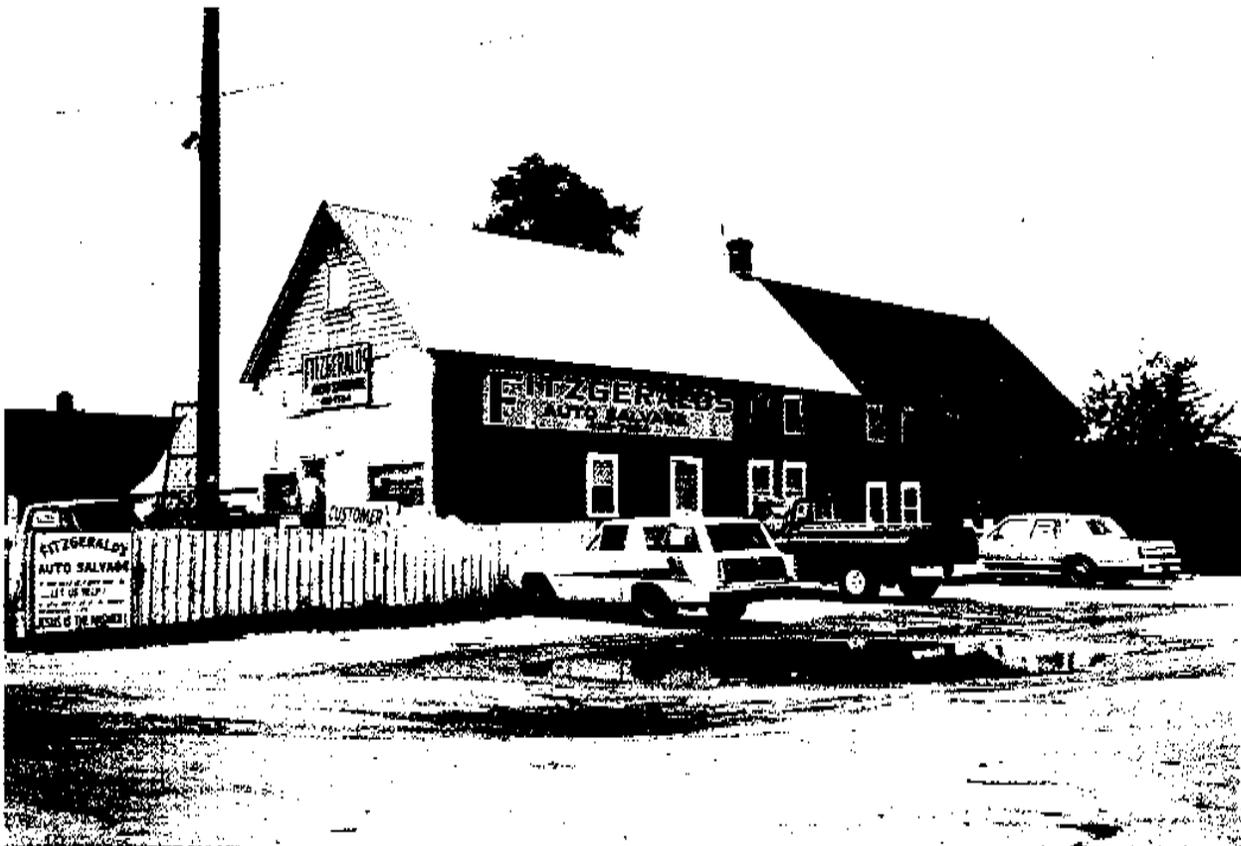
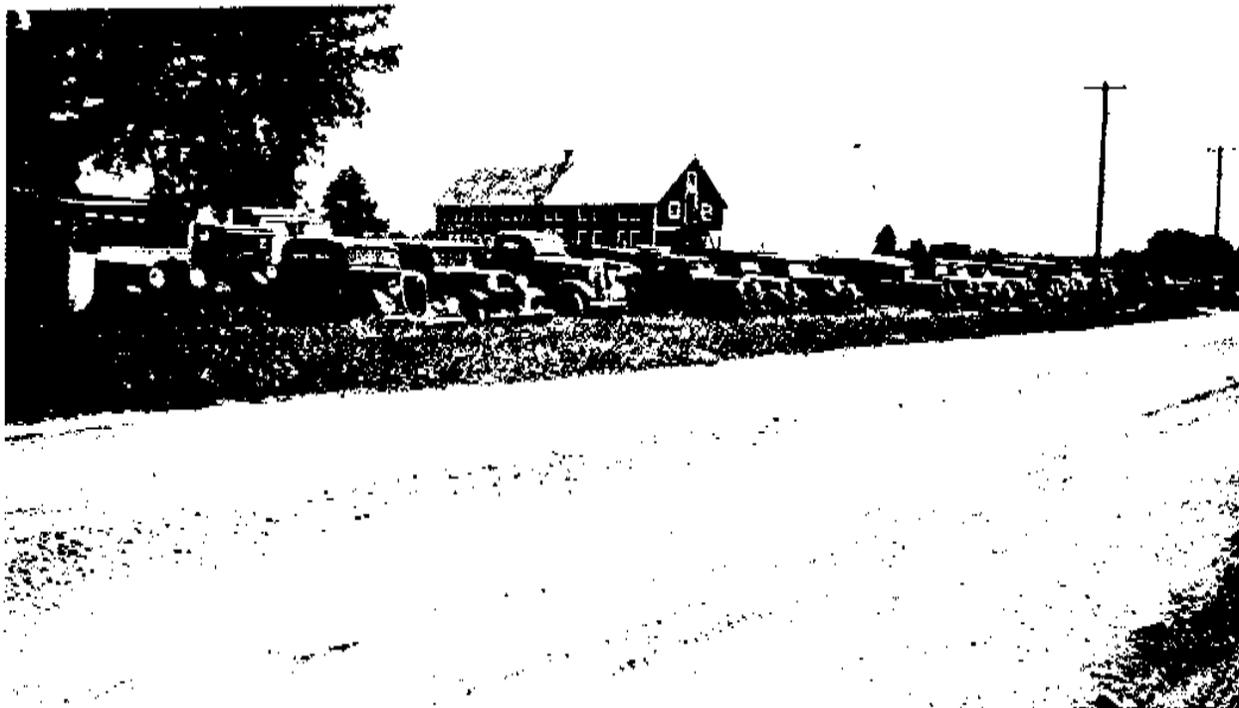
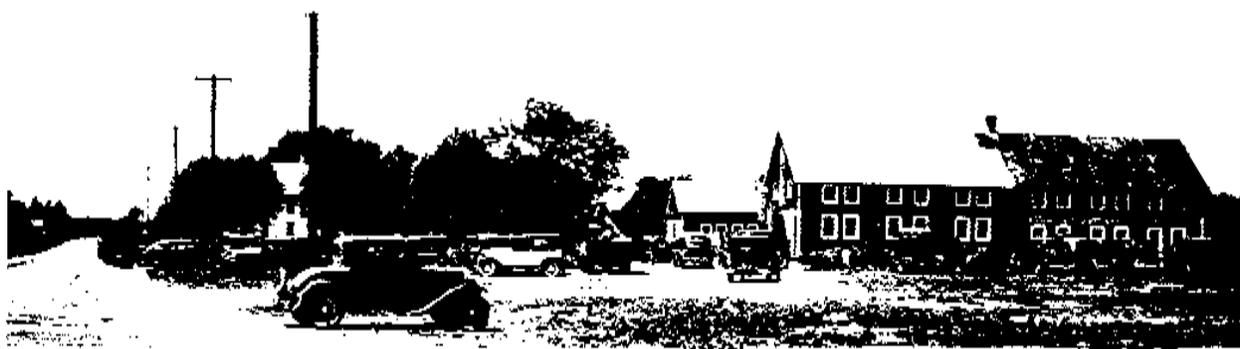
**5. Fitzgerald's Auto Salvage (S-3941)  
Road 207 at Route 113 (1-30-6-88)  
(Plates 5, 6, 7)**

**Description:** This commercial enterprise occupies some 40 acres at the northwest corner of the Route 113-Road 207 intersection. Apart from a gravel parking lot along Route 113, the tract is devoted to an extensive scrap yard containing hundreds of automobiles, a large number of buses, heaps of tires, and piles of steel debris. Toward the southeast corner of the property, fronting on Road 207, is the administrative center of the concern. The principal building, situated nearest and parallel to Route 113, is a two-story frame building with front-gable orientation, set on a concrete foundation and clad with brown wood shingles. The long side elevations are divided into 12 bays by regularly spaced 6/6 and 2/2 windows very subtly grouped in pairs. Many window openings have been filled in and shingled over, but their placement is still readily evident. A small brick chimney is centered on the roof ridge at the point where the composition roof shingles change color. The main (south) elevation is clapboarded, and has a large picture window beside a raised doorway. Immediately within is a public "reception" area, with plank floor and two long wooden counters. To the rear are informally partitioned offices. A second-story entry, originally accessed by a flight of wooden stairs, has been closed and is partly obscured by a wooden sign. West of this building is a smaller frame structure, again oriented to face Road 207. This smaller building is one story high and four bays long, with gable roof. Most of the 6/6 double-hung sash windows have been shingled over, and the large sliding doors at the south end have been replaced with a man-door between two single-sash windows. Toward the rear, a one-story concrete block wing with entrance large enough to accommodate a vehicle extends to the east. Also on the property are several gabled frame sheds and, to the rear of the administrative complex, a large modern, metal-clad building, located within the scrap yard.

**Evaluation:** Fitzgerald's Auto Salvage potentially meets National Register Criterion C as an excellent representative of a particular type of commercial enterprise which emerged in response to the automobile as a perishable commodity in the decades prior to World War II. While businesses such as gas stations, motels and produce stands catered to the auto traveler, others were oriented toward the automobile owner and various stages in the "process" of ownership. In the first stage, new autos were purchased in dealers' sales emporia; in the second stage, repair shops addressed the wear of use; and in the their and last stage, salvage yards offered a means by which ultimately unwanted vehicles could be discarded and, however gradually, recycled. Fitzgerald's Auto Salvage exemplifies the latter type, with its few sturdily functional buildings, built during the 1930's, and extensive scrap yard.

Fitzgerald's Auto Salvage was founded in 1935 by John T. Fitzgerald, Sr., who was born and lived in the front-gabled house directly to the west. The original building of the salvage firm still exists as the southern section of the main building, where the public reception area and business offices are located. Soon thereafter, Fitzgerald erected the smaller frame building to the west, and later expanded the original building to its present length (Mary Fitzgerald, Alvin Fitzgerald, and John "Jack" Fitzgerald, personal communication 31 May 1991). Photographs in the firm's office, appearing to date from the late 1930s or early 1940s, indicate that the two wood frame structures retain a good measure of exterior integrity, in terms of shingle siding and fenestration pattern. The property also retains integrity of association, as three generations of the Fitzgerald family currently participate in the enterprise.

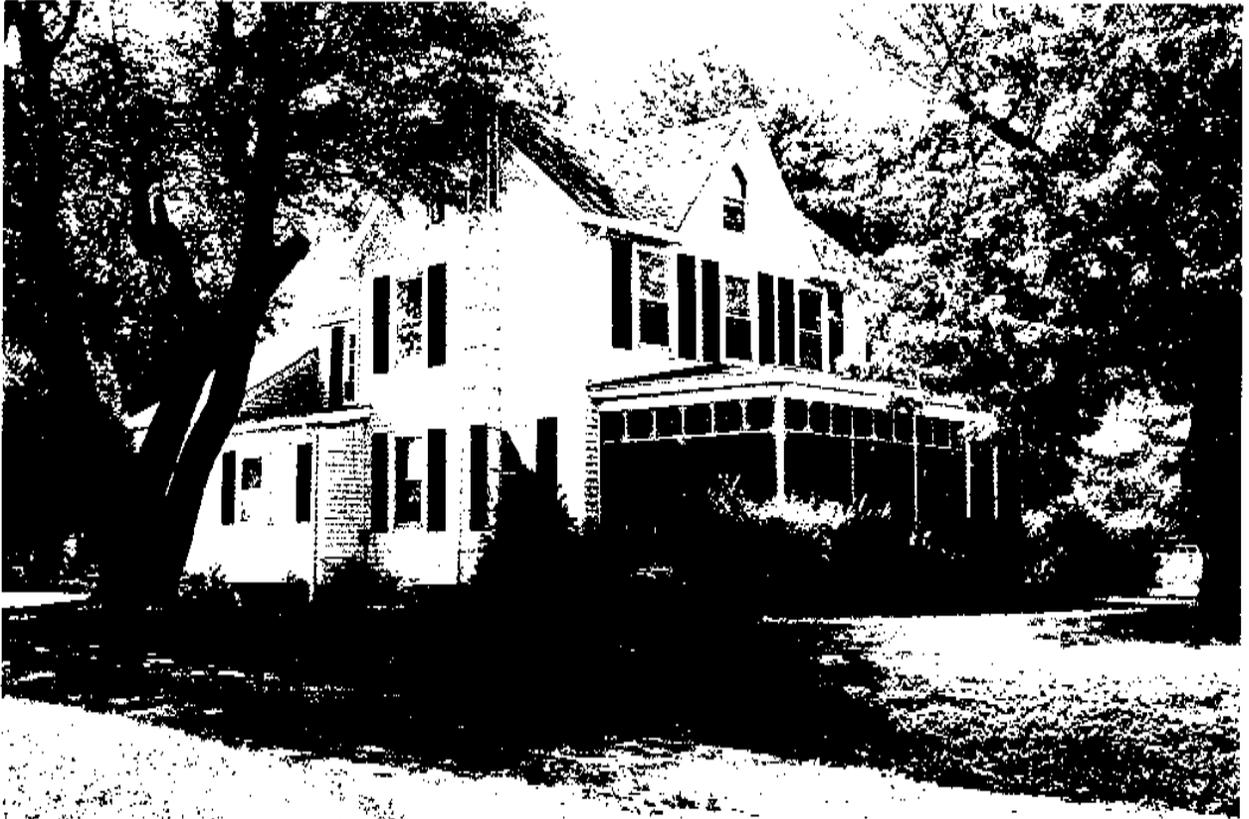
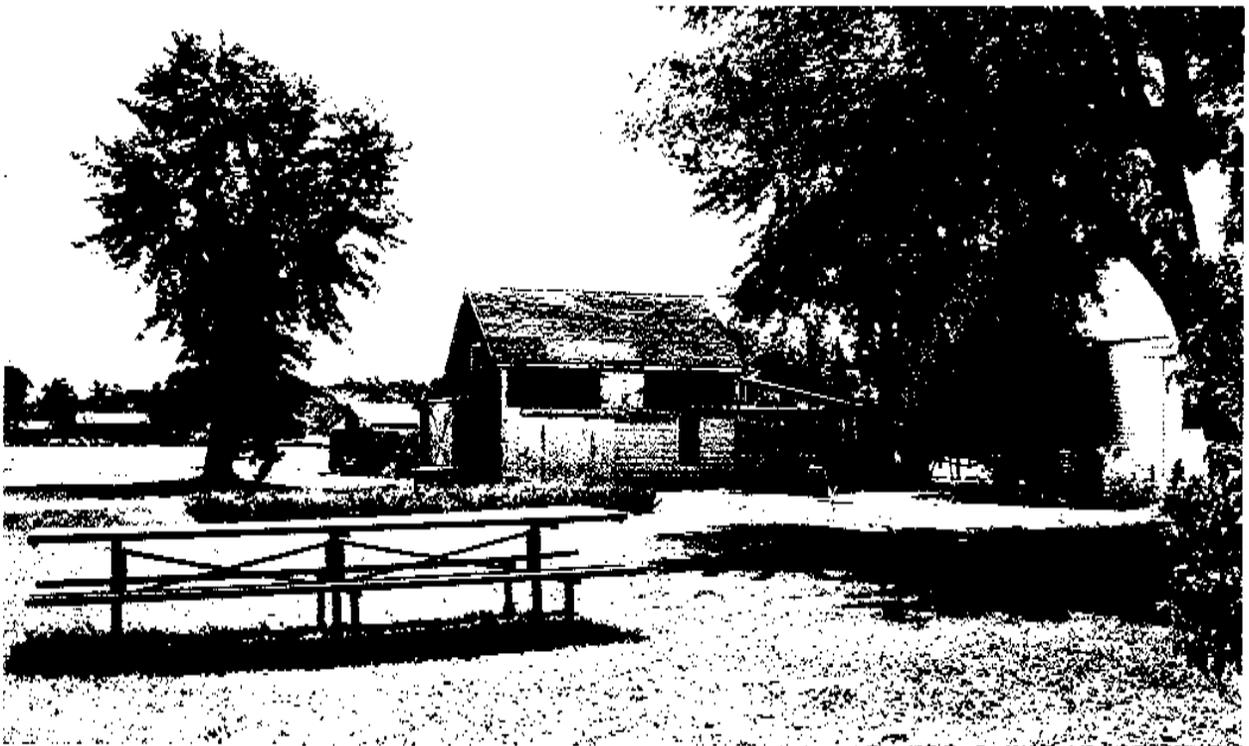
**7. Douglas Morgan House (S-3940)**  
**Road 207 (2-30-5-10.3)**  
**(Plates 9, 10)**

**Description:** This property consists of a late nineteenth-century dwelling and two outbuildings located on the south side of Road 207 east of Route 113. The dwelling is a two-story, three-bay hall-parlor type, with full-height rear ell and screened porch across the front. The re-entrant formed by main block and ell has been enclosed to create one or more additional rooms. A one-room gabled kitchen section, with 3/1 window sash, appears to have been added in the 1920s or 1930s. The aluminum-sided frame house is set on a cinder block foundation, and the side-gable roof is covered with composition shingles. The siding obscures the trim around 1/1 aluminum window sash. Small triangular-headed windows set at attic level in the side gables and in the gabled center-front dormer are distinctive features. A brick chimney rises inside the south gable end (at the rear of the ell).

The two outbuildings are a combination corn crib-machine shed, with lean-to sections flanking a gabled center section raised on clay tile footings; and a two-level side-gable frame barn with asphalt shingle siding and a large lean-to garage unit off the west end.

**Evaluation:** The Morgan house is significant under Criterion C as a representative example of a regional variation on two-story, hall-parlor or center-hall house type, in which the basic side-gable single-pile block is ornamented with a center front gable and (often but not always) triangular-headed attic windows. The central gable and triangular-headed attic windows, perhaps remotely derived from the Gothic Revival and/or later Victorian Gothic styles, represent an architectural "treatment" broadly popular in rural areas of the mid-Atlantic and southeast regions during the 19th century.

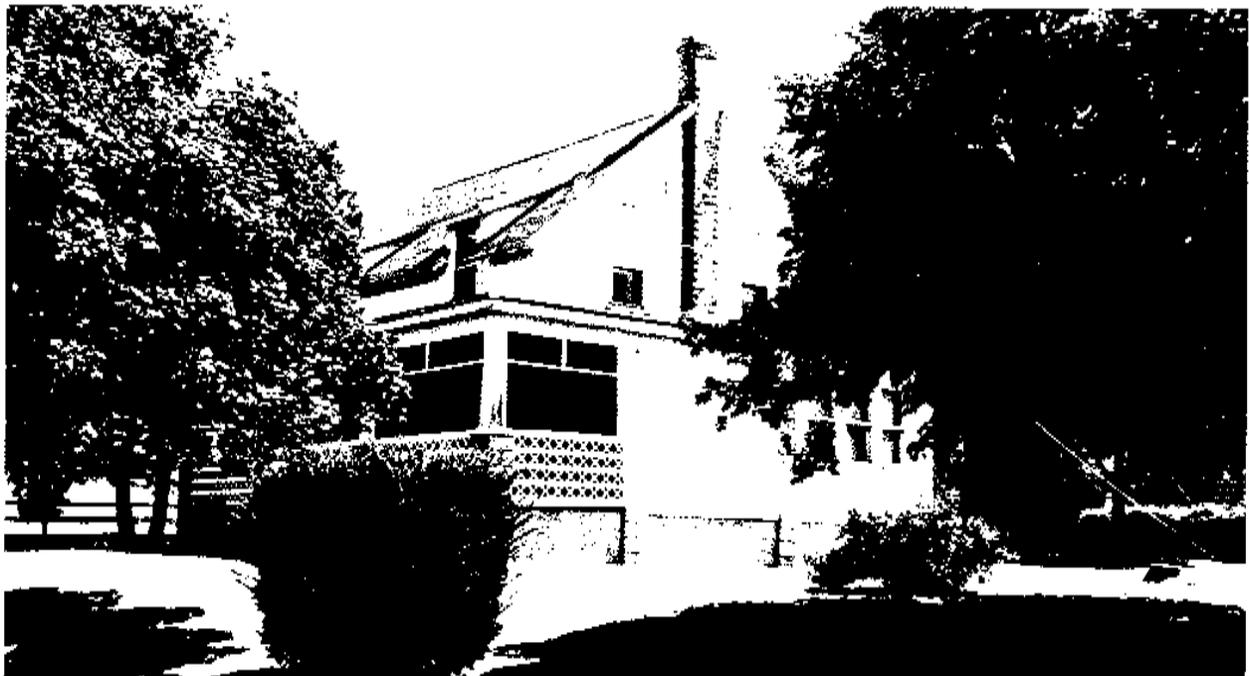
**PLATE 12: Building 9, Kathlene Bullock House, View to Southeast**

**Description:** This structure is a 1 1/2-story frame dwelling erected on a cast concrete block foundation. The exterior is clad with asbestos shingle siding, the side-gable roof with composition shingling. A screened porch, with flat roof and battered wood posts set on high concrete block pedestals, extends across the main (north) elevation and wraps around the northwest corner to become fully enclosed along the west side. Two shed-roofed dormers on each roof slope illuminate the upper story. Windows have 1/1 sash, the openings edged with flat trim. A lean-to addition extends across the rear. Behind the house is a small frame garage.

**Evaluation:** This house, which appears to date from the late 1930s or early 1940s, combines Period Colonial Revival massing with details, such as the shed dormers and battered porch posts, derived from the Craftsman idiom. Although the juxtaposition of "colonial" and Craftsman features was not uncommon during the period, this house does not constitute a particularly noteworthy representation of the phenomenon. No documentary basis for association with important persons or events has been identified. As such, it does not meet National Register Criteria for Evaluation, and no further work is recommended.
