V. Field Results and Interpretations

A. Excavations Associated with the House Foundation

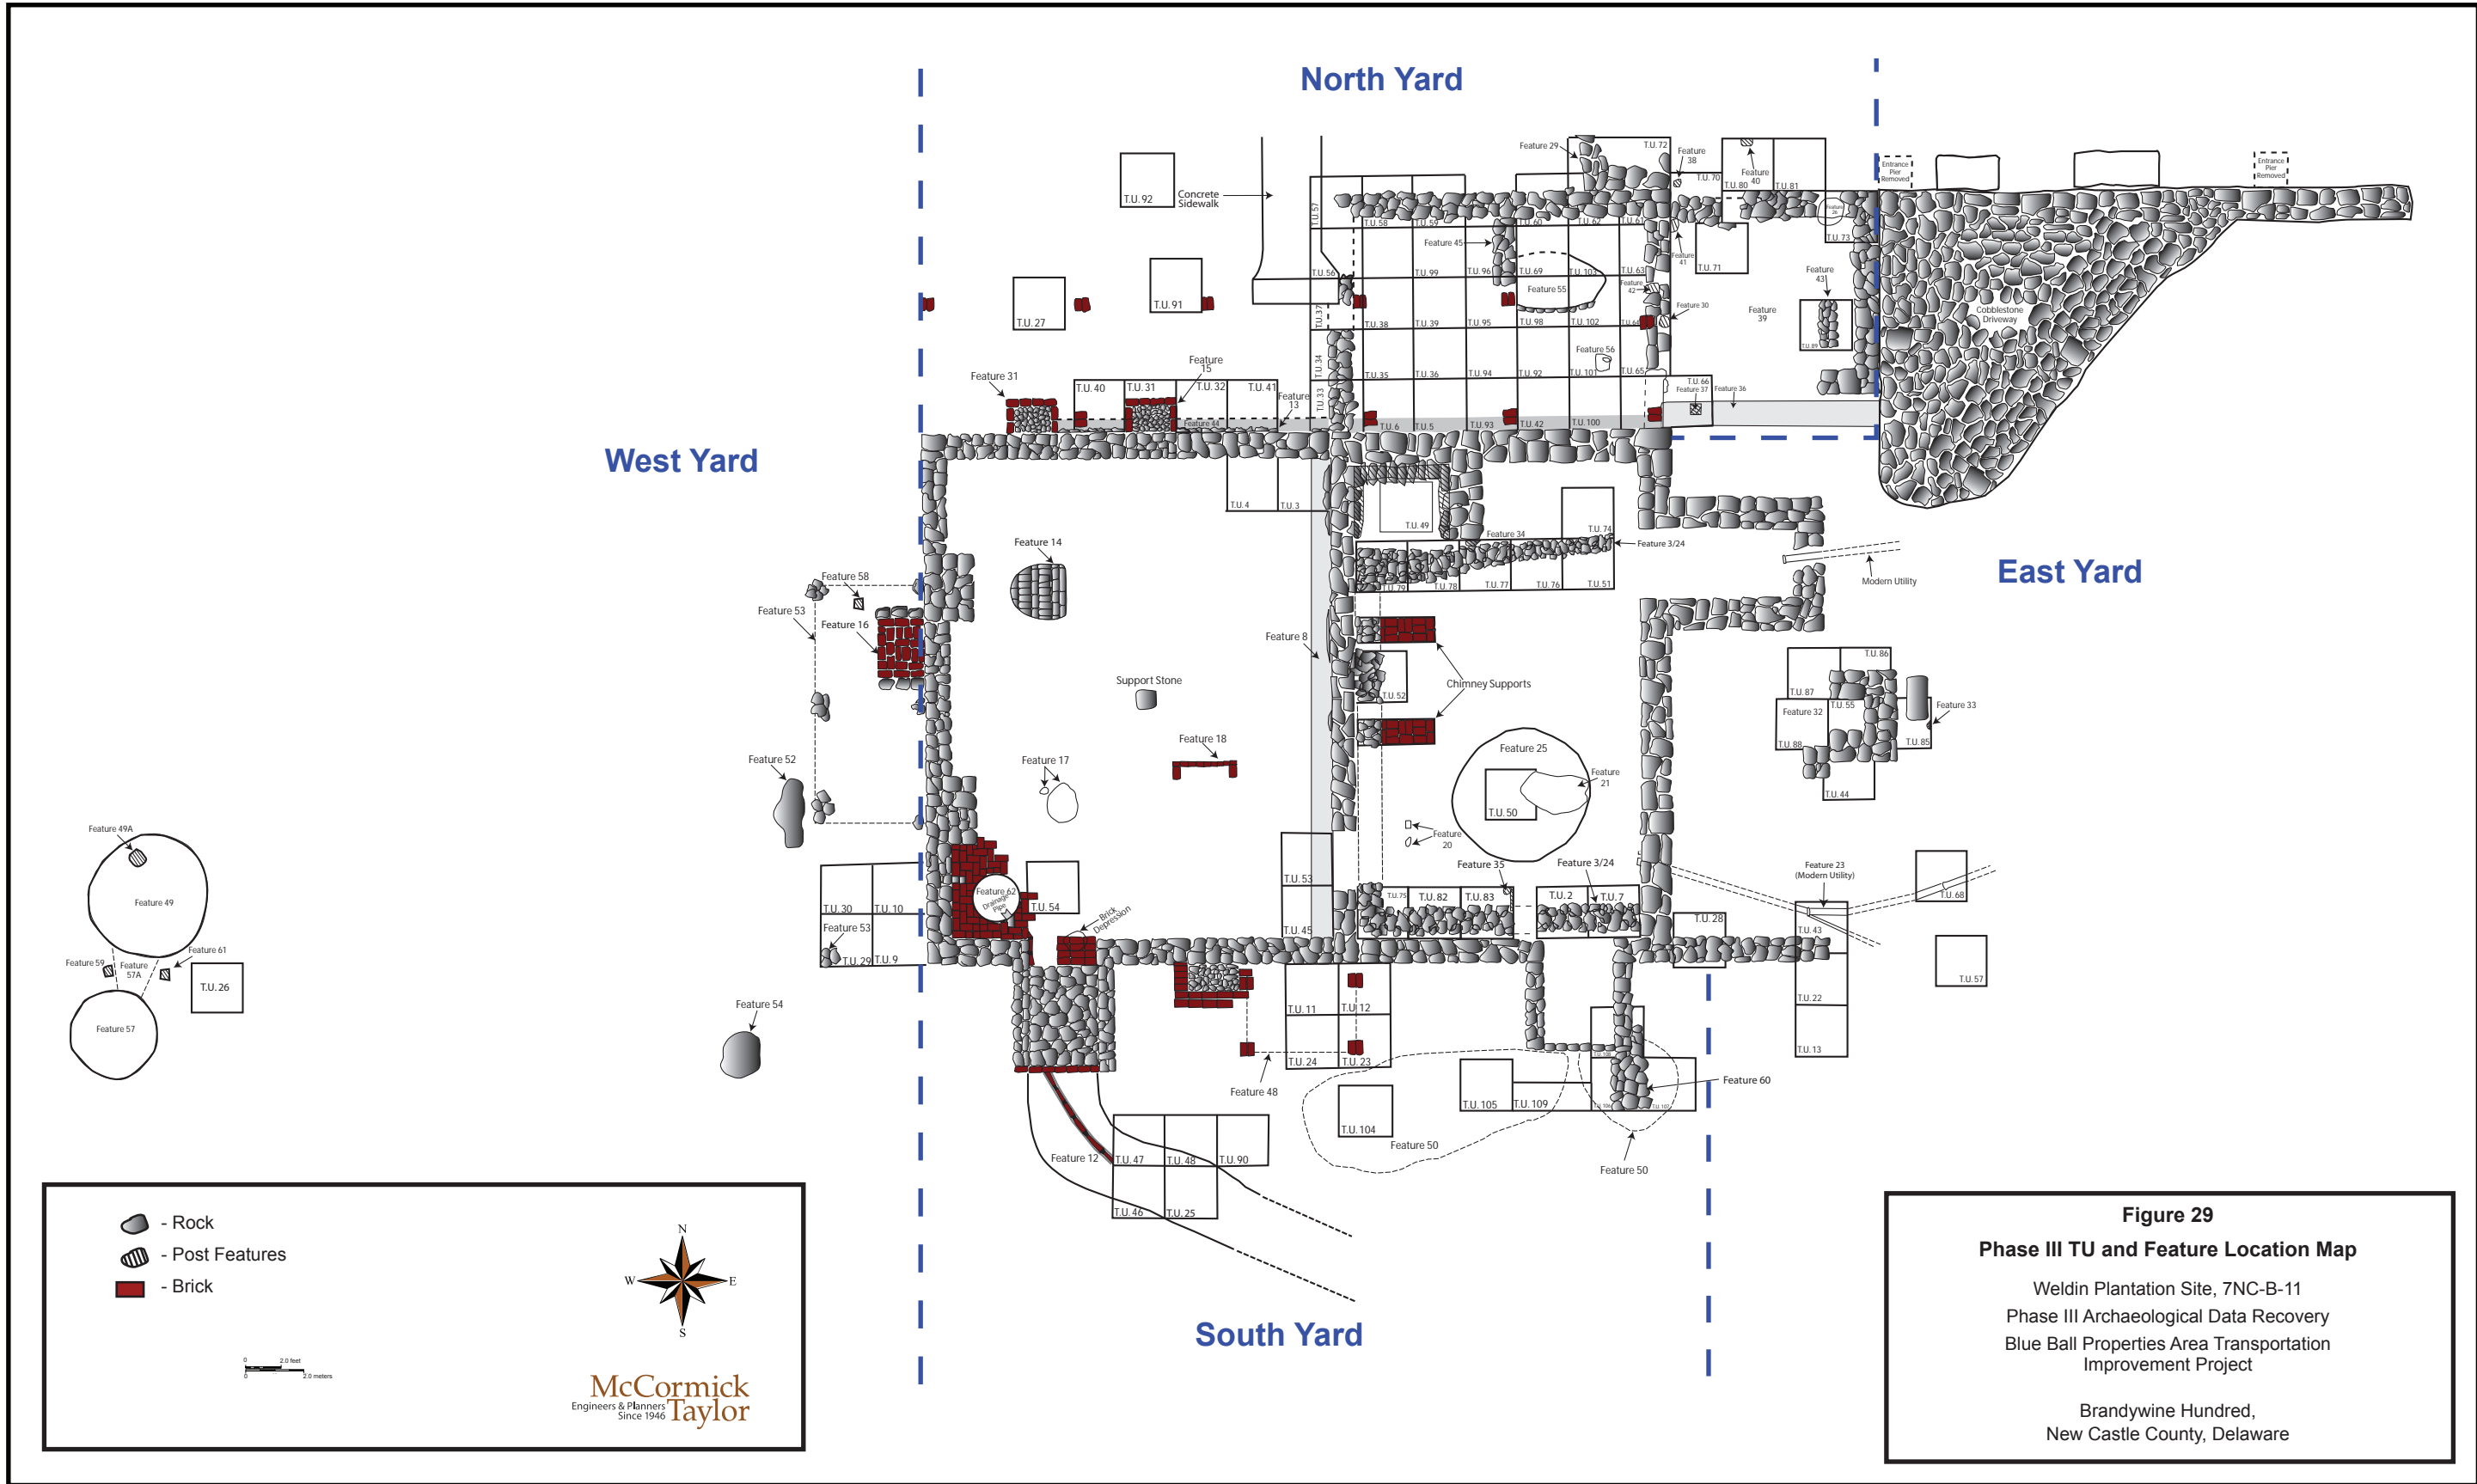
Figure 29
Phase III TU and Feature Location Map
 Weldin Plantation Site, 7NC-B-11
 Phase III Archaeological Data Recovery
 Blue Ball Properties Area Transportation
 Improvement Project
 Brandywine Hundred,
 New Castle County, Delaware

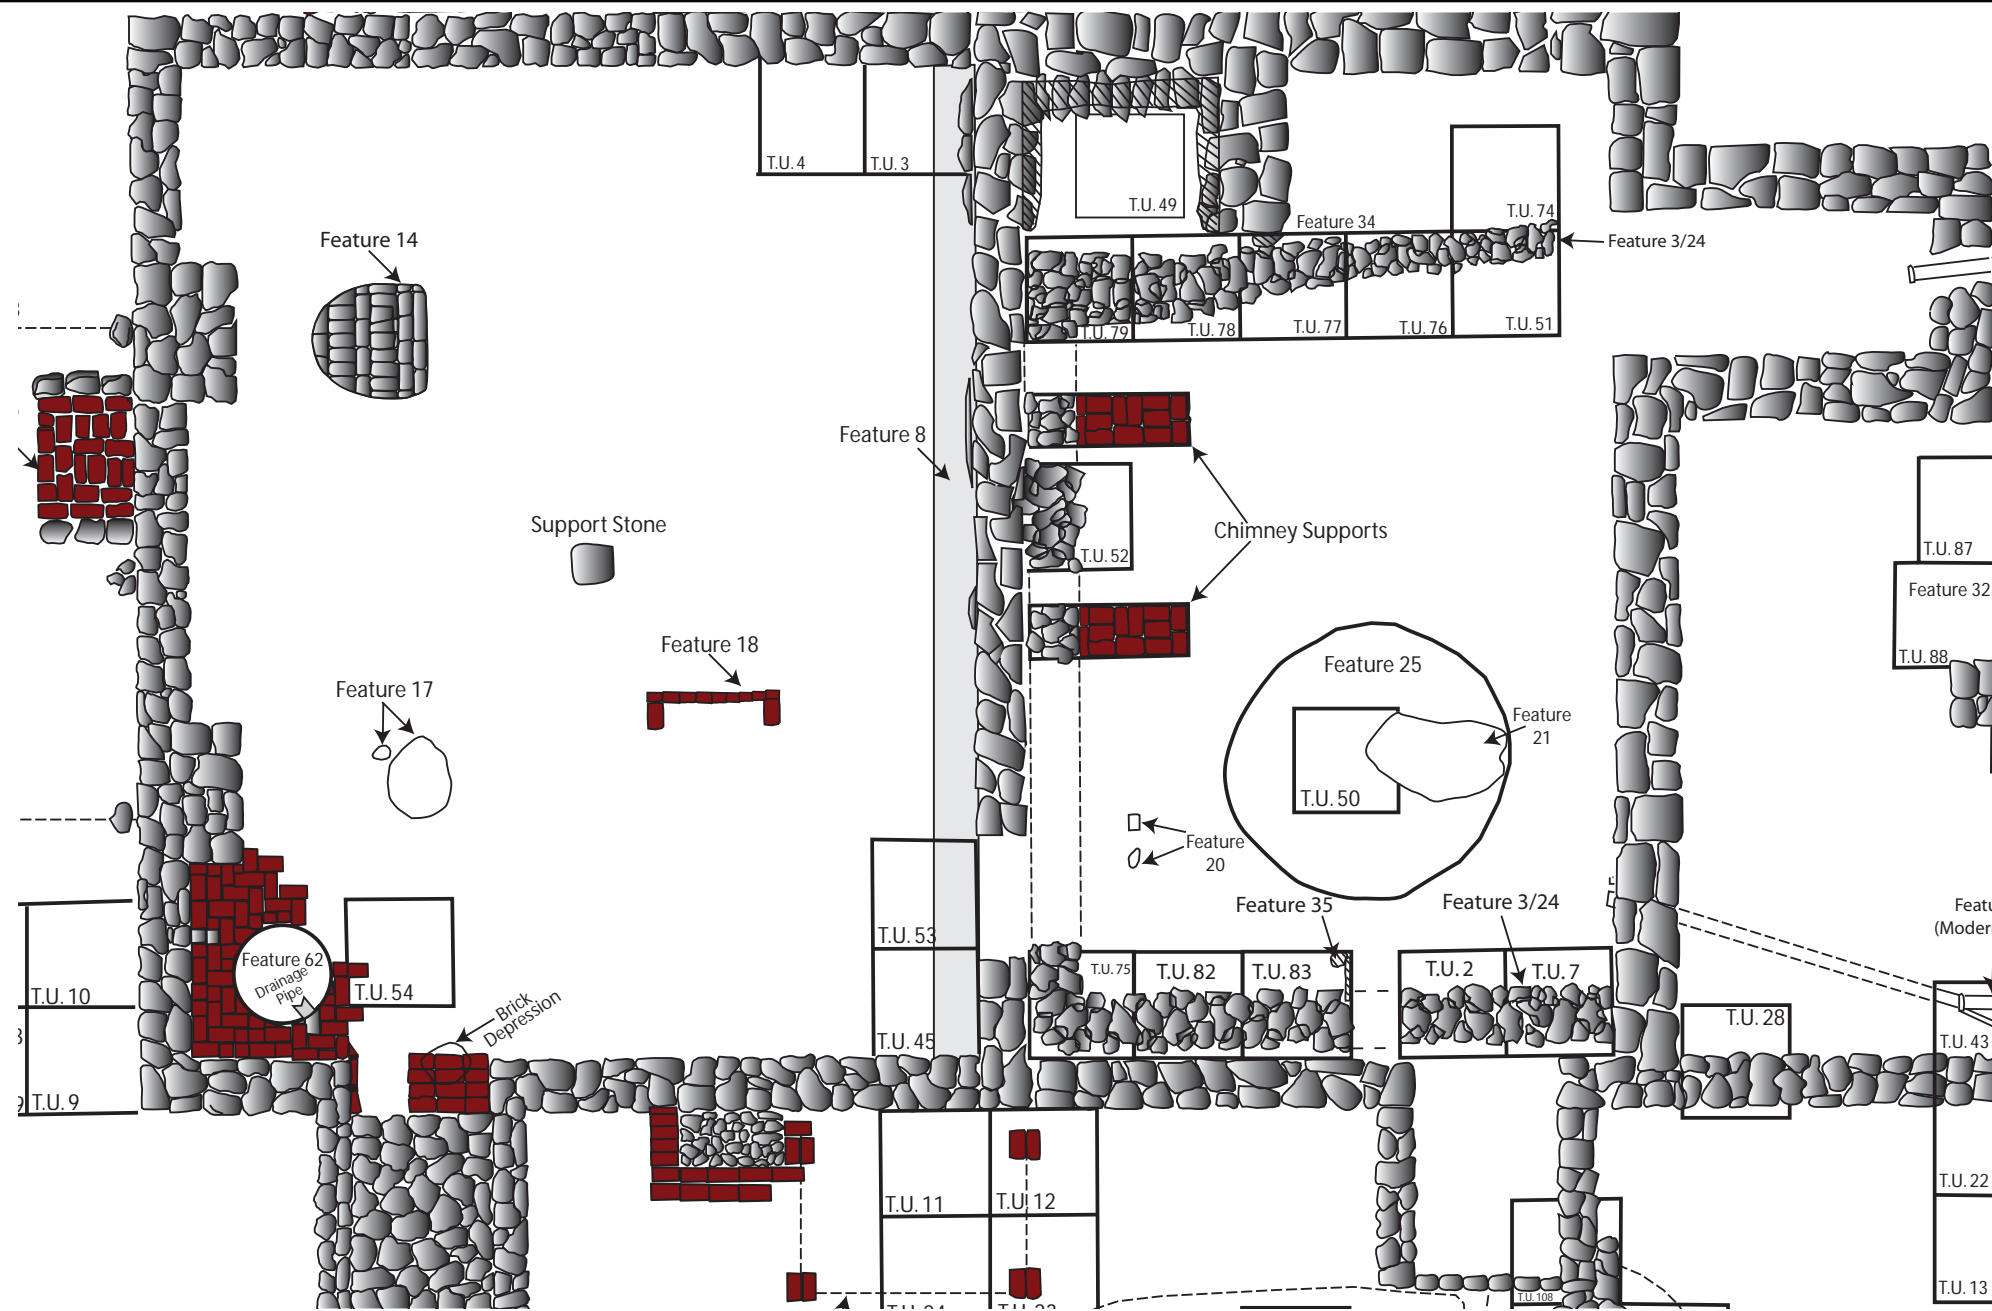
Figure 30
Detail of Phase II/III Testing Associated with the Interior of the House Foundation
 Weldin Plantation Site, 7NC-B-11
 Phase III Archaeological Data Recovery
 Blue Ball Properties Area Transportation Improvement Project
 Brandywine Hundred,
 New Castle County, Delaware

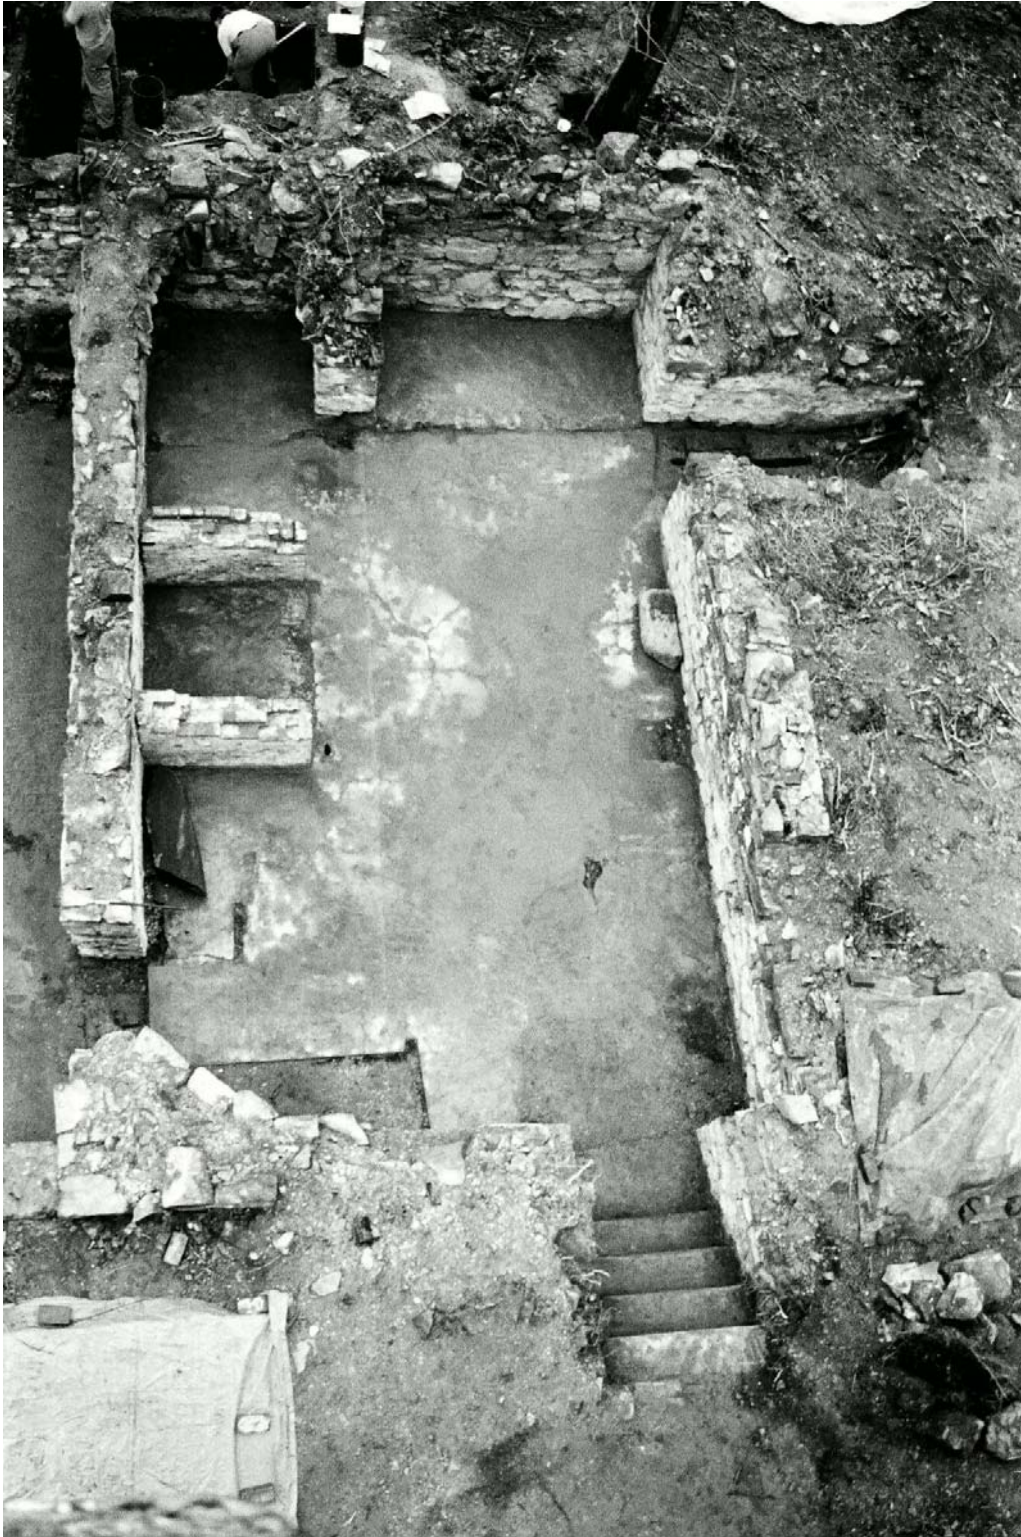
Photograph 27: View of east half of house foundation, facing north.

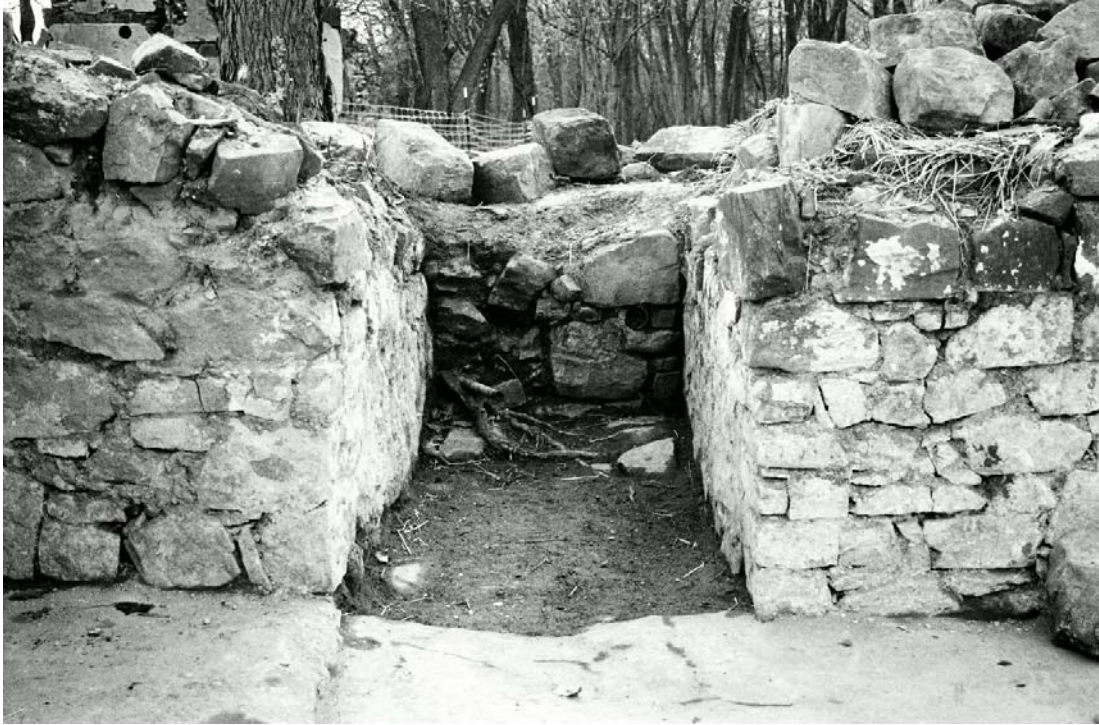
Photograph 28: Basement bulkhead at the southeast corner of the house, facing south.

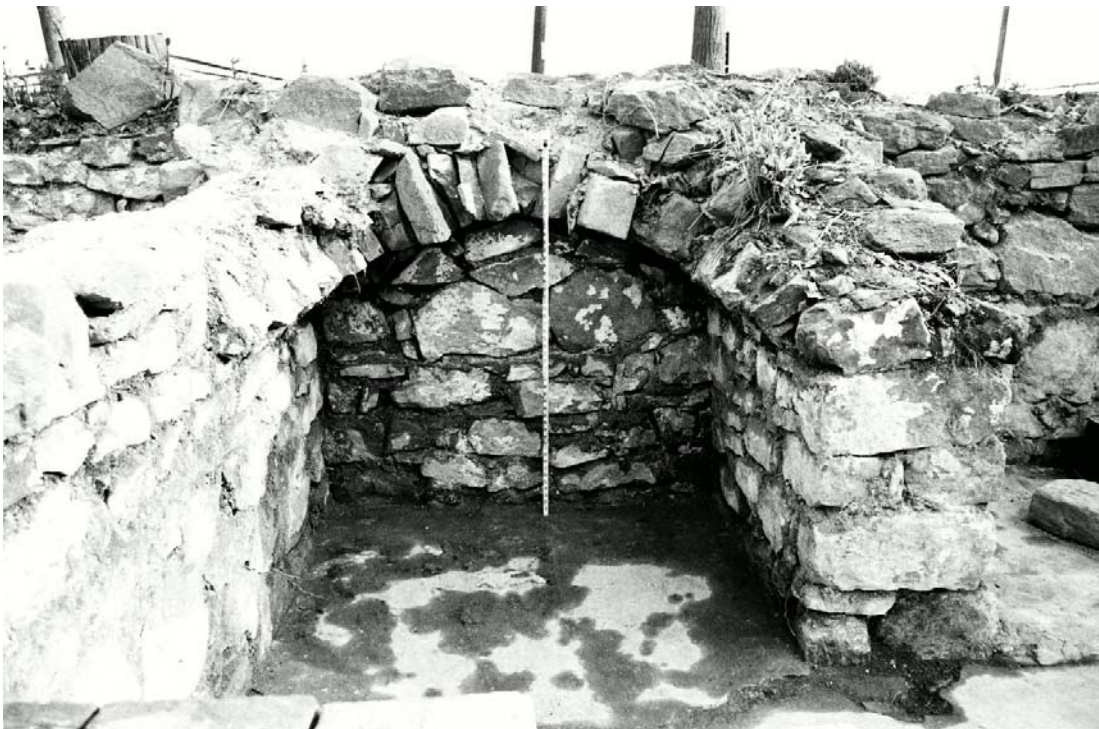
Photograph 29: View of fireplace support arch in the north wall of the house foundation, facing north.

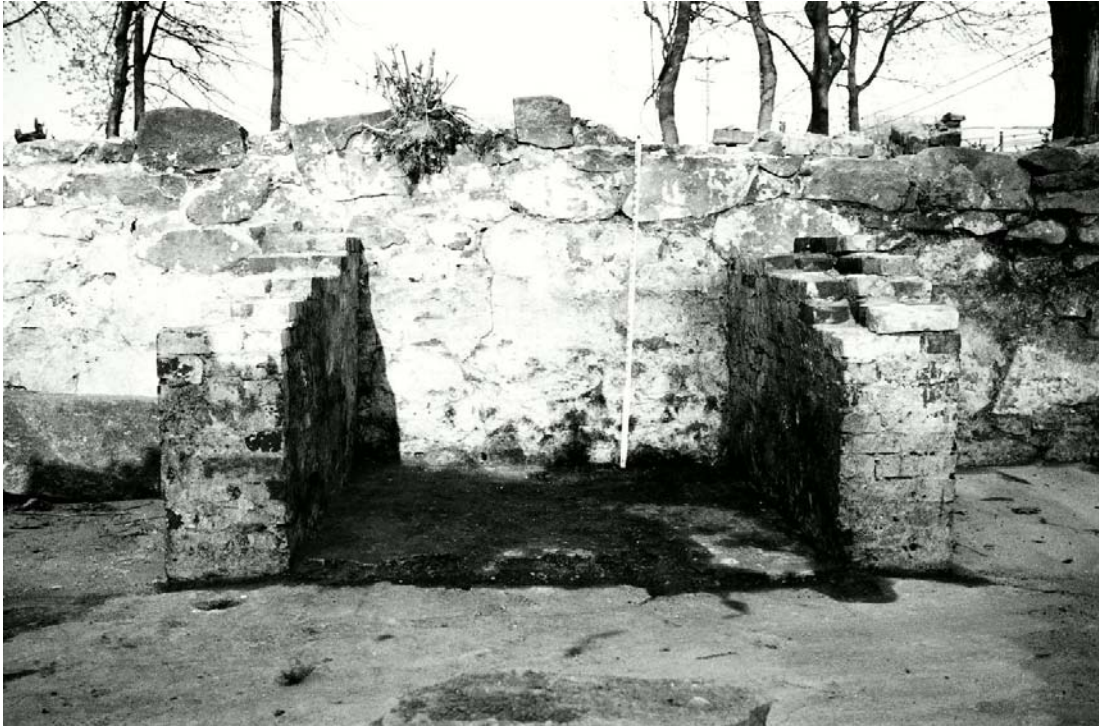
Photograph 30: Brick fireplace supports along the west wall of the east half of the cellar, facing west.

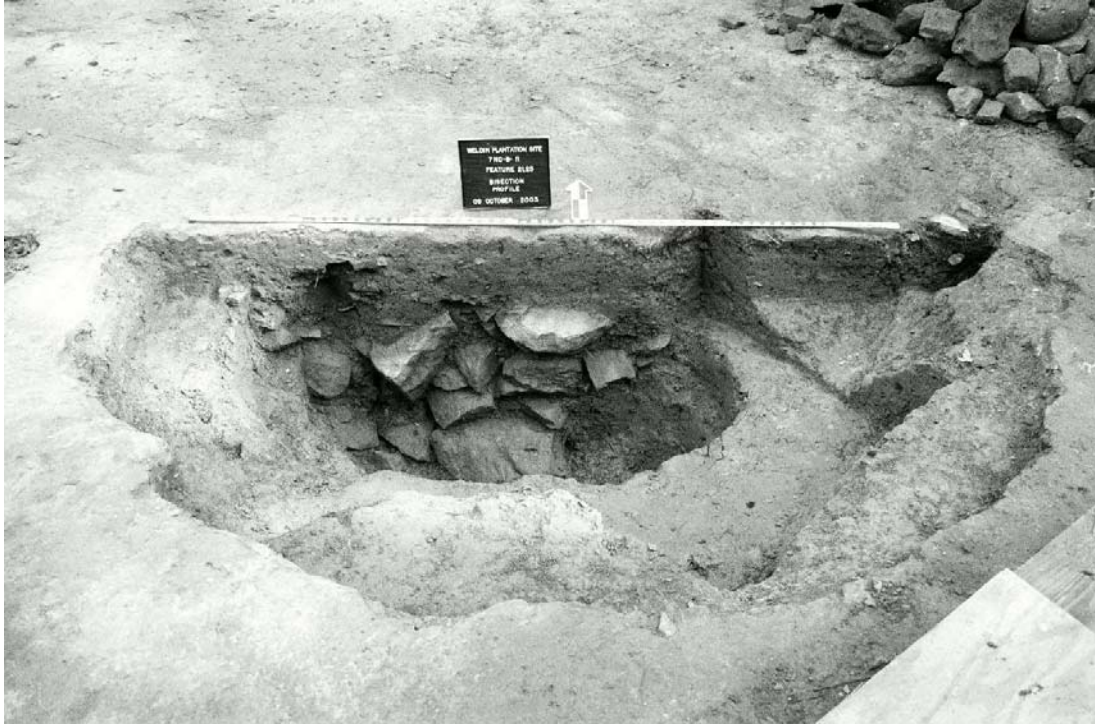
Photograph 31: Feature 21/25 north profile.

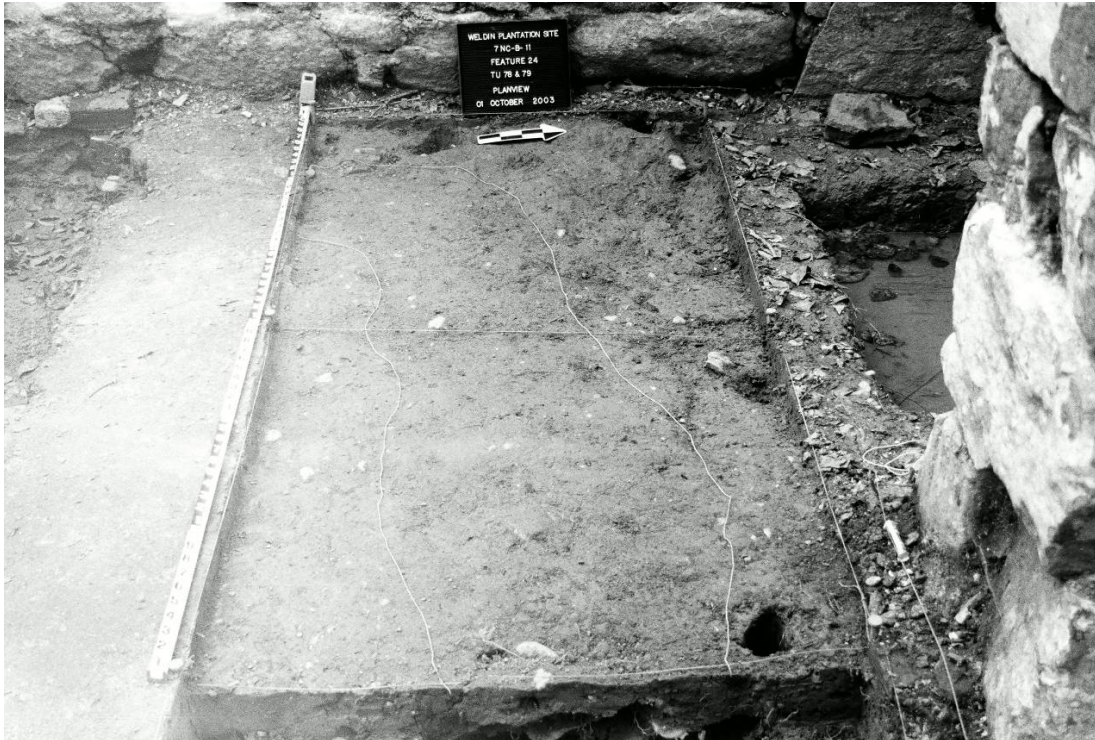
Photograph 37: Feature 3/24 planview, facing west.

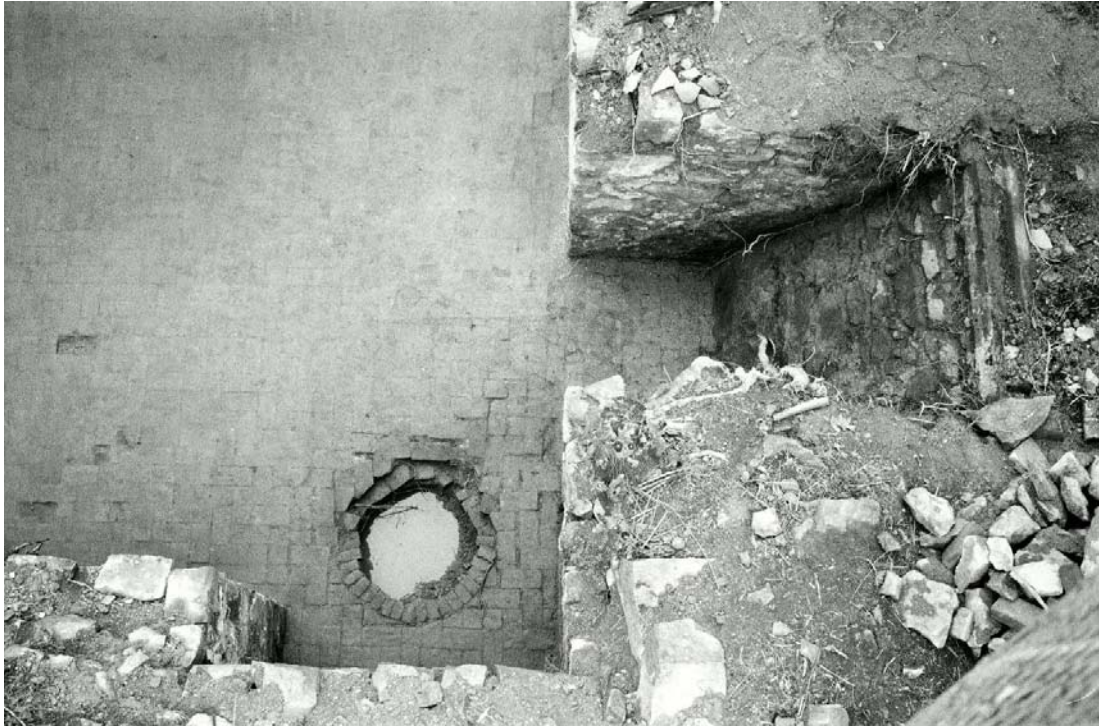
Photograph 39: View of the bulkhead at the southwest corner of the house foundation, facing east.

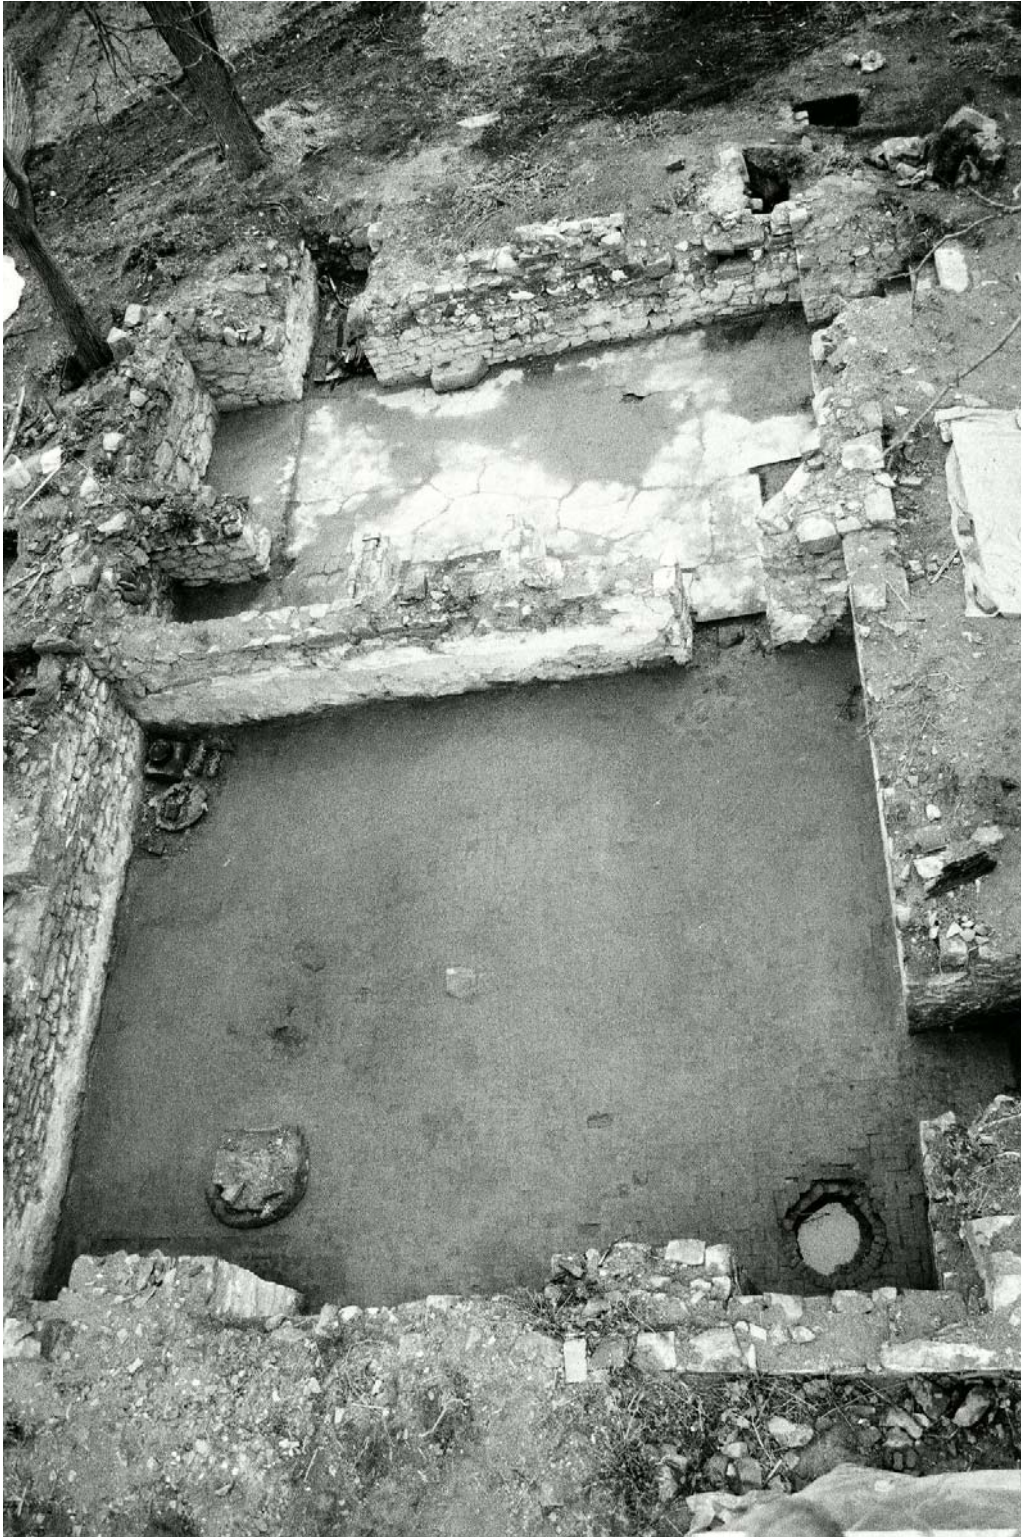
Photograph 40: View of the house basement post-excavation, facing east.
(Chimney piles are located along the west wall at the bottom of the photograph.)

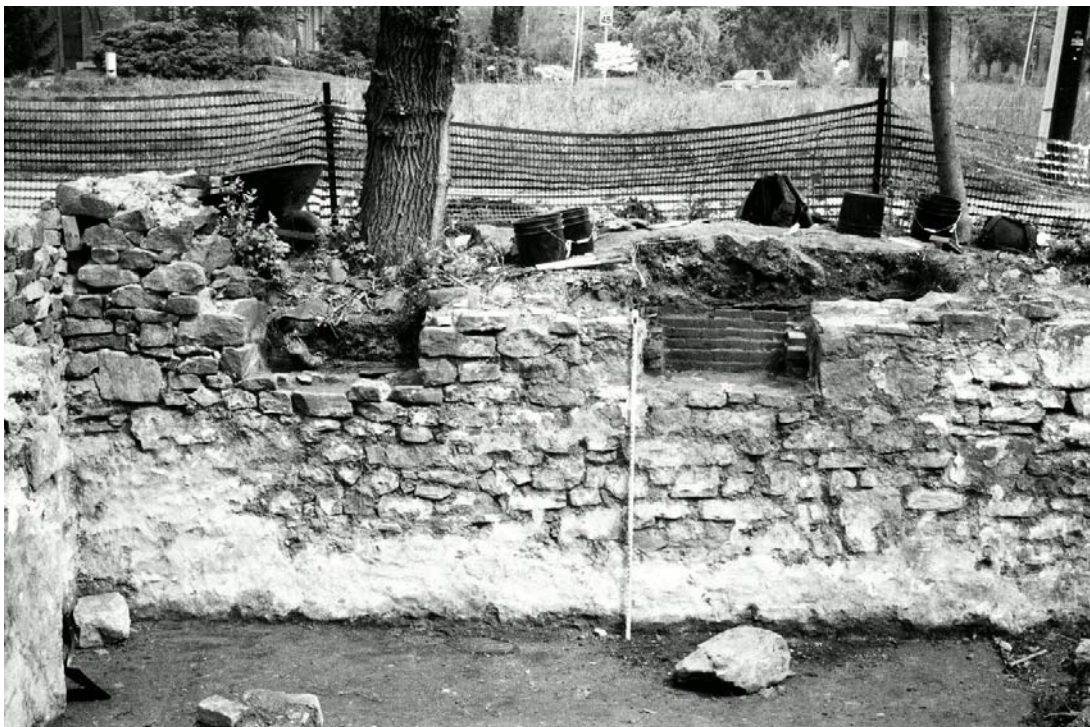
Photograph 44: View of Features 15 and 31 (window wells), facing north.

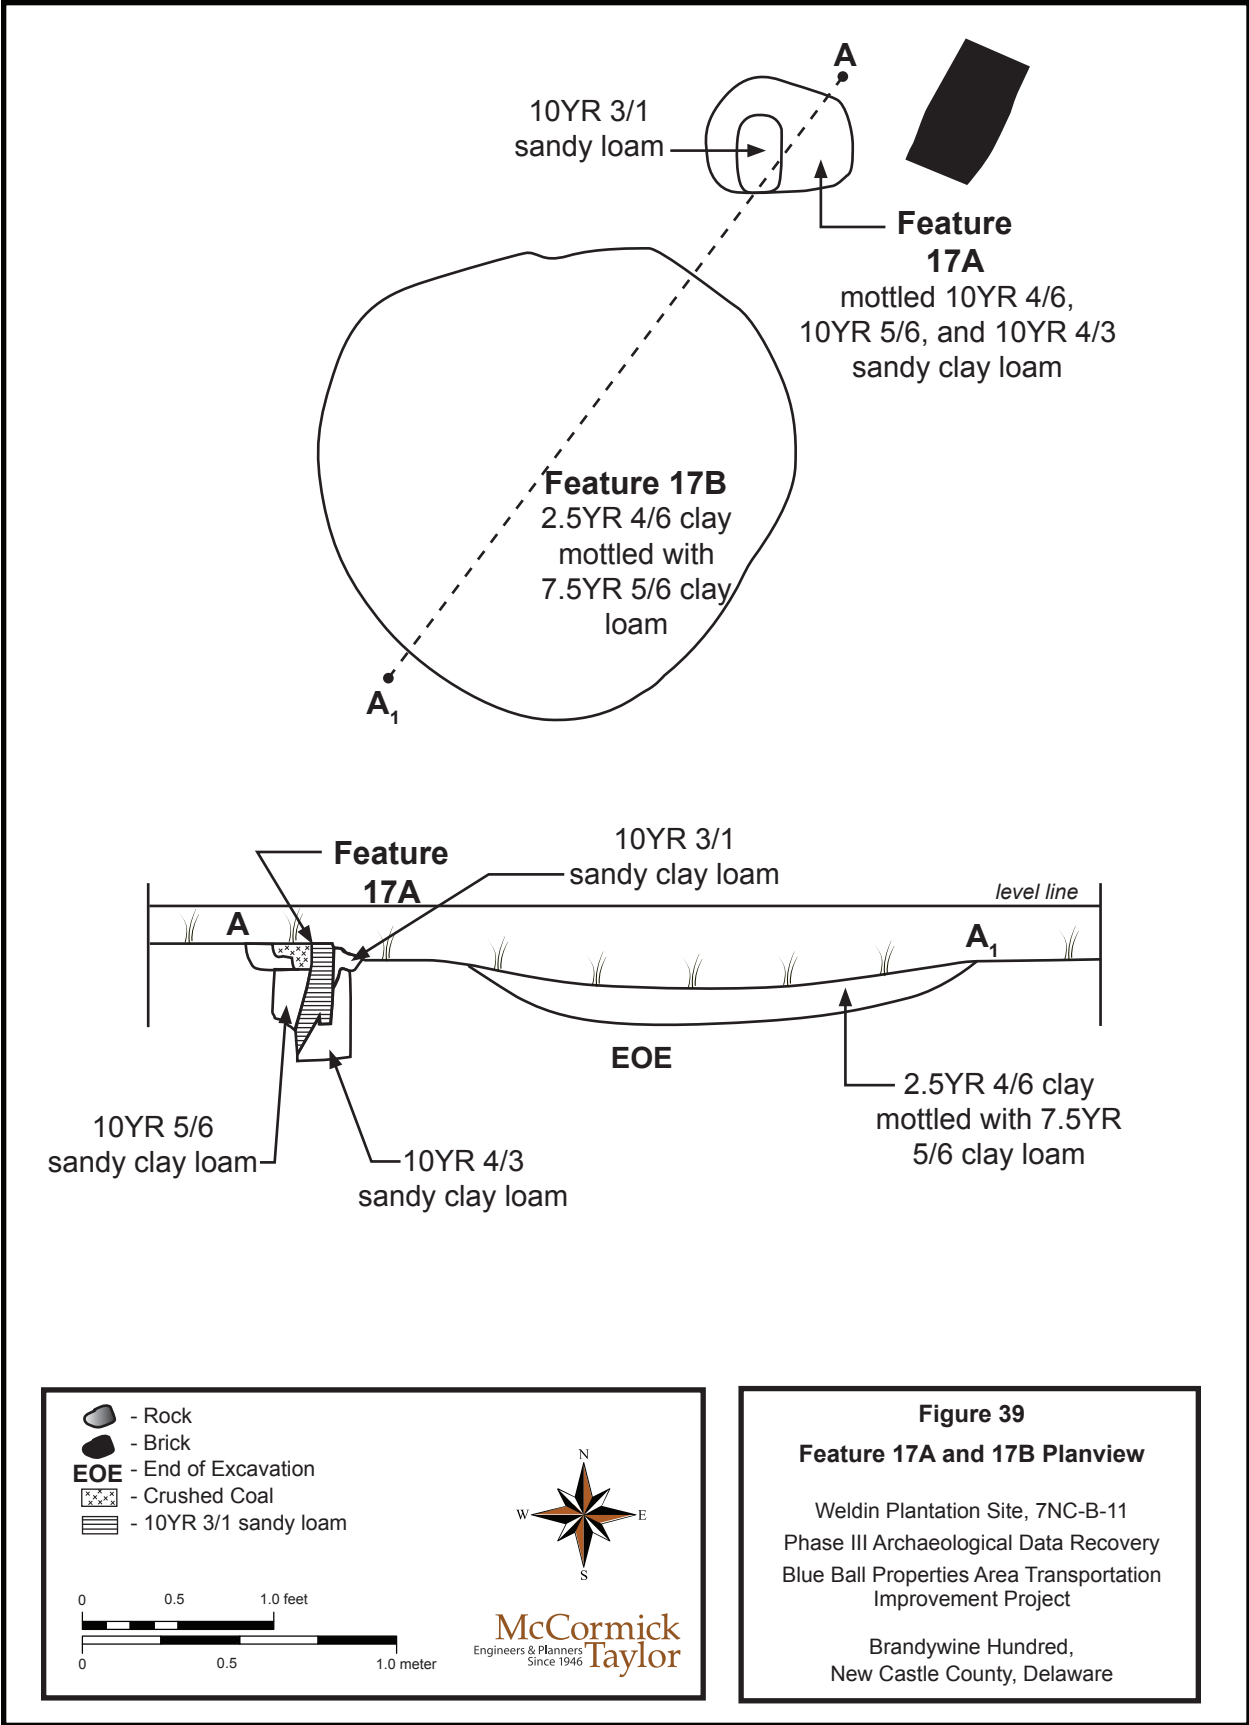
Feature 62 was a circular dry-laid brick sump located in the southwest corner of the basement (*Figure 30*). TAA originally documented this feature during the Phase I survey. Their investigations into the feature involved the removal of a 0.5 foot layer of fill that was found to overlay a brick cap. TAA archaeologists removed 1.4 feet of the sand and gravel beneath the brick cap before terminating excavations (Taylor et al. 1989: 231). During the data recovery excavations, the remainder of Feature 62 was excavated. A backhoe was used to remove the subsoil adjacent to the southern edge of the feature, and the bricks and feature fill were removed from the south side of the feature by hand. The dry-laid bricks composing the feature were

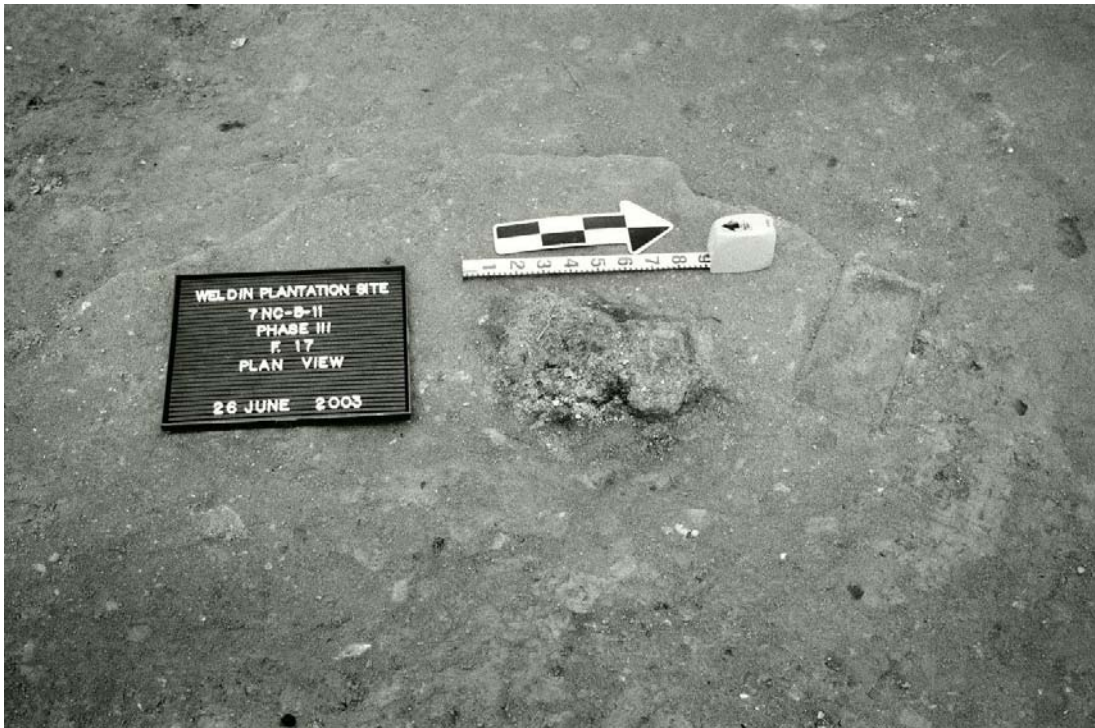
Photograph 45: Feature 17 planview, facing west.

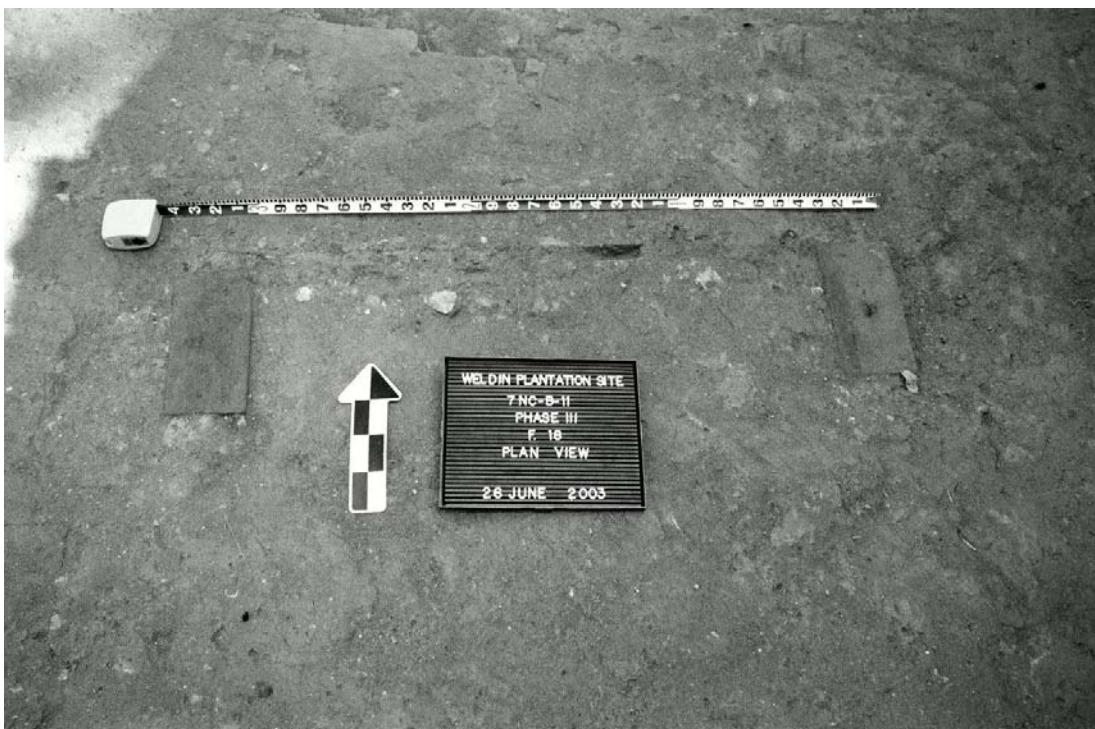
Photograph 46: Feature 18 planview, facing north.

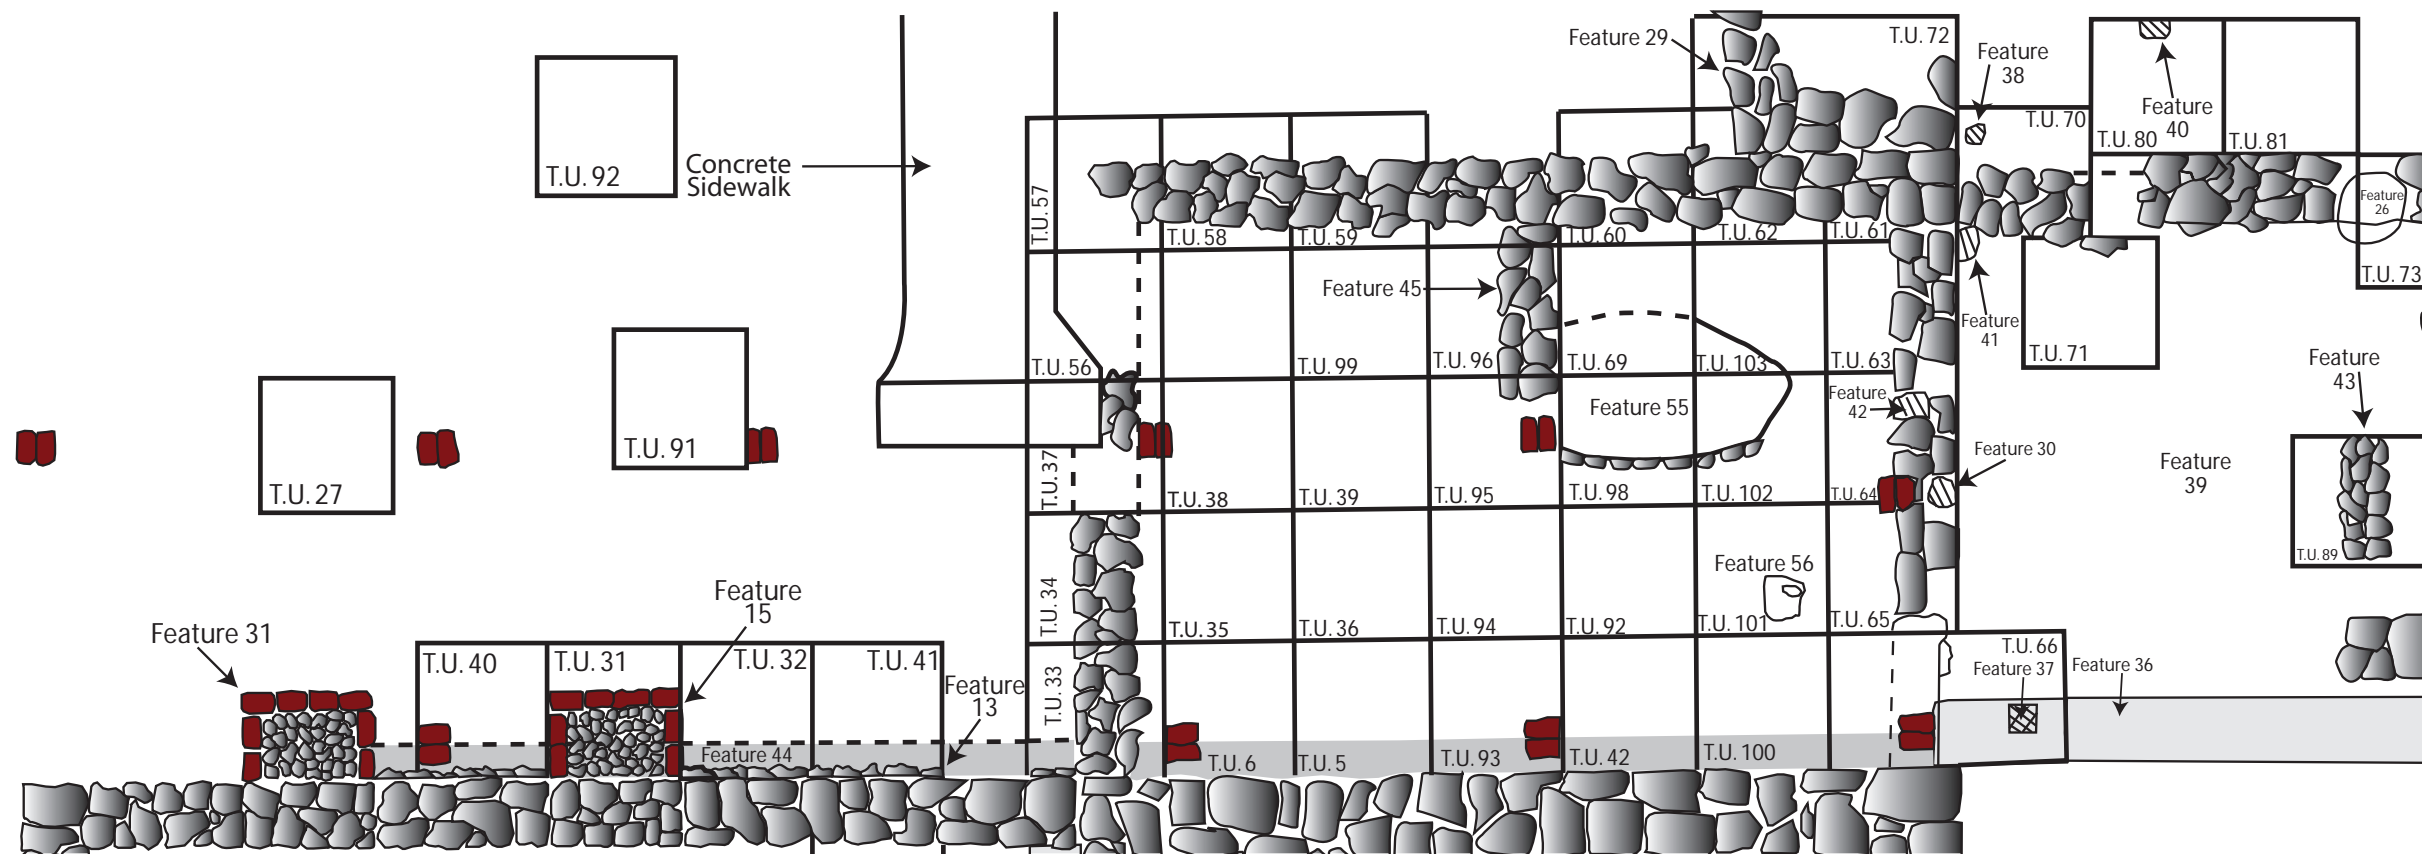
Figure 45
Detail of Phase II/III TU and Feature Locations in the North Yard

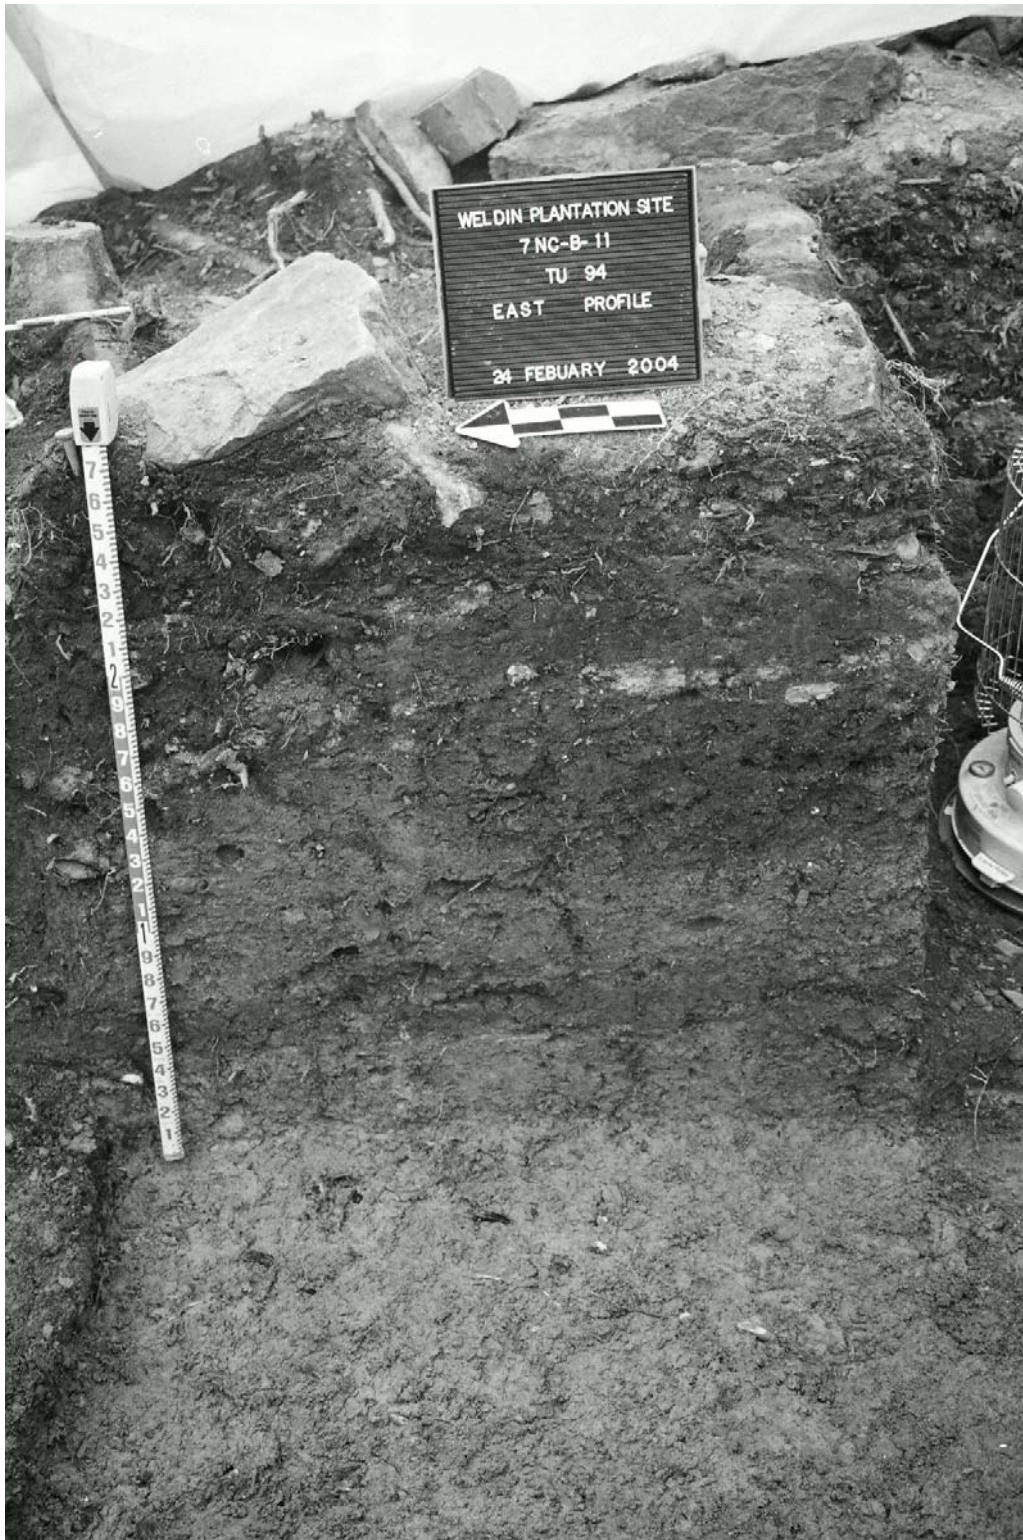
Photograph 50: TU 94 west profile.
