V. Field Results and Interpretations

A. Excavations Associated with the House Foundation

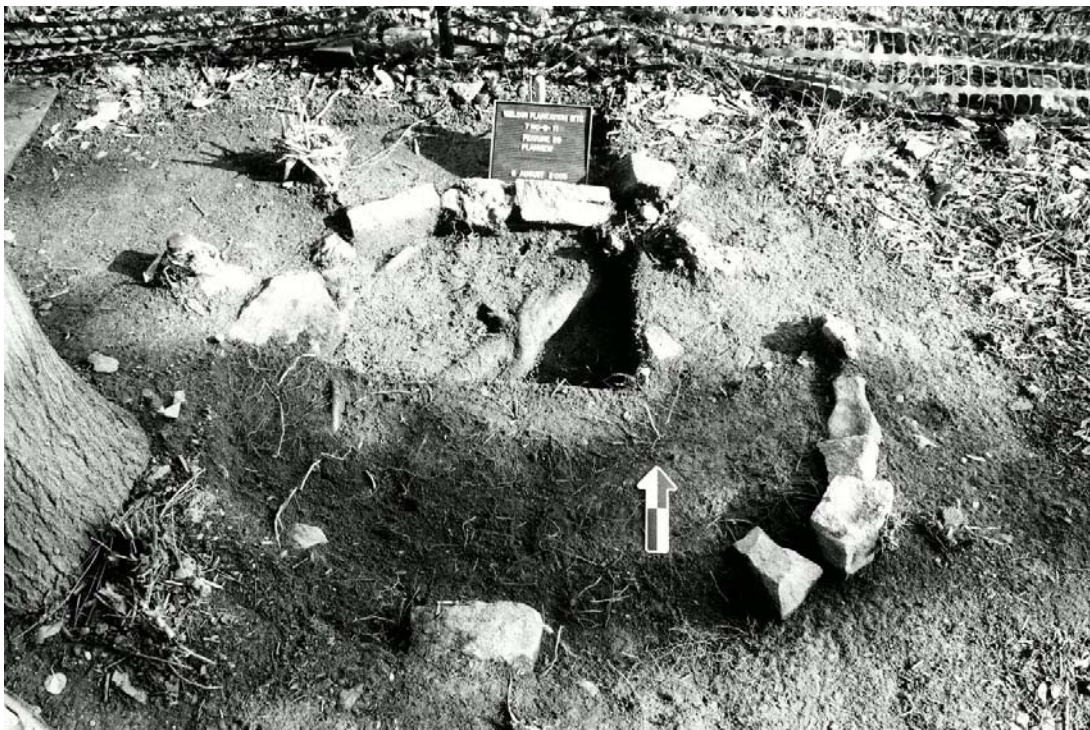
Photograph 51: Feature 28 planview, facing north.

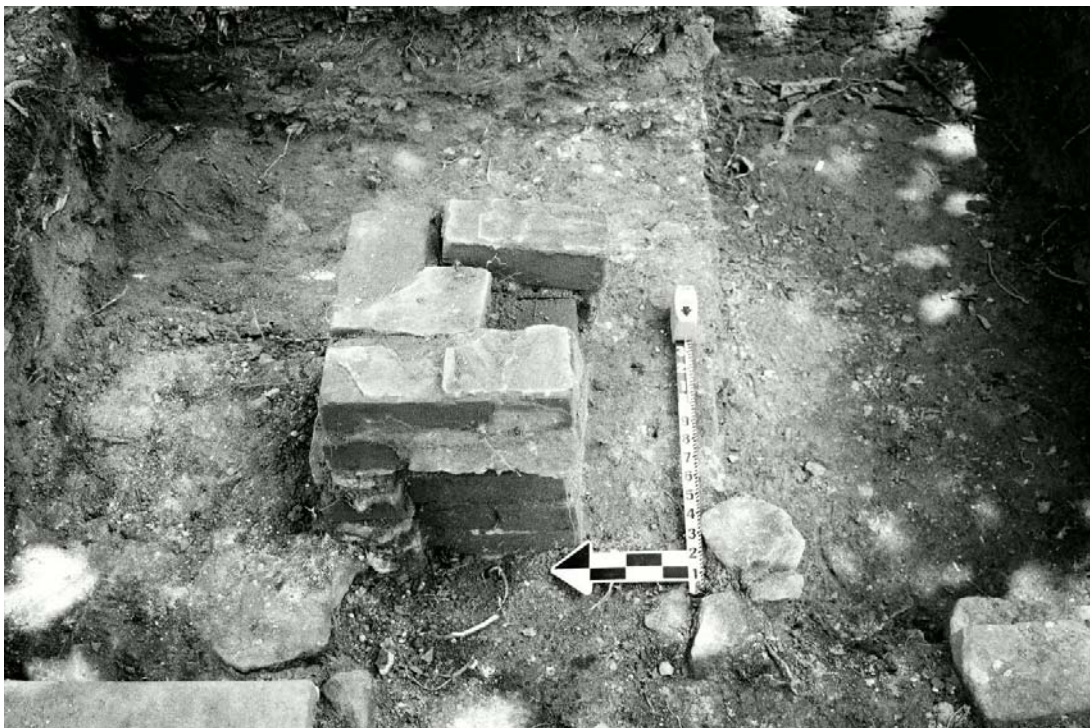
Photograph 52: Brick footer associated with Feature 44, facing east.

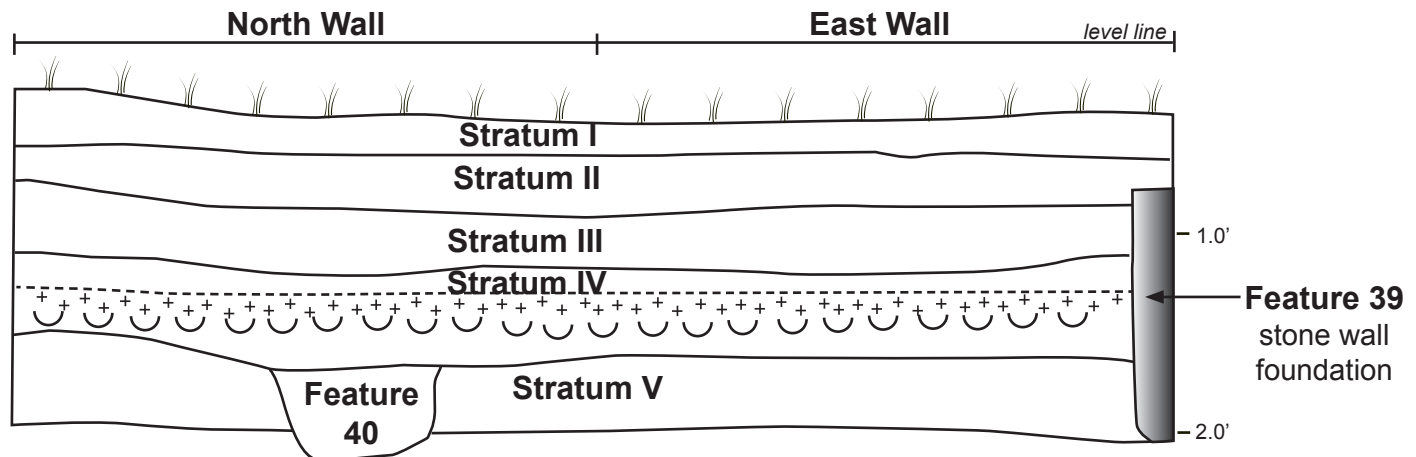
- Stratum I:** 10YR 3/2 silt loam (AC1)
- Stratum II:** 10YR 4/2 silt loam (AC2)
- Stratum III:** 10YR 4/6 mottled with 10YR 4/2 slightly clayey silt loam with loose stones (AC12)
- Stratum IV:** 10YR 4/4 with pockets of 10YR 5/4 silt loam with numerous pea gravels
- Clay Lense:** 5YR 5/6 clay with pea gravels (AC9)
- Shell Lense:** 10YR 5/4 slightly clayey silt loam with carbon chunks and dense oyster and clam shell debris (AC9)
- Subsoil:** 10YR 5/6-5/8 yellowish-brown clayey silt loam with gravels (very high moisture content) (AC50)

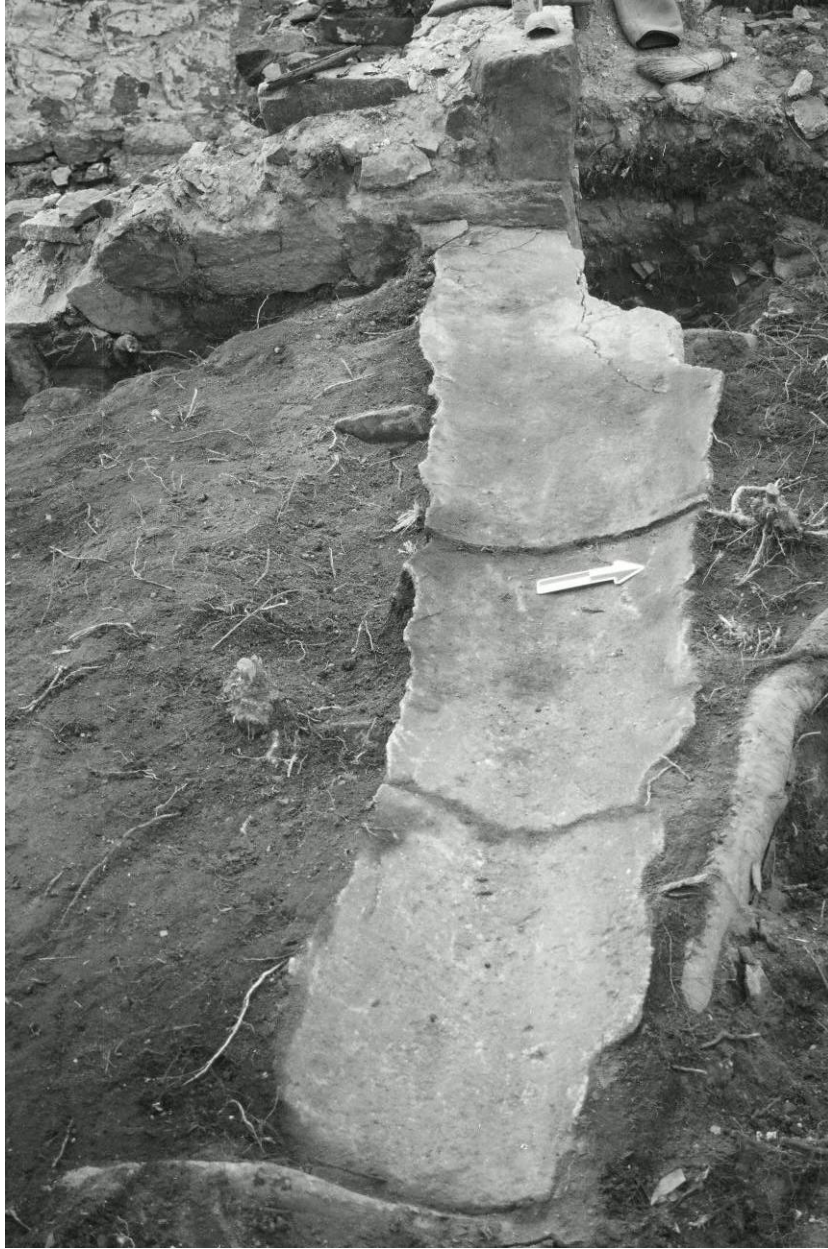
Photograph 55: Feature 36 planview, facing west.

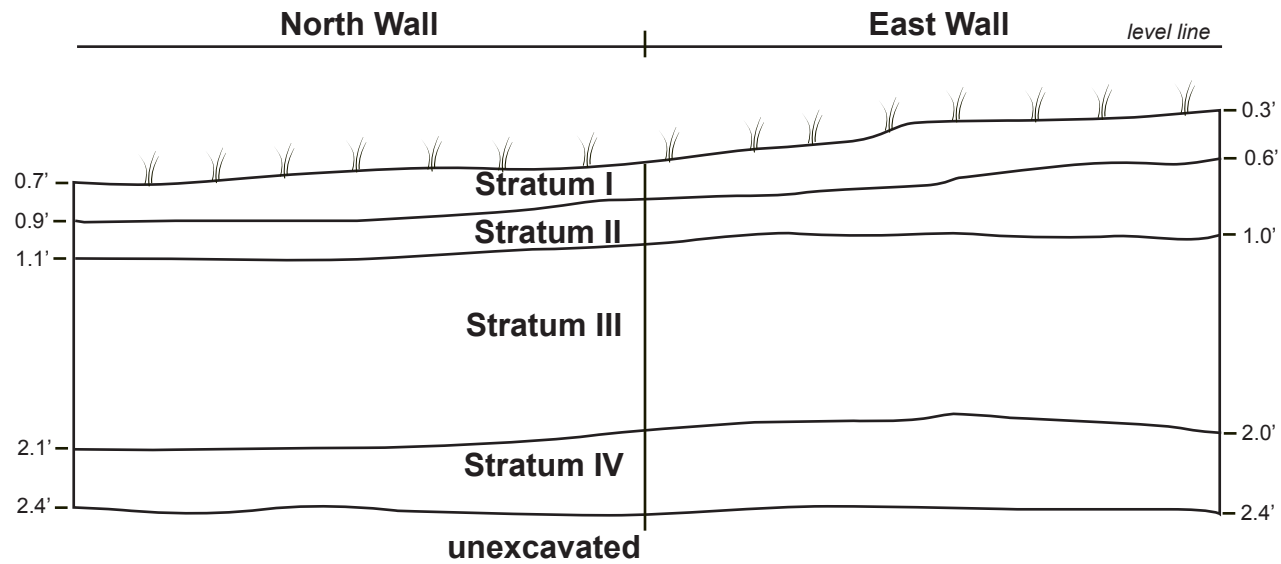
- Stratum I:** 10YR 3/3 silt loam (AC1)
- Stratum II:** 10YR 4/2 silty loam and slate inclusions (AC2)
- Stratum III:** 10YR 4/3 mottled 10YR 5/6 and 7/5YR 5/8 silt loam (AC13)
- Stratum IV:** 10YR 5/6 yellowish brown clay silt (AC50)

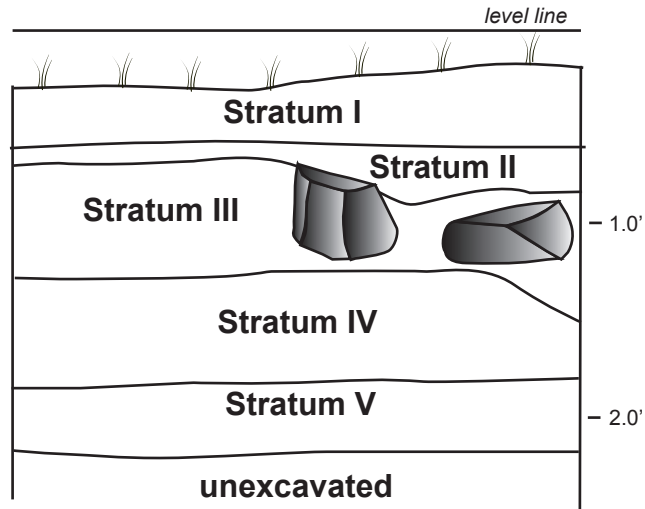
- Stratum I:** 10YR 2/1 silt loam (AC1)
- Stratum II:** 10YR 3/3 silt loam (AC2)
- Stratum III:** 7.5YR 5/8 mottled with 10YR 3/3 silty clay (AC18)
- Stratum IV:** 10YR 4/4 silty loam (AC20)
- Stratum V:** 10YR 5/8 sandy clay (AC50)

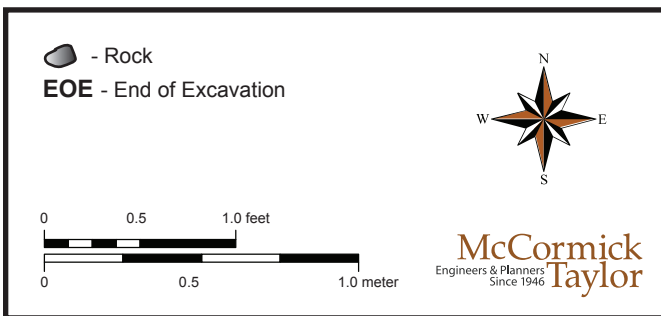
Figure 72
TU 106 and Feature 60 South Profile
 Weldin Plantation Site, 7NC-B-11
 Phase III Archaeological Data Recovery
 Blue Ball Properties Area Transportation
 Improvement Project
 Brandywine Hundred,
 New Castle County, Delaware

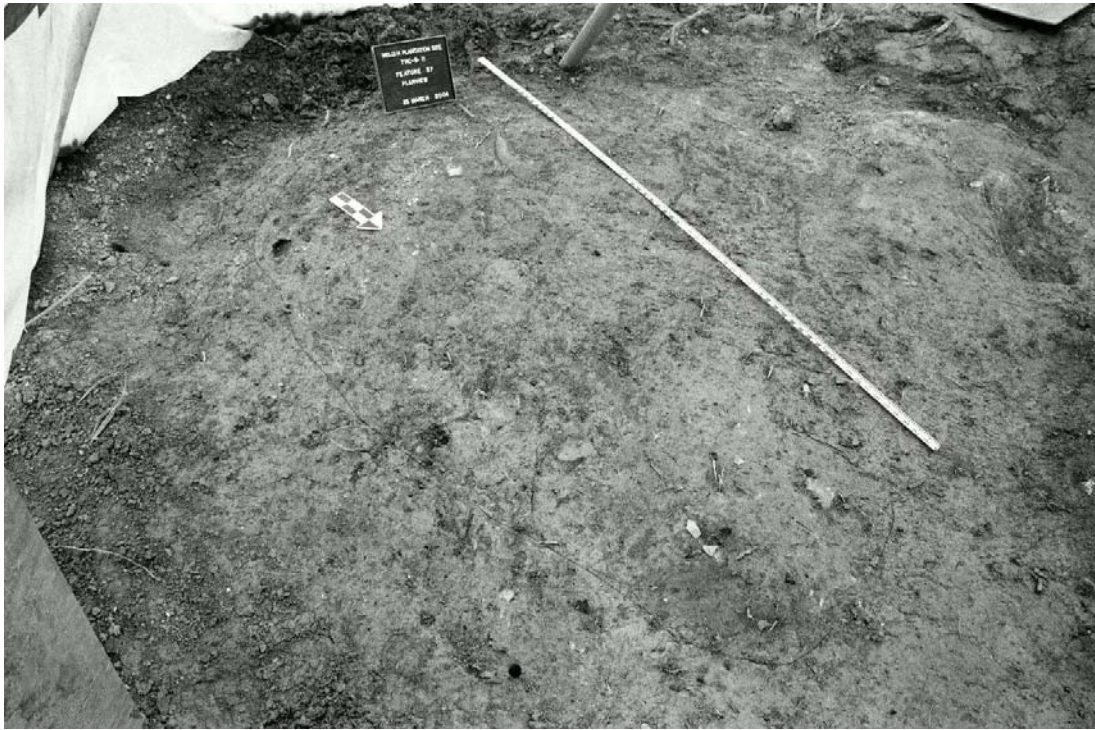
Photograph 65: Feature 57 planview, facing south.
