Nathan Zimmerman
EPS Tech V
E&S Control Program
Manager

LESSONS LEARNED FROM THE FIELD

EPA EDITION!

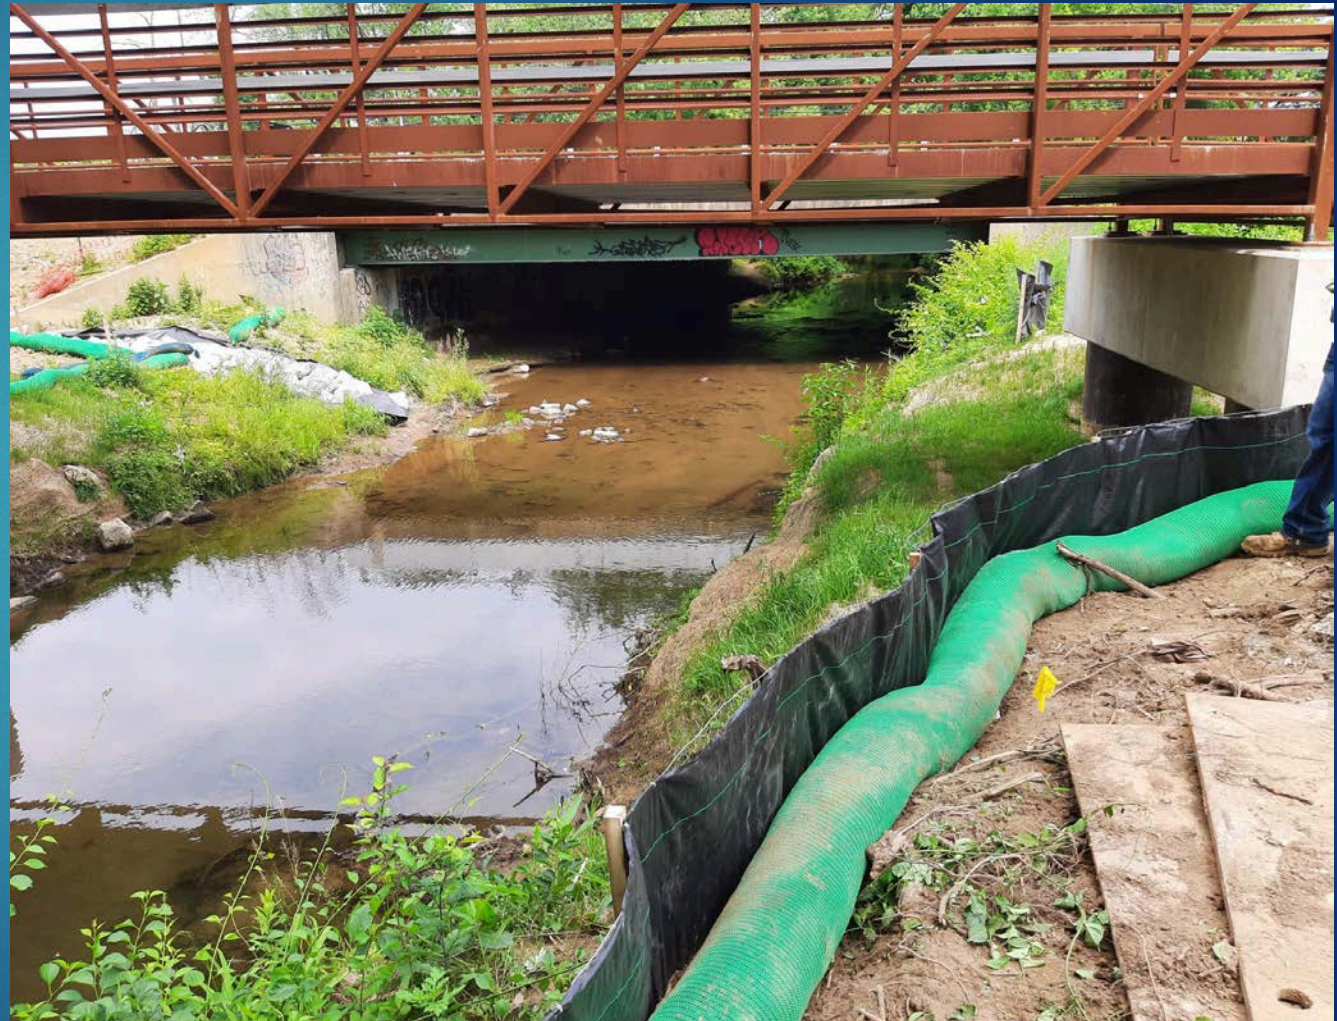
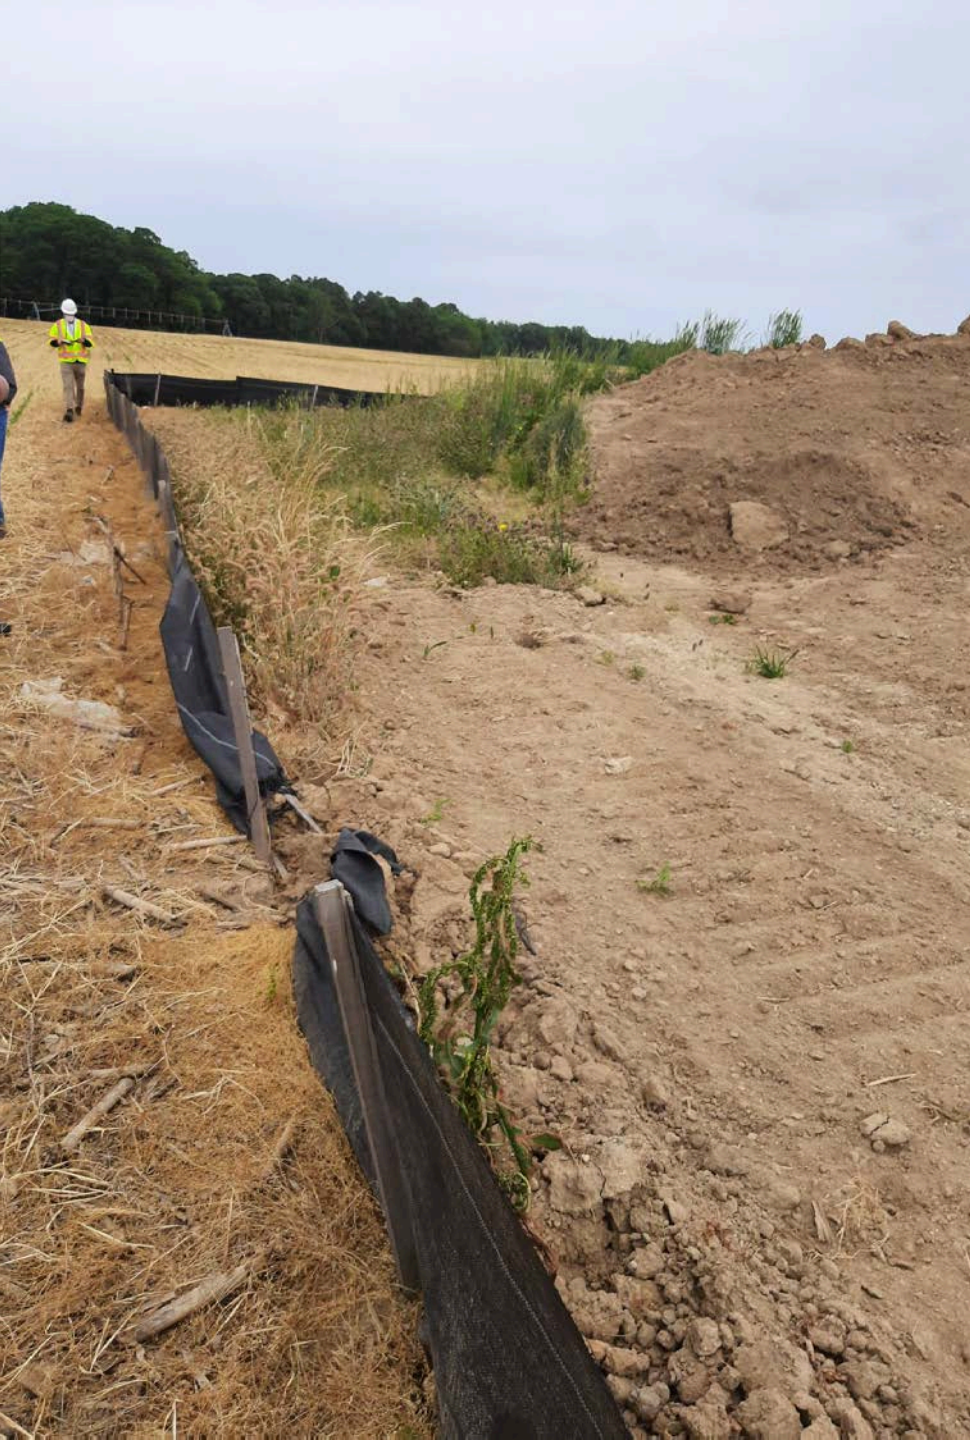
- ▶ Contractor had taken it upon himself to install additional Erosion and Sediment control measures (Compost Filter log) in area to prevent erosion he had noticed.
- ▶ The EPA inspector noticed this compost filter log was not shown on the approved plan. This was noted as possible violation due to site conditions not matching the approved plan. (Even good deeds can go punished)

- ▶ Communicate with the ESL regarding any deviations from the approved plan no matter how small or insignificant the changes may seem.
- ▶ BMP removal, even for BMP's which have obviously been phased out, must be approved by the ESL prior to removal.

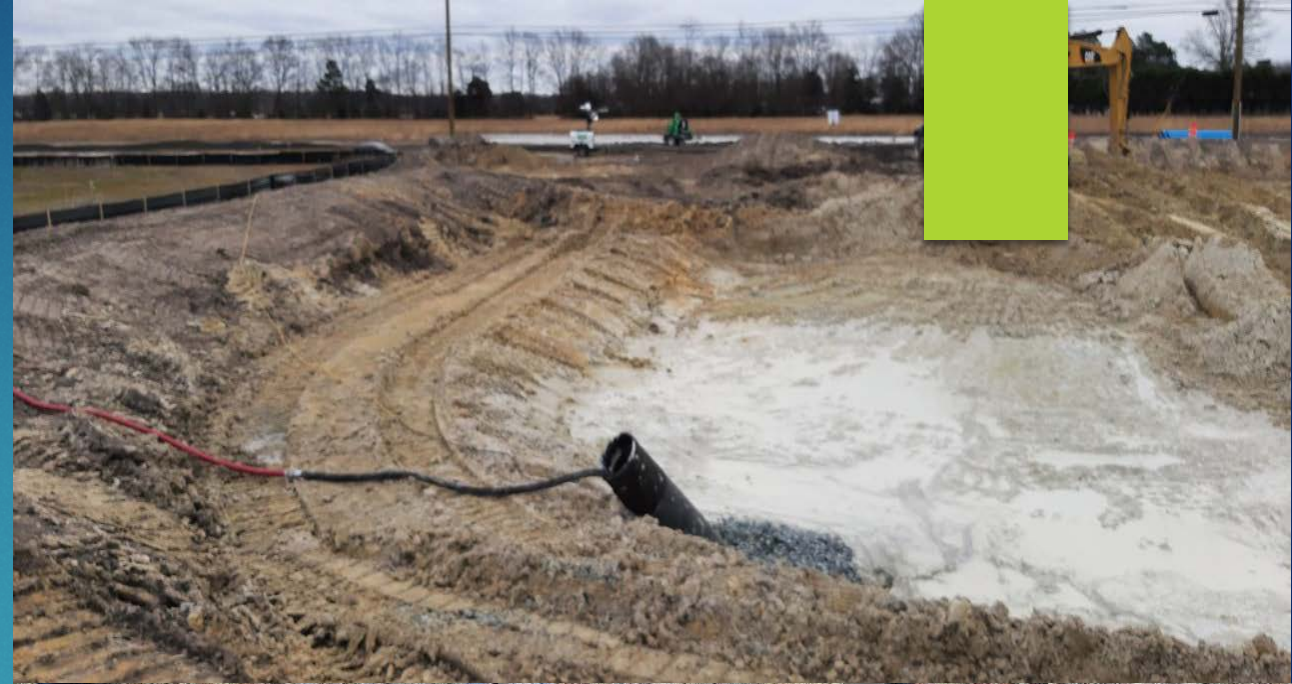
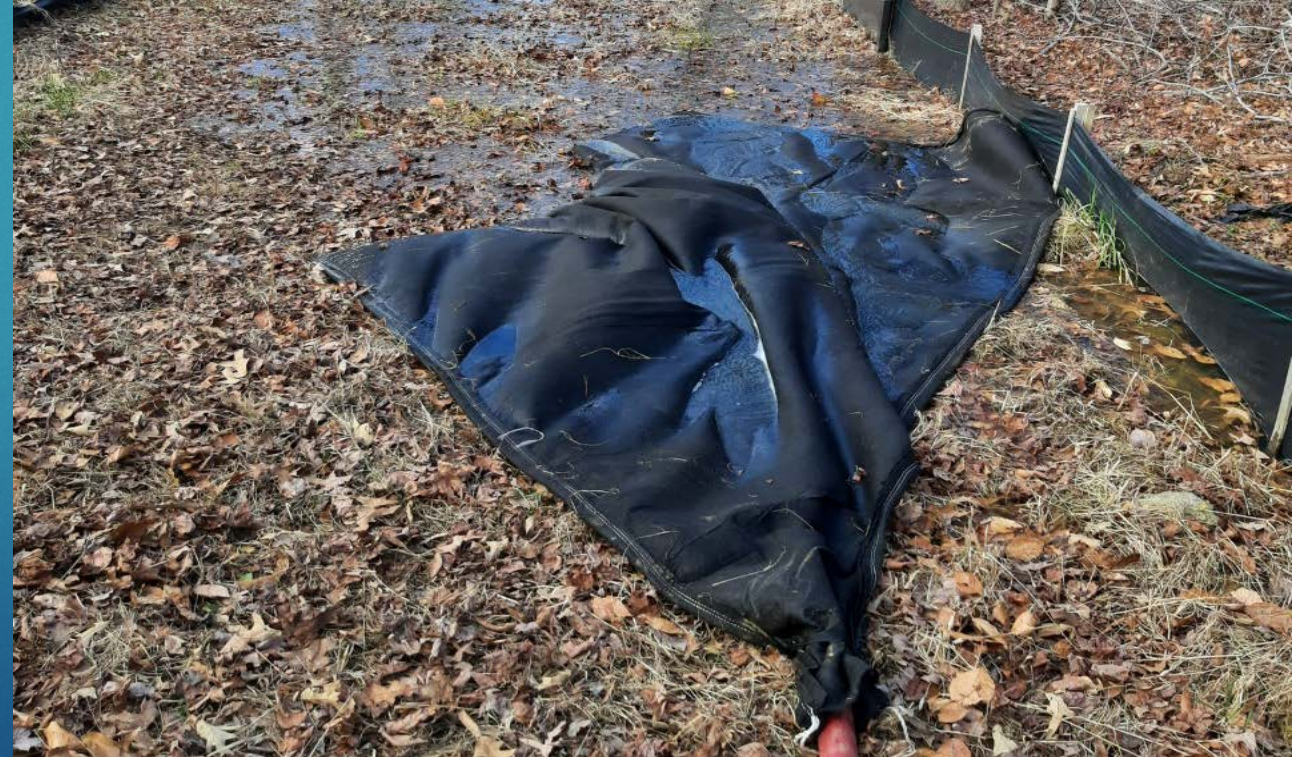
- ▶ Always filter on intake and discharge ends.
- ▶ Cause of many violations
- ▶ Can result in an instant NOV from DNREC is performed improperly
- ▶ If unsure...ask your CCR, ESL or me for guidance and pre-inspection of your dewatering set up.
