Missed Opportunities

DelDOT Lessons Learned Workshop

March 7, 2022

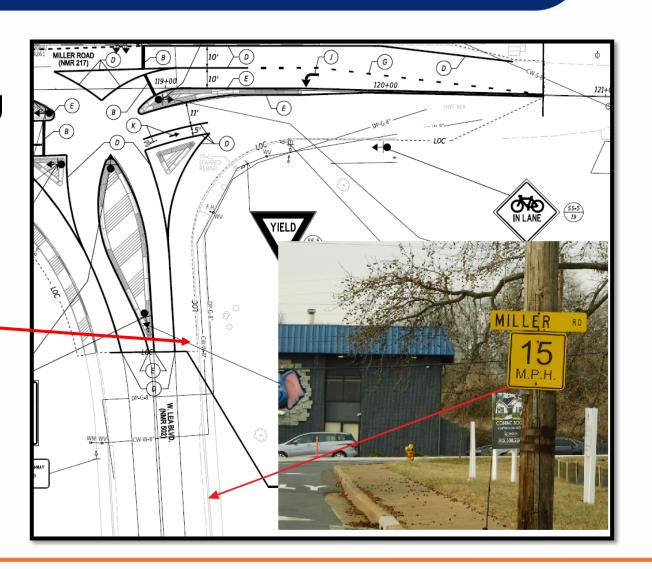
Scoping – Existing Signage

- Sign evaluations during scoping
 - Physical condition and hardware
 - Retro-reflectivity
 - Coloration
 - Sign size
 - Font size
 - L.O.C. capture all? -

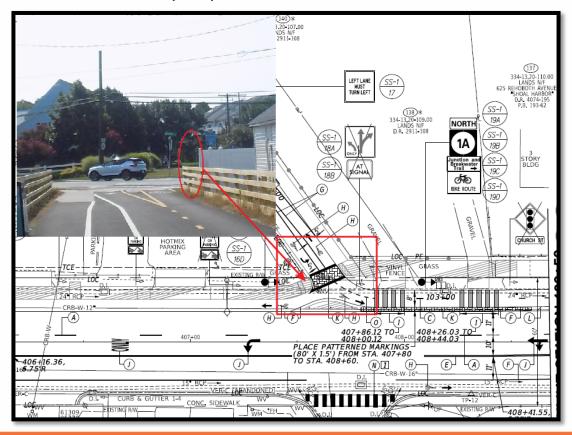
Scoping - Proposed Signage

- Does proposed signage consider all-users?
 - Privacy fence creates blind bicycle/pedestrian intersection
 - Stop sign should have been proposed and has been recommended

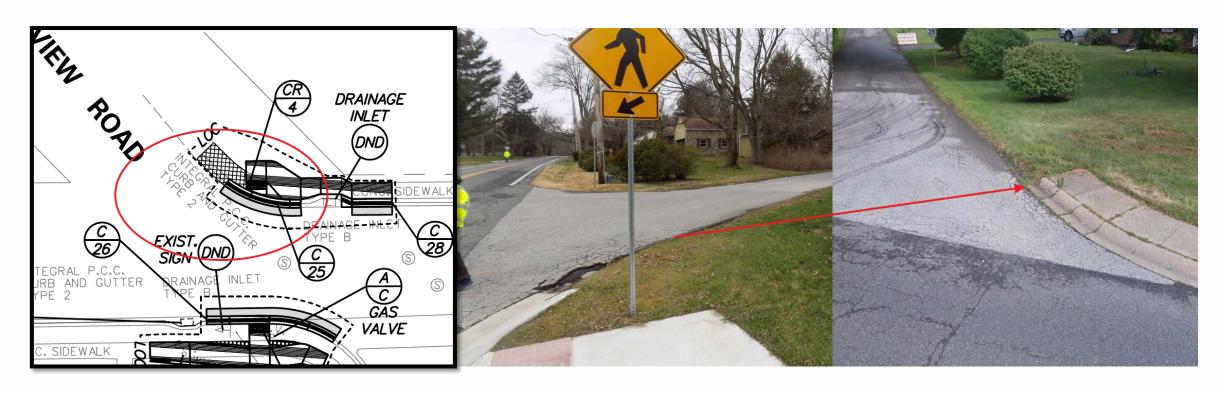
- Proposed curbing did not match previous limit
 - Location already subject to inundation due to topography

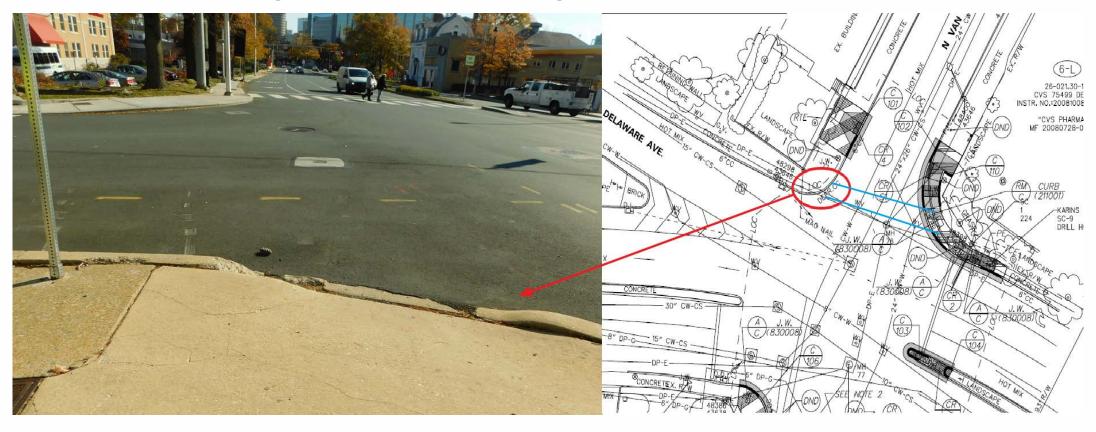
- Depressed CC (curb-cut) shown on Plans
 - Crosswalk realigned and pre-existing curb ramp left in-place

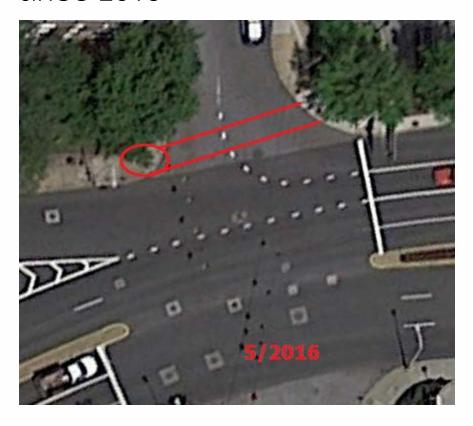
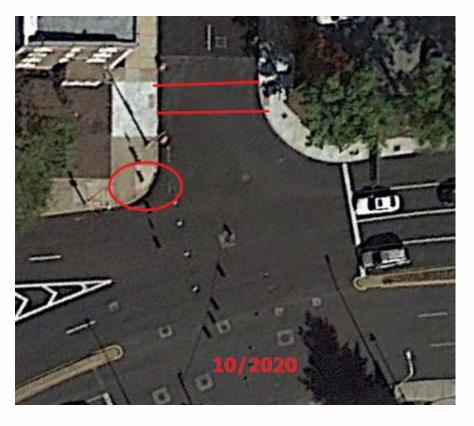
Design – L.O.C?

Depressed curb opening been in place through three different projects since 2016

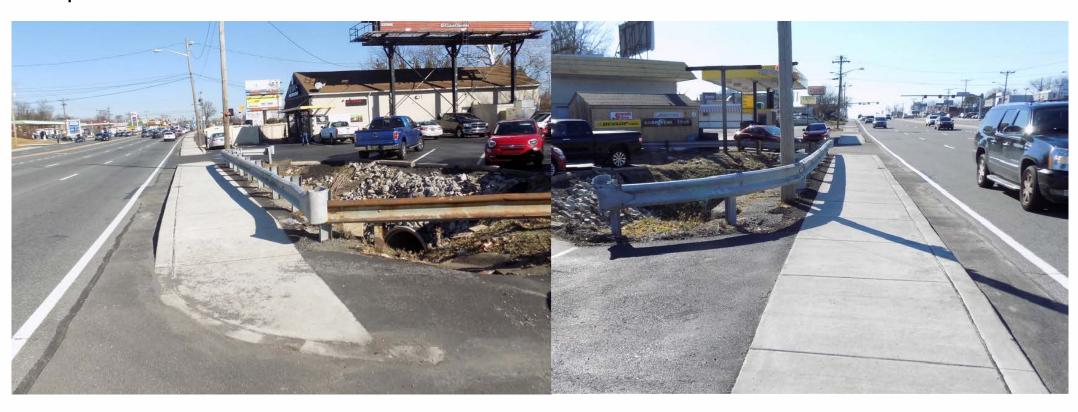
There was another location on the project where guardrail was improved

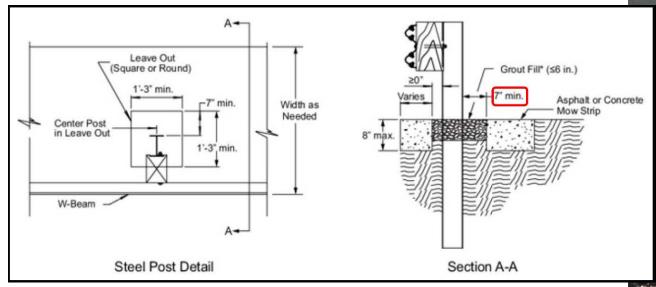
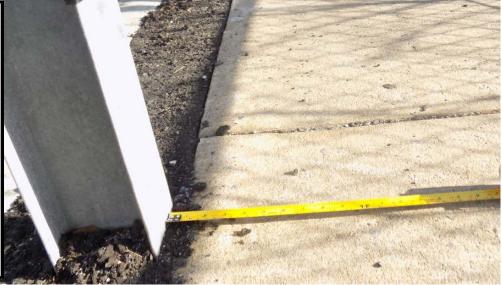
Design - Eng. Judgement and Communication

Technically there should not be concrete directly behind the

guardrail posts (per RDG)

Strong post W-beam guardrail posts in mow strips face similar problems as posts in rock formations. Details for installation of strong post W-beam guardrail posts in rock have also been developed, which differ from that in rock formations. The critical feature of the mow strip installation is the portion of the mow strip around the post omitted for the post rotation, also known as the "leave-out". The leave-out's critical measurement is from the back of the post to the edge of the mow strip and should be a minimum of 175 mm [7 in.], as shown in the details in Figures 5-52(a) and 5-52(b). Leave-outs can be filled with low-strength grout, a two-part polyethylene foam or other material that has a compressive strength of 0.85 MPa [120 psi] or less. During an impact, the leave-out material allows for some degree of post rotation by deforming or crushing prior to generating sufficient force to cause post failure. Failure of the sacrificial leave-out backfill material also minimizes damage to the surrounding mow strip. Some states backfill with a coarse aggregate material and seal the surface with an asphaltic sealer material. High tension cable barrier posts do not need a leave-out in the mow strip.

- A decision was made to remain
 - Based off of crash data
 - No history of crashes
- How do we prevent reoccurrence?
 - Communicate with designer

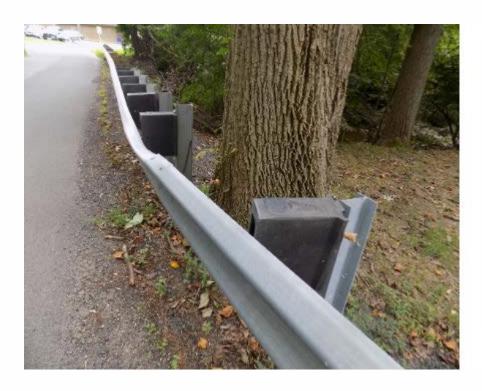
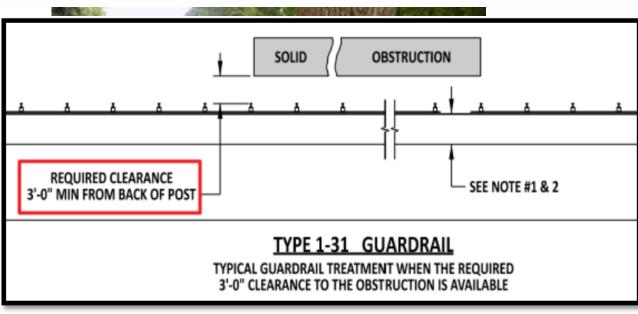
Design - Replace in Kind or Address?

Guardrail should have appropriate clearance to obstructions

Snapshot taken from the 2017 Standard Details, <u>Standard No. B-1 (2017)</u>

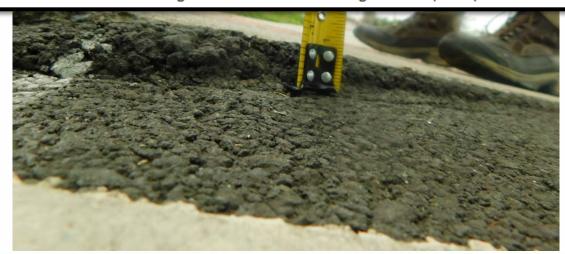
Figure 3.1.5.2.1 Vertical Change in Level (303.2)

01 Changes in level of 0'-0.25" high maximum shall be permitted to be vertical. (303.2)

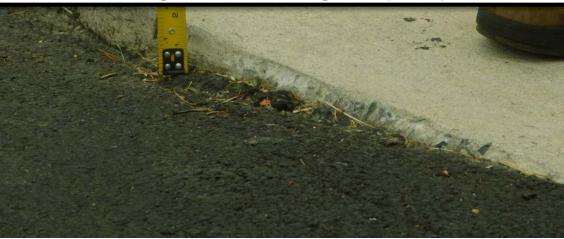
Figure 3.1.5.2.2 Beveled Change in Level (R302.7.2)

Vertical surface discontinuities between 0'-0.25" and 0'-0.50" shall be beveled with a slope not steeper than 50 percent. The bevel shall be applied across the entire vertical surface discontinuity (R302.7.2)

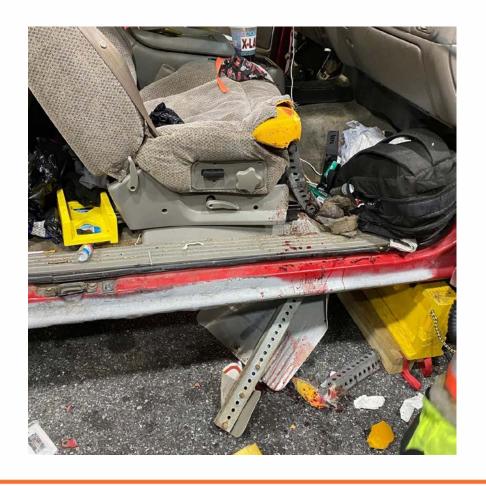
- Sign stubs require proper embedment to perform properly
- Snagging hazard
- Sign may pull from ground versus yielding
