**DELAWARE RTT/RWT FACILITIES MASTER PLAN**  
**KENTMERE TRACK**  
**ENVIRONMENTAL FEATURES**  
**MARCH 2006**

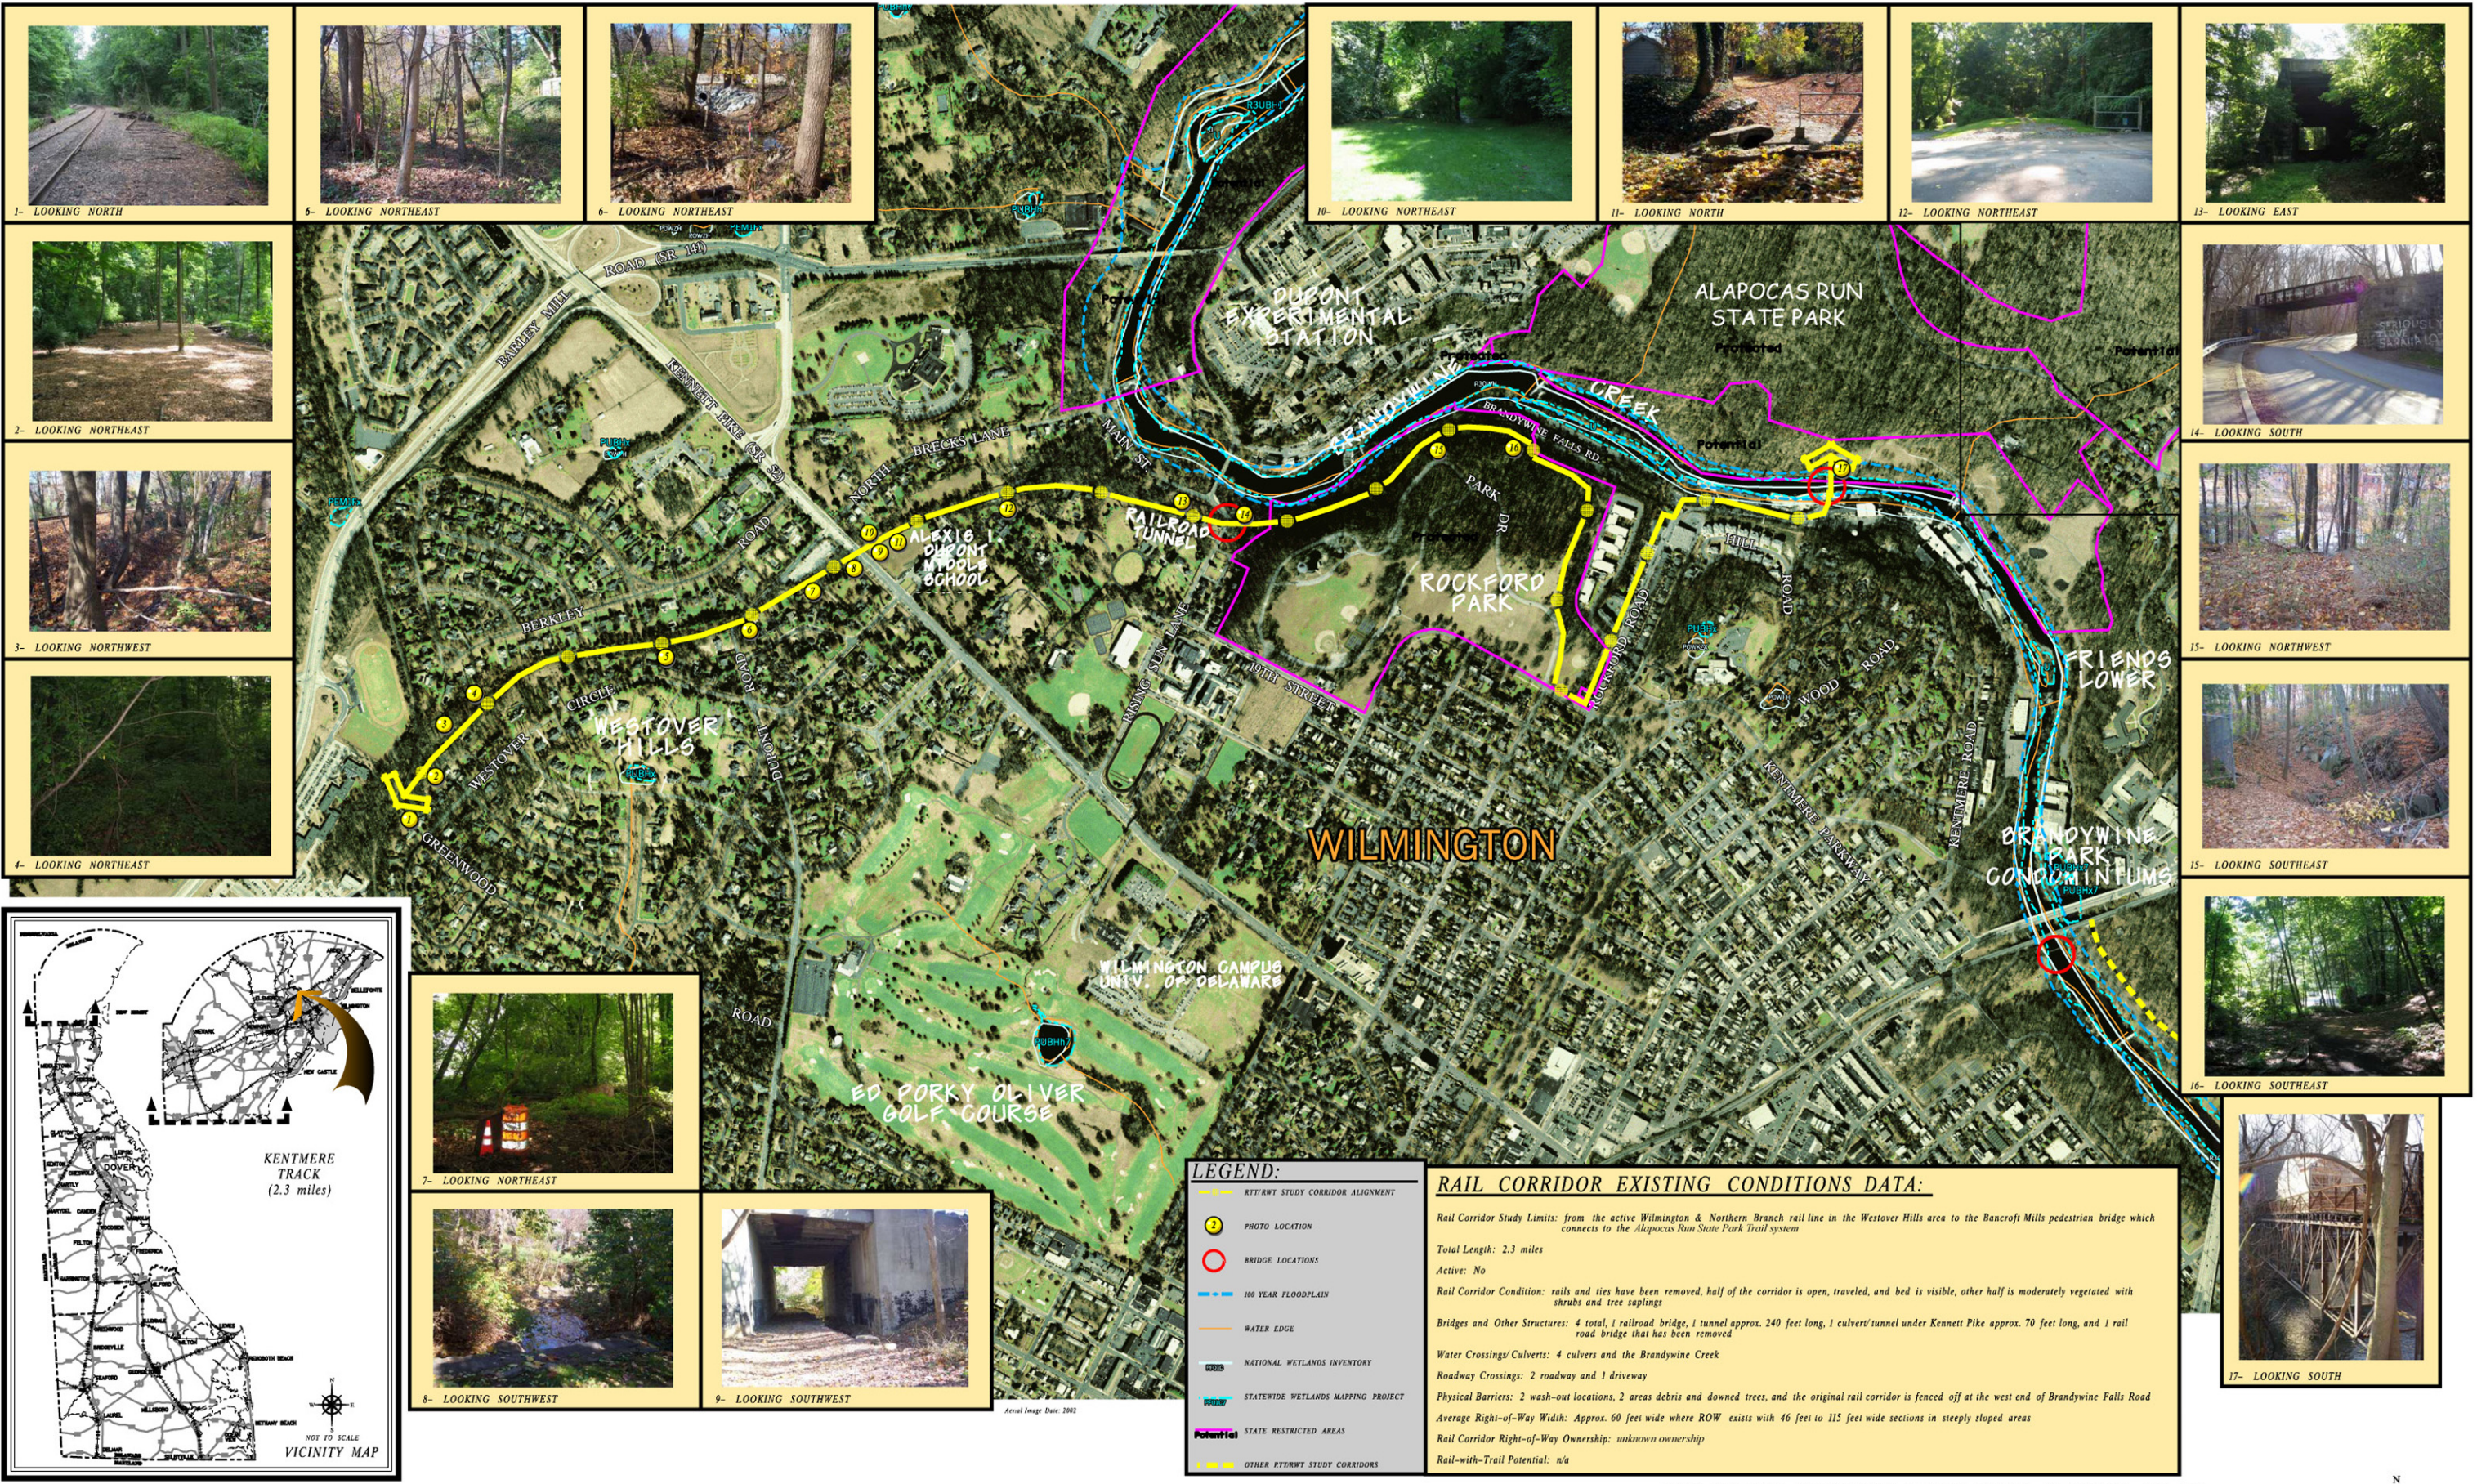
Rail Corridor Condition: rails and ties have been removed, half of the corridor is open, traveled, and bed is visible, other half is moderately vegetated with shrubs and tree saplings

Bridges and Other Structures: 4 total, 1 railroad bridge, 1 tunnel approx. 240 feet long, 1 culvert/tunnel under Kennett Pike approx. 70 feet long, and 1 rail road bridge that has been removed

Water Crossings/Culverts: 4 culverts and the Brandywine Creek

Roadway Crossings: 2 roadway and 1 driveway

Physical Barriers: 2 wash-out locations, 2 areas debris and downed trees, and the original rail corridor is fenced off at the west end of Brandywine Falls Road
