PHASE I ARCHITECTURAL ASSESSMENT OF THE
PROPOSED EXTENSION OF THE
JUNCTION AND BREAKWATER TRAIL
LEWES, SUSSEX COUNTY, DELAWARE

AGREEMENT #1536, TASK 4

prepared for
DELAWARE DEPARTMENT OF TRANSPORTATION
DOVER, DELAWARE

by
JOHN MILNER ASSOCIATES, INC.
WEST CHESTER, PENNSYLVANIA

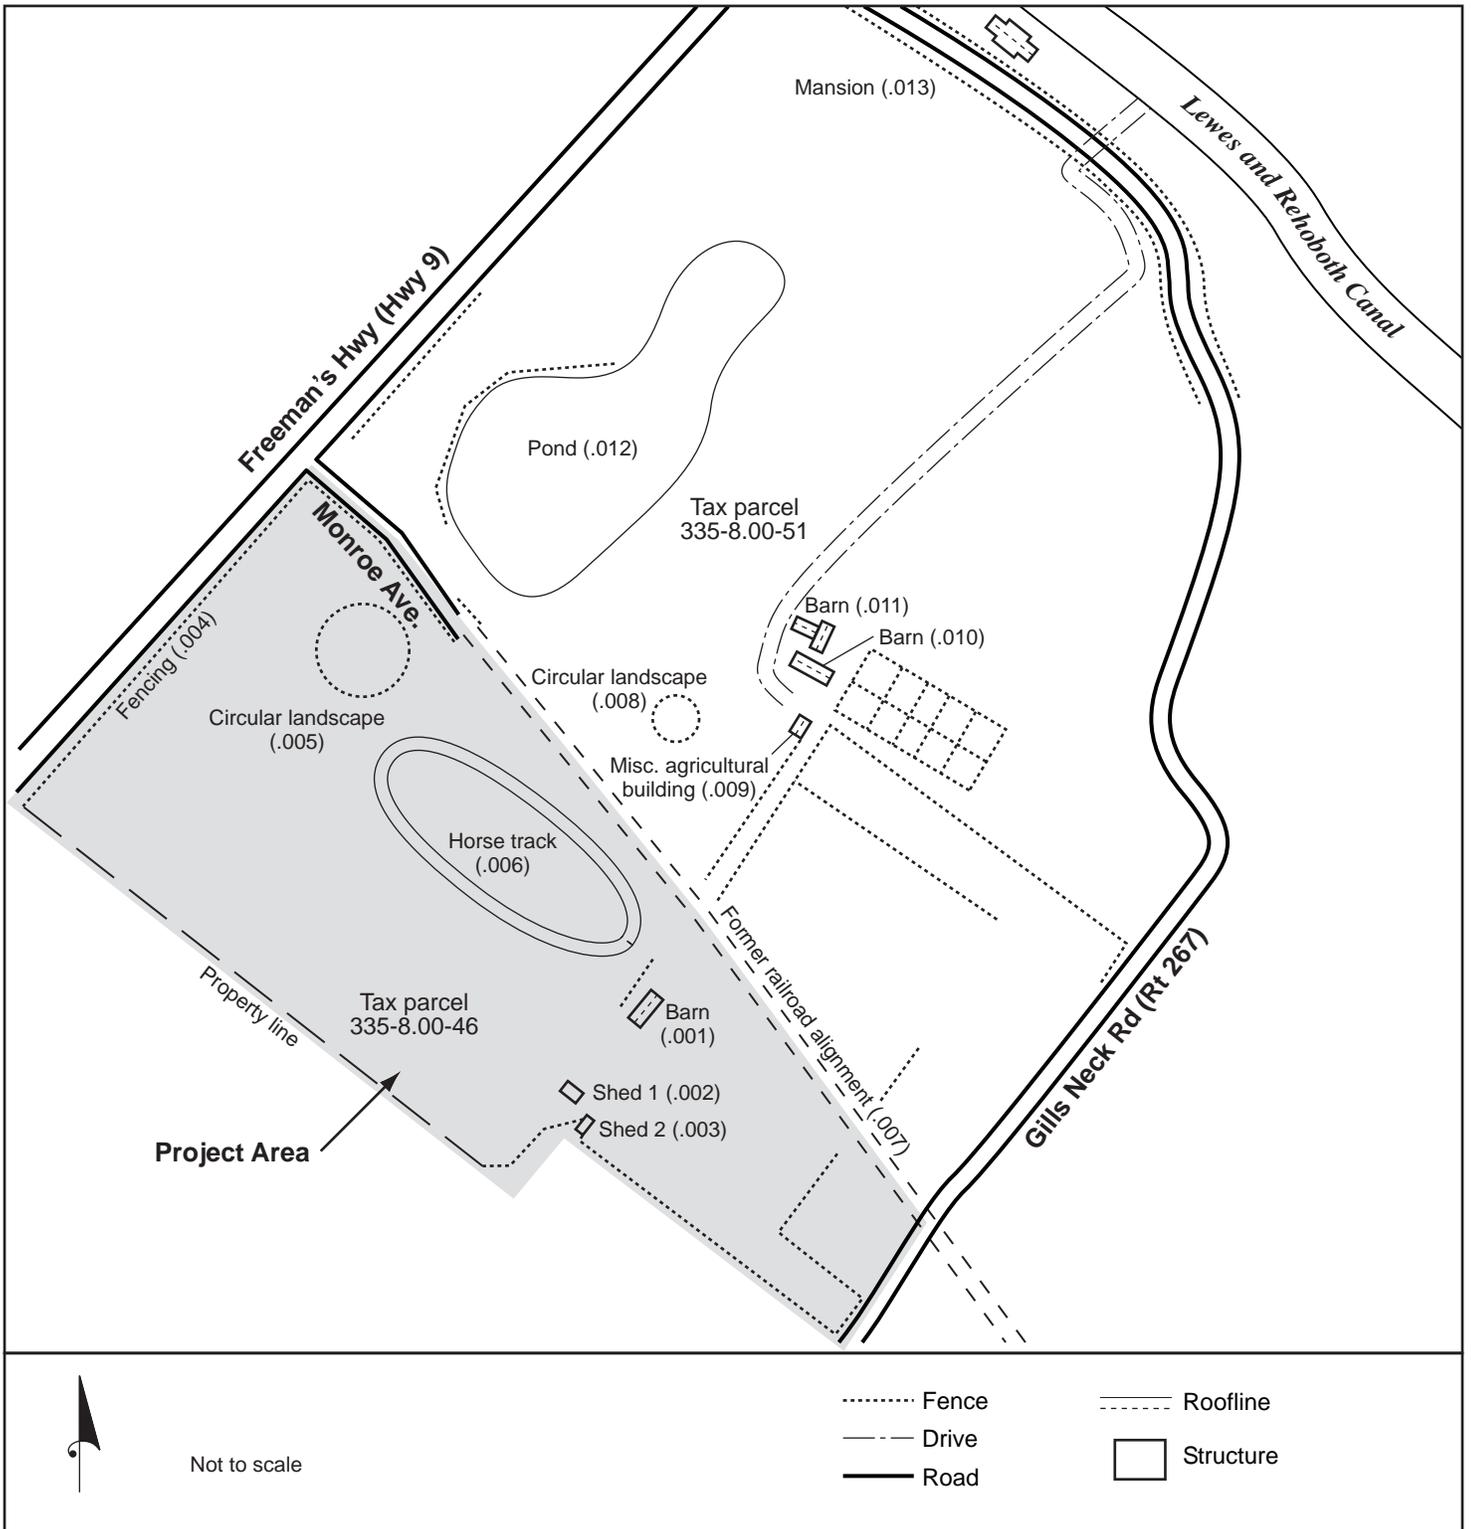
Figure 3. Site plan of Bay Manor Farm (S1052).

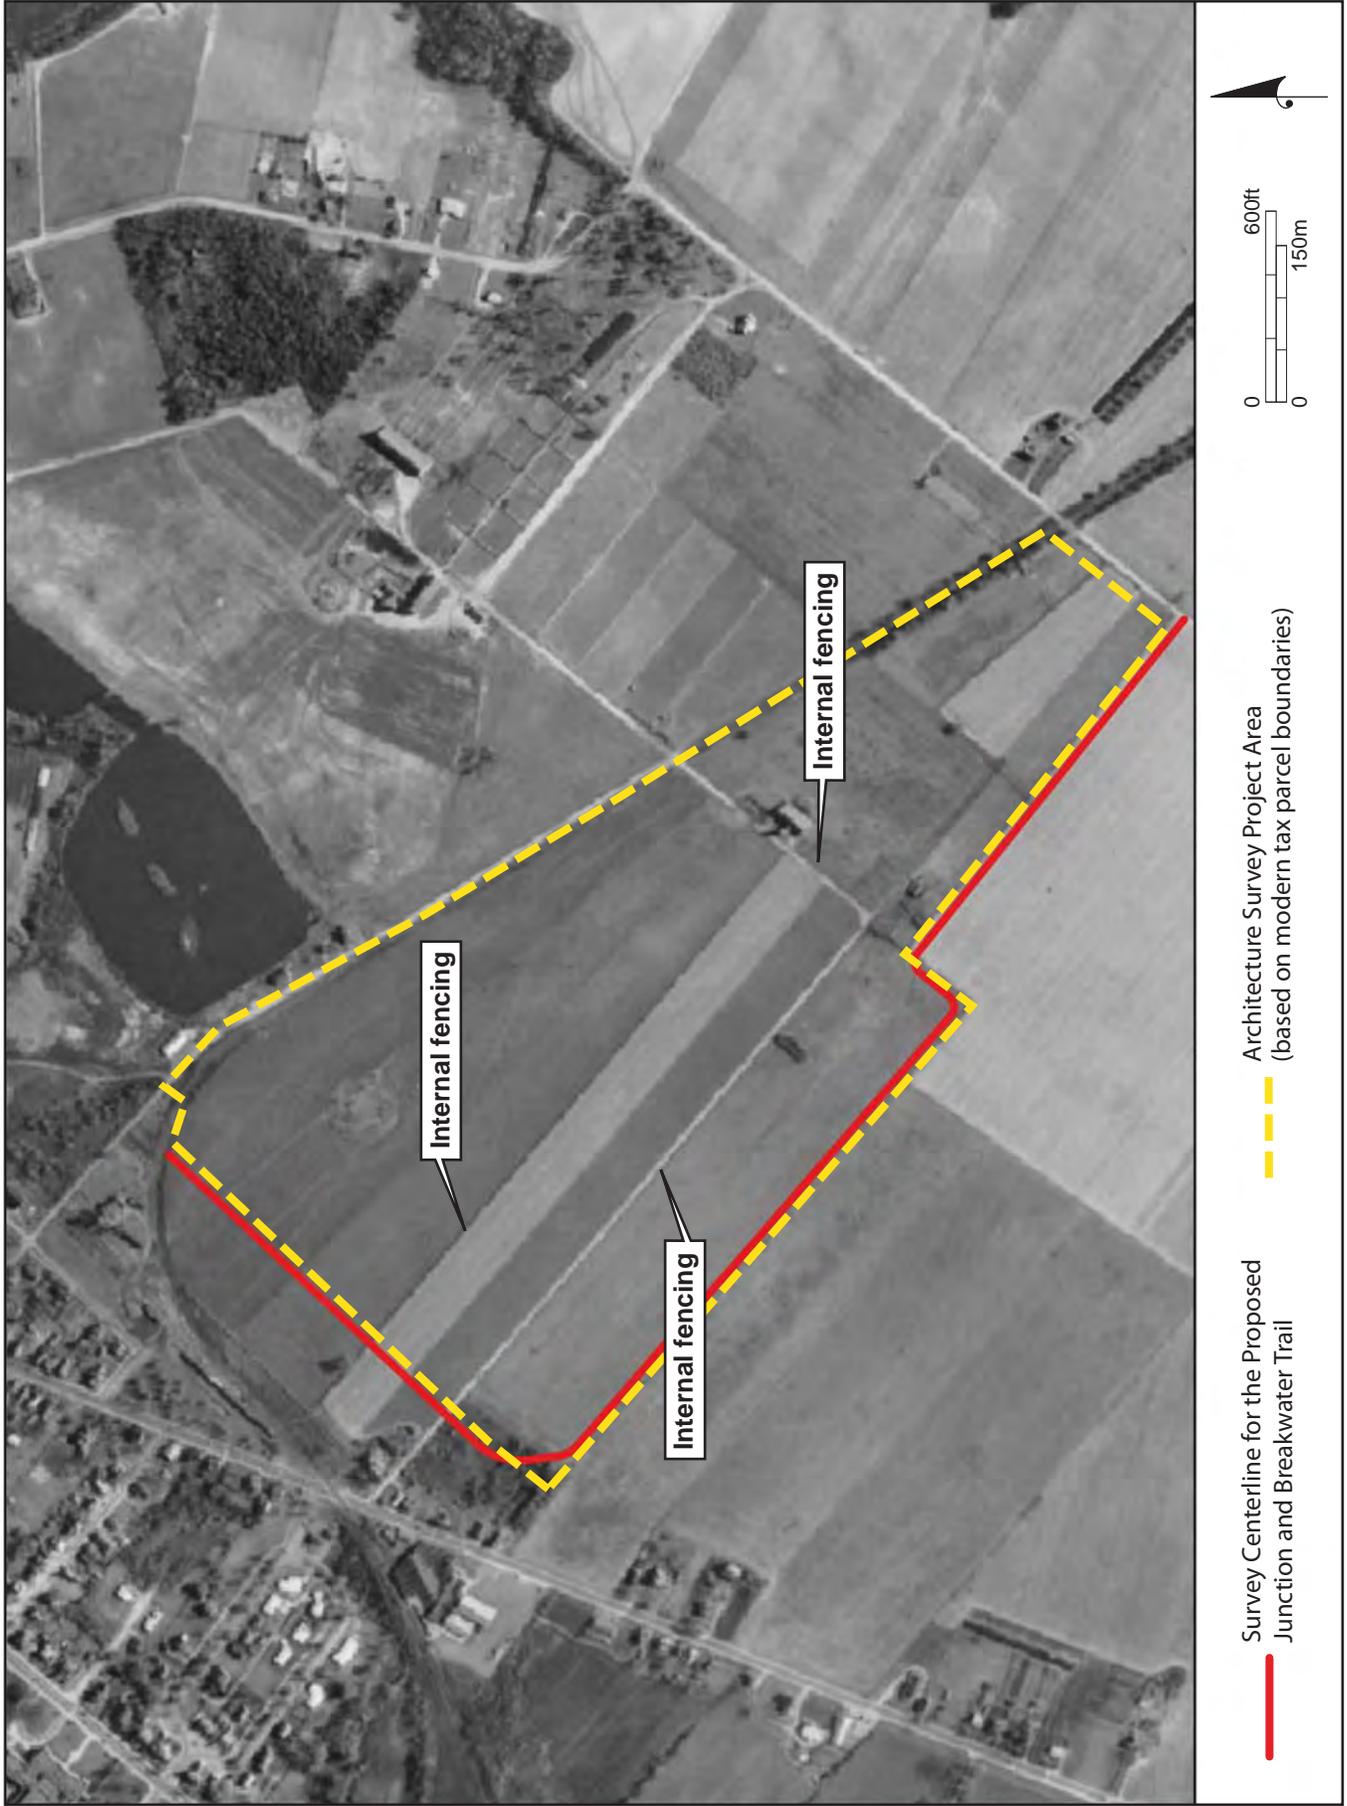
Figure 15. Detail of 1961 AS&CS aerial image with visible denotations of internal fencing.

Another element of note on the 1961 aerial includes internal fencing around the farm. Southwest of the circular landscape is a visible fence line that once stood in a northwest-southeast direction, encompassing a long rectangular section of land that stretched from the railroad to the internal road path that lay in front of the barn (located on the southeastern portion of the property) (Figure 15). As noted earlier, the Smiths fenced their property with notable concrete post-style fencing. This section of land, which was historically owned by the late Joseph Lafetra and later sold in 1908, was owned by Walter T. Virden and remained in the his family's ownership until 1980

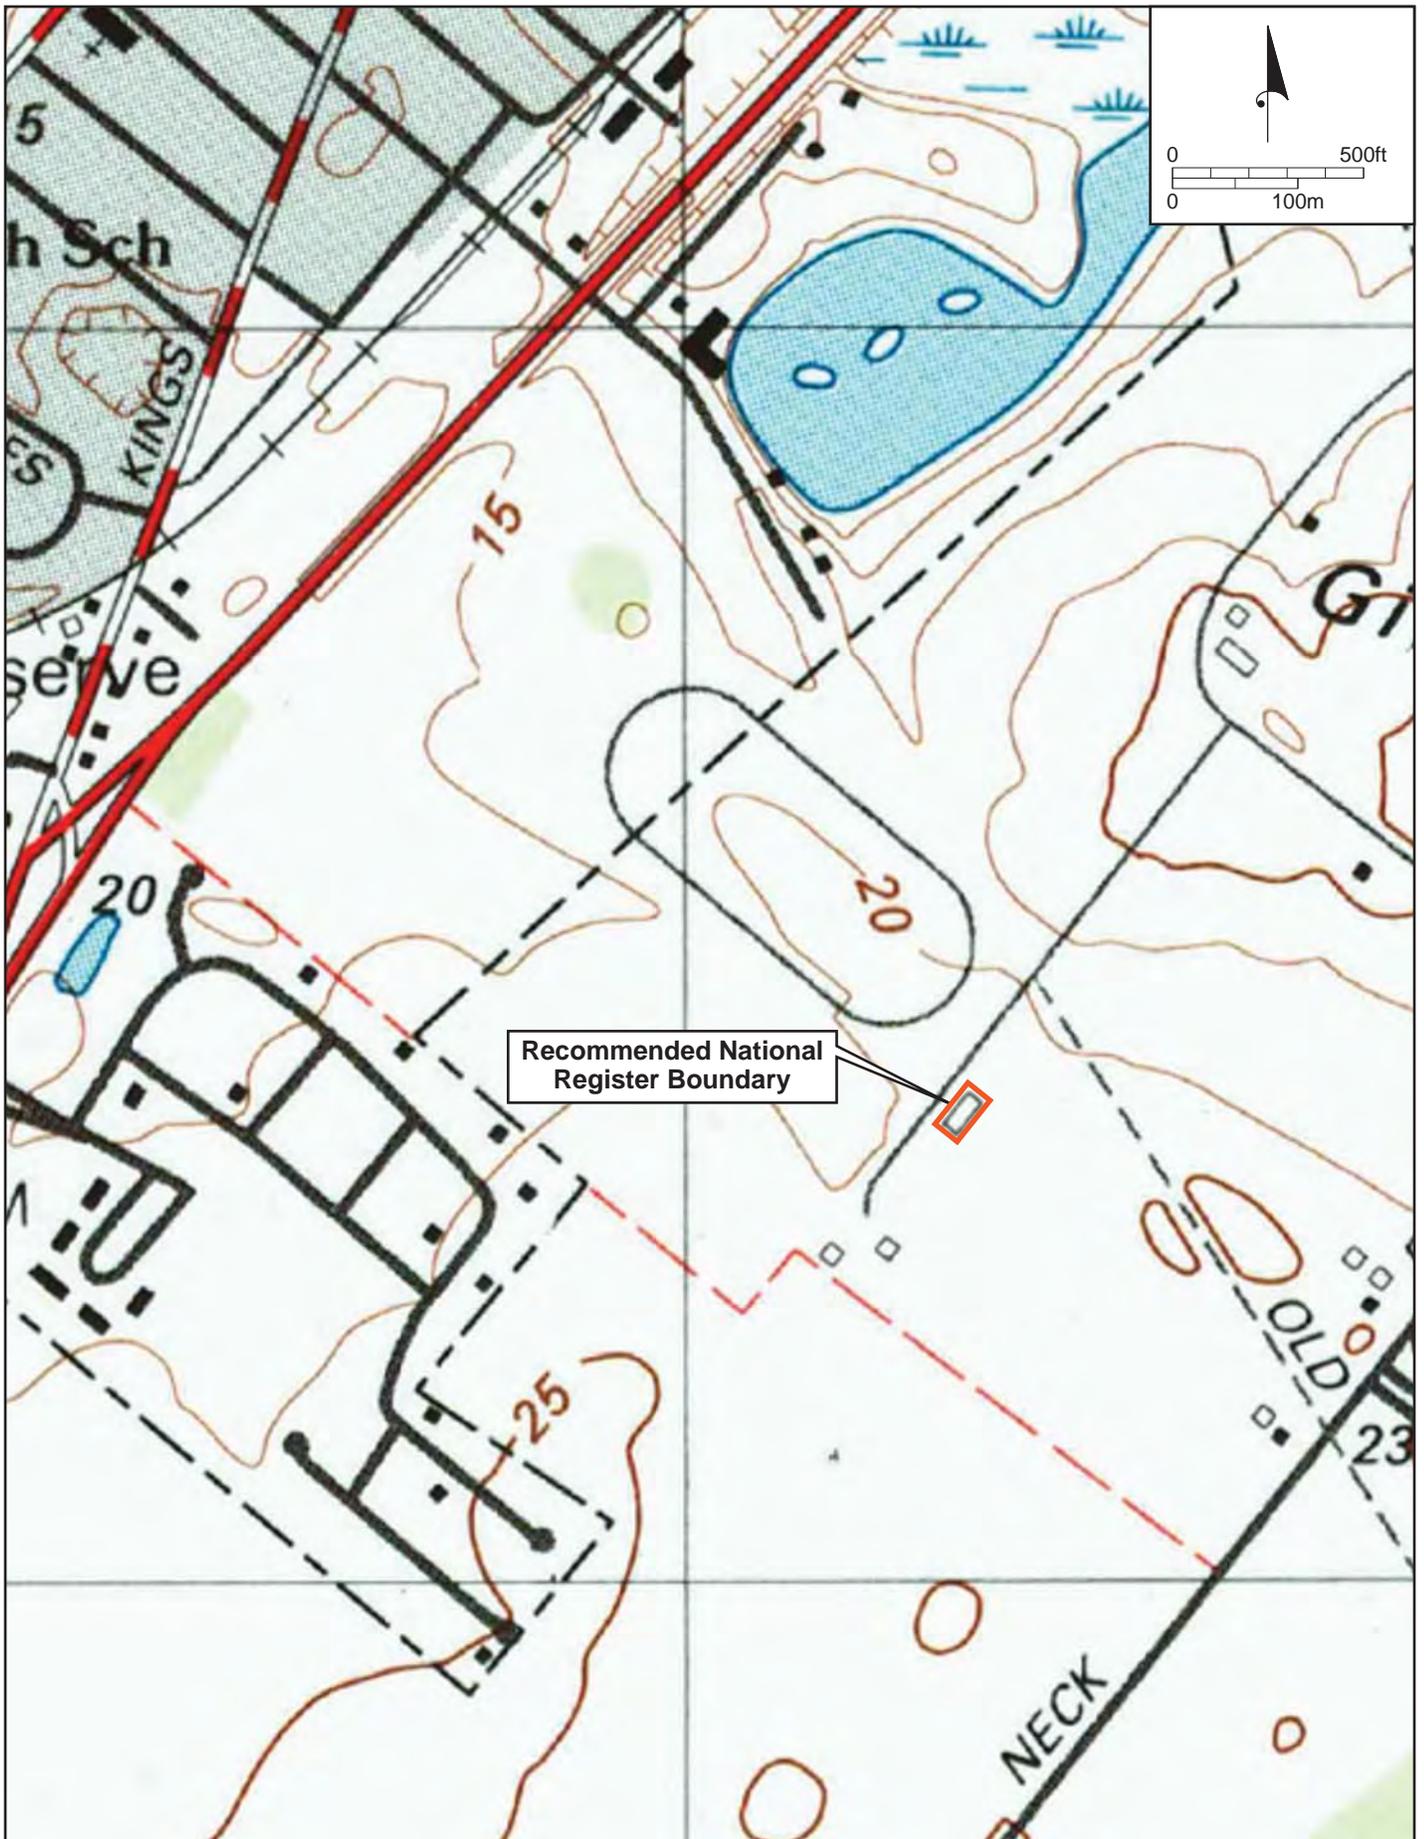
Figure 18. Detail of the *Lewes, Del.* topographic quadrangle, 7.5-minute series (USGS 1997), showing recommended National Register boundary of former Otis Smith barn.

Selecting a National Register boundary of an agricultural property requires a consideration of extant buildings, landscapes, and structures, and the interrelationships among the three. The barn clearly possesses the architectural significance necessary for National Register eligibility. The remaining outbuildings and farm fields do not. Therefore, the recommended National Register boundary for this portion of the former farm includes only a portion of the parcel. The recommended National Register boundary consists of a polygon-shaped boundary around the outer walls of the barn (Figure 18).

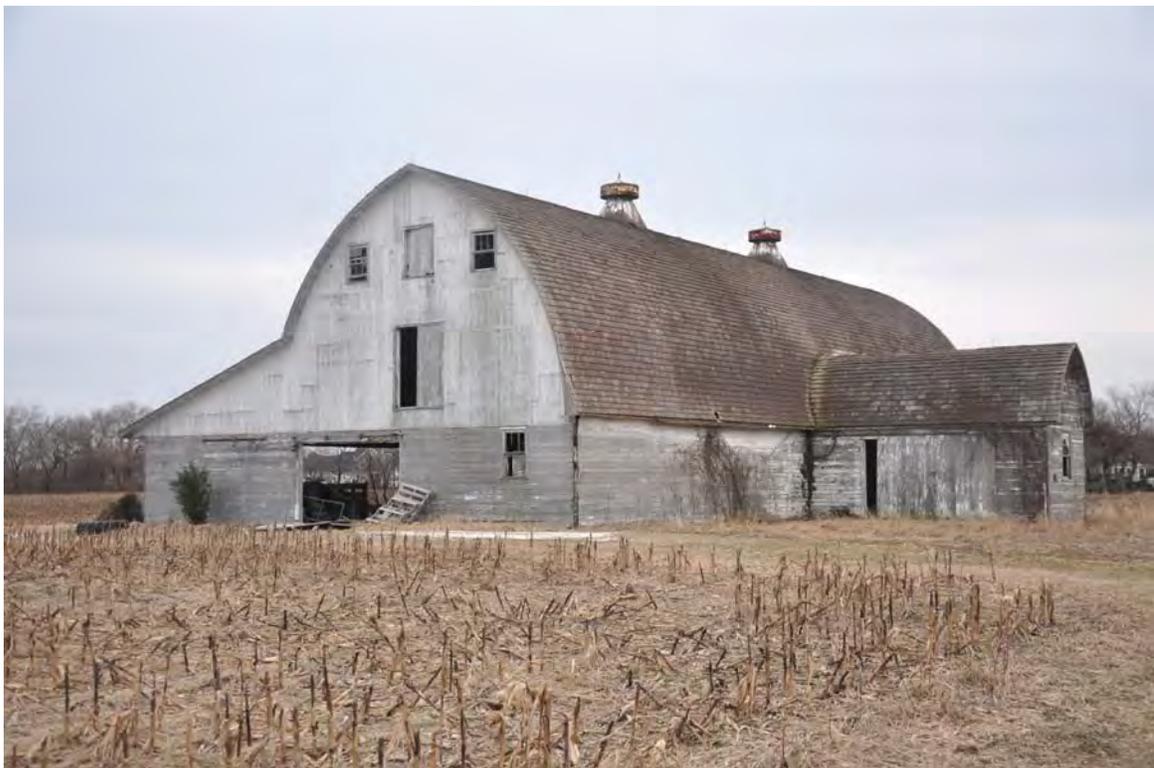
Plate 6. Barn. Northeast and northwest elevations; view looking south-southwest.

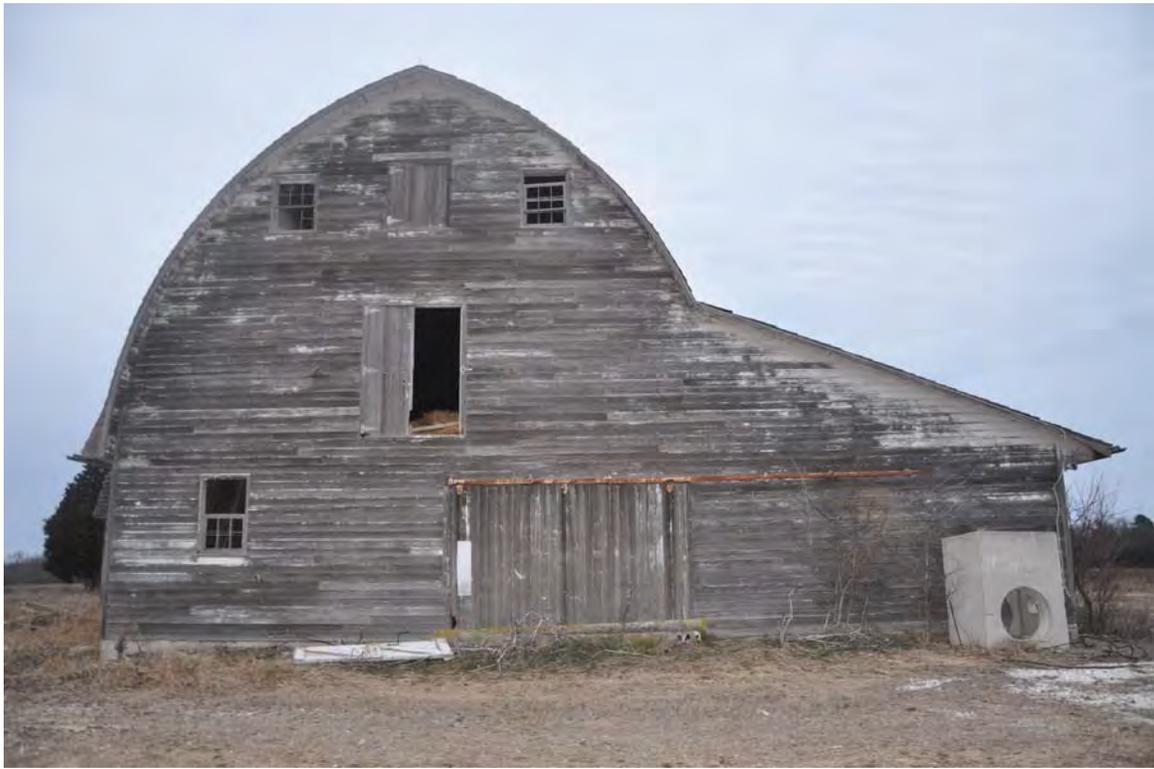
Plate 7. Barn. Southwest elevation; view looking northeast.

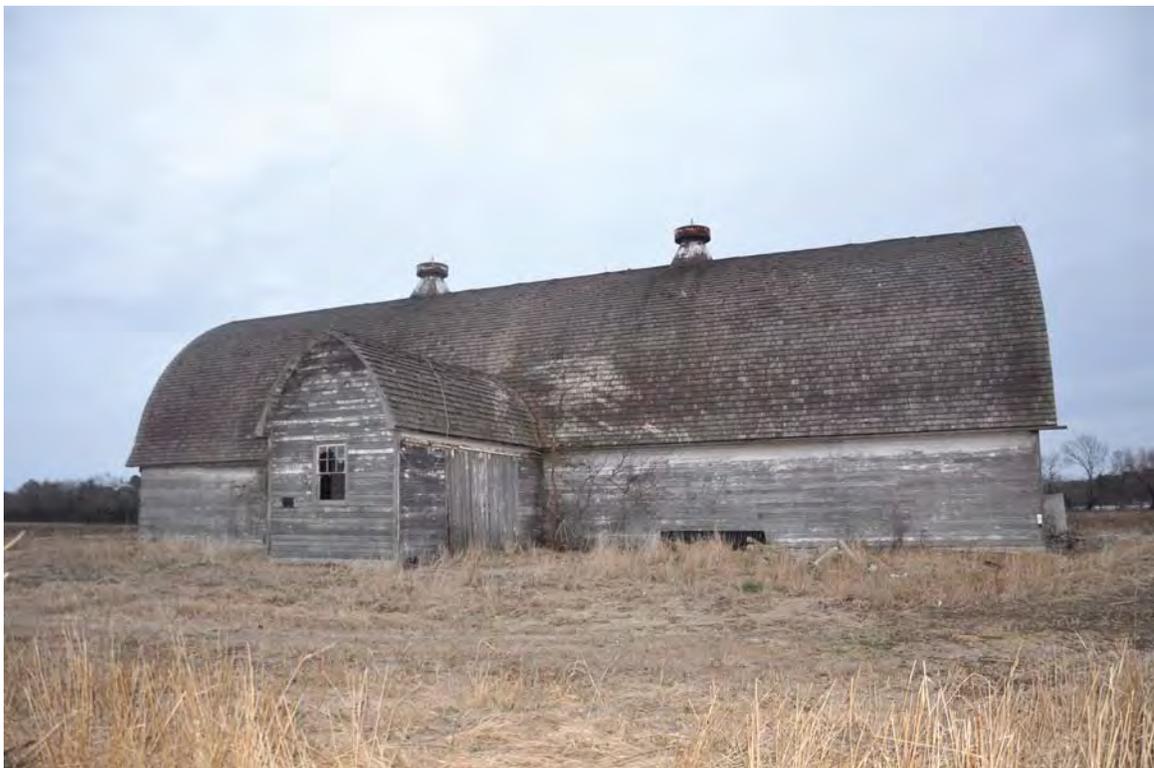
Plate 8. Barn. Northwest elevation; view looking southeast.

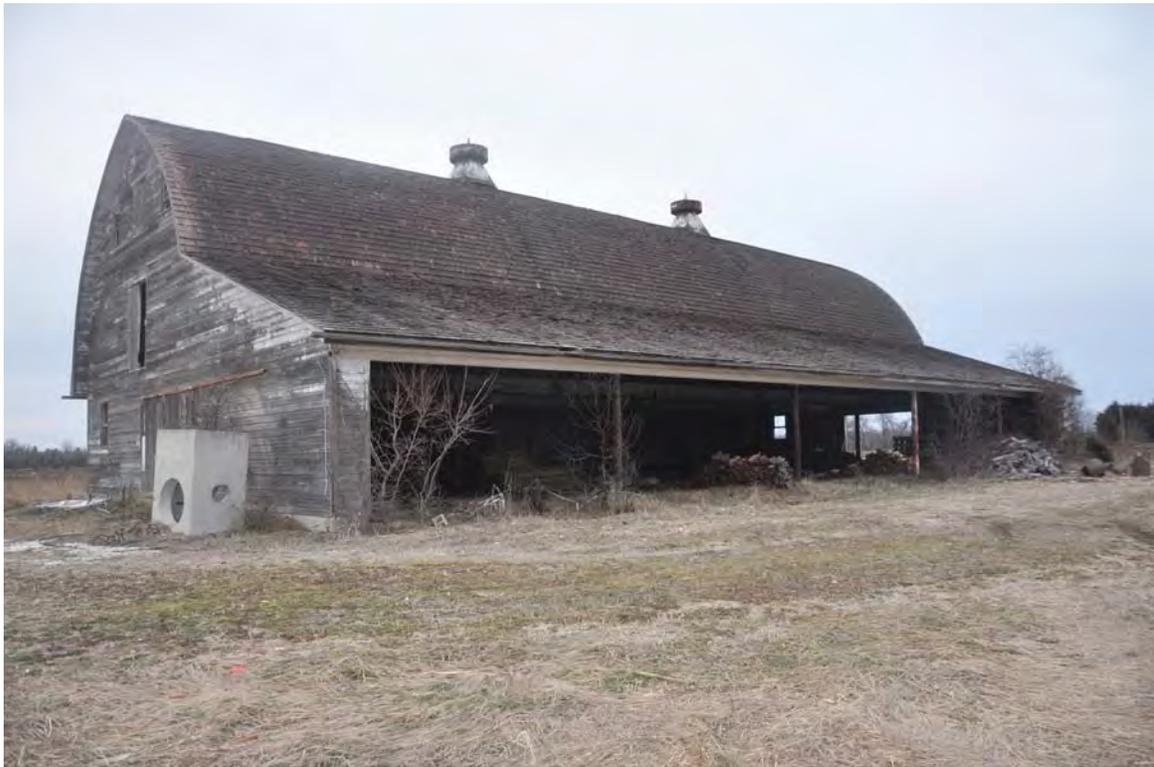
Plate 9. Barn. Southwest and southeast elevations; view looking north.

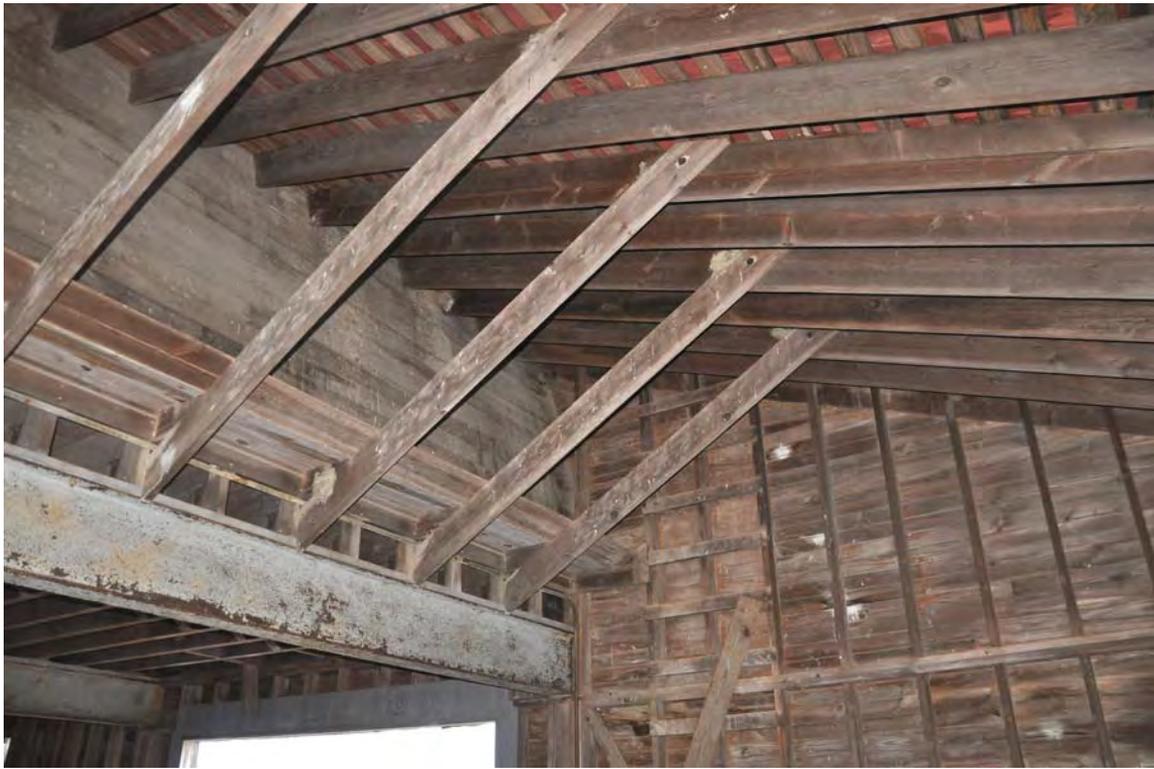
Plate 15. Barn. Detail of rafter system outside centralized, enclosed upper-level loft.

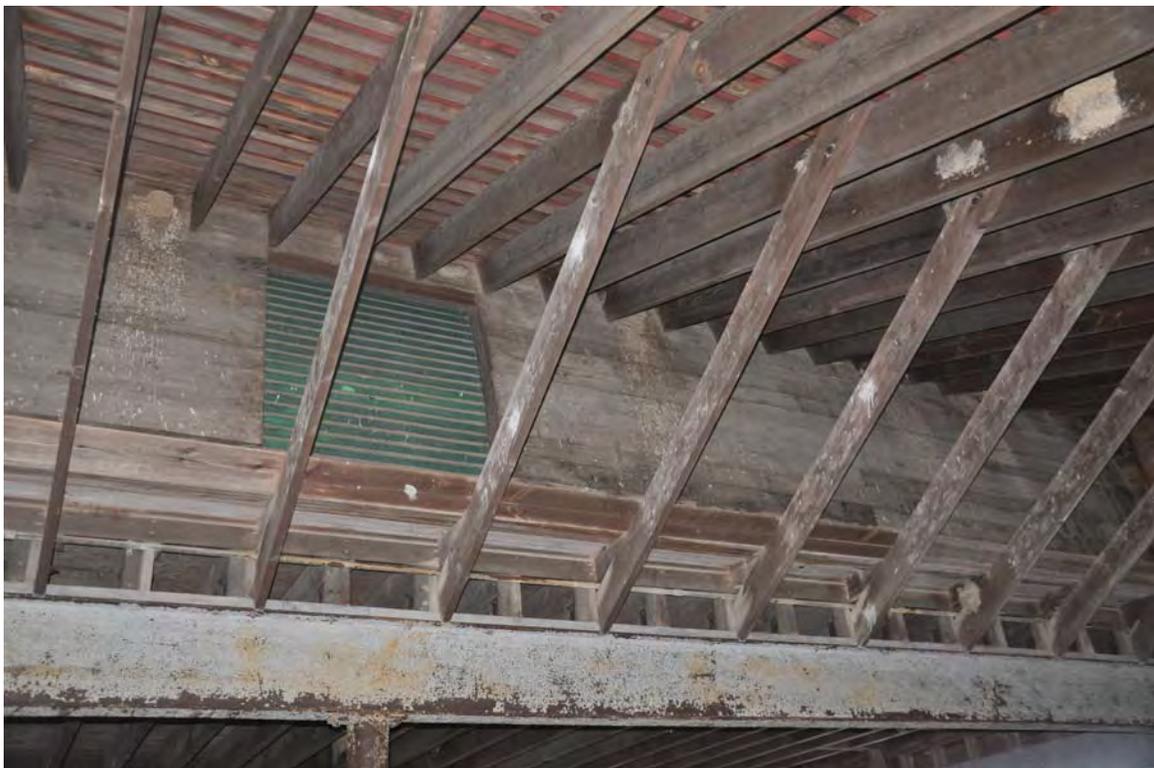
Plate 16. Barn. Detail of rafter system and centralized, enclosed upper-level loft.

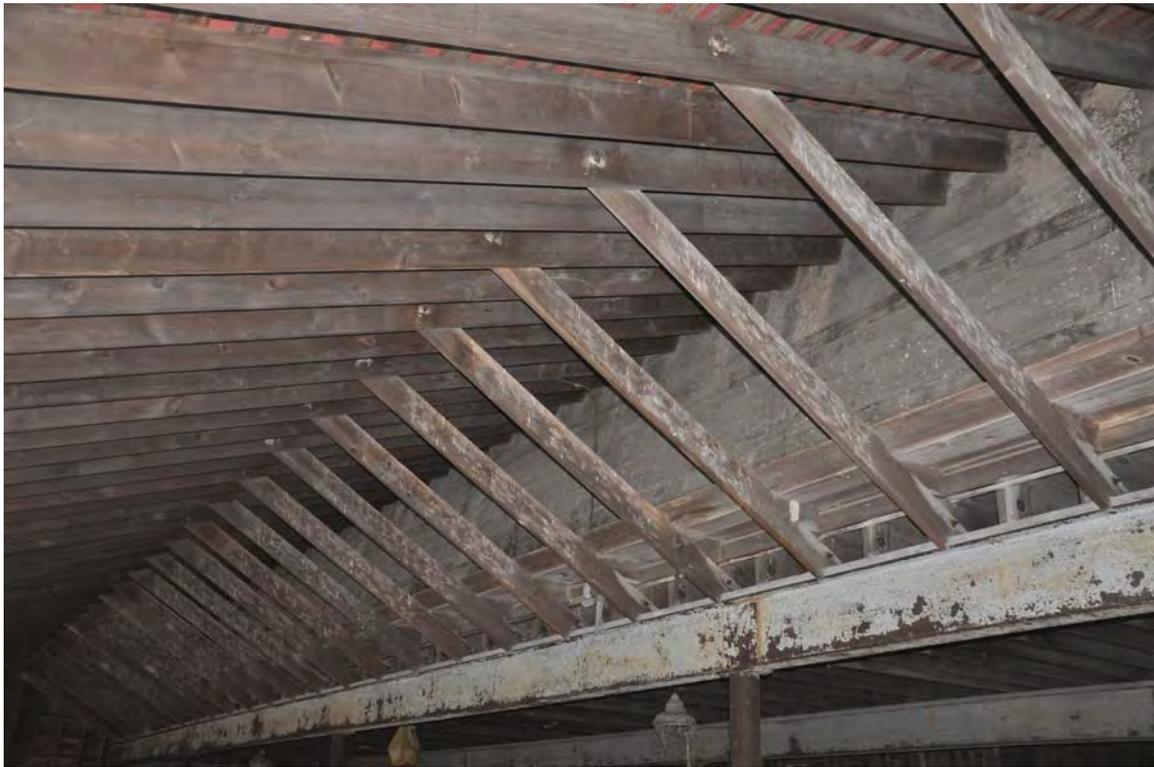
Plate 17. Barn. Detail of rafter system outside centralized, enclosed upper-level loft.

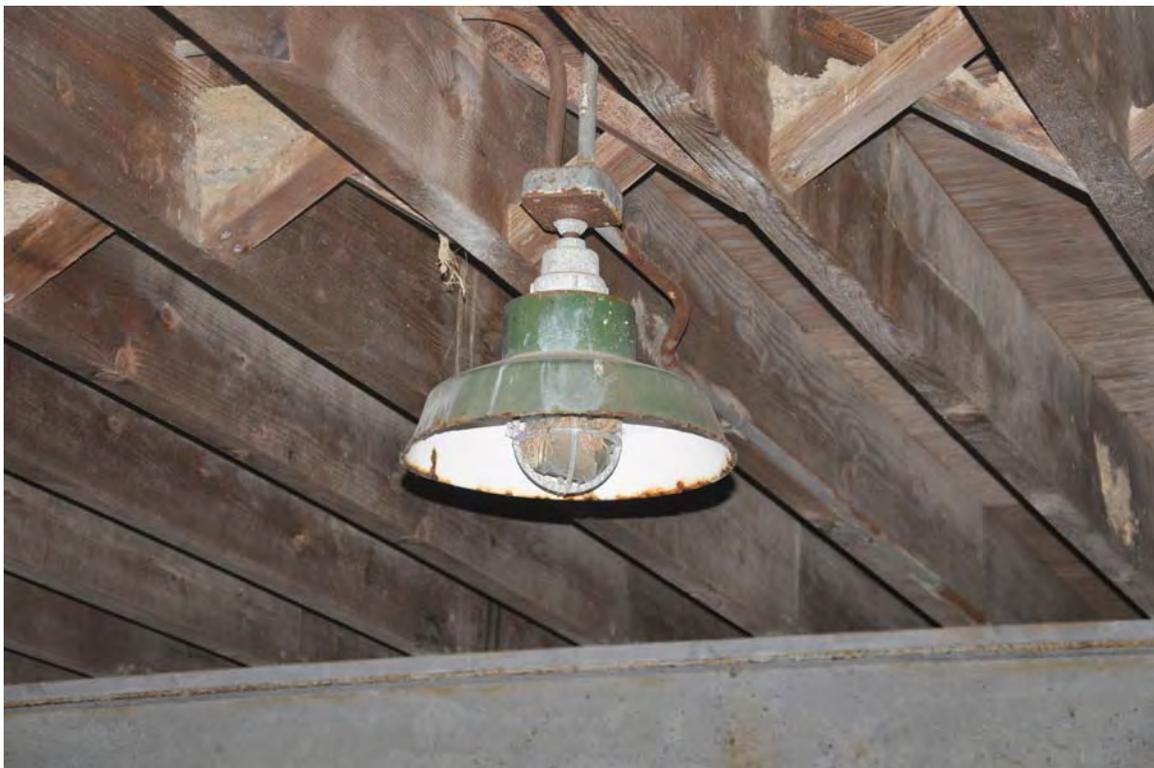
Plate 18. Barn. Detail of upper level flooring and lighting from ground level.

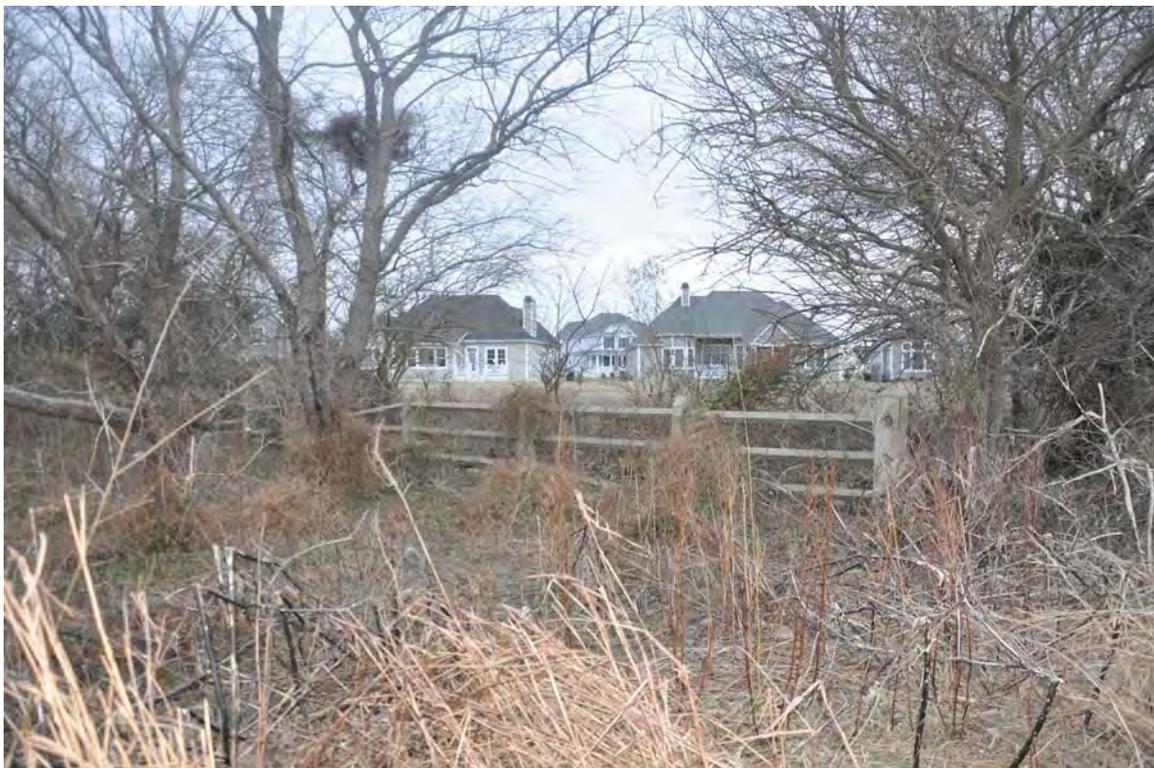
Plate 24. Fencing. Detail of masonry post with masonry stretcher fencing found along southwest side of property; view looking southwest.

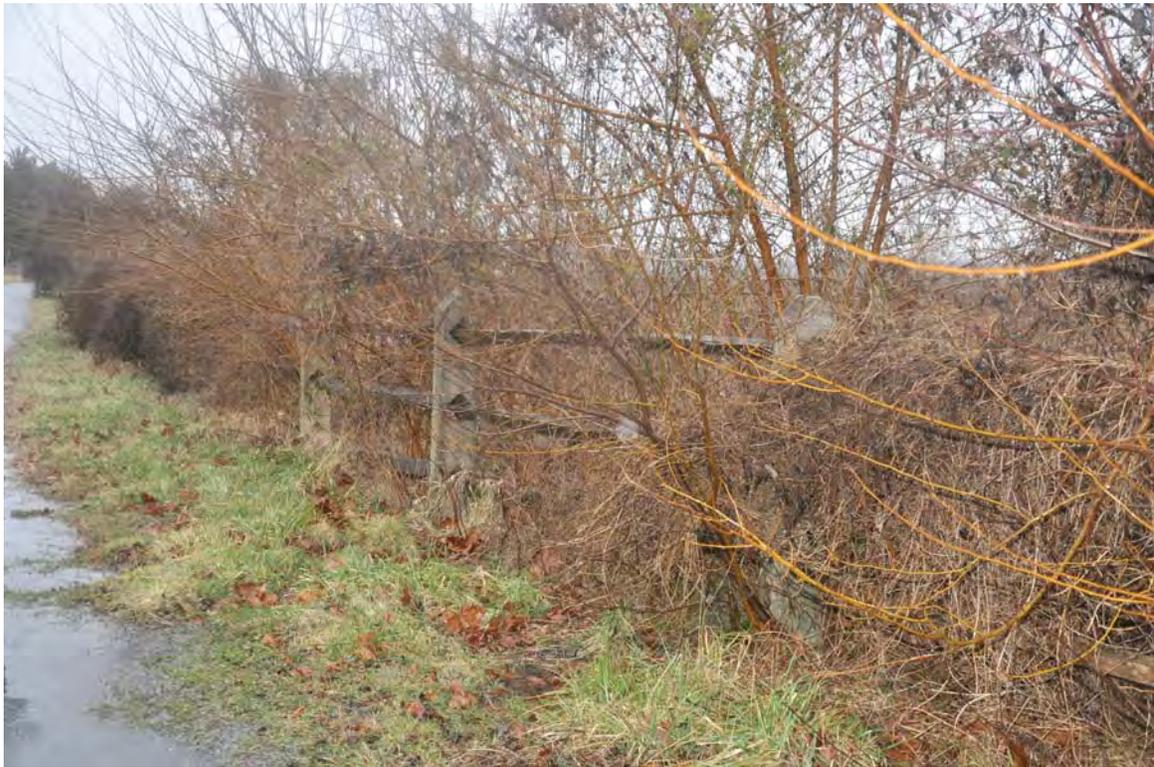
Plate 25. Fencing. Detail of masonry post with wood stretcher fencing found along northeast side of property (along southwest side of Monroe Avenue); view looking south.

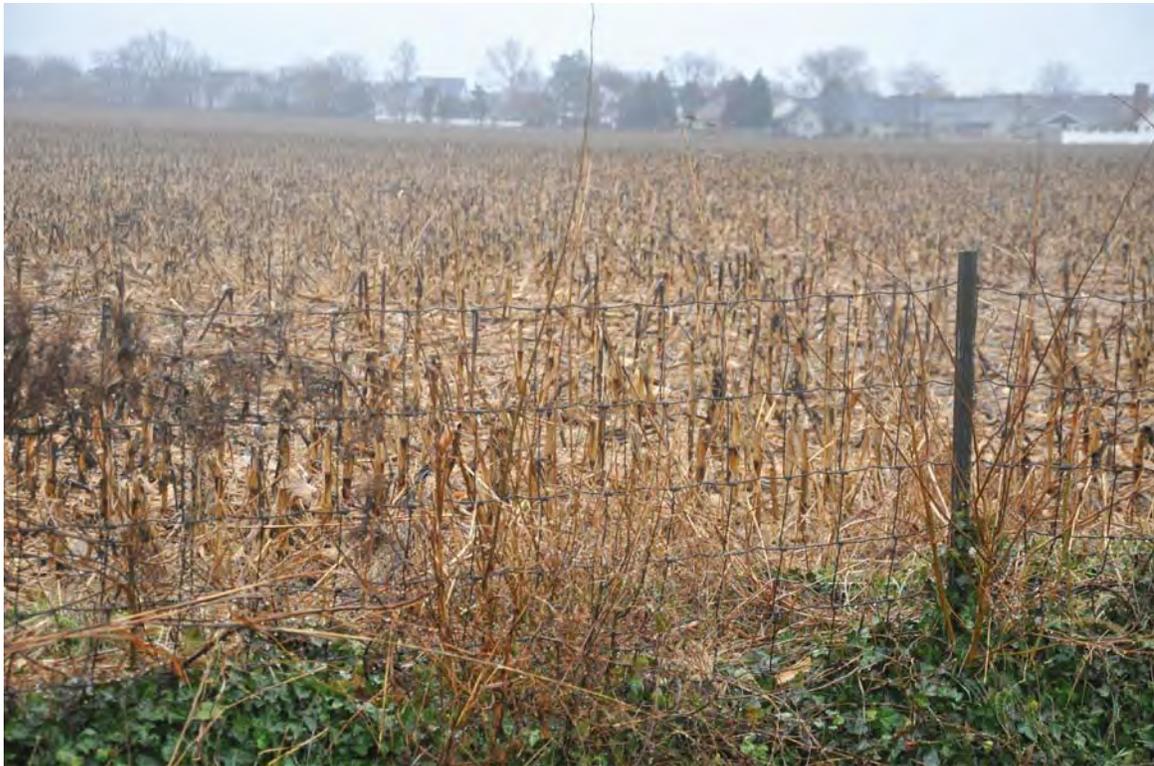
Plate 26. Fencing. Detail of wire mesh fencing found along northwest side of property (along southeast side of Freeman's Highway); view looking south.

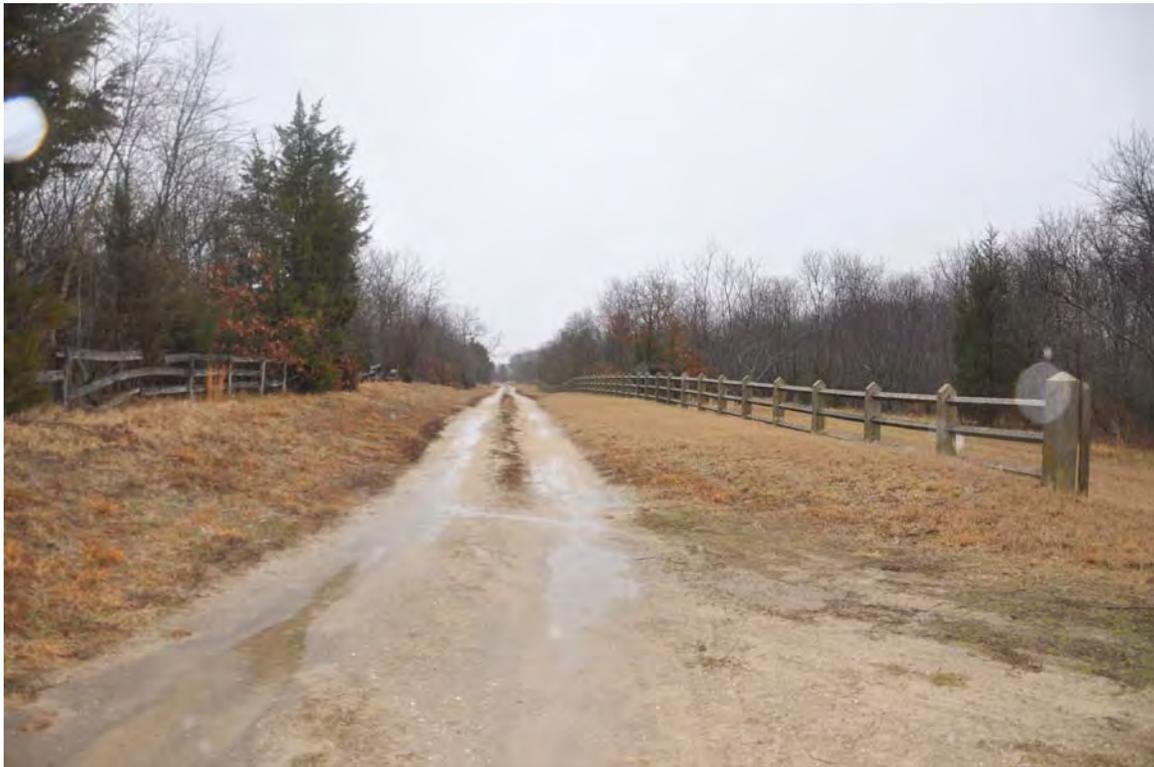
Plate 27. Fencing. Detail of masonry post with masonry stretcher fencing and wood fencing found toward the middle northeast side of the property. Fencing flanks internal road path that lies between project property and adjacent property, leading to additional outbuildings (see Plates 1-3); view looking northeast.
