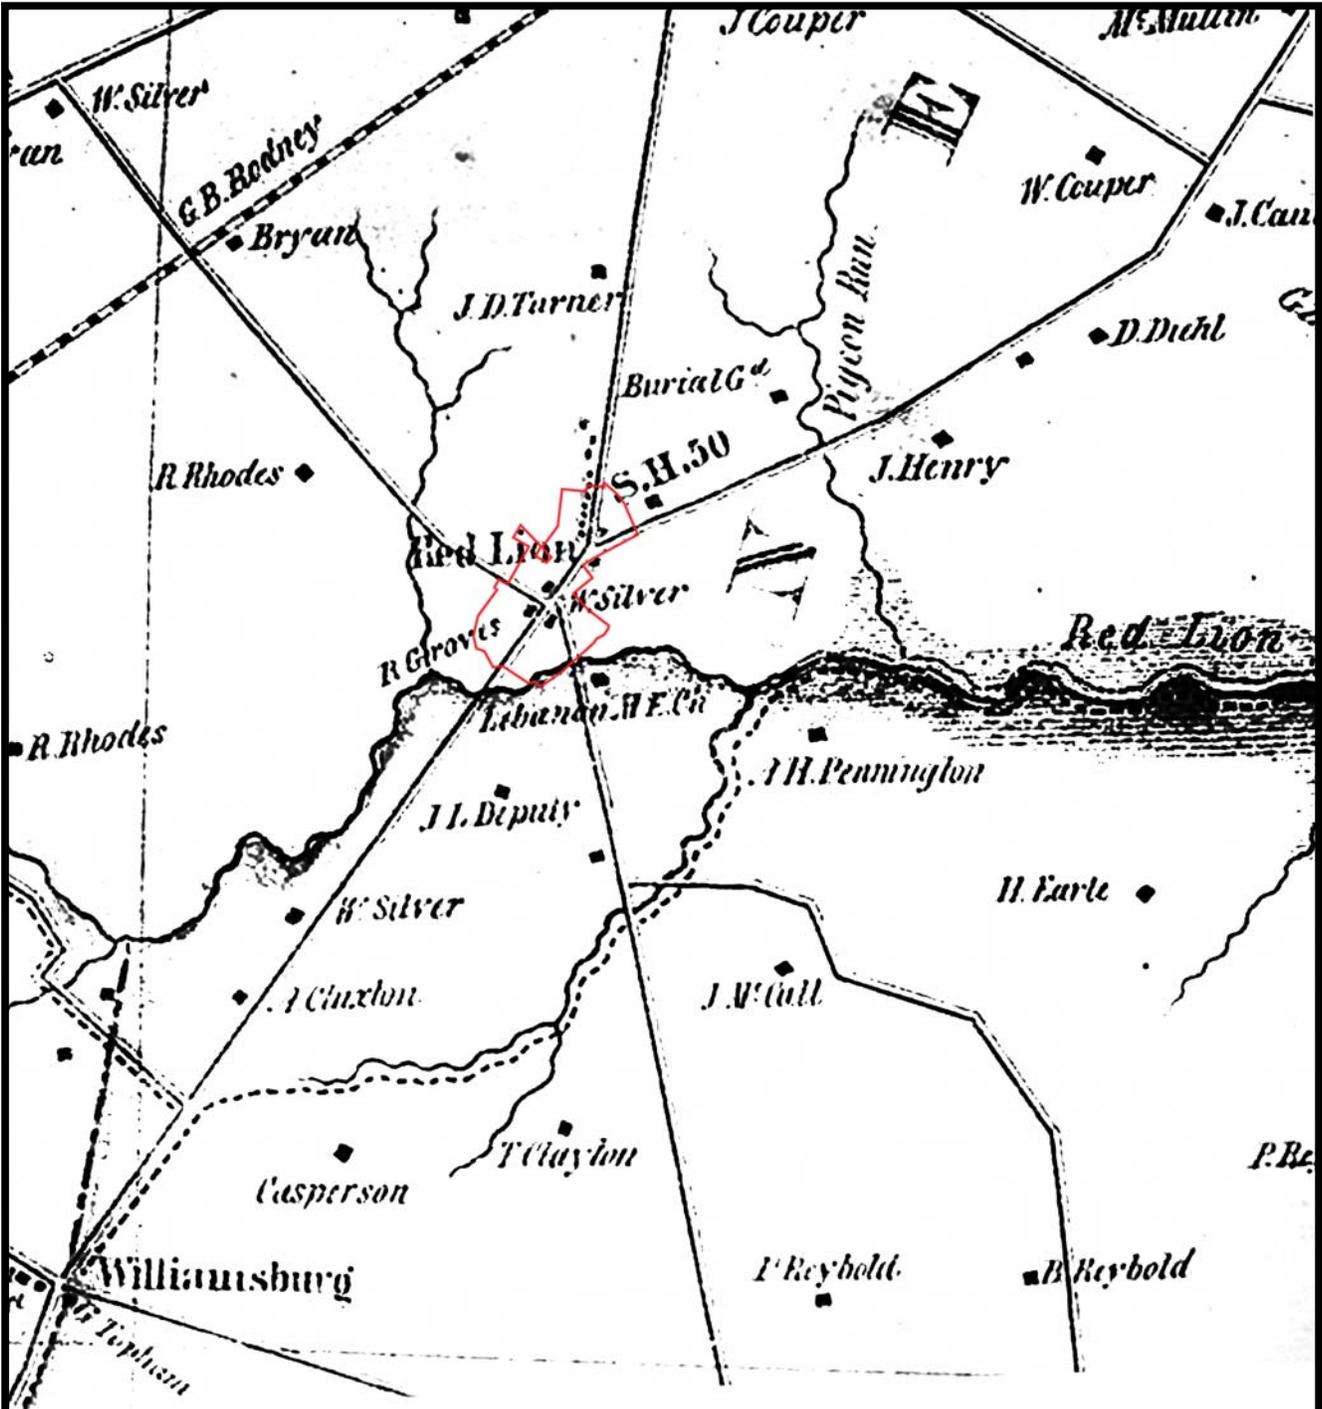
FIGURE 2

PROJECT AREA CIRCA 1849

By 1849, Church Road had been opened northwestward from an intersection with Red Lion Road in Red Lion, and the village contained about a dozen structures (Figure 2; Price and Rea 1849). Roughly two-thirds of those structures were located within the APE. They comprised:

Of the structures denoted around the intersection of Church Road and Bear Corbitt Road on the 1849 map (Figure 2; Price and Rea 1849), only the structure attributed to “R. Groves” might still be extant. Its location is occupied today by a historic farmhouse estimated to have been built around 1850, and identified in a Delaware Cultural Resource Survey Locus Identification Form as the “Silver Farmhouse (CRS N01237)” (Kuncio 2003a:n.p.).

Denoted outside the APE on the 1849 map—but still an important component of Red Lion village—was “S[chool] H[ouse] 50,” a public schoolhouse built in 1836 to replace “the first schoolhouse in this locality, [which had been located] near the Indian Mound” (Scharf 1888:853; Figure 2; Price and Rea 1849). The 1836 Red Lion schoolhouse would be replaced by a new schoolhouse in 1882 (Scharf 1888:853) (the latter structure is still standing at 124 Red Lion Road). Also denoted in the 1849 map outside the APE was the Lebanon Methodist Episcopal Church. This forerunner of the present-day Red Lion United Methodist Church was a “plain wooden structure” built in 1819 by “the Methodists of the Red Lion area [who] wanted their own church so that they could have services every Sunday.” This building “served as the worship center for the people of this community for thirty-four years” (Anonymous 1977:n.p.).

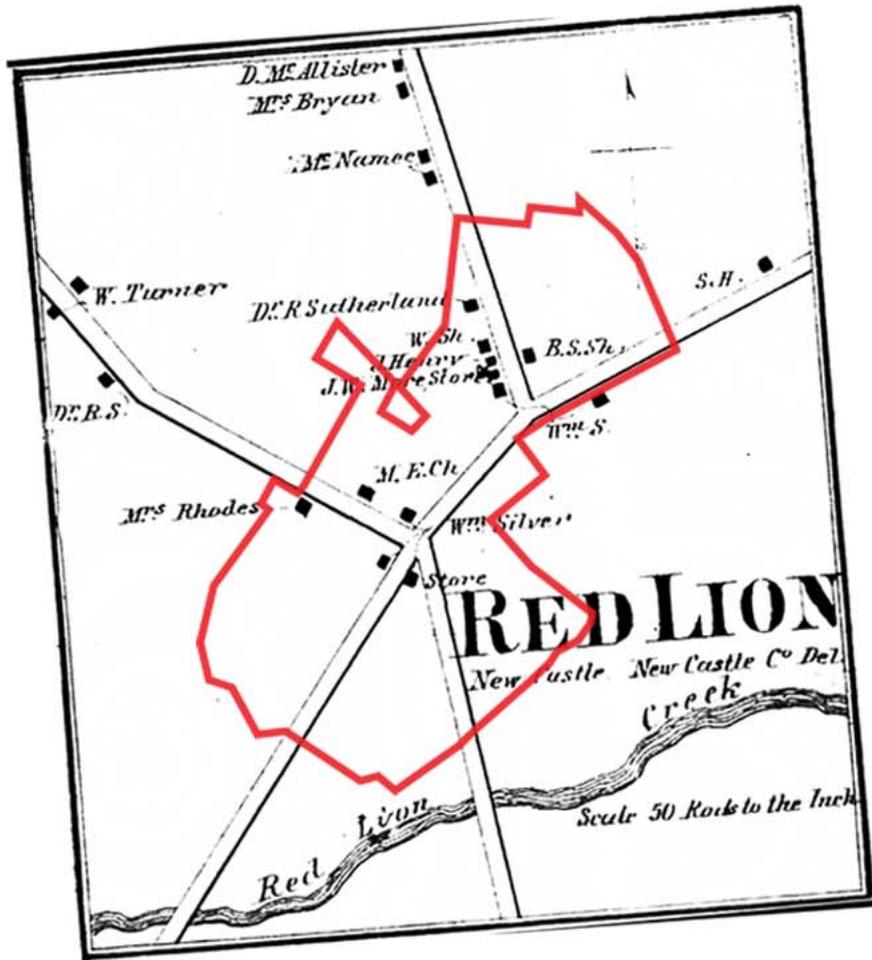
FIGURE 3

PROJECT AREA CIRCA 1868

As reflected on maps of Red Lion and vicinity published in 1868, 1881, 1893, and 1906, changes to the constellation of structures within the APE (i.e., the village core) over the course of four decades following the Civil War appear to have been limited to the removal and partial replacement of structures on the west side of Bear Corbitt Road immediately north of its intersection with Red Lion Road (Beers 1868b; Figure 4; Hopkins 1881; Baist 1893; Figure 5; USGS 1906). A description of the village penned in 1888—“It is a post-office and country trading point, having a church, stores, shops and half-a-dozen residences” (Scharf 1888:853)—would have been applicable to the village anytime during the late nineteenth and early twentieth centuries. The same could be said of the following description, published in 1899: “Red Lion, a small but thriving village six miles from New Castle, in the southern part of New Castle hundred, and about a mile from Bear station, D.R.R., has one church, the Methodist Episcopal, and is surrounded by grain, vegetable, and small fruit farms” (Runk 1899:1436).

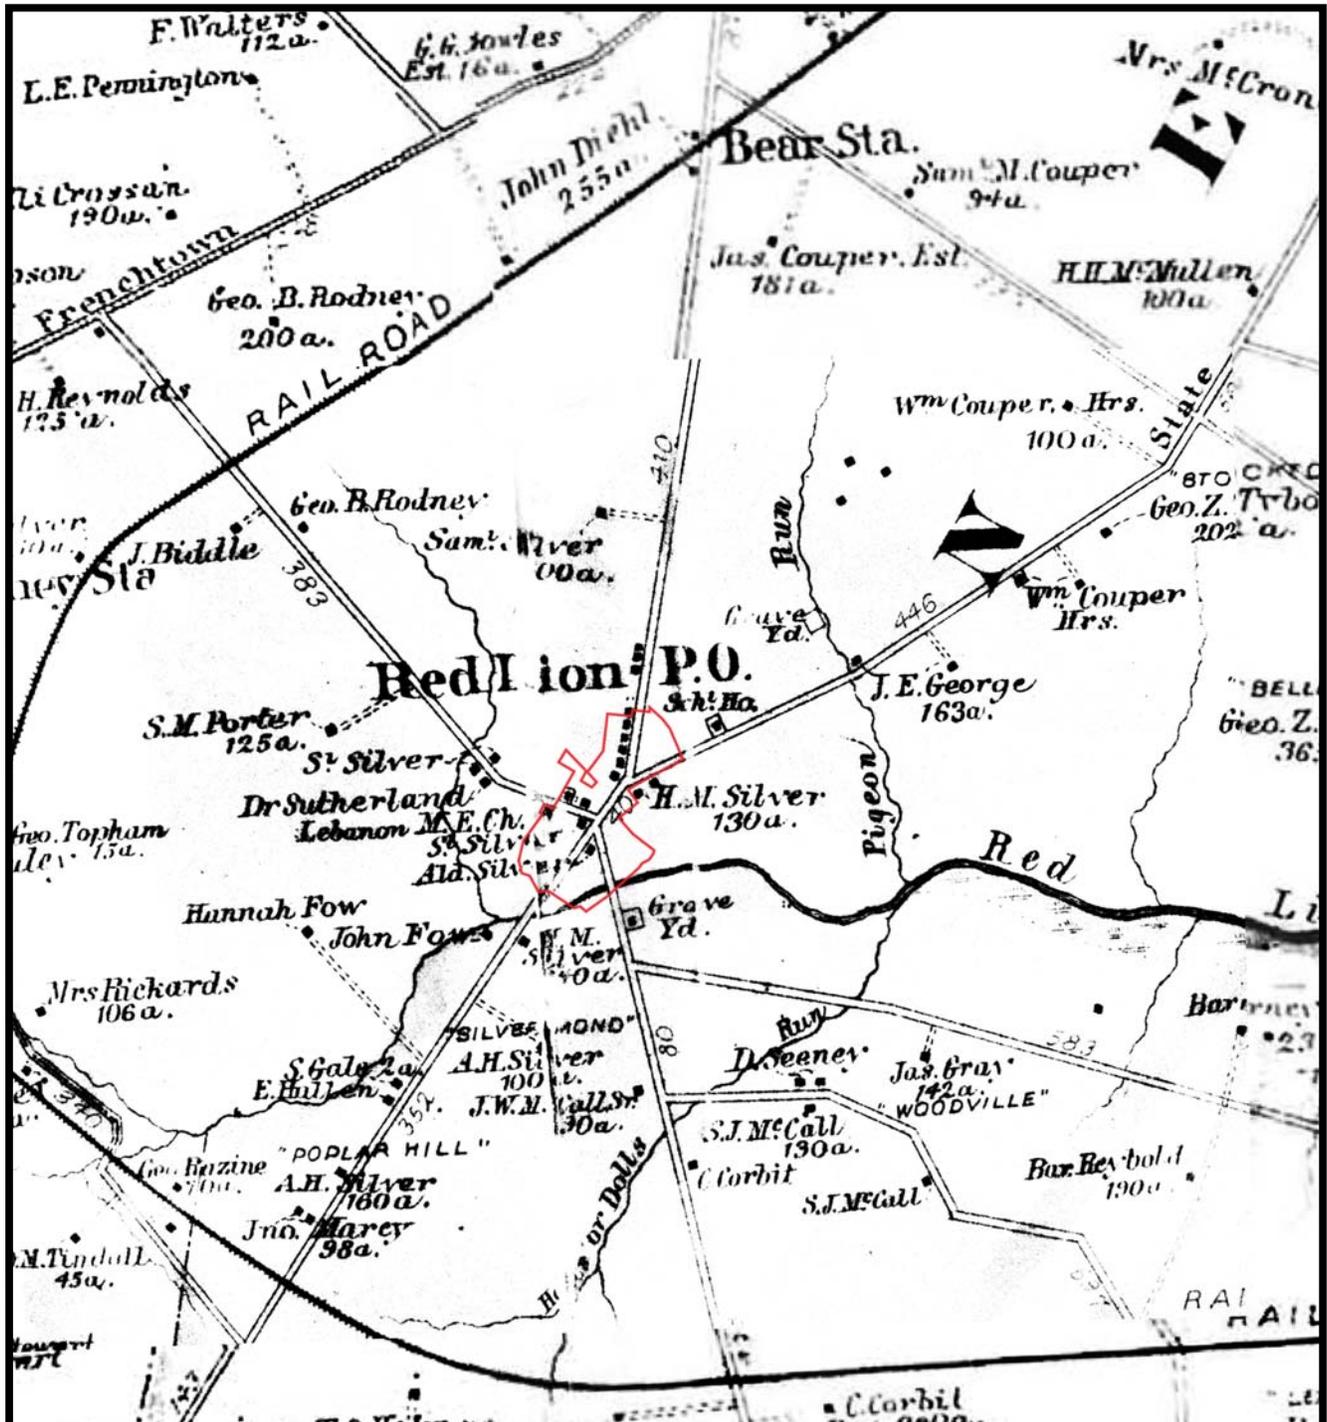
FIGURE 4

PROJECT AREA CIRCA 1881

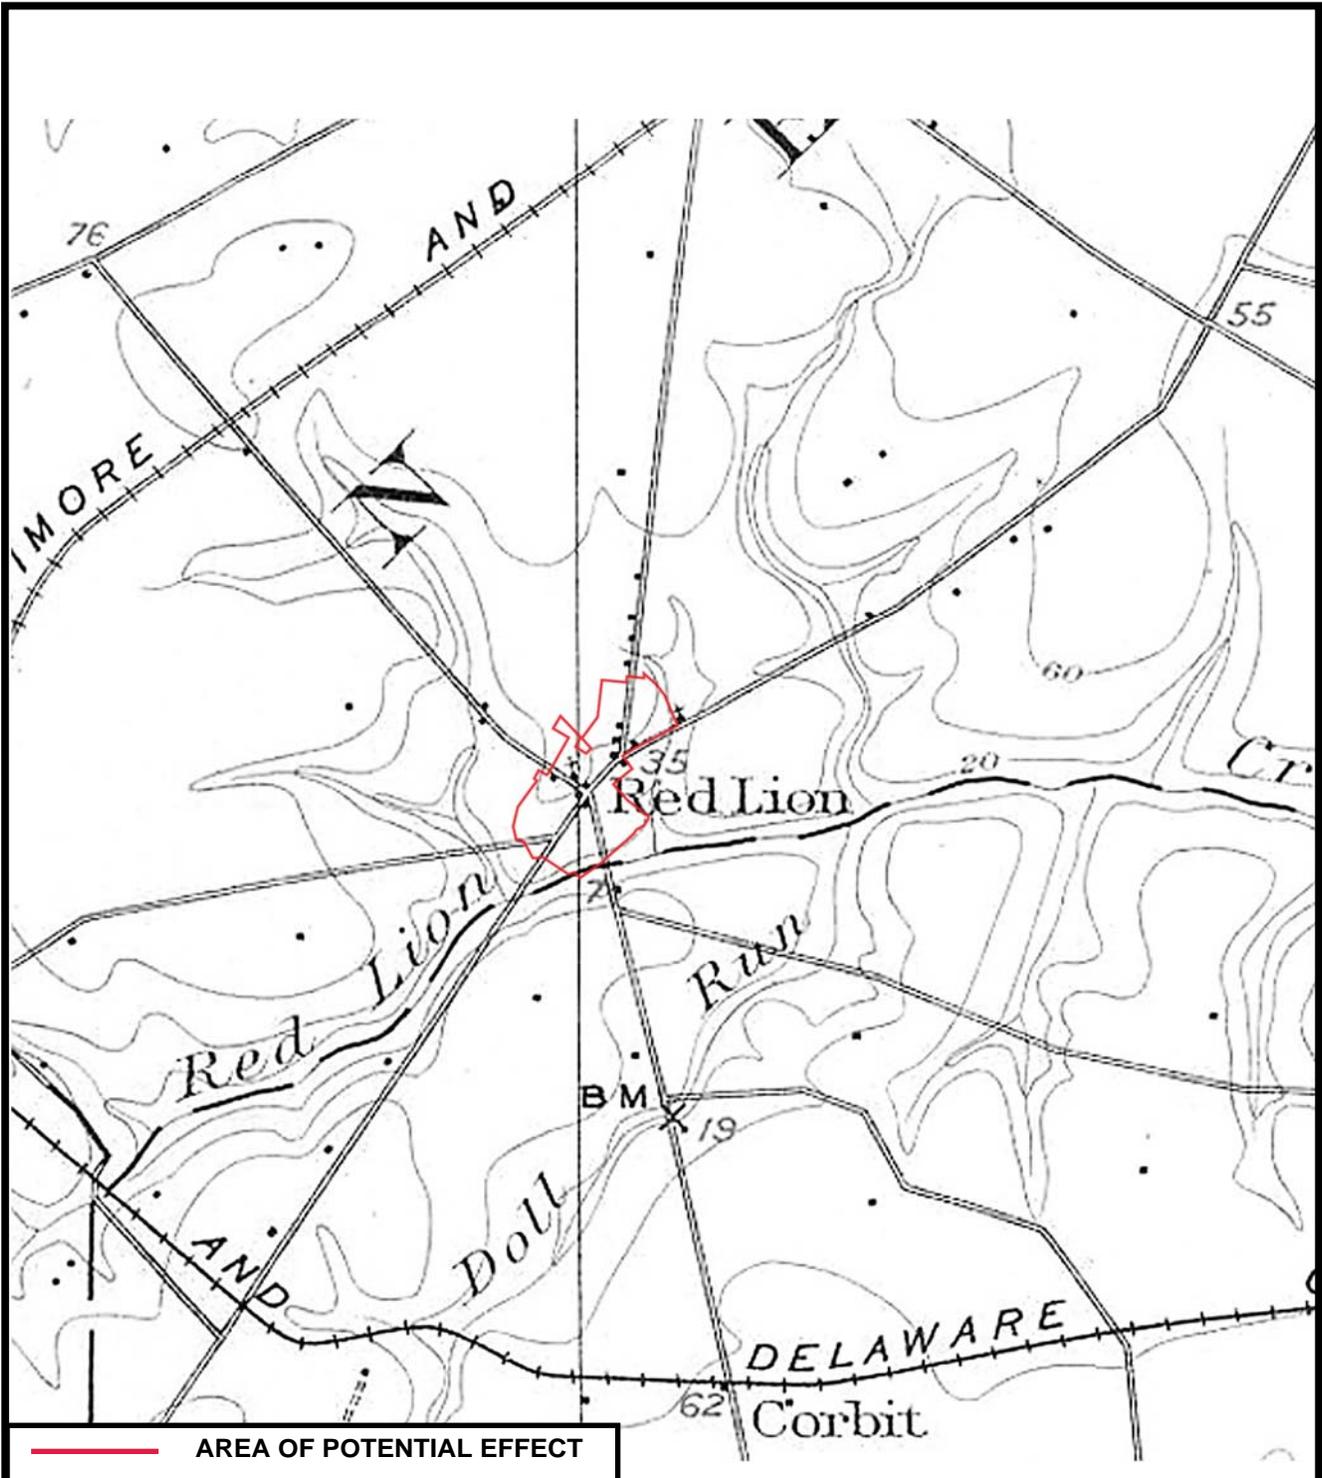
<p>0ft 2000ft</p> <p>0m 609.6m</p> <p>Prepared by CHRIS, Inc.</p>	<p>USGS 1906 WILMINGTON, DE</p>
PROJECT AREA CIRCA 1906		FIGURE 5

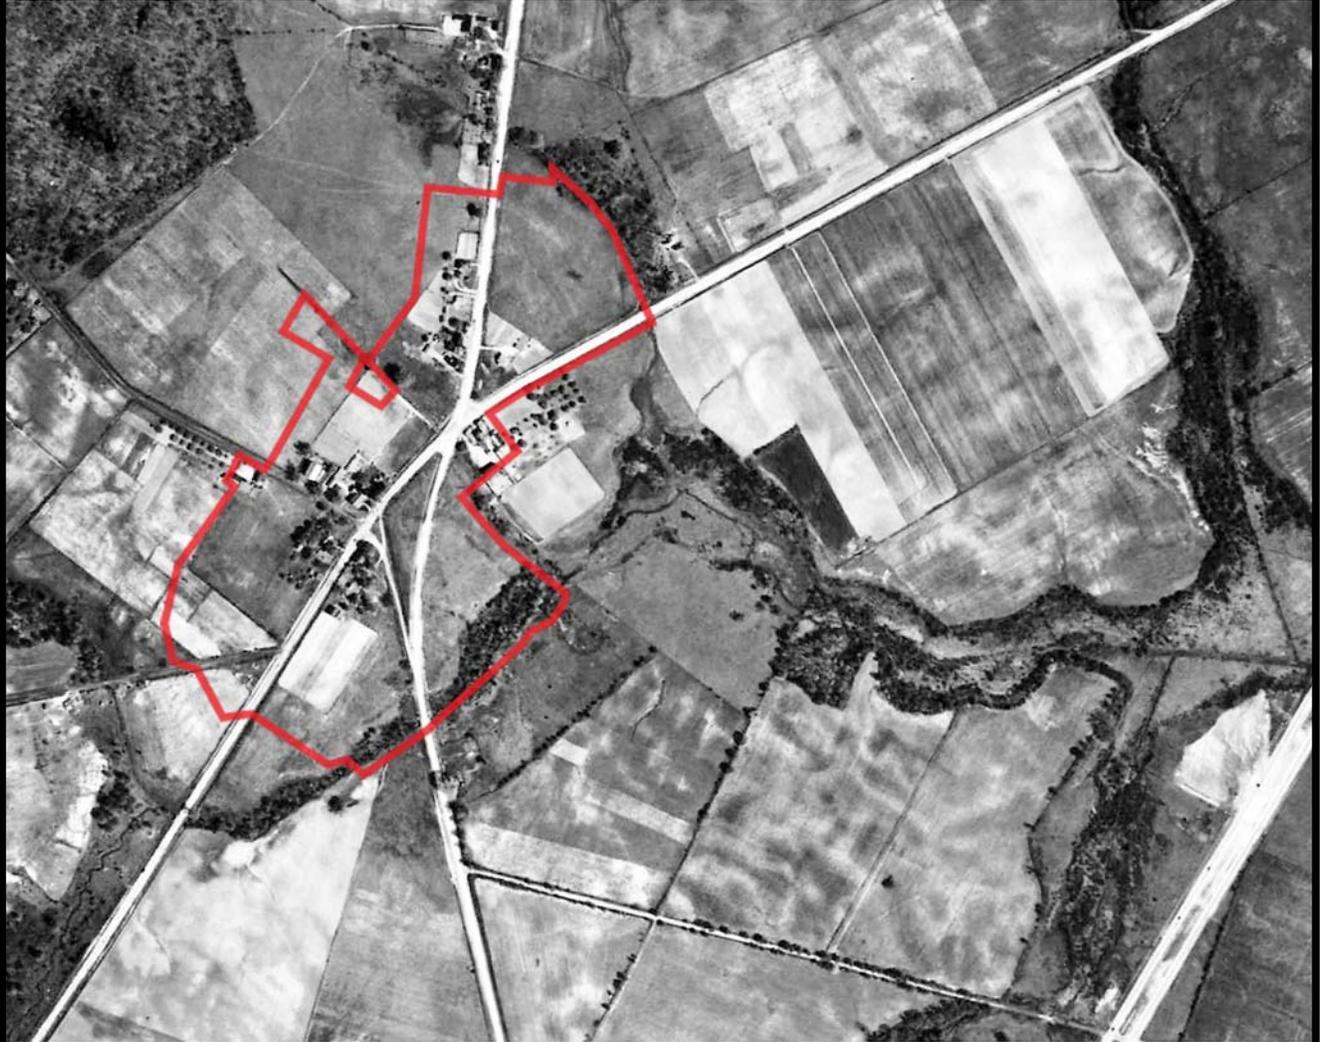
FIGURE 6

PROJECT AREA CIRCA 1932

Red Lion's minimal rate of development persisted through the first four decades of the twentieth century, as reflected on aerial photographs taken in 1932, 1937, and 1945 (Figure 6; Anonymous 1932; Anonymous 1937; Figure 7; Anonymous 1945). During that period, the village was bypassed by a second major transportation artery. Completed in 1925, the 98.13-mile-long DuPont Highway approached within 3,200 feet of Red Lion's central intersection (John Milner Associates, Inc. 2005:13). In providing a vastly superior intrastate alternative to Routes 7 and 71, the DuPont Highway (eventually designated State Route 13 between Wilmington and Dover) diverted considerable non-local traffic from Red Lion's roadways (John Milner Associates, Inc. 2005:5). Two years after the DuPont Highway debuted, the State Highway Department replaced its wooden Bridge 298 carrying State Route 7 (Bear Corbitt Road) over Red Lion Creek in the southwestern corner of the APE. The new 20'-6" span was "an example of a concrete frame bridge type [commonly] constructed during the early growth period and the period of rapid expansion of the [Delaware] state road network" (Anonymous n.d.:1).

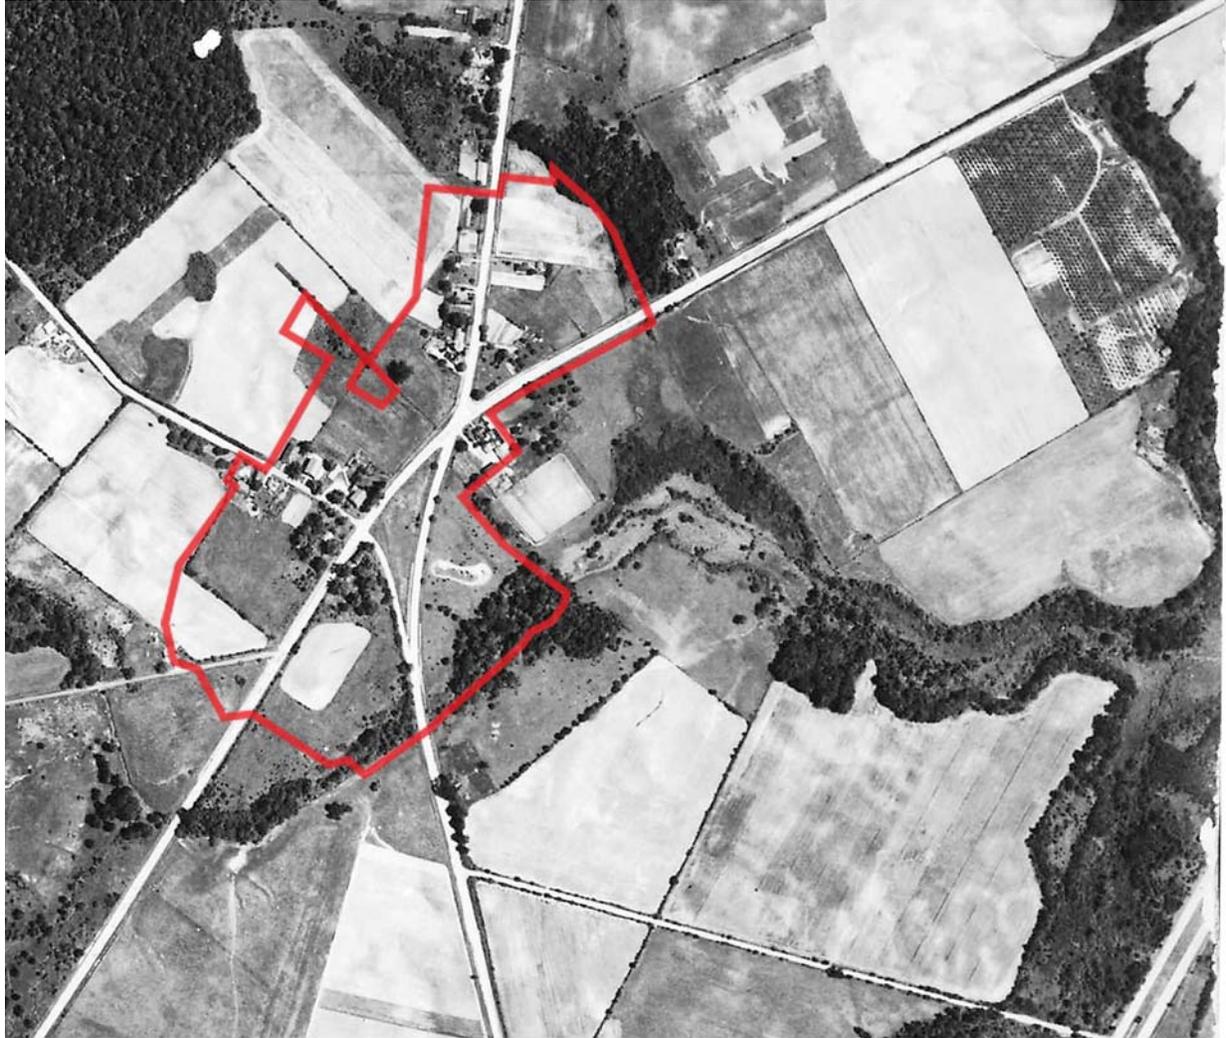
FIGURE 7

PROJECT AREA CIRCA 1945

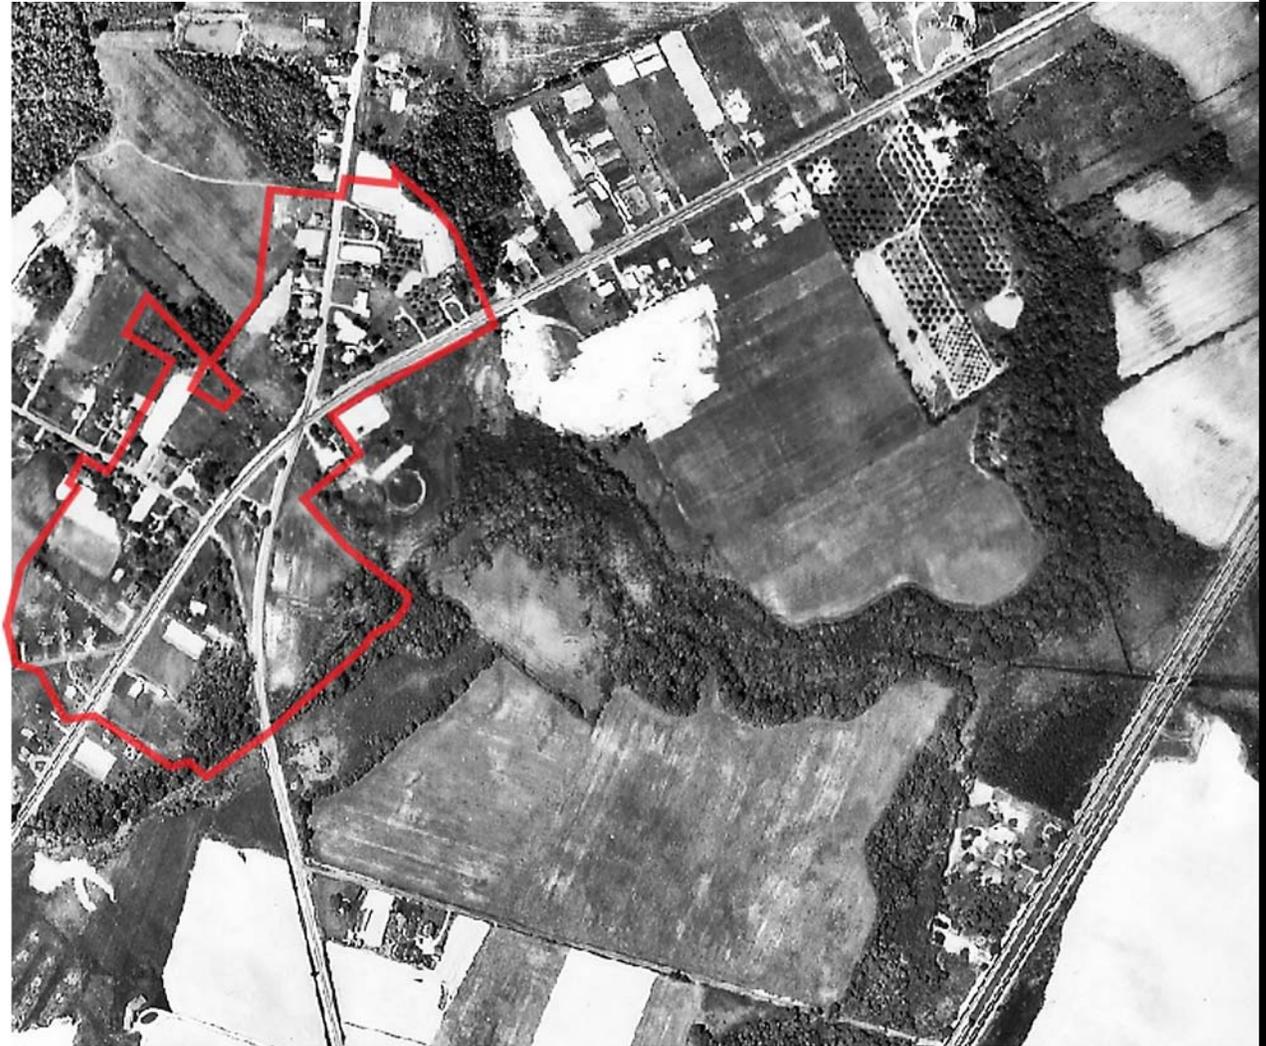
FIGURE 8

PROJECT AREA CIRCA 1961

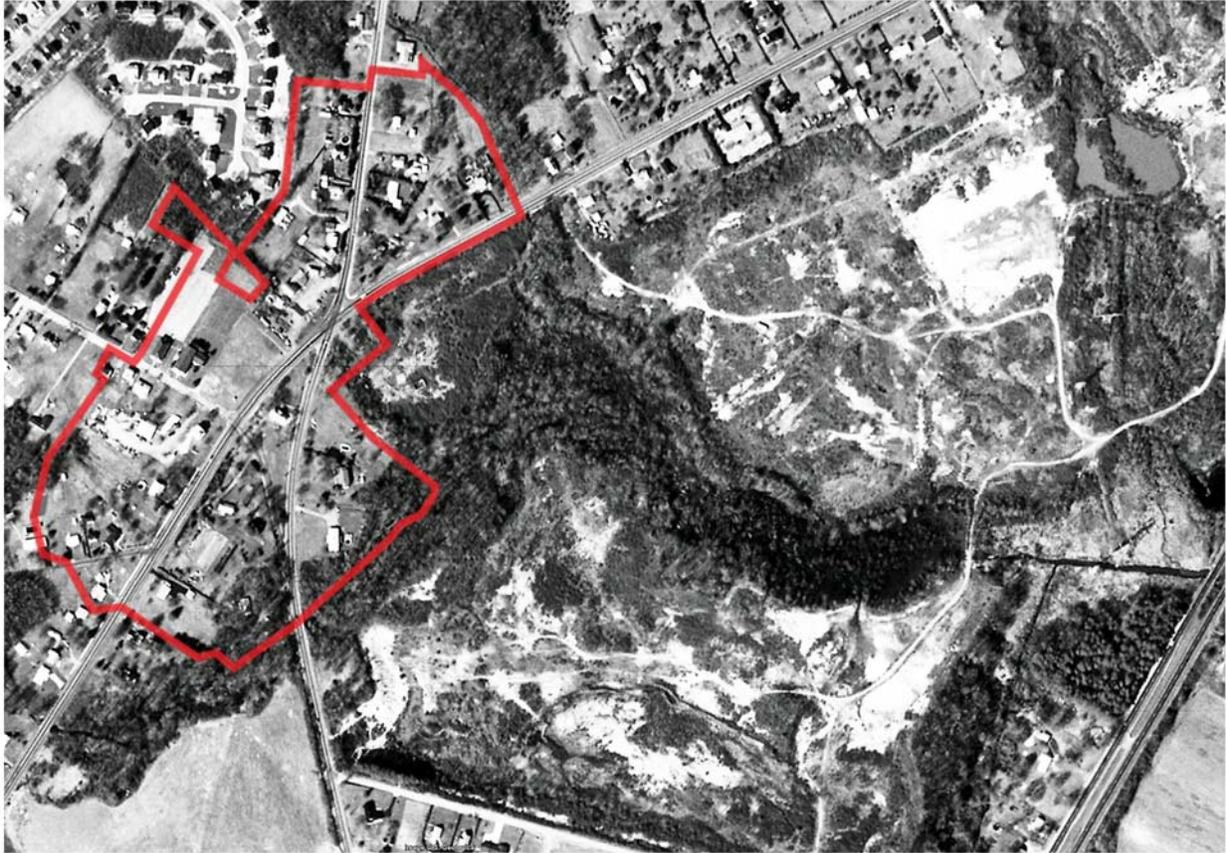
FIGURE 9

PROJECT AREA CIRCA 1992
