HISTORIC AMERICAN BUILDINGS
SURVEY

ALEXANDER WILSON
AGRICULTURAL WORKS COMPLEX

Prepared by
Bernard L. Herman
and
David L. Ames

December 1983

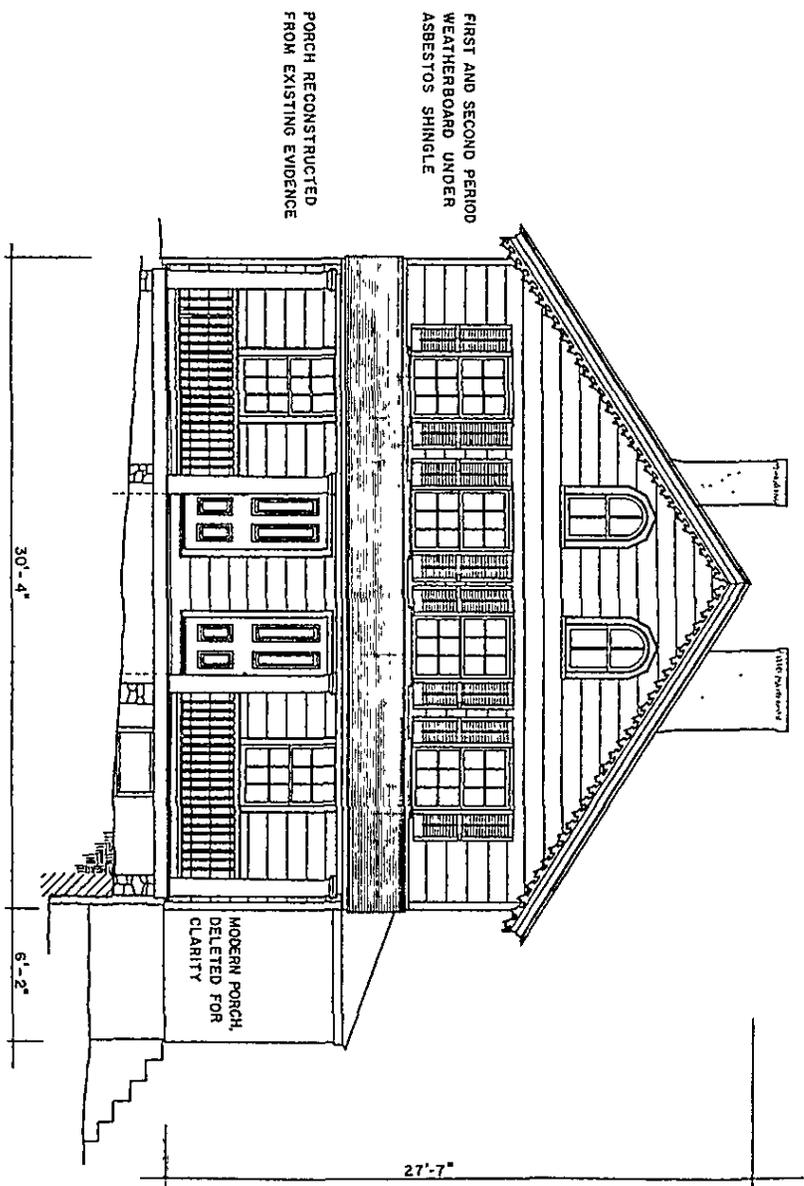
SOUTH ELEVATION

PORCH RECONSTRUCTED
FROM EXISTING EVIDENCE

MODERN PORCH,
DELETED FOR
CLARITY

- a. Dwelling: A one-story, tetra-style porch 29'-4" x 7'-3" spans the south elevation. Four squared columns 10" x 10"

at the base and 9" x 9" at the cornice line supported the porch roof on approximate 9'-6" centers. The columns were unadorned except for plainly molded Doric-like capitals. Balustrades run between the outside pairs of columns and are built of stick balusters on 5" centers joined to unornamented base and hand rails. The porch framing is carried on 1" thick stone walls running out from the foundation wall. Overhead the porch ceiling is composed of boards placed to create a shallow paneled finish. The entire porch support system was disassembled in the mid-twentieth century and stored in the second floor of the shop.

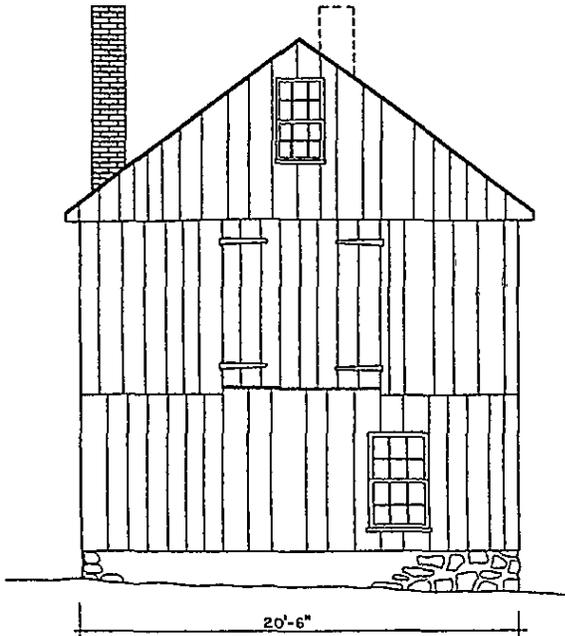
WEST ELEVATION

VERTICAL BOARD SIDING
UNDER ASBESTOS SHINGLE

- b. Agricultural Works: Exterior walls are of principal post and rail construction originally covered with 9" to 1'3" face tongue-and-groove vertical board siding and later covered with asbestos shingle.

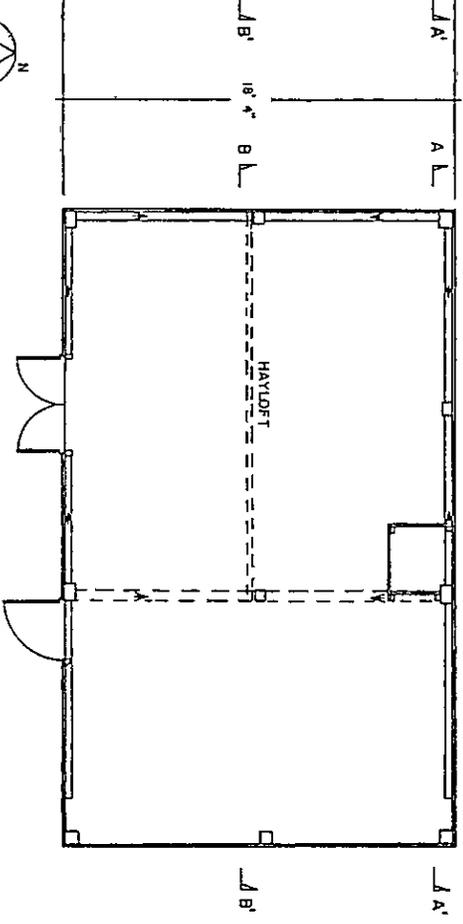
SECOND FLOOR PLAN

◀ Up Brice
◻ Opened Horizes For Missing Stud

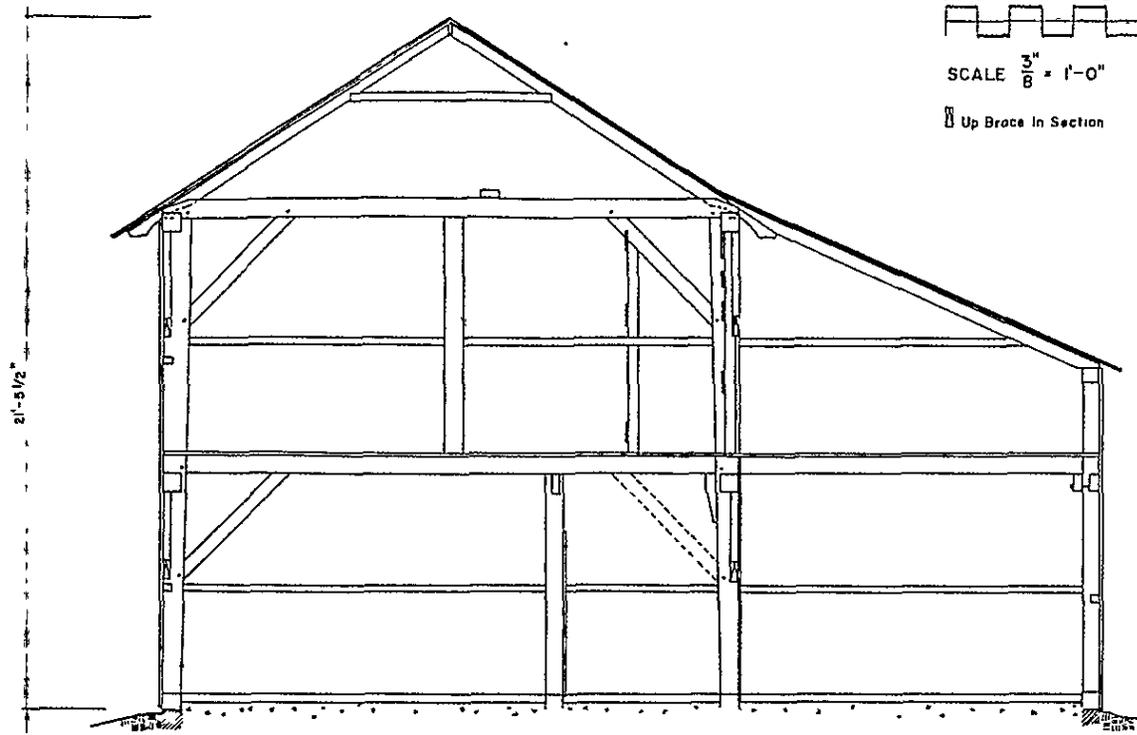
SECTION A-A'

Up Brace In Section

Notable differences however, are evident in the juncture at roof and wall and in the internal partitions. The barn roof rests directly on a 7 1/2" x 7 1/2" plate. The rafter feet extend 1' out from the plate and have concave molded tails creating an open cornice. The original shed roofed leanto to the east is built of common rafters nailed to the backs of the rafters covering the main block of the barn. These 3" thick timbers decrease in size from a 4" depth at their meeting with the outside plate to 3" at their lapping over the rafters of the main block. No joists frame in the overhead loft although single 3" x 6" and 3" x 9" ties span the breadth of the two bays. Internal partitions are composed of 3 1/2" x 5 1/2" studs regularly spaced between central 5 1/2" x 5 1/2" principals. The interior partitions are clad with horizontal 1" x 9" board siding and 1" x 2 1/2" slats for ventilation.
