CULTURAL RESOURCE SURVEY
SURVEY UPDATE FORM

CRS # K-02748

1. HISTORIC NAME/FUNCTION: J.B. Tracy House/Miller's House/Dwelling

2. ADDRESS/LOCATION: 776 McGinnis Pond Road/400 ft south of intersection with Barratts Chapel Road

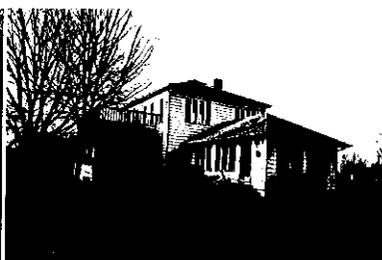
DX-34.JPG

- a. Facade: direction: North
 - 1) bays: 1
 - 2) windows: 0
 - 3) door(s): 1 hinged wood door
 - 4) other: N/A

C-4868:28 McGinnis Pond bridge and fish ladder, E elevation, facing NW; C-4868:29 McGinnis Pond bridge, facing SW; C-4868:30 McGinnis Pond, dam, and bridge, W elevation, facing NE; C-4868:34 Shed (.003), N and W elevations, facing SE; C-4868:35 House (.001), S and E elevations, facing NW; C-4868:36 Garage (.002), N and W (front) elevations, facing SE

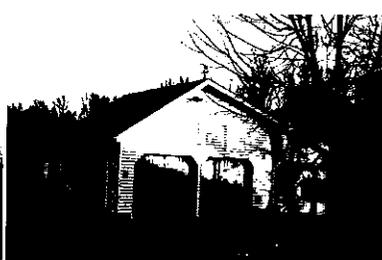
DX-35.JPG

<u>list major alterations and additions with years (if known)</u>	<u>year</u>
a. South side addition with rooftop deck	ca.1995
b. East side enclosed porch	ca.1990

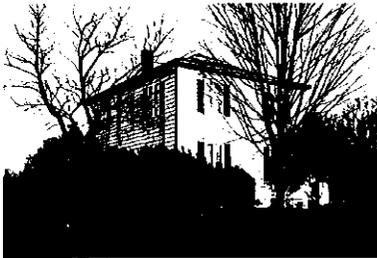
DX-01.JPG

C-4867:1 House (.001), N and W elevations, facing SE; C-4867:2 Millstone address marker, W elevation, facing SE; C-4867:3 House (.001), W and S elevations, facing NE
