CULTURAL RESOURCE SURVEY
SURVEY UPDATE FORM

CRS # K-02749

1. HISTORIC NAME/FUNCTION: Mcllvaine/Johnson House (T.H. Mcllvaine House)]/Dwelling

2. ADDRESS/LOCATION: 865 McGinnis Pond Road/NW quadrant of intersection with Barratts Chapel Road

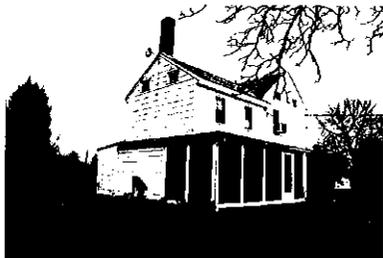
DX-14.JPG

C-4867:14 House (.001) , W (rear) and S elevations, facing NE; C-4867:15
Outbuilding (.003), S (front) and E elevations, facing SW; C-4867:16 Outbuilding (.002), E and N
(front) elevations, facing SW; C-4867:17 House (.001), S and E (front) elevations, facing NW
