CULTURAL RESOURCE SURVEY
SURVEY UPDATE FORM

CRS # K-02750

1. **HISTORIC NAME/FUNCTION:** Jerome Tenant House (J.B. Tracy Tenant House)
2. **ADDRESS/LOCATION:** 1008 McGinnis Pond Road/800 ft north of intersection with Barratts Chapel Road
3. **CURRENT CONDITION:** excellent good fair poor demolished
4. **INTEGRITY:** The house has been altered by additions (partial enclosure of wrap-around porch and a gable roof addition) and the replacement of original materials (clapboards replaced with vinyl siding, fluted porch posts replaced with prefabricated wood posts, most of the original 6/6 windows have been replaced with 1/1 sash).
5. **SETTING INTEGRITY:** A subdivision is located to the northeast of the property. The parcel no longer includes the farmland that was historically associated with the property.

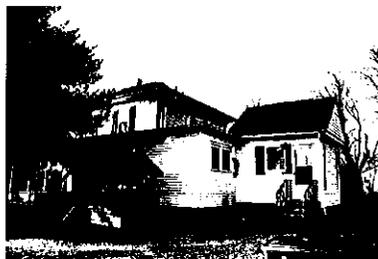
DX-08.JPG

C-4867:8 House (.001), E (rear) and N elevations, facing SW; C-4867:9 House (.001), S and E (rear) elevations, facing NW; C-4867:10 Outbuilding (.004), W and S elevations, facing E; C-4867:11 Outbuilding (.003), N and W elevations, facing SE; C-4867:12 Outbuilding (.002), E and N (front) elevations, facing SW; C-4867:13 House (.001), W (front) and S elevations, facing NE
