IV. Survey Results

A. Archaeological Identification Survey

Figure 12
Index Map
Archaeological Area of Potential Effects
Phase I Archaeological Identification Survey
Blue Ball Properties Area Transportation Improvement Project
Brandywine Hundred, New Castle County, Delaware

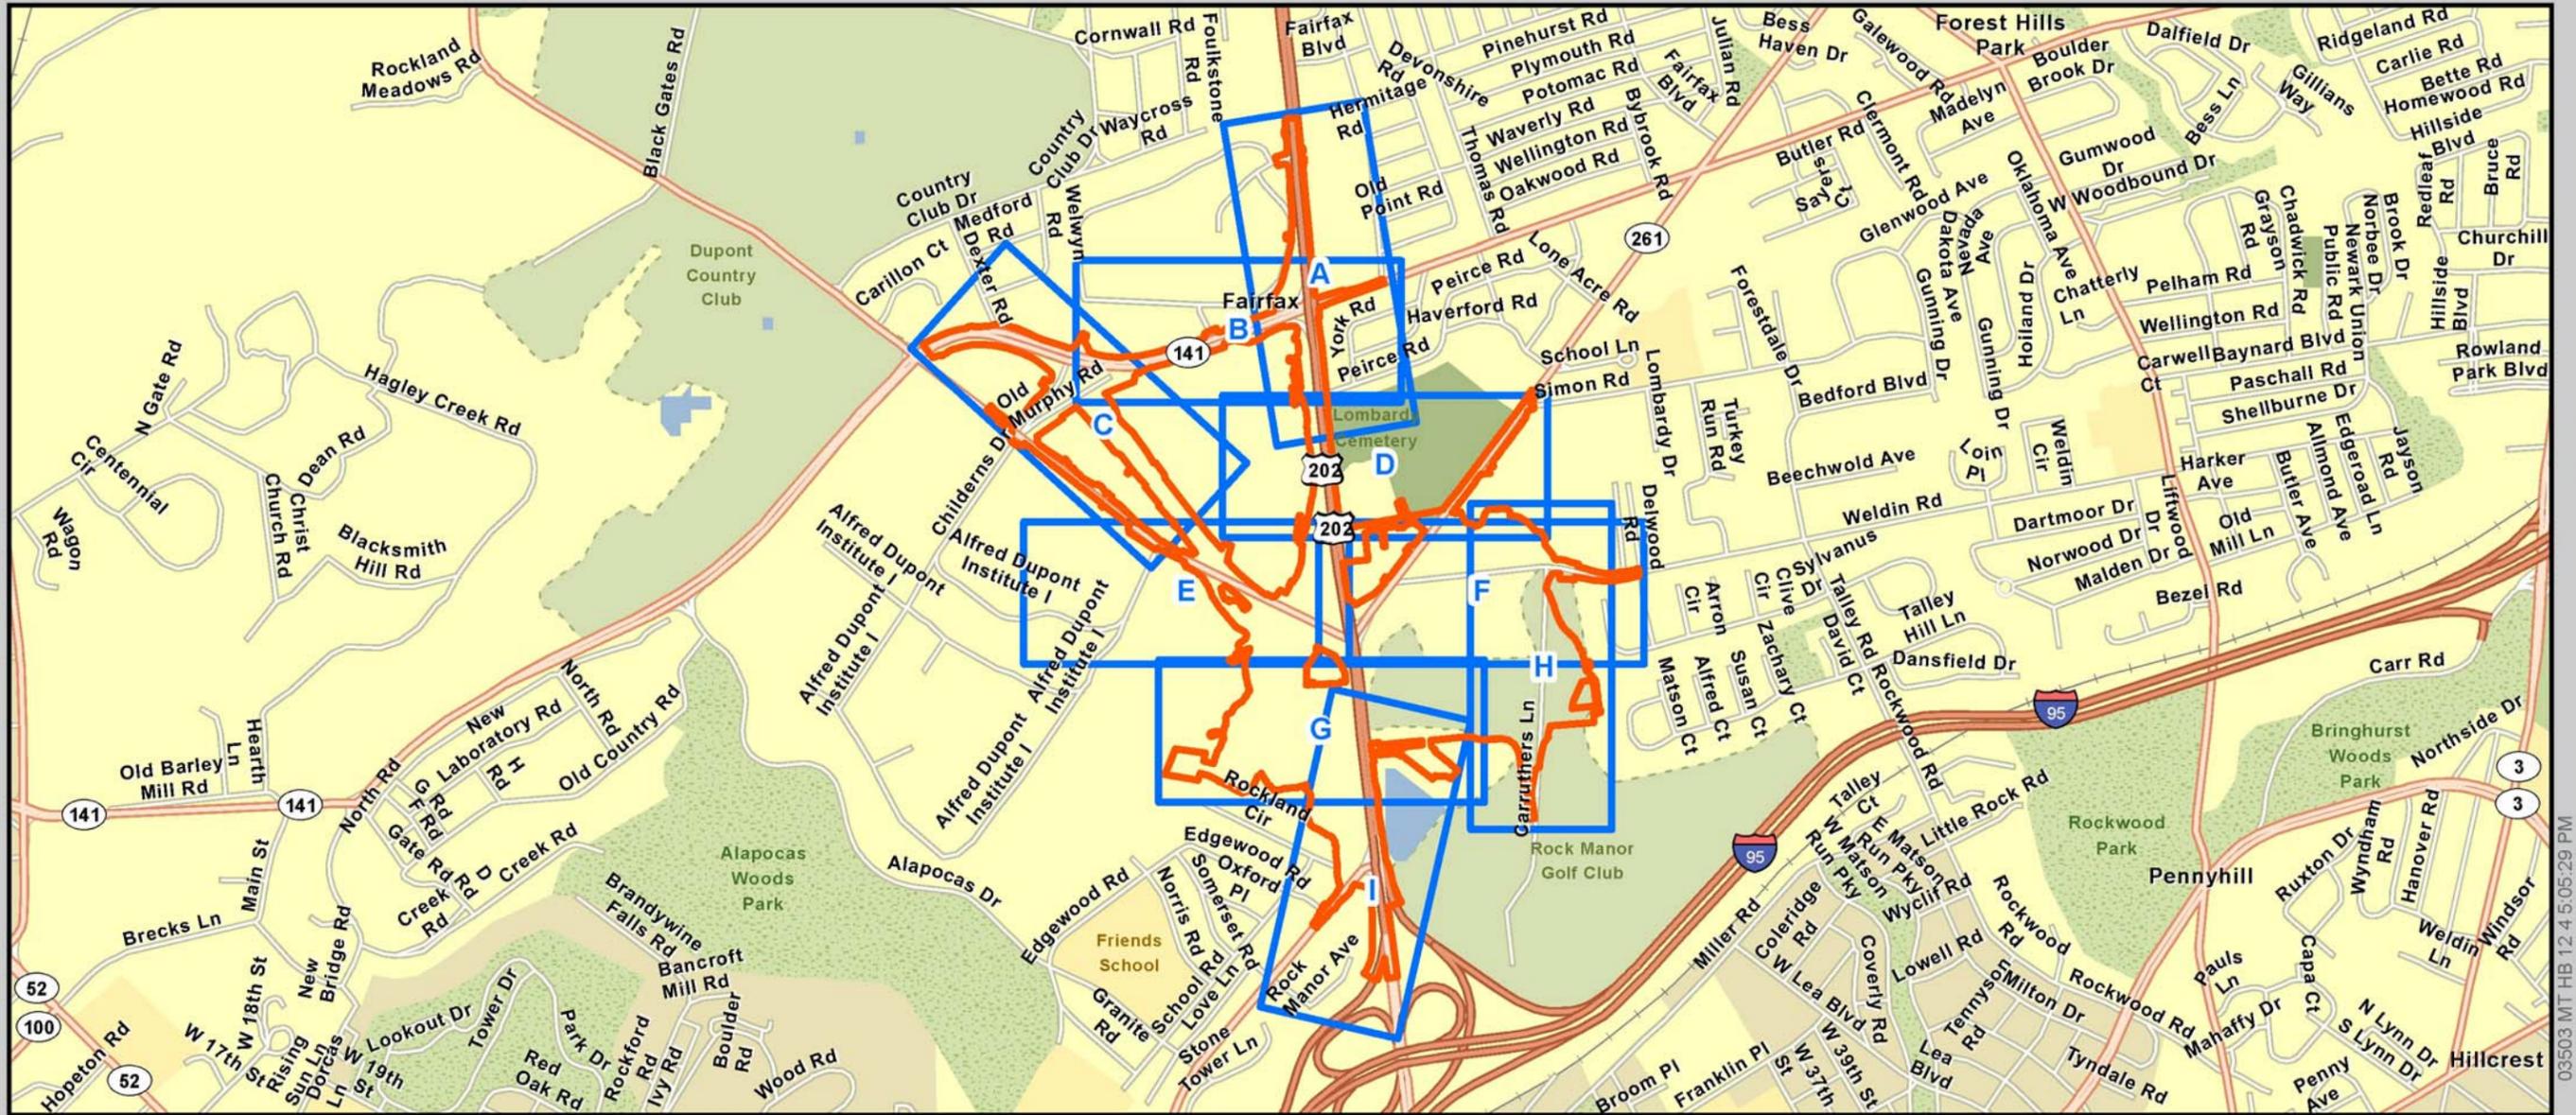
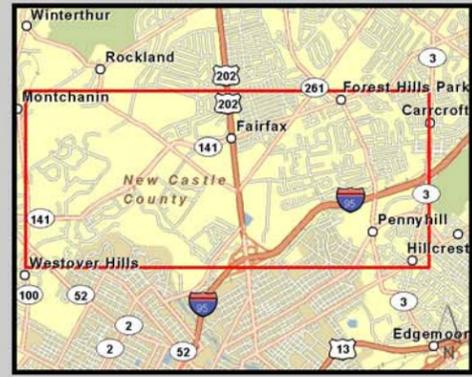
The archaeological APE included relatively large areas that were previously tested, disturbed or exhibited low potential (*Figure 12*). In order to facilitate the presentation of the field results, the portions of the project that were subjected to subsurface investigations was divided into thirteen arbitrary areas designated Areas A-M (*Figure 11*). A total of 496 STPs was excavated at a 15 meter (49.2 foot) interval during the Phase I survey.

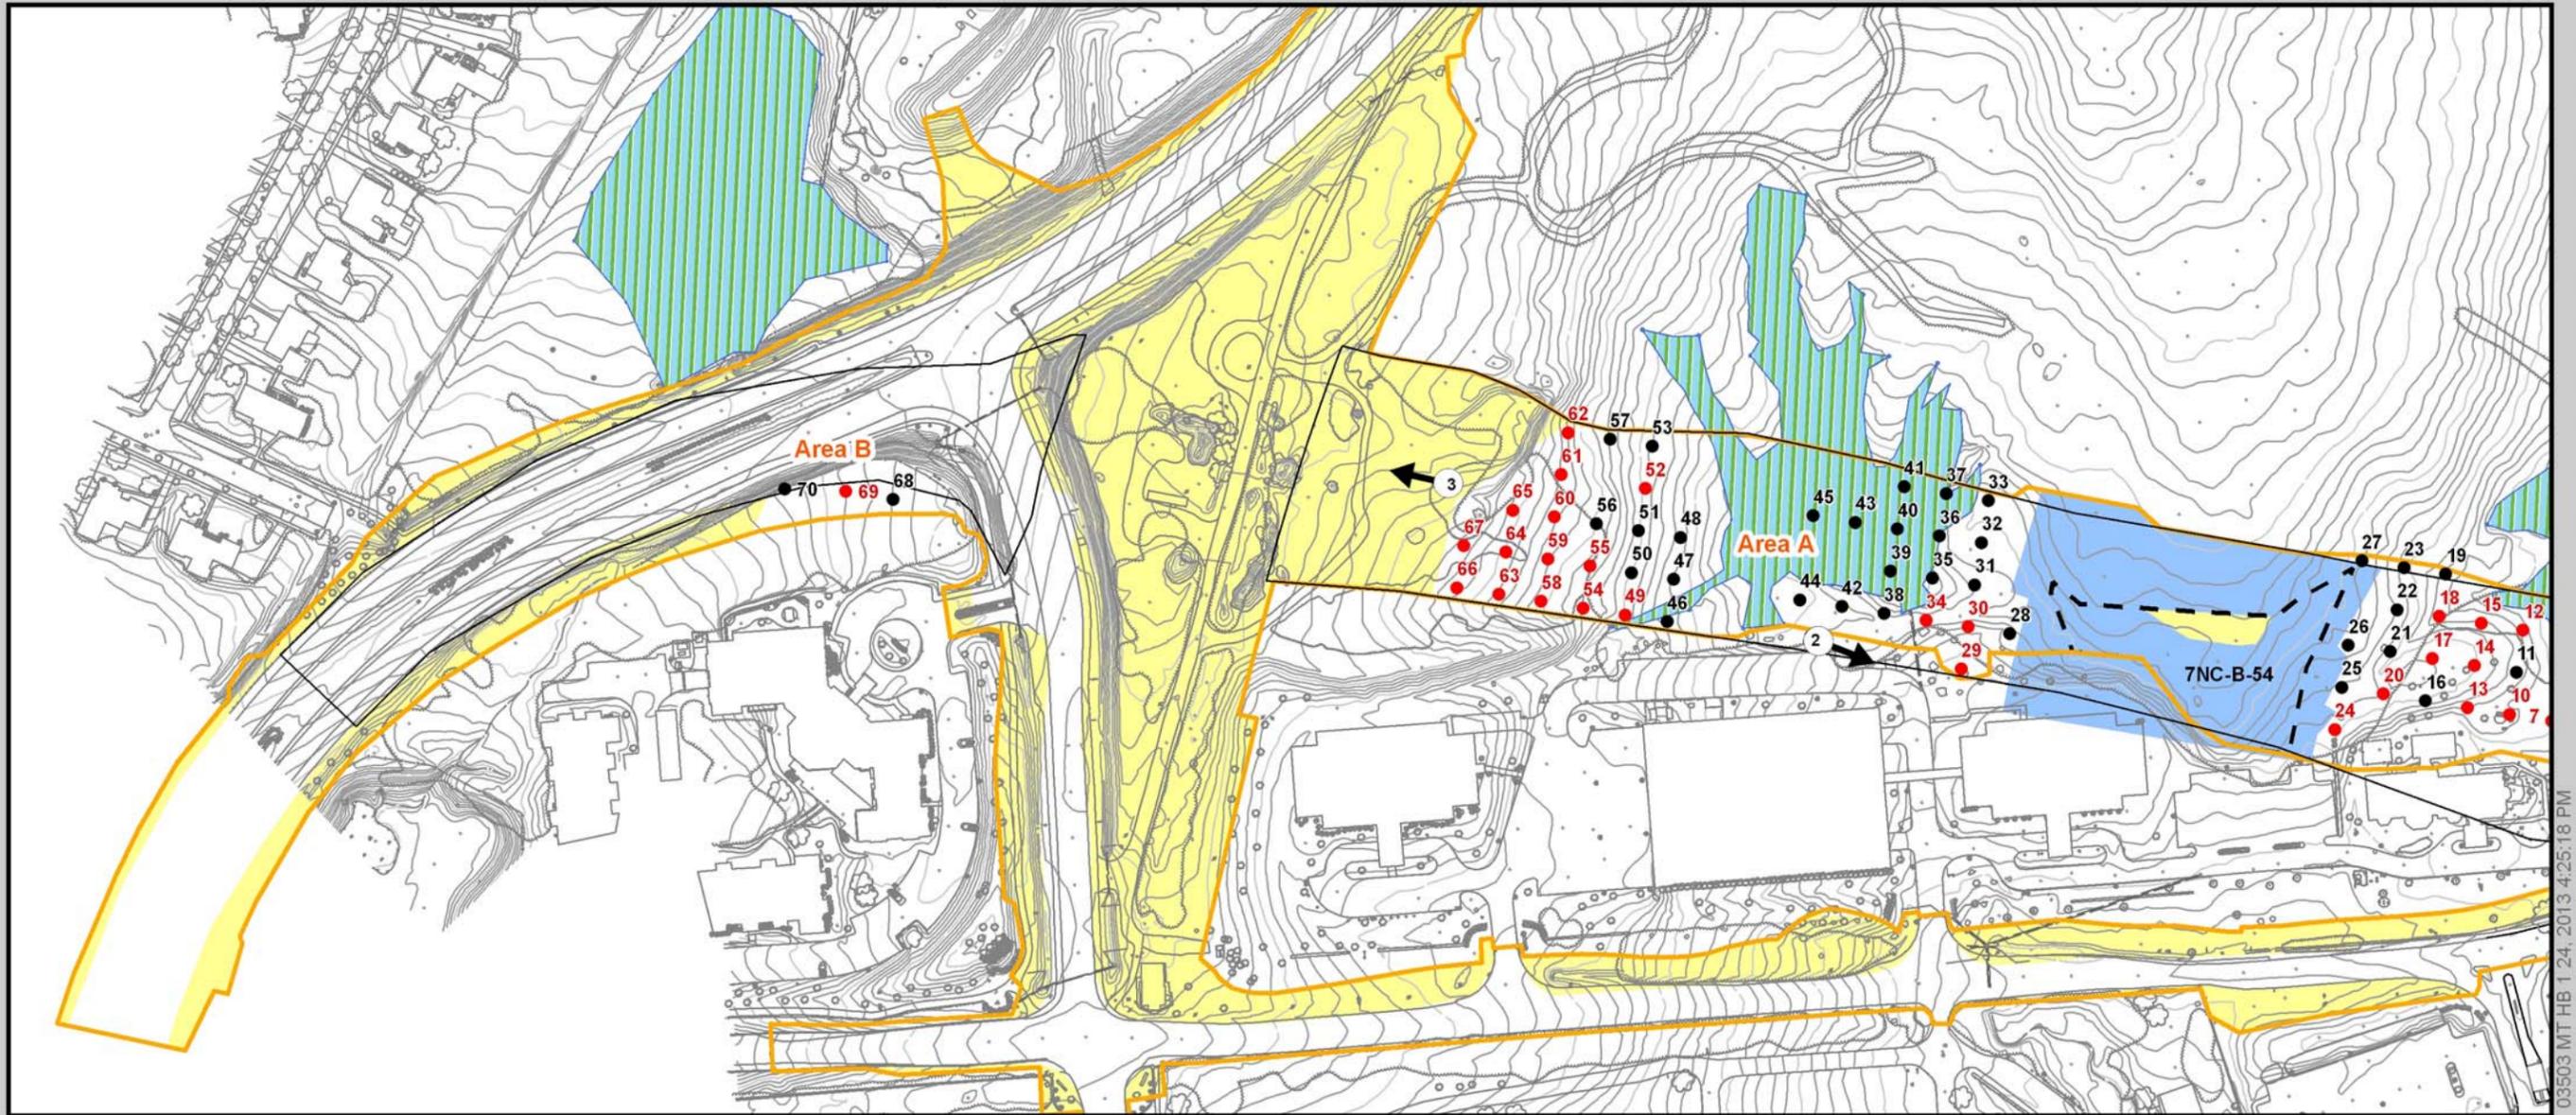
Figure 12C

STPs 28-67 were excavated in the mostly wooded settings to the west of the 7NC-B-54 site boundary (*Figure 12C*). The portion of the APE northwest of STP 39 and southeast of the transect containing STPs 46-48 was not tested due to the presence standing water associated with the existing wetlands. Additionally, several shovel test pits that were excavated in proximity to the Nemours Health Clinic (*Photograph 2*), such as STP 29, revealed a disturbed profile consisting of various levels of deep fill (*Figure 13*). As a result, the remainder of the STPs on the southernmost transect were not excavated on the landforms associated with the Health Clinic. The remaining STPs excavated in Area A exhibited mostly undisturbed profiles, consisting of an initial brown (10YR 4/3) silt loam overtop a yellowish brown (10YR 5/4) silt loam and a yellow to pale yellow subsoil horizon, as seen in the profile for STP 46 (*Figure 13*). The area north of STPs 66 and 67 was heavily disturbed by recent construction activities, therefore it was not tested (*Photograph 3*).

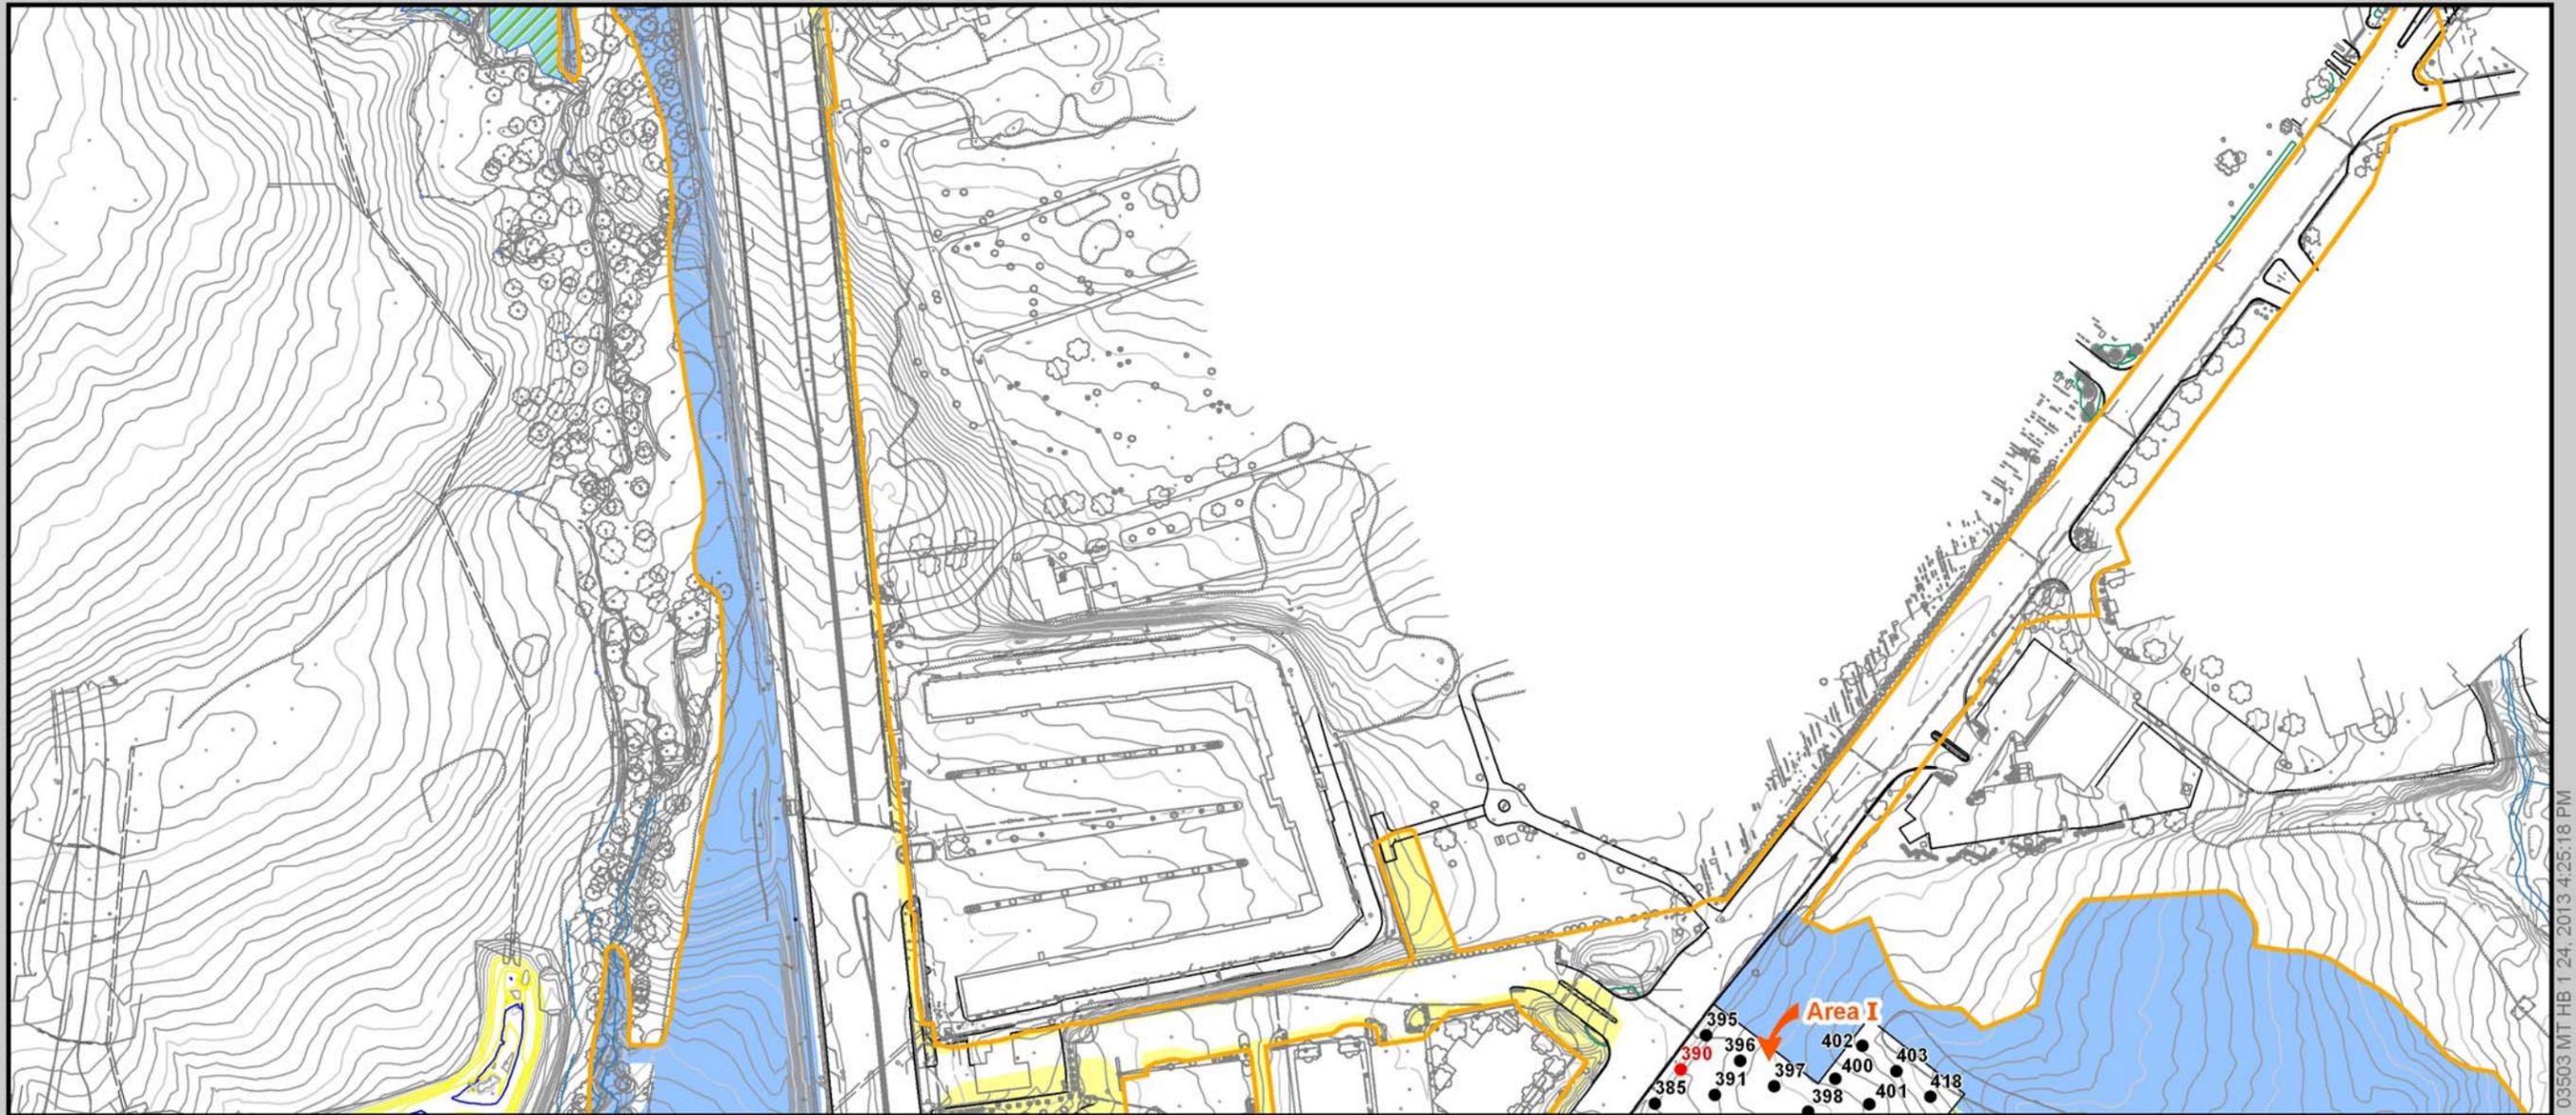
Figure 12D

Shovel tests 1-27 were placed just north of the Ronald McDonald House and to the south of an existing wetland (*Figure 12D*). STPs 1-18 fell either within the Ronald McDonald House lawn or a denuded area adjacent to the lawn, while STPs 19-27 were inside the tree line of the woodlands. The soil profile for STP 14 is representative of the STPs excavated outside of the tree line; it consisted of two mixed fill levels over a poorly drained gray (2.5Y 5/1) and yellowish red (5YR 5/6) silty clay subsoil, suggesting that the mixed fill horizons comprising Strata I and II had been placed over a wetland (*Figure 13*). The STPs excavated inside the tree line, such as STP 26, were mostly intact and exhibited a brown (10YR 4/3) silt A/O horizon that lay overtop a light olive brown (2.5Y 5/4) silt E horizon and a yellowish brown (10YR 5/8) silt B horizon, respectively (*Figure 13*).

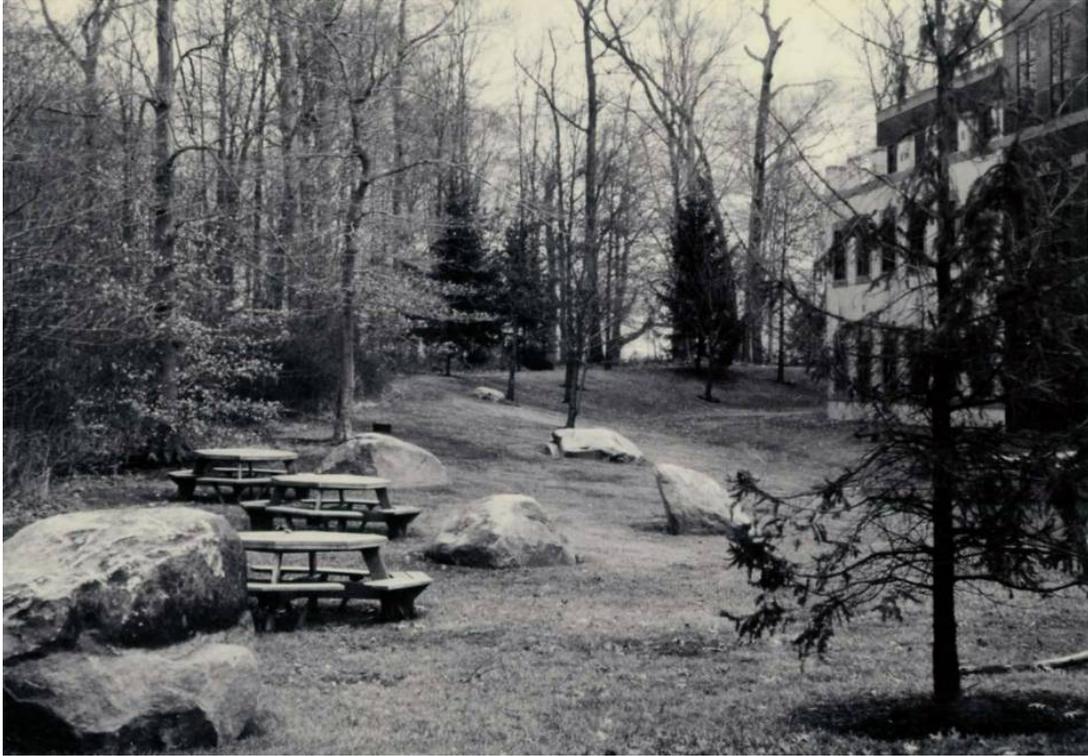
Photograph 2: Disturbed landform adjacent to the Nemours Heath Clinic, facing southeast.

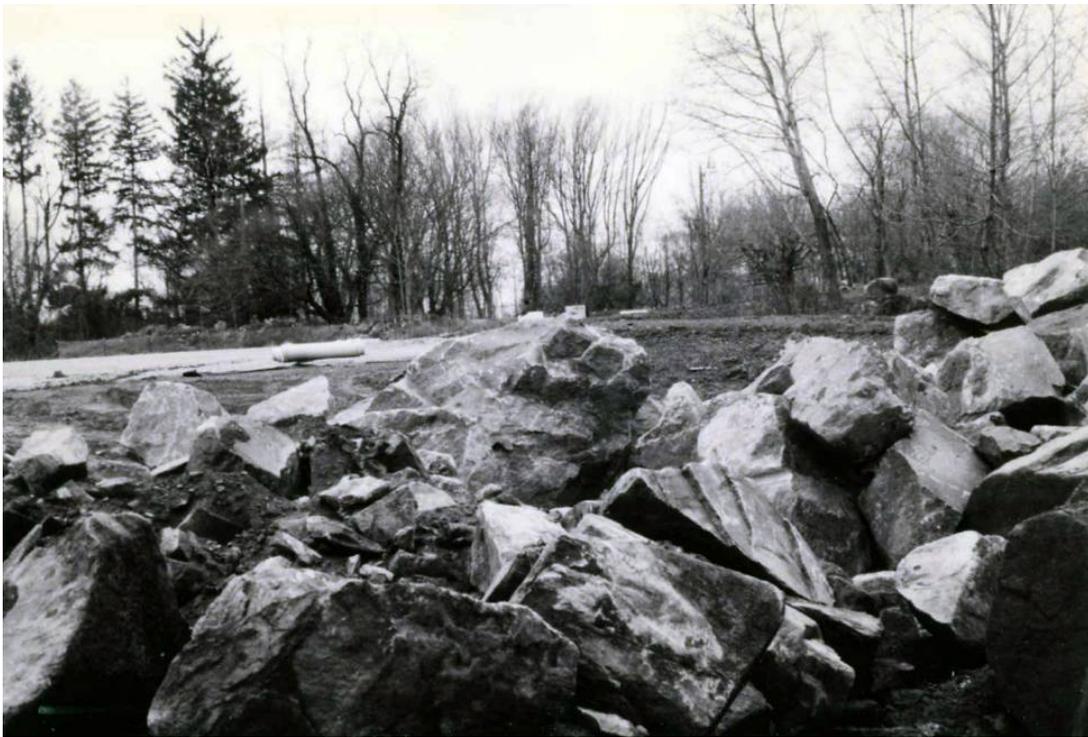
Photograph 3: Disturbed area at northern terminus of Area A APE, facing northwest.

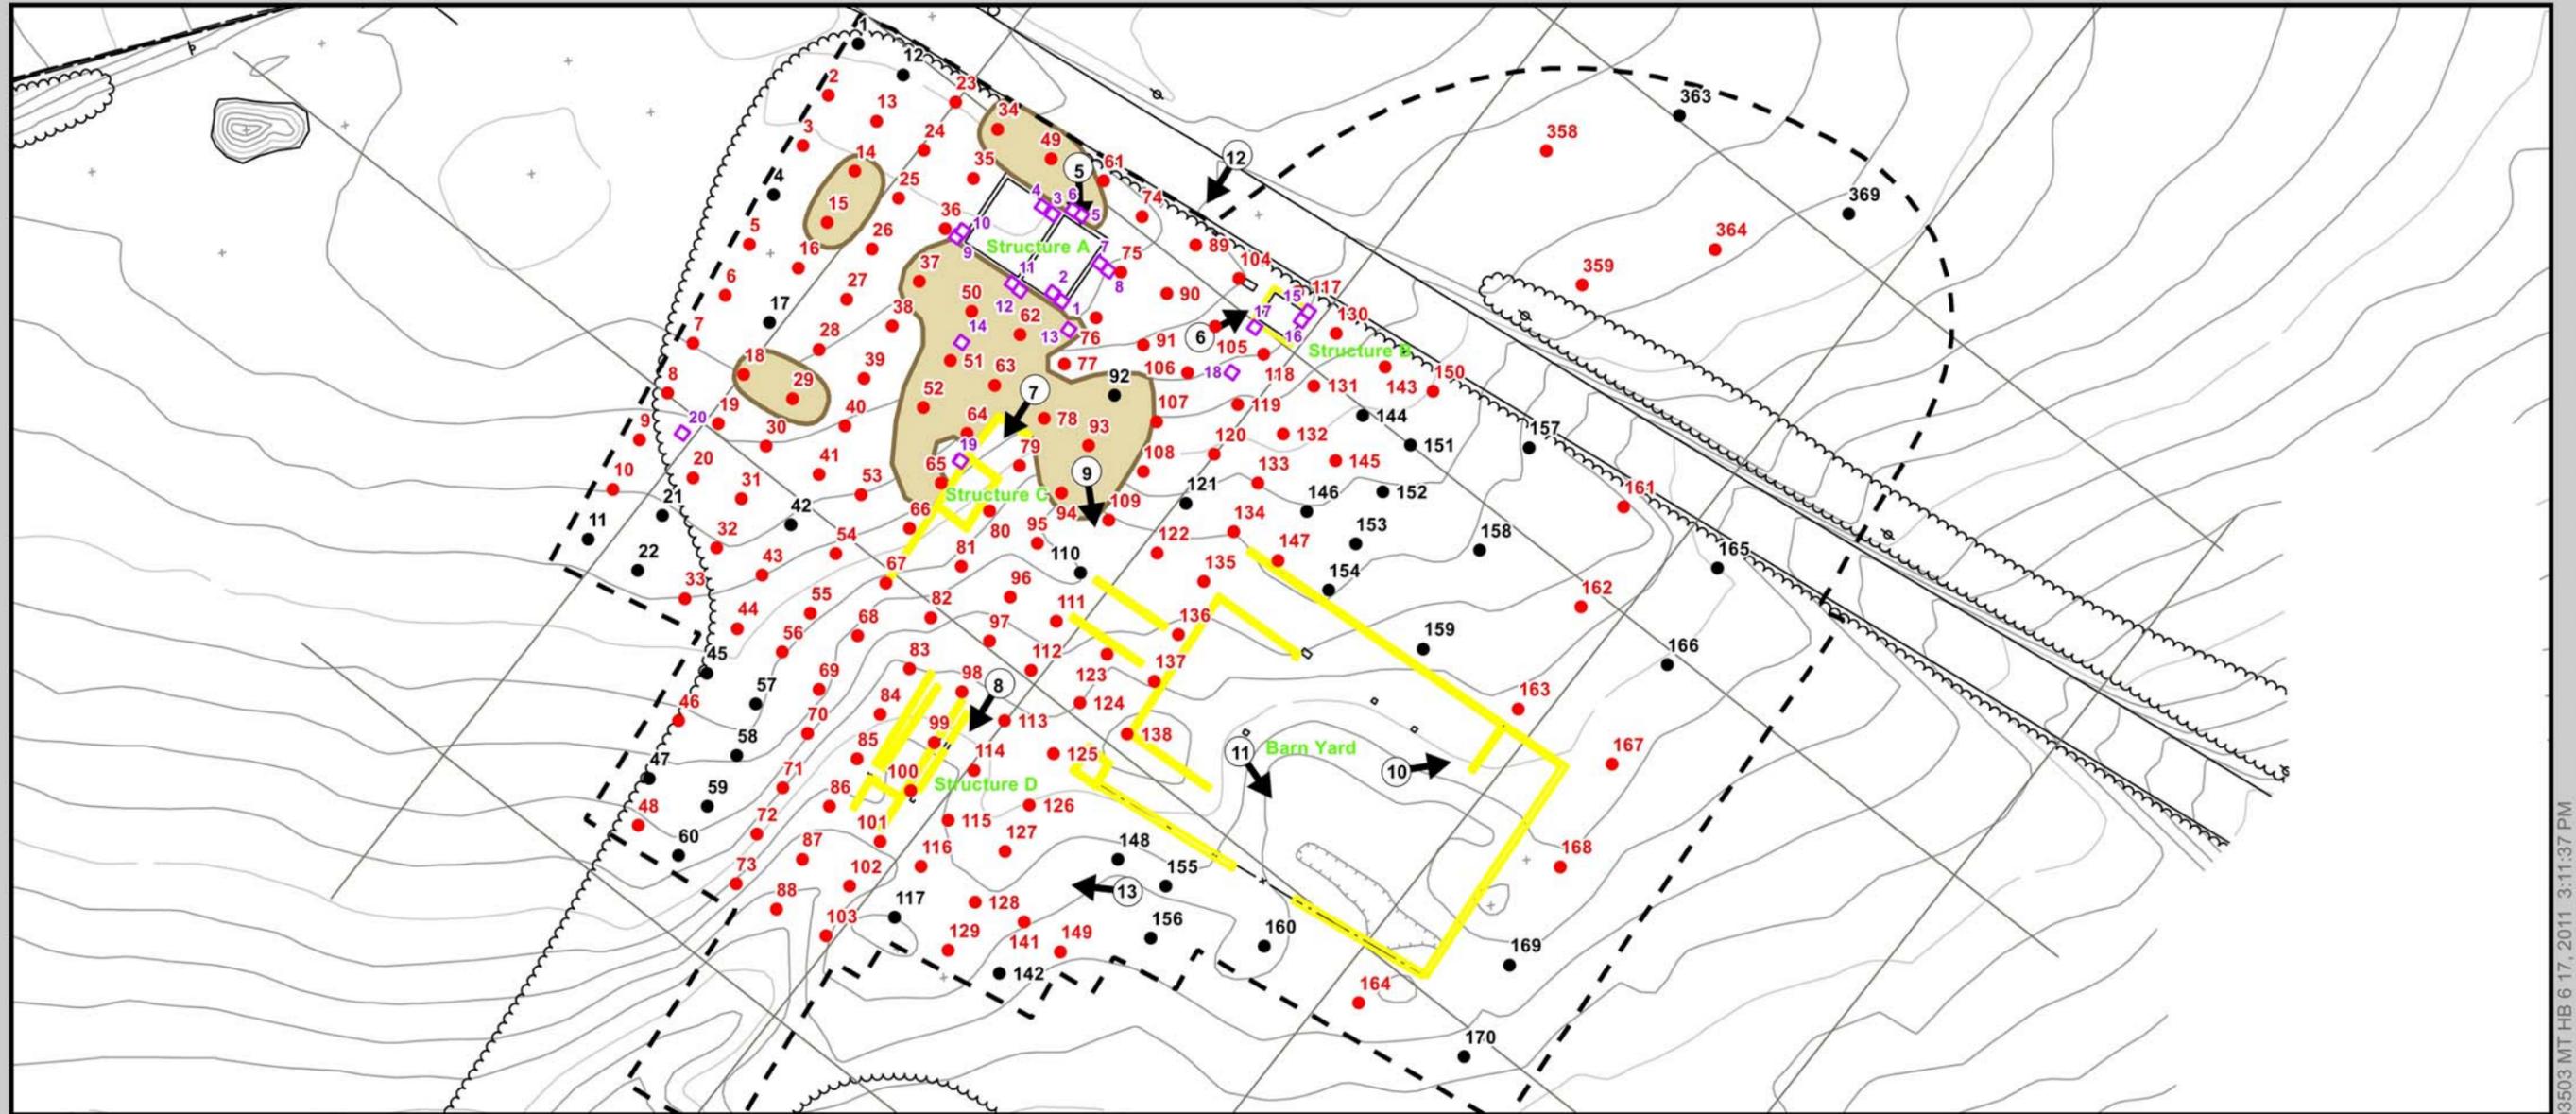
Figure 16
Weldin Plantation Site (7NC-B-11)
Phase II Archaeological Evaluation Testing
Blue Ball Properties Area Transportation Improvement Project
Brandywine Hundred, New Castle County, Delaware

Test Units 1 and 2 were placed in the southeast corner of the Structure A, several feet south of the suspected doorway to the house (*Figure 16*). Interestingly, a large rectangular stone with the initials "WT" carved into the face was located on the surface of the demolition debris near this location. This stone probably represents the lintel that would have been located above the doorway. The letters inscribed into the lintel stone may represent the last initials of Jacob Weldin and his wife Hannah Talley; deed research failed to identify any other inhabitants of the property with the initials WT.

Test Units 3 and 4 were excavated in the northeastern corner of the western portion of Structure A (*Figure 16*). Strata I and II were mostly composed of demolition debris, with Level 1 exhibiting a slightly darker matrix due to the accumulation of organic material. Both Levels yielded artifacts dating predominantly to the twentieth century. The architectural debris was underlain by a brick basement floor laid in a herring-bone pattern. The brick floor was found to overlie a relatively thin horizon of brown (7.5YR 5/6) sandy fill (Level IV), which was void of cultural materials. Subsoil (Level V) was contacted approximately 7.2 feet (~2.2 meters) below ground surface. It consisted of a mottled yellowish red (5YR 5/8) and light yellowish brown (2.5Y 6/4) silty clay. Feature 8 was discovered along the east wall of TU 3.

TUs 7 and 8 were placed on the eastern side of Structure A against the south bulkhead wall (*Figure 16*). Level I was composed of a mottled dark yellowish brown (10YR 4/4) and strong brown (7.5YR 5/6) loam that contained foundation stones, brick fragments and numerous twentieth century artifacts. It was interpreted as a fill horizon associated with the demolition of the structure in the twentieth century. Level II, a very dark grayish brown (10YR 3/2) silt loam appeared to represent an A/O horizon. Level III consisted of the yellowish brown (10YR 5/6) clay loam subsoil, although a small pocket of mottled brown (10YR 4/3) and yellowish brown (10YR 5/4 and 10YR 5/6) was found in TU 7 at the interface with the subsoil. This soil deposit may represent the original truncated A/Ap horizon (*Figure 22*). Two irregular soil anomalies containing modern artifacts were found to be intrusive to the subsoil. The first, located in TU 7, originated at the existing ground surface and was composed of Level I soils, and the second, located in the southwest corner of TU 8, originated at the interface of Levels II and III and contained Stratum II soils. All of the contexts from TUs 7 and 8 contained modern artifacts. It appears that the area around the bulkhead was subjected to relatively severe ground disturbing activities sometime during the 20th century, likely during the demolition of the structure.

Test Units 11 and 12 were placed along southern wall of Structure A at the approximate location of the interior partition wall (*Figure 16*). The stratigraphy of the units closely matched that of TUs 9 and 10. The portion Structure A exterior exposed in TU 11 indicates that the western portion of the foundation likely represents a later addition to the house. The eastern portion of the foundation exhibited a finished wall at its southwest. At this point the western portion of the foundation appears to be butted against the east section (*Photograph 18*).

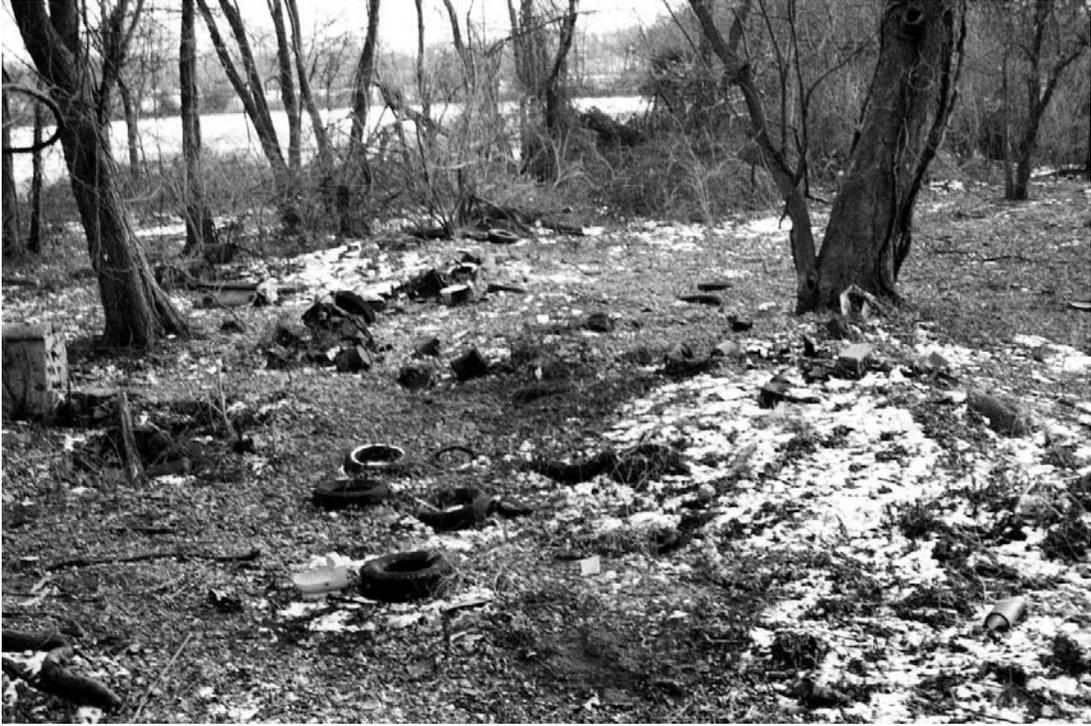
Photograph 13: Weldin Plantation Site, view of twentieth century dump, facing southwest.

The density of historic artifacts across the site was found to be variable due to the amount of secondary deposition of twentieth century debris on the site, and for this reason, artifact counts encountered in the STPs were deceptively high. This was particularly evident in the area roughly bounded by STPs 41, 45, 137, and 156. This portion of the site was used as a dump throughout the twentieth century. Modern artifacts such as rusty buckets and barrels, tires, plastic and glass bottles, sheets of aluminum, mattress springs, chunks of concrete, assorted car parts and other twentieth century materials were observed on the ground surface (*Photograph 13*). Therefore,

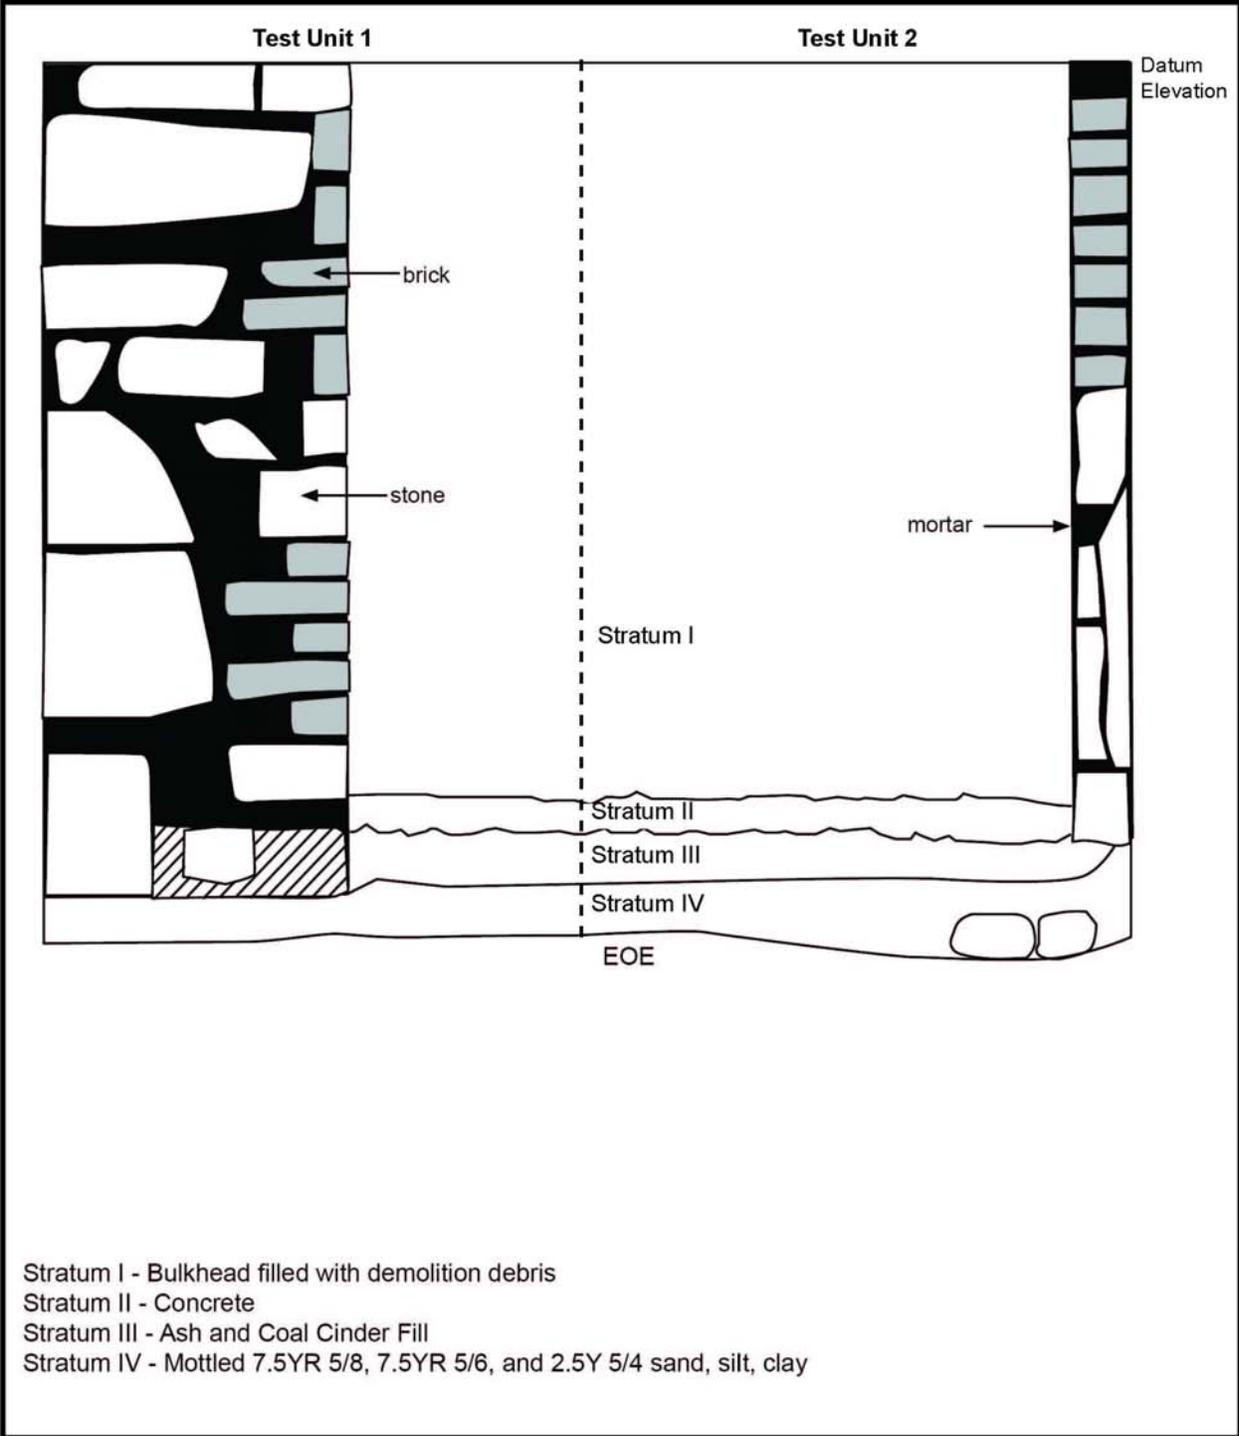
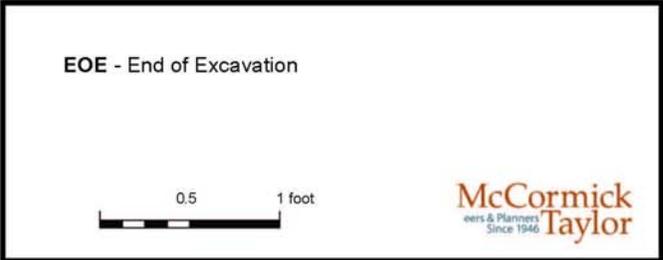
Figure 18
Test Unit 1 and 2 South Profile

Level I of the excavation consisted of demolition debris containing predominantly unconsolidated large foundation stones and decaying mortar. Several bricks were also noted within the architectural debris. The bricks were probably associated with a brick-lined bulkhead entrance which was situated along the south wall approximately 1.5 feet (~0.5 meter) west of the southeast corner. Level I was excavated to approximately 4.5 feet (~1.4 meters) below ground surface where a concrete basement floor (Level II) was uncovered. The concrete floor was removed and was found to overlie a layer of coal slag and ash fill (Level III) approximately 0.2-0.3 feet (0.06-0.09 meter) in thickness. Level III, was underlain by a thin mottled sand silt and clay fill horizon which (Level IV), in turn overlaid subsoil (*Figure 18*).

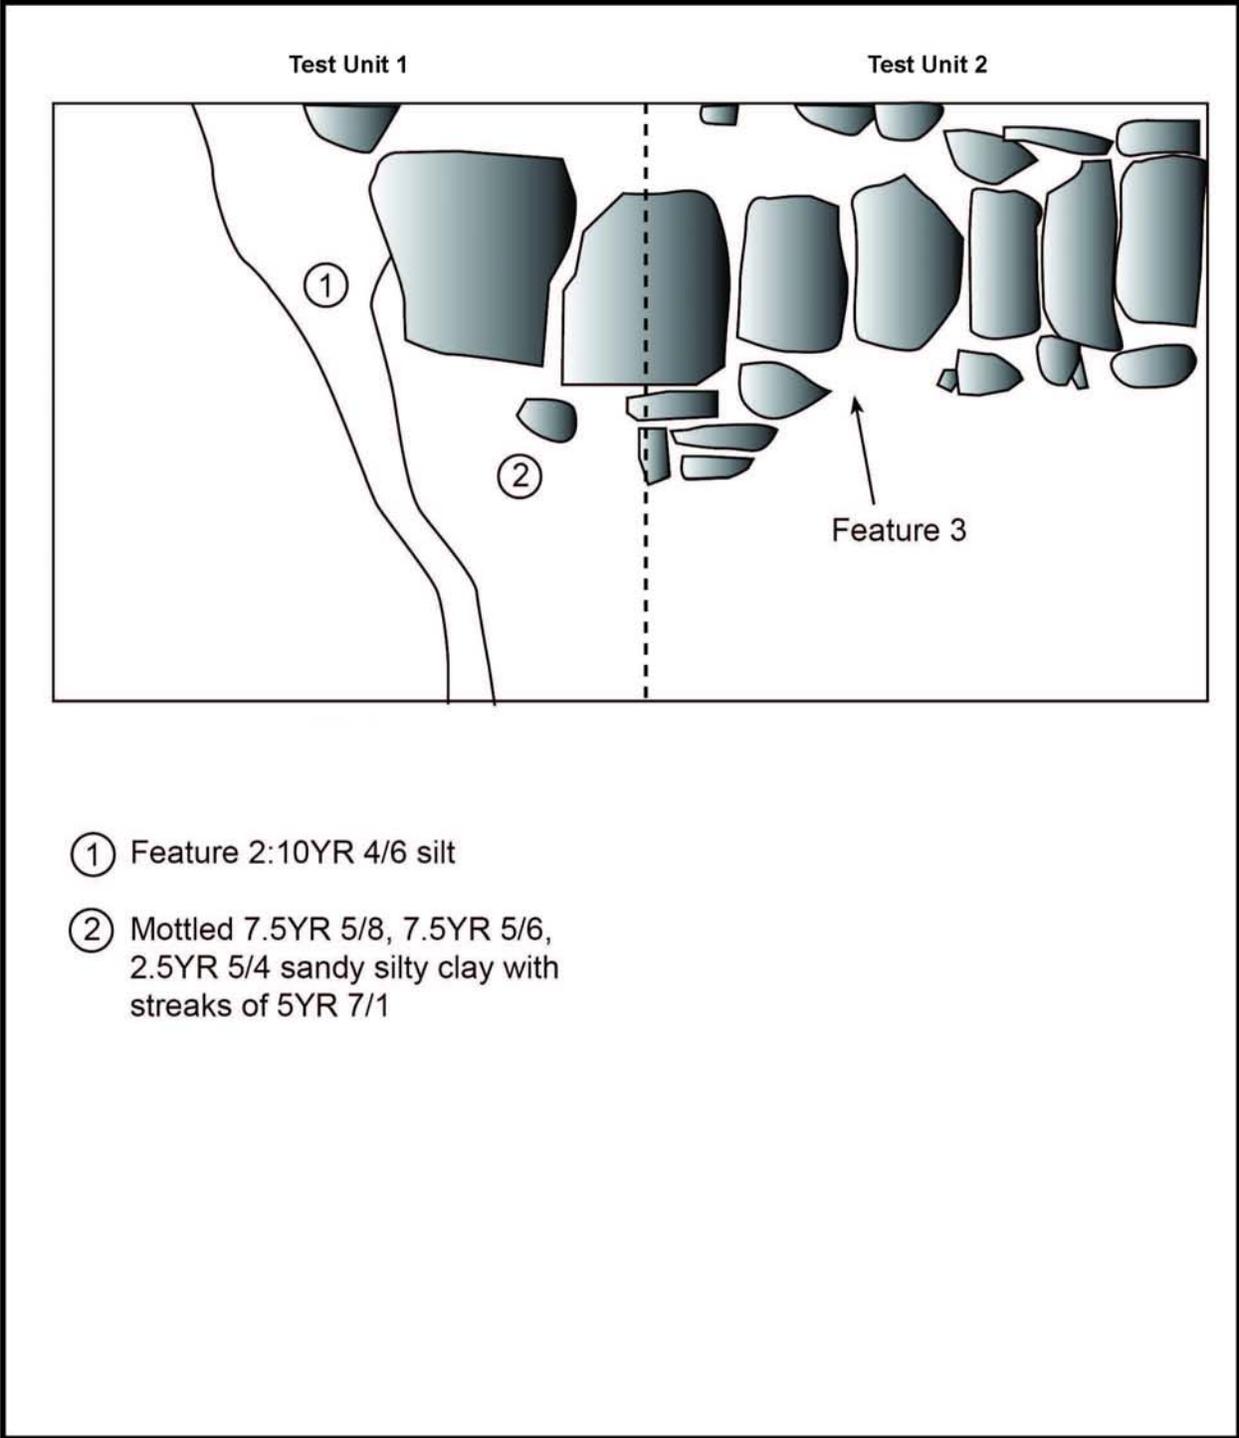
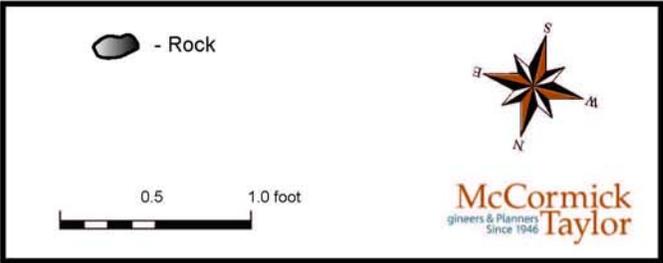
Figure 19
Planview of Feature 2 and 3

Feature 2 was identified by a dark yellowish brown (10YR 4/6) funnel-shaped stain near the center of TU 1 (*Figure 19*). The anomaly measured approximately 0.8 feet (~0.24 meter) wide at the southern terminus of the unit and narrowed to 0.2 feet (0.06 meter) at the northern limits of excavation. Feature 2 was relatively shallow (0.1-0.2 feet [0.03-0.06 meter] in depth) and was excavated in its entirety. The feature fill was silty in texture and contained some carbon flecking. Artifacts recovered from the feature included six pieces of brick, five pieces of redware, and one piece of window glass. It is possible that Feature 2 represents the remains a small drainage channel associated with Feature 3.

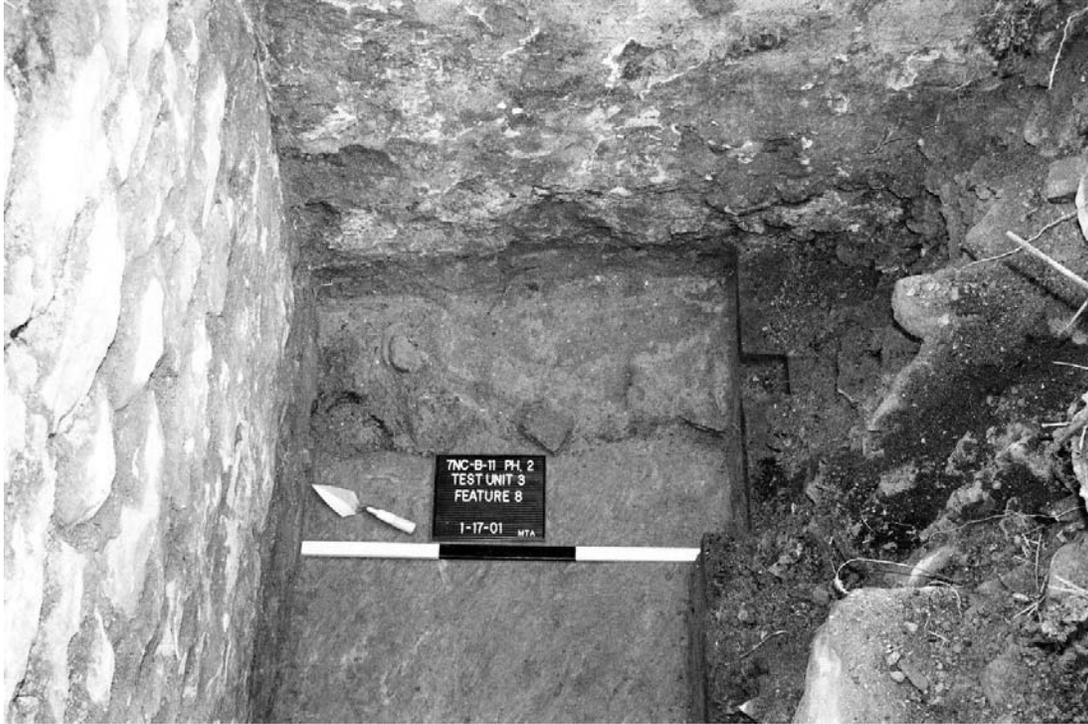
Photograph 15: Weldin Plantation Site, Feature 8 planview, facing east.

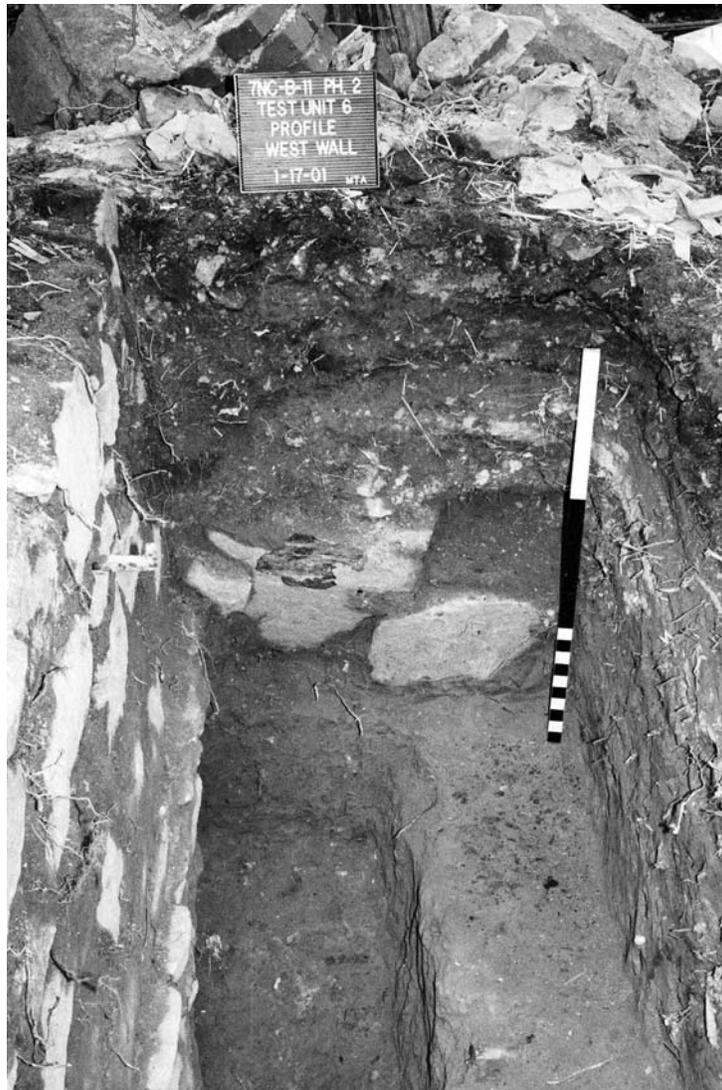
Photograph 16: Weldin Plantation Site, Test Unit 6 west profile.

The brownish yellow (10YR 6/6) clayey silt subsoil was reached approximately 3.0 feet (~0.9 meter) below ground surface in both test units (*Figure 21 and Photograph 16*). It contained 16 artifacts in TU 5 and was void of artifacts in TU 6. The artifacts found in the subsoil were likely deposited through the heavy bioturbation noted within the overlying stratum.

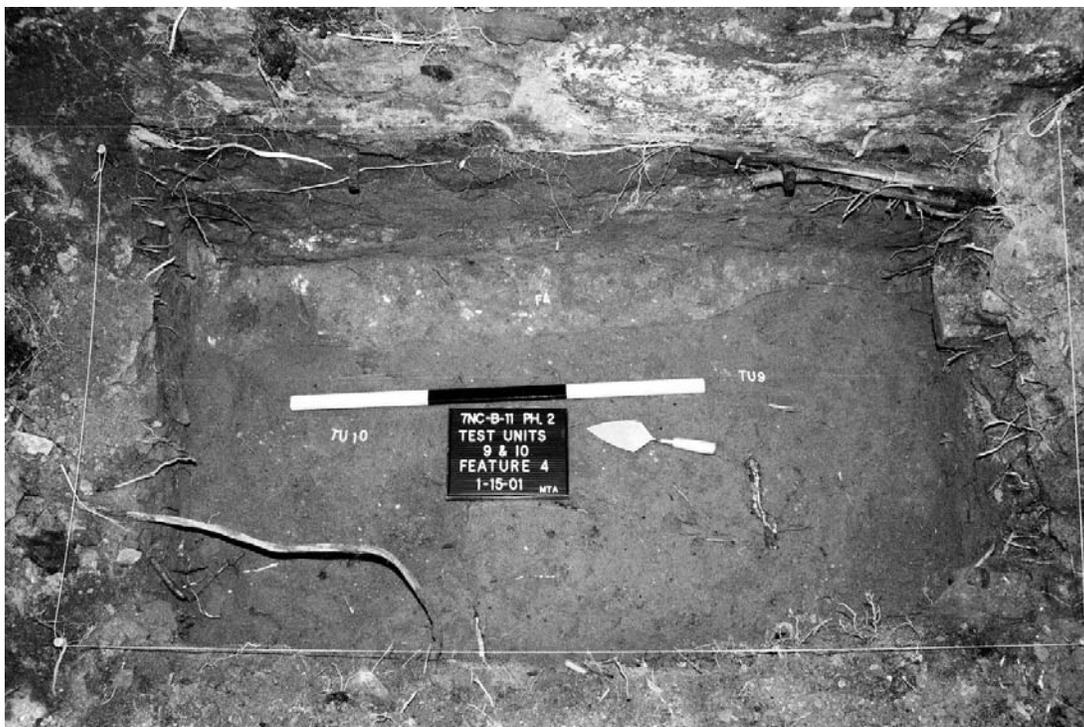
Photograph 17: Weldin Plantation Site, Feature 4 planview, facing east.

Feature 4, a linear trench feature comprised of 7.5 YR 5/8 silty clay fill, was found at the interface of Levels II and III along the Structure A foundation (*Photograph 17*). This feature was possibly created during the excavation of the cellar hole and was filled subsequent to the construction of the foundation wall. The feature fill contained four chunks of mortar, one cut nail, one shard of creamware, and one shard of pearlware.
