IV. Survey Results

A. Archaeological Identification Survey

Figure 12
Index Map
Archaeological Area of Potential Effects
Phase I Archaeological Identification Survey
Blue Ball Properties Area Transportation Improvement Project
Brandywine Hundred, New Castle County, Delaware

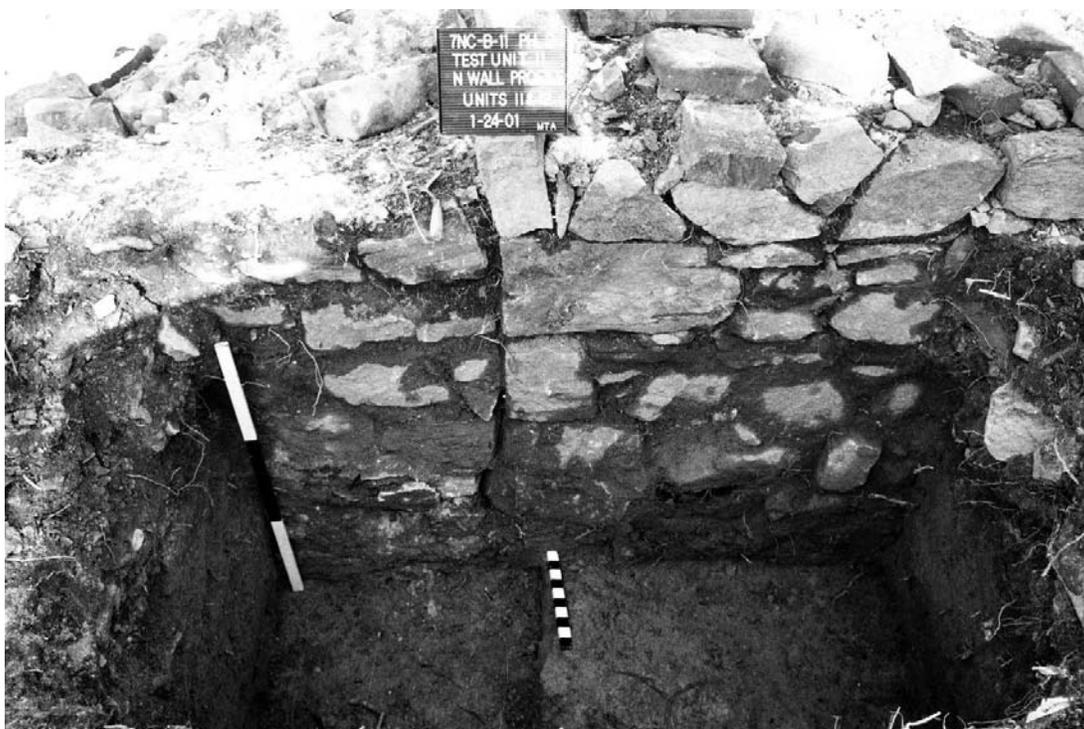
Photograph 18: Weldin Plantation Site, Test Units 11 and 12 north profile.

Test Units 11 and 12 were placed along southern wall of Structure A at the approximate location of the interior partition wall (*Figure 16*). The stratigraphy of the units closely matched that of TUs 9 and 10. The portion Structure A exterior exposed in TU 11 indicates that the western portion of the foundation likely represents a later addition to the house. The eastern portion of the foundation exhibited a finished wall at its southwest. At this point the western portion of the foundation appears to be butted against the east section (*Photograph 18*).

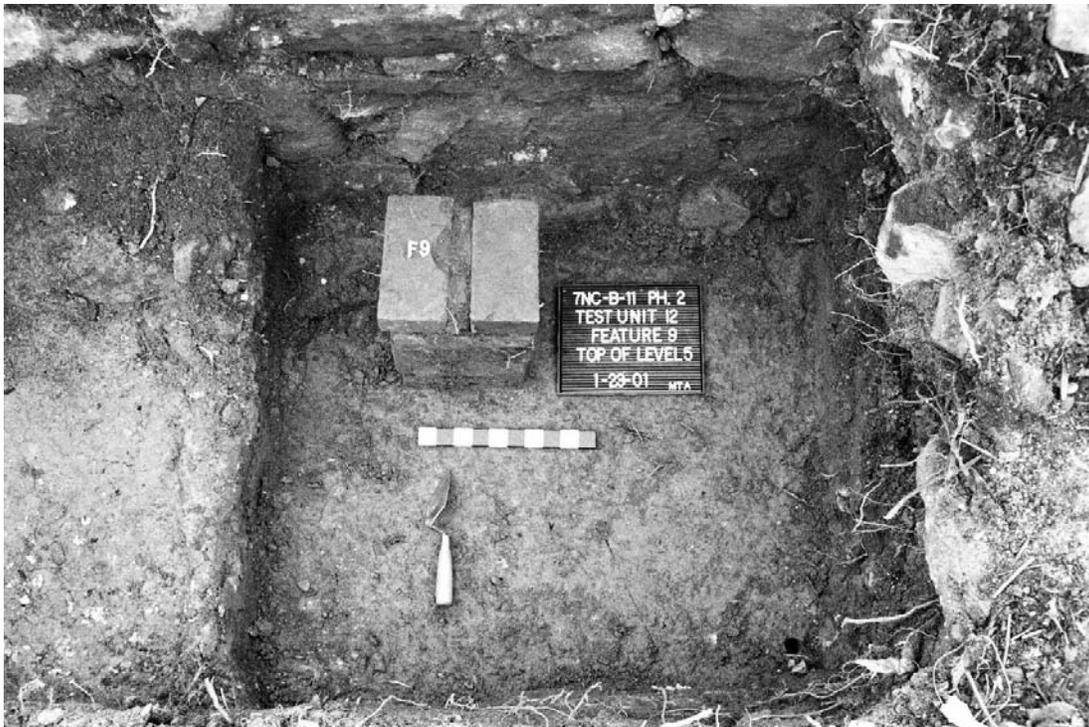
Photograph 19: Weldin Plantation Site, Feature 9 planview, facing north.

Feature 9 consisted of a brick footer that was four courses in thickness and two bricks in width (*Photograph 19*). The bricks were built upon a stone foundation that rested on the subsoil. Along with the brick footer found in TU 6, Feature 4 was interpreted as the footer for a porch. It was exposed within the fill layer overlying the original A horizon. Based on its stratigraphic position, it likely dates to the mid nineteenth century.

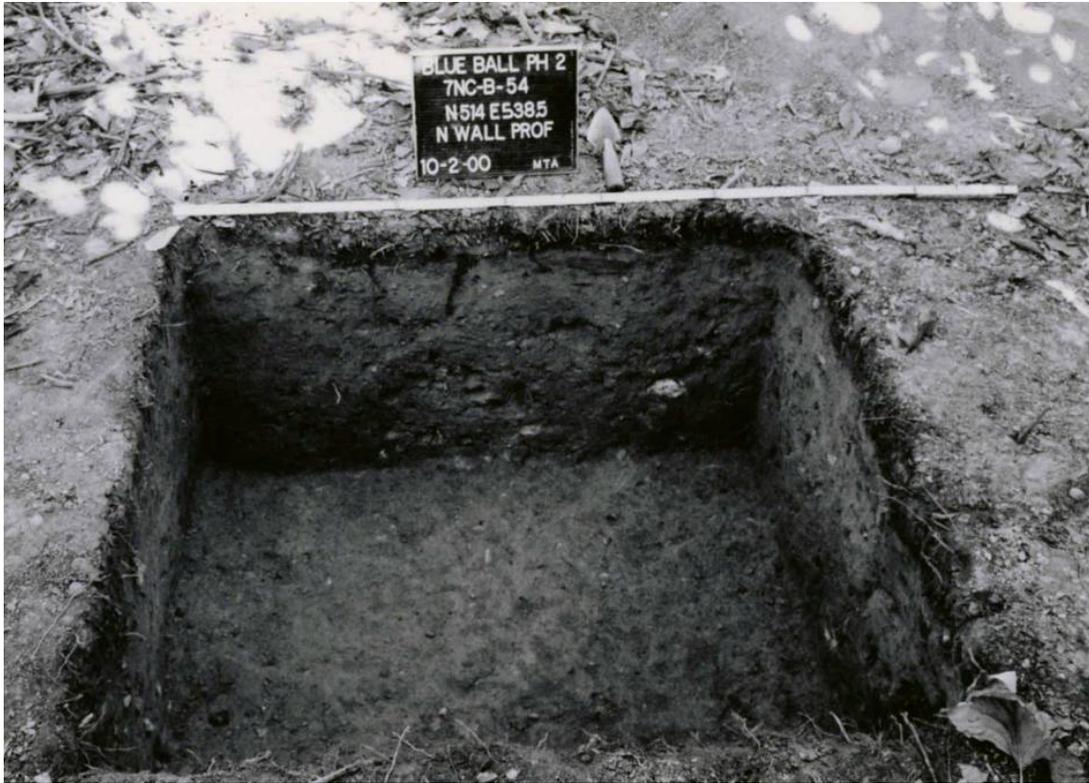
Photograph 20: Ronald McDonald House Site, Test Unit N514 E538.5 north profile.

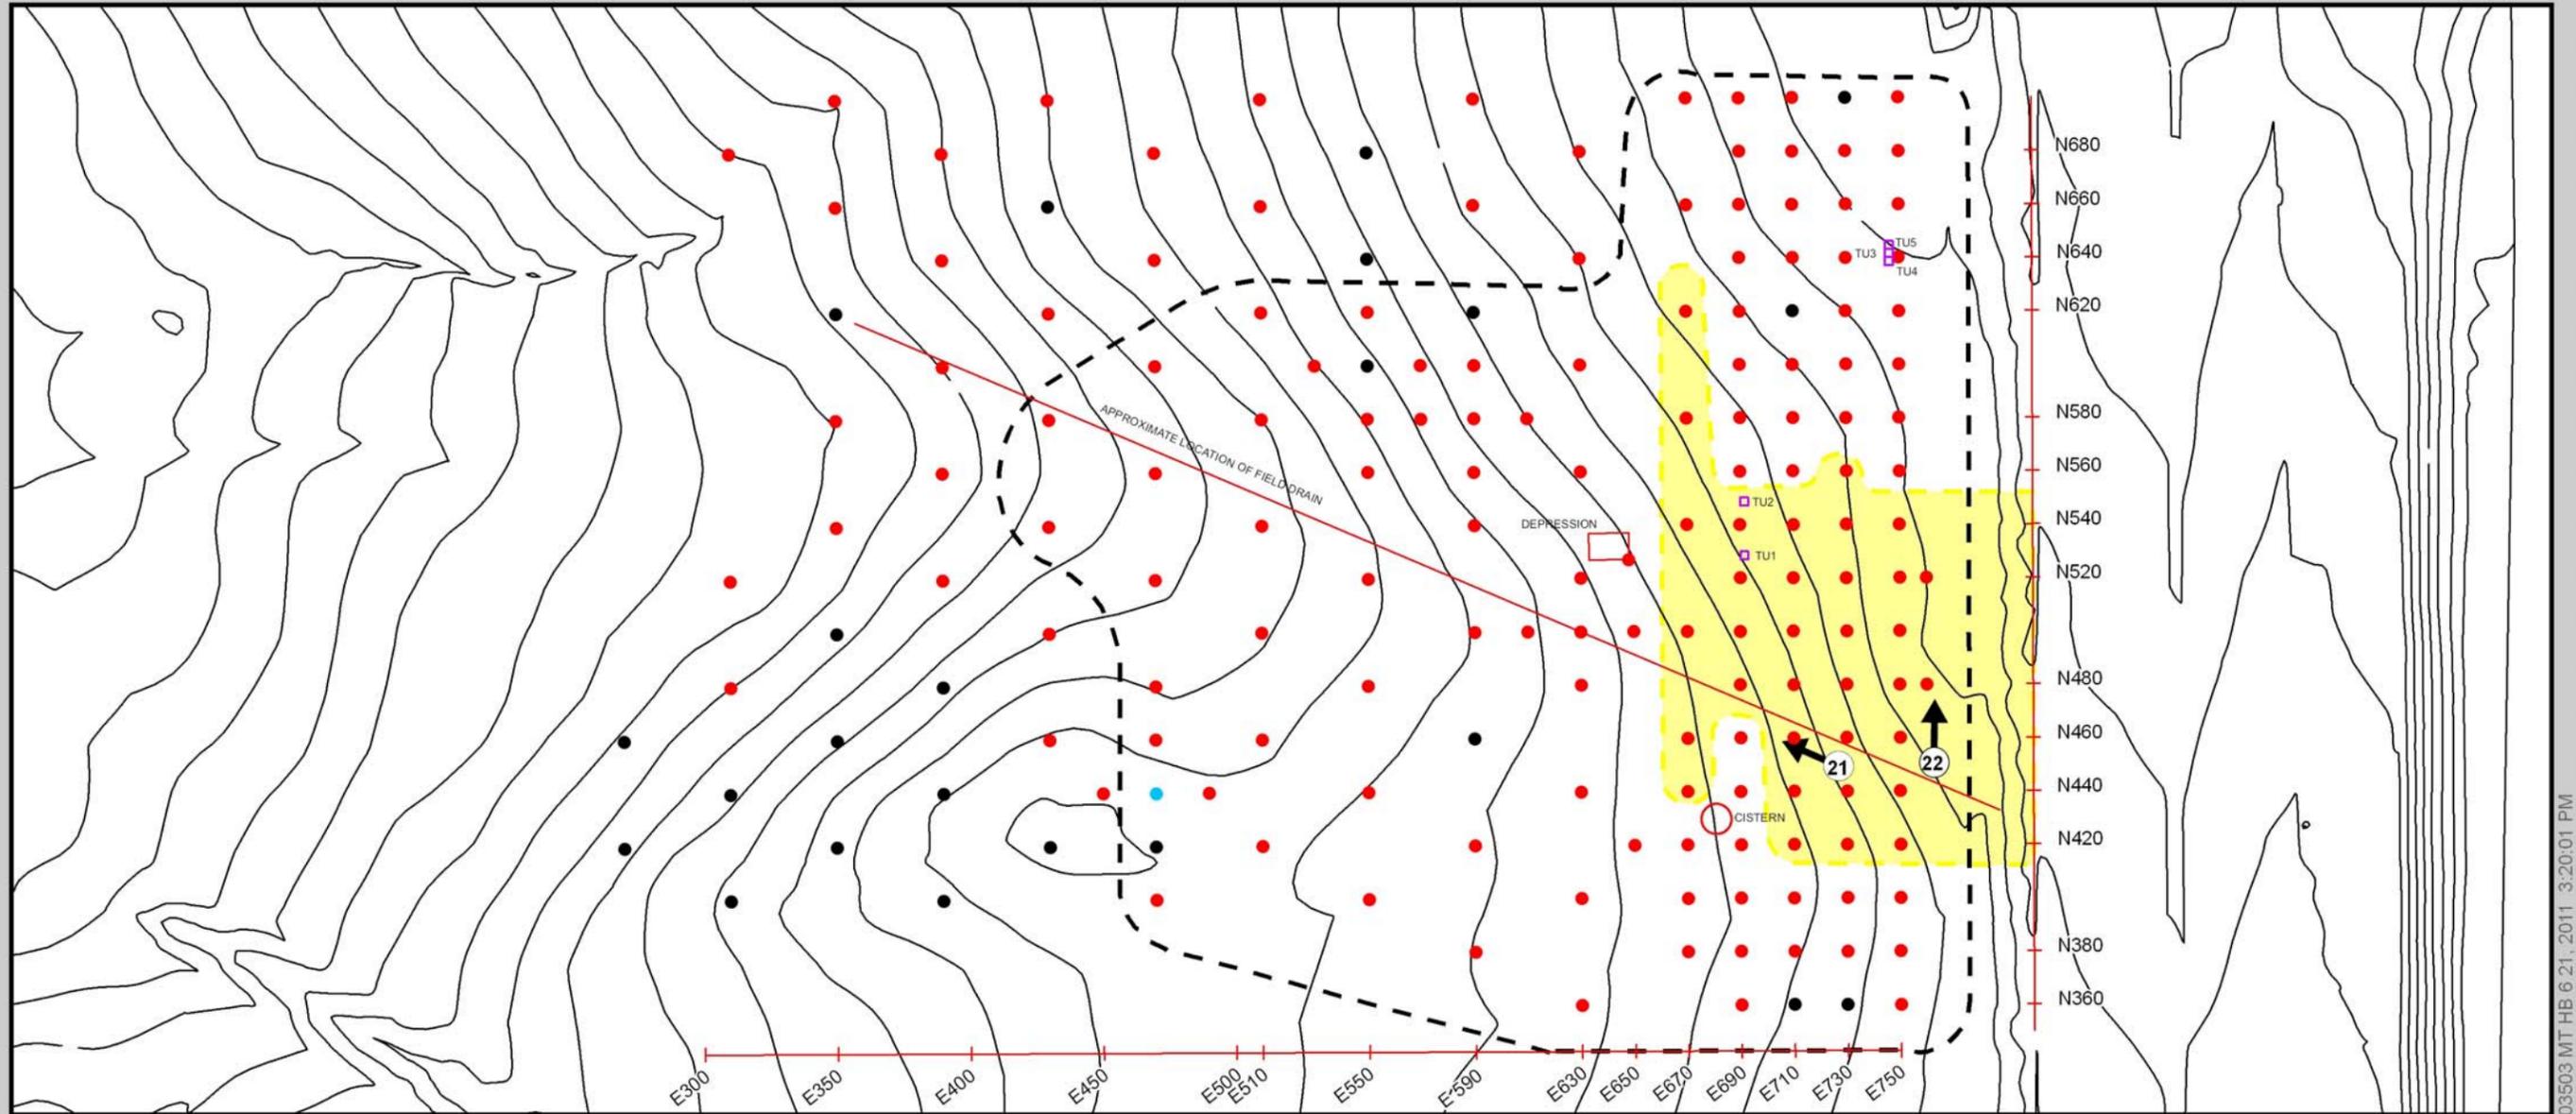
Figure 31
Augustine Cutoff Site (7NC-B-49)
Phase II Archaeological Evaluation Testing
Blue Ball Properties Area Transportation Improvement Project
Brandywine Hundred, New Castle County, Delaware

In addition to the cistern, a 10 by 15 foot rectangular depression located approximately 100 feet (~30 meters) north of the cistern (~160 feet [~49 meters] west of the existing edge of Concord Pike) was discovered during the shovel testing of the field containing the site (*Figure 31*). Shovel test N527E648 was excavated at the southeastern corner of the depression. In this shovel test, a rectangular postmold was encountered at the interface between the plowzone and the subsoil. To expose the feature in its entirety, the shovel test was expanded to comprise an area measuring approximately 2x3 feet (~0.6x0.9 meter). The postmold measured approximately 0.6x0.8 feet (~0.18x0.24 meter) in plan size and was found to lie just outside of the depression at the corner. The depression probably represents the previous location of an outbuilding.
