**HISTORIC DOCUMENTATION PREPARED BY
LICHENSTEIN CONSULTING ENGINEERS, INC.**

Historic Documentation

BRIDGE 68 (West Rockland Road over Wilson Run)

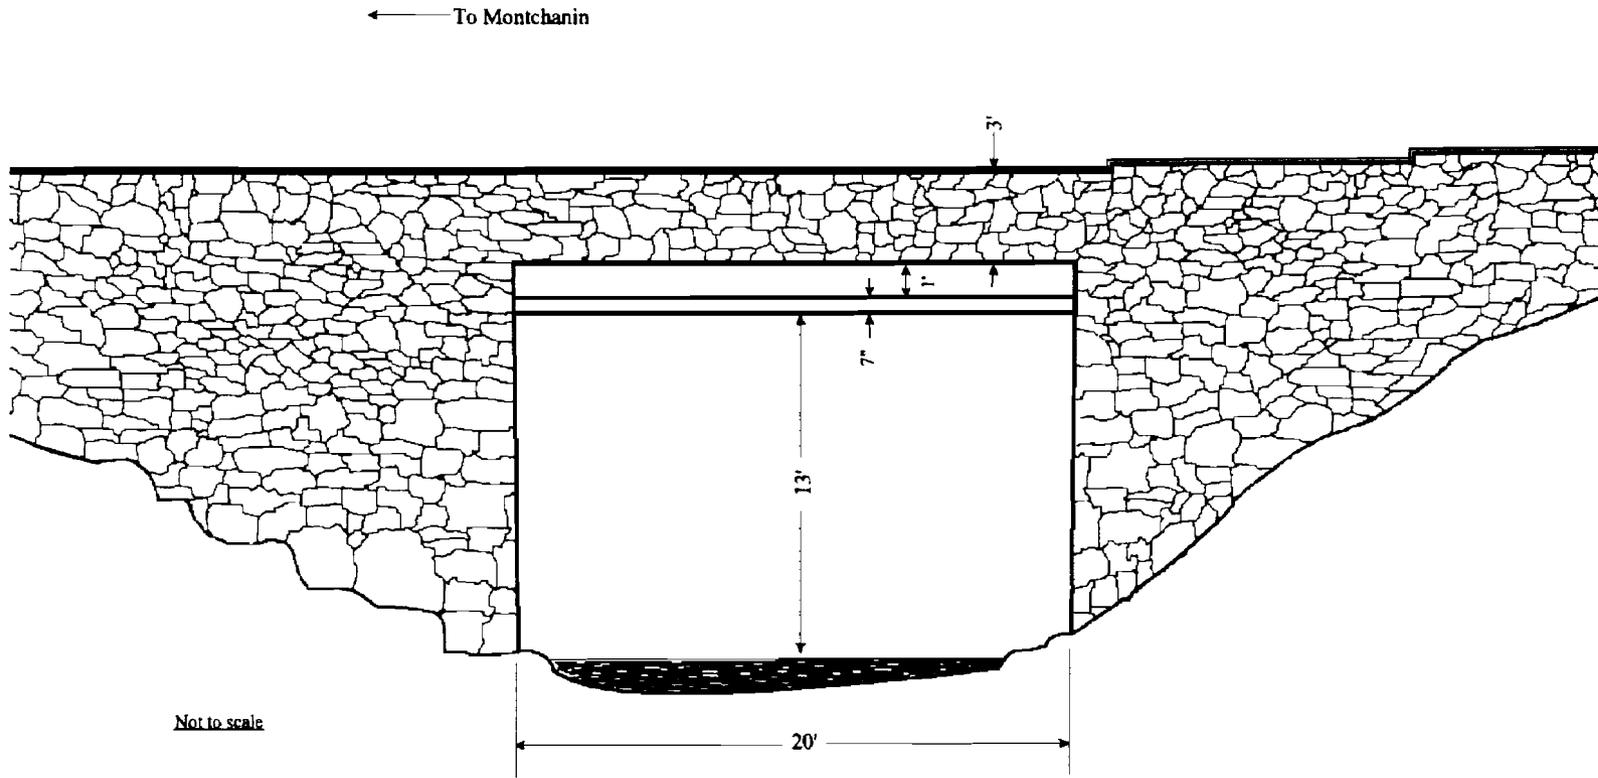
EAST ELEVATION

Elevation sketch
 From field measurements, Dec. 2004
 By P. Harshbarger
 Lichtenstein Consulting Engineers

Bridge 68 is a 22'-long (as measured out-to-out of the beams), concrete-encased, steel multi-girder bridge (see sketches and plan sheet, pp. 12-14; 35 mm photos, Roll 1). It has a 20'-long clear span (opening between the abutments). The girders, also known as stringers, are eight lines of 16"-deep, wide-flange (I-shaped), steel beams. The beams are encased in concrete with the top flanges embedded in a 7"-deep, reinforced-concrete slab deck. The beams are stiffened by a single line of reinforced-concrete diaphragms between the beams.

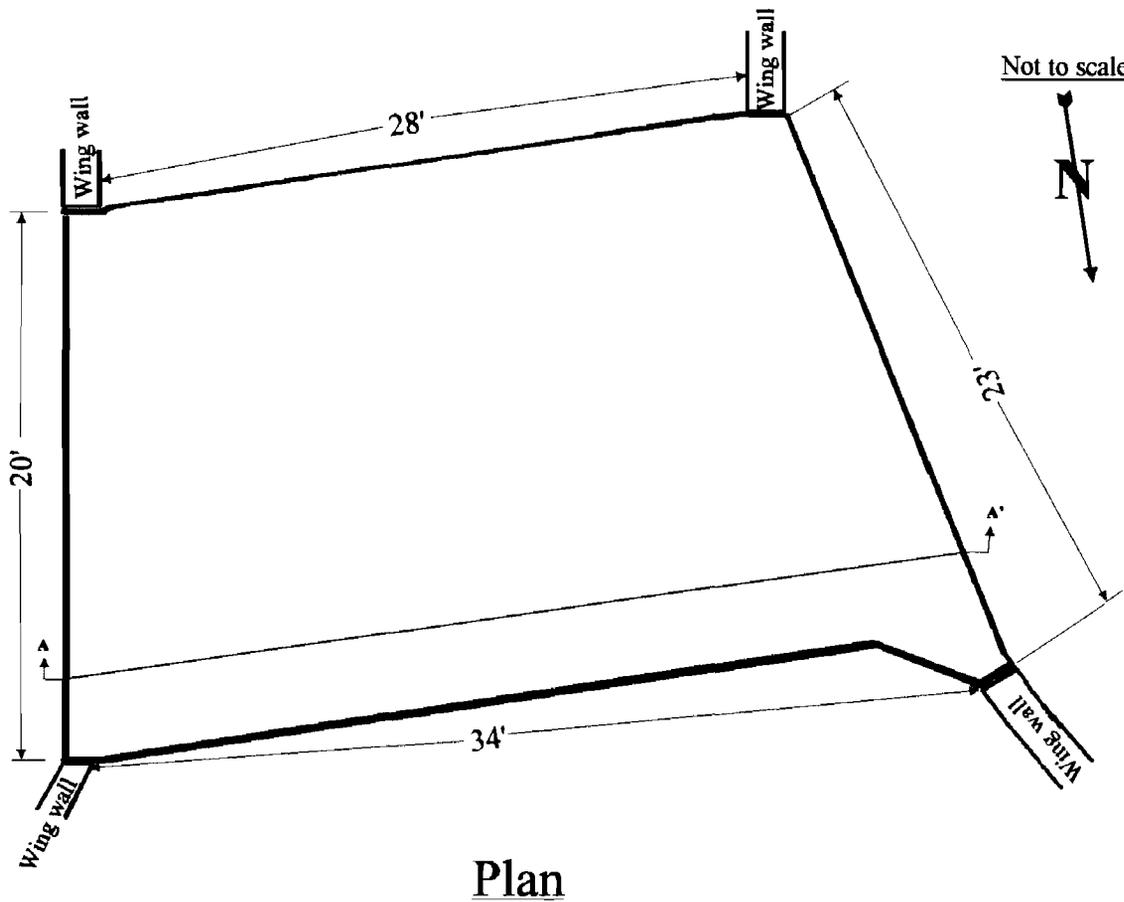
Plan and section sketches
 From field measurements, Dec. 2004
 By P. Harshbarger
 Lichtenstein Consulting Engineers

The bridge flares in plan from approximately 28' wide at its south end to 34' wide at its north end. The flared end accommodates traffic movements at the intersection of Rockland Road and Adams Dam Road at the bridge's north end. The upstream (westernmost) fascia beam is skewed to take into account the difference in width from one end of the bridge to the other.

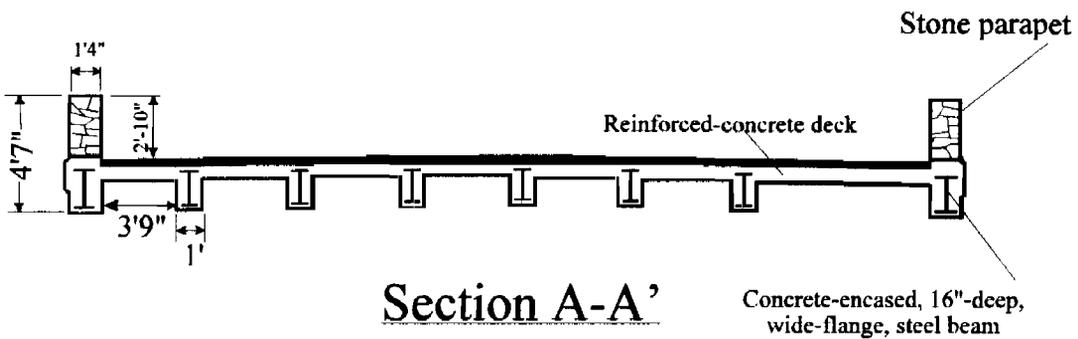
Section A-A'

Concrete-encased, 16"-deep,
 wide-flange, steel beam

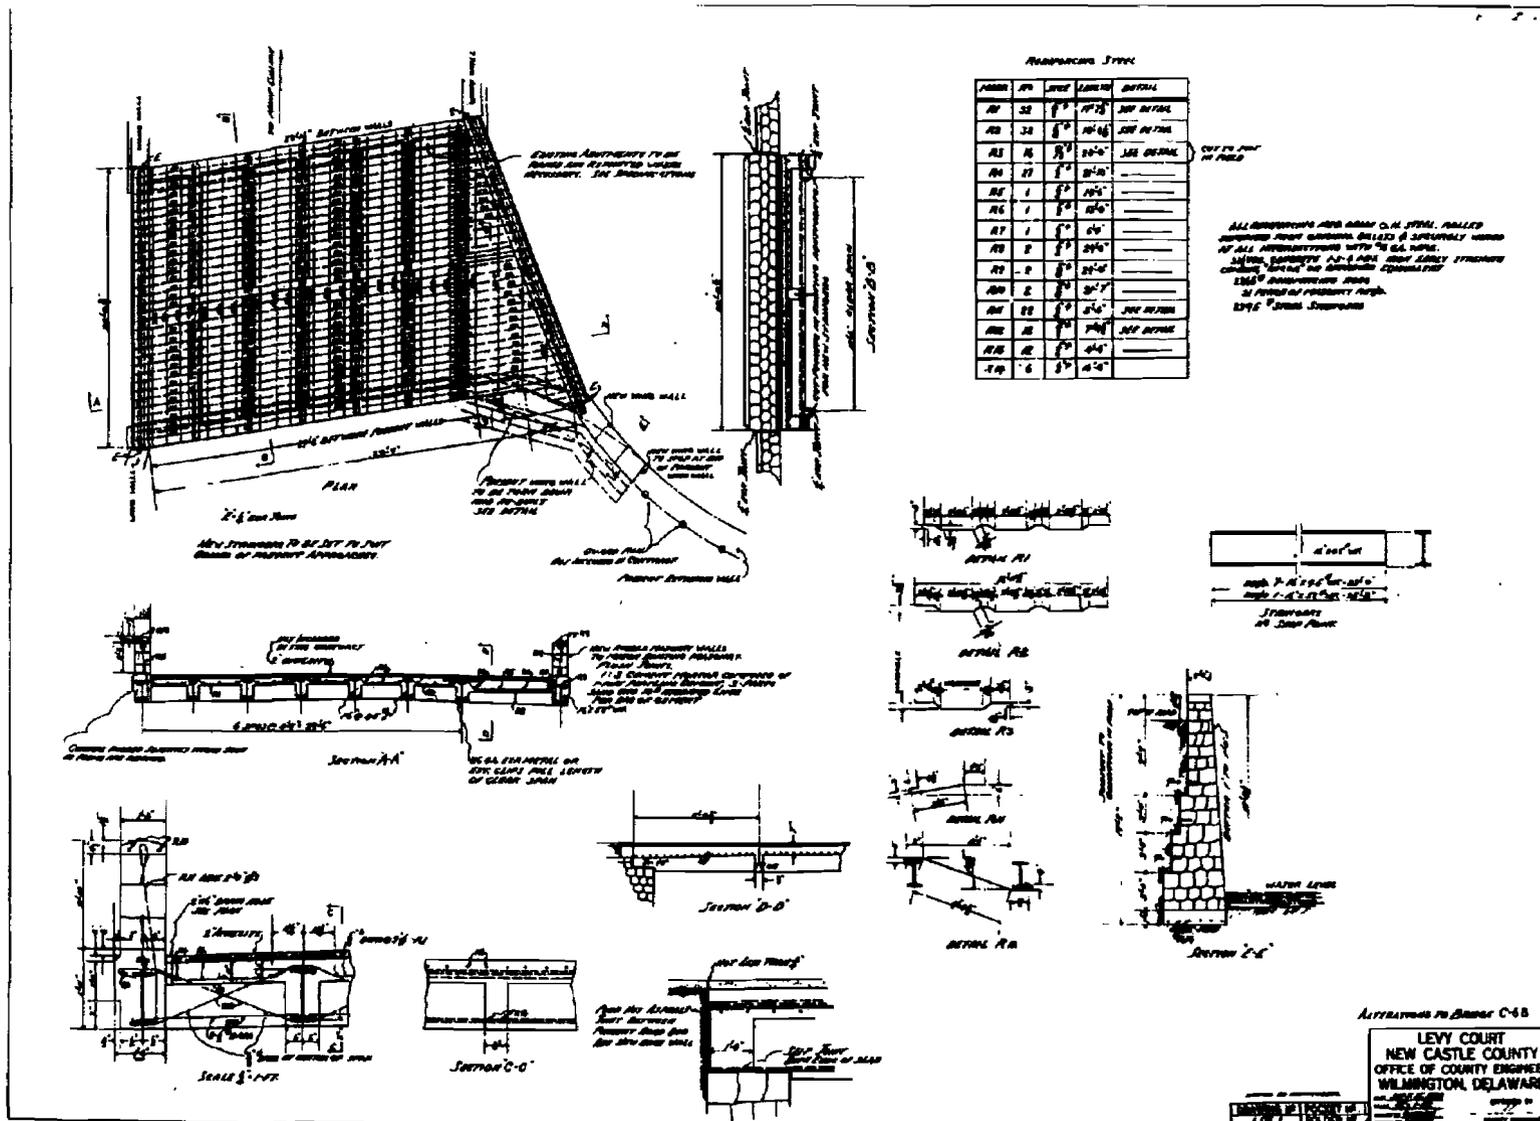
Plan for Bridge 68, 1932. From digitized original plans, DelDOT, Dover. The design prepared by the county engineer in 1932 closely matches the as-built dimensions taken by field measurement in Dec. 2004.

The removal of Bridge 68 was monitored and documented with photography in February 2005 (see 35mm photos, Roll 2). As-built dimensions (size of beams, etc.) were field checked to confirm that they did in fact match the original 1932 county plans.

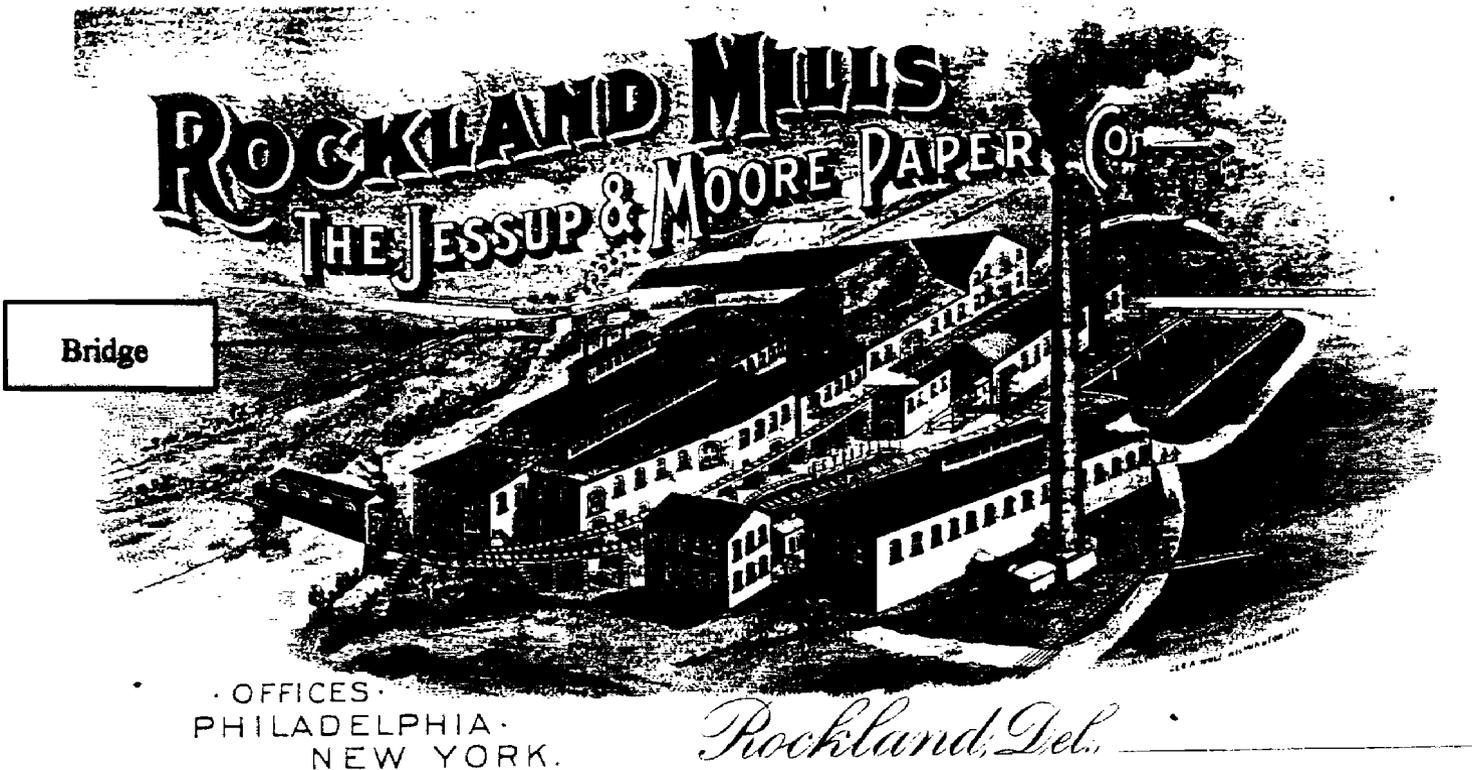
A metal pony-truss bridge with stone abutments and wingwalls is shown in the background of this lithograph from the Rockland paper mill's stationery, circa 1890. The pony truss was replaced by the concrete-encased, steel multi-girder bridge in 1932. Accession 1020, Hagley Museum and Library, Wilmington.

The oldest identified visual representation of the West Rockland Road bridge is in the background of an engraving of the Rockland Mills on company stationery, circa 1890 (see p. 16). The

engraving illustrates a short pony-truss bridge on prominent stone abutments and wingwalls. The existence of a metal pony truss is confirmed by a snapshot photo dating from the 1920s in the New Castle County bridge photo collection at the Delaware Department of Transportation in Dover (see p. 17) This bridge, which was removed in 1932 to make way for the present bridge, was an 18½'-long, Warren, riveted pony truss dating by style to circa 1890.⁹
