IV. ARCHITECTURAL RESOURCES: DESCRIPTION AND EVALUATION

C. RESOURCES IN THE BRIDGES 526 AND 527 PROJECT AREA

D. RESOURCES IN THE ROUTES 26 AND 17 PROJECT AREA

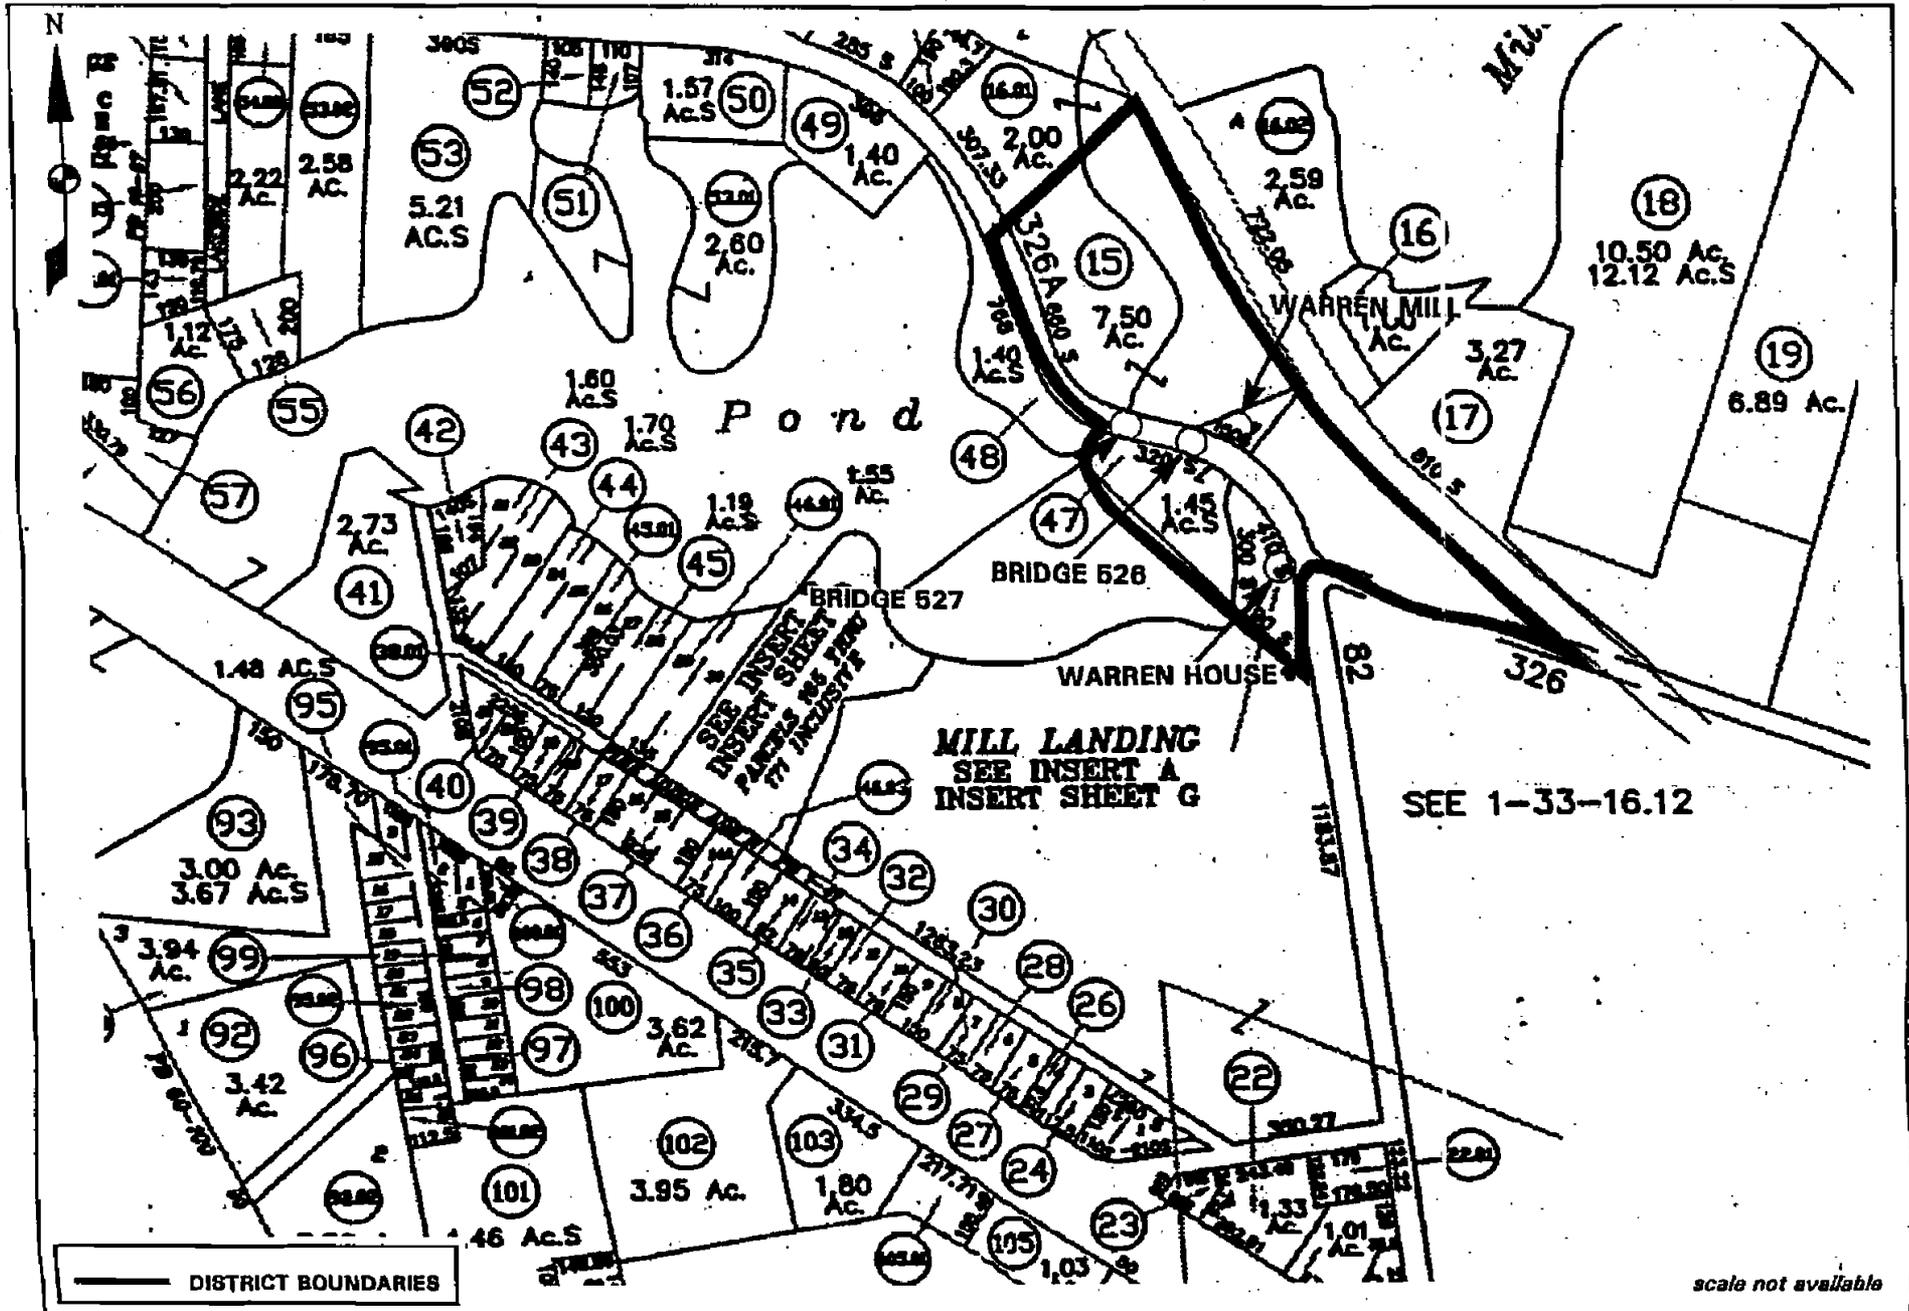
FIGURE 5: Warren Mill Historic District Boundaries and Contributing Resources

Description: The Warren Mill Historic District is located along Route 326, on a small stretch of land between Betts Pond and Millsboro Pond near the town of Millsboro. The district includes all of Tax Parcels 47 and 15, and is bounded on the south by Routes 326 and 82, Betts Pond and Tax Parcel 48 on the west, Tax Parcel 16.01 on the north, and the railroad right-of-way to the east (see Figure 5). This site contains two parcels of land historically associated with the Warren family who have owned the mill seat since the 1920s. The district encompasses the entire mill seat, including the mill, races, Warren House, and Bridges 526 and 527. This site has been an active milling center since the mid-eighteenth century, and presently contains four contributing architectural resources.

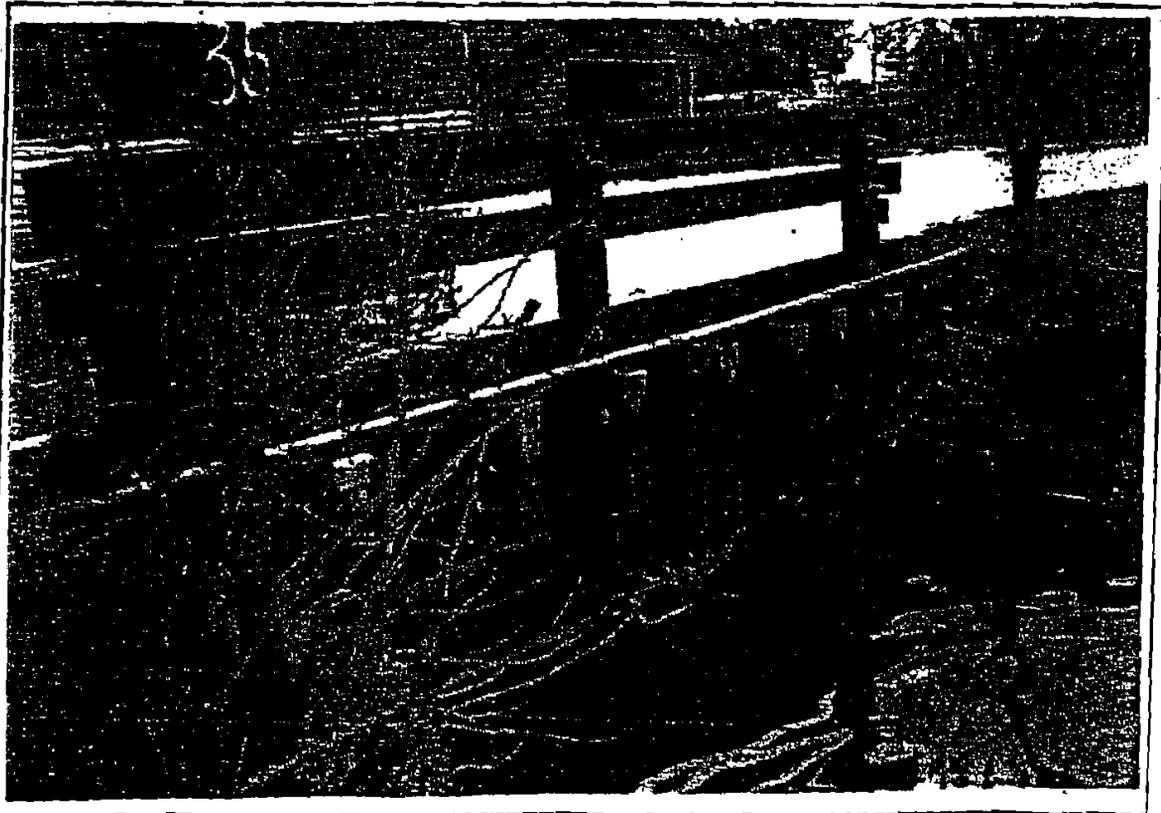
PLATE 6: Bridge 526 (S-9147.3), South Elevation, Northeast View

Description: Bridge 526, constructed circa 1935, carries Route 326 over a mill trace that flows under the Warren Mill, located on the north side of the road (Plate 5). It is a timber and concrete culvert with concrete abutments. The structure is 10 feet long and 30 feet wide. It also had a timber deck covered with an asphalt wearing surface all on top of the timber frame and concrete superstructure. Wood railings are attached to the deck. A timber spill-gate has been constructed on the south elevation of the structure which controls the flow of water from Betts Pond, located southeast of the mill seat. The structure extends underneath both Route 326 and the Warren Mill, located on the north side of the road, eventually ending at a second spillway. This spillway, located on the north side of the mill, has concrete walls which channel the water flowing from the pond and under the road and mill to a small stream that empties into Millsboro Pond. The structure is in good condition.

According to local property owner Ralph Warren, his father, Wilford Warren, constructed a timber bridge at this site around the mid-1930s. DeIDOT currently maintains the structure. Their bridge maintenance records reveal that the current bridge has a timber frame superstructure at the end facing Betts Pond, with a standard poured reinforced concrete box culvert section added to the north side of the timber structure. The reinforced concrete portion of the structure extends under the Warren Mill and the north side of Route 326. Research at the DeIDOT archives in Dover failed to uncover any information concerning the origins of the structure, or if DeIDOT had reconstructed part of the bridge by adding the reinforced concrete section. However, highway improvement plans from 1956 describe major road improvements, involving road widening and grading improvements, to portions of Routes 326 and 82, as well as other sections of local roads within the Millsboro vicinity. This activity suggests a major DeIDOT initiative to upgrade local roads near Millsboro. It is possible that the section of Route 326 containing Bridge 526 was improved as part of some related but unrecorded project occurring within the same time period. Such a project would have required the widening of the culverts and the addition of the reinforced concrete portion to Bridge 526.

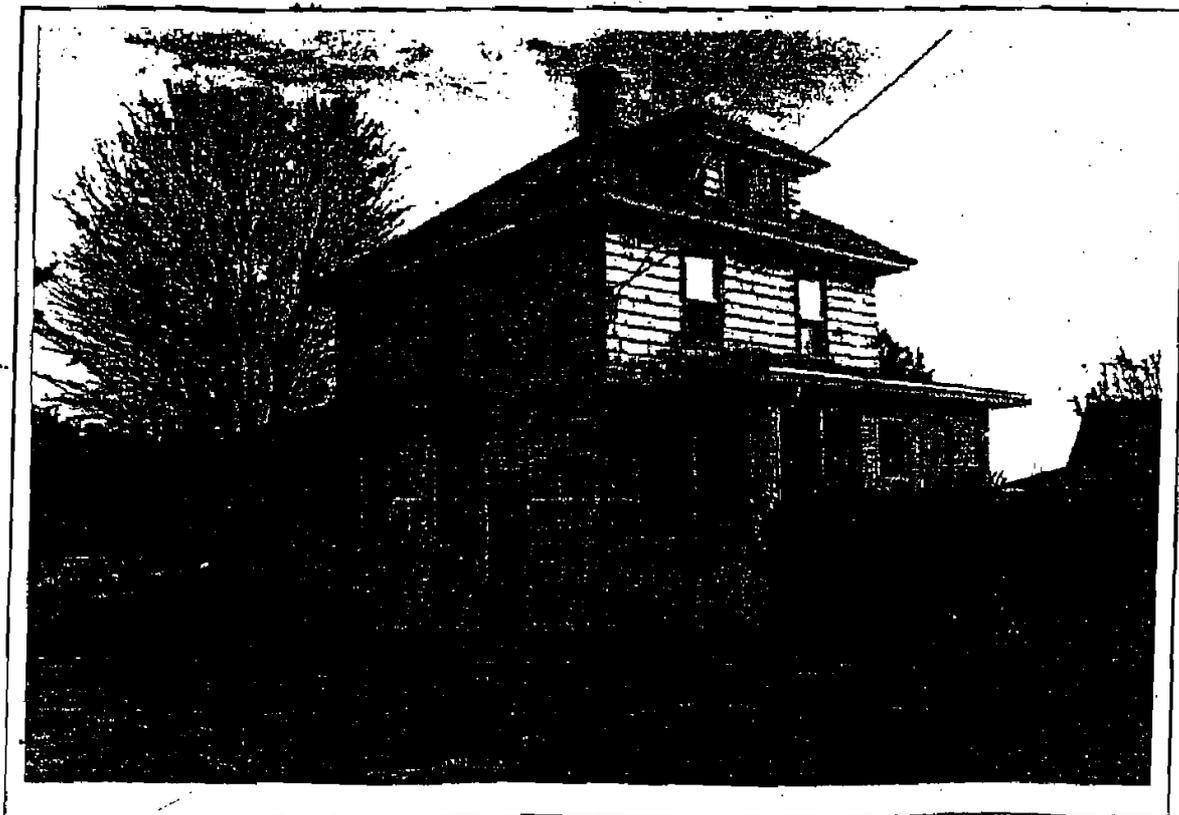
PLATE 8: C.J. Raubacher House (S-2478), South and West Elevations, Northeast View

Description: The C.J. Raubacher House, constructed circa 1918, is a 2½-story four-square dwelling with a concrete-block foundation, interior brick chimney, asbestos-shingle-clad walls, and an asphalt-shingle-clad hipped roof with boxed eaves (Plate 7). The windows are four-over-one, double-hung wood-sash units. The south (front) elevation has a hipped dormer with a four-light and a one-light wood window, and an enclosed one-story hipped porch with two-over-two, double-hung wood sash windows and a two-light wood-paneled door. The west elevation has a one-story, hipped roof bay projects and a single-leaf three-light wood-paneled door on the main block. A one-story front-gable addition projects from the north elevation. It has a concrete-block foundation, wood-paneled walls, and on its west side is a nine-light paneled wood door on a wood stoop. The house is in fair condition.

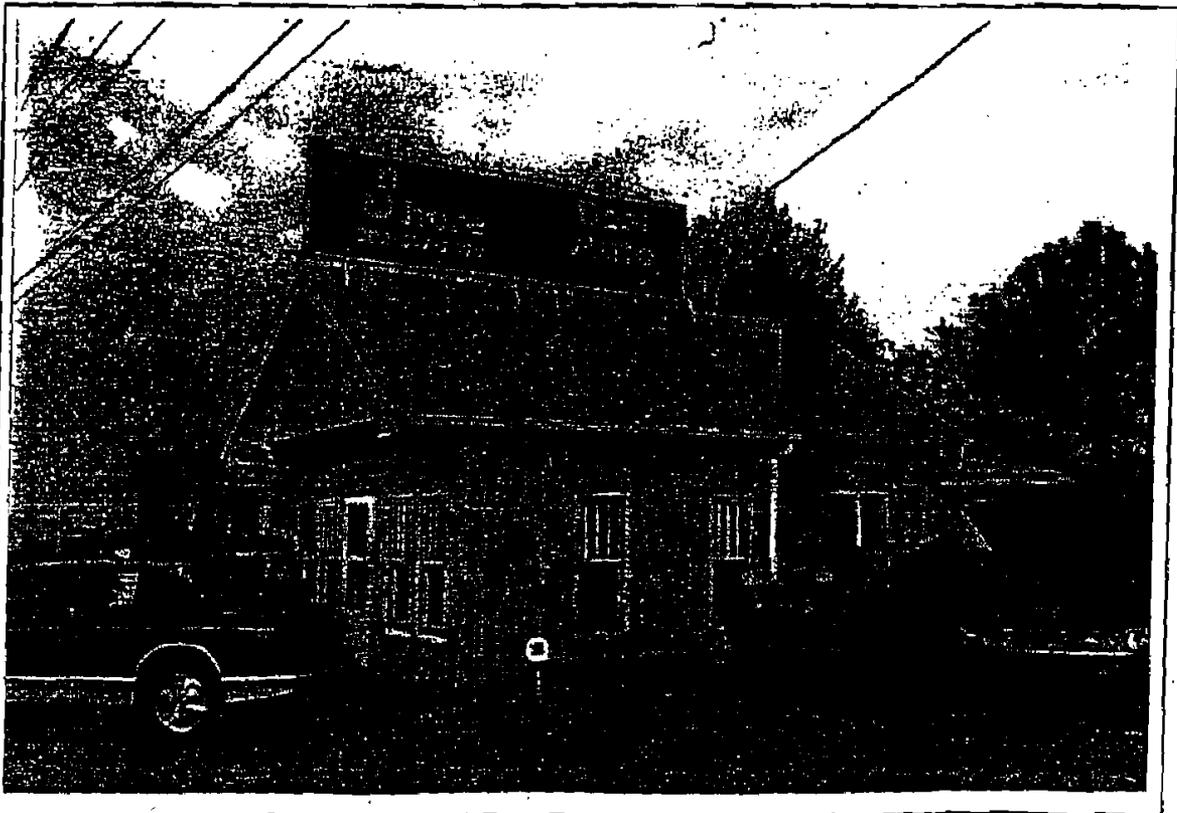
PLATE 10: Shore Deal Auto Property (S-9148), South and East Elevations, Northwest View

Description: The Shore Deal Auto Property is located on a 1.48-acre tract on the north side of Route 26 at its intersection with Route 17. The property contains one building. It is a one-story, wood-frame vernacular commercial building constructed circa 1930 which is currently used as a car dealership. Late twentieth-century vertical wood paneling conceals the foundation. The asphalt-shingle-clad, front-gable roof is slightly cantilevered over the south (front) elevation. The windows, original to the building, are four-over-one, double-hung wood sash units. The south (front) elevation has paired windows flanking a single-leaf paneled wood door. There is an exterior chimney on the east elevation, and a hipped roof bay projects from the north (rear) elevation. A wooden commercial sign has been added atop the roof. The building is in good condition.
