Archaeological Survey Report Form

- 1. Report title:** Phase I Archaeological Survey for Bridges 2-104A, 2-104B, and 2-104C, Kent County, Delaware.
- 2. Date:** 11/10/2011, Revised 3/29/2011
- 3. Author(s):** Kenneth J. Basalik, Ph.D., Philip Ruth, and Justin McKissick, David S. Clarke
- 4. Consulting firm name and address:** CHRS, Inc., 451 N. Cannon Avenue, Suite 100B, Lansdale, PA 19446, Delaware Department of Transportation
- 5. Client agency:** Delaware Department of Transportation (DeIDOT)

- 9. Dates of fieldwork:** 10/21/11 - 10/22/11
- 10. Size of area covered:** unit used: acres hectares
project area: 1.6 surveyed area: 0.5
- 11. Project description (describe location and nature of project):**
The proposed project consists of stream improvements at three bridge locations along Kenton Road in Kent County, Delaware. The three locations, Bridge 2-104A (BR2-104A), Bridge 2-104B (BR2-104B), and Bridge 2-104C (BR2-104C) were identified as areas

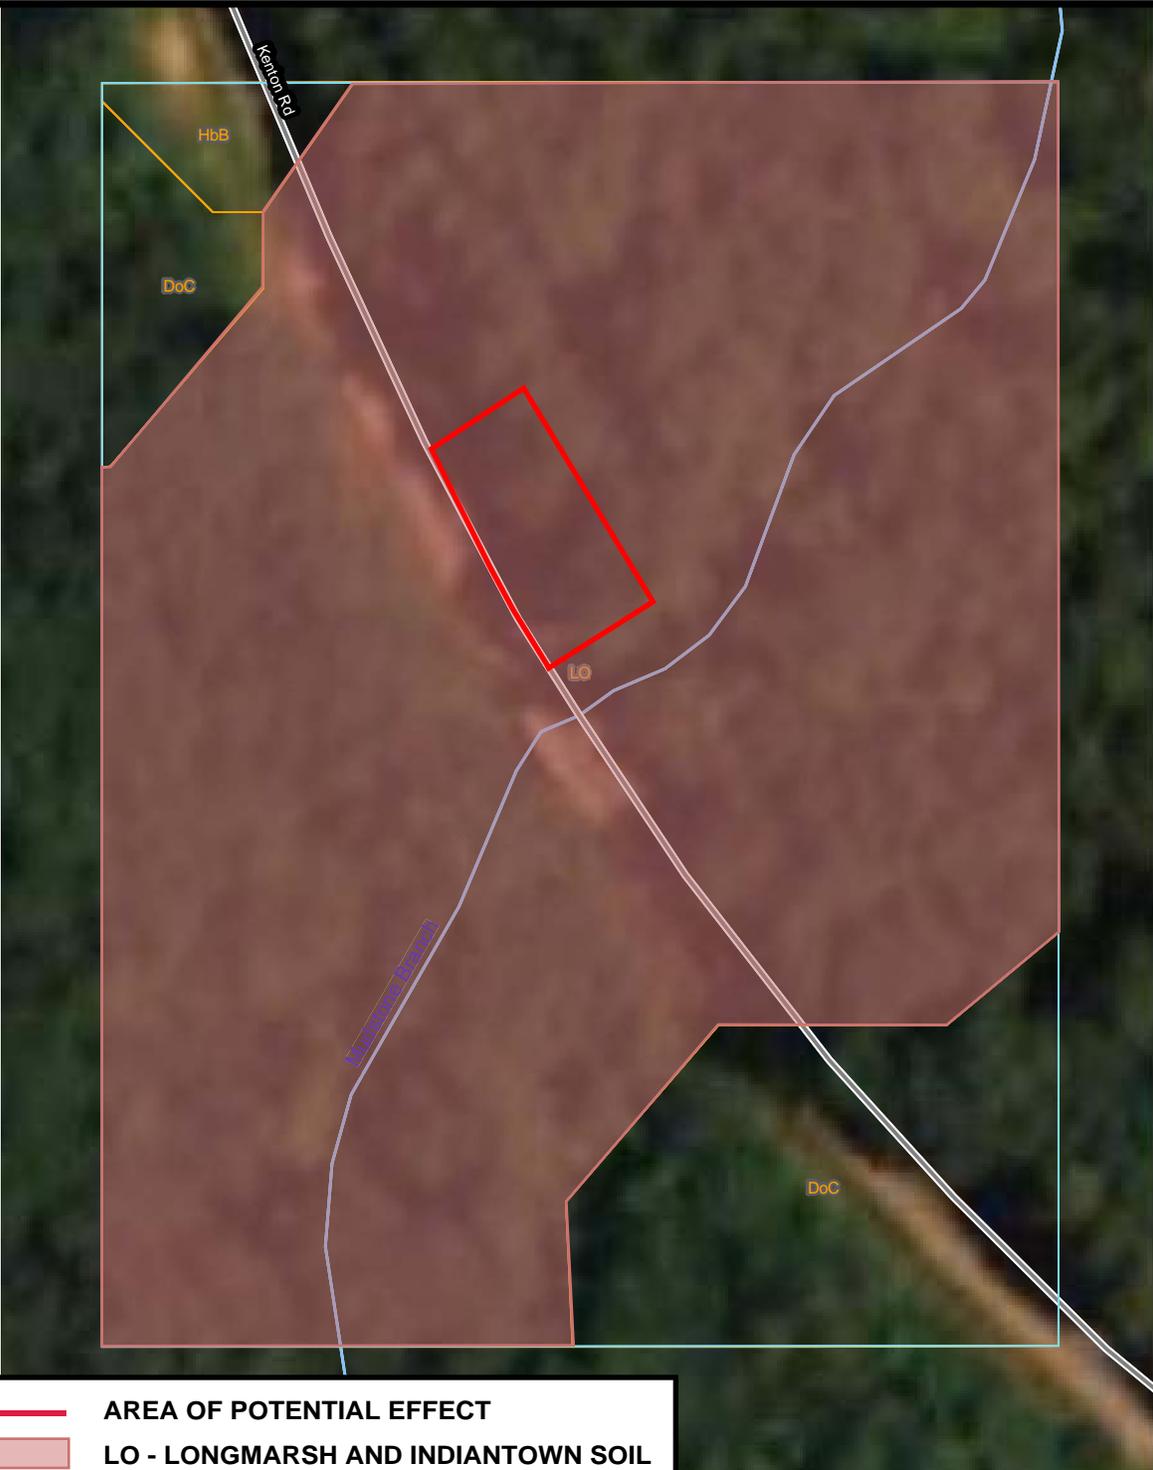
Bridge 2-104A: The APE for Bridge 2-104A is located northeast from the center of the bridge within a semi-wooded landscape (Figure 1; USGS 1993) (Photographs 1-2). The on-site soils are mapped as very poorly drained Longmarsh and Indiantown (LO) soils with slopes of 0 to 1 percent (Figure 11; NRCS 2010). The nearest natural body of water is the Cahoon Branch, which borders the APE to the south. A total of three shovel test pits were excavated in a single transect within the APE at Bridge 2-104A (Figure 12).

BRIDGE 2-104A: SOIL MAP	FIGURE 11
--------------------------------	------------------

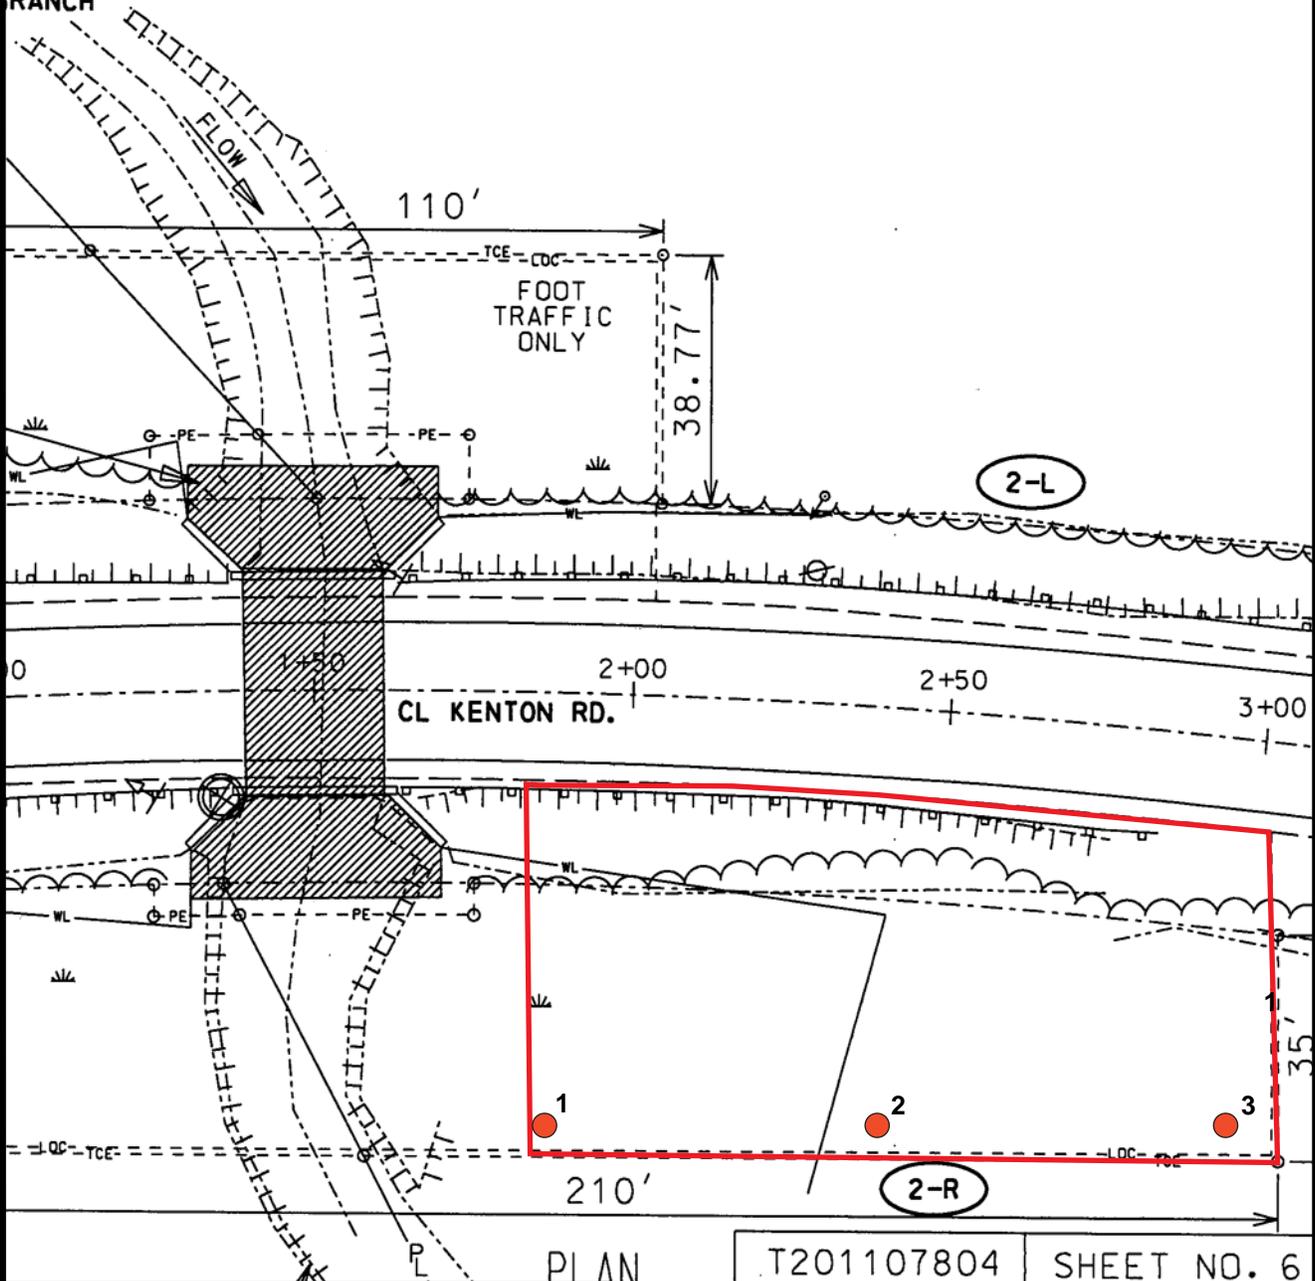
FIGURE 12

BRIDGE 2-104A: SHOVEL TEST PIT LOCATIONS

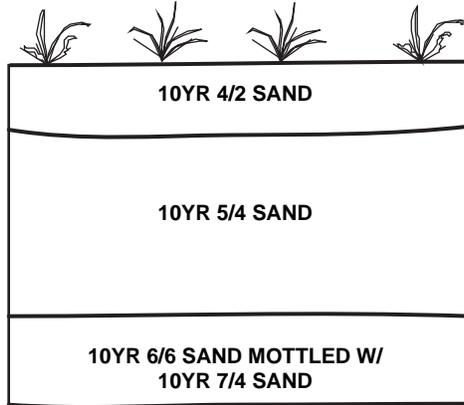
**BR2-104A
SHOVEL TEST PIT 2**

All three shovel test pits contained similar profiles, which consist of approximately 7 centimeters of dark grayish brown (10YR 4/2) sand over approximately 19 centimeters of yellowish brown (10YR 5/4) sand, all overlaid on a very compacted and mottled brownish yellow (10YR 6/6) sand with very pale brown (10YR 7/4) sand, culturally sterile subsoil (Figure 13).

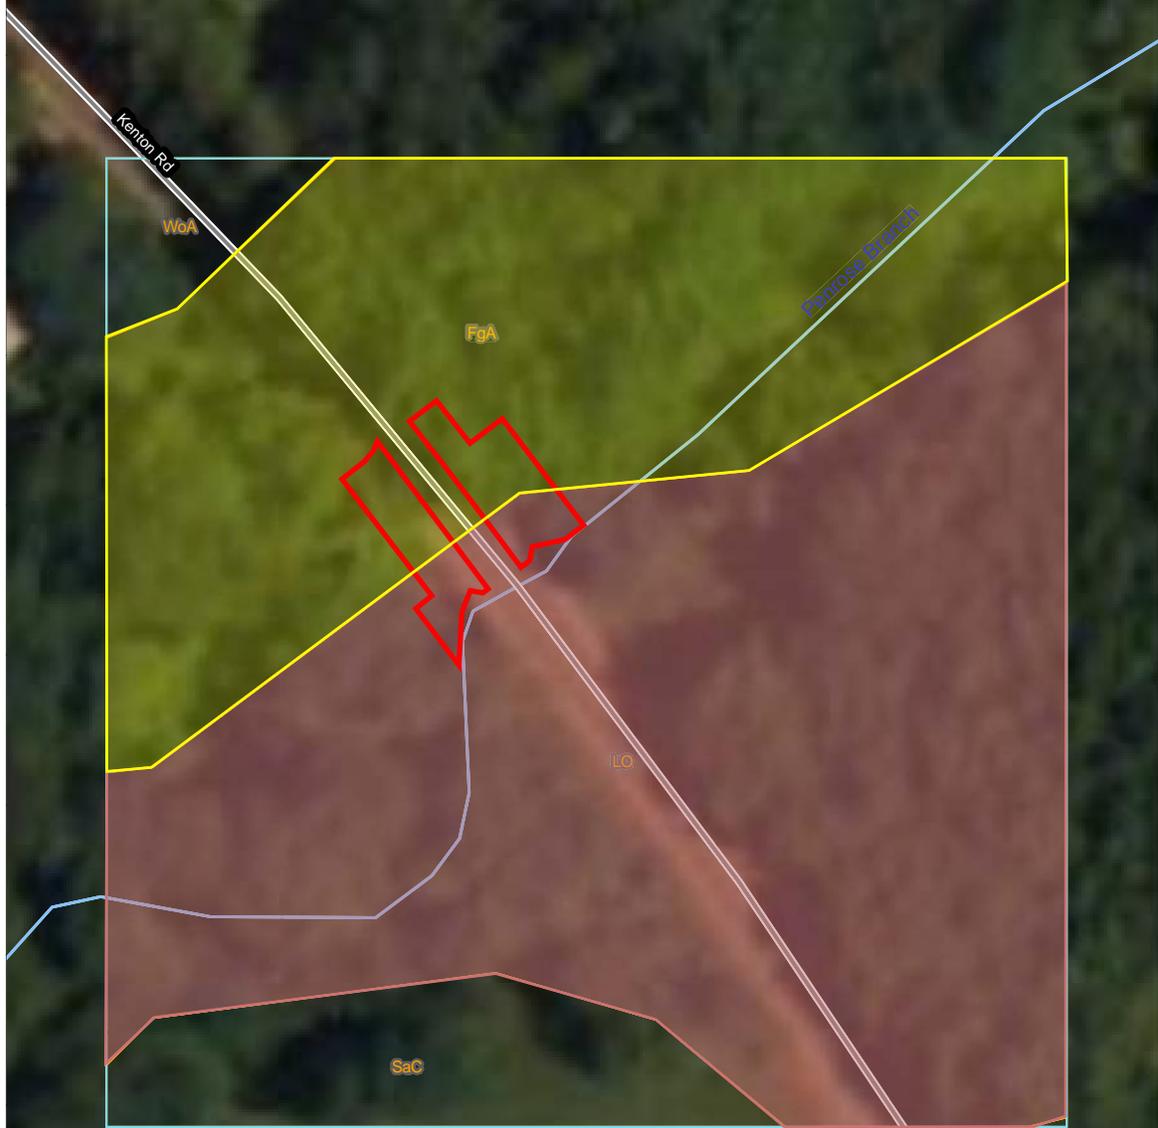
USGS 1993) (Photographs 3-6). The on-site soils are mapped as very poorly drained Longmarsh and Indiantown (LO) soils with slopes of 0 to 1 percent and poorly drained Fallsington Loam (FgA) with slopes of 0 to 2 percent (Figure 14; NRCS 2010). The nearest natural body of water is the Mudstone Branch, which borders the APE to the south. A total of nine shovel test pits were excavated in three transects within the APE at Bridge 2-104B. Shovel Test Pits 1 through 5 were excavated northeast of the bridge and STPs 6 through 9 were excavated northwest of the bridge (Figure 15).

BRIDGE 2-104B: SOIL MAP	FIGURE 14
--------------------------------	------------------

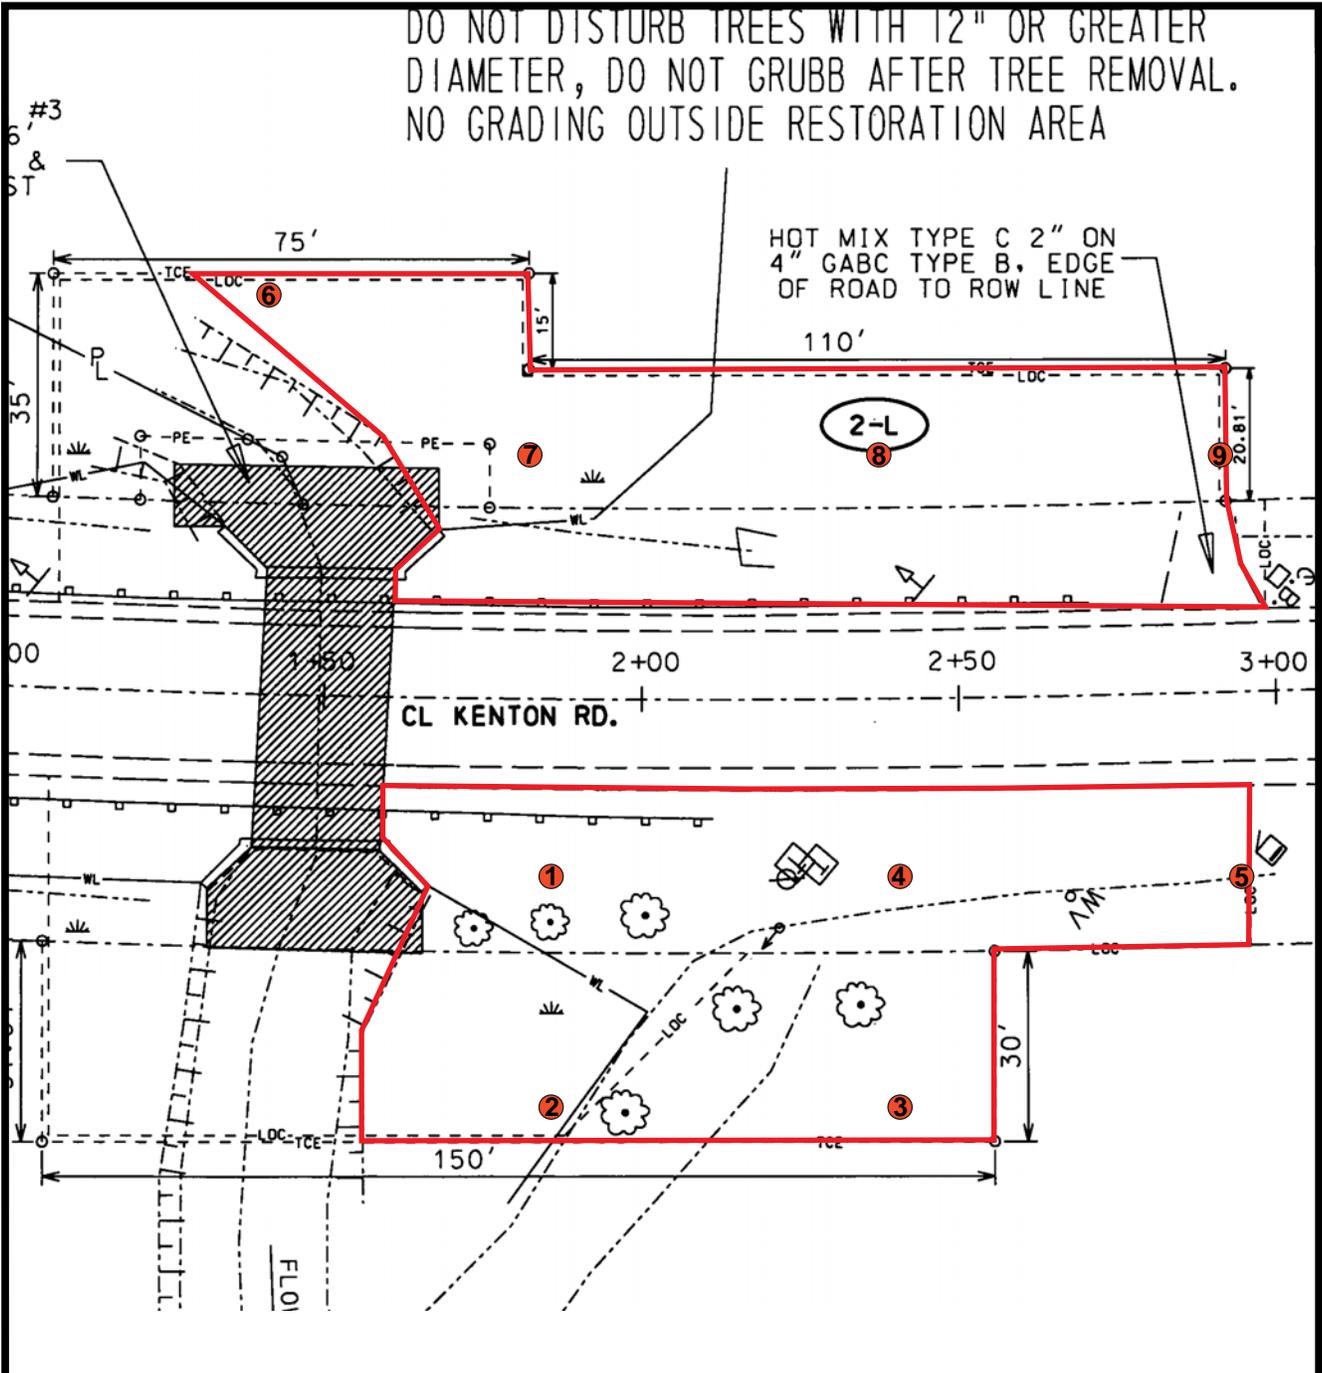
FIGURE 15

BRIDGE 2-104B: SHOVEL TEST PIT LOCATIONS

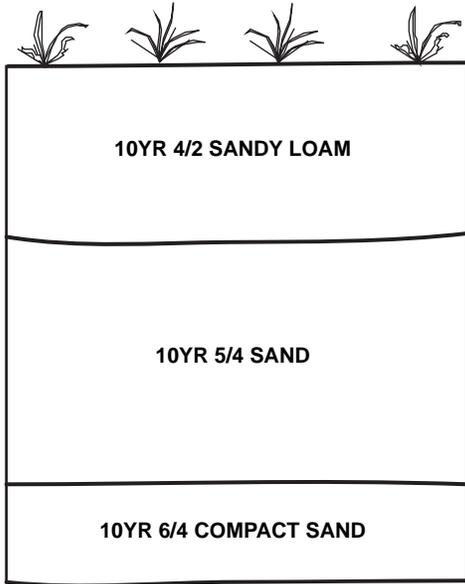
**BR2-104B
SHOVEL TEST PIT 2
16a**

Shovel Test Pits 1, 2, 6, and 9 contain similar profiles, which consist of approximately 18 centimeters of dark grayish brown (10YR 4/2) sandy loam overlaid on 26 centimeters of yellowish brown (10YR 5/4) sand, all overlaid on a light yellowish brown (10YR 6/4) compacted sand, culturally sterile subsoil (Figure 16a). Shovel Test Pits 3, 4, and 5 contain similar profiles, which consist of approximately 34 centimeters of yellowish brown (10YR 5/4) sandy loam, overlaid on 13 centimeters of dark yellowish brown (10YR 4/4) compact sandy loam, all overlaid on a yellowish brown (10YR 5/6) compact sand, culturally sterile subsoil (Figure 16b). Shovel Test Pits 7 and 8 contain similar profiles, which consist of approximately 13 centimeters of dark grayish brown (10YR 4/2) sandy loam, over approximately 11 centimeters of brown (10YR 5/3) silt clay, over approximately 18 centimeters of grayish brown (10YR 5/2) silt clay, all overlaid on a light brownish gray (10YR 6/2) sand, culturally sterile subsoil (Figure 16c).

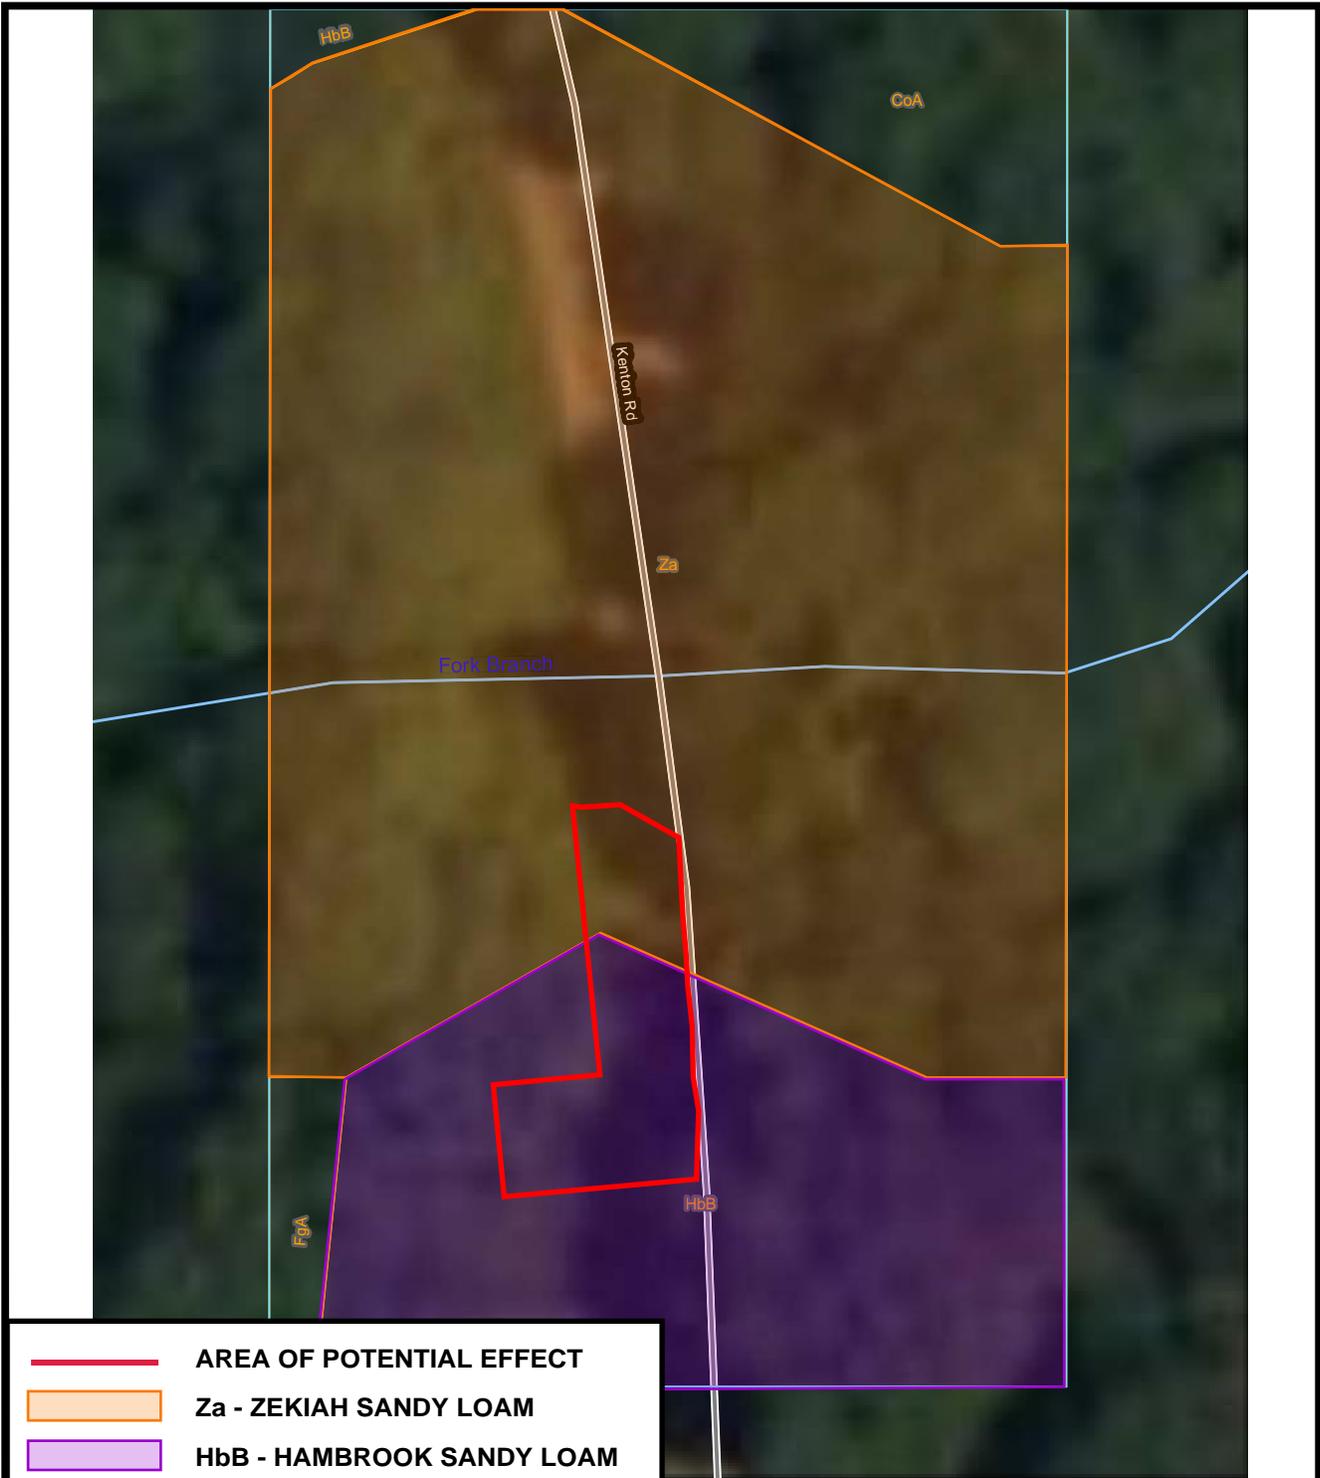
Bridge 2-104C: The APE for Bridge 2-104C is located southwest from the center of the bridge within a partially wooded landscape and agricultural field (Figure 1; USGS 1993) (Photographs 7-8). Remnants from the old roadway were noticeable within the APE (Photographs 9-10). On-site soils are mapped as well drained Zekiah Sandy Loam (Za) and well drained Hambrook Sandy Loam (HbB) with slopes of 2 to 5 percent (Figure 17; NRCS 2010). The nearest natural body of water is the Fork Branch, which borders the APE to the north. A total of six shovel test pits were excavated in two transects within the APE at Bridge 2-104C (Figure 18).

BRIDGE 2-104C: SOIL MAP	FIGURE 17
--------------------------------	------------------

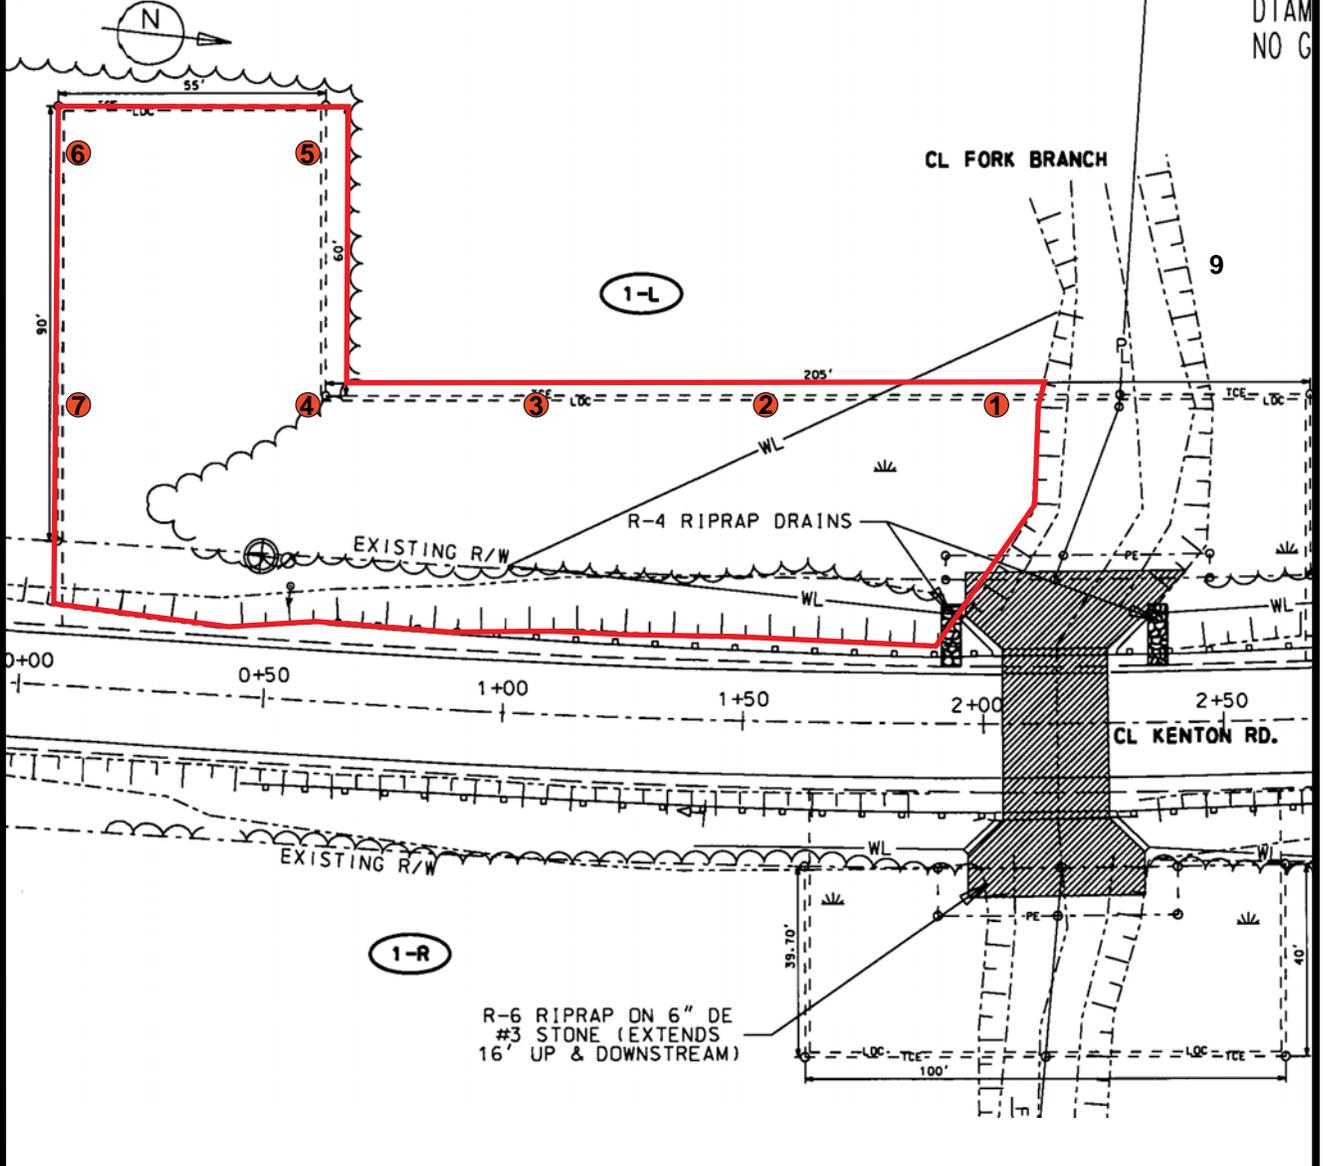
FIGURE 18

BRIDGE 2-104C: SHOVEL TEST PIT LOCATIONS

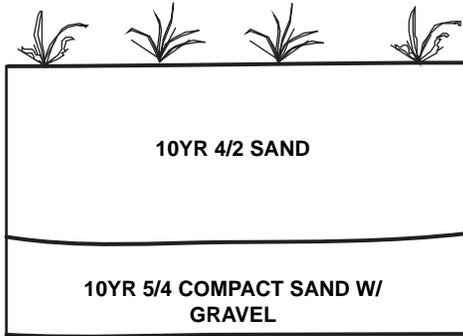
**BR2-104C
SHOVEL TEST PIT 3
19a**

Shovel Test Pits 2, 3, 4, and 7 contain similar profiles, which consist of approximately 18 centimeters of dark grayish brown (10YR 4/2) sand overlaid on a yellowish brown (10YR 5/4-5/6) compact sand with gravel, culturally sterile subsoil (Figure 19a). Shovel Test Pits 5 and 6 contain similar profiles, which consist of approximately 8 centimeters of dark grayish brown (10YR 4/2) sand, over approximately 41 centimeters of dark yellowish brown (10YR 4/4) sand, all overlaid on a brown (10YR 5/3) sand, culturally sterile subsoil (Figure 19b). Shovel Test Pit 1 contains a profile that consists of approximately 17 centimeters of very dark gray (10YR 3/1) silt loam, over approximately 37 centimeters of gray (10YR 5/1) sand, all overlaid on a black (10YR 2/1) clay, culturally sterile subsoil (Figure 19c).

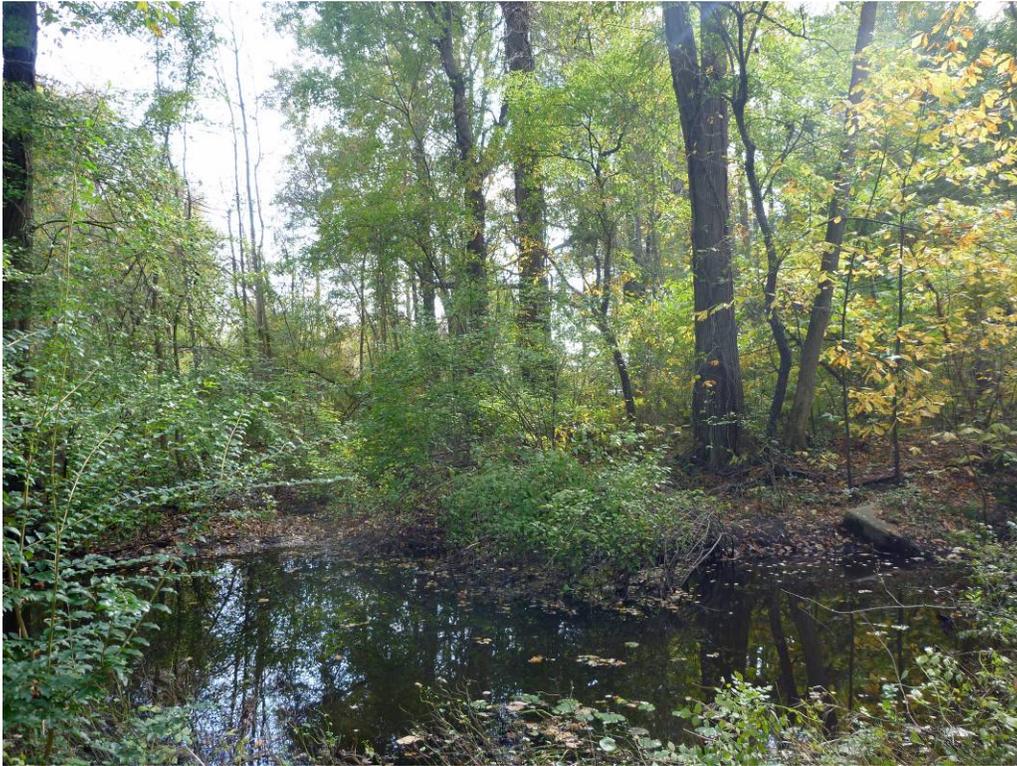
Photograph 9: Overview of the “mound,” or remnants from the original roadway within the APE at Bridge 2-104C, facing south.

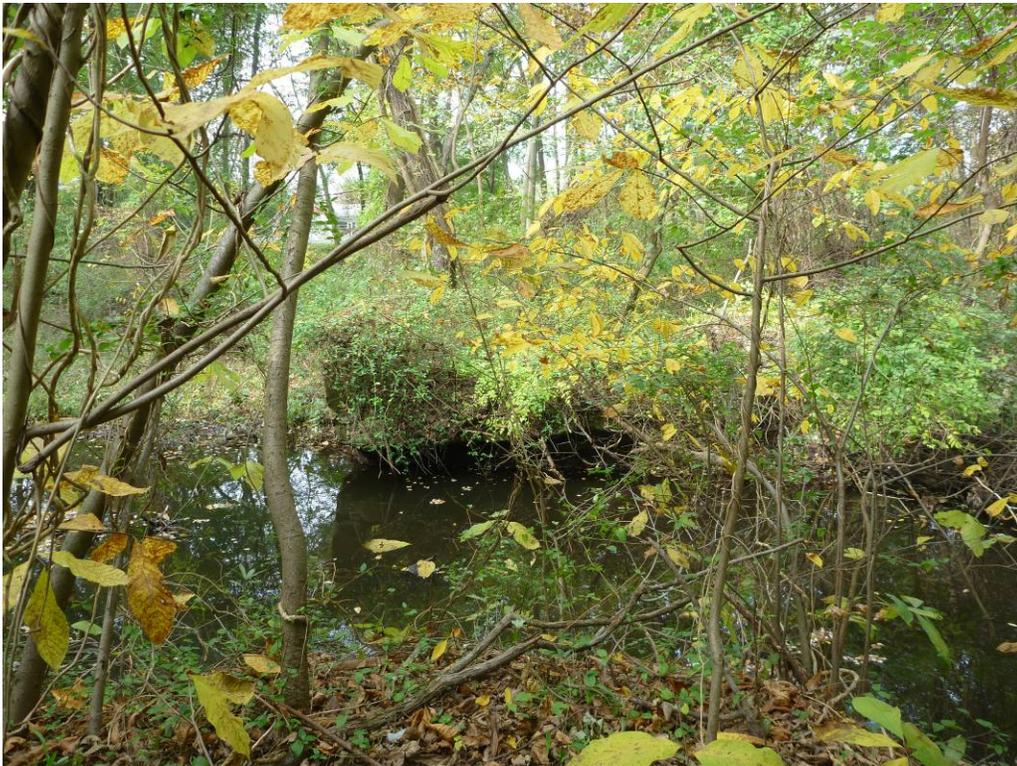
Photograph 10: Overview of the original roadway within the APE at Bridge 2-104C, facing north.
