PROJECT RESULTS

Architectural Analysis

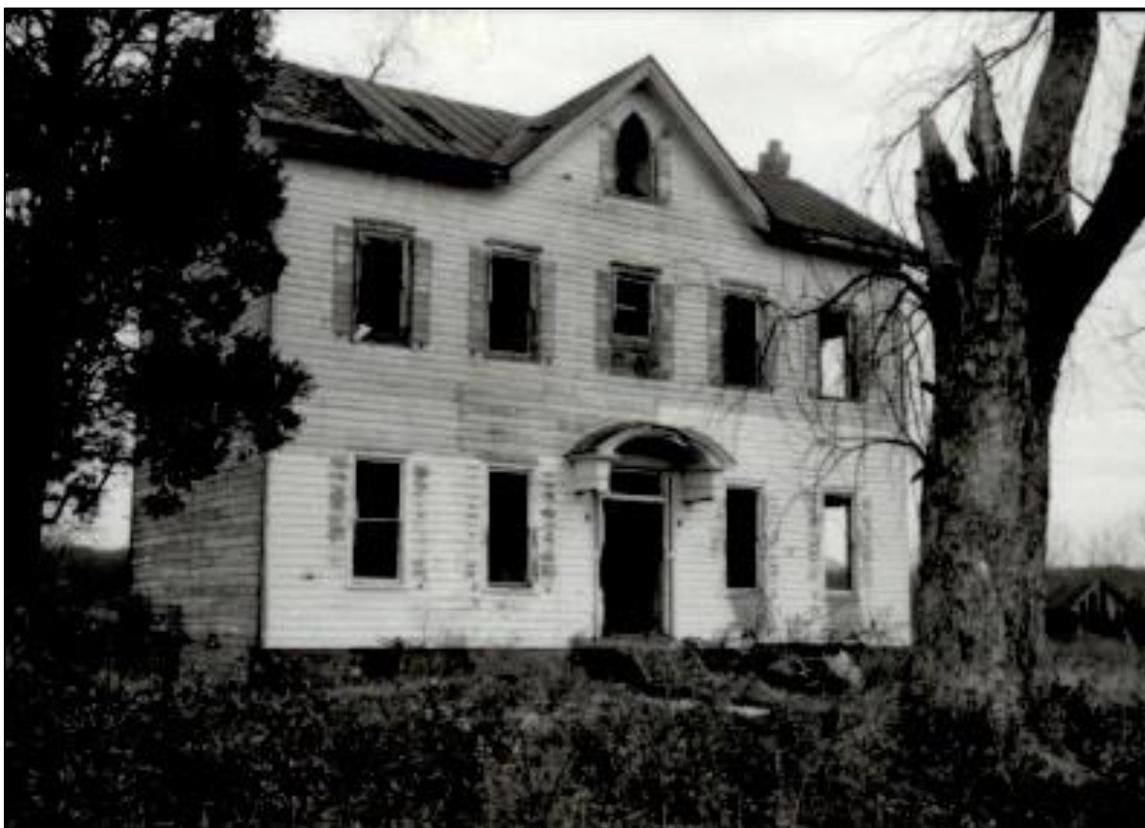
Figure 17: Burnham House in 1988, Southwest Oblique (N-5151).

Although the Burnham House was no longer extant during the current investigation, field observations, aided by a set of documentary photographs captured in 1988, helped decipher its construction chronology and building style. As originally built, the late-1860s Burnham House was a two-story, five-bay, vernacular Gothic Revival I-house with an L-shaped plan (Figure 17–Figure 20, p. 32–34). The foundation was formed of uncoursed stone rubble fastened with unlimed mud mortar, and the timber frame was clad in weatherboard.

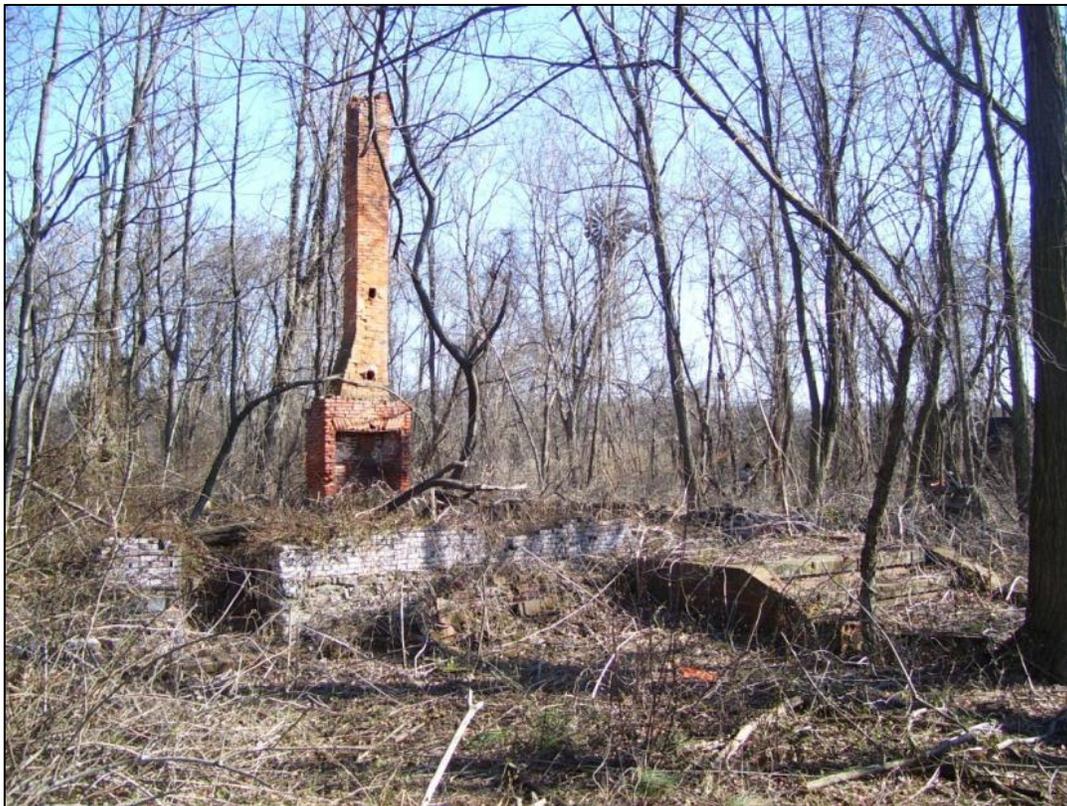
Figure 18: Overview of the Burnham House Today, facing Northeast.

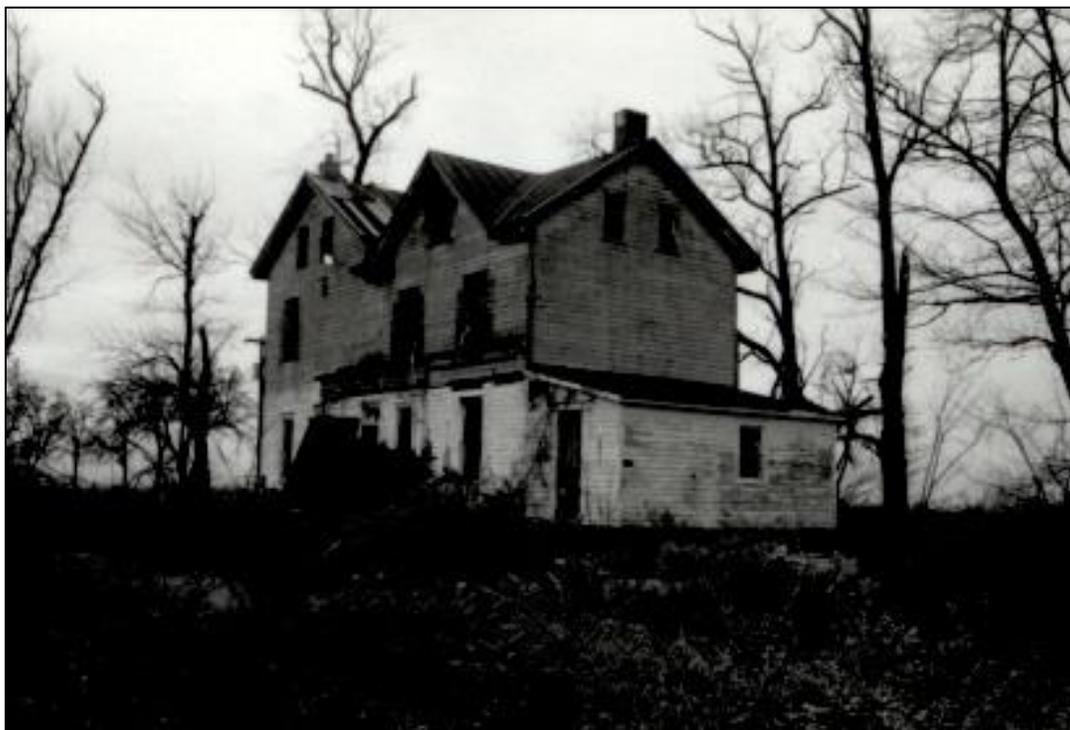
Figure 19: Northeast Oblique of the Burnham House in 1988 (N-5151).

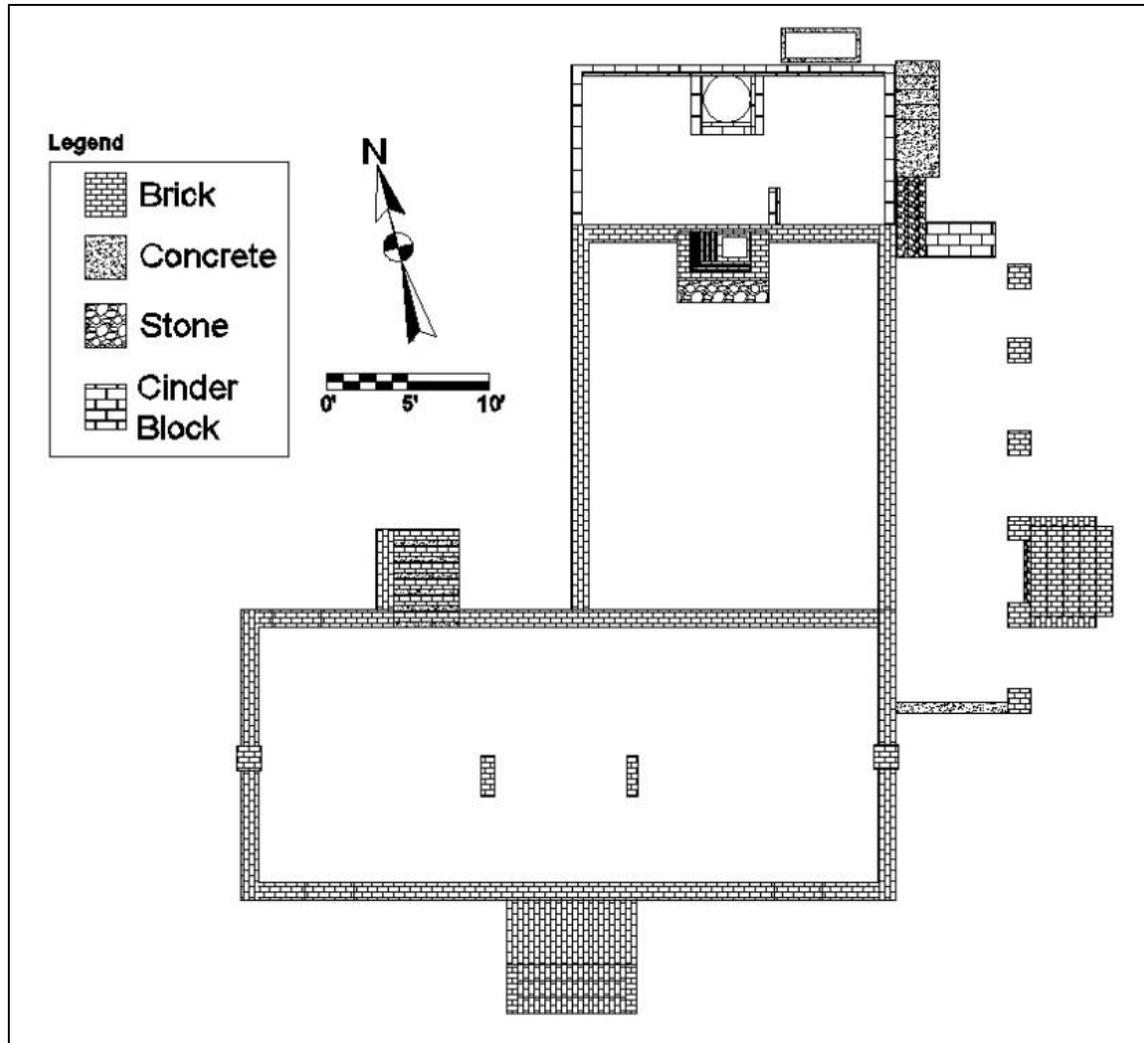
Figure 20: Detail Measured Drawing of the Burnham House.

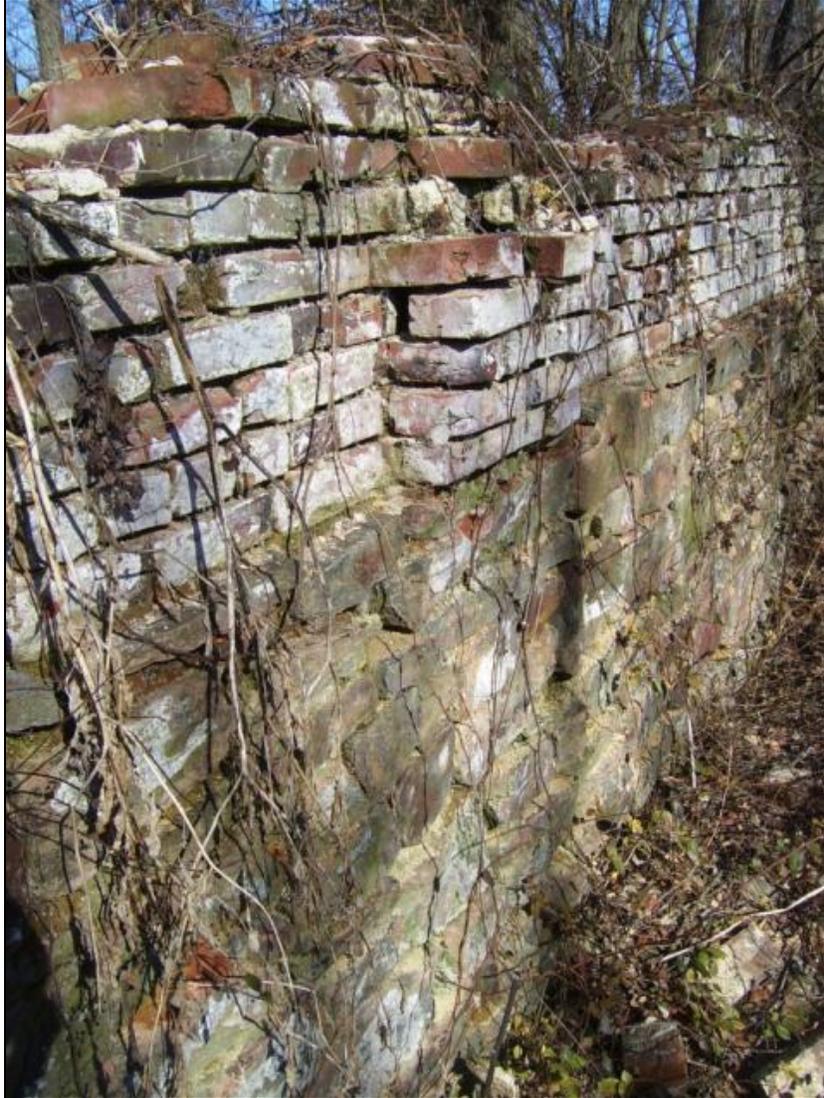
Figure 21: Wall Detail Showing Brick Transition over Stone Foundation.

One of the most interesting features of the house was the brick transition noted on top of the foundation that provided an anchor for the timber frame above. The existing transition is formed of early-twentieth century, machine-pressed bricks fastened with Portland cement (Figure 21, p. 35). Each elevation is laid in a different brick bond (3:1, 5:1, and 7:1 common bond); all three bonds are intermixed on the north elevation alone. Given the late-1860s construction date of the main house and the presence of low-fired, hand-made brick elsewhere in the structural composition, it is thought that the transition was originally formed of hand-made brick. With the extreme porosity of the brick material (as evidenced on the extant hand-made brick chimney in the kitchen ell) and overall softness of the brick body, it appears that the original brick foundation-to-superstructure transition failed and was replaced piecemeal in the early-twentieth century. This clarifies the use of multiple brick bonds, as the transition was knocked out section by section and replaced, thus avoiding the need to lift the entire home to replace this structural feature.

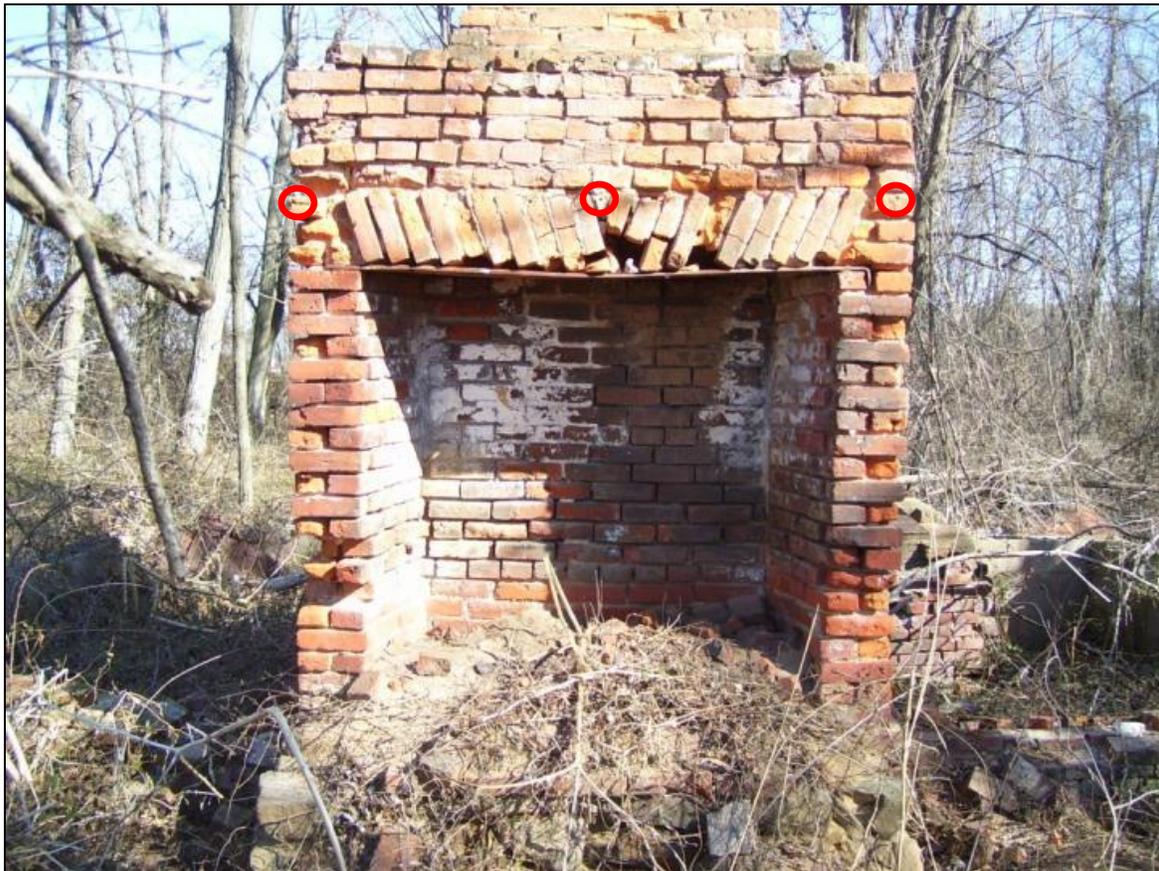
Figure 22: Detail of Kitchen Chimney, Looking North.
Mantle putt-holes circled in red.

The two-story kitchen ell on the rear (north) of the home was constructed at the same time as the original massing, in the late 1860s. The foundation, brick transition, structural system and roofing are all composed of the same materials as the main section of the house. One notable difference is the retention of the original hand-made brick used to construct the large kitchen firebox and chimney. Although recently deteriorated due to two decades of exposure to elements, the chimney still retains numerous clues on the interior decoration of this space, such as the use of mud plaster with a lime-based finishing coat covered in whitewash on the walls, and the presence of a no-longer-extant wooden mantle over the jack-arched firebox (evidenced by putt-holes in the brick and central keystone) (Figure 22). Subsequent additions to the main house included a one-story sleeping porch along the east elevation and a one-story, shed-roofed cinderblock addition on the north side of the kitchen ell.

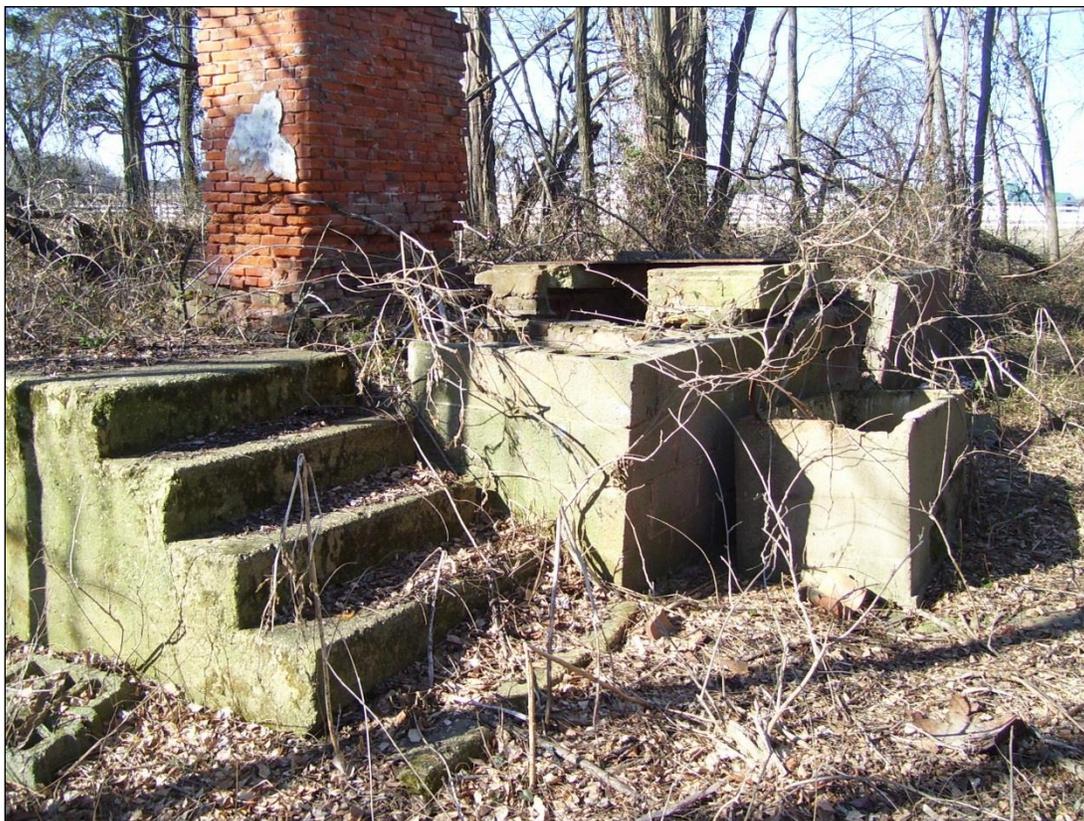
Figure 23: Rear Cinderblock Addition.

vernacular Gothic Revival style. It underwent two subsequent large-scale modifications. One set of changes occurred in the early-twentieth century, when the sleeping porch was appended to the east elevation, and the brick transition between the stone foundation and timber frame structural system was replaced. It is probable that the Craftsman/Colonial Revival primary entry hood was also added at this time. The second set of changes was completed in the mid-twentieth century when the rear cinderblock addition was attached to the kitchen, and the steps leading to both the main doorway and the east entry were rebuilt (Figure 23). The entire building was demolished by fire sometime after 1992.

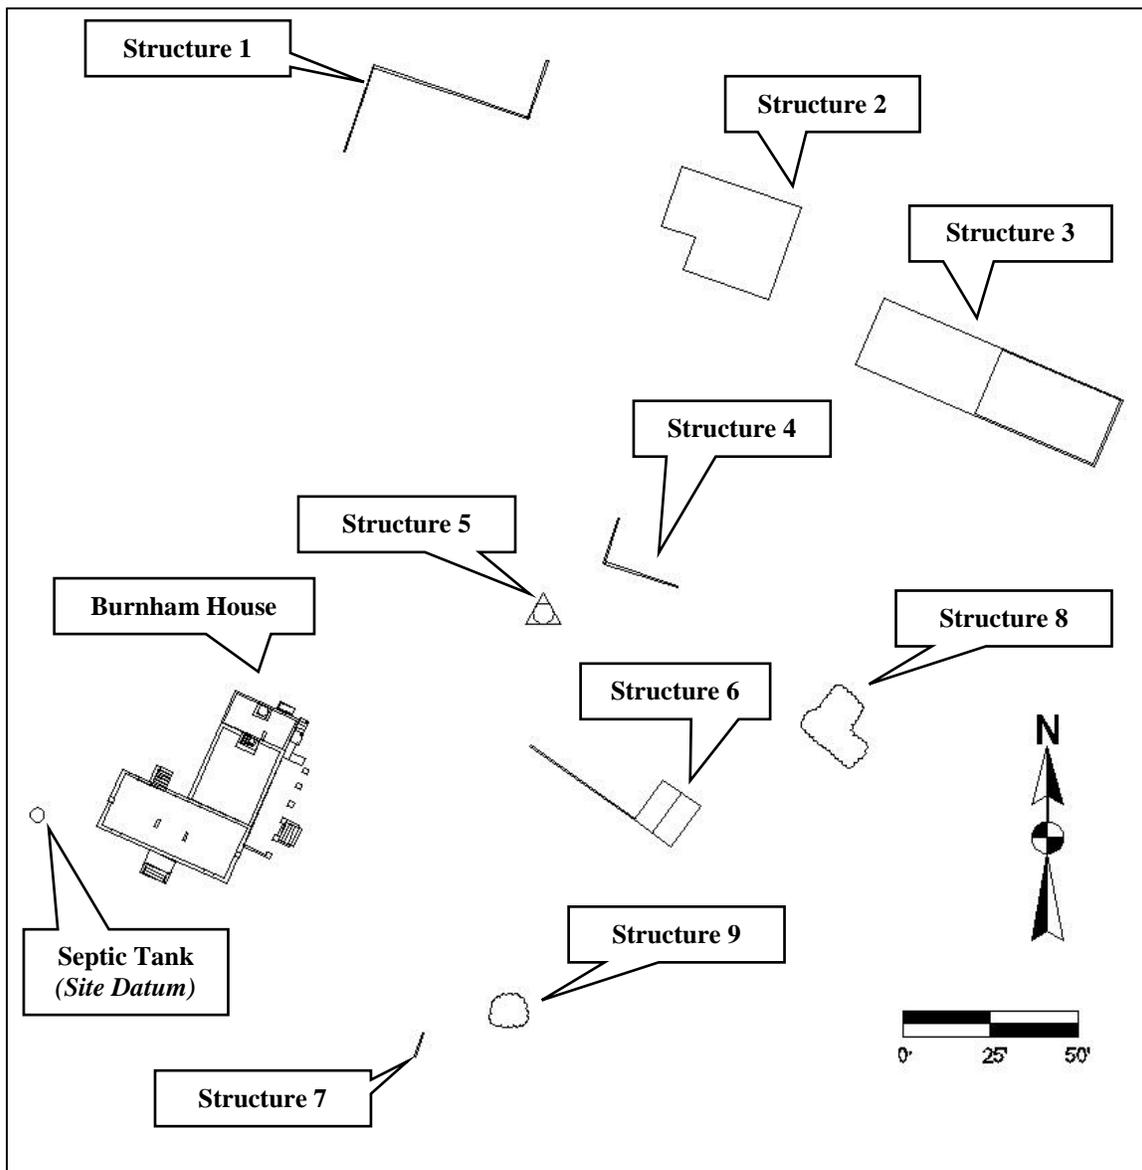
Figure 24: Burnham House Site (7NC-F-157) Plan Map.

The house has one possible associated structure, and eight known associated structures. These remains were given sequential structure numbers as reflected on the site plan map (Figure 24, p. 38). [Note: They were labeled as “structures” and not “buildings” because their use was not known, i.e., barn, shed, animal pen, work platform, etc).

The Dovetail architectural analysis resulted in the identification of nine buildings/structures across the property in addition to the Burnham House ruins (see Figure 24, p. 38). The results of the architectural investigation directly shaped the Phase II testing strategy, as most of the test units were placed adjacent to identified above-ground resources or in areas where additional architectural remains were identified below the ground surface (Figure 32, p. 45).

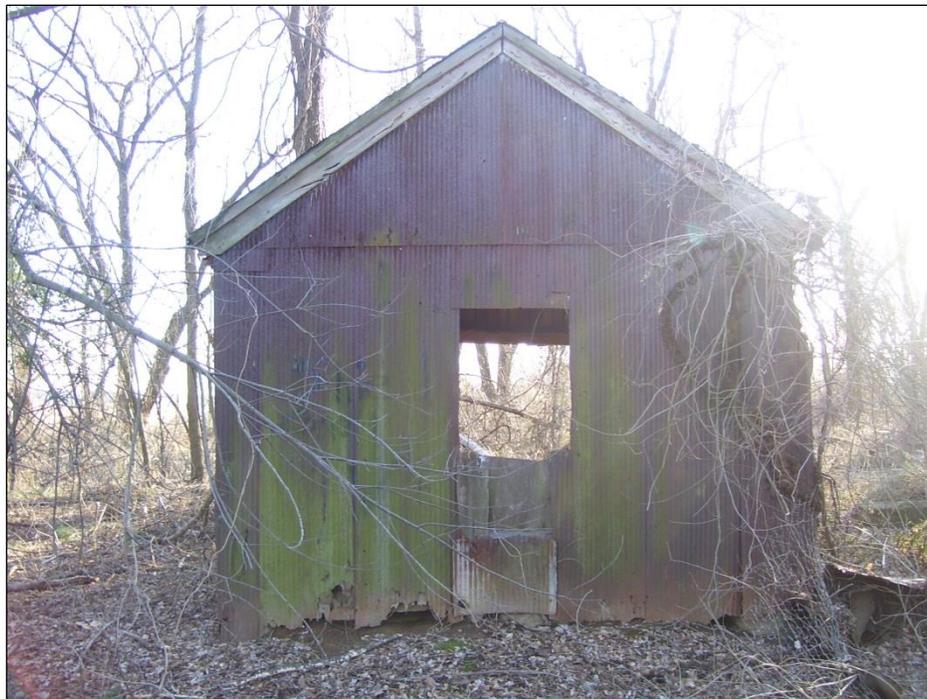
Figure 25: Standing Shed, Structure 6.

The possible structure visible in mid-twentieth century aerial views now consists of a push pile. The eight known structures represent several construction methods, although the usage for many remains a mystery. Of the structures, two consist of a stone and mortar foundation, three consist solely of a poured concrete foundation, one consists of both concrete block and poured concrete foundation, one is a windmill, and one is a shed which is still standing (Figure 25, p. 39). The windmill (Structure 5), constructed of

The shed (Structure 6) is timber-framed, constructed mostly of hand-hewn beams joined through mortise, tenon, and peg technology. The front-gable roof and sides are clad with corrugated tin siding and rest atop a stone pier foundation. A central entryway with opposing window opening is located on the gable sides. Within the shed are multiple cut-outs in the upper gable sides, possibly the location of past beams used for the drying of various materials. Extending approximately 40 feet (12.2 m) west of the shed is a poured concrete retaining wall. The wall has collapsed in parts, but appears to have been used as an animal pen, given the presence of fencing throughout the area.

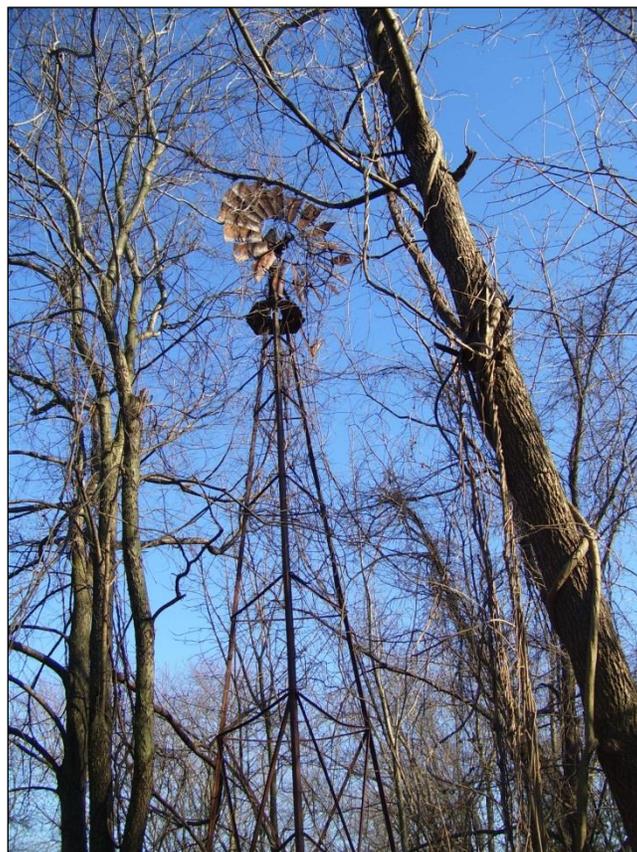
Figure 26: Standing Windmill, Structure 5.

Structure 5 is the windmill and associated well noted by A.D. Marble (Baublitz et al. 2006) in their Phase IA report. The windmill stands 45 feet (13.72 m) tall. A machine-made brick-lined well lies adjacent to Structure 5. No test units were excavated at this location because the primary goals of this Phase II investigation were to identify the location/extent, function, and temporal affiliation of the site components. Given the above-ground materials and construction methods observed, Dovetail concluded that no subsurface investigation was warranted.

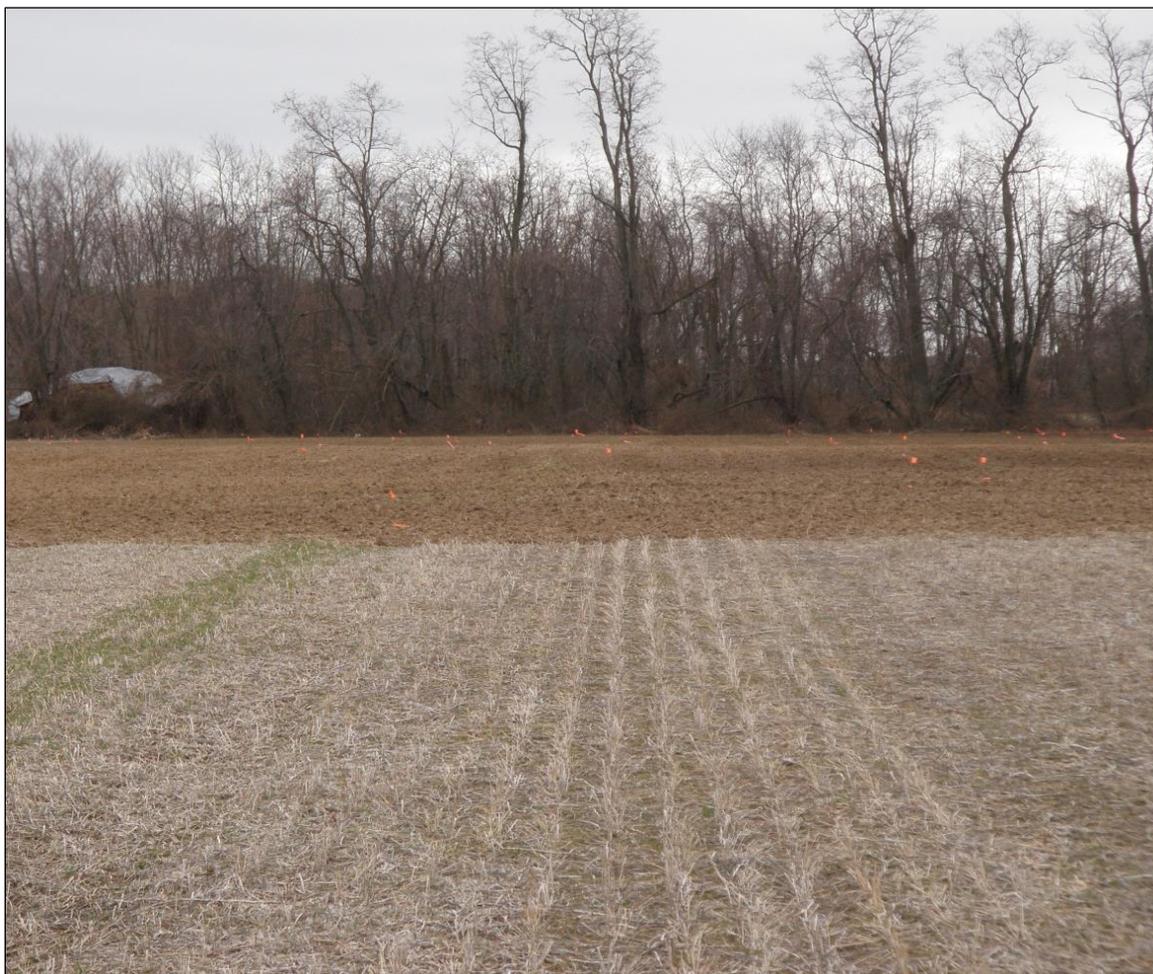
Figure 27: Phase I Survey Area with Pin Flags Marking Surface Finds.

In support of the site size determination goal previously outlined as well as to more conclusively define site boundaries, Phase I investigations were conducted adjacent to the known Burnham House location (Figure 27). Survey occurred along the 5.6-acre (2.3-ha) area located north and south of the main site nucleus as depicted on the project maps (see Figure 6 and Figure 7, pp. 7–8). The northern and southern areas were delineated in a proposed meeting with DelDOT and the DE SHPO based on the limitation of project construction and natural landscape features. The northern survey area is bounded on the east, north, and west by the limits of construction and to the south by a tree line (Figure 28 and Figure 29, p. 42). The southern survey area was bounded by construction limits on the east, south, and west and by a tree line to the north (see Figure 6, p. 7).

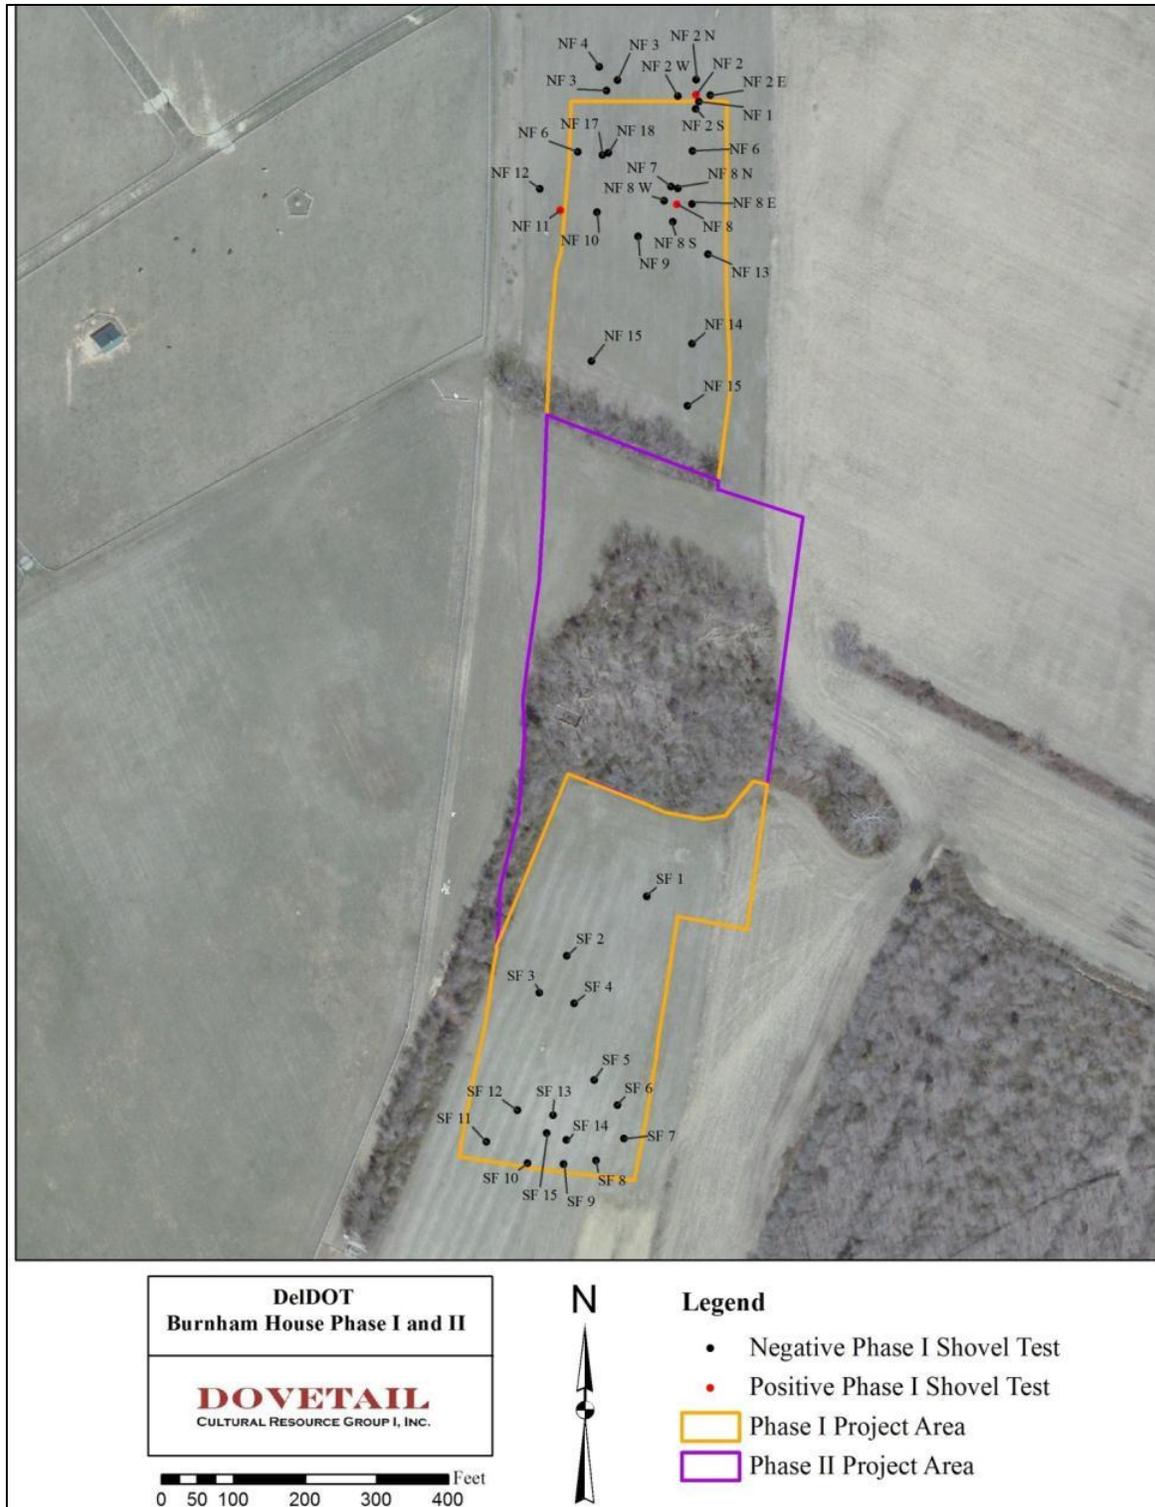
Figure 29: Phase I Shovel Testing Locations (SF=South Field, NF=North Field).

Phase I shovel testing was conducted in areas where clusters of artifacts were found and areas where notable artifacts were recovered (see Figure 29, p. 42). This testing revealed the presence of both modern and historic plow zones. The modern plow zone extended to an average depth of 11.5 inches (29.2 cm) and a maximum depth of 15 inches (38.1 cm). It was characterized as a brown silty loam (10YR 4/3). Beneath the modern plow zone was a truncated historic plow zone that ranged from 4 to 6 inches (10.2 to 15.2 cm) in thickness. It was classified as a dark yellowish brown (10YR 4/4) silty loam. This historic plow zone overlay a culturally sterile yellowish brown (10YR 5/6) sandy clay subsoil. Shovel tests overall depth averaged 16.9 inches (42.9 cm), with the deepest being 20 inches (50.8 cm) (Figure 30). Given the low density of artifacts recovered across a large area, the decision was made in consultation with DelDOT and the DE SHPO not to excavate test units in the Phase I project area.

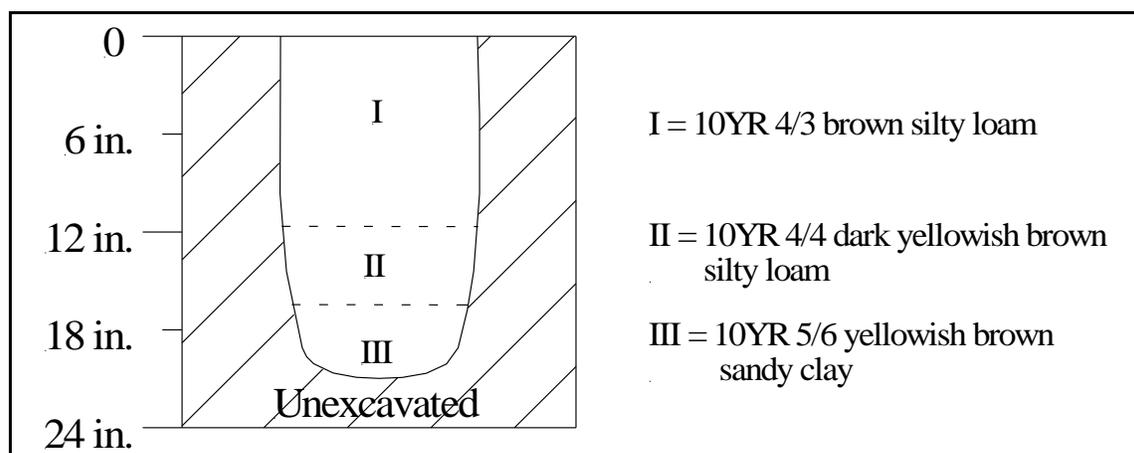
Figure 30: Representative Profile for Phase I Shovel Tests.

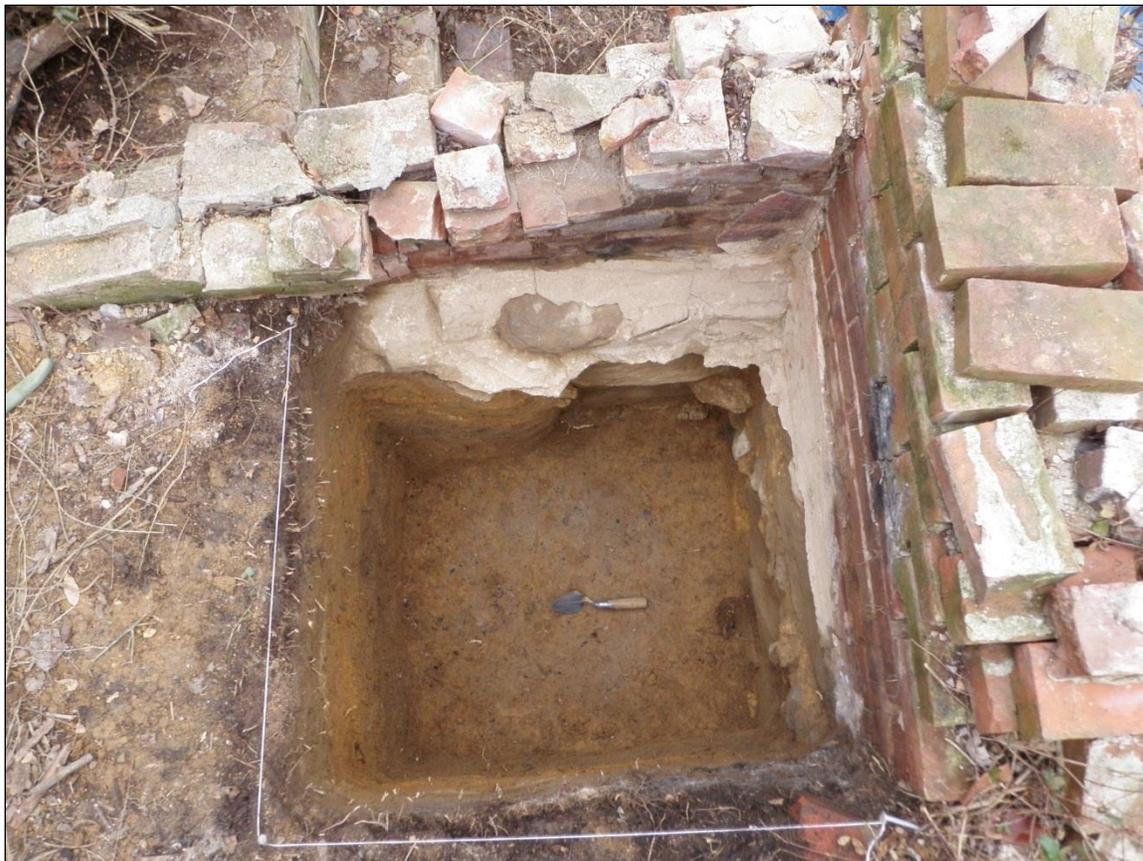
Figure 32: Test Unit 3 Laid into the Corner of the Burnham House Foundation.

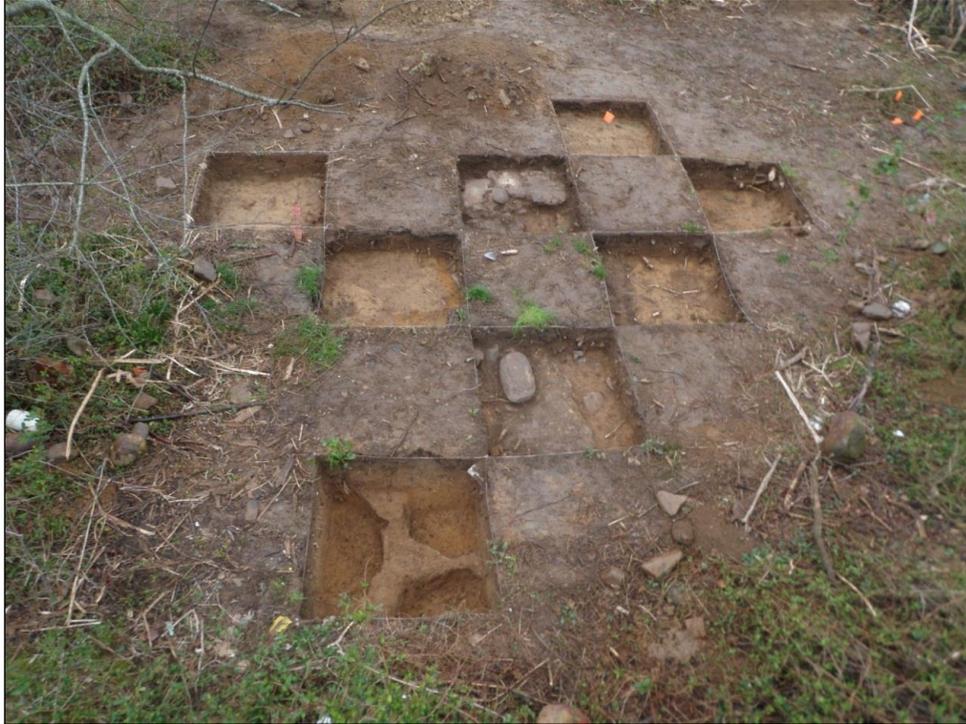
Figure 34: Checkerboard Pattern of Test Units Allowed for a More Nuanced Investigation of Soils at the Burnham House Site.

Close-interval shovel testing resulted in the excavation of 233 shovel tests across the entire Phase II project area; of these, 85 were positive for cultural material (Figure 33, p. 46). All artifacts recovered during this testing were historic remains. Shovel test stratigraphy within the boundaries of the Phase II area was highly variable ranging from 6 inches (15.2 cm) to 36 inches (91.4 cm) in depth. These shovel tests, which contained as few as two layers to as many as four layers, indicated the amount of disturbance that had taken place within the core area of the Burnham House site. Therefore, rather than addressing the varied stratigraphic profiles of the shovel tests in this section, site stratigraphy is addressed with regard to the test unit excavations. (The test units allowed for better interpretations of stratigraphy and soil disturbance due to their larger size and spatial distribution across the site and should be seen as more reliable in this regard concerning soil formation at the Burnham House site) (Figure 34, p. 47).

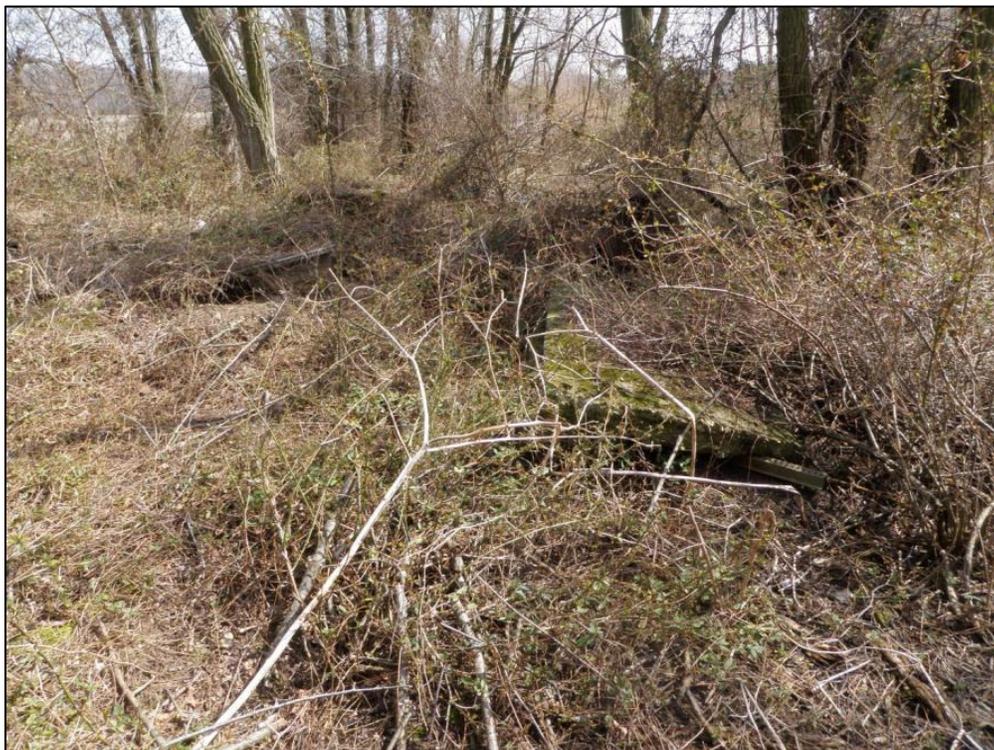
Figure 35: Push Pile Disturbance Common Across the Site, Facing Northeast.

Also noted during close-interval shovel testing was extensive surface disturbance in the form of push piles created by heavy machinery as well as widespread historic and modern dumping (Figure 35, p. 47). Multiple shovels test, especially those adjacent to these push piles or dumps, showed evidence of subsurface stratigraphic disturbance as manifested by truncated or absent A-horizons, mottled clay-rich fill strata, and the presence of subsoil

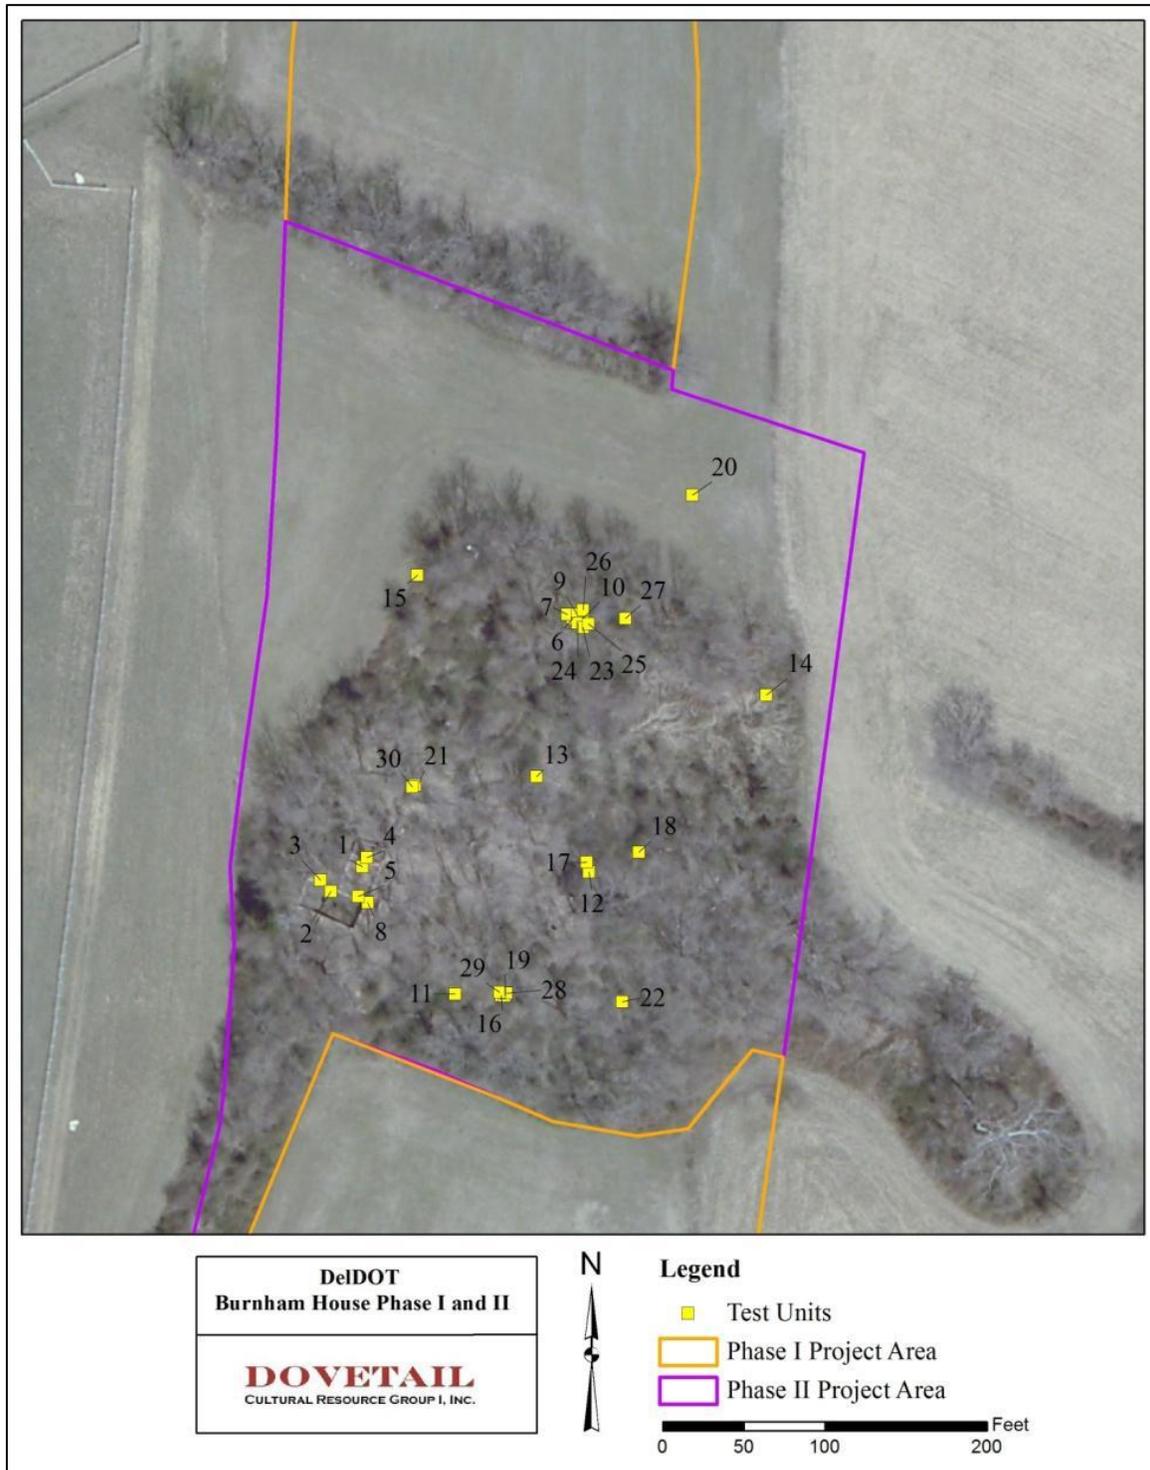
Figure 36: Phase II Test Unit Location Map.

It was anticipated that up to 40 test units would be excavated across the Phase I and Phase II project areas. Yet, as previously described, the lack of concentrated artifacts identified during the Phase I examination obviated test unit excavation in these areas. As such, during the field consultation meeting on March 7, 2011 with DelDOT, it was decided that 30 test units would be sufficient to fully examine and evaluate the Burnham House site, with all units being concentrated in the Phase II project area (Figure 36, p. 49).

Test units excavated around the main house revealed a great deal about construction methods, as well as the general site and depositional history. All the test units excavated at the main house (Units 1–5 and 8 shown in Figure 36, p. 49) showed evidence for the burning of the house. Based on aerial photography, the house burned between 1992 and 1997 (Division of Historical & Cultural Affairs, CHRIS 2011). Evidence for this burning episode was manifested by 1–2 feet (30.5–60.9 cm) of burn fill in all the test units within and adjacent to the house (Figure 38, p. 50). This stratum contained a mixture of burned modern and historic debris. It was removed in 4-inch (10.1-cm) arbitrary levels and screened for cultural materials in Test Units 1–4, but removed as a single unscreened stratum in Units 5 and 8. The decision to not screen this burn/disturbance stratum was made in consultation with DelDOT on March 7, 2011. This decision was based on the redundancy of artifacts from this context as well as the questionable integrity of this excavation stratum.

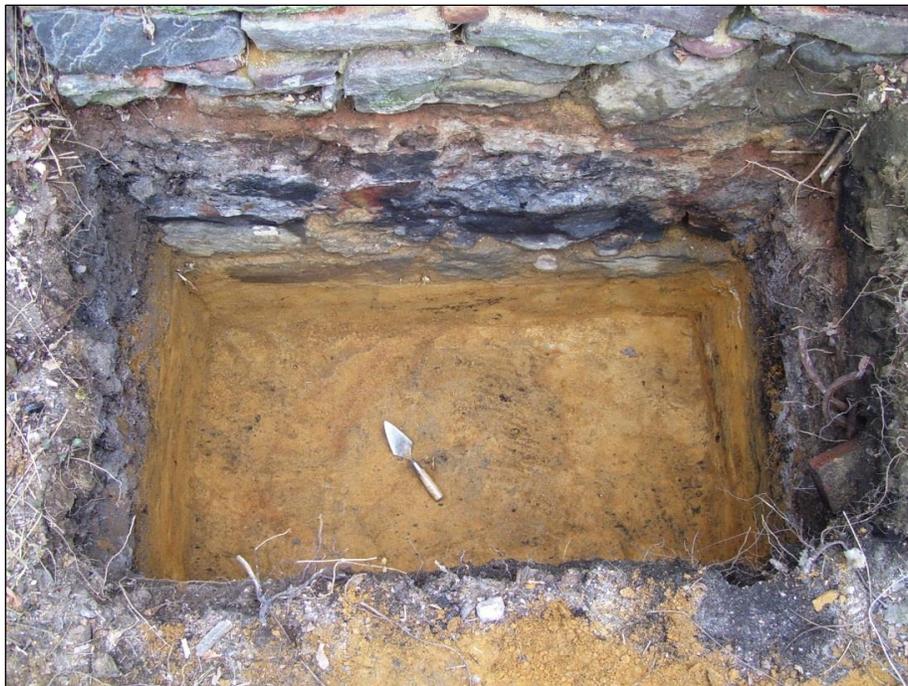
Figure 37: Test Unit 2 Abutting Foundation Remains.

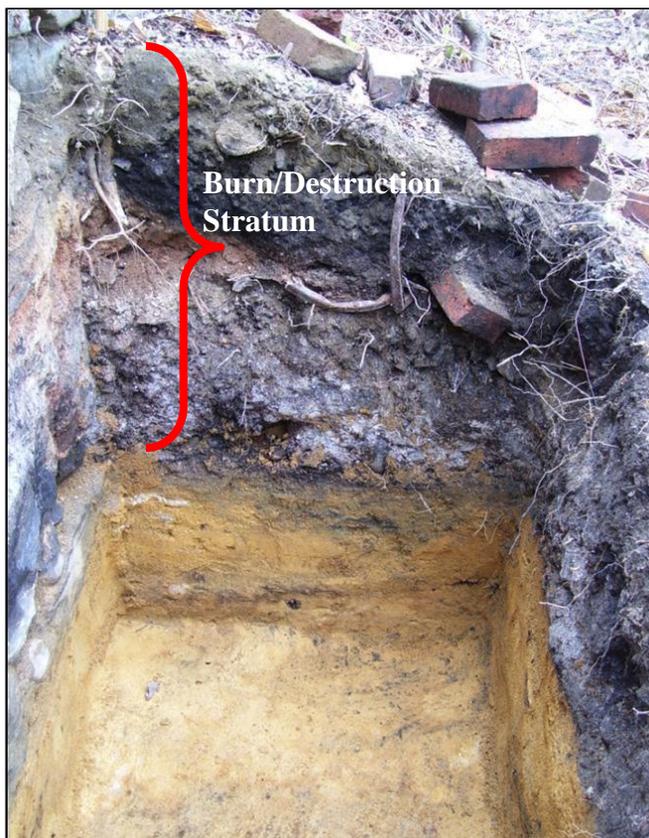
Figure 38: East Profile of Test Unit 2, Note the burn stratum.

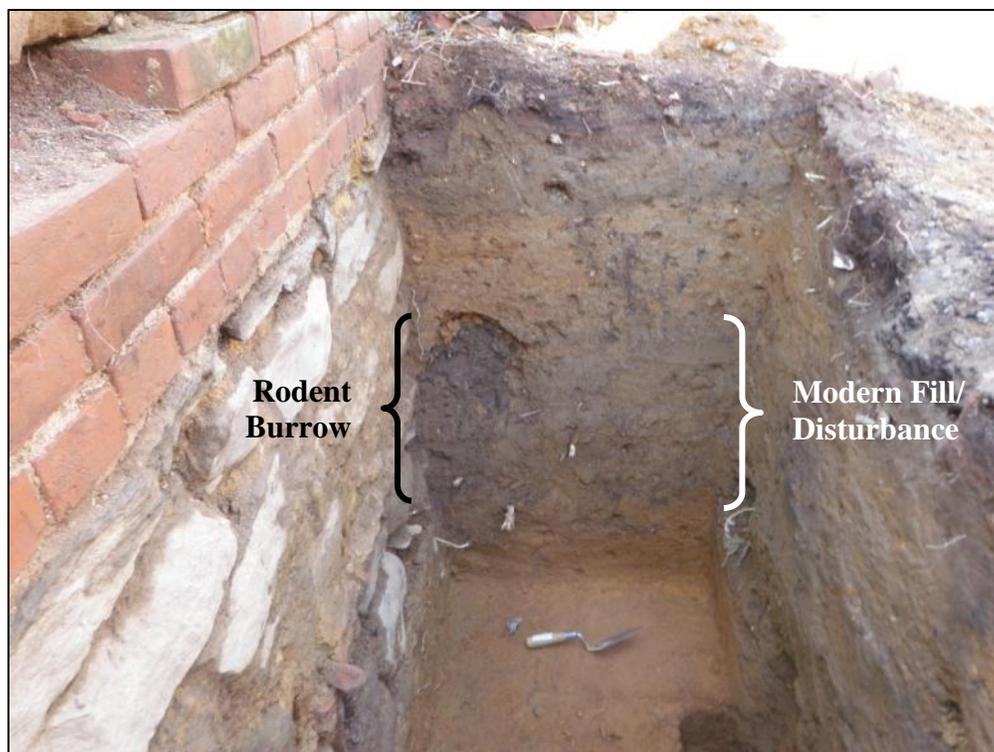
Figure 39: West Profile of Test Unit 4, Note Modern Fill and Rodent Burrow.

The strata below the burn/destruction layer in the test units around the house showed a notable lack of vertical integrity (Figure 39, p. 51). Test units located on the exterior of the house showed repeated evidence of intrusions in the form of scrape and fill layers associated with the mechanical disturbance of the ground surface. Most notably, clay fill layers containing modern trash such as aluminum Coke cans, plastic bags, Styrofoam, and plastic containers were found intermixed with historic strata to depths of 4 feet (121.9 cm) below the 1860s stone foundation supporting the house. In addition to this twentieth century human disturbance, test units showed extensive bioturbation from

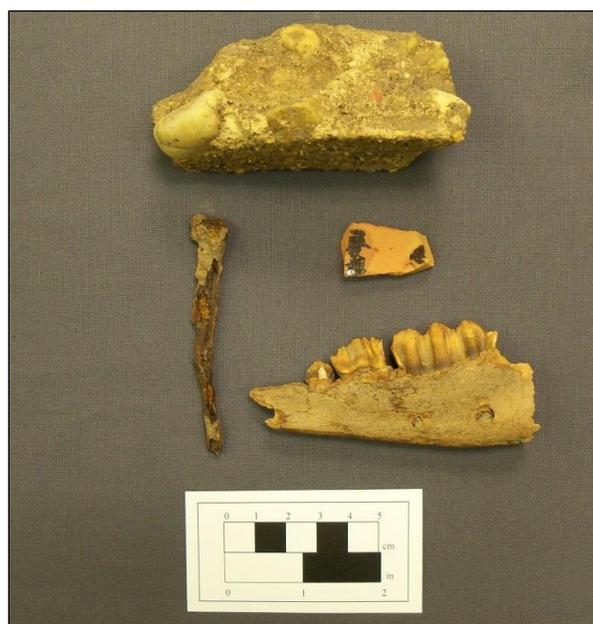
Figure 41: Artifacts from Structure 3. From top: cement fragment, cut nail with cut head, black lead glazed redware, and mammal mandible.

Structures 3, 4, and 7 were all represented on the surface by poured concrete foundations and each was investigated further by test unit excavation. Test Unit 14 explored the northeastern interior corner of the Structure 3 (Figure 41). Test Unit 14 excavation revealed a shallow concrete foundation, lacking a footer. Structure 4 was investigated with Test Unit 13, placed exterior at the southwest corner of the above-ground foundation. Test Unit 11 was placed on the east side of the exposed poured concrete foundation associated with Structure 7.

Test Unit 14 (Structure 3) yielded a total of 26 artifacts, consisting of mammal bone, concrete, cut nails (1815–1890), mortar, cement, flat pressed metal, and one fragment of black lead-glazed redware (1700–1900). Eighty artifacts from Test Unit 13 (Structure 4), similar in composition to those recovered from Test Unit 14, were recovered. A total of 19 artifacts was recovered from Test Unit 11 (Structure 7) and included only architectural materials. These consisted of mortar, post-industrial window glass, cut nails (1815–1890), and brick fragments. The artifact assemblages from these test units, as well as the construction techniques observed, suggest that these structures were likely built in the early part of the twentieth century when the property underwent large-scale updating. Also, all appear to be outbuildings associated with the farming of the property. They all characteristically lacked domestic materials and their orientation on the property and historic aerial photography strongly indicates their agricultural function.
