PROJECT RESULTS

Architectural Analysis

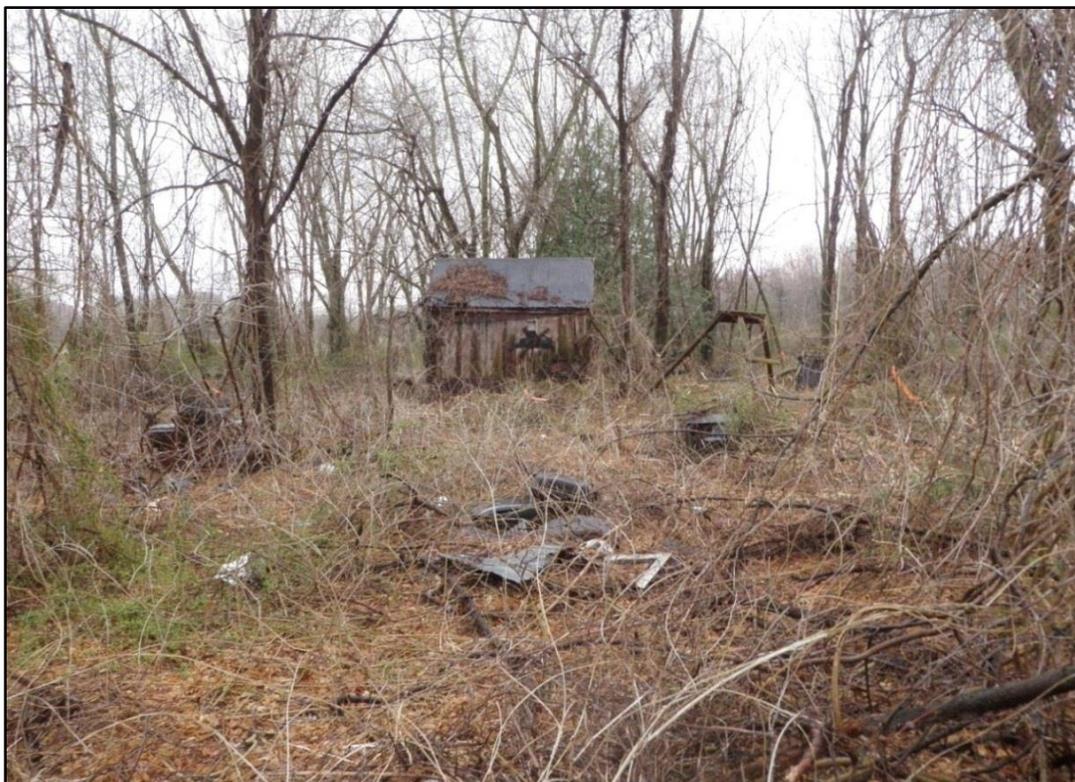
Figure 42: View of Structure 6, Facing East.

Test Units 12 and 17 were used to further explore the construction methods and the function of Structure 6, a standing framed shed (Figure 42, p.50). The most compelling physical evidence of the eighteenth/nineteenth/twentieth century interface, Structure 6 sits east of the Burnham House. The one standing outbuilding on the property exhibits construction modifications from three occupation centuries. Upon initial investigation, the building appears to be a dilapidated garage. Architectural analysis highlights original eighteenth century construction. The structure has a timber frame built using hand-hewn beams joined through mortise and tenon and peg technology. The structure was augmented and reused in the nineteenth century, when a new roof was installed. The interior was resurfaced with circular-sawn lumber fastened with cut nails. It was changed again in the twentieth century to accommodate the new automotive needs of the occupations through the installation of a large garage door on the south elevation and other structural changes utilizing ungalvanized wire nails.

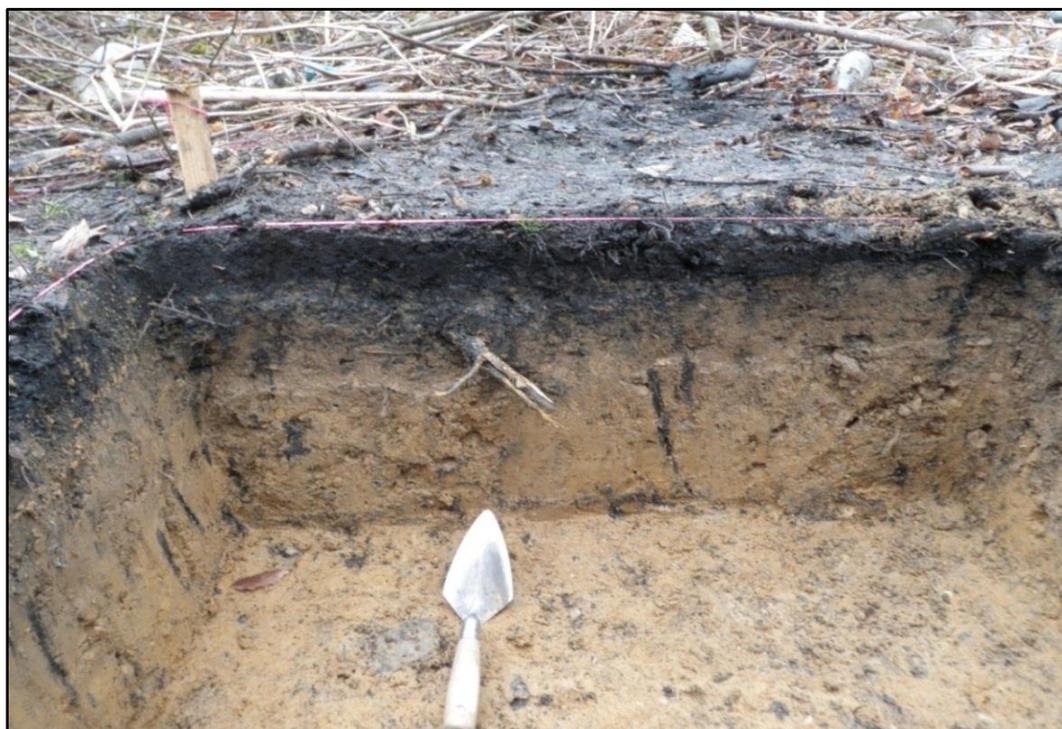
Figure 43: North Wall Profile of TU 12, Showing Disturbance from Burning and Truncation.

Test Unit 12 was placed directly adjacent to the northeastern corner of Structure 6, to examine the rock pier foundation (Figure 43, p. 54). During the course of excavation, rock fall associated with the foundation was discovered. To further explore the nature of these stones, Test Unit 17 was opened to the northwest. Test Unit 17 confirmed the stones to be haphazardly arranged and lacking any clear articulation, thus confirming that they were likely displaced from the nearby foundation. Continued excavation in Test Unit 12 indicated that the building's corner was supported by a shallow stone pier. Additionally, excavation in both Test Units 12 and 17 showed evidence of periodic replacement of the corrugated metal siding on the building. This, along with the interior construction methods, suggest the building had undergone a series of structural, and likely functional, changes throughout its history.

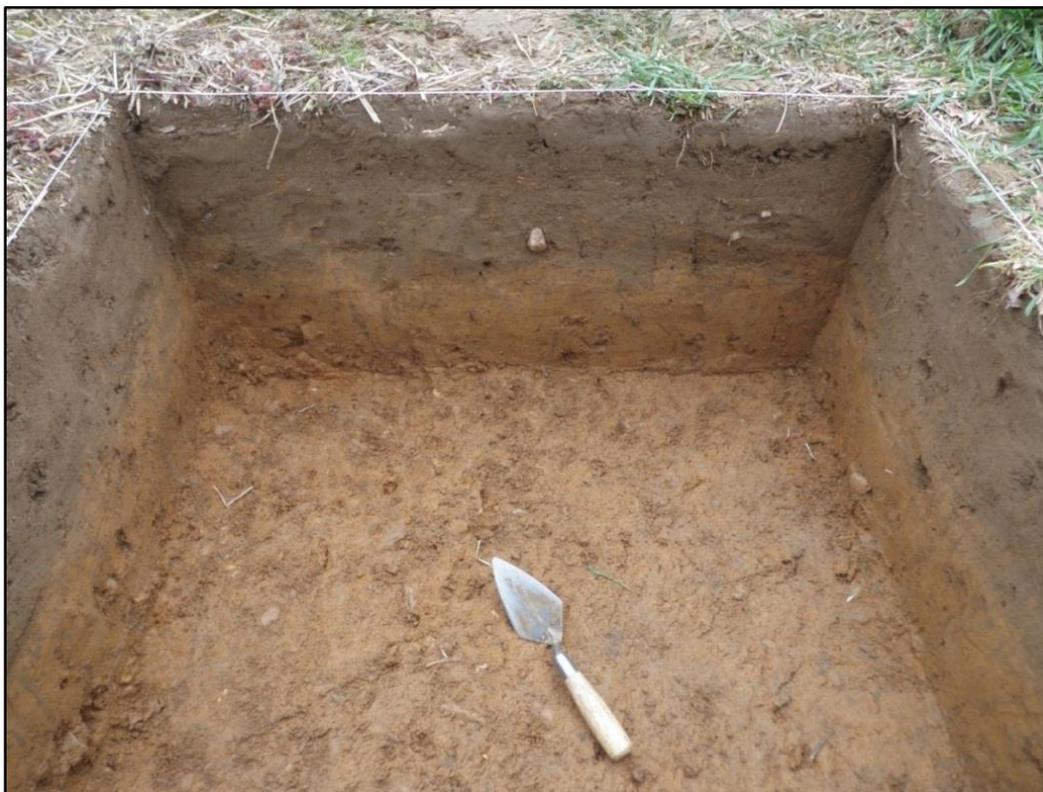
Figure 44: North Wall Profile of TU 18, Showing Truncated Plowzone.

The final outbuilding, Structure 8, was recorded as a possible structure because it is represented only through the presence of a large debris push pile. Contained within this push pile are an abundance of twentieth century remains including bottle glass, vessel glass, modern trash, and a limited amount of architectural remains. These architectural remains prompted further investigation to ascertain the location of a structure if present. As such, Test Unit 18 was excavated along the southwest margin of the push pile (Figure 44). No intact structural or building remains were encountered during this investigation.

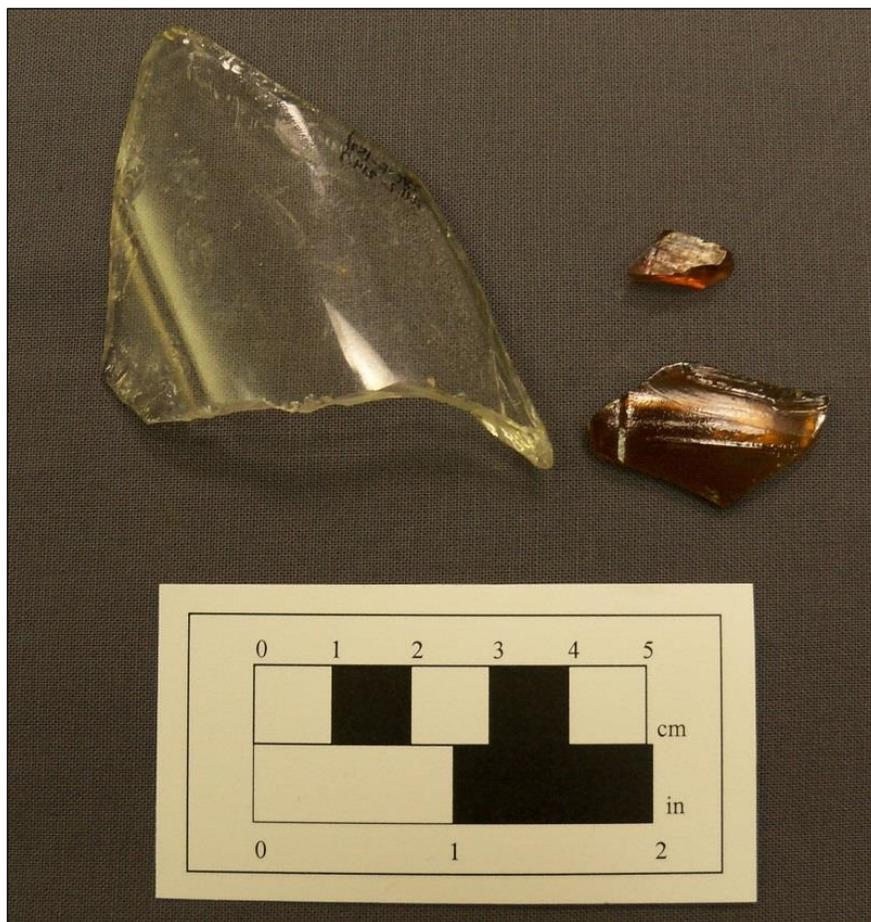
Figure 46: A Sample of Glass Collected from Structure 1.

Overall, the Phase II testing resulted in the recovery of 6,989 artifacts from 233 close-interval shovel tests and 30 test units (Figure 45; Figure 33 and Figure 36, pp. 56–46). The overall Phase II assemblage was dominated by architectural artifacts (72.1 percent; n=5,037), which is not surprising given the above-ground remains of the Burnham House and remnants of nine other structures. The collection also contains an abundance of vessel and/or bottle glass (14.5 percent; n=1,014). Large quantities of this artifact category is commonplace on twentieth century sites and is likely reflective of the later occupation of the property. During this period, glass was beginning to be mass produced and seen as a more disposable resource—a one-time use container in contrast to ceramics which continued to be reused (Figure 46, p. 56).

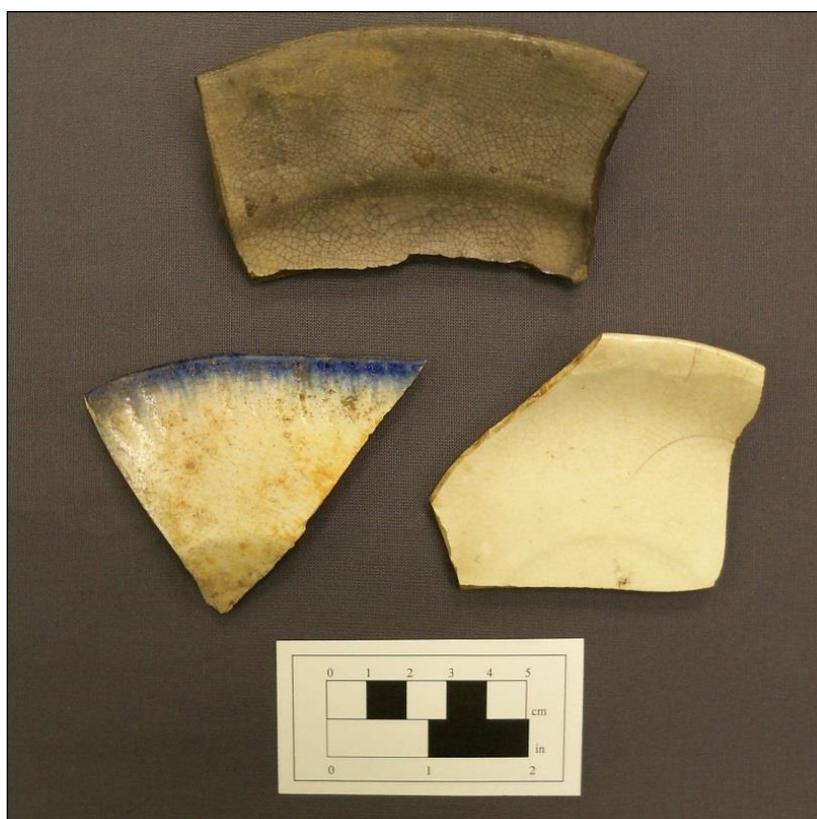
Figure 47: Sample of Nineteenth-Century Ceramics. Clockwise from top: burned whiteware rim, plain ironstone rim, blue shell-edged whiteware rim.

The ceramic assemblage comprises 2.4 percent (n=168) of the overall Phase II collection (Figure 47, p. 57). This assemblage is particularly useful in further assessing the site's occupation timeframe and was used in this analysis to augment interpretations from both the archival and architectural analysis of the site. A calculation of the Mean Ceramic Date (MCD) which generally indicates a central habitation period, results in a mean occupation date of 1882 (Table 2, p. 58). According to historic documentation and the architectural analysis, the Burnham House was constructed in the late 1860s. Subsequently, in the early-twentieth century, the property underwent extensive renovation and updating. The MCD obtained from the site confirms this site history; however, it should also be noted that the reliability of MCDs post-1850 is suspect. During this period the variety of ceramics being manufactured was greatly reduced. From 1765–1840 ceramic manufacturing changed rapidly, thus making the pre-1840 period an optimal time for MCD calculation (Deetz 1996; National Park Service [NPS] 2011).

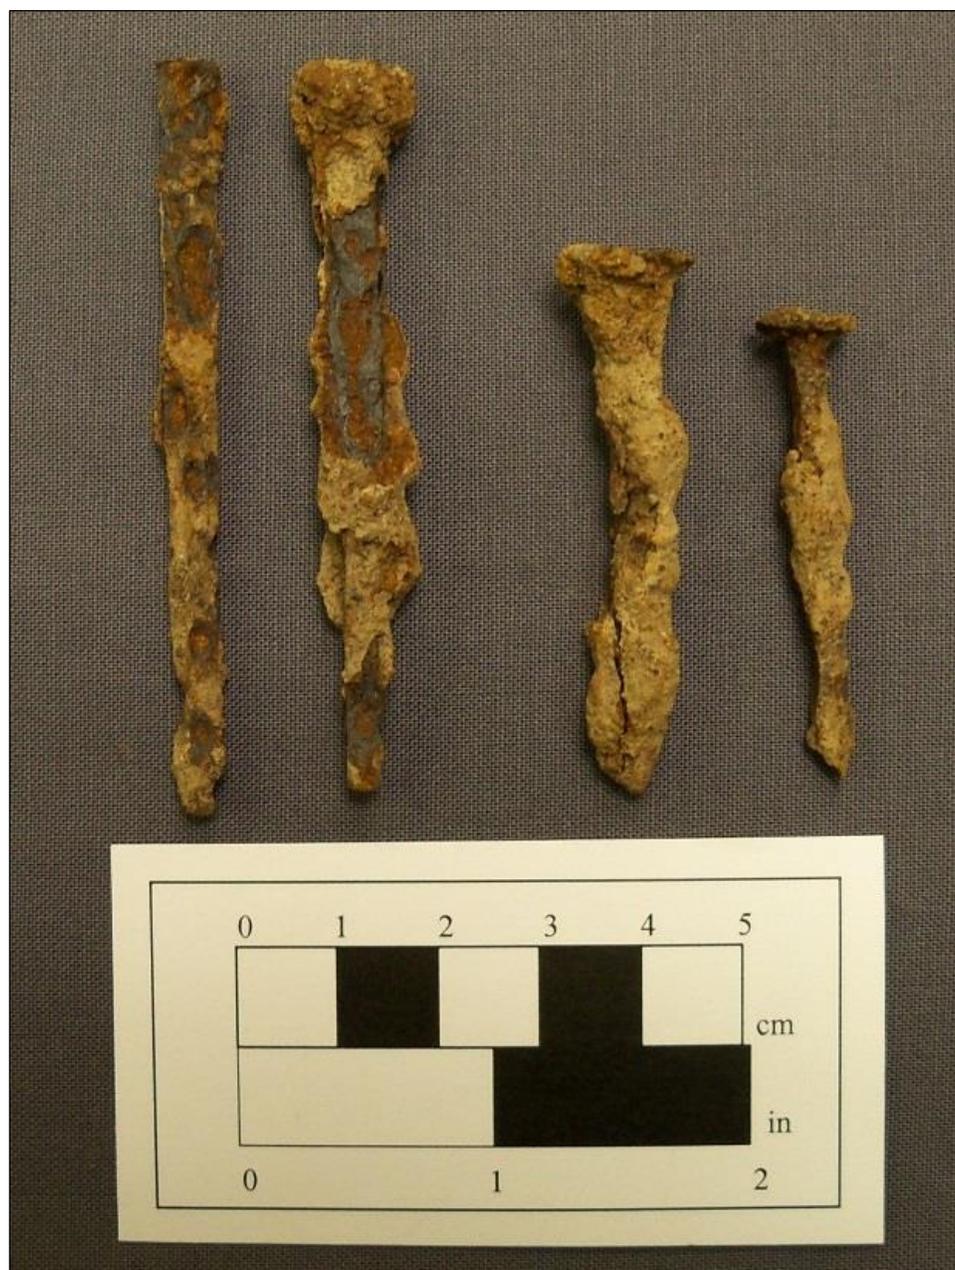
Figure 48: From Left: Cut Nails with Cut Heads (2) and Ungalvanized Wire Nails (2).

The ceramic assemblage is dominated by whiteware and ironstone artifacts, which refers to the mid to late-nineteenth century occupation of the Burnham House. The composition of the nail assemblage recovered from the Phase II investigation in the core area of the Burnham House site also corroborates this date, with the vast majority of nails being shafts with cut heads and only a small percentage being wire nails, most of those being ungalvanized (Figure 48, p. 59 and Figure 49, p. 60).

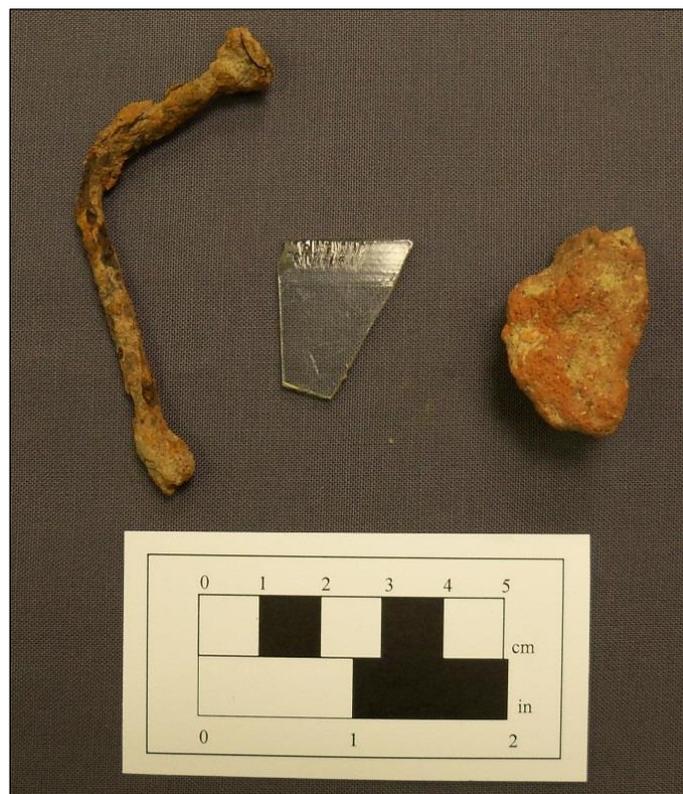
Figure 51: Sample of Architectural Materials. Clockwise from top: ungalvanized wire nail, burned handmade brick, and window glass.

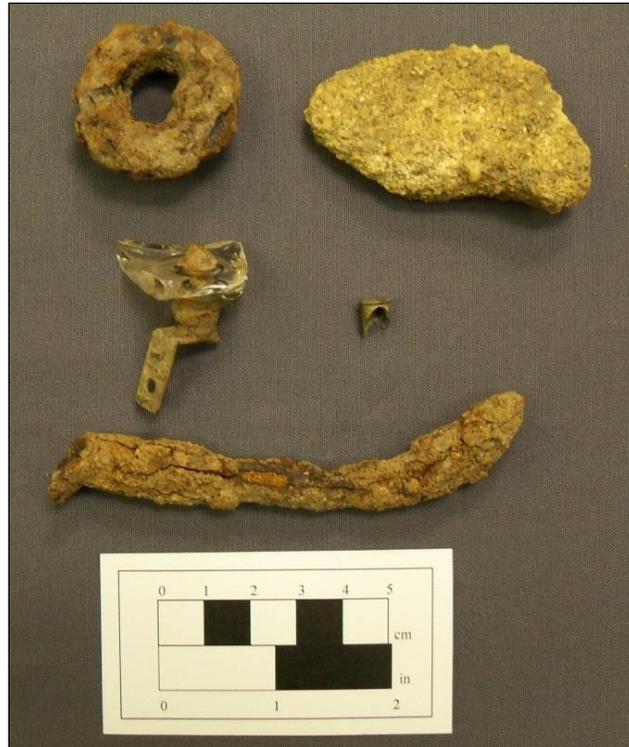
Figure 52: Sample of Architectural Artifacts. From top left: iron nut, Portland cement, lighting fixture fragment with brass attachment, .22 shell casing, iron bolt.

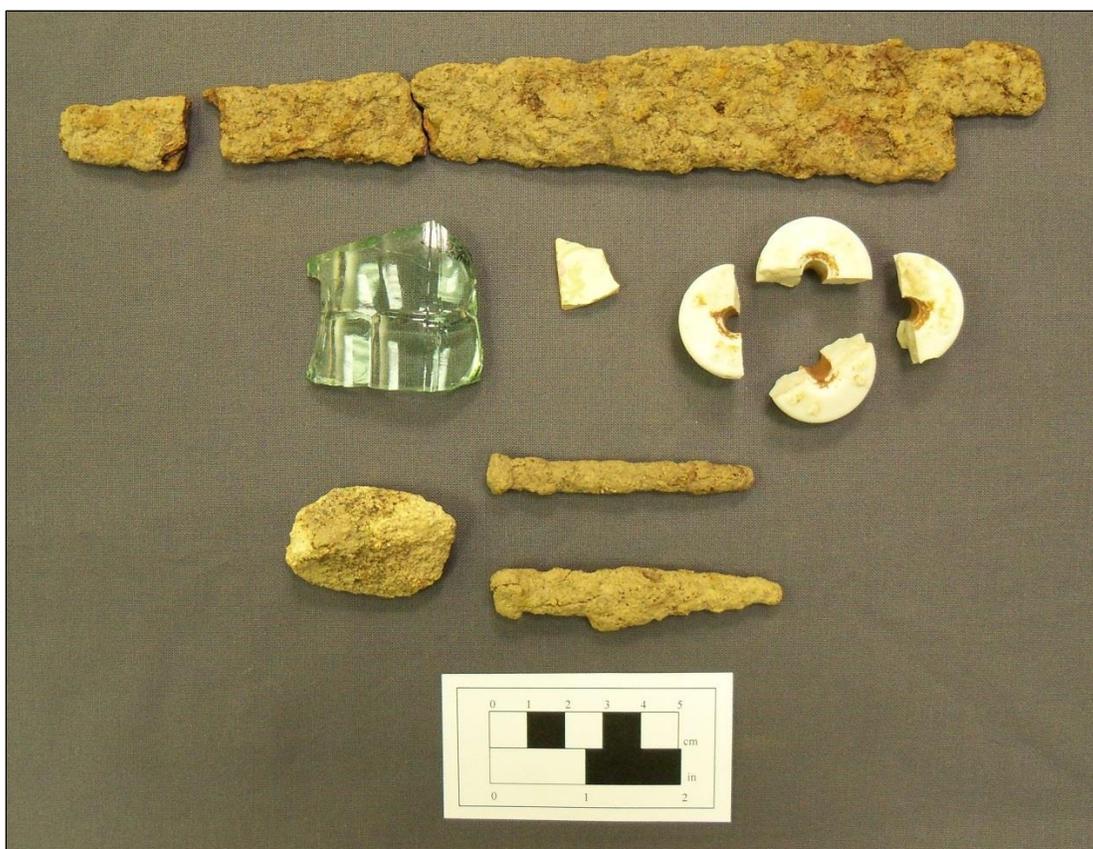
Figure 60: Artifacts from Structure 6. From Top: large knife blade, green bottle glass with painted label, handpainted overlazed ironstone, porcelain insulators, mud mortar, cut nails with cut heads.

The artifacts recovered from Test Units 12 and 17 (Structure 6) totaled 119 (Figure 60). Not surprisingly the assemblage was dominated by architectural and metal materials, with a small number of ceramic, glass, organic, and other category artifacts. While the artifact assemblage suggests a later date, architectural components possibly date Structure 6 to the pre-Burnham House occupation of this general area. However, due to re-use of structural elements, as previously explained, a definitive date cannot be assigned to shed construction. The artifacts and exterior remains indicate a multipurpose agricultural shed, used over three centuries time, with tool, chain, hardware, and various glass remains. Additionally, the remains of exterior animal pens were observed along the western margin of the building.

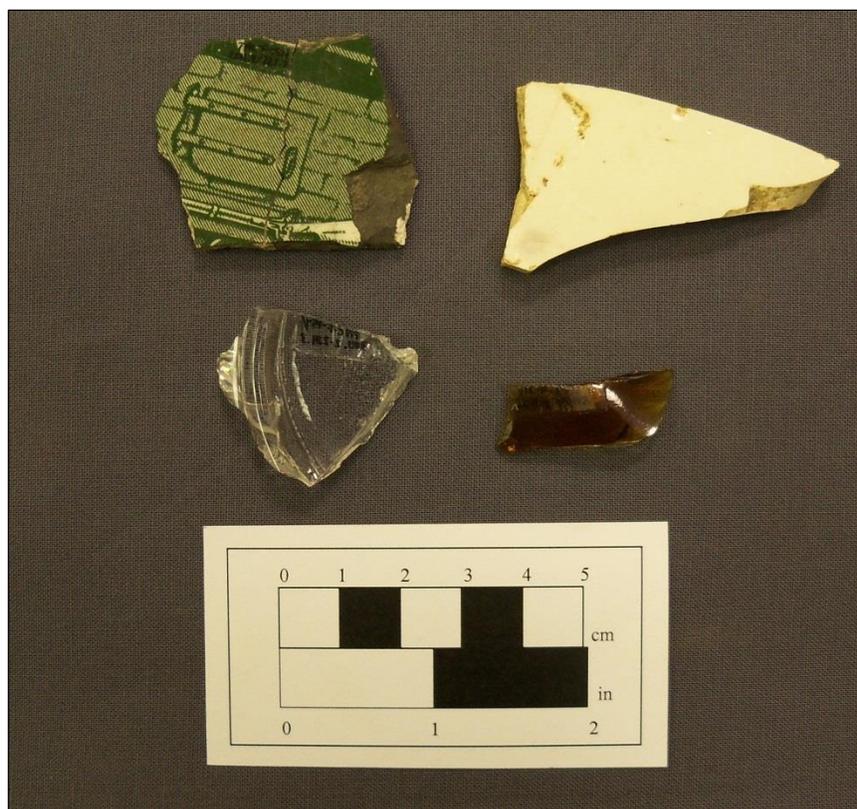
Figure 61: Artifacts from Structure 8. From Left Clockwise: green transfer-printed whiteware, plain ironstone, clear bottle glass base, amber bottle glass.

A total of 16 artifacts were recovered from Test Unit 18 (Structure 8) and significant amount of modern debris and trash was observed (Figure 61, p. 70). These results, with the lack of identifiable structural remains, indicate that the push pile likely resulted from the cleaning of the site, similar to the mechanized destruction/cleaning observed at Structure 2.

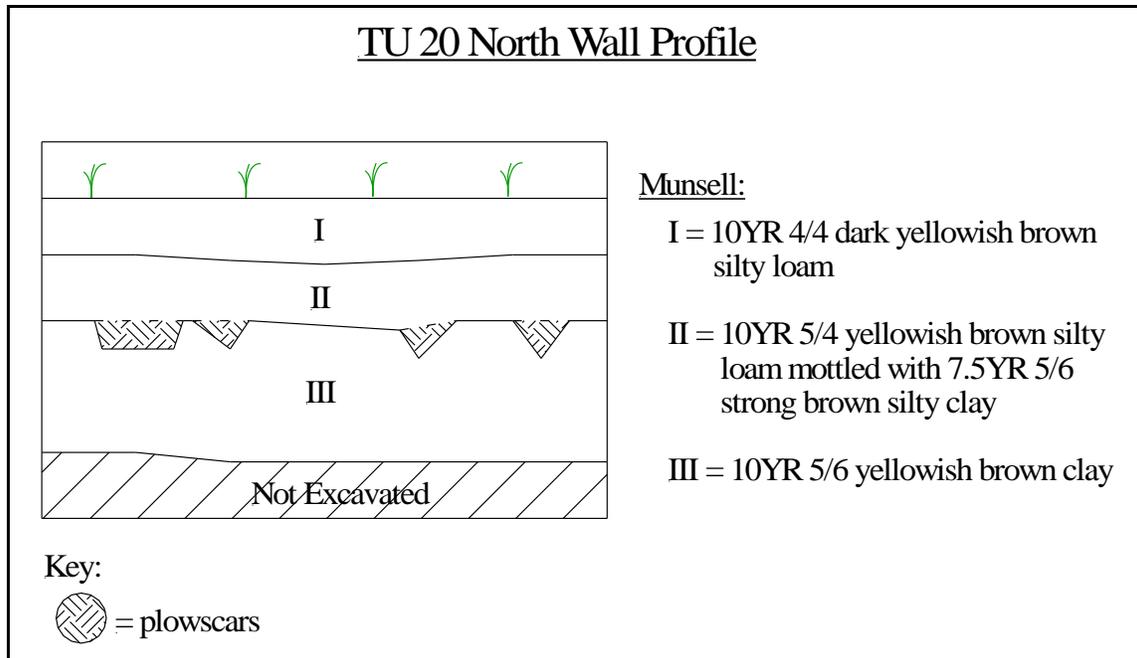
Figure 62: Test Unit 20 North Profile.

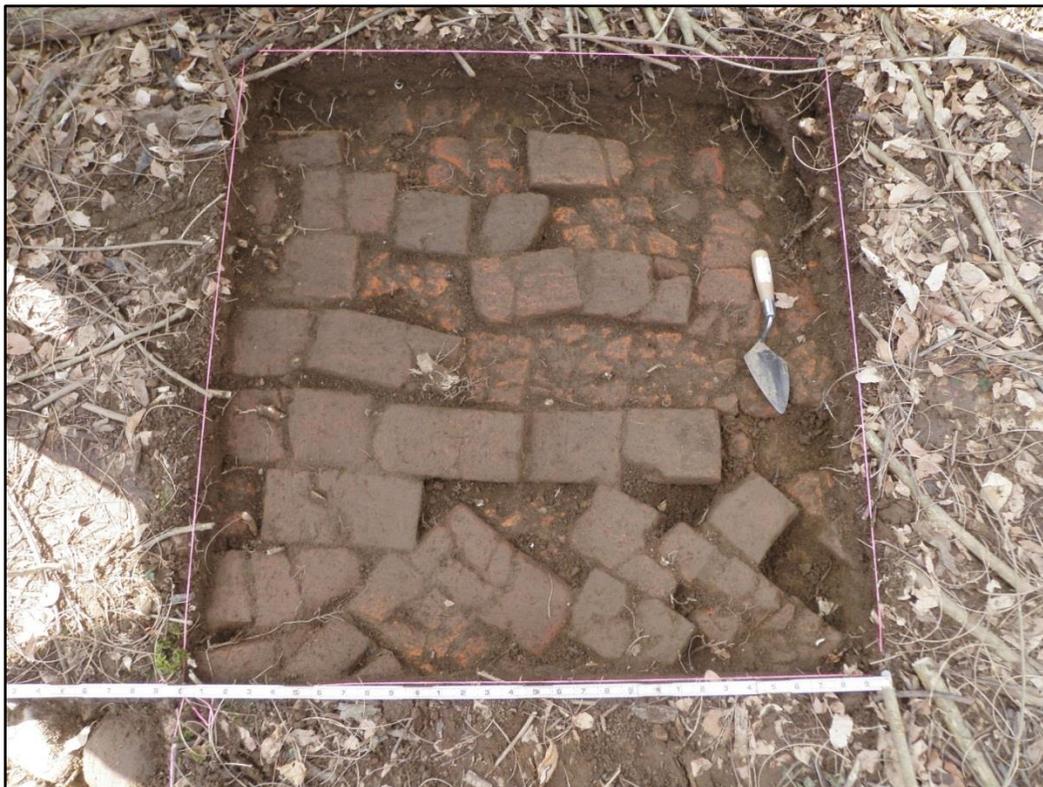
Figure 63: Plan View of TU 30 Showing Brick Patio Remains.

Test Units 21 and 30 were excavated northeast of close-interval shovel test N1100, E1050 and were placed in this location to further explore high artifact densities at this and adjacent shovel test locations. Test Unit 21 revealed a shallowly buried stone alignment that lacked mortar or other binding agents. To further understand the origin or association of this alignment, Test Unit 30 was opened to the southwest. Unit 30 contained a dry-laid brick patio revealing that the stone alignment observed in Test Unit 21 was the stone edging for this patio (Figure 63, p. 71).

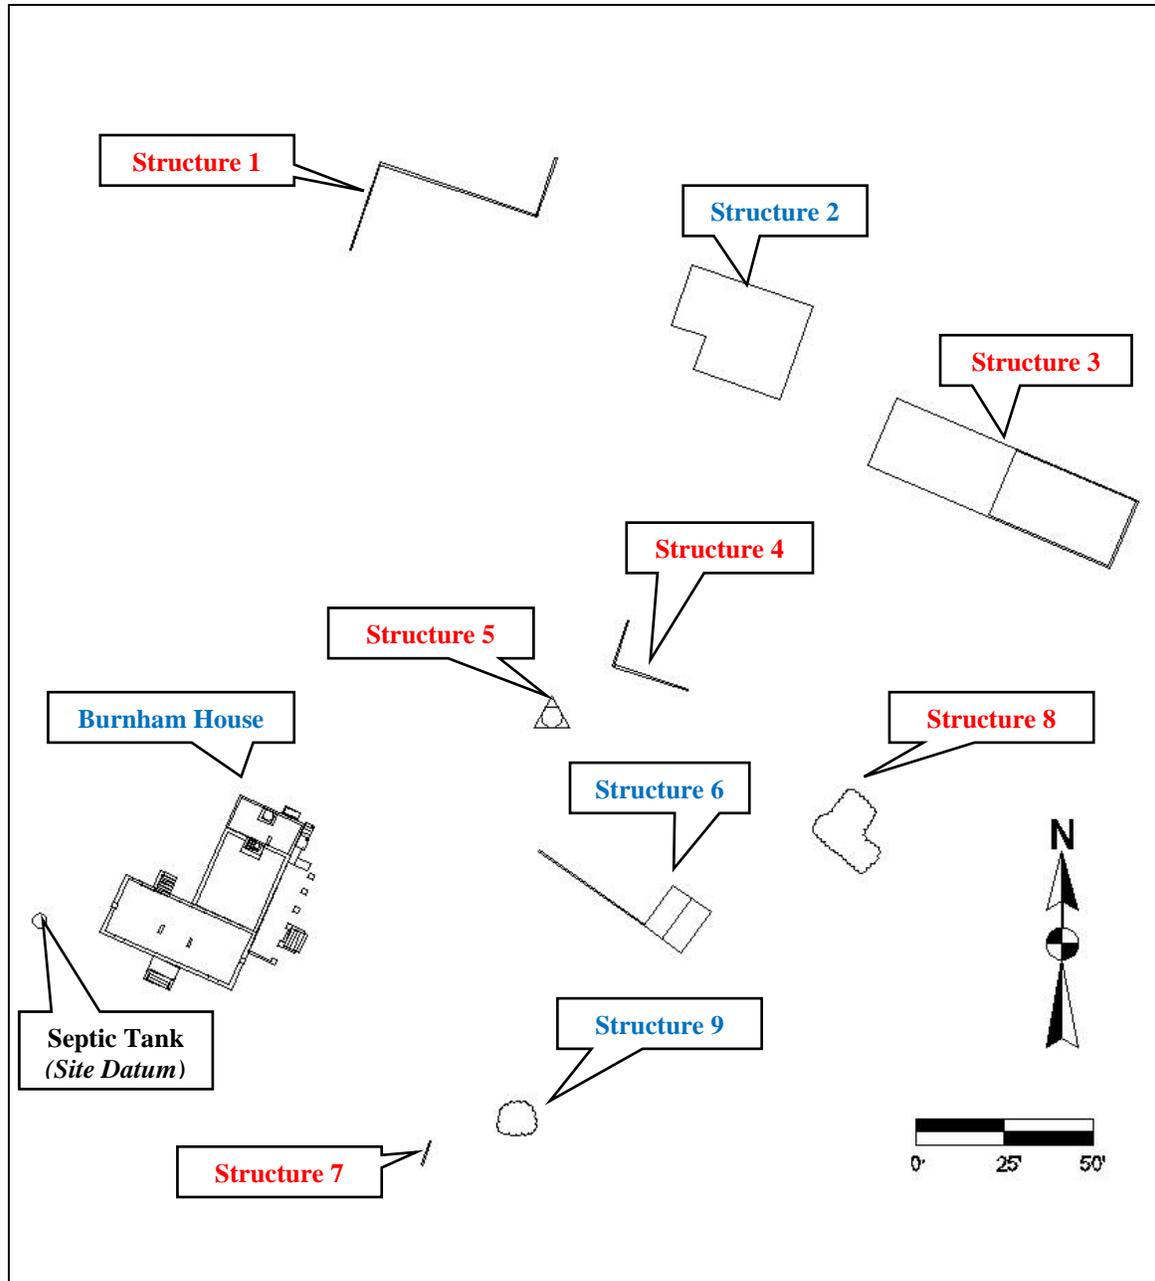
Figure 65: Burnham House Site (7NC-F-157) Plan Map with Early-Twentieth Century Structures Highlighted in Red and Late-1860s Structures in Blue.

The archaeological, architectural, and historical evidence not only reveals the construction date for the Burnham House and the initial occupation of the site, but also helps to show the history and chronology of landscape change (Figure 65, p. 76). The architectural analysis of the Burnham House ruins shows that the building underwent two large-scale renovations, one in the early-twentieth century and the other in the mid-twentieth century. Archaeological evidence for the construction dates of the outbuildings associated with the Burnham House also reveal that a significant rebuilding and landscape change occurred in the early-twentieth century since five of the eight dateable structures were erected during this period (Table 3, p.74). While no artifacts were
