field investigations

## MOUSLEY PROPERTY

Prepared by John P. McCarthy,  
MAAR Field Supervisor

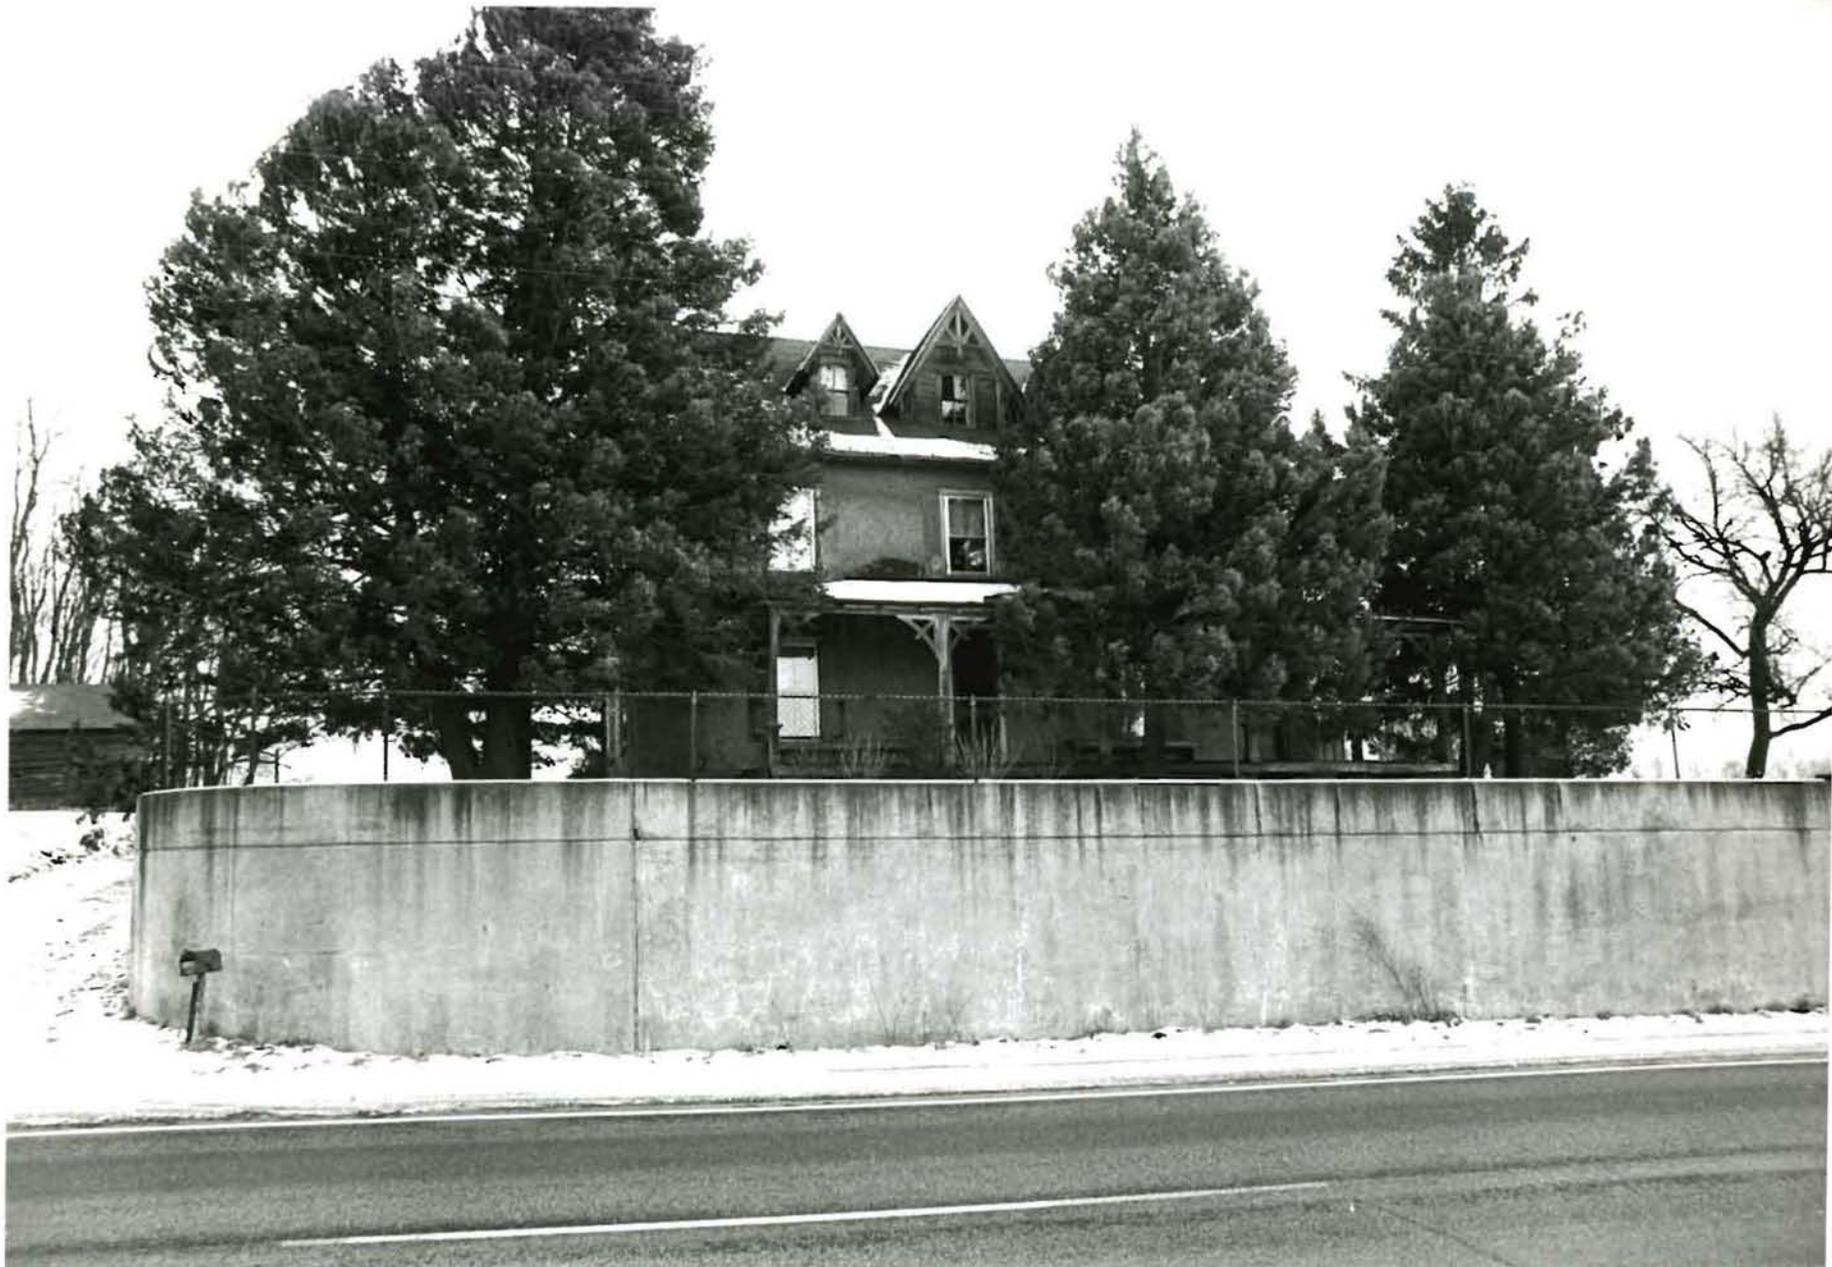
Figure 6: Mousley Property  
(N-563)  
Front View

Originally a two-story, single-pile, three-bay stone house facing south, it was later enlarged to the north and its extended west wall was then made the facade of a Gothic Revival transformation.

Of the original building walls there remain only the south and east walls and portions of the north and west walls. Although now almost entirely covered with plaster, they are of dark gray "Brandywine Granite", laid in white lime mortar. The original front entrance door and frame are still in place. The door is of an unusual stile-and-rail design, with eight raised panels and sheathed on the back with vertical boards. The best preserved of the original windows is in the south wall at the first floor where it is protected by a porch roof. Here, the narrow-muntined six-light sash and the shutters appear to date from the original construction. The shutters are of stile-and-rail design with raised panels, sheathed on the back and hung on hand-forged strap hinges. Inside the house, little can be said to have survived the restyling operation except some first floor construction and an enclosed, winding stairway in the northeast corner. Locations of the original chimneys cannot be established without further on-site research. Architrave and panel moldings are of an ogee-and-bead type that can be found in the George Read and Senator Van Dyke houses in New Castle, Delaware. Although the floor plan of the original house appears to have been of an early type - two rooms on each floor - all other indications are that it was constructed around 1800.

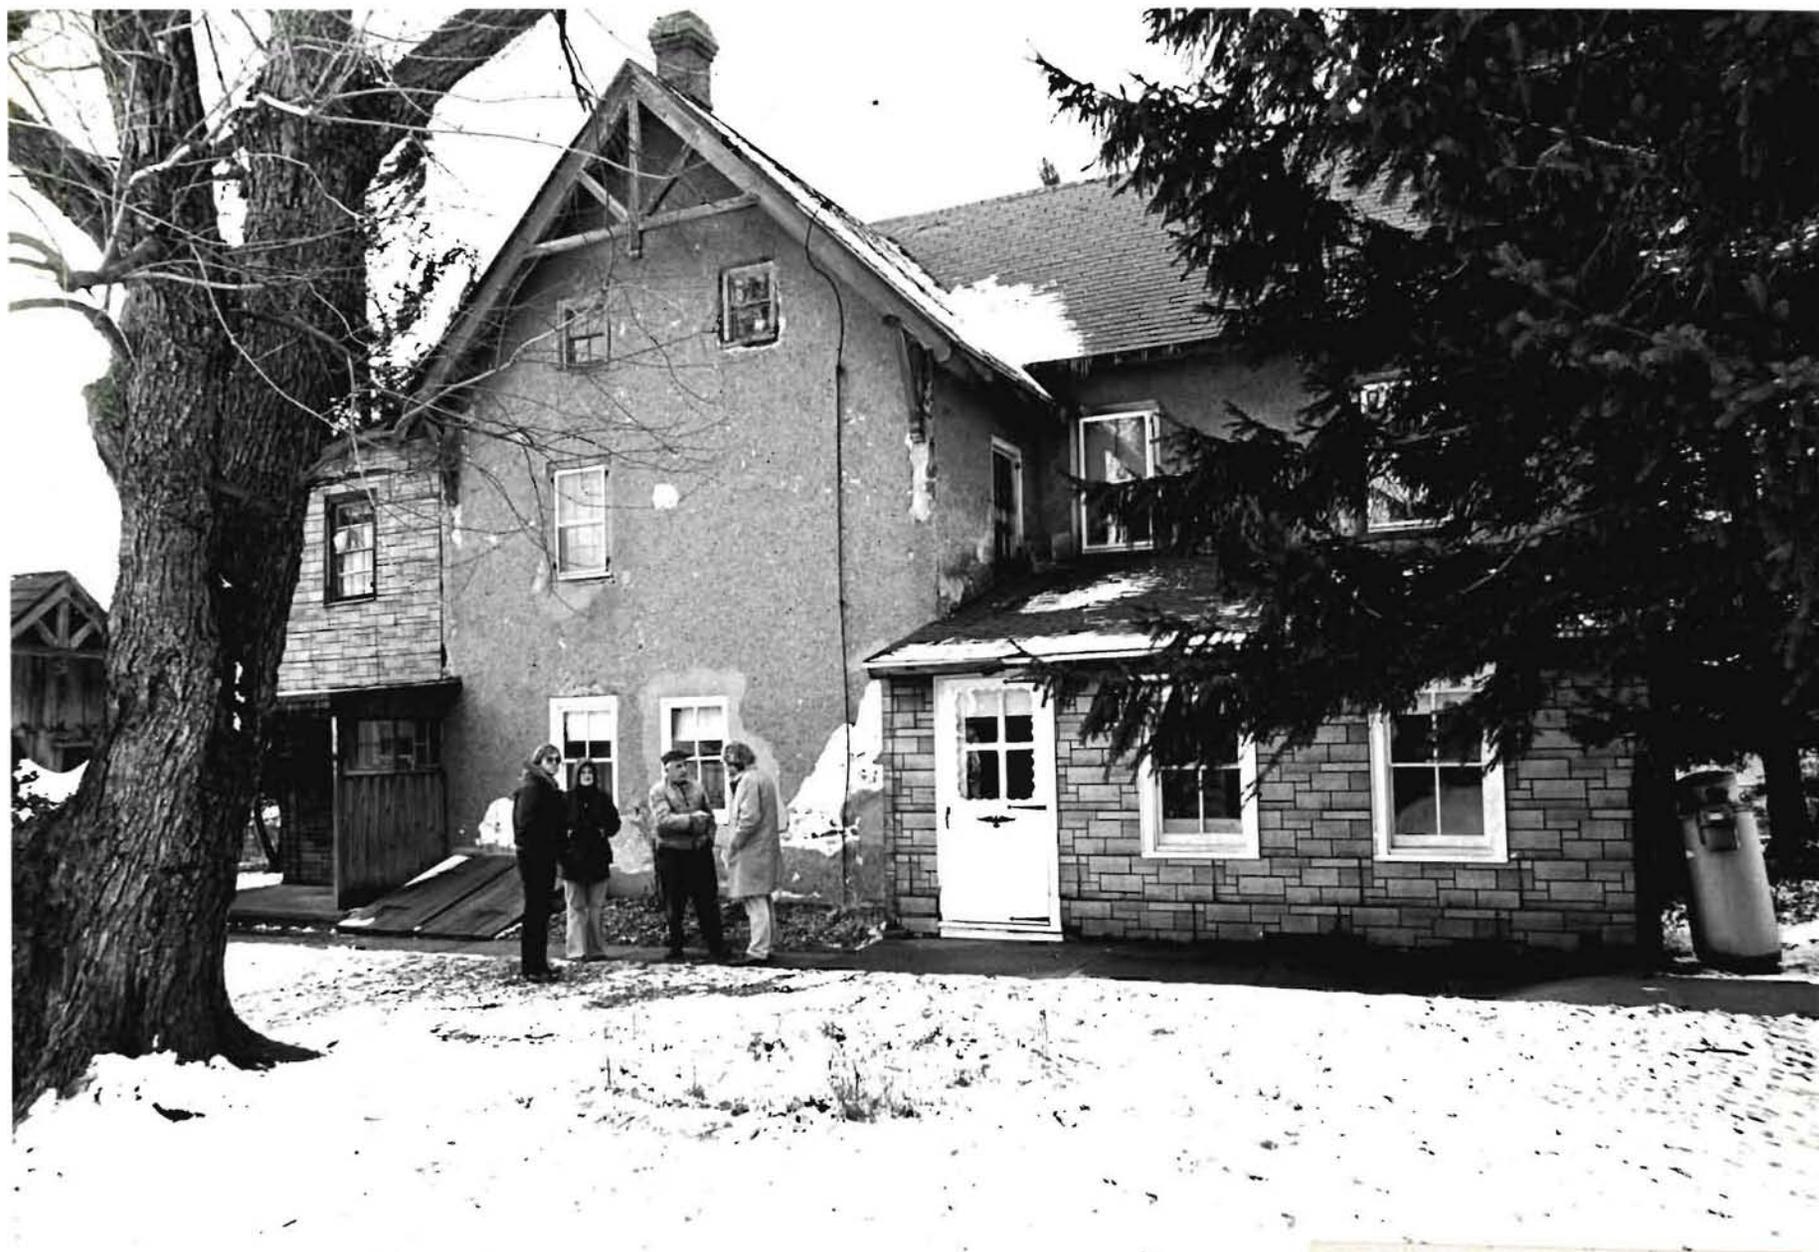
Figure 7: Mousley Property  
(N-563)  
Rear View

In later times a kitchen addition was placed against a portion of the south wall; still later, this was expanded vertically to provide a bathroom and a small bedroom on the second floor. Another kitchen has since been built in the angle of the L. These are all of frame construction, with low-pitched shed roof and ashlar-pattern asphalt roll siding.

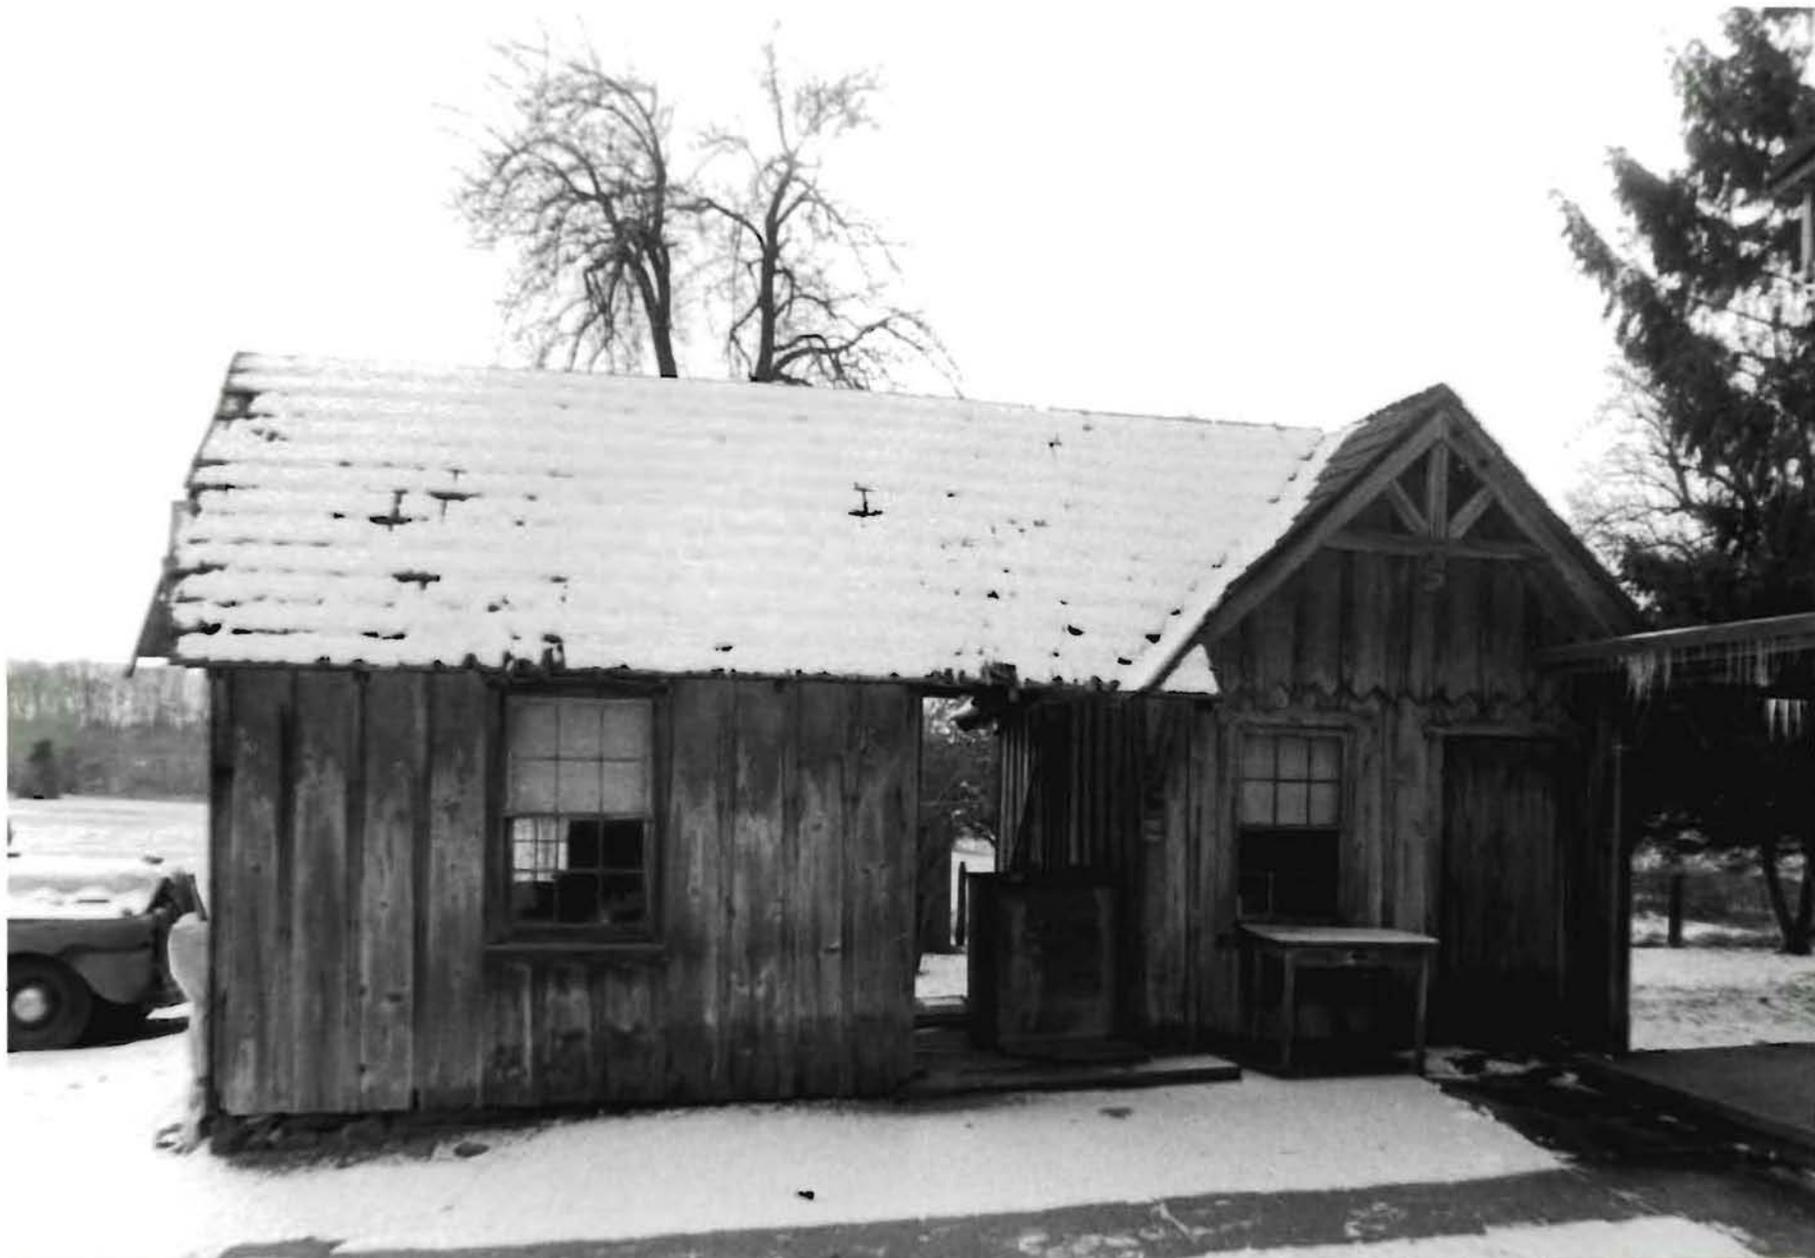
Figure 8: Mousley Property  
(N-563)  
Summer Kitchen

The combination summer kitchen - milk house and the nearby privy are styled to match the main house's Gothic Revival appearance. All roof trim features are repeated. Both buildings are sheathed in vertical board-and-batten siding. Windows, where they occur, have six-light, double-hung sashes. Doors are ledge type. It is probably safe to assume that these two structures are coeval with the mid-19th Century transformation of the house.

But it is in the summer kitchen that the Gothic Revival treatment employed in the house has been fully developed. This is a truly delightful little structure worthy of preservation. The same may be said of the similarly-detailed privy with but little less enthusiasm. These three buildings deserve more attention than they have received in the recent past.

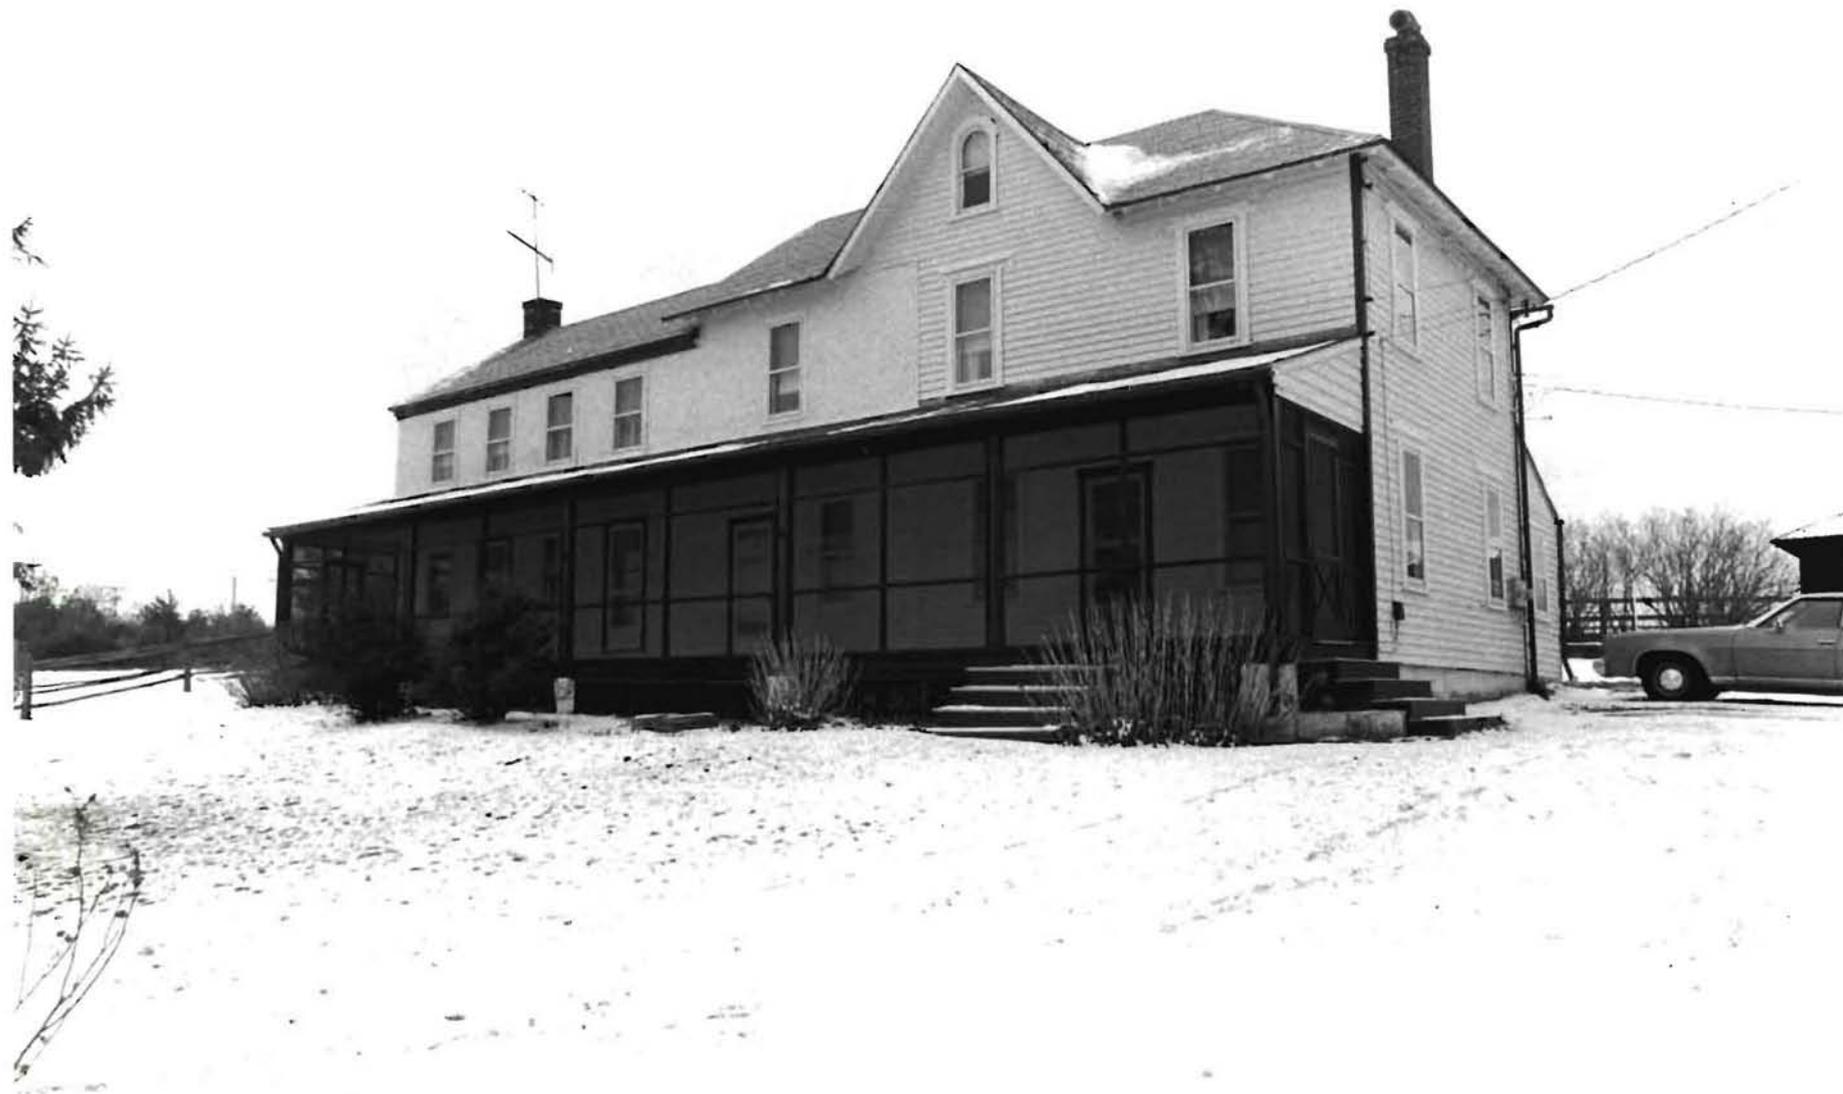
Figure 9: Woodlawn Trustees  
Property (N-564)  
Front View

Originally a two-story, two-family stone house, it has been enlarged not less than twice. The first addition was a one-story stone wing on the north; the second was a larger stone and frame addition, again on the north. The one-story porch, that extends along the entire east front, was probably built at the time the second addition was made.

The original stone structure, probably built in the 1820's, was a four-bay single-pile house of a simple character that suggests that it was designed to serve as tenant's or workmen's housing. The low-pitched roof and decorative brick cornice are typical of Pennsylvania stone houses of the period. First floor joists appear to be original; rotted at their bearings in the west wall, they have been bolstered by a heavy timber frame. The one remaining fireplace chimney has been closed up, and serves as a flue for the present heating furnace. Window frames appear to be original, but sashes are replacements. The two door openings in the east front have been retrimmed; the doors themselves are late 19th Century types. The door and frame in the west wall seems to have been installed at a later date, probably at the time of the second addition.

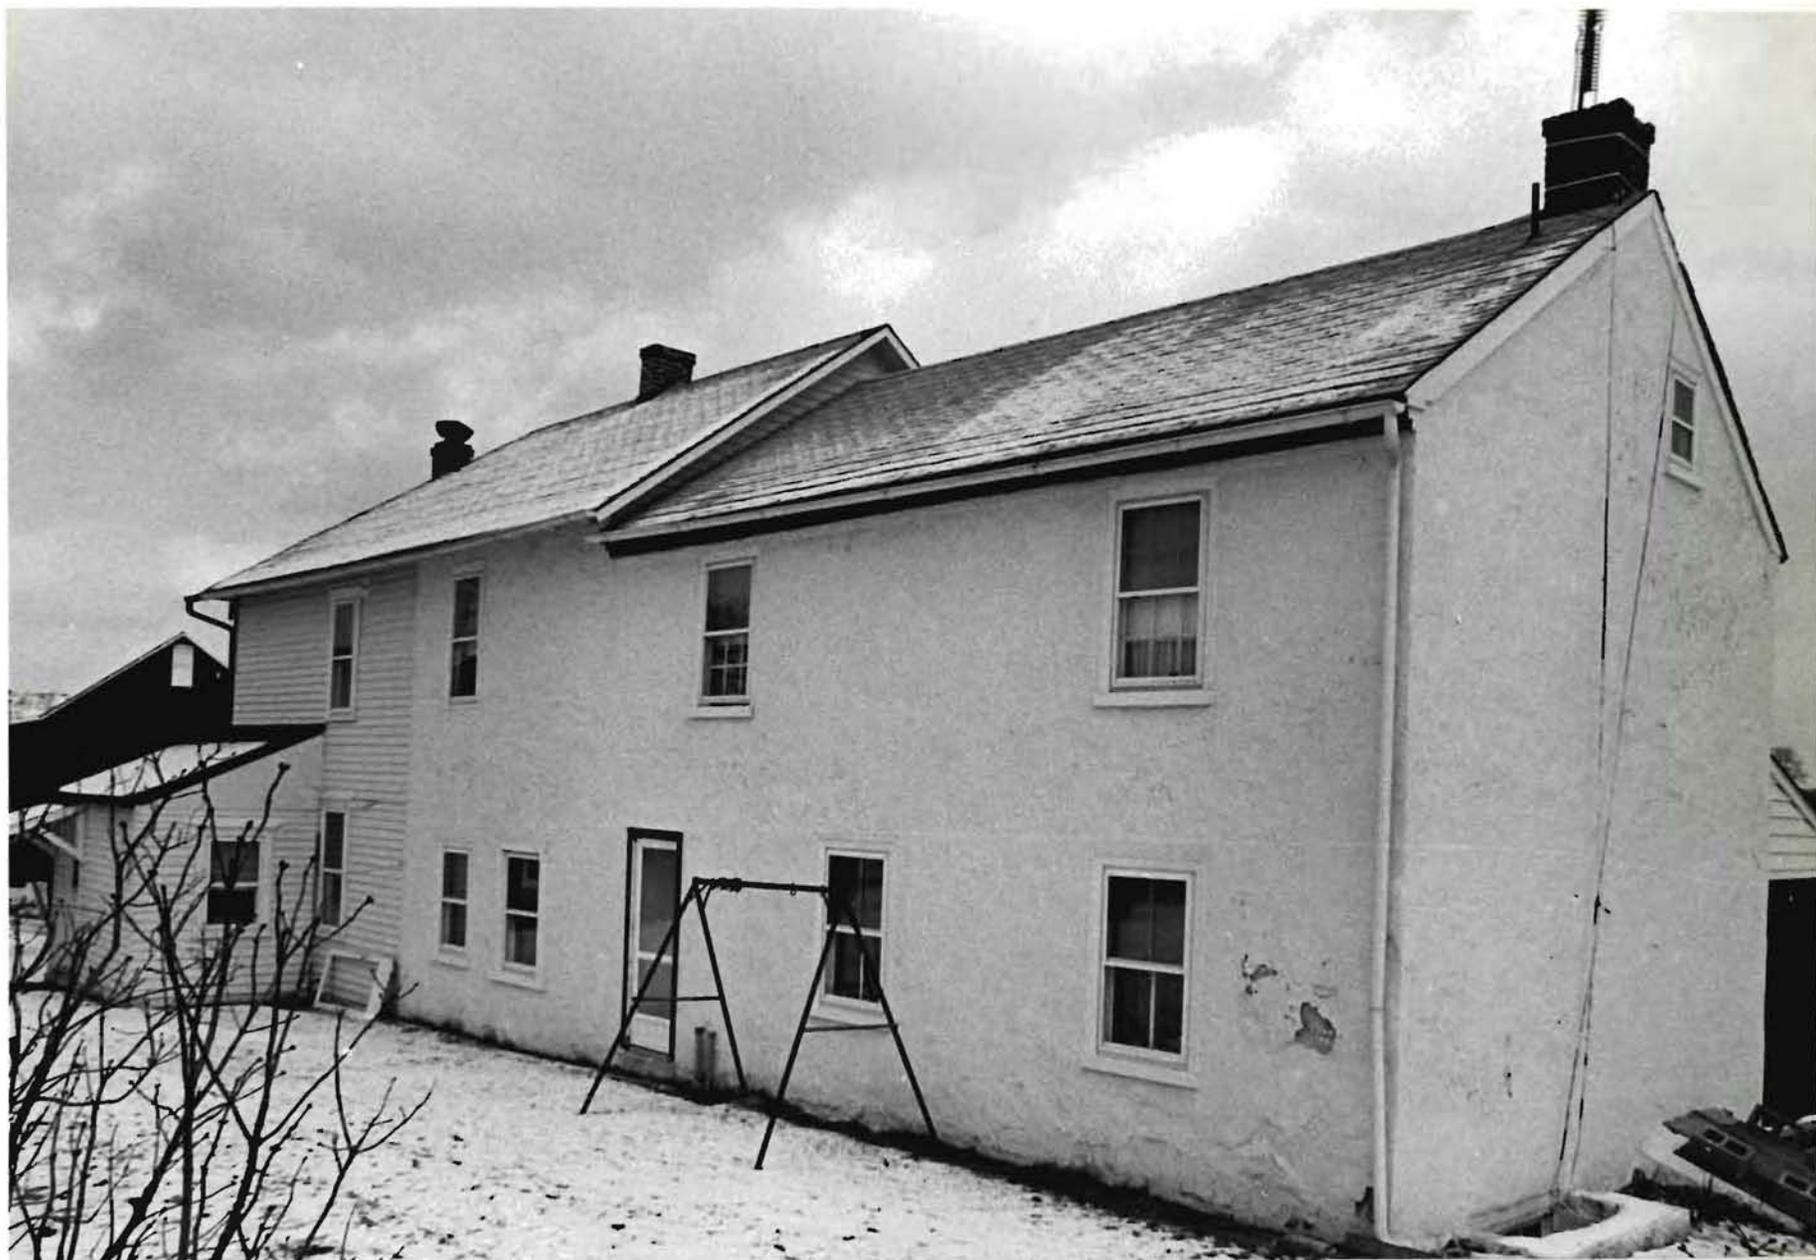
Figure 10: Woodlawn Trustees  
Property (N-564)  
Rear View

In the second addition, the roof of the little north wing was removed, a second floor was installed, and the east and west walls were raised with stone. A two-story frame extension to the north completed the addition. A single new

roof covers the raised stone wing and the frame extension. The roof is hipped at the north end, rafter ends are exposed at the eaves and a simple Gothic gable is centered on the east side. The previously mentioned porch conceals the erratic fenestration pattern of the east wall. This second addition seems to date from sometime in the last two decades of the 19th Century.

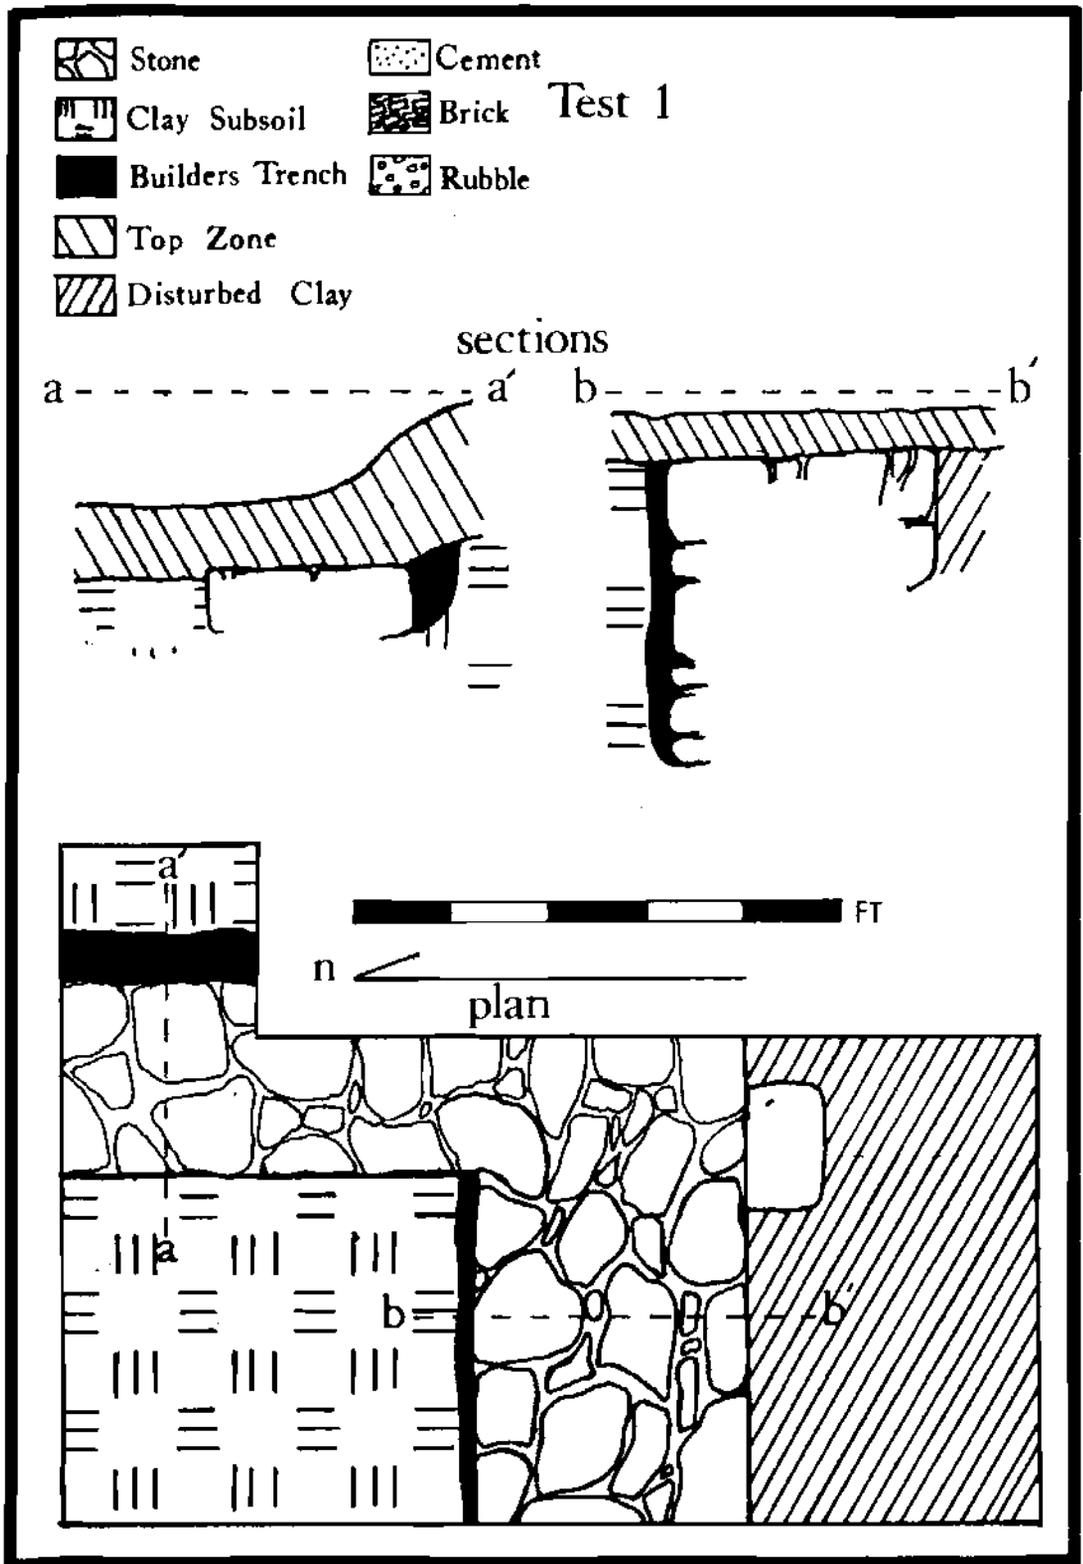
Figure 19: Test 1 Plan View & Profile

Test units 1 - 4 and Trenches 1, 3 and 4 were located on the house/tavern site (See figure 18). Test 1 was located at the north end of the stone wall where the documents indicated that the southeast corner of the building once stood. Under a layer of disturbed soils the stone foundation of the building was found. The south wall was 34 inches wide and 46 inches deep while the east wall was 24 inches wide and 9 inches deep (see Figure 19 and Plate Ia and b).

A six inch wide builders trench was located on the exterior of the east wall. It contained four sherds of window glass, a wire nail, three sherds of whiteware and one sherd of redware. A narrow builders trench (1-2") was in evidence on the interior of the south foundation wall. No artifacts were found in the interior trench. On the exterior side of the wall mottled soils were encountered suggesting disturbance. The exterior side of the builders trench was not located. In the interior of the structure clay subsoil was found.

The tests revealed parts of the house's foundations including segments with builders trenches. The varying thickness and depth of wall segments would suggest several construction periods and construction techniques. This is supported by the contents of the builders trench found on the exterior of the east wall as found in Test 1. The white ware indicates a date of construction after 1820 (South 1972) while the wire nail would mean a construction date after 1850 (Nelson 1968).

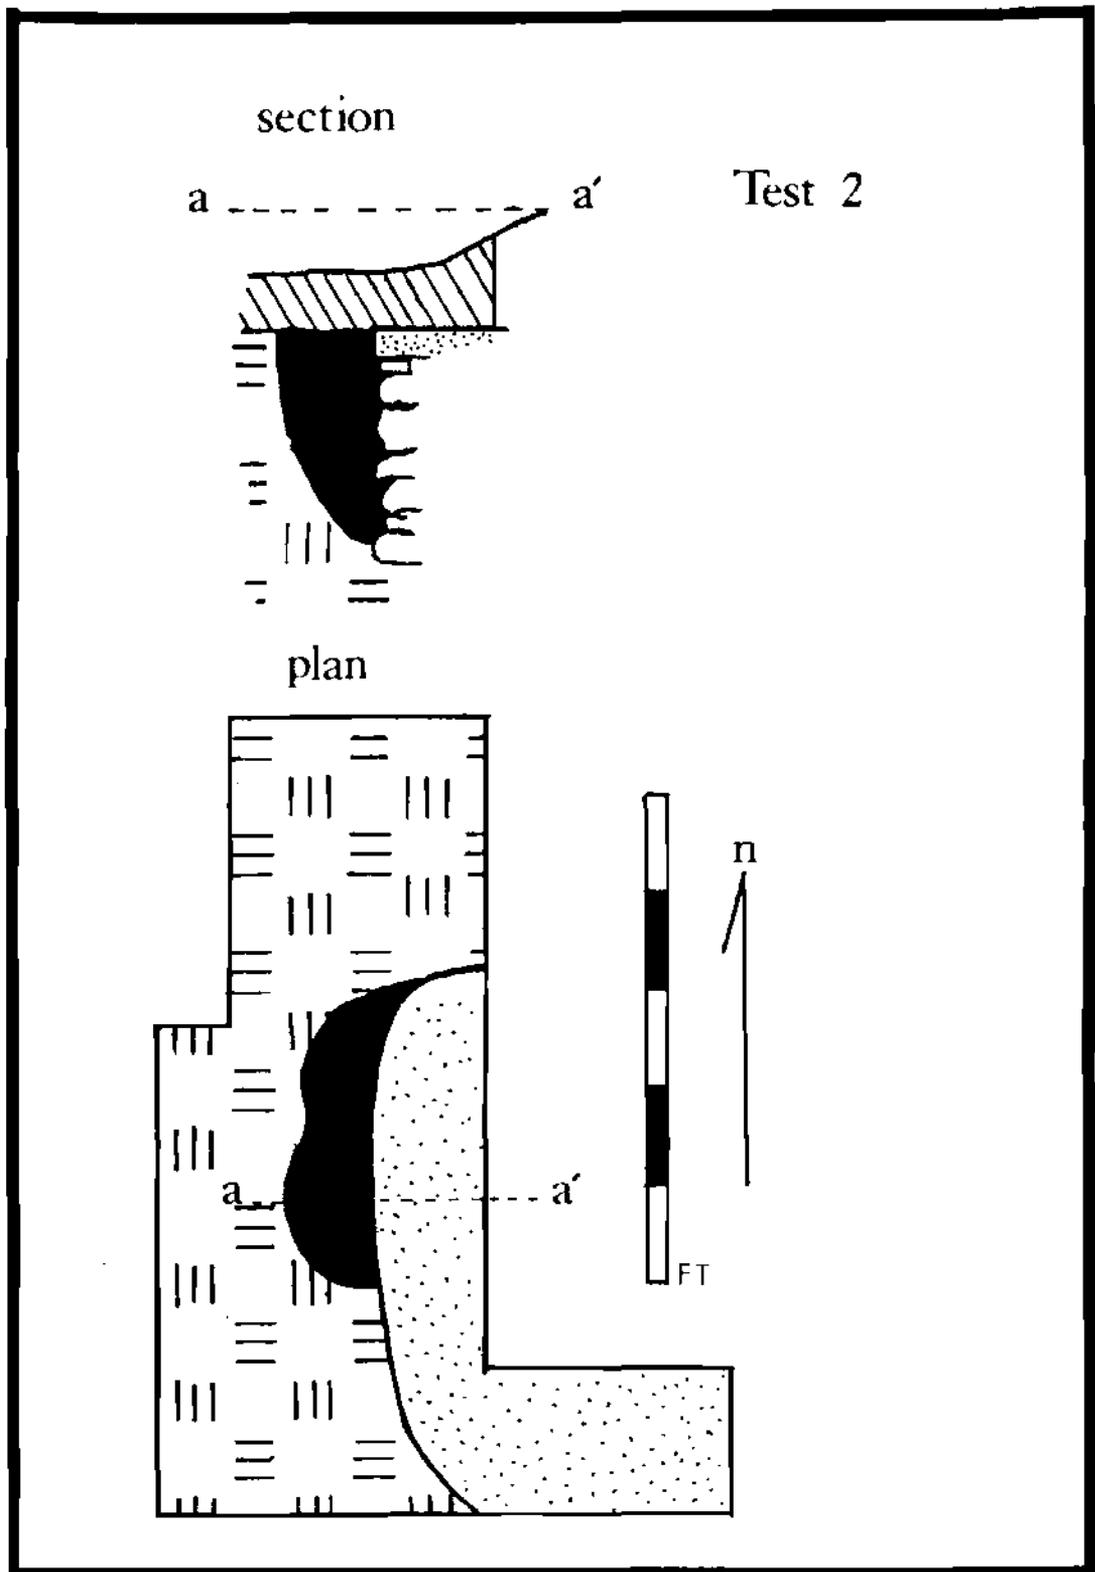
Figure 20: Test 2 Plan View and Profile

Test 2 was excavated at a point thought to be the northeast corner of the structure (see Figure 18). Under the disturbed soil, instead of a foundation wall, a cement pallet was found. At the northwest corner of the pallet, a dark stain became evident in the clay subsoil. Excavation of the stain showed it to be a builders trench containing whiteware sherds, redware sherds, glass vessel sherds, nails, bone fragments, window glass sherds and other materials including a red balloon. The trench proved to be from nine to twenty-five inches deep. Excavation of the trench also revealed a curved stone wall under the cement pad (see Figure 20). The feature would seem to be a sealed well.

The possible well and cement cap's builders trench-fill dates to the mid-nineteenth century with the exception of the balloon which is twentieth century. The excavation must have been carried out when the feature was capped and the fill might have been part of a trash midden located nearby.

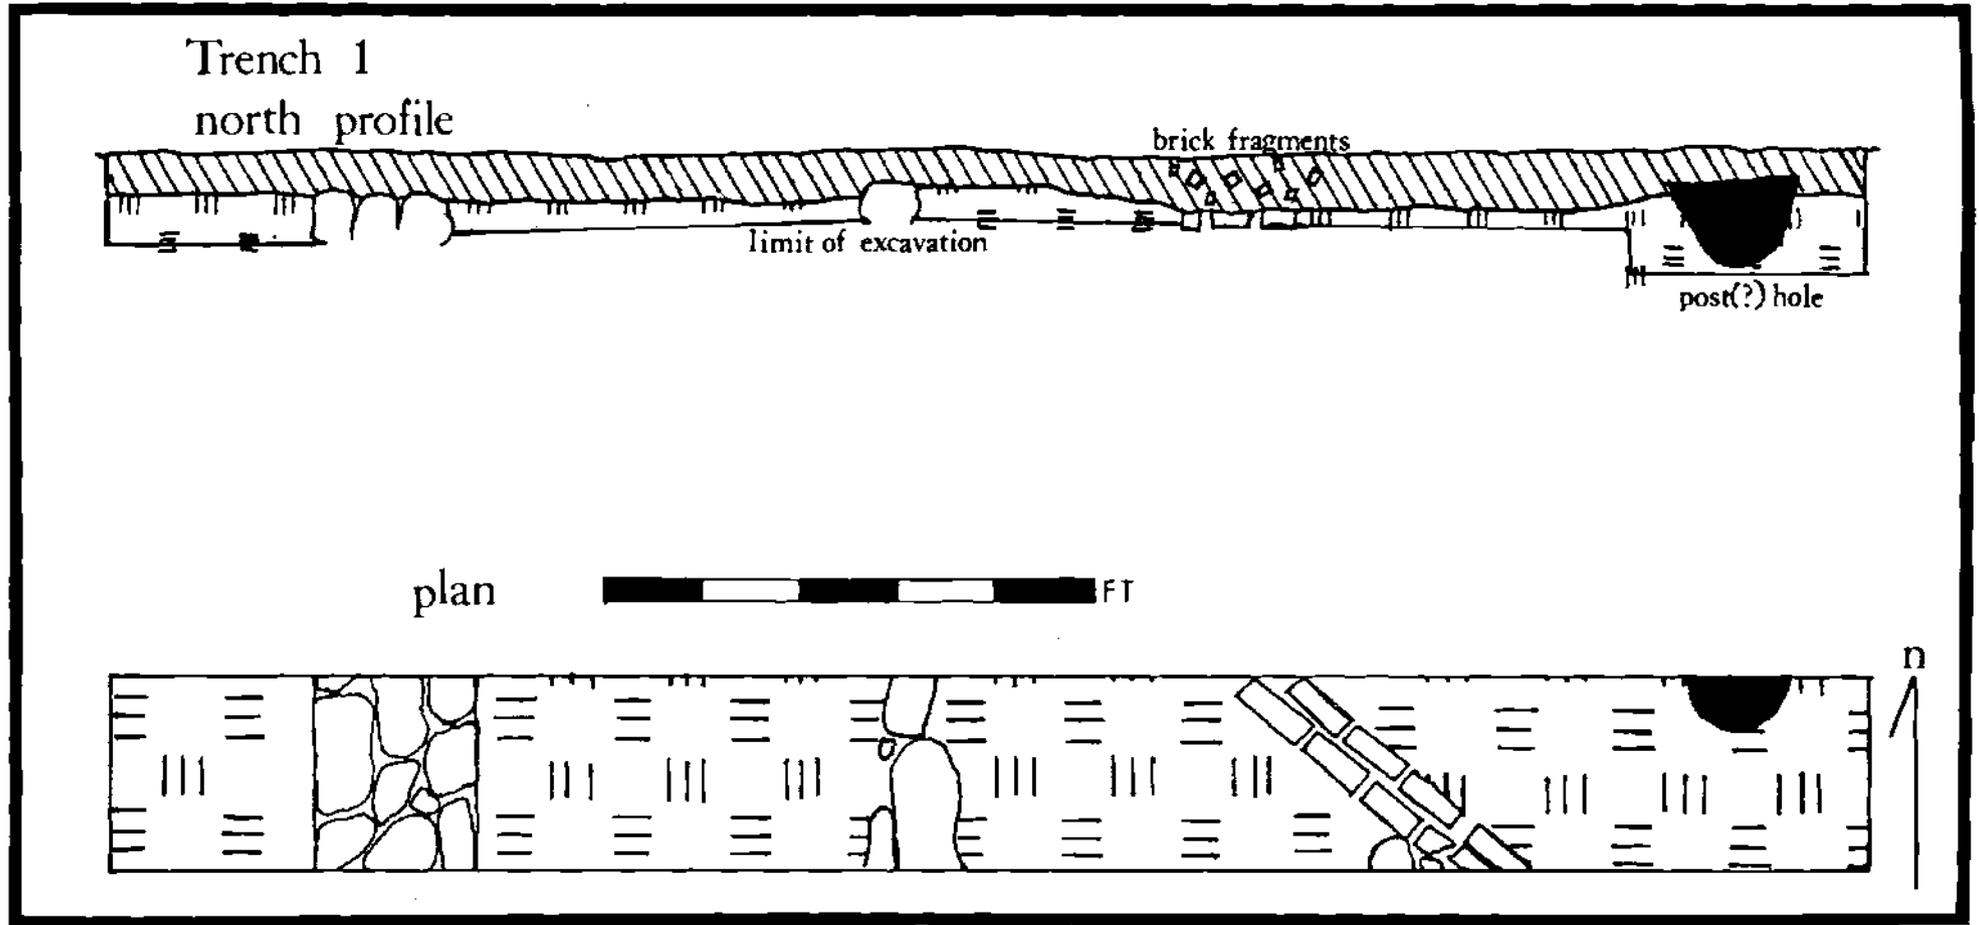
Figure 21: Trench 1 Plan  
View & Profile

Trench 1 was excavated to reveal a segment of the building's west wall (see Figure 21 and Plate IIb). Under the disturbed soil zone, a 20 inch thick segment of the west wall was found. Approximately six feet east of the west wall a second wall section was found. This wall segment was less than a foot thick. Both of the foundations were only one course of stone thick and no builders trenches were found. Nearly three feet east of the second wall segment a brick feature running diagonally was found. Four feet further east, a pit-like feature, possibly a posthole, was found (see Figure 21.) The clay subsoil was in evidence on the interior and the exterior of the foundations.
