The following is a description of each of the historic properties with the APE for this project. These locations of these properties are illustrated in Figures 20 and 21.

PREVIOUSLY EVALUATED PROPERTIES

NEWLY SURVEYED PROPERTIES

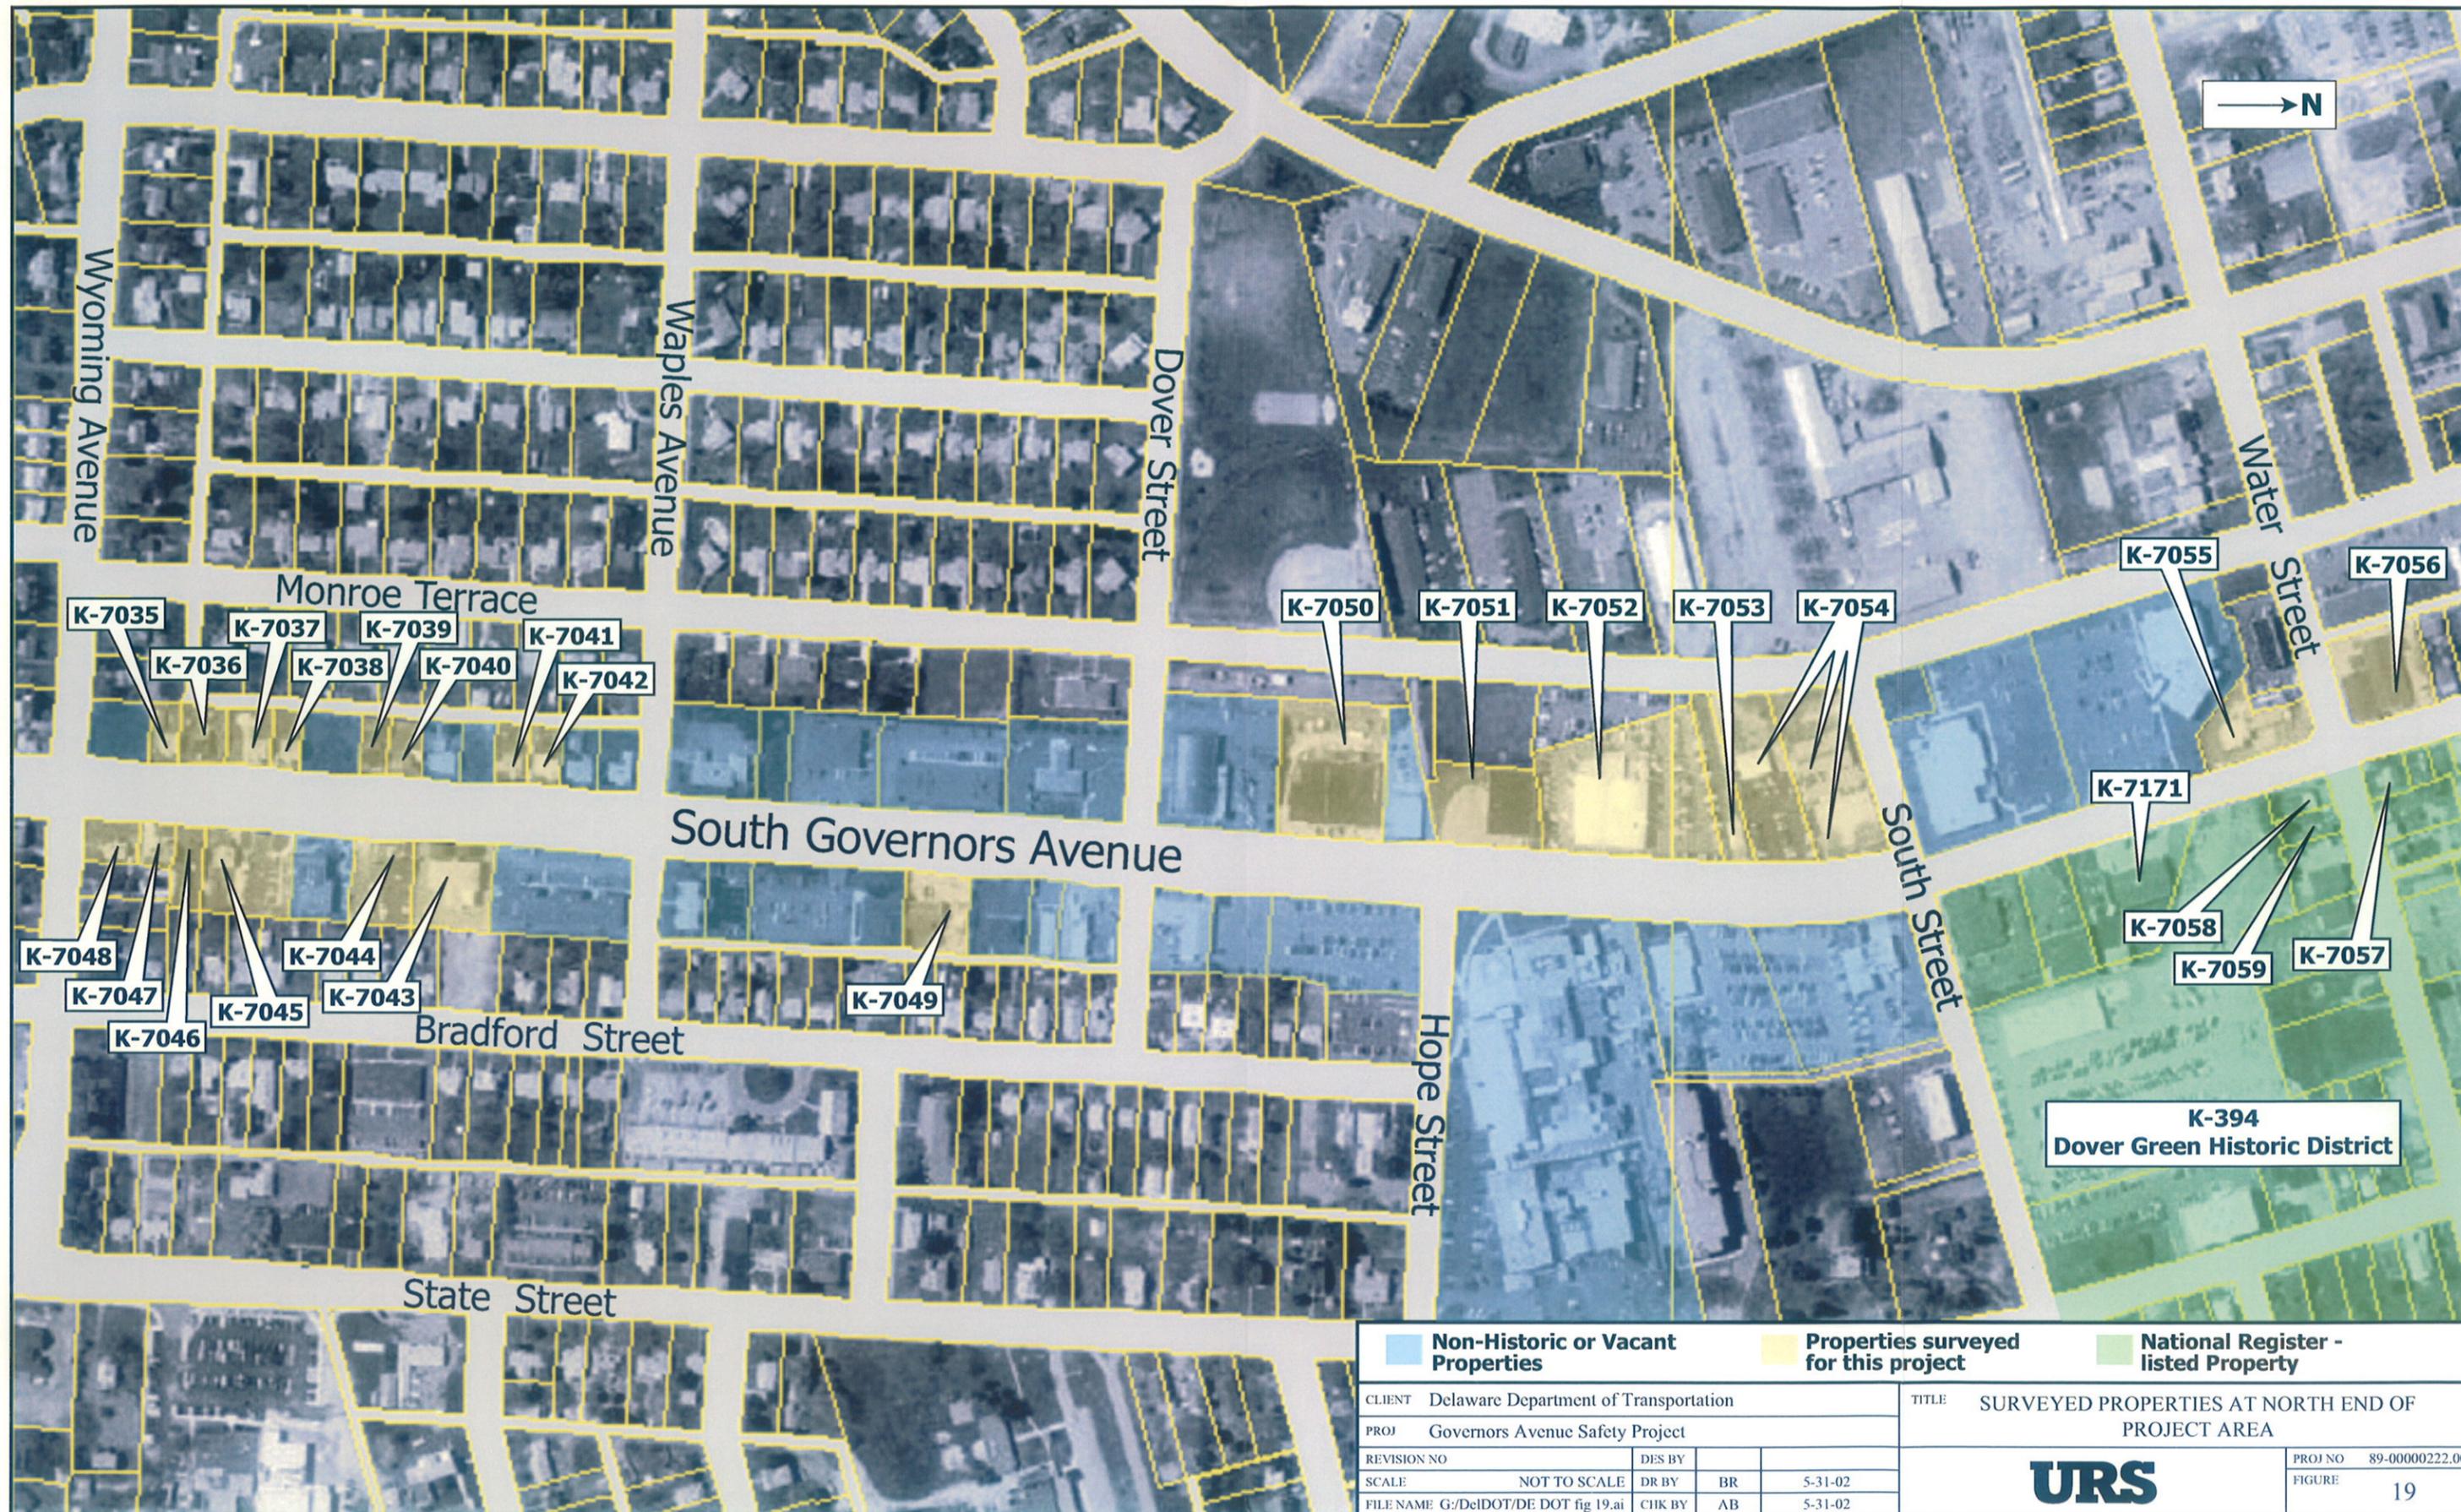
■ Non-Historic or Vacant Properties		■ Properties surveyed for this project		■ National Register - listed Property		
CLIENT	Delaware Department of Transportation			TITLE	SURVEYED PROPERTIES AT NORTH END OF PROJECT AREA	
PROJ	Governors Avenue Safety Project					
REVISION NO		DES BY				PROJ NO 89-00000222.00
SCALE	NOT TO SCALE	DR BY	BR	5-31-02		FIGURE 19
FILE NAME	G:/DelDOT/DE DOT fig 19.ai	CHK BY	AB	5-31-02

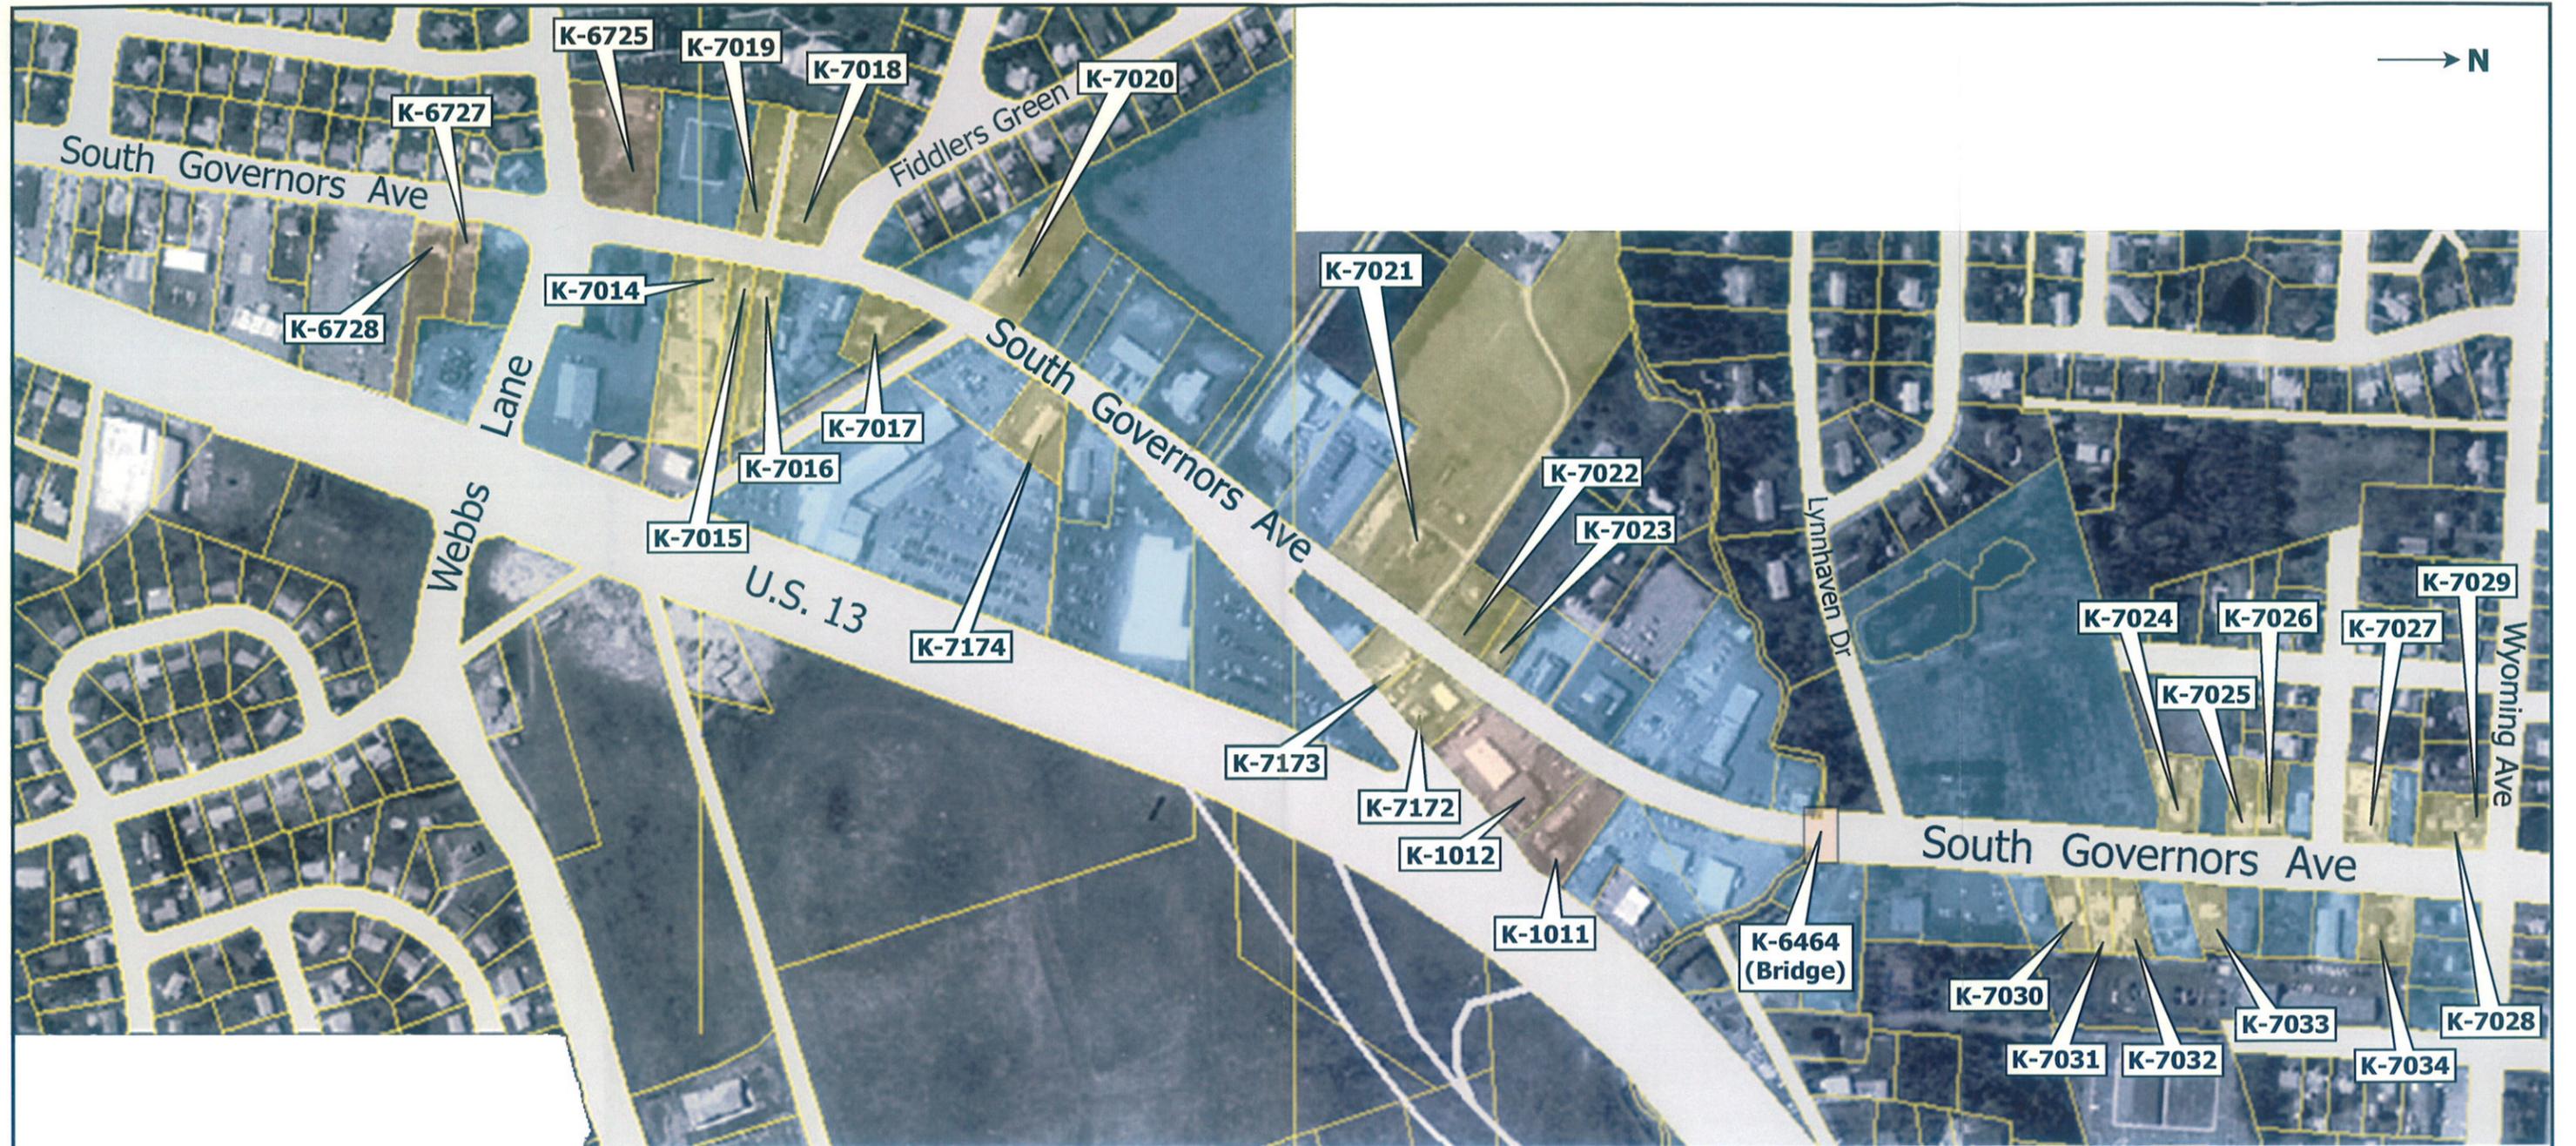
- Non-Historic or Vacant Properties
- Properties Surveyed for this Project
- Previously Surveyed Properties

CLIENT Delaware Department of Transportation				TITLE SURVEYED PROPERTIES AT SOUTH END OF PROJECT AREA		
PROJ Governors Avenue Safety Project						
REVISION NO	DES BY					FIGURE
SCALE NOT TO SCALE	DR BY	BR	5-31-02			20
FILE NAME J:/DelDOT/DE DOT fig 7.ai	CHK BY	AB	5-31-02

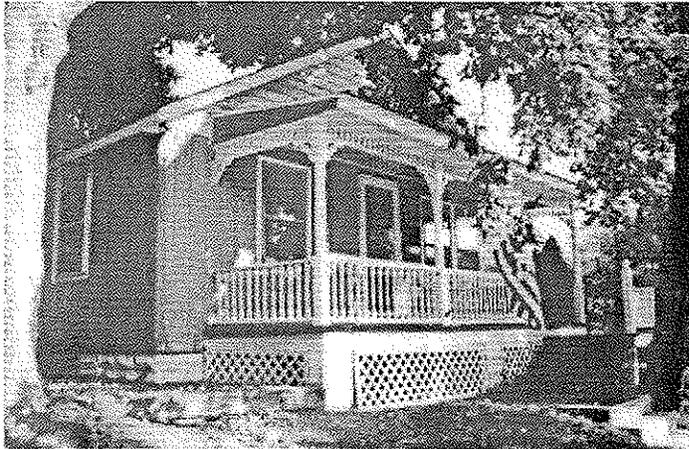
K-7057 Gable-Front Bungalow, 447 South Governor's Avenue

The building at 447 South Governor's Avenue (K-7057), built circa 1925 is a one-and-a-half story gable-front bungalow featuring a shed roof over the primary or southeastern façade. The open porch features replacement woodwork demonstrating Victorian-inspired elements, including turned posts, balustrade and brackets.

The building does not feature bay windows, a character-defining feature of the property type. In addition, extensive alterations, including the installation of T-111 plywood siding and the replacement of the original windows, have compromised the integrity of the building in design, materials, and feeling. This property lacks the necessary physical integrity to be eligible for listing in the National Register of Historic Places.

Because its integrity has been compromised, this property lacks important character-defining features of a gable-front house, as defined in the research design. The building's original wood clapboard siding has been obscured by the installation of T-111 siding. Clapboard siding is considered to be an important character-defining feature of early twentieth-century gable-front houses. In addition, the use of replacement Victorian-inspired woodwork on the front porch is more characteristic of Folk Victorian buildings than the visual simplicity that defined the later bungalow building type. Thus, this property is not considered eligible for listing under Criterion C either as a contributing resource to the Dover Green Historic District or on an individual basis.

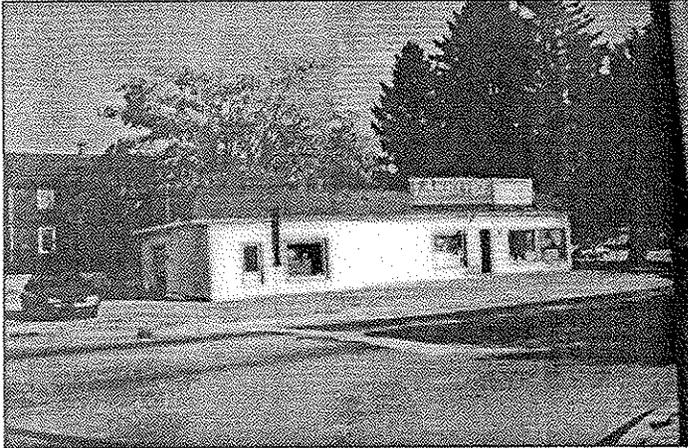
K-7058 Larrivee Hardware Design Center, 505 South Governor's Avenue

Larrivee Hardware Design Center at 505 South Governor's Avenue (K-7058) is a commercial building but may have originally served as an outbuilding for a demolished house. An interview in November 2001 with the property owner, Mr. Larrivee, revealed that the building may have been constructed in the early nineteenth century, but was substantially altered when it was converted to commercial use.

Through the drastic alterations made to the original building, key character-defining features have been obscured or replaced. More importantly, the original building is no longer discernable as a distinctive building type, as its important character-defining features have been almost completely obscured by the twentieth-century commercial addition. Similarly, the 1945 addition is not compatible with the older building in terms of materials, form, and massing. For example, the roof form is different and out of character with the building type. Thus, this property lacks the necessary physical integrity to be eligible for listing in the National Register of Historic Places.

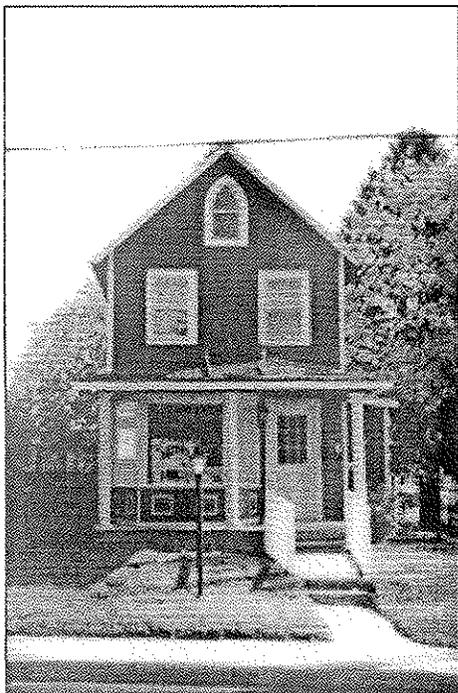
K-7059 Gable-Front House, 120 Water Street

The house at 120 Water Street (K-7059) is considered a contributing element of the district. The two-and-a-half-story gable-front residence was built circa 1890 and has been converted to commercial use. The building's exterior is faced with wooden clapboard siding with corner boards. The building includes an undecorated bargeboard in its front gable, and features a symmetrical division of fenestration, with 1/1 plain wood sash windows, and a pointed arch window in the attic on the building's primary or northern façade. The first story on the primary façade also features a modern bay window addition, flanked by a modern 6-light door. The façade is flanked by a hip roof porch featuring three wood Tuscan columns.

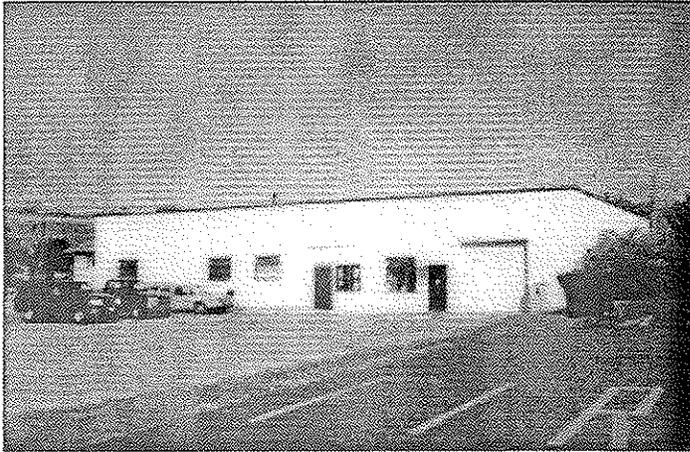
K-7171 Industrial/Storage Facility, 547 South Governor's Avenue

The industrial/storage facility at 547 South Governor's Avenue (K-7171), constructed circa 1950, features a rectangular form, exterior walls of unornamented cinder block, a flat roof, and metal multi-pane windows with pivoting center panes set in an asymmetrical fashion. The building features two metal rolling garage bay doors on its primary or eastern façade.

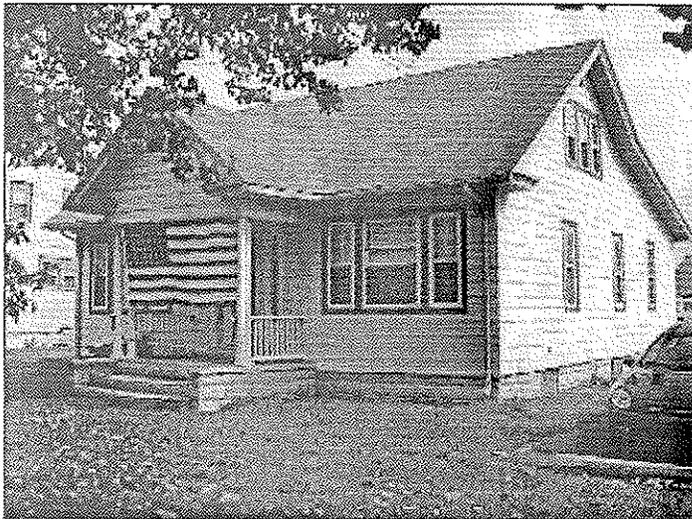
K-7014 Doll-House Kindergarten School/Side-Gable Cottage, 1339 South Governor's Avenue

This side-gable one-and-a-half-story cottage, built circa 1925, features a rectangular plan with a projecting porch and rear ell with a one-story rear shed addition. The wood frame building is three bays wide and features vinyl siding, which obscures the original wood siding. The side-gable roof also features an intersecting gable porch roof with cornice returns on the western or primary façade. The porch is wood frame with a cast concrete block foundation and wing walls with Tuscan columns. The central porch features a modern replacement door flanked by original 4-pane sidelights. The residence features regular, symmetrical fenestration on the primary or western façade with large 1/1 vinyl replacement windows flanked on either side by smaller 4/4 vinyl replacement windows.

This property lacks the necessary physical integrity to be eligible for listing in the National Register of Historic Places. Key character-defining features have been obscured or replaced, including original wooden clapboard siding, wood sash windows, and a wood door.

Because its integrity has been compromised, this property lacks important character-defining features of a side-gable cottage, as defined in the research design. The building's original wood clapboard siding has been obscured by replacement vinyl siding. Clapboard siding is considered to be an important character-defining feature of early twentieth-century side-gable cottages. In addition, side-gable cottages were notable for their wood sash windows, which the building also does not possess. This building lacks critical character-defining features associated with its property type. Thus, this property is not considered eligible for listing under Criterion C.

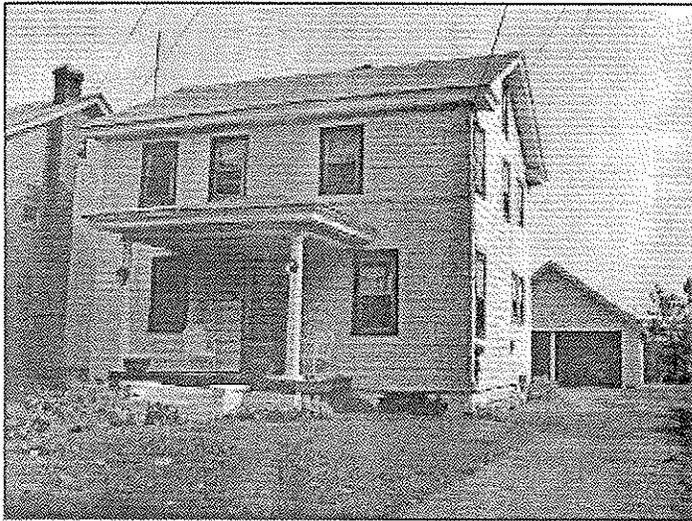
K-7015 Side-Gable House, 1333 South Governor's Avenue

This two-story, side-gable house, built circa 1900, features vinyl siding, which obscures the original wood siding. The rectangular, wood-frame building is three bays wide and features original 1/1 wood sash windows, with regular fenestration on the first floor and offset on the second floor. The building features an offset masonry chimney set below the ridgeline, and a central hipped-roof porch flanking the western primary façade, which is supported by Tuscan columns. The site also features a gravel driveway and wood-frame two-car gable-front garage, built circa 1940, which features vertical board siding.

This property lacks the necessary physical integrity to be eligible for listing in the National Register of Historic Places. Key character-defining features have been obscured or replaced, including original wooden clapboard siding.

Because its integrity has been compromised, this property lacks important character-defining features of a side-gable house, as defined in the research design. The building's original wood clapboard siding has been obscured by replacement vinyl siding. Clapboard siding is considered to be an important character-defining feature of early twentieth-century side-gable houses. In addition, side-gable houses were notable for symmetrical placement of windows (windows are not regularly spaced on the primary façade) and were often one story (this building is two stories). This building lacks critical character-defining features associated with its property type. Thus, this property is not considered eligible for listing under Criterion C.

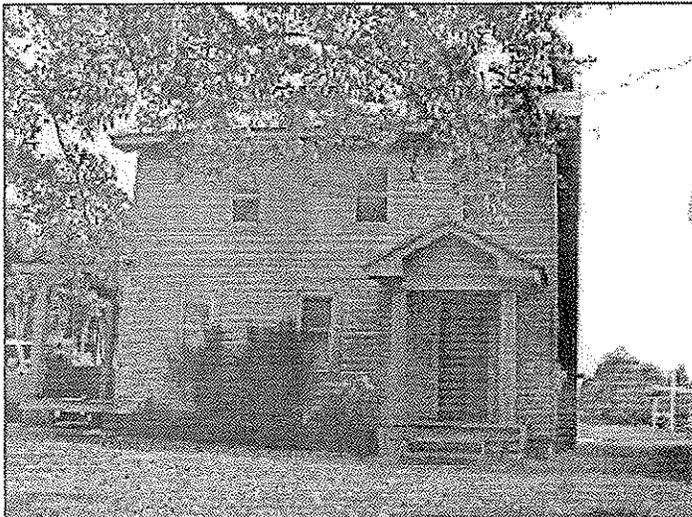
K-7016 Accu-Arc Custom Welding/Side-Gable House, 1331 South Governor's Avenue

This side-gable, two-story frame house, which was built circa 1900, features wooden drop siding and is three bays wide on its primary west façade. The gabled roof features asphalt shingles and simple box cornice with returns. Windows are 1/1 wood sash and are irregularly spaced on the 1st and 2nd floors. The primary entrance, set within the primary or northern façade, is wood paneled. The secondary entrance, an unornamented paneled wood door with an original screen door, is located at the southwestern corner of the western façade. The building features a gabled porch with simple wood supports flanking the western façade, and an enclosed hipped-roof porch flanking the northern façade. A front-gabled wood frame garage, circa 1935, with wood siding is situated to the northeast of the residence. Asymmetrical arrangement of the building's windows may be an indication of alteration either through the addition of an upper story or the relocation of windows.

This property lacks the necessary physical integrity to be eligible for listing in the National Register of Historic Places. Key character-defining features have been obscured or replaced, including the gable-roof porch addition, which obscures the primary façade.

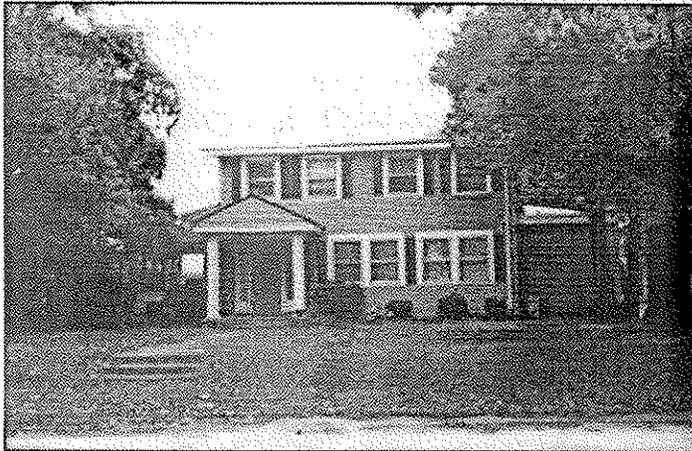
K-7017 KB's Plumbing/Side-Gable House, 1305 South Governor's Avenue

A frame side-gable house, this example dates to circa 1915 and features two stories and incorporates Colonial Revival details, including a pediment porch entrance and an end gable with a cornice following the rake. The pediment porch features a wood door flanked by sidelights. The frame building features vinyl siding, which obscures the original clapboard, and one-story enclosed additions on the south, north and east façades. The foundation consists of pressed, textured concrete block, and the building features a masonry exterior chimney on the south façade. The gabled roof features modern asphalt shingles. The original wood windows have been replaced with vinyl-clad units. The building is three bays wide (typical of side-gabled houses). The site also features a circa 1960 side-gable garage to the southeast of the residential structure. The residence is flanked by several mature deciduous and coniferous trees.

This property lacks the necessary physical integrity to be eligible for listing in the National Register of Historic Places. Key character-defining features have been obscured or replaced, including the original wood clapboard siding. Furthermore, enclosed additions on three of the building's four façades have interrupted the historic massing and scale. Because of these additions, the building does not maintain the architectural rhythm and symmetrical division

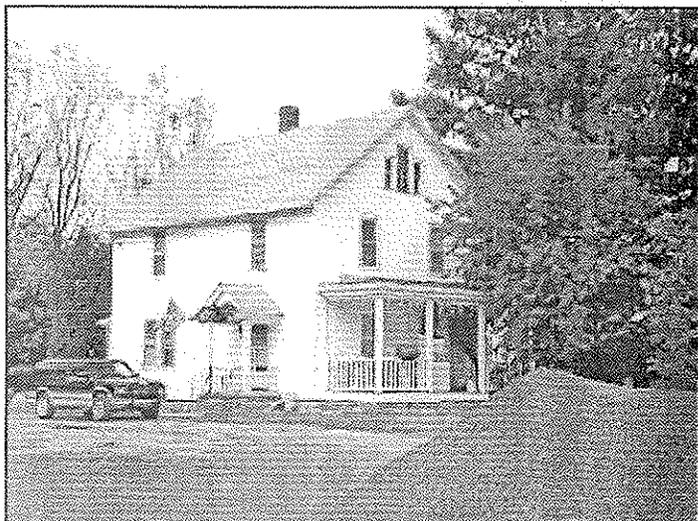
This gable-front two-story house, built circa 1905, features a rectangular plan and a hip roof porch, which is open with wood posts and square balusters and that shelters the eastern or primary façade. The building is faced with asbestos shingles obscuring the original wood materials. The foundation is brick masonry, and the building features a corbelled brick masonry chimney set along the central roofline, with a secondary exterior masonry chimney flanking the west façade. The building features original 1/1 double-hung wood sash windows, and a tripartite window atop the original door in the eastern façade's gable. The primary functional entrance has been moved to the rear or western façade. A small rectangular garage, built circa 1930, is placed to the southwest of the primary building. The gabled garage features double sliding doors and is covered with sheet metal.

This property lacks the necessary physical integrity to be eligible for listing in the National Register of Historic Places. Key character-defining features have been obscured or replaced, including the building's original wood clapboard siding. The use of wood is identified as an important, character-defining feature for this property type.

Because its integrity has been compromised, this property lacks important character-defining features of a side-gable cottage, as defined in the research design. The building's original wood clapboard siding has been obscured by replacement vinyl siding. Clapboard siding is considered to be an important character-defining feature of bungalows. In addition, open-air porches were an important design feature of this property type. This building lacks critical character-defining features associated with its property type. Thus, this property is not considered eligible for listing under Criterion C.

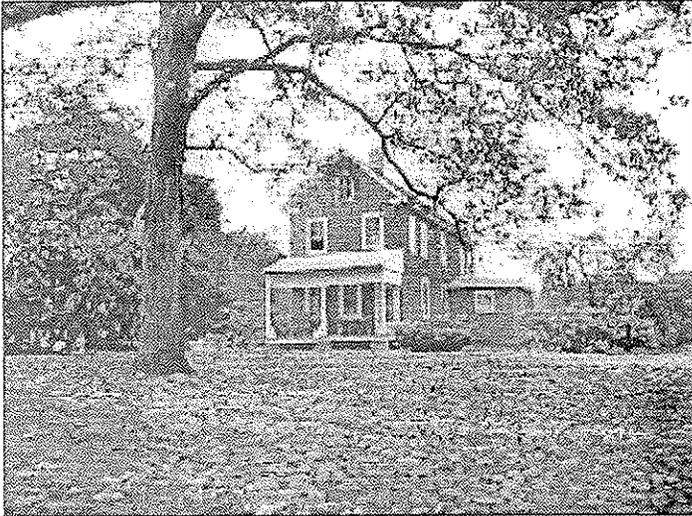
The house at 1198 South Governor's Avenue is a two-and-a-half-story frame gable-front house constructed circa 1880-90. The house is two bays wide and three bays deep and is built on a side-hall plan under a front gable roof. The foundation is brick and siding consists of "brick patterned" asbestos panels on the first floor and asbestos shingles in an ornamental shape on the second floor.

Two one-story additions were added on the west end of the north and south façades. Both of these additions rest on concrete foundations with hip roofs. The southern addition appears to be an enclosed porch and bathroom. The northern addition may be a kitchen addition. Both additions were added in the early twentieth century.

This building lacks critical character-defining features associated with its property type. Although the site displays character-defining features of a “house and garden” agricultural complex, the residential building (a critical feature of the site’s property type) is missing a key character-defining feature of the Folk Victorian and gable-front residential property types. The use of patterned asphalt siding obscures the building’s original wood clapboard siding, which is an important character-defining feature of the period of significance and property type. This prevents the building from displaying important information about its original design and property type. Although the overall site and building retain physical integrity for listing under Criterion A, the residential building is not considered a significant and excellent representative example of its property type. Thus, this property is not considered eligible for listing under Criterion C.

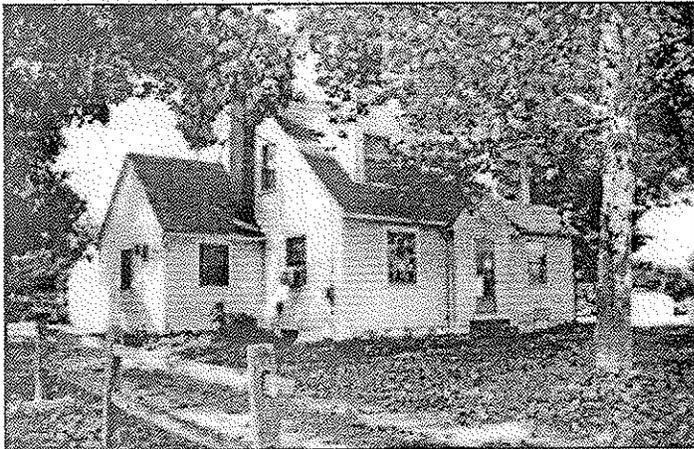
This one-and-a-half story side-gable cottage, built circa 1940, features a center hall plan and two front gable dormers punctuating the primary or eastern façade. The wood frame building is three bays wide and features a large rear shed roof one-story addition flanking the western façade. The exterior walls feature vinyl replacement siding that obscures the original wood siding. The foundation is faced with ornamental concrete block. The window openings maintain regular fenestration, but feature 6/6 vinyl replacements. A window flanks each side of a central primary entrance on the eastern façade. The central entrance is set beneath a front-gable protrusion, and features a vinyl unornamented door. The southern façade is flanked by a small gabled addition. A small gable-front shed and garage are set to the west of the cottage, set along a rough dirt road.

and an ornamental concrete block foundation. The primary or eastern façade features a central entrance set in the porch, consisting of a divided light wood door. The building features original clapboard on all façades, and 1/1 double-hung wood sash windows. The building features an enclosed chimney set along the ridgeline. There is a small gabled rear entrance asymmetrically placed on the western façade. A metal shed, built circa 1970, is set to the northwest of the building.

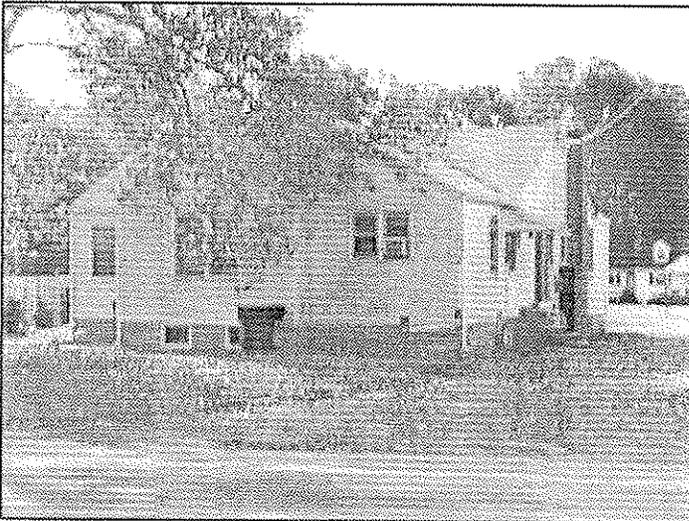
This one-story bungalow, which was built circa 1930, features a cross-gable roof with a projecting gable on the eastern or primary façade. The foundation is of poured concrete, and the building's exterior is faced with composition board, which obscures the original siding. The building's windows are 1/1 double-hung sash with irregular spacing. The building's original entrance, on the eastern façade, has been covered over. Two sliding doors along the north façade now serve as the primary entrance. A small gable completes the cross on the building's western façade. The northern façade is surrounded by a parking lot. The bungalow currently serves as an apartment.

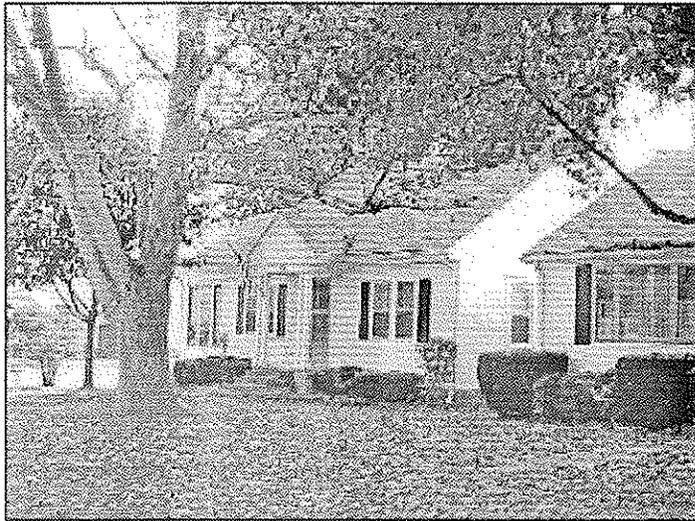
This one-story side-gable cottage, built circa 1940, features a typical 3-bay rectangular center-hall plan. The exterior siding consists of composition board, and the building features 1/1 double-hung sash wooden windows, symmetrically placed and paired on the eastern or primary façade. The façade also features a central gabled entrance with a multi-light door, and paired Tuscan columns. The building features an exterior masonry chimney on the southern façade, and is also flanked by a gabled addition (enclosed porch) on the southern façade. A small gable-front garage, built circa 1940, is set to the west of the primary building. A large sycamore partially obscures the eastern façade.

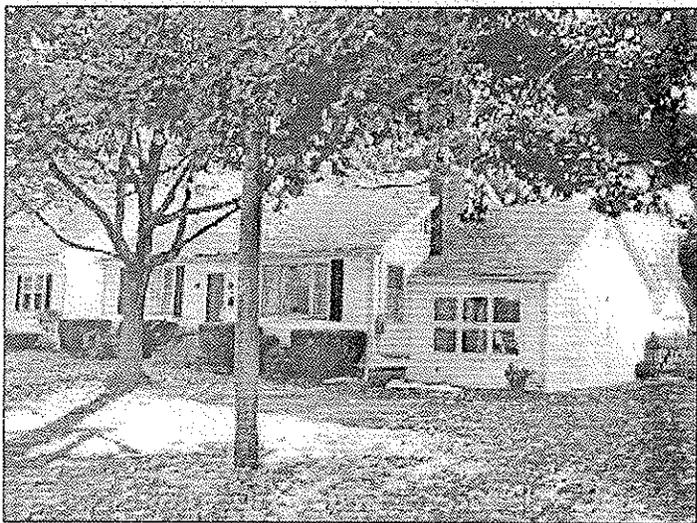
This one-story side-gable cottage, built circa 1940, features a typical 3-bay rectangular center hall plan. The original siding has been obscured by vinyl replacement siding. The building also features 1/1 sash double-hung vinyl-clad replacement windows, with the exception of two “Chicago style” windows that flank either side of the central entrance on the eastern primary façade. The building features a concrete foundation and a small side-gable entrance flanking the northern façade.

This property lacks the necessary physical integrity to be eligible for listing in the National Register of Historic Places. Key character-defining features have been obscured or replaced, including the building’s original wood clapboard siding and wood sash windows.

Because its integrity has been largely compromised, this property lacks important character-defining features of a side-gable cottage, as defined in the research design. The building’s original wood clapboard siding has been obscured by replacement vinyl siding. In addition, many original windows have been replaced with vinyl-clad units. This building lacks critical character-defining features associated with its property type. Thus, this property is not considered eligible for listing under Criterion C.

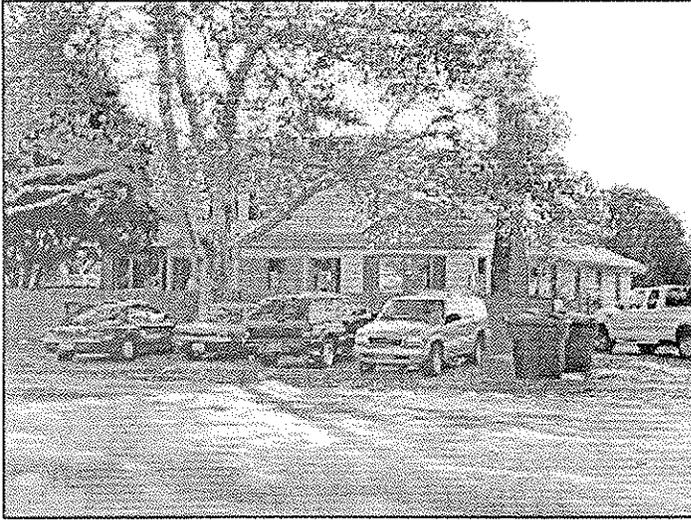
This two-story side-gable building, originally a residence, was built circa 1900 and features 6/6 double-hung wood sash windows. The side-gable roof features molding with box cornice returns. The building's primary or eastern façade features a brick veneer recessed porch with wood square posts and beaded vertical wood siding, with an asymmetrical 6-paneled unornamented wood door. The original side-gable residence is flanked by large recent additions on the north façade and west façade. The additions are covered with aluminum siding.

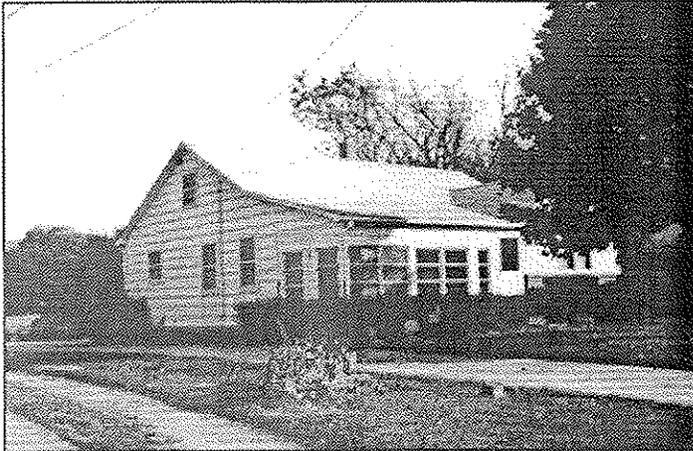
This side-gable cottage is one-and-a-half stories in height. Constructed circa 1950, the building features an enclosed front porch along its western façade, with louvered fenestration. The building is clad with composition board and brick veneer, and an interior chimney set along the gable ridge. The building is flanked by an attached gabled garage along the east façade.

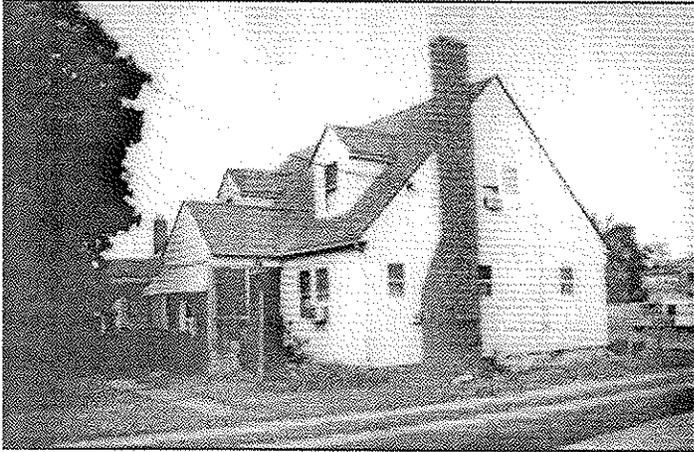
This side-gable cottage is one-and-a-half stories in height. Constructed circa 1945, the building is clad with composition board and features a central gable entrance on the primary or western façade. The porch for this entrance was once open but has been enclosed. The entrance is flanked by 1/1 sash wood windows on either side, and also features two front gable dormers and an exterior masonry brick chimney.

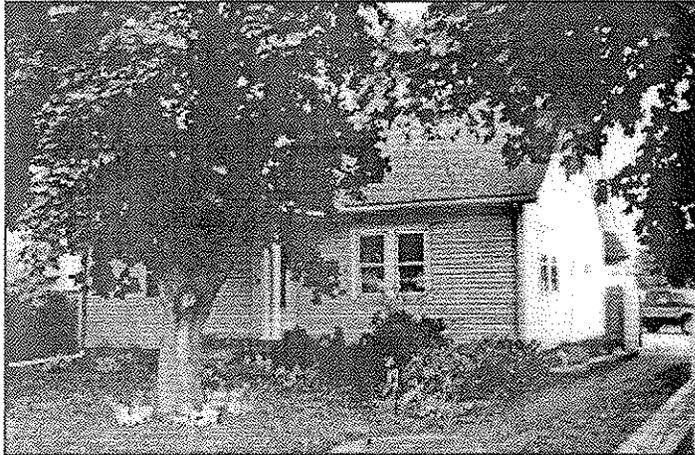
The side-gable cottage, one-and-a-half stories and constructed circa 1945, features vinyl replacement siding. The foundation is of poured concrete, and the simple frame building features 1/1 sash vinyl replacement windows. The building features a gabled primary replacement vinyl door in the primary or western entrance, and is flanked by a rear gabled addition on the eastern façade. The gabled entrance is flanked on either side by vinyl replacement windows, and the entrance featured poured concrete Tuscan columns.

This property lacks the necessary physical integrity to be eligible for listing in the National Register of Historic Places. Key character-defining features have been obscured or replaced, including the building's original wood clapboard siding and wood sash windows.

Because its integrity has been compromised, this property lacks important character-defining features of a side-gable cottage, as defined in the research design. In particular, the replacement of its exterior wood siding and simple double-hung windows prevent the building from being identified as an exemplary specimen of its building type. Therefore, this property is not considered eligible for listing under Criterion C.

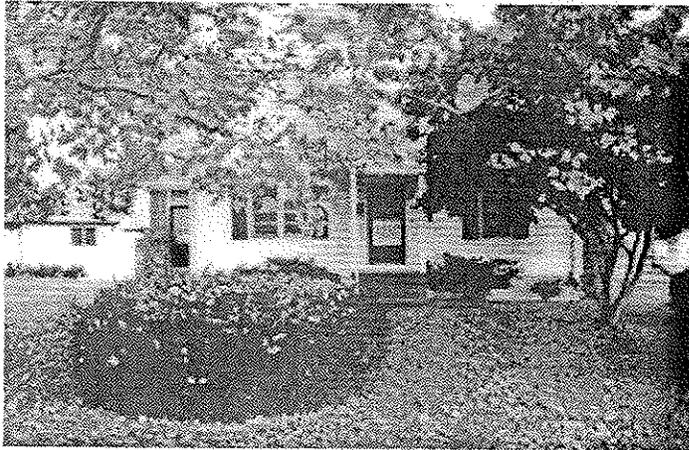
This minimal traditional one-story building, built circa 1945, features a low-pitched hipped roof. All exterior façades are covered with composition board. The primary or western façade features a central gabled entrance with a simple wood door. Irregularly spaced fenestration features 2/2 double-hung wood frame windows. The building's northern façade is flanked by an enclosed shed roof porch with unornamented wood posts.

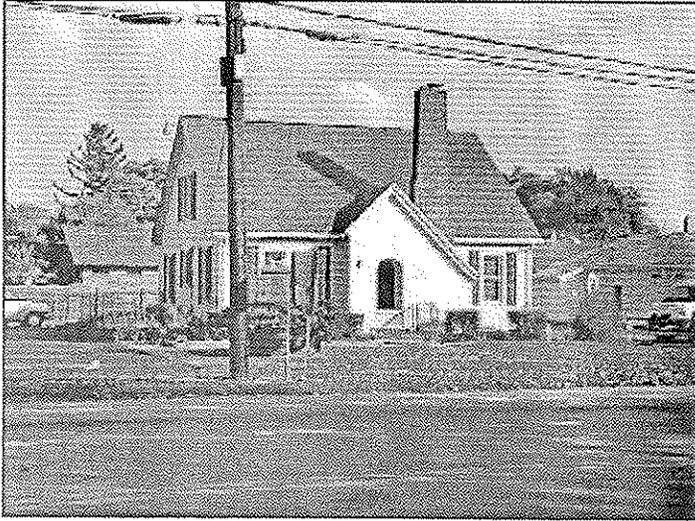
This one-story Tudor Revival cottage, built circa 1930, features an arched central entrance on the primary or western façade. The recessed door also features an arched top. The rectangular, side-gable building features vinyl siding on its exterior façades, which obscure the original masonry material. The building also features 1/1 double-hung vinyl-clad replacement windows. The building's eastern façade has a large modern, flat-roof addition, which connects the building to a gabled structure, possibly the original garage.

This property lacks the necessary physical integrity to be eligible for listing in the National Register of Historic Places. Key character-defining features have been obscured or replaced, including the building's original masonry siding and wood sash windows. In addition, the flat-roof addition is not consistent with the form, massing or materials of the original building.

Because its integrity has been compromised, this property lacks important character-defining features of a side-gable cottage, as defined in the research design, including the building's original masonry siding and wood sash windows. Exterior materials that reflected both standardized production and rustic (textured) appeal were important. In addition, the building's flat-roof addition is not consistent with the form, massing or materials of the original building. Therefore, this property is not considered eligible for listing under Criterion C.

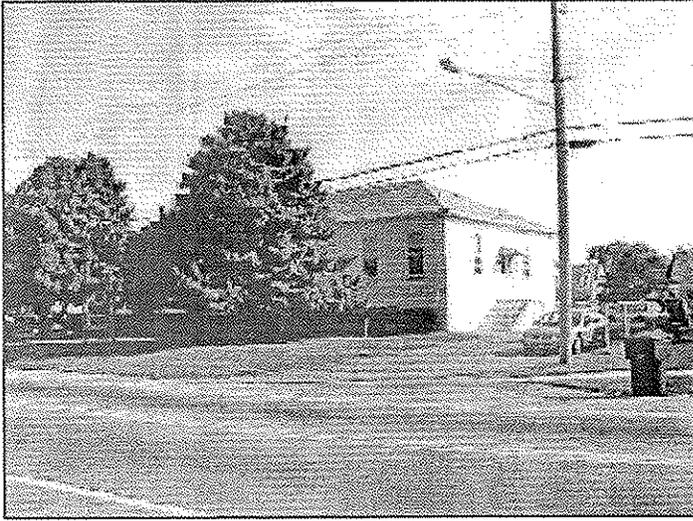
The Capital Grange Hall building faces west and is located at 911 South Governor's Avenue. It was constructed in 1949-50 by the Grange members as their permanent meeting hall to replace a series of rented spaces. The T-shaped building is constructed of concrete block masonry with brick details. The exterior is parged with a cementitious material, leaving a cornerstone at the south end of the west façade exposed. This stone bears the inscription "Capital Grange 1950." Two large holly trees, which were likely planted at the time of construction, grace the lawn on either side of the front walk.

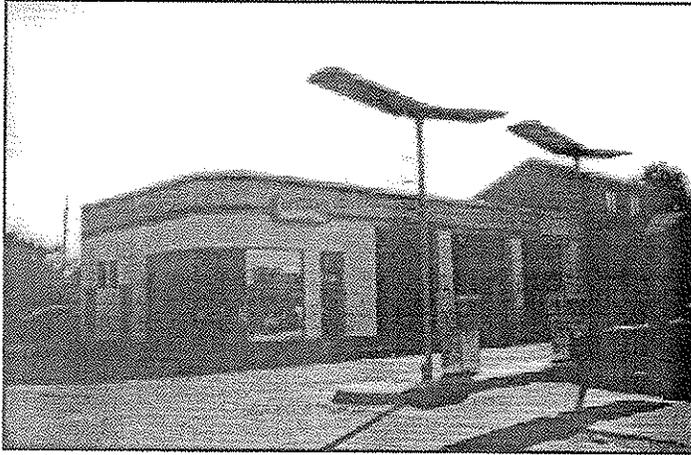
The gas station located at 825 South Governor's Avenue was constructed circa 1940. The building is constructed of porcelain enamel panels hung on a steel frame. Historic multi-pane rolling doors shield the three car bays on the main façade. A standard size door enters into an office with a canted corner with a large plate glass window. The building contains restrooms along the south side with exposed concrete block construction to the rear. Islands with historic lights are still located in the front, although the original gas pumps have been replaced with newer pumps.

In its construction, form, and materials, Joe's Garage is a representative and fairly intact example of gas station architecture from the 1940s. Typical stations of this era were porcelain enamel on metal frame boxes "with aluminum accents and all-glass fronts" (Margolies 86). The choice of porcelain enamel panels was quintessential in station design of the period, as it was "perfectly suited for use in gas stations. It was inexpensive (at least it was then) and it was durable and nearly maintenance-free. Its baked enamel surface was impervious to damage, and could be easily cleaned by hosing it off." (Margolies 96). According to Daniel Vieyra such materials were frequently employed in what he refers to as "Streamlined Moderne" gas station designs:

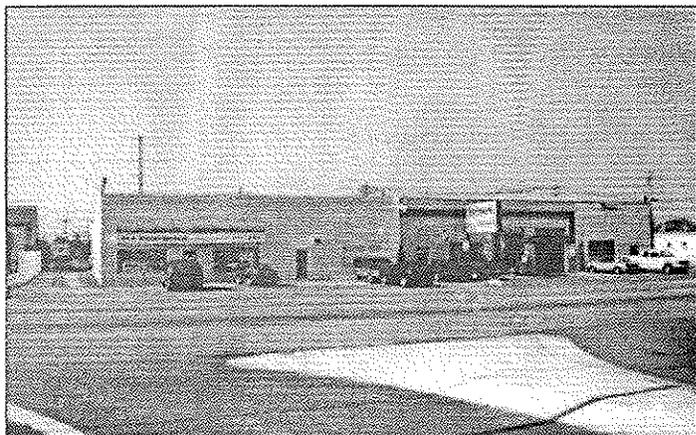
This one-story commercial enframed window wall building, built circa 1945, features a flat roof with a stepped parapet along the east and west façades. Beneath the parapet are expansive bays of rolling metal doors. The exterior walls are faced with parged concrete block, although vinyl replacement siding has been added to 720 and 722 South Governor's Avenue. The eastern or primary façade features four paired plate glass windows, each flanked by a metal and glass door, and interrupted by a pair of metal rolling doors indicating a car bay. The fenestration on the southern façade is three pairs of 12-pane fixed metal frame windows, and four 25-pane metal frame windows along the northern façade (with one opening filled in). The western façade features three rolling metal doors for car bays.

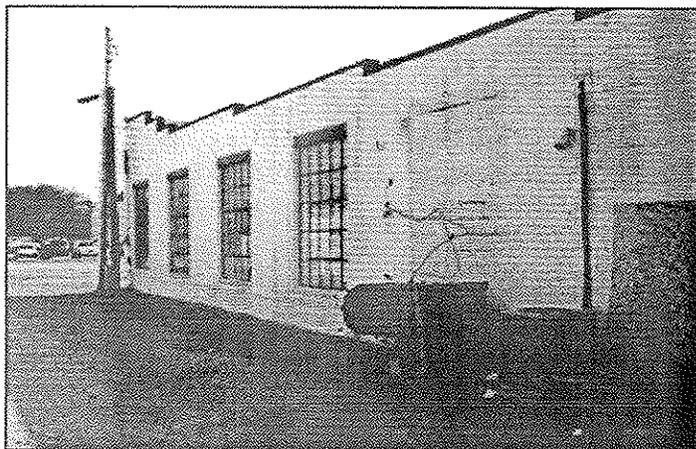
This one-story commercial building, built circa 1945 features simple, unornamented features. The exterior walls along the primary or eastern façade feature a tan brick veneer placed over the original concrete block construction found on other exterior walls. The roofline features brick corbelling above a belt course of rowlocks. Large plate glass openings have replaced the original multi-paned steel windows along the primary or eastern façade. Three bands of plate glass are flanked by metal doors, with a simple wood shed roof over the northern door. The north façade features three large multi-pane steel windows.
