The following is a description of each of the historic properties with the APE for this project. These locations of these properties are illustrated in Figures 20 and 21.

PREVIOUSLY EVALUATED PROPERTIES

NEWLY SURVEYED PROPERTIES

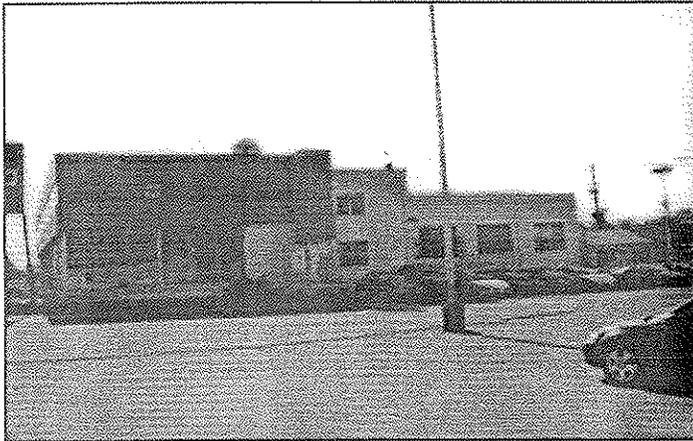
This two-story automobile showroom, built circa 1945, features a central shed roof flanked by two smaller arched roofs, all with parapets. The primary or eastern façade was altered when it was encased in metal panels in 1971. This façade also features a continuous wall of spandrel windows. The northern, southern and western façades feature the building's original multi-pane large steel frame windows with pivoting center sections. There are three garage bay entrances at the rear western façade.

Key character-defining features have been obscured or replaced, including the encasement of the original primary façade with replacement metal panels in 1971. Interior alterations have also

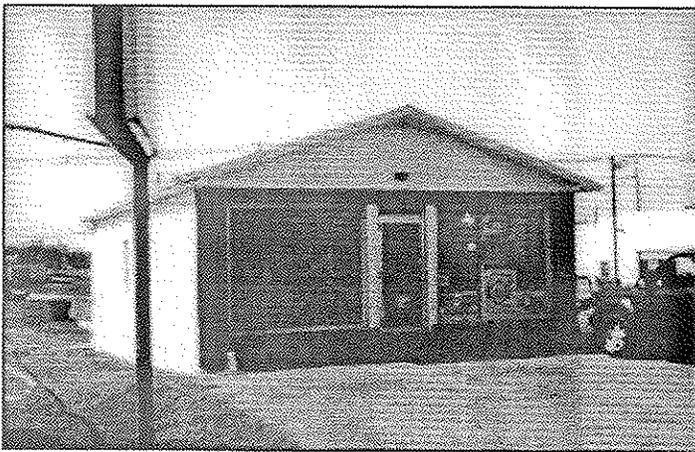
The one-story commercial enframed window wall building, built circa 1950, features concrete block walls with brick veneer on the eastern primary façade. Two large plate glass windows flank the central metal and glass door. The rear western façade features a rolling metal door, indicating a car bay. Two 6/6 steel framed windows punctuate the southern façade. The building features a flat roof.

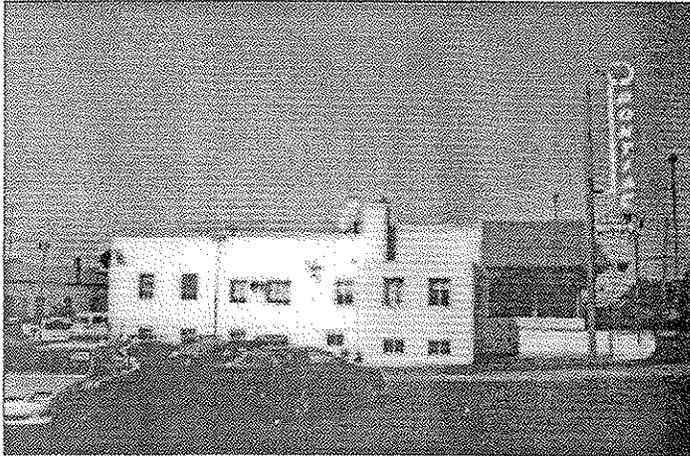
The Matthews Pontiac property at 600 South Governor's Avenue consists of four historic buildings and a historic sign. The main building was rebuilt after a fire in 1952, although portions of the foundation date to the original construction in 1936.

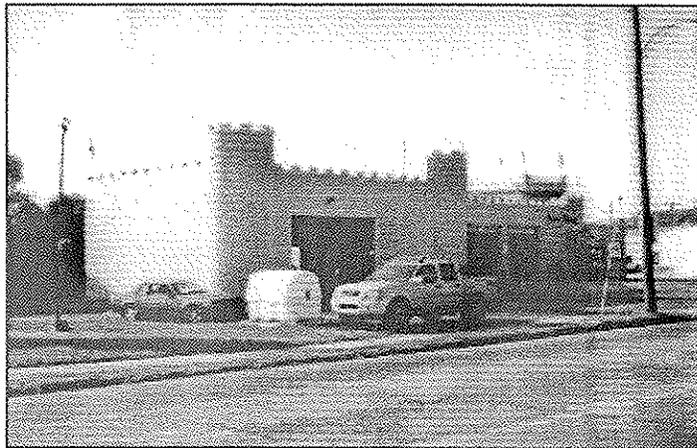
This one-story automotive service building, built circa 1955-1960, features crenellated concrete block along the eastern or primary façade, joined to a false turret set atop the southeast corner. The exterior walls feature parged concrete block, and 4-pane steel frame windows on the north and west façades. The primary façade features three garage bays.

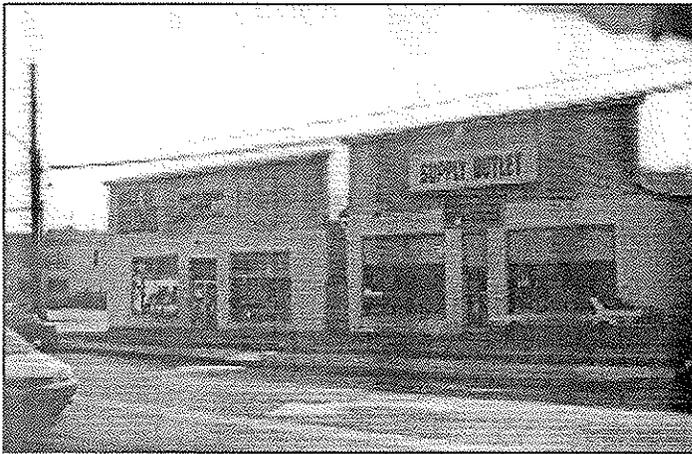
The building at 446-448 South Governor's Avenue was constructed in two phases. The northern portion (446) was constructed in circa 1932-33 and southern portion (448) was added circa 1934-35. Both portions are similar in style, form, and materials. They are both front-gable masonry buildings constructed of ornamental concrete block cast to look like rough-cut stone. Each has a false-front high-frame parapet with modest cornice.

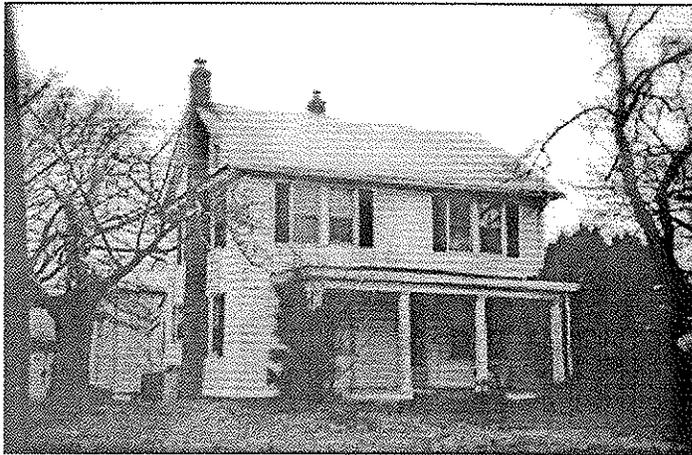
This side-gable, two-story house, built circa 1925, features Colonial Revival features including a pedimented box cornice. The exterior walls feature composition board, and the eastern or primary façade features a central door flanked by a shed roof open porch with simple square posts. The building features 1/1 double-hung replacement vinyl-clad windows flanked by black vinyl shutters.

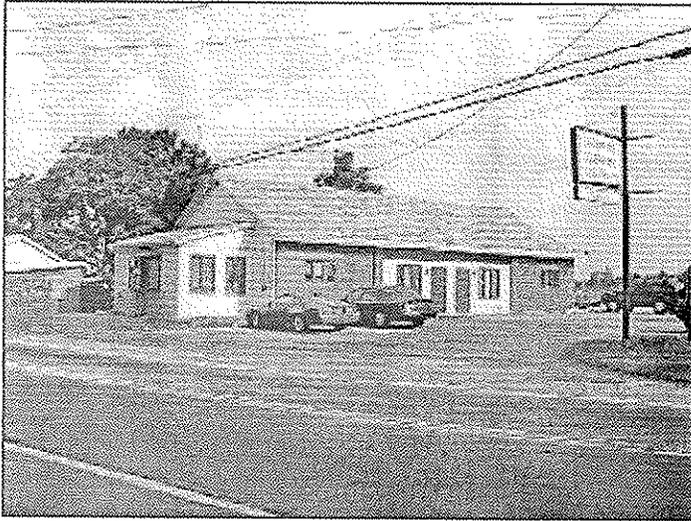
This one-story simple gable-front commercial building, built circa 1940, features concrete block exterior walls. The southern façade has a brick veneer that obscures the original wall material. A projecting addition on the western or primary façade has filled in original fenestration with masonry. The building features vinyl-clad replacement windows. Two metal doors are located in the center of the southern façade.

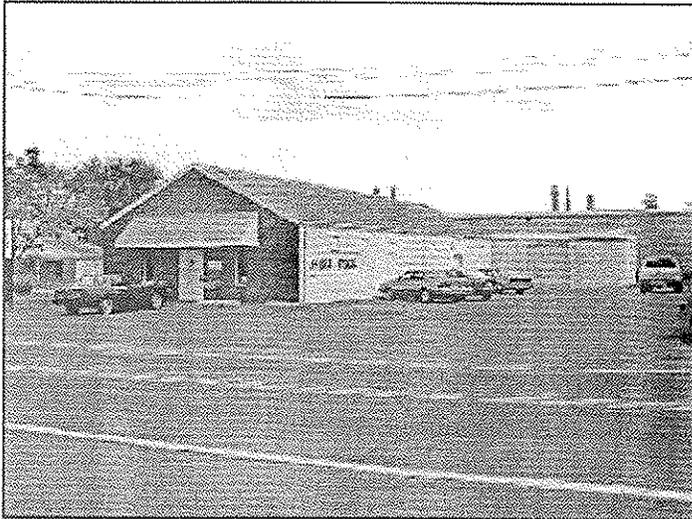
This simple one-story commercial building features a gable-front façade with a modern encased window wall. Constructed ca. 1940, the building originally had a concrete block exterior. A brick veneer obscures the original exterior material on the primary or western façade. A recent shed addition also obscures the primary entrance, which features a central replacement door. The building also features original fenestration openings along the east and west façades, which have been bricked in but have original projecting brick masonry sills. A small garage addition features a rolling metal bay door.

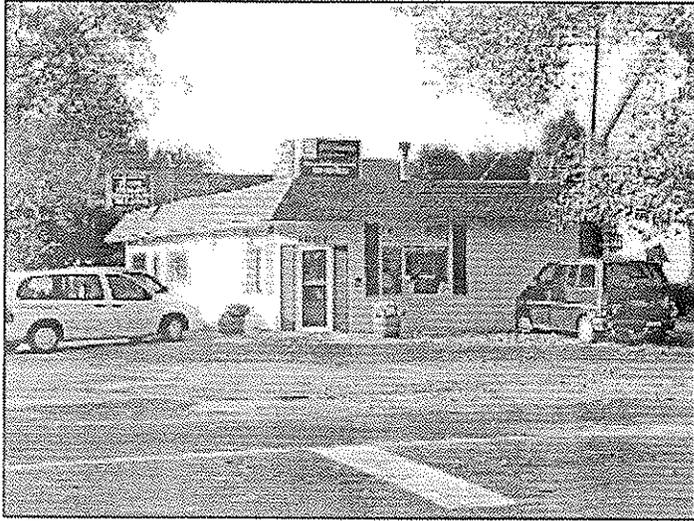
Special consideration was given to the commercial building at 1002 South Governor's Avenue, which may be taken under the proposed improvement project.

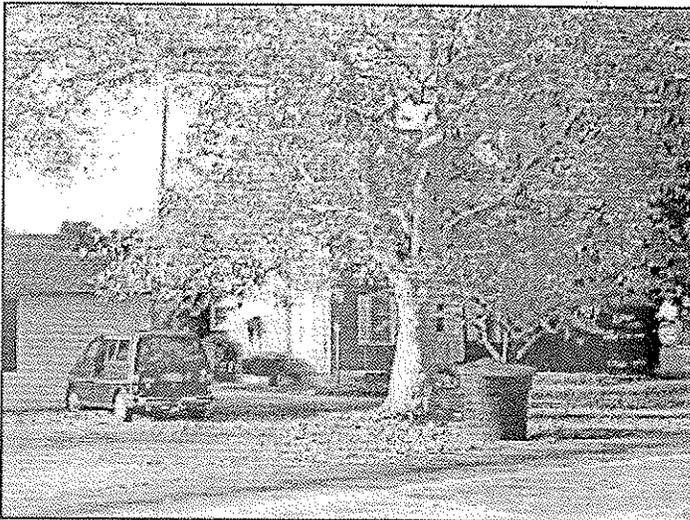
This two-story, side-gable house features a central entrance on the north or primary façade. The entrance is unsheltered and is flanked by 1/1 wood double-hung sash windows with louvered shutters, which are symmetrically placed in the rest of the building. The building features white clapboard trim and unornamented side-gables. The building is flanked by a historic gable front clapboard garage, constructed circa 1930, which is located to the southeast of the house.

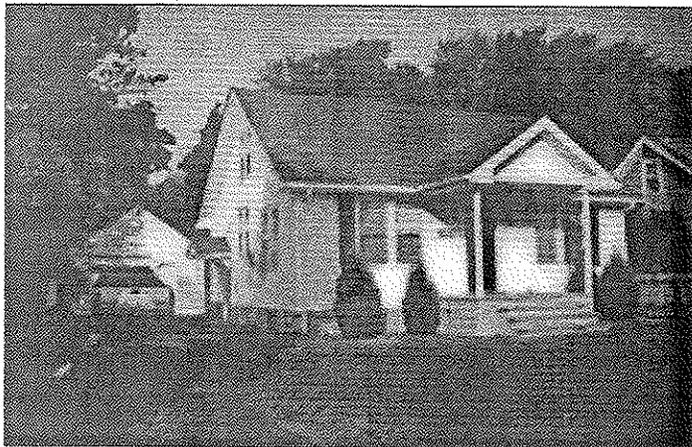
This one-story side-gable cottage, built circa 1925, features a central entrance set beneath a gable-front open porch with metal supports, projecting from the roof, on the building's primary or eastern façade. The open concrete porch features wide steps. The entrance is flanked on either side by a pair of 1/1 double-hung wood sash windows. The building features a small gable-front side entrance on the southern façade, set into the raised concrete block foundation.

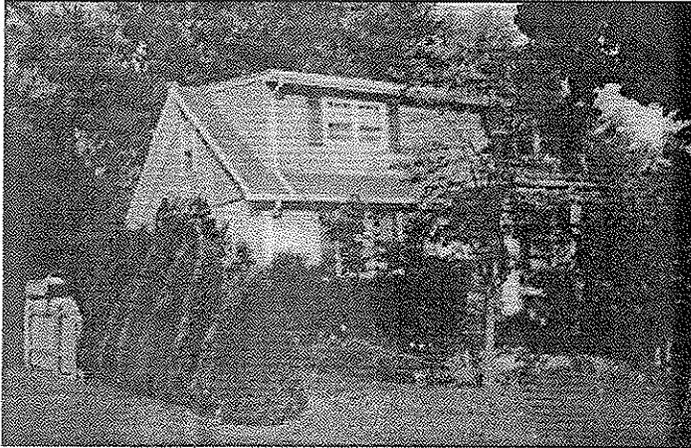
K-7036

This circa 1935 one-and-a-half story side-gabled cottage is three bays wide and features regular fenestration of 6/6 double-hung vinyl-clad replacement windows. The building features an exterior of parged concrete on the first floor, with vinyl siding on the second floor. The building features large “dustpan” dormers on both slopes of the gable roof, and a flat roof open porch over the central entrance on the primary or eastern façade, which features Tuscan columns. The building is bordered by a gravel driveway to the north, and a hedge row of pine trees to the south.

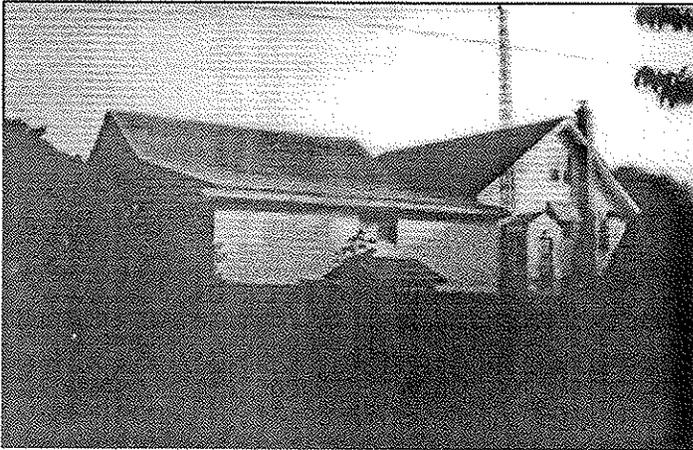
This one-story side-gable bungalow, built circa 1930, features a central gabled entrance with an unornamented wood door on the eastern or primary façade. The entrance is flanked by 1/1 wood sash windows on either side. The windows are paired on the north and south façades. The small porch on the eastern façade has been enclosed. The building's exterior is faced with composition board. The enclosed porch is flanked by a pair of cherry trees. A circa 1945 gable-front two-car garage, faced with composition board is set to the southeast of the residence.

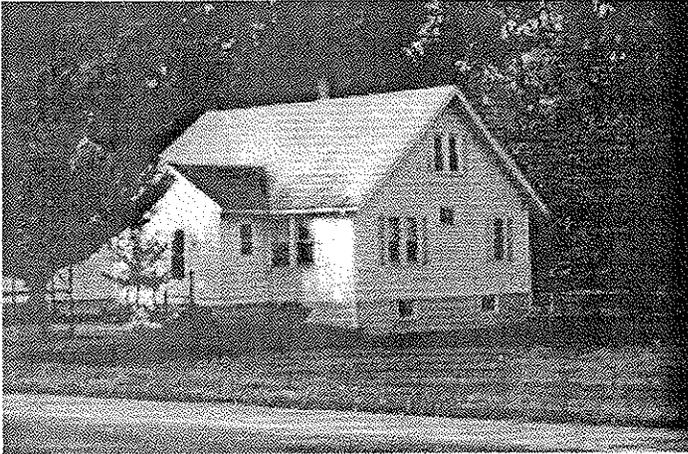
This one-story side-gable bungalow, built circa 1930, features a central gabled enclosed front entrance projecting from the primary or eastern façade. The entrance is flanked on either side by 1/1 replacement vinyl-clad double-hung sash windows. Other façades feature regularly spaced fenestration and an ornamental concrete block foundation. The building features a central masonry chimney set along the ridge. The building's exterior features replacement asbestos shingle siding.

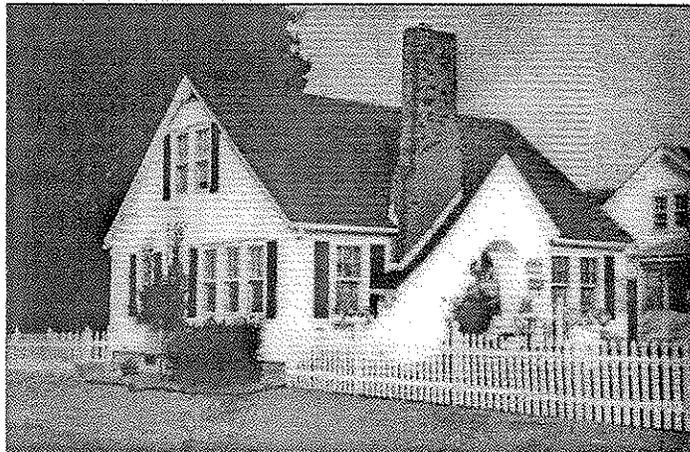
This one-and-a-half story Tudor Revival Cottage, constructed circa 1935, features a central entrance with an arched wood door along the primary or eastern façade. The door is flanked to the north by a pair of 6/1 vinyl-clad sash windows and to the south by a single 6/1 vinyl-clad sash window. Paired or tripled windows are featured on the northern and southern façades. The western façade features an offset unornamented secondary entrance. The building features vinyl replacement siding on the exterior and a shouldered brick chimney on the eastern or primary façade. The yard is enclosed by a picket wood fence, and a small gabled garage, built circa 1960 is set to the northwest of the residence.

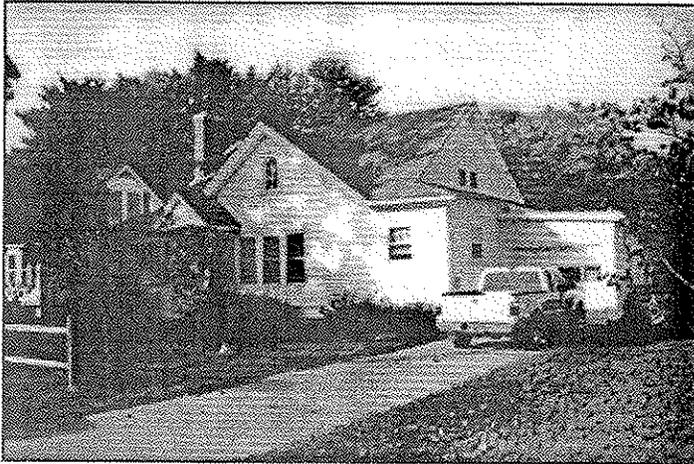
This one-and-a-half-story side-gable cottage, built circa 1910, is seven bays wide and features a large complex cross gable along the eastern or primary facade, above the central entrance. The roof's northern gable is hipped and pent. The southern façade is flanked by an enclosed porch with vinyl siding and louvered vent plastic windows. A small one-car garage with a shed roof, built circa 1960, flanks the northern façade. The building's façades feature 6/1 vinyl replacement windows, which flank the central entrance, and are covered with vinyl replacement siding.

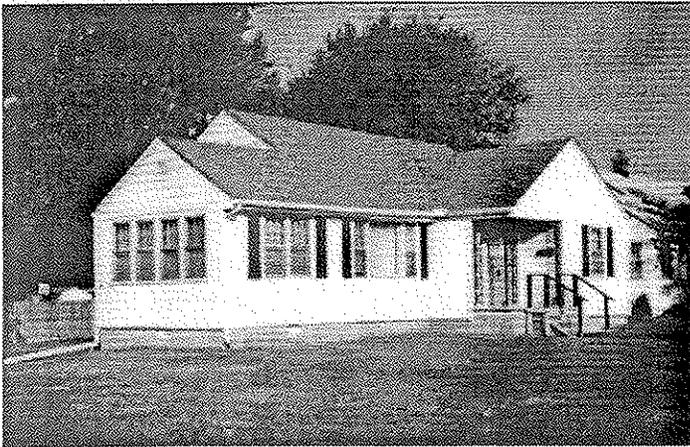
This one-story side-gable cottage, built circa 1948, features a large projecting gable along the eastern or primary façade. A recessed entrance and porch, with metal supports, is beneath the gable. The building features 6/1 wood sash windows, which are irregularly spaced. A Chicago-style picture window (fixed flanked on either side by narrow fixed windows) is set to the south of the entrance. A smaller side-gable porch protrudes from the building's southern façade. A small secondary door is featured on the rear or western façade. The building features an ornamental concrete block foundation and its exterior is faced on the exterior is faced with composition board siding.

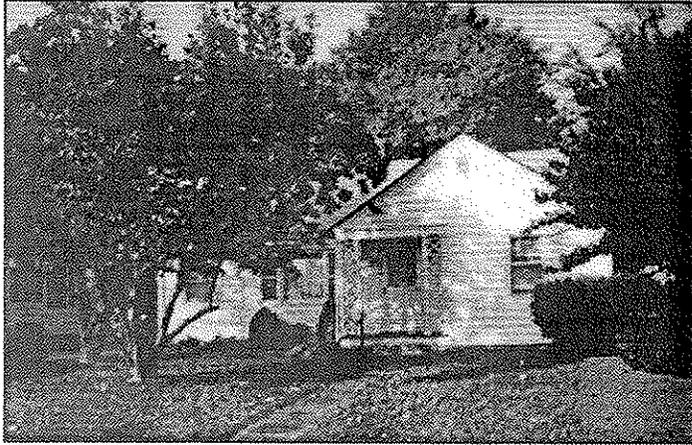
This side-gable one-story cottage, built circa 1948, is four bays wide and features an offset projecting gable. A multi-light door is set within a recessed primary entrance underneath the projection. A Chicago-style picture window (fixed flanked on either side by narrow 1/1 windows) is set to the south of the entrance. The building features a screened frame porch with a shed roof flanking the southern façade. The building features irregularly placed 6/1 wood sash windows. The building's façades are faced with composition board.

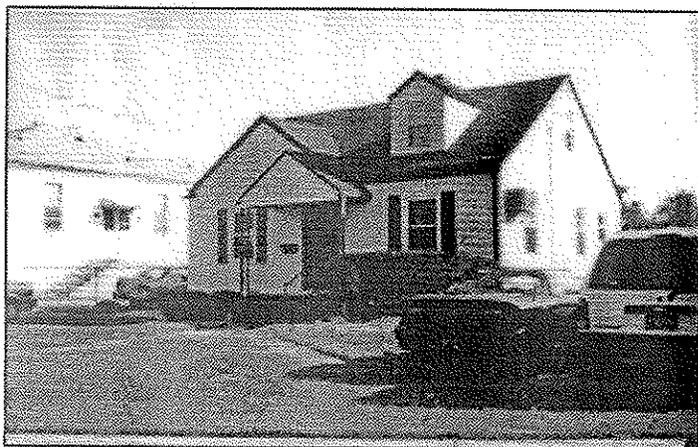
This one-and-a-half-story side-gable cottage, built circa 1945, features an offset gabled dormer on the western or primary façade and a central gabled dormer on the eastern façade. A modern replacement door is set beneath a small gable with metal supports. The building features 1/1 replacement vinyl-clad sash windows flanking the entrance and regularly spaced on the side and rear façades. The building's façades are faced with replacement vinyl siding.

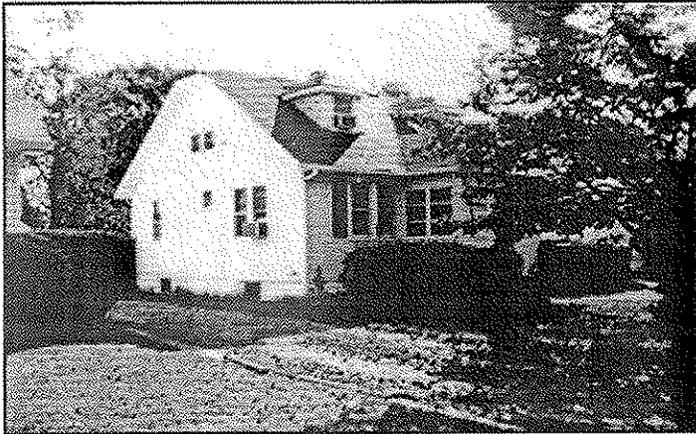
This one-and-a-half-story, side-gable bungalow, built circa 1925, features two hipped-roof dormers along the roofline of the western or primary façade. Beneath the dormers is a projecting hipped-roof enclosed porch, with a central entrance. The building features 4/1 vertical pane sash replacement vinyl windows, which are irregularly spaced and paired on the southern façade. A small gable-roofed garage, constructed circa 1960, is set to the southeast of the building.

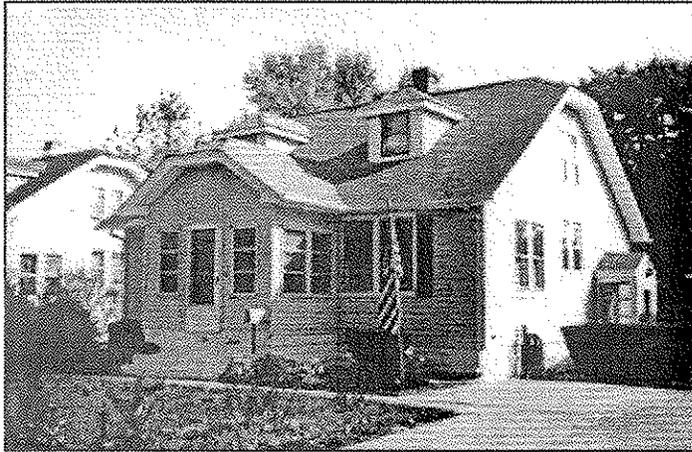
This one-and-a-half-story, side-gable bungalow, built circa 1925, is three bays wide and features a jerkinhead side-gable roof with a central projecting gabled-roof porch, which is flanked on either side by small hipped-roof dormers. A central entrance is set beneath the projecting gable, within an enclosed porch. The building features paired 1/1 double-hung sash windows flanking either side of the entrance and spaced regularly throughout the rest of the building. The building's façades are faced with vinyl replacement siding. A small gable-roof garage, constructed circa 1960, stands to the east of the house.

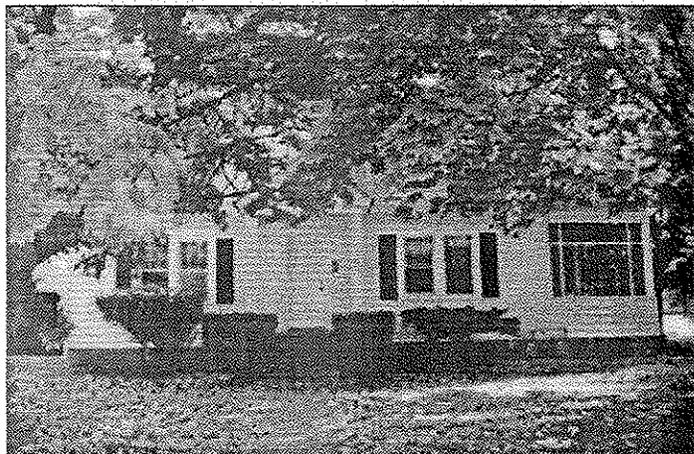
This one-and-a-half story side-gable cottage, constructed circa 1945, is five bays wide and features two gabled dormers on the western or primary façade, and a single gabled central dormer on the eastern façade. A central four-paneled wood door is set beneath a small projecting gabled entrance, and is flanked on either side by paired 6/1 replacement vinyl-clad windows, which are also irregularly placed on other façades. The building features a side-gable enclosed porch addition flanking the southern façade. The building's façades are faced with vinyl replacement siding.
