CRS No. K-7622

Name: Dwelling, 249 Bowers Beach Road

CULTURAL RESOURCE SURVEY
PROPERTY IDENTIFICATION FORM

1. HISTORIC NAME/FUNCTION: Dwelling, 249 Bowers Beach Road
2. ADDRESS/LOCATION: 249 Bowers Beach Road
3. TOWN/NEAREST TOWN: Little Heaven vicinity?
4. MAIN TYPE OF RESOURCE: building structure site object
landscape district
5. MAIN FUNCTION OF PROPERTY: Residential
6. PROJECT TITLE/ REASON FOR SURVEY (if applicable):
SR1, Little Heaven Grade Separated Intersection Improvements

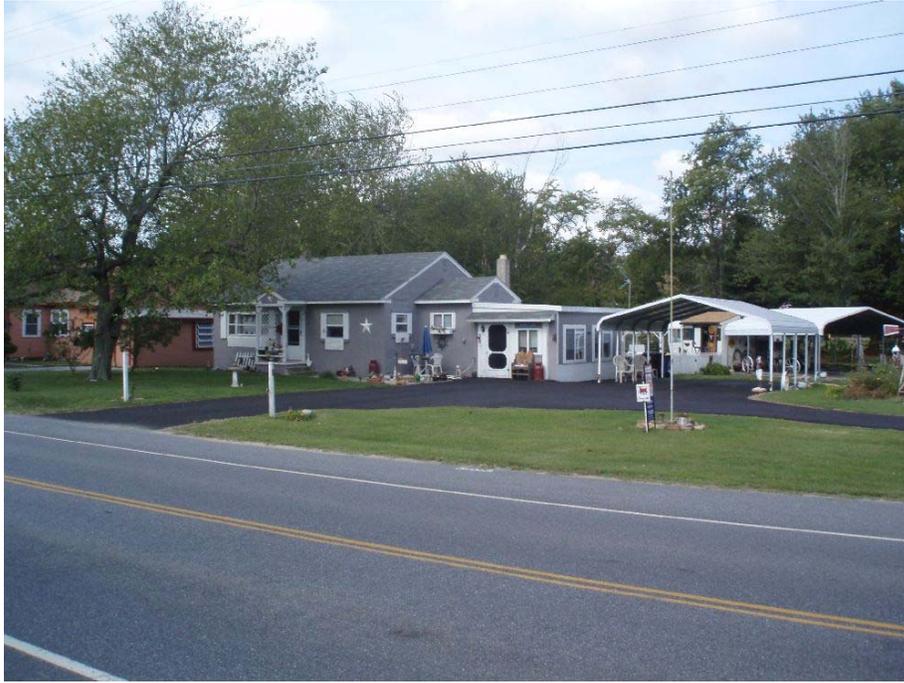
K-7622. Photograph 1: Overview of 249 Bowers Beach Road, looking northwest. This dwelling was constructed by the Roberts family ca. 1955.

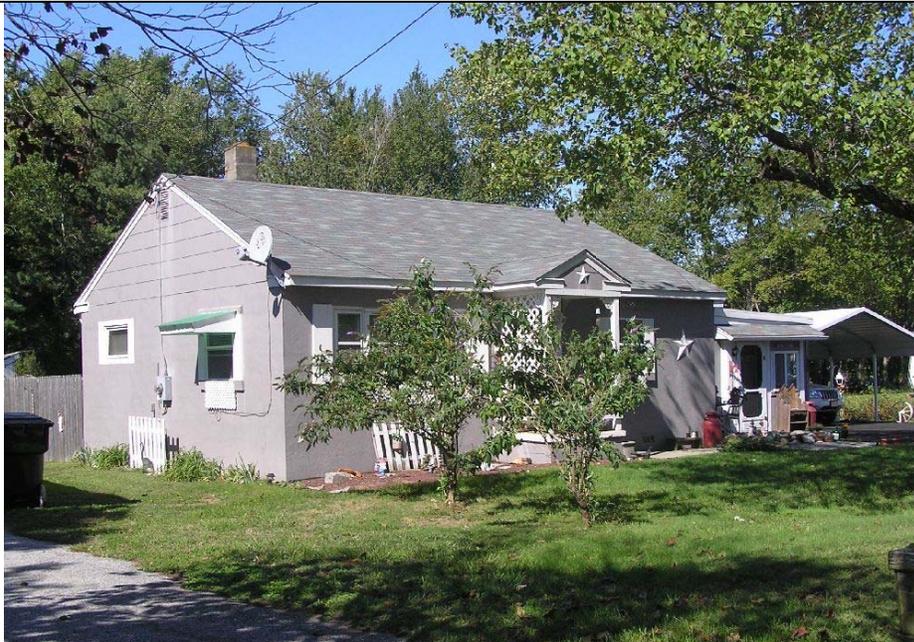
K-7622. Photograph 2: Dwelling, west and south elevations, looking north. This side-gable dwelling is clad in stucco and asbestos shingles and is primarily lit by one-over-one light, double-hung sash, vinyl replacement windows.

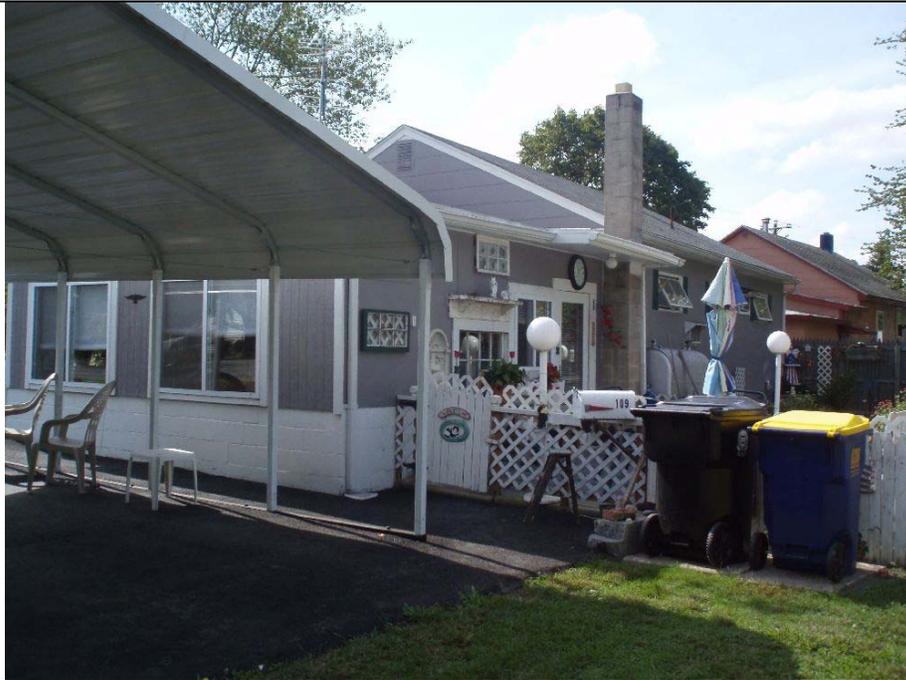
K-7622. Photograph 3: Dwelling, east and north elevations, looking southwest towards the addition. The carport in the left half of the photograph is modern.

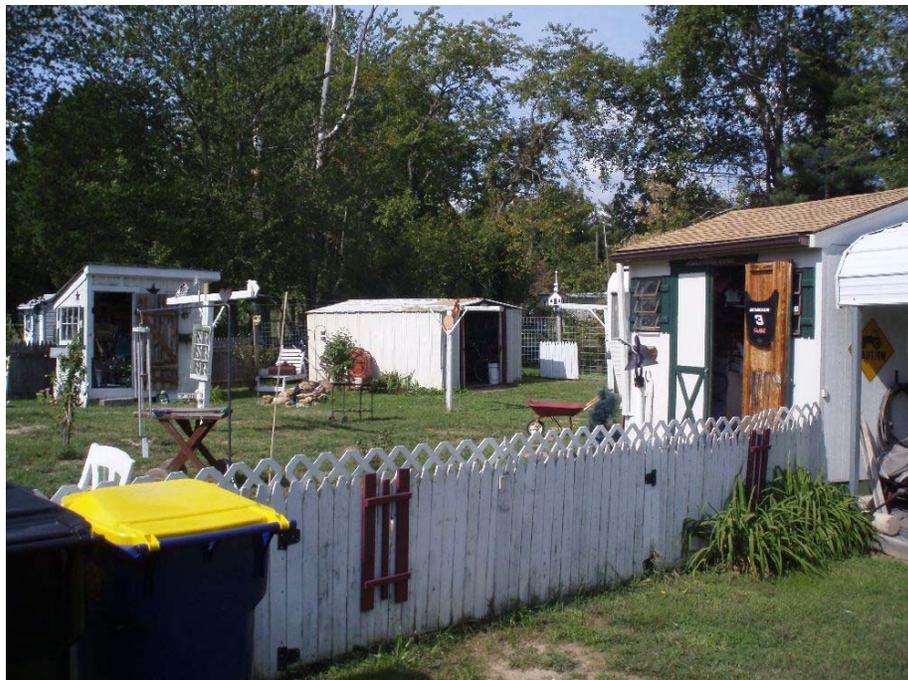
K-7622. Photograph 4: Overview of rear yard, looking northwest. The tool shed located on the left side of the photograph is the lone outbuilding on the property constructed before 1961.
