**CRS No. K-7628**

Address: 192 Bowers Beach Road

Name: Robert and Amelia Warren Property

CULTURAL RESOURCE SURVEY  
PROPERTY IDENTIFICATION FORM

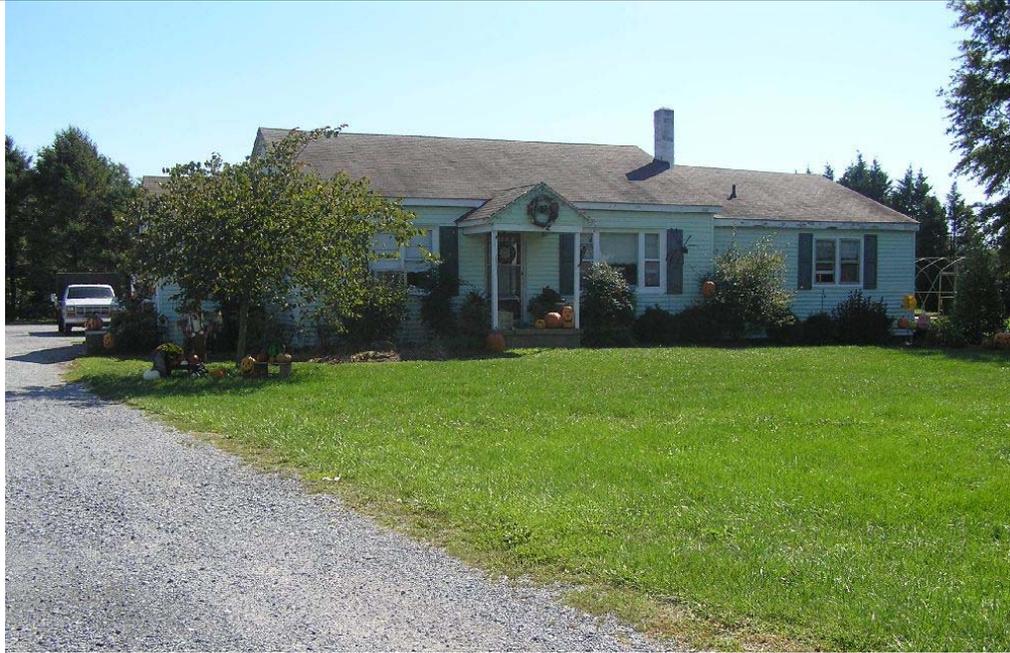
K-7628. Photograph 1: Overview of 192 Bowers Beach Road, looking southeast. The dwelling is clad in vinyl siding. Note the addition on the right side of the photograph, which was constructed ca. 1970.

The one-story dwelling sits back from Bowers Beach Road and faces slightly to the northwest, parallel to the roadway. The one-story dwelling features a side-gable roof with a central gabled entrance porch and a one-room hyphen extending from the east elevation. This original form is identical to the original forms of three dwellings located to the north and east along Bowers Beach Road (i.e., 239 Bowers Beach Road [K-7623], 249 Bowers Beach Road [K-7622], and 264 Bowers Beach Road [K-7629]). The exterior walls of the dwelling are clad in vinyl siding and the side gable roofs are sheathed with asphalt shingles. A one-story, side-gable addition, also clad in vinyl, extends from the west elevation of the core. A concrete block chimney is located between the core and the addition. Characteristic of the Minimal Ranch type, the dwelling has a Chicago-style picture window, shallow eaves, and a central gabled porch entry. The dwelling is generally lit by one-over-one light, double-hung sash wood windows, with the exception of a nine-light aluminum window in the east elevation of the hyphen. The gabled porch entry is sheathed in asphalt shingles and is supported by wood posts that rest on a poured concrete stoop. A raised, poured concrete patio extends the width of the east elevation of the hyphen. A paneled steel door with nine lights provides access in the east elevation into the dwelling.

a. Overall shape: Rectilinear Stories: 1  
Additions: 2-bay-wide by 2-bay-deep, vinyl-clad addition extends from west elevation. The addition rests on a concrete block foundation and has a side gable roof sheathed with asphalt shingles. The addition is lit by 1/1 double-hung sash wood windows.

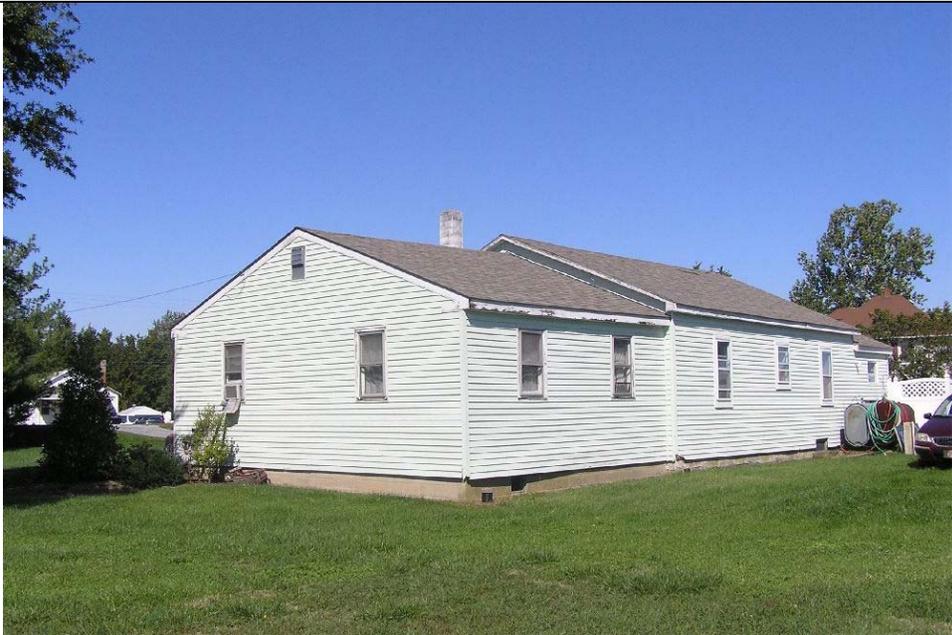
K-7628. Photograph 2: Dwelling, west and south elevations, looking northeast. The addition, in the foreground of the photograph, was constructed ca. 1970.

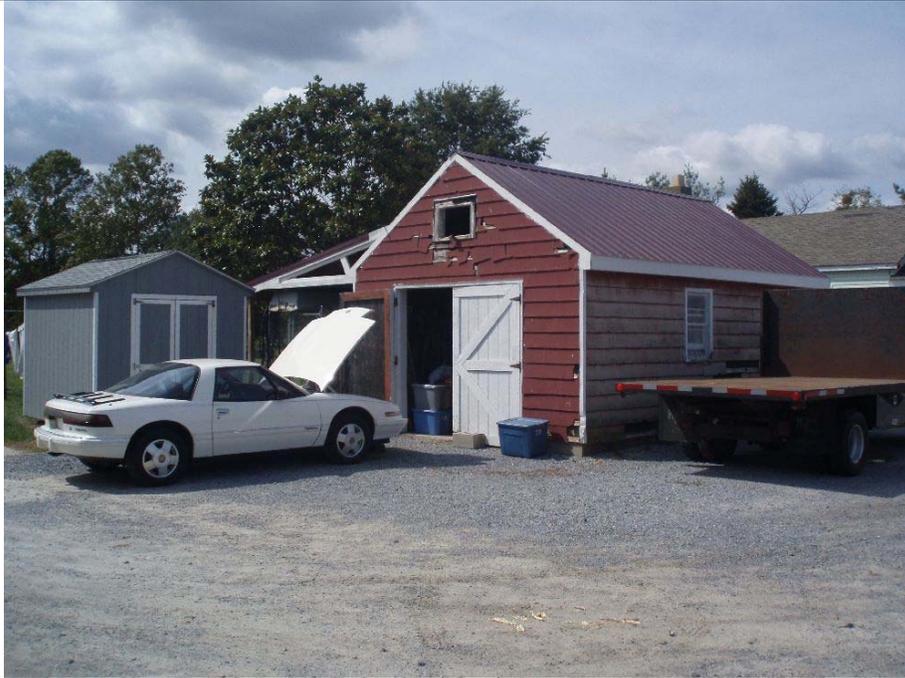
K-7628. Photograph 3: Shed, south and east elevations, looking northwest. This shed was constructed ca. 1950. Note the modern, prefabricated shed on the left side of the photograph.

South of the dwelling rests a one-and-one-half-story shed. The shed rests on a concrete block foundation, and the exterior walls are clad with asbestos shingles. The front gable roof is sheathed in standing seam metal. A shed roof that extends from the west elevation is also sheathed in standing seam metal and shelters a dog pen enclosed by chain-link fencing. Paired plank wood doors provide access to the interior in the south elevation, and double-hung sash wood windows light the east, west, and north elevations. A modern, prefabricated shed is located adjacent to the southwest corner of the shed.

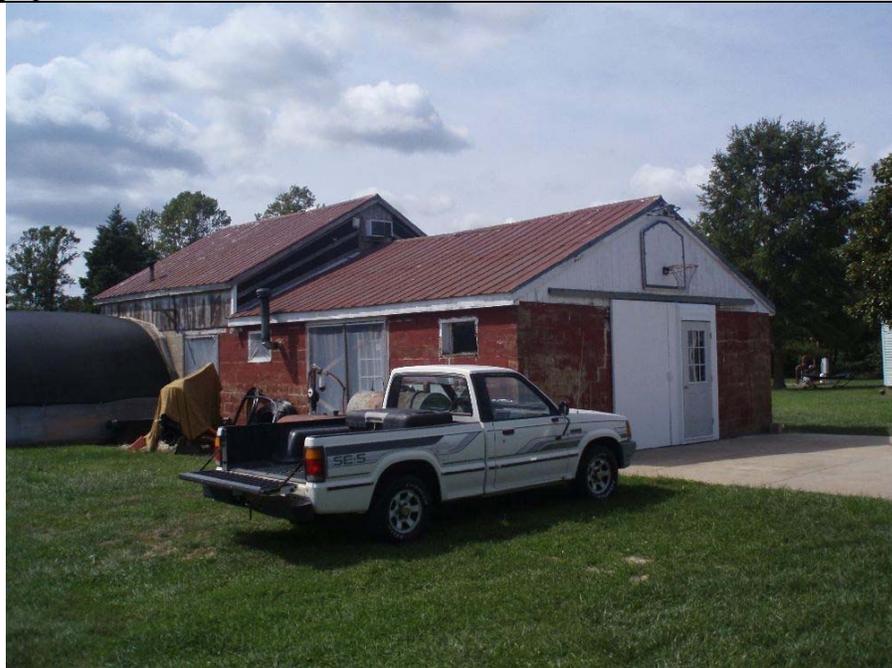
K-7628. Photograph 4: Garage/workshop, south and east elevations, looking northwest. Note the greenhouse that extends from the south elevation of the barn.

A *circa*-1950 concrete block garage/workshop is located to the southwest of the shed. The eastern half of the garage/workshop stands one story tall; while the western half of the garage/workshop stands one and one-half stories tall. The building rests on a poured concrete slab. Concrete block comprises the first story of the building, and vertical board siding covers the exterior walls of the upper half story of the western half. The front gable roofs are clad in standing seam metal. Paired, sliding wood doors provide access to the interior in the east

elevation. The northern door has been altered by the insertion of a paneled steel door into the flush wood door. Rectangular openings covered with plastic light the north, west, and south elevations. Four-over-four light, double-hung sash, vinyl windows light the west elevation's half story, and flank a modern steel door that once provided access to a balcony or set of steps (now removed). Pedestrian entries in the north elevation consist of deteriorating flush wood doors. Steel replacement pedestrian doors are also located in the west and south elevations. A greenhouse extends from the western half of the south elevation.

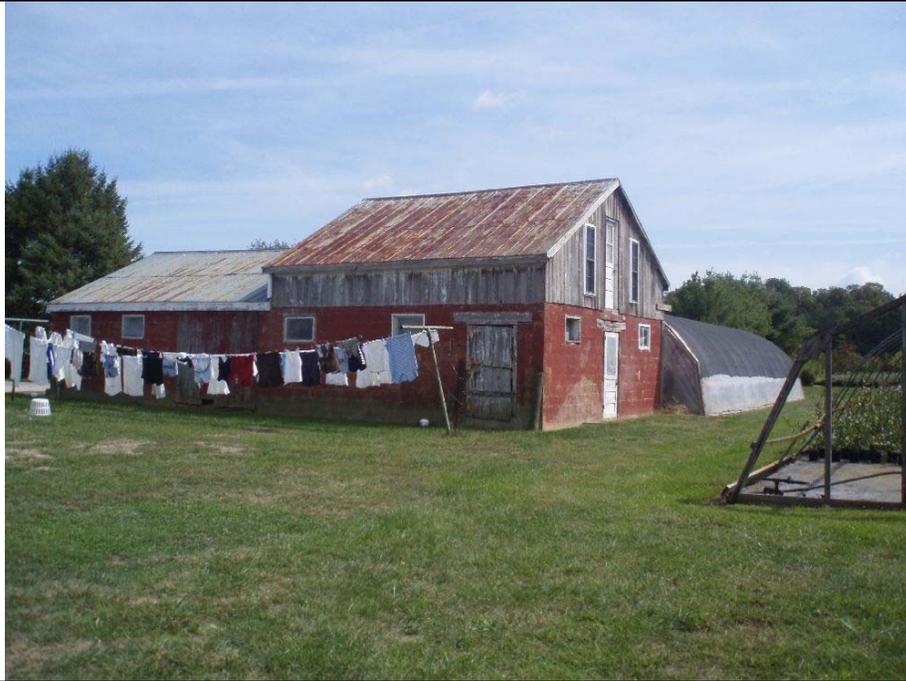
K-7628. Photograph 5: Garage/workshop, north and west elevations, view looking southeast. The garage/workshop is in fair condition and has several modifications, including the installation of modern doors and windows in the half story.

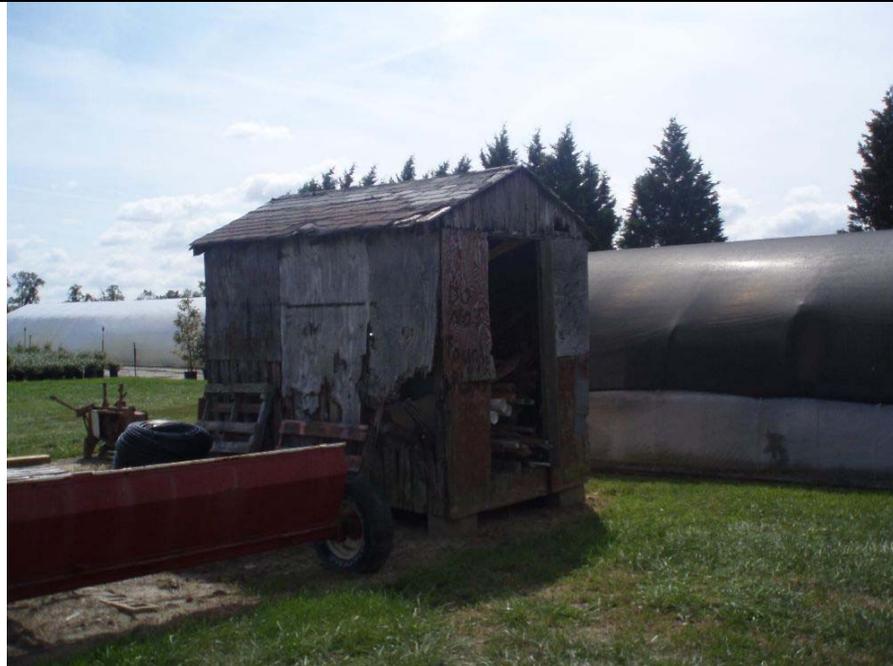
K-7628. Photograph 6: Tool shed, east and north elevations, view looking southwest. The shed, clad in plywood, is in poor condition.

A *circa*-1950 wood frame tool shed that is partially clad in plywood is located to the south of the garage/workshop. The tool shed rests upon four concrete blocks. The north elevation has one opening, but a door was not visible. The gabled roof is sheathed with asphalt shingles.

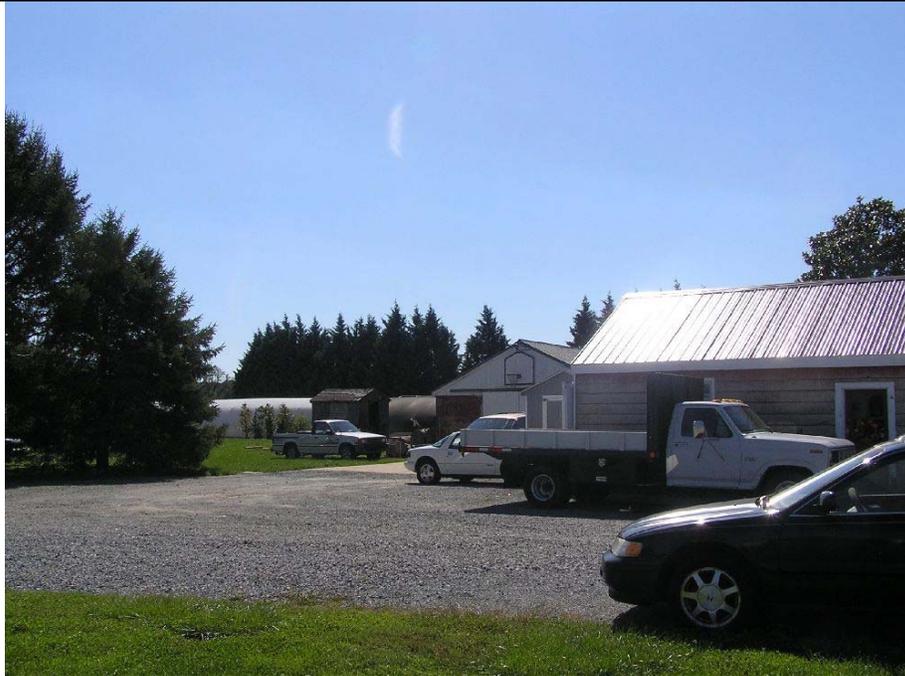
K-7628. Photograph 7: Overview of the outbuildings, looking southwest.

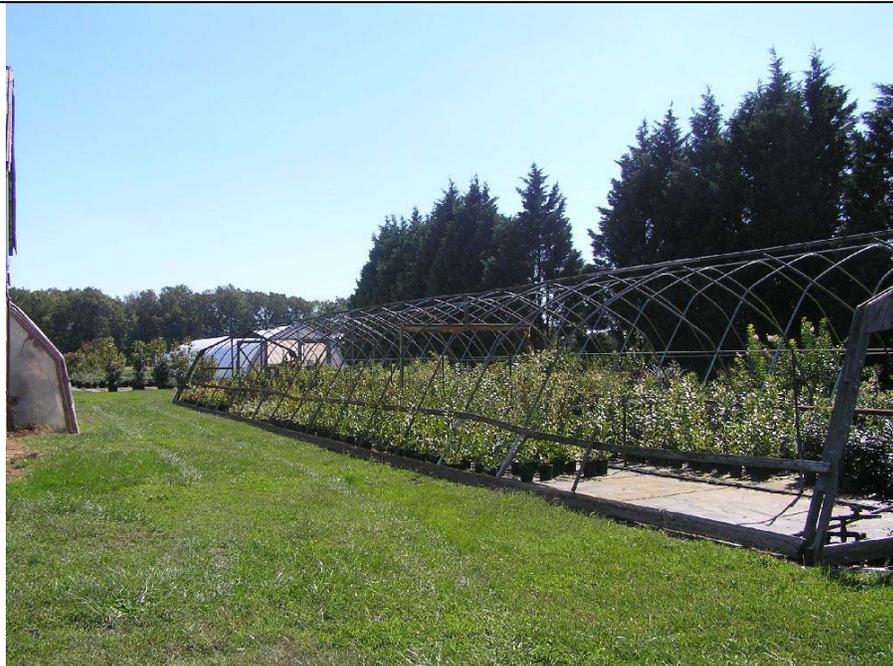
K-7628. Photograph 8: Overview of greenhouses and planting beds, looking south.

South and southwest of the tool shed are several modern, metal-framed greenhouses. A baseball field is located south of the building complex beyond a tree line. The property is used by a landscaping business to cultivate flowers and other plantings.
