11. WILLIAM MORRIS CARNEY'S TOFT

THE CARNEY FARMHOUSE (K-6691) is the centerpiece of the Delaware Agricultural Museum in Dover. This house formerly stood in the project area (7K-C-408), on the west side of McKee Road (PLATES 30-32). William Morris Carney and his wife Sallie built the two-story clapboarded frame house in 1893. Their grandson, Noland Morris, sold it in 1970.

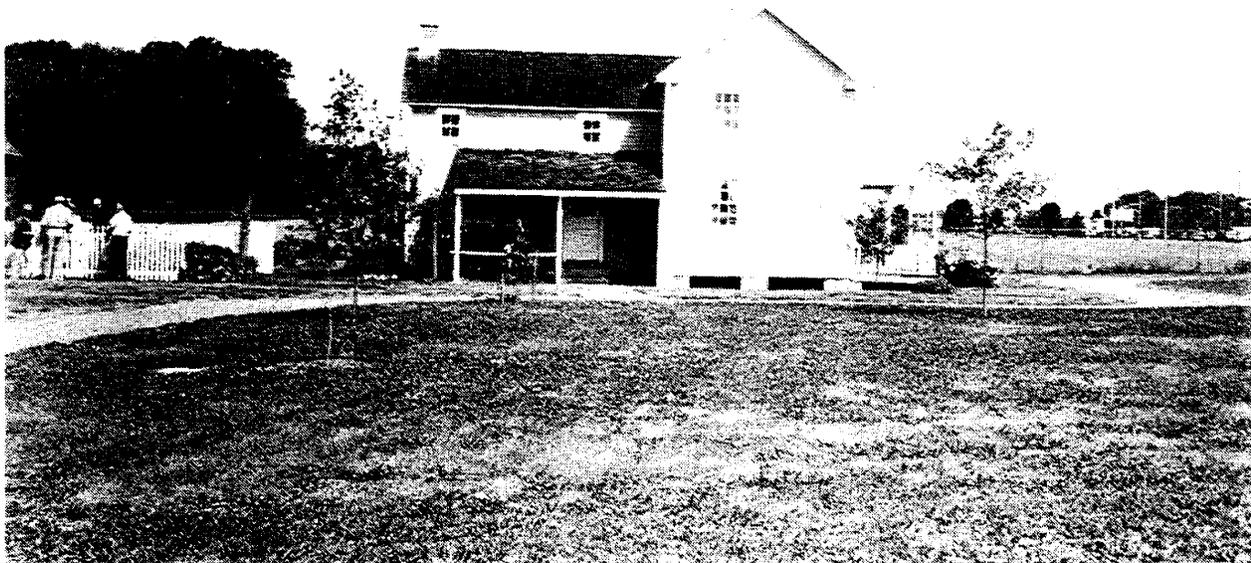
Plate 30

William Morris Carney House, now at the museum grounds, looking north

The two-story frame Carney house, as it now exists at the museum, is a hall-and-parlor house built in the one-room-plan tradition. The front room was the formal parlor, containing the best furniture and the pump organ. It opened on the primarily decorative front porch that faced McKee Road.

Behind, with its gable at right angles, was a second block, also consisting of one room, which would have, in earlier times, been called the hall. This room opened onto two functional back porches, one of which connected to the kitchen. Here the family worked, ate, and socialized.

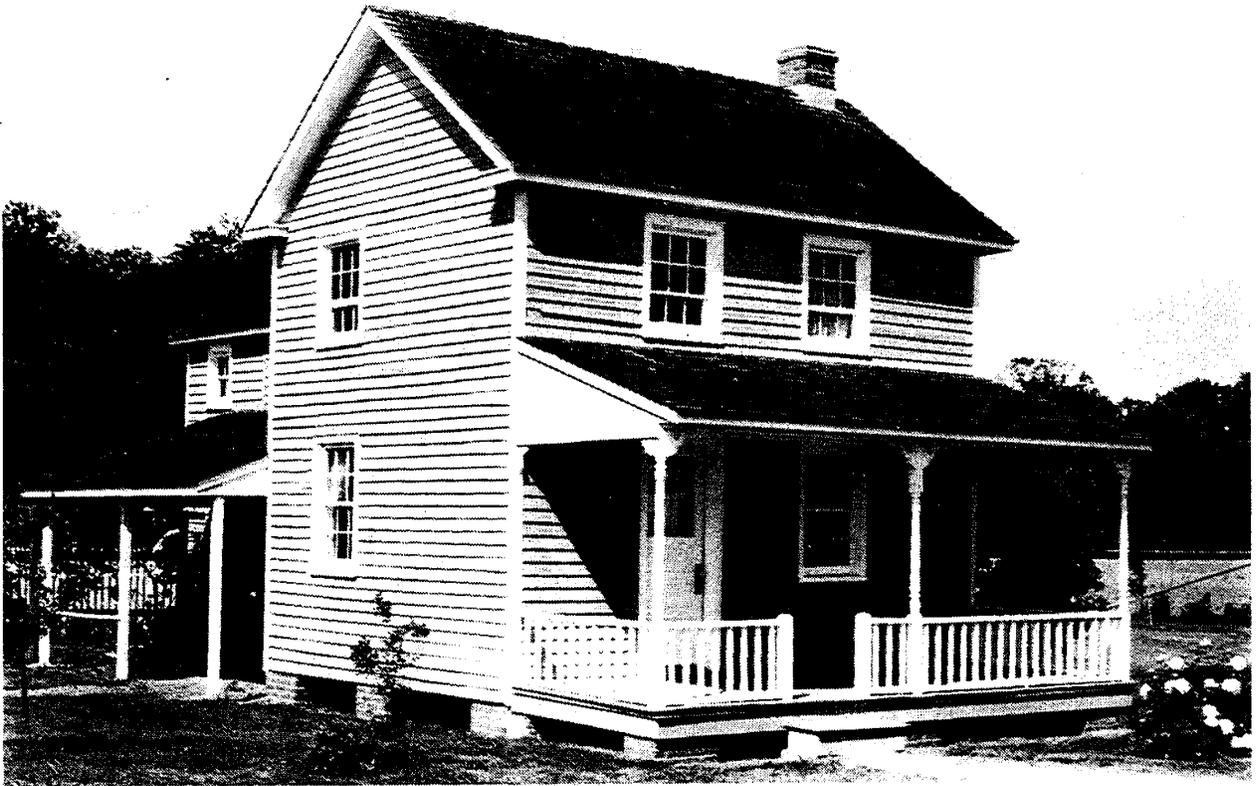
Plate 31
William Morris Carney House at the museum, from the southeast

Two back porches were the focus of family and farm activity. On the south side of the rear ell a covered porch gave access to the pump. A grapevine grew along the back of this porch. On the north was a porch that connected the house with the kitchen and served as a work area for kitchen-related activities. When the house stood on its original site, the north porch had been enclosed, as had the porches on the other surviving houses.

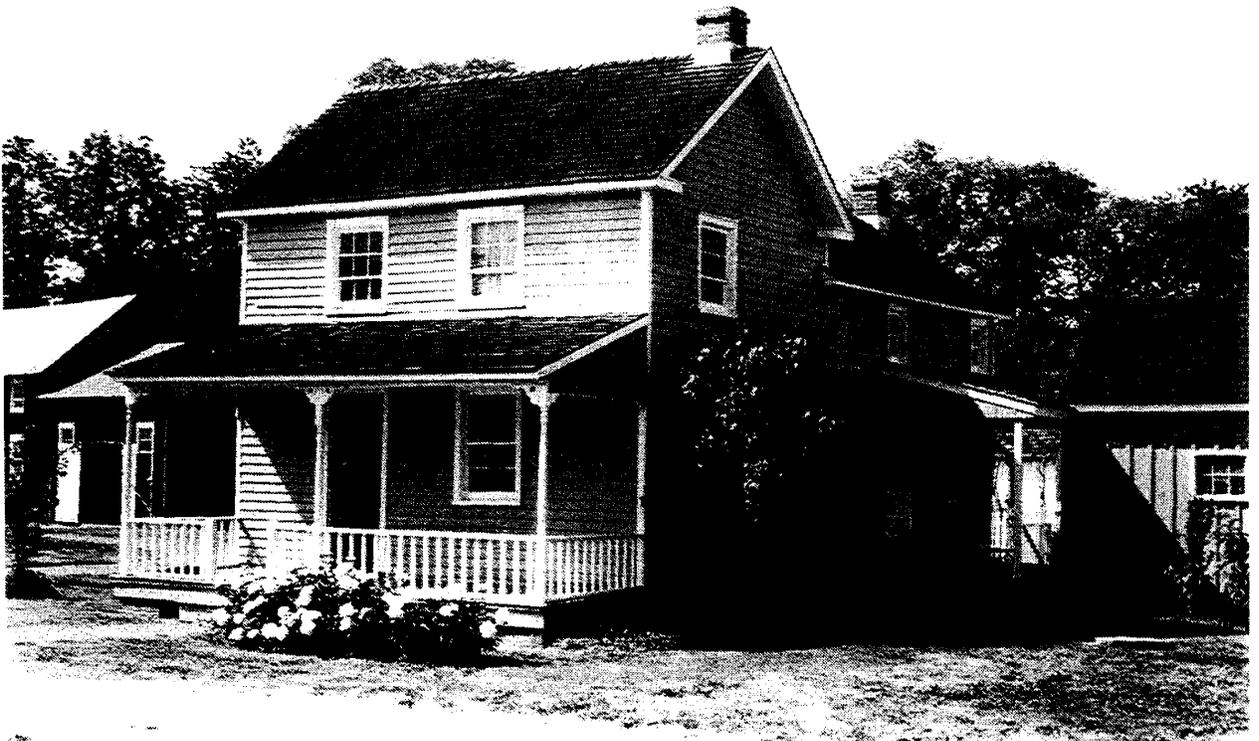
Plate 32
William Morris Carney House at the museum, from the northeast
