4.0 ARCHITECTURAL INVENTORY AND EVALUATION

4.3.1 14559 Sand Hill Road, Broadkill Hundred, Sussex County, Delaware (CSR #S-9851)

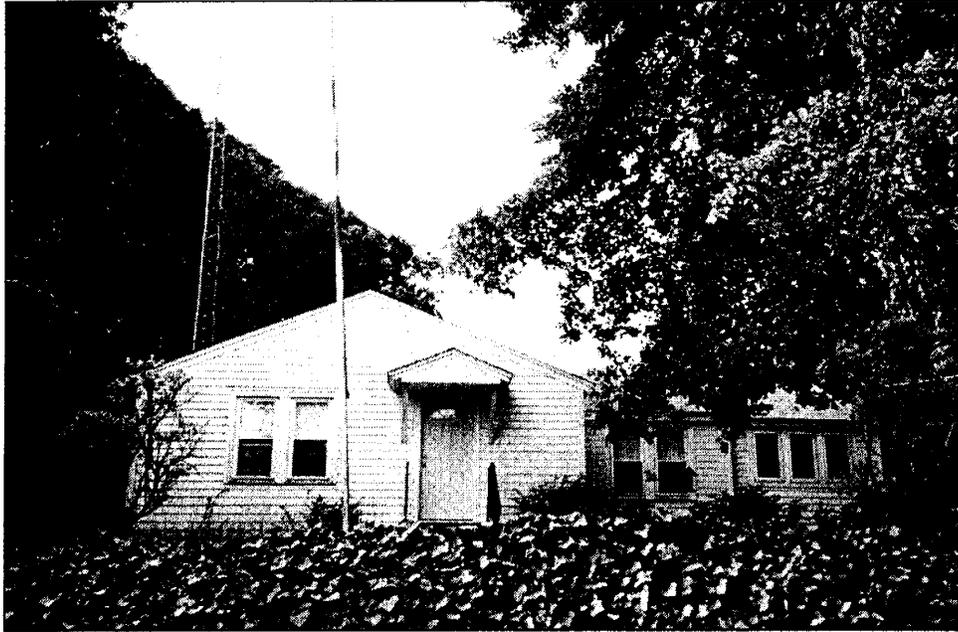
Main House. The one-story, four bays wide, vernacular house is oriented north towards Sand Hill Road. The layout of the building is T-shaped consisting of the main block of the house at the east and the shaft of the T extending west (Figure 14). The house is constructed upon a raised, parged concrete foundation and is faced in wood siding (weatherboard). The house has a modest molded wood cornice and a low-pitched, cross-gable roof with a shed roof extension at the southeast corner of the rear elevation. The roof is clad in asphalt shingles.

Figure 14. View of 14559 Sand Hill Road, main elevation (9/2002)

The main (north) elevation is four bays wide with the main block of the house consisting of two bays with a pair of 1/1 double-hung, vinyl sash replacement windows with modest wood sills and surrounds at the east bay. The main entrance, located at the second bay, has a modern metal and glass, single-leaf door with a semi-circular pane. Concrete stairs lead to the main entrance and the entrance is capped by a projecting, pedimented hood. The shaft of the T is recessed from the main block and includes a pair of 1/1 double-hung, vinyl sash windows with modest wood sills and surrounds at the third bay. The west end of the main elevation is pierced by a ribbon (3) of vinyl casement windows with vinyl sills and surrounds.

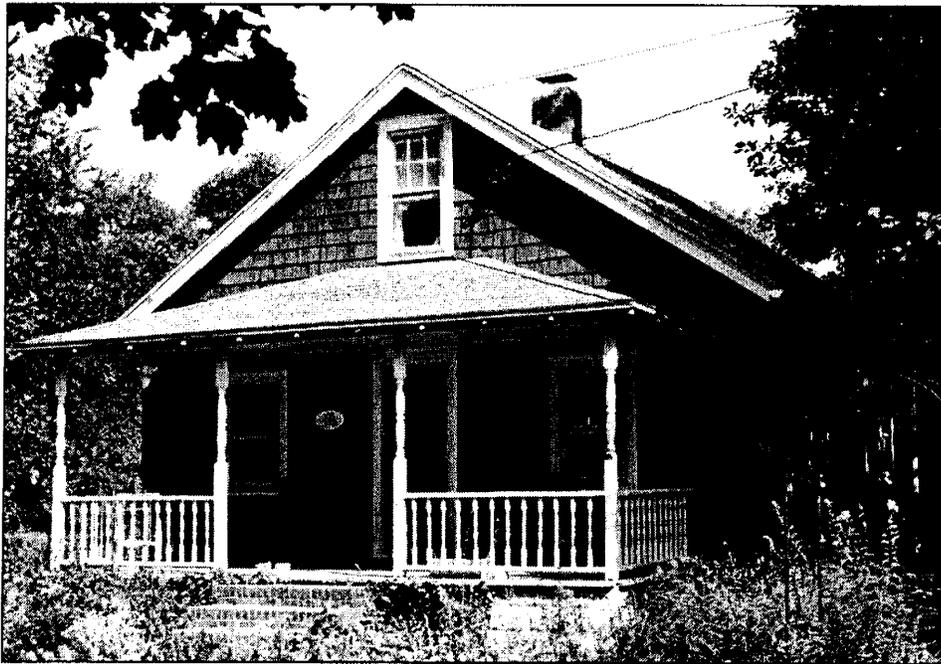
Main House. The one-and-a-half story, three-bays wide bungalow is orientated south towards Sand Hill Road (Figure 15). The layout of the main block of the building is rectangular with a one story, one room deep, kitchen addition at the rear. The frame construction of the house is faced in wood shingles and constructed upon a raised, rock-faced concrete block foundation. The house has a full, unfinished basement level. The house has a modest wood cornice and a front-gable roof clad in asphalt shingles with a center, brick chimney.

Figure 15. View of 14102 Sand Hill Road (Rose Cottage), main elevation (9/2002)

The main (south) elevation is three bays wide with the first story pierced by two 6/1 double-hung, wood sash windows flanking a 15-light, single-leaf, wood and glass door. The windows and main entrance have a decorative wood surround with a molded cap. The one story porch has a concrete floor with spindle balusters and turned porch supports. The Queen Anne style balusters and porch supports are not original to the building and were installed during the later two decades of the 20th century. The half-hipped roof is clad in asphalt shingles and the rafters are exposed. A 6/1 double-hung, wood sash window pierces the gable end.

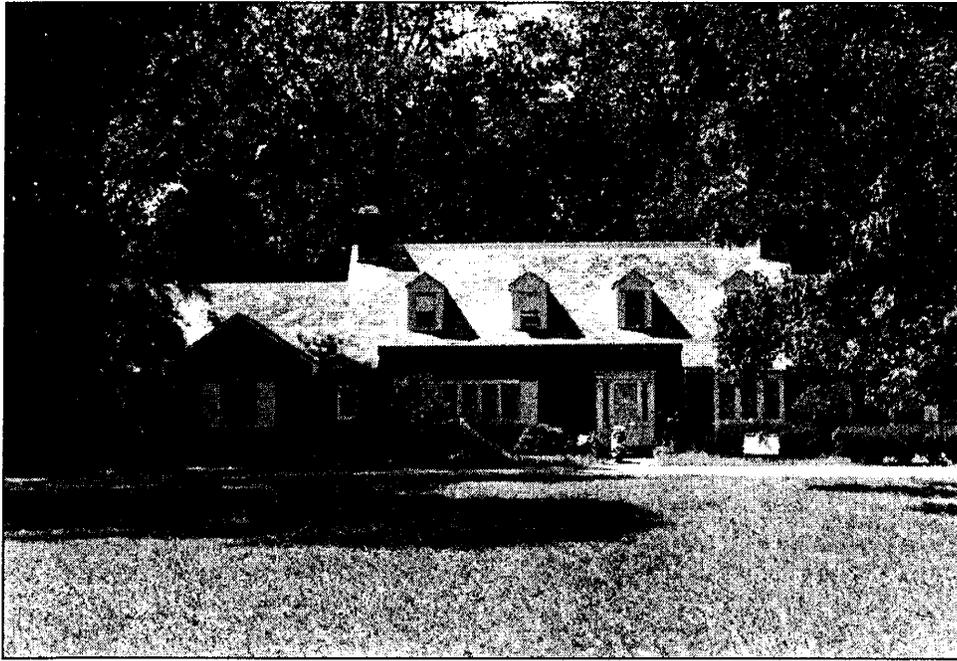
Main House. The Draper/Bonk House is a one-and-a-half story, eight bays, house designed in the Colonial Revival style. Constructed in 1938, the house is clad in clinker brick and is apparently constructed with a steel girder frame (Bonk 2002). The house is presented in three sections, the one-and-a-half story center and main block of the house, the one-story garage wing to the north and the one-story wing to the south (Figure 16). The asymmetrical house has a modest wood cornice with the side gable roof clad in slate shingles at the main, center block. An interior brick chimney is located at each gable end of the main block. The garage wing has a half-gable roof with a projecting front gable at the main and rear elevations. The south wing has a side gable roof with a projecting front gable at the main and rear elevations. The roof of the two wings is also clad in slate shingles.

The east (main) elevation is pierced by a 6/6, double-hung, wood sash window with a pair of two-paneled, fixed wood shutters at the first bay and an 8/1 double-hung, wood sash window at the projecting gable (second bay) of the south wing. The main block of the house is pierced by a single, multi-diamond pane casement window at the third bay, a ribbon (4) of multi-diamond pane casement windows with a pair of two-paneled, fixed wood shutters at the fourth bay and a projecting ribbon (3) of multi-diamond pane casement windows at the sixth bay. The two bays of the garage wing have a 6/6 double-hung, wood sash windows with two-paneled, fixed wood shutters at each bay. The main entrance, located at the fifth bay, has a wood paneled door with multi-pane sidelights and a molded, wood surround with an entablature and pilasters. The second story of the main block is pierced by four gabled dormers with 6/6 double-hung, wood sash windows. The second story of the garage wing (north) has a single, flat roof dormer with a multi-diamond pane casement window.

Figure 16. View of Draper/Bonk House, main (east) elevation (9/2002)

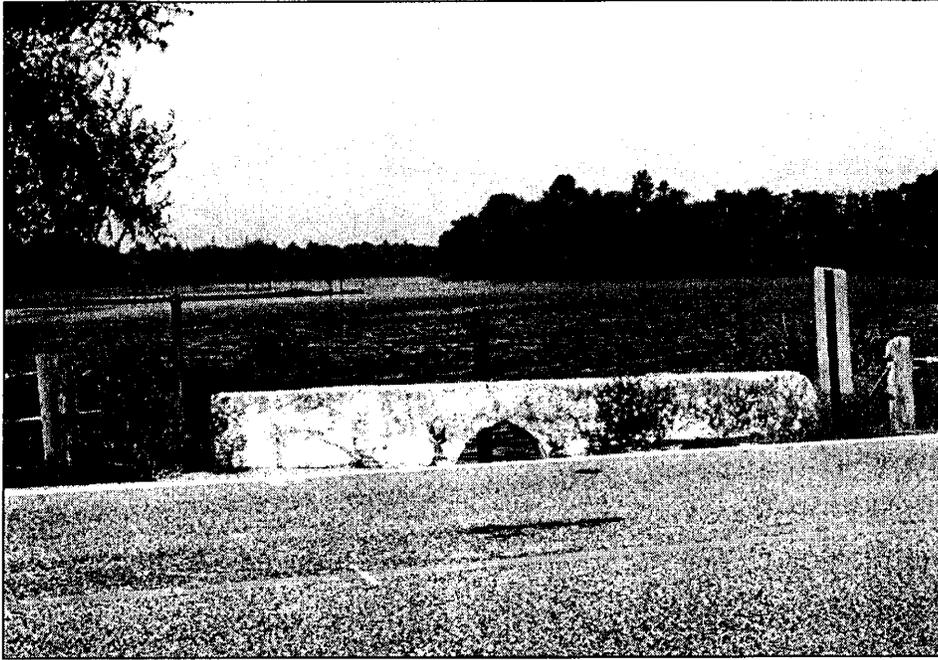
The Reynolds Mill Pond Bridge (3-918) is a reinforced concrete box culvert with a dual function, to carry traffic over the waterway and provide water flow control (Figure 17). The ca. 1925 bridge is a single cell, 10' long, 34' wide structure with a single rectangular parapet wall with a single, low arch at the west side of Route 30. The parapet wall is not architecturally adorned and is modest in design. U-Shaped concrete wingwalls extend west from the parapet wall. A metal sluice gate, located in the waterway below the parapet wall, replaced a wood version in 1979. The single parapet wall rises to a height of approximately 2 ½' from ground level. The parapet wall measures approximately 8" thick and is constructed of rebar and concrete. The dam portion of the culvert was altered with the introduction of textured steel in isolated sections with the remaining portion retaining their wood construction (ca.1970s). The water flow is regulated through the raising and lowering of this gate.

Figure 17. View of Bridge 3-918's parapet wall (west) at Reynolds Mill Pond (9/2002)

The Reynolds Mill Pond Bridge is in disrepair with exposed rebar throughout and settlement of the wingwalls. The concrete contains cracks and spalling (erosion) and DelDOT has previously repaired the concrete to control the problem.

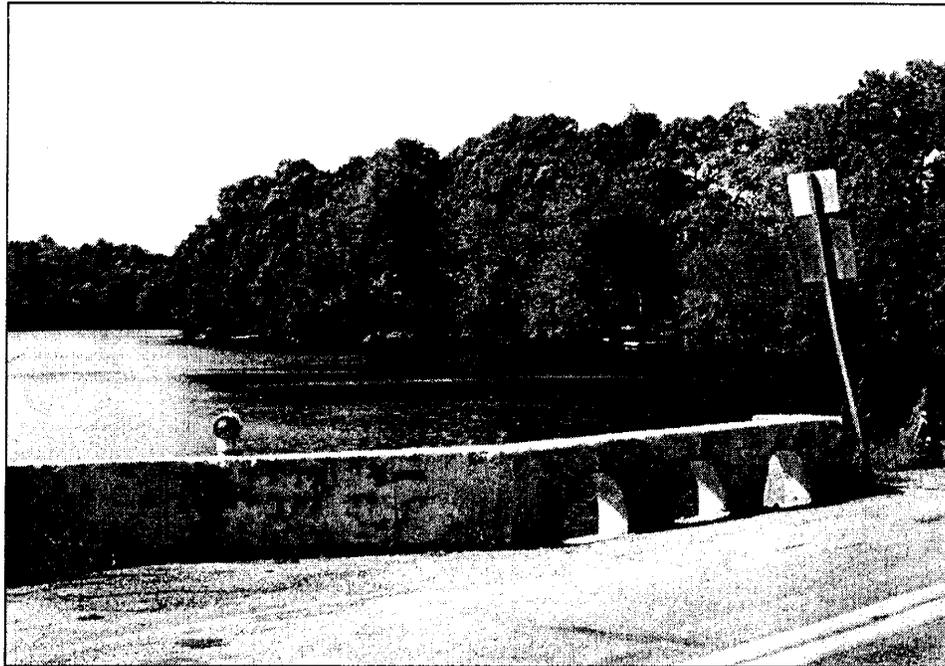
Bridge 3-806 is a reinforced concrete box culvert which carries a two-lane road over the waterway of Diamond Pond. The dual function of the bridge includes carrying traffic over the waterway and water flow control. The ca. 1917 bridge is a single span, triple-cell, 14'-long, 22'-wide structure with two parapet walls each pierced by three arches (Figure 18). The parapet walls are not architecturally embellished and are modest in design. The concrete parapet walls

are approximately 3' from ground level and are approximately 8" thick. U-shaped concrete wingwalls extend from the parapet walls. The spillway of the multi-cell box culvert allows the water from the pond to spill into a stream. At the time of its construction, Bridge 3-806 water control functions included providing upstream water storage for the mills on Wagamon Pond less than a mile away (demolished ca.1991). The functional wood gates that controlled the amount of water moving through the spillway are no longer extant. These gates were in existence as recently as 1992 (DelDOT 1992).

Figure 18. View of Bridge 3-806's parapet wall (south) at Diamond Pond (9/2002)

Bridge 3-806 has undergone a degree of deterioration to the parapet walls, wingwalls, and apron corner. The design of Bridge 3-806 has been attributed to the same designer of Bridge 3-808 and its associated penstock bridge off of Wagamon Pond on Route 197 in Milton (demolished ca.1991). Bridge 3-806 and the penstock bridge were both multiple-cells, single span reinforced concrete box culverts with three arches in the parapet walls. The penstock bridge had a single parapet wall with functioning wood gates. Bridge 3-808 was a larger, multiple-cell, two-span, bridge and water flow control structure measuring 23' in length with six arches in each parapet wall. The multi-arch design in the otherwise modest parapet wall at Bridge 3-806 is considered an "unusual design" and has been found on only two other inventoried bridges in the state, Bridge 3-808 and the penstock bridge at Wagamon Pond (P.A.C. Spero & Company 1991:136; Heite 1991:34). The demolition of the bridges at Wagamon Pond leaves Bridge 3-806 as the only extant example of this parapet wall design in Delaware.
