APPENDIX VI  
EVALUATION OF STANDING STRUCTURES

**HISTORIC PROPERTY EVALUATION ON OLD BALTIMORE PIKE  
BETWEEN ROUTES 7 AND 896**

Submitted to:  
Delaware Department of Transportation

10 September 1987

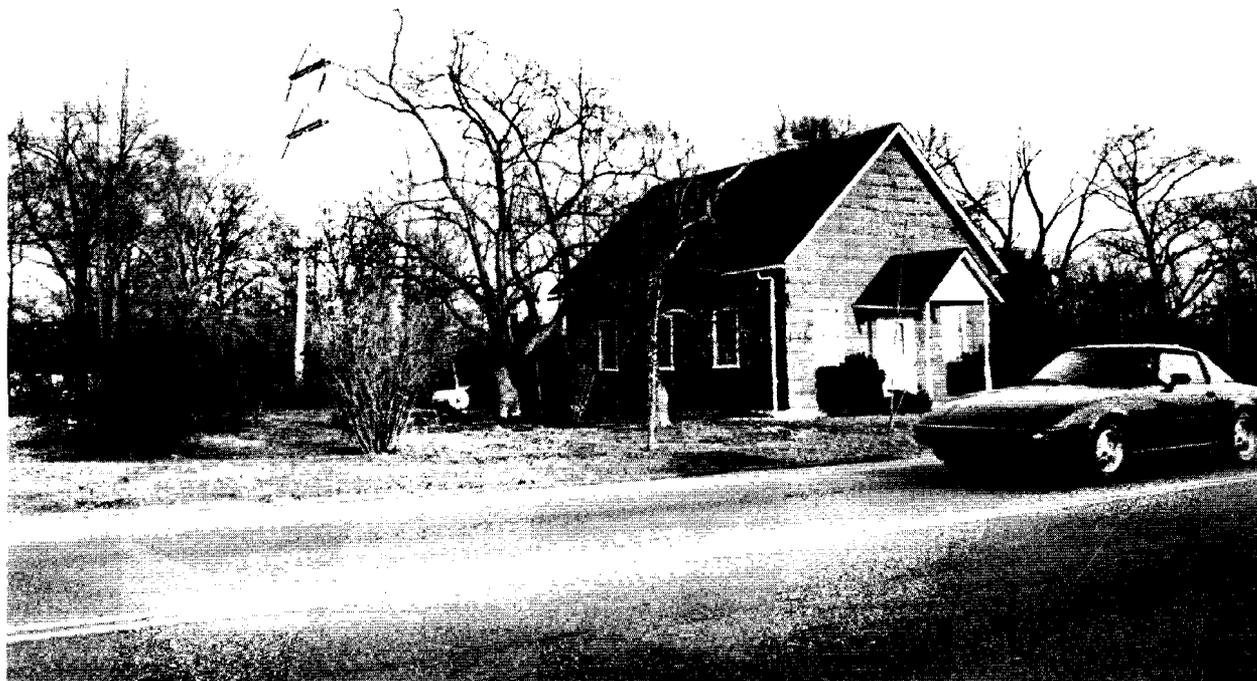
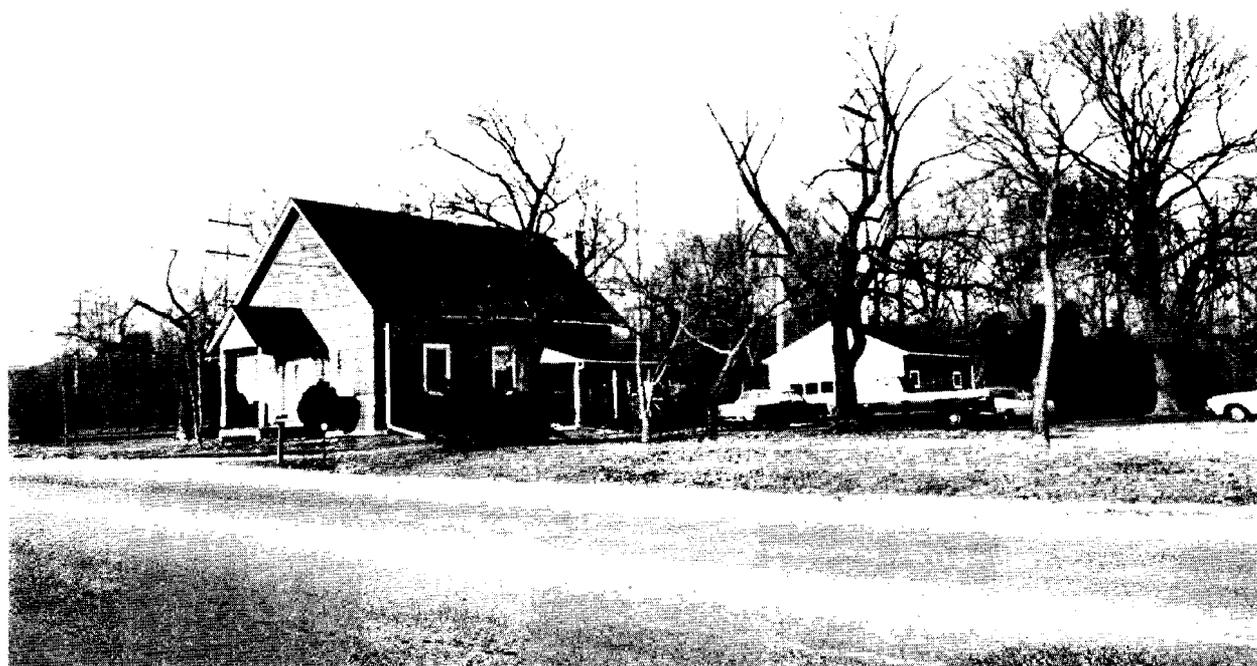
This building follows the traditional schoolhouse form, but atlases, deeds, school histories and a map of rural schools never point to a school on this site. In 1893 the site is noted as the residence of Wm. and Eliz. Curlett. Therefore, if this was ever a school, it was moved to this site as is suggested by the existence of a modern foundation, or, it was always a residence.

Top: looking east; Bottom: looking north

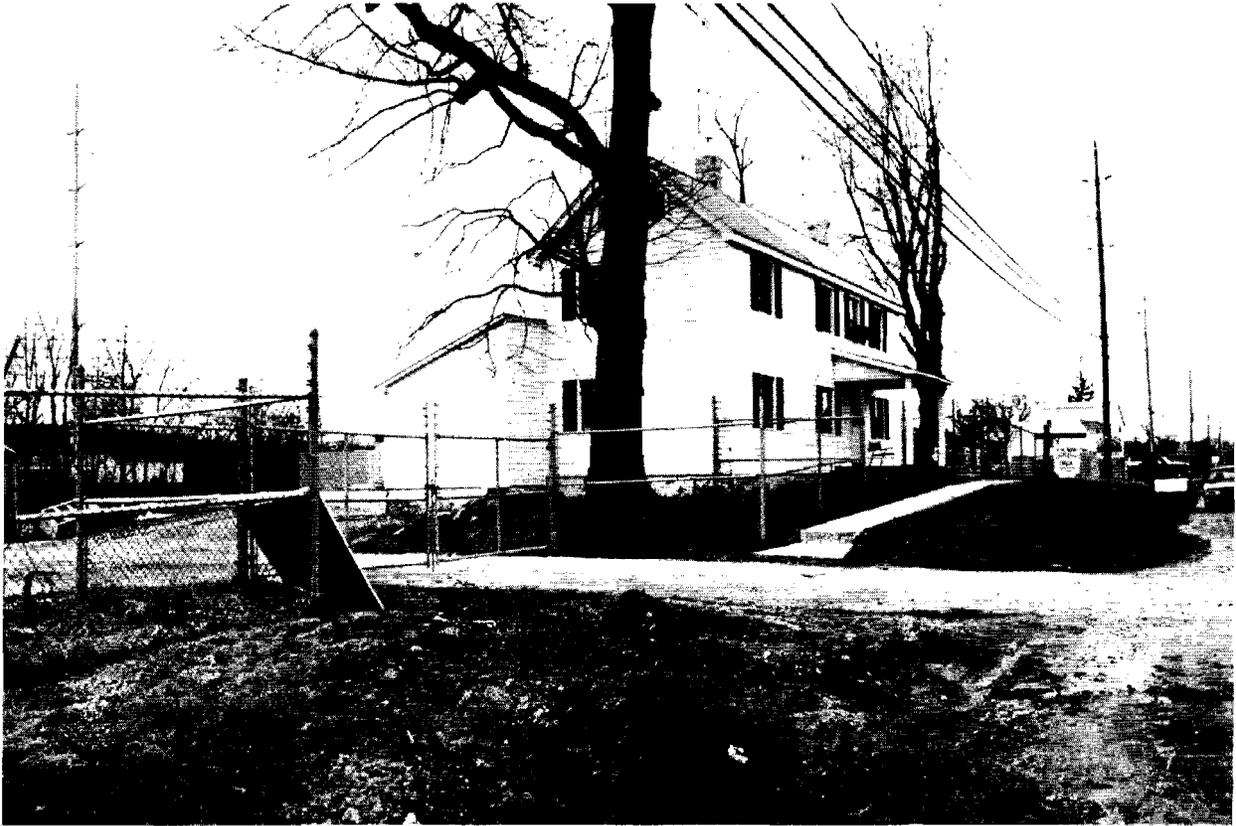
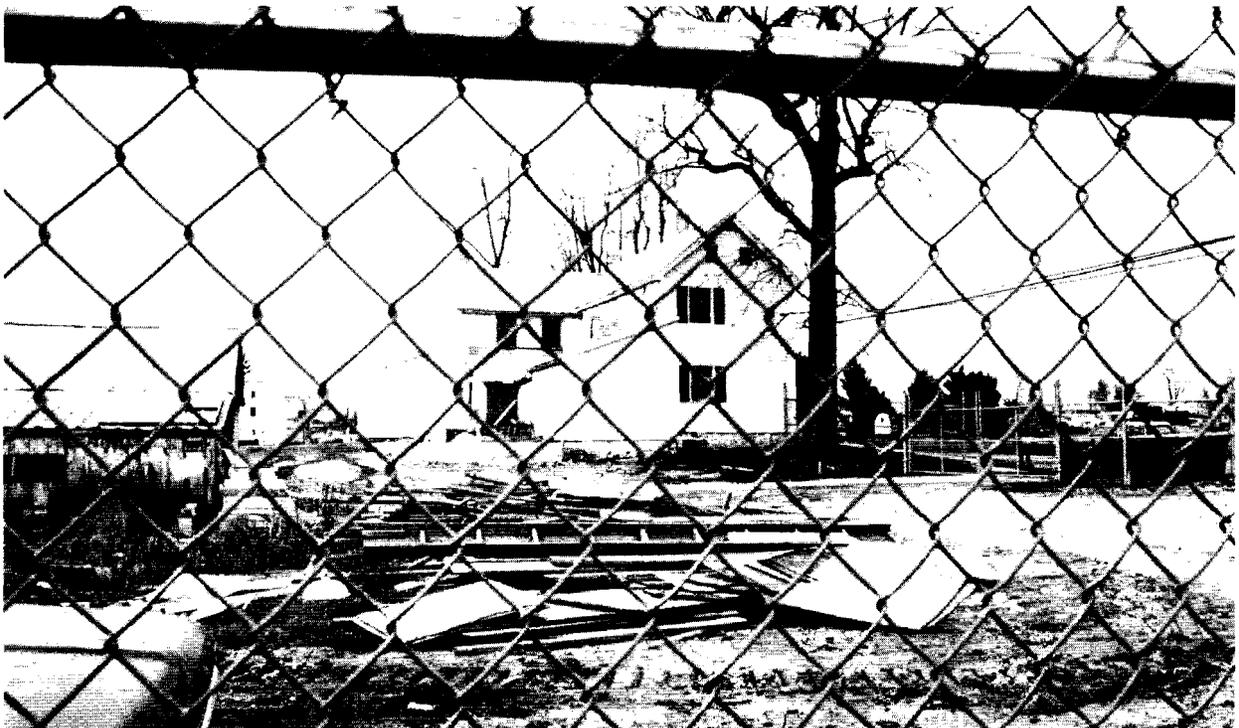
COOCH TENANT HOUSE N-11176

Located along the Christina Creek where the tailrace flows from the Dayett Mill is this 2 1/2-story, 4-bay house built on a rubblestone foundation. The frame construction house appears to have been built in the mid-19th century as a 3-bay structure with a one-bay addition. Although the house is not of exceptional architectural merit due to its residing and sash alterations, its historic association with the Cooch/Dayett Mill makes it a contributing resource to the Cooch's Bridge Historic District and therefore warrants inclusion.

- a) Overall shape L  
     stories 2 1/2  
     bays 4 (3+1)  
     wings rear wing, rear additon
- b) Structural system frame
- c) Foundation materials rubblestone  
     basement partial
- d) Exterior walls materials vinyl  
     color(s) white
- e) Roof shape; materials gabled; paneled metal  
     cornice panned with aluminum  
     dormers none  
     chimney location(s) interior end; interior between 3 and 1-bay increments;  
     rear wing interior.
- f) Windows spacing regular  
     type modern 1/1 double hung with snap-in muttins to resemble 6/6  
     trim panned with aluminum  
     shutters black louvered plastic
- g) Door spacing off center  
     type 6-panel single leaf  
     trim panned with aluminum
- h) Porches location(s) front  
     materials aluminum sheathed  
     supports posts with aluminum  
     trim none
- i) Interior details (if accessible)

Top: looking north; Bottom: looking northeast

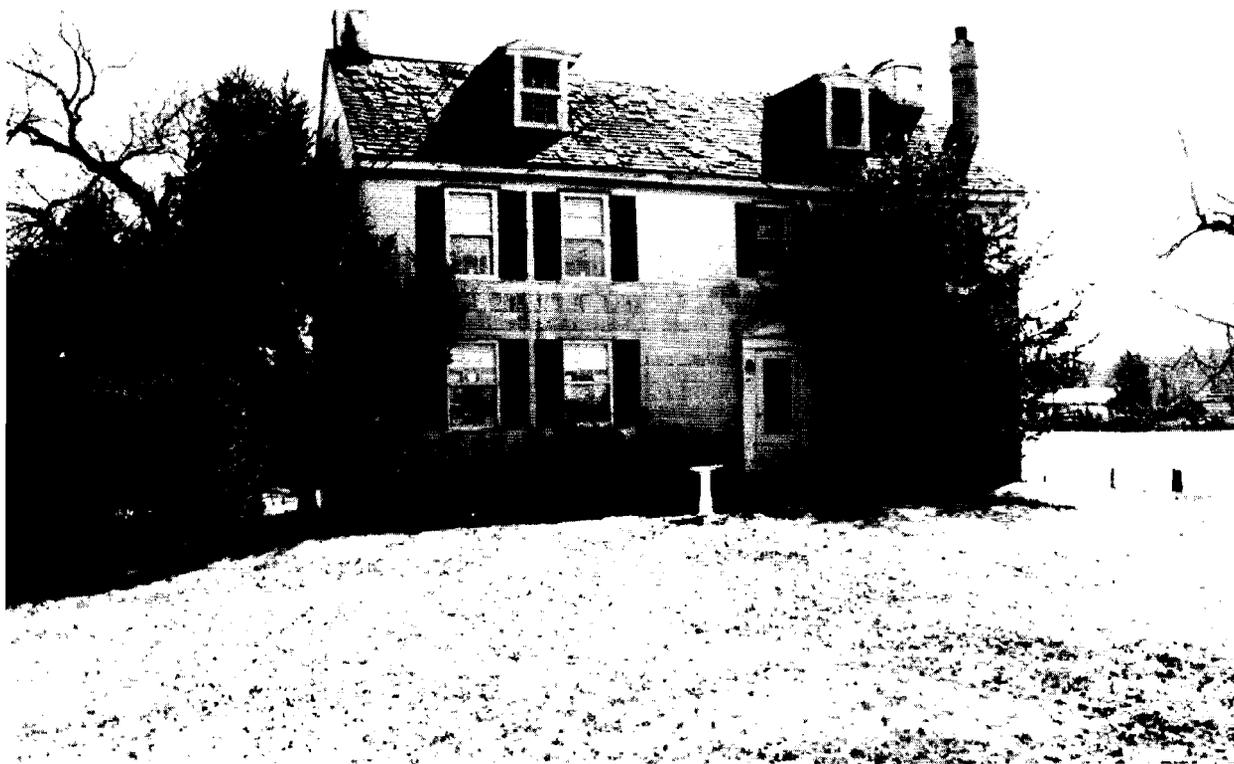
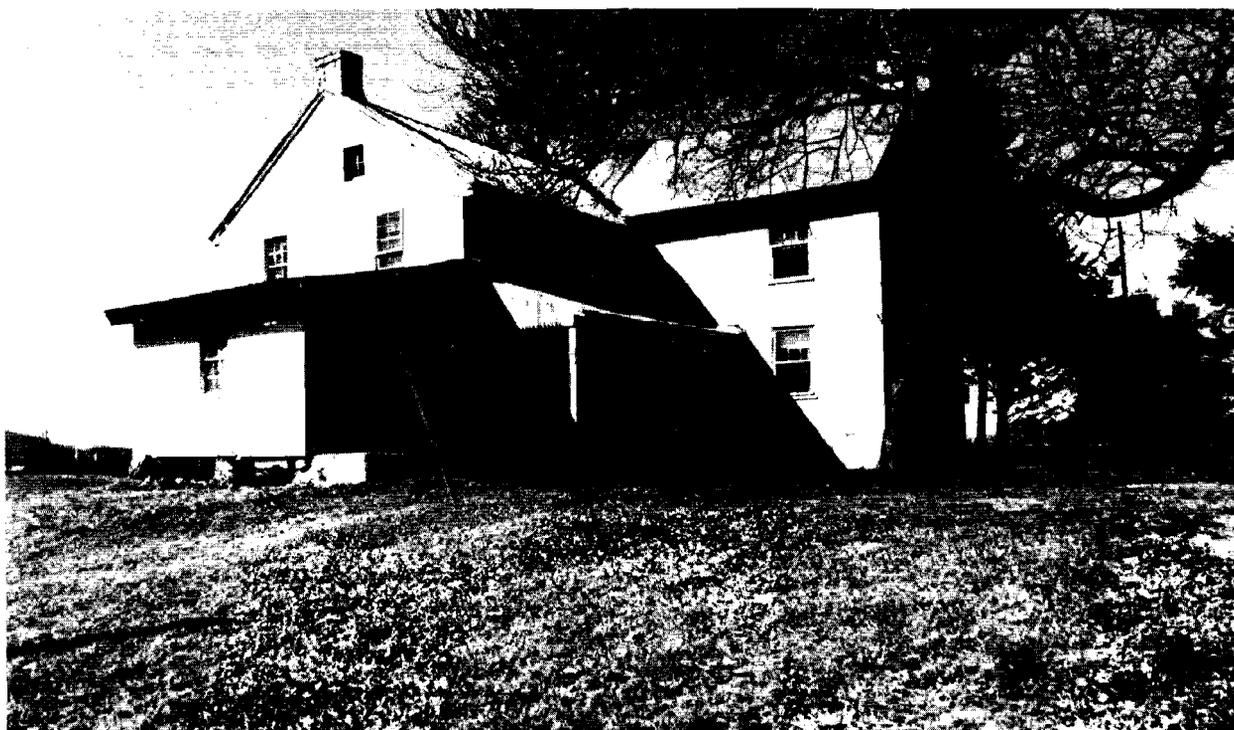
COMLY FARM - N-11171

The Comly farm consists of a circa 1820 3-bay house, possibly over an earlier log section, and a mid-19th century 2-bay side addition and rear addition with Victorian porch. The house underwent considerable renovation by the current owner circa 1950 when the house was in an extreme state of disrepair. These alterations included residing with asbestos, a new door with colonial frontispiece, and extensive interior remodeling. The 19th century barn collapsed approximately 40 years ago although its stone foundation remains for use as a shed. Compared to the McAntier farm of the same period (N-11172), located across Old Baltimore Pike, the Comly farm is not of architectural significance.

- a) Overall shape L  
stories 2 1/2  
bays 3 + 2  
wings rear ell 2 1/2 story addition;  
rear 1 story addition
- b) Structural system frame
- c) Foundation materials stucco over rubblestone  
basement yes

Top: looking south; Bottom: looking west

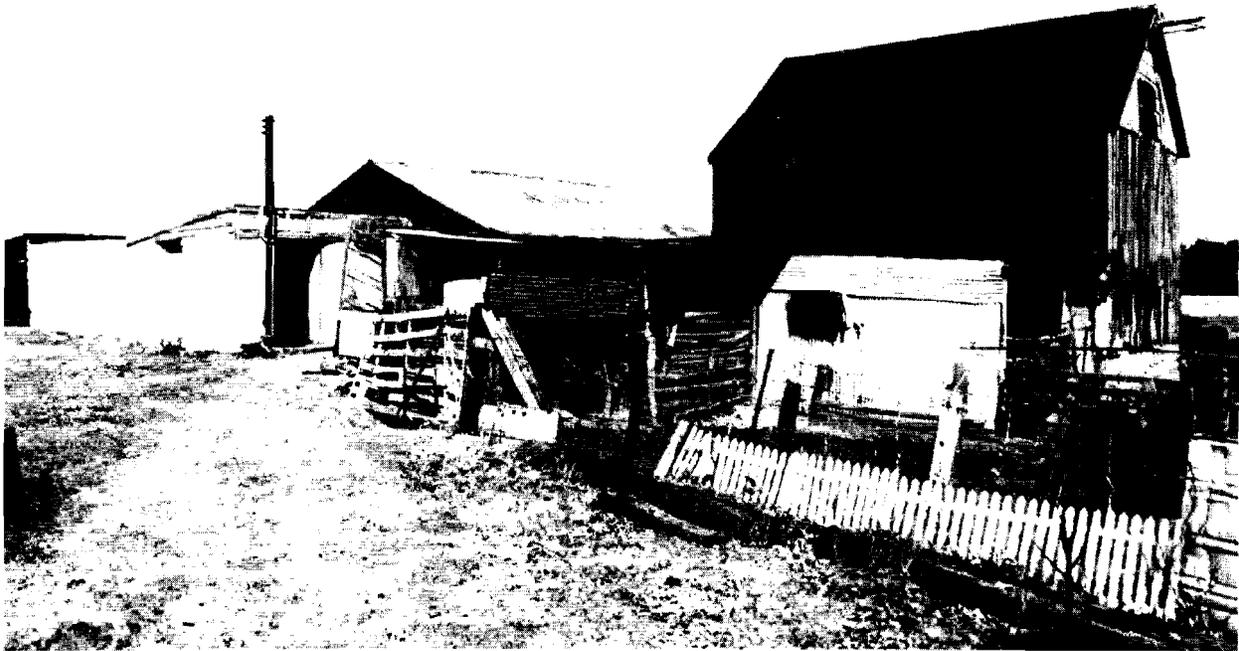
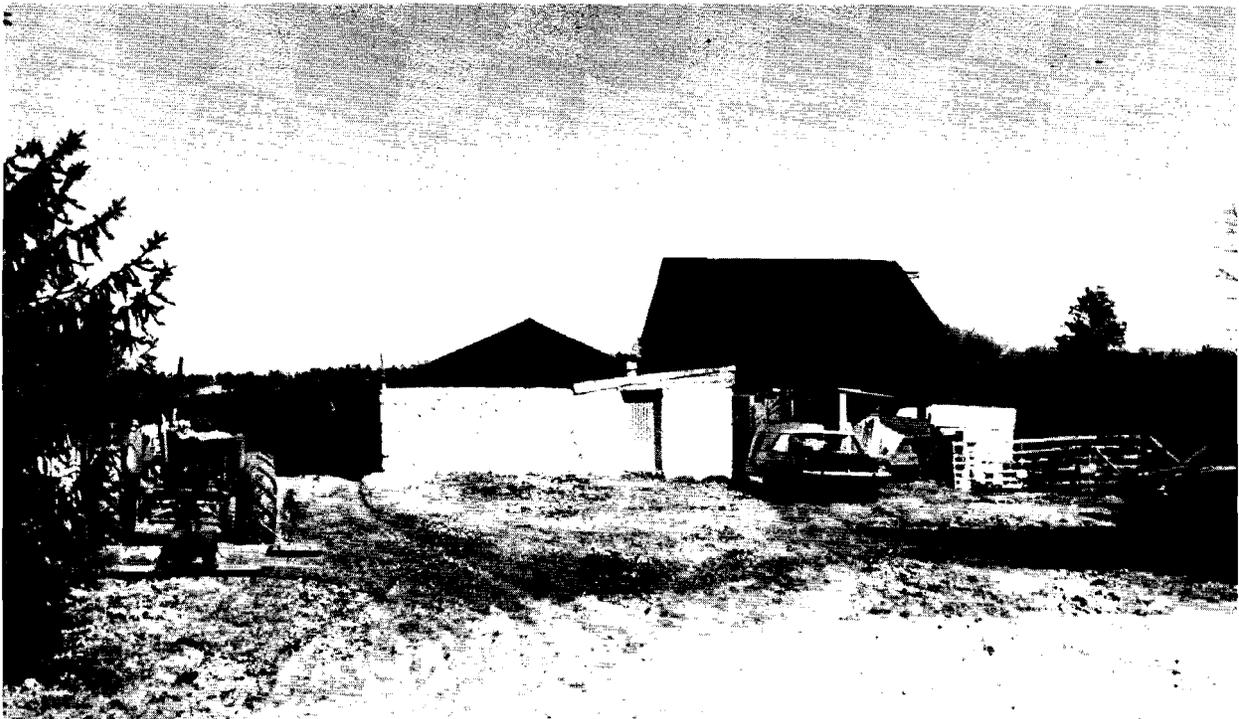
COMLY FARM - N-11171

Top: looking northeast; Bottom: looking east - barn & dairy barn

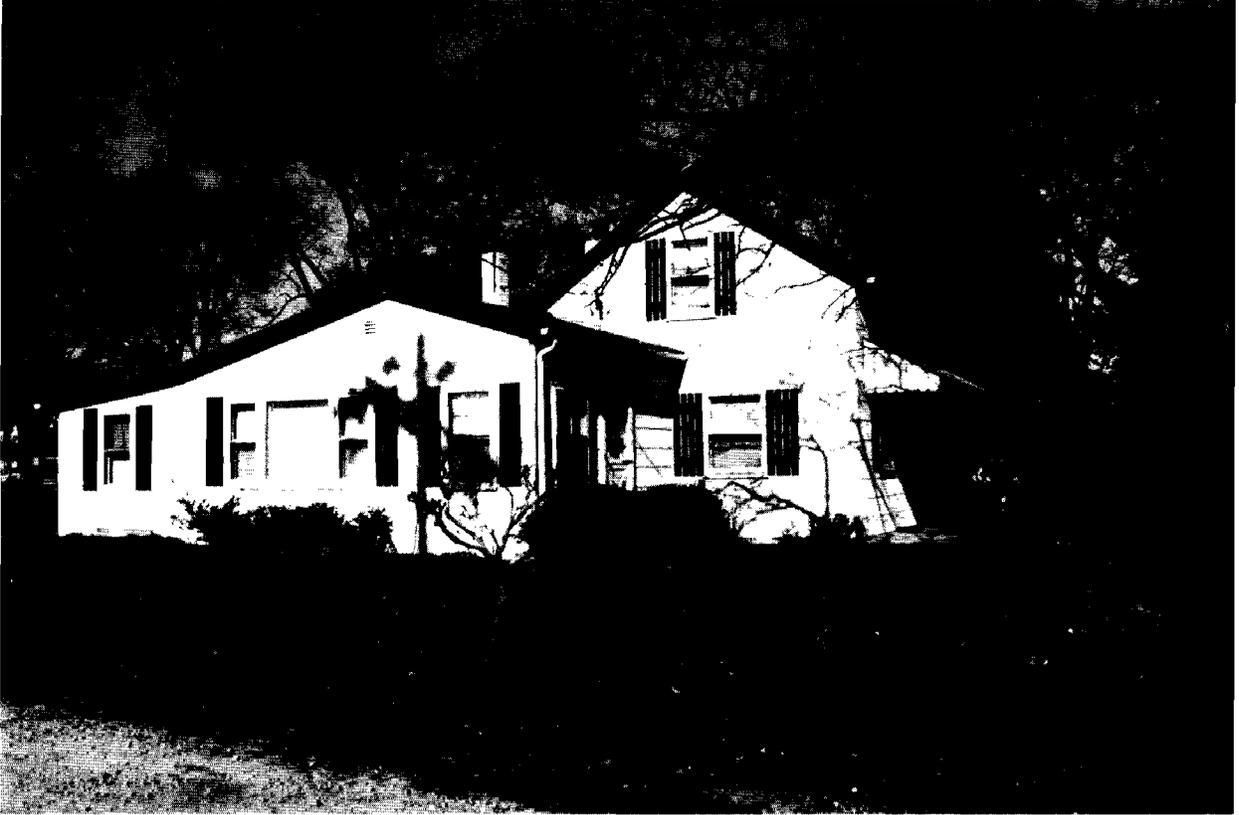
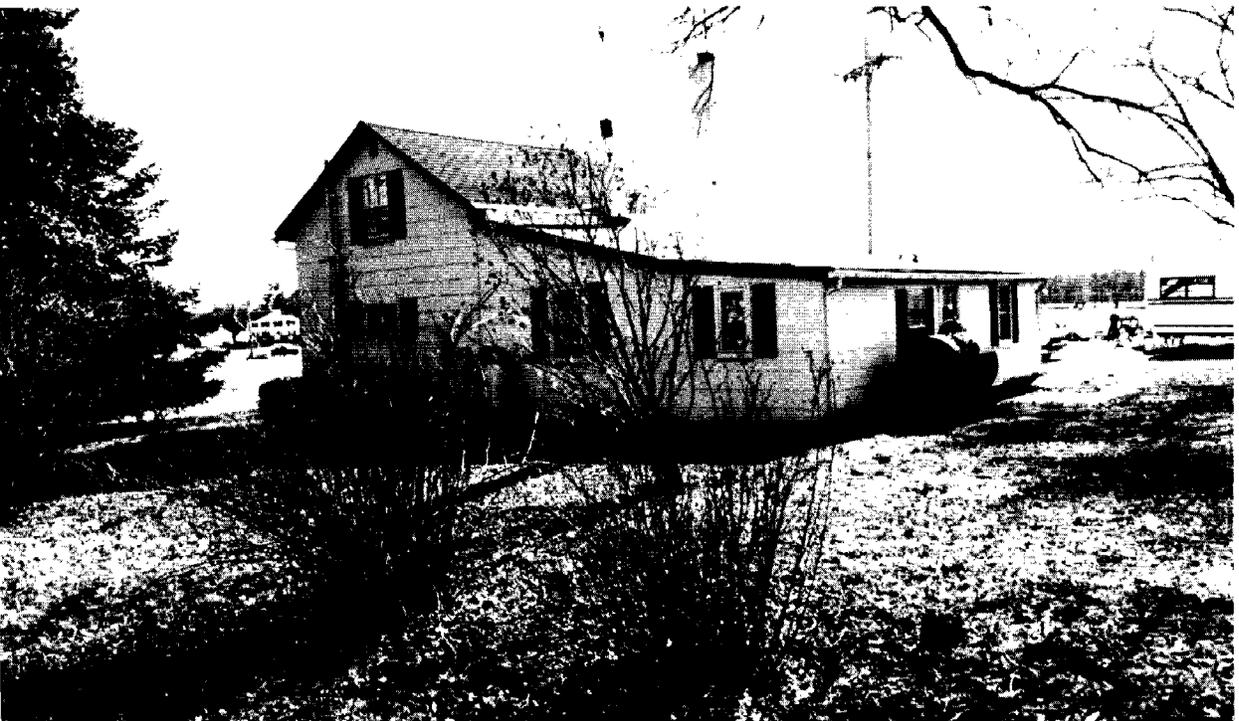
LEACH HOUSE - N-11174

- a) Overall shape rectangular  
stories 1 1/2  
bays 2  
wings side and rear additions
- b) Structural system frame
- c) Foundation  
materials concrete  
basement none
- d) Exterior walls  
materials asbestos- scalloped  
color(s) white
- e) Roof  
shape; materials gabled; asphalt  
cornice simple box  
dormers none  
chimney location(s) see plan
- f) Windows  
spacing  
type 1/1; 6/6 in addition  
trim  
shutters green picket
- g) Door  
spacing off center  
type single leaf glazed  
trim simple molded
- h) Porches  
location(s) front  
materials aluminum awning  
supports  
trim
- i) Interior details (if accessible)

Top: looking north; Bottom: looking south

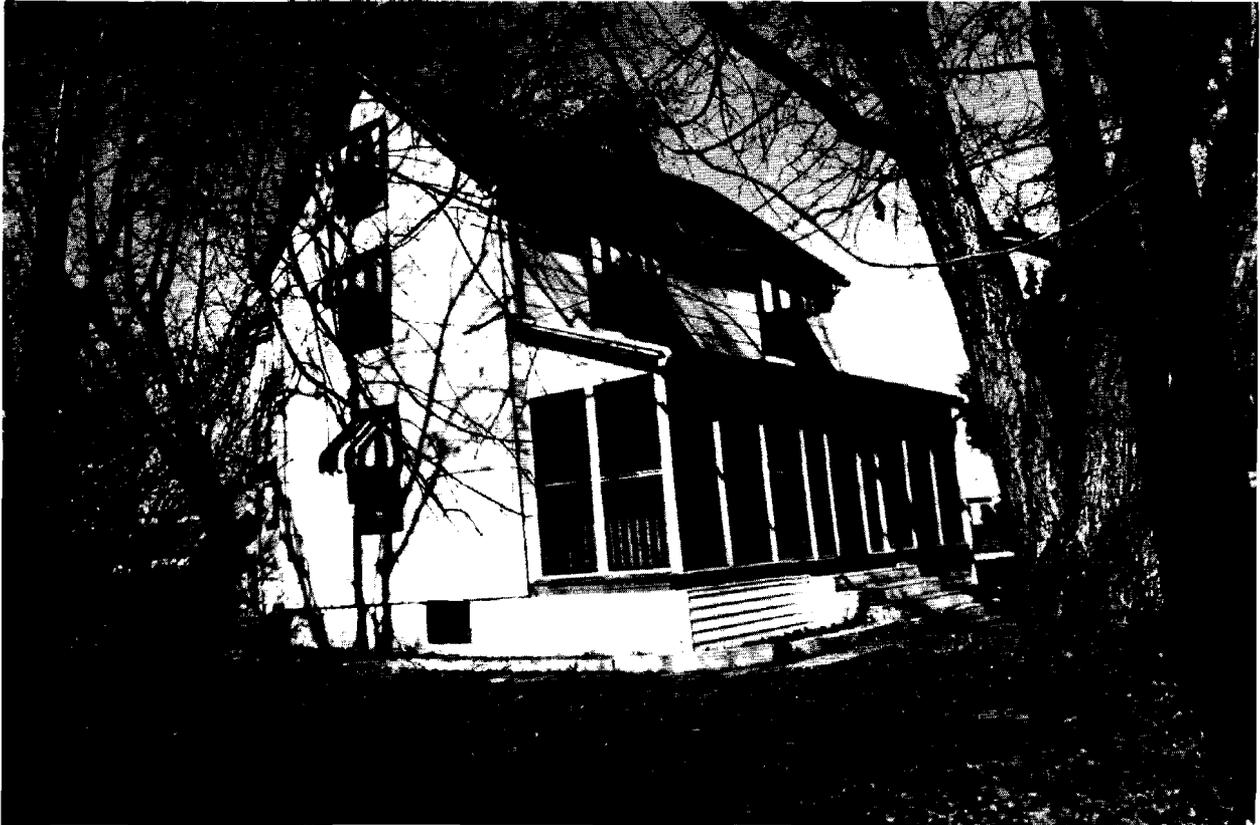
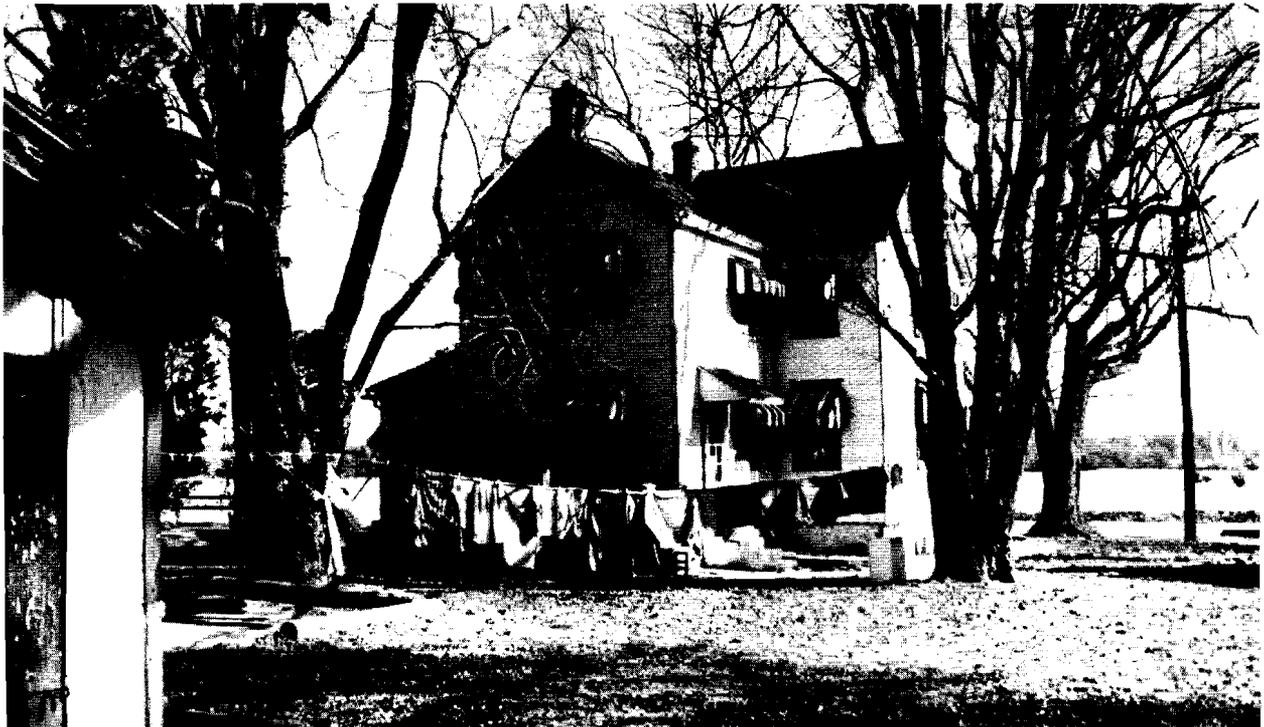
- a) Overall shape T  
     stories 2 1/2  
     bays 2  
     wings side enclosed shed addition
- b) Structural system frame
- c) Foundations  
     materials concrete  
     basement yes
- d) Exterior walls  
     materials German siding under asbestos shingles  
     color(s) white
- e) Roof  
     shape; materials gabled; asphalt  
     cornice simple  
     dormers none  
     chimney location(s) center along ridge
- f) Windows  
     spacing regular  
     type 2/2 double hung  
     trim thin entablature lintels, awnings  
     shutters none
- g) Door  
     spacing central  
     type glazed single leaf  
     trim
- h) Porches  
     location(s) front  
     materials screened in  
     supports turned posts with brackets  
     trim
- i) Interior details (if accessible)

Because the house does not appear on the 19th century atlases and it sits upon a modern foundation, it appears to have been moved to this site in the mid-20th century. It continues to be used as a single family residence.

Top: looking northeast; Bottom: looking southeast

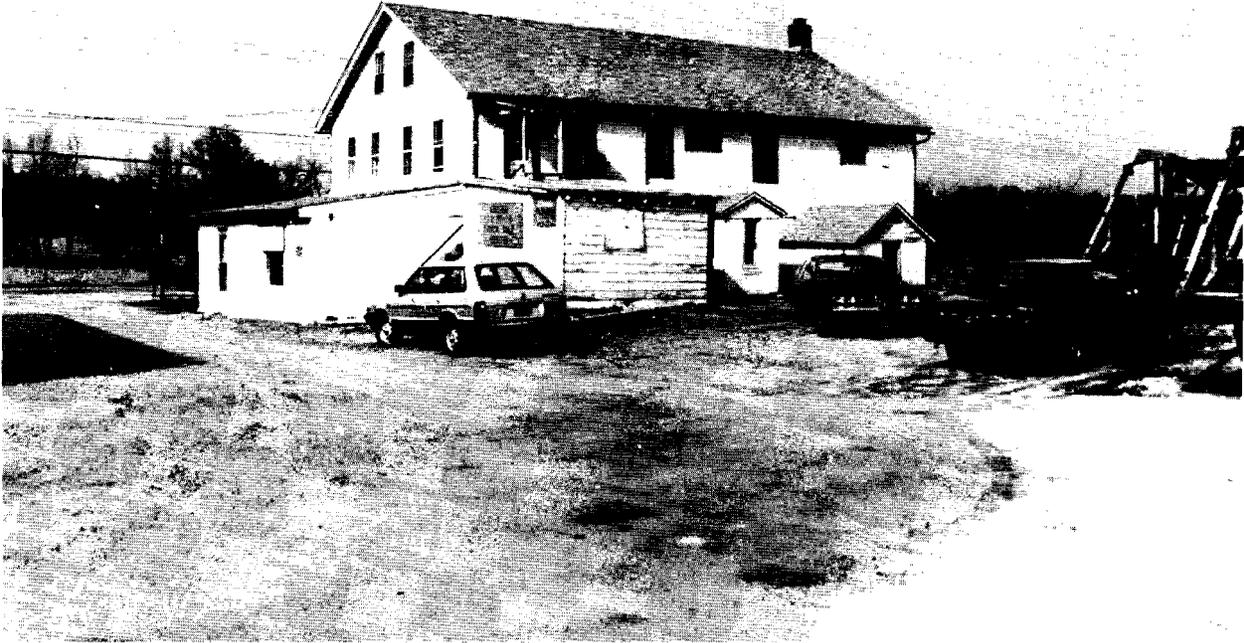
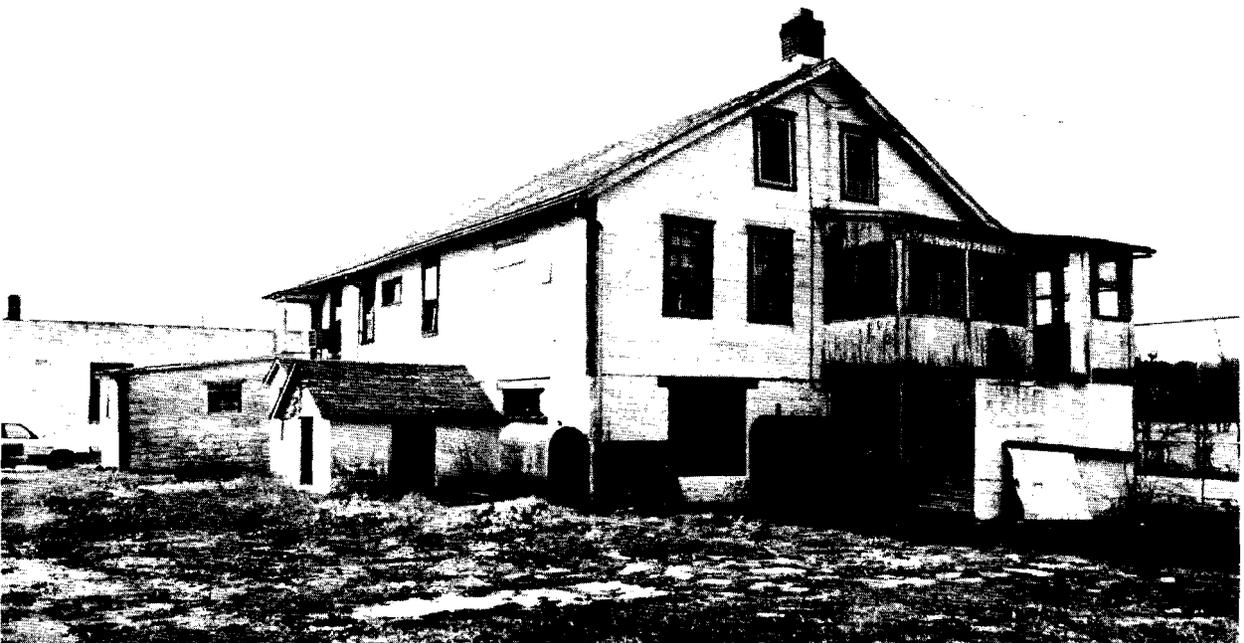
OBP INDUSTRIAL PARK - N-11170

Top: looking southeast; Bottom: looking northeast

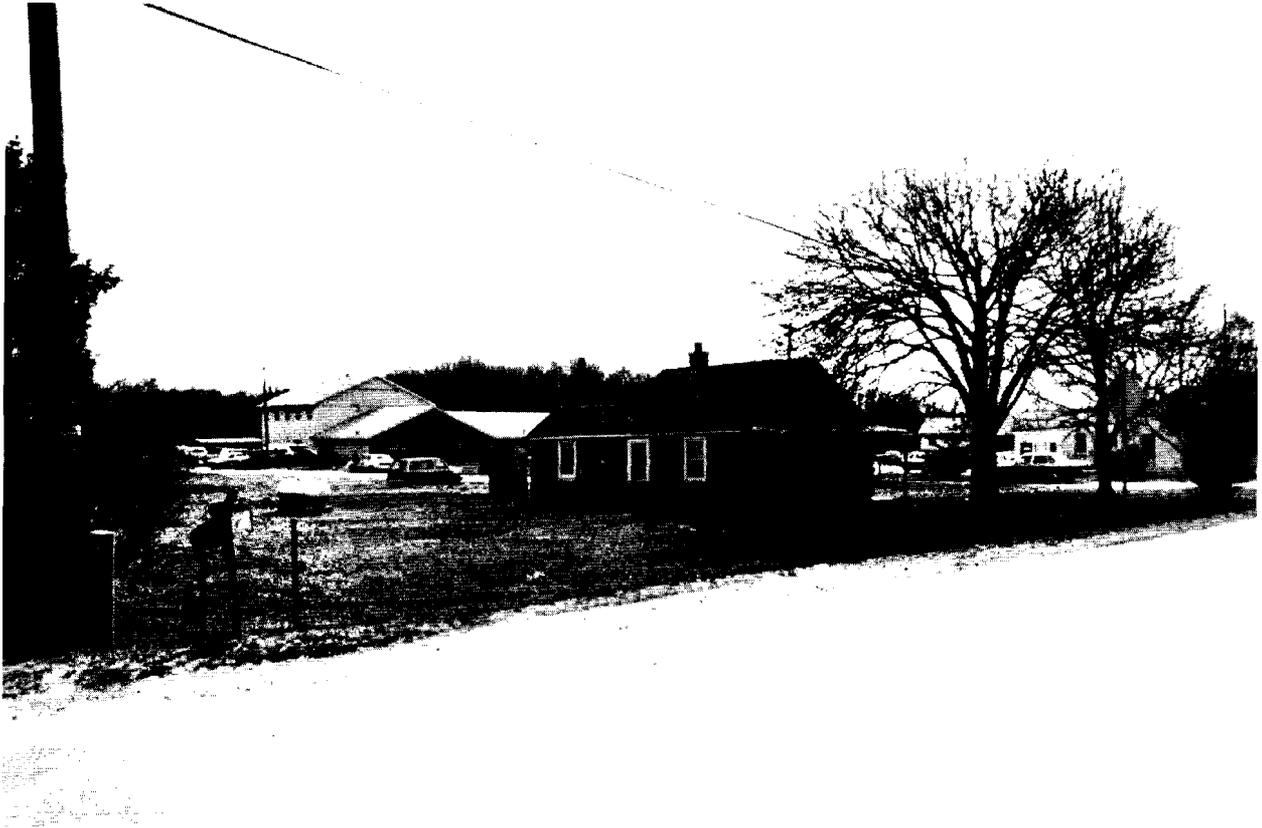
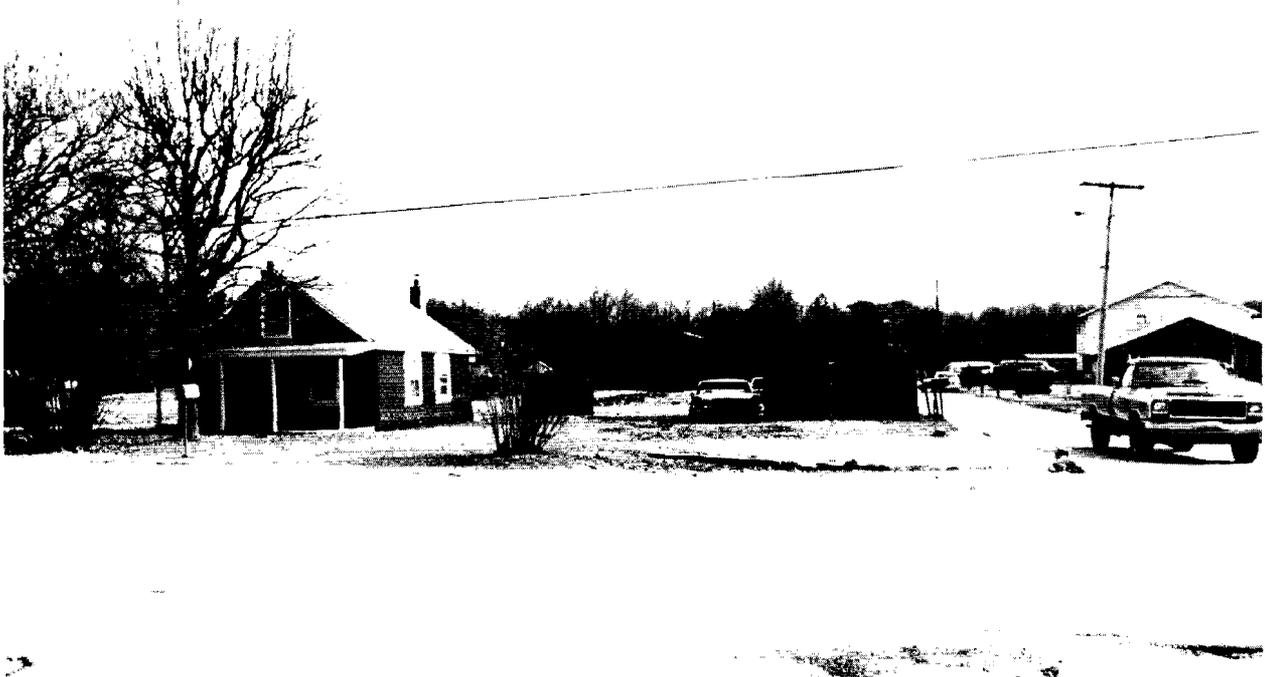
WORKERS HOUSE #3 - N-11169

Top: looking southwest; Bottom: looking south

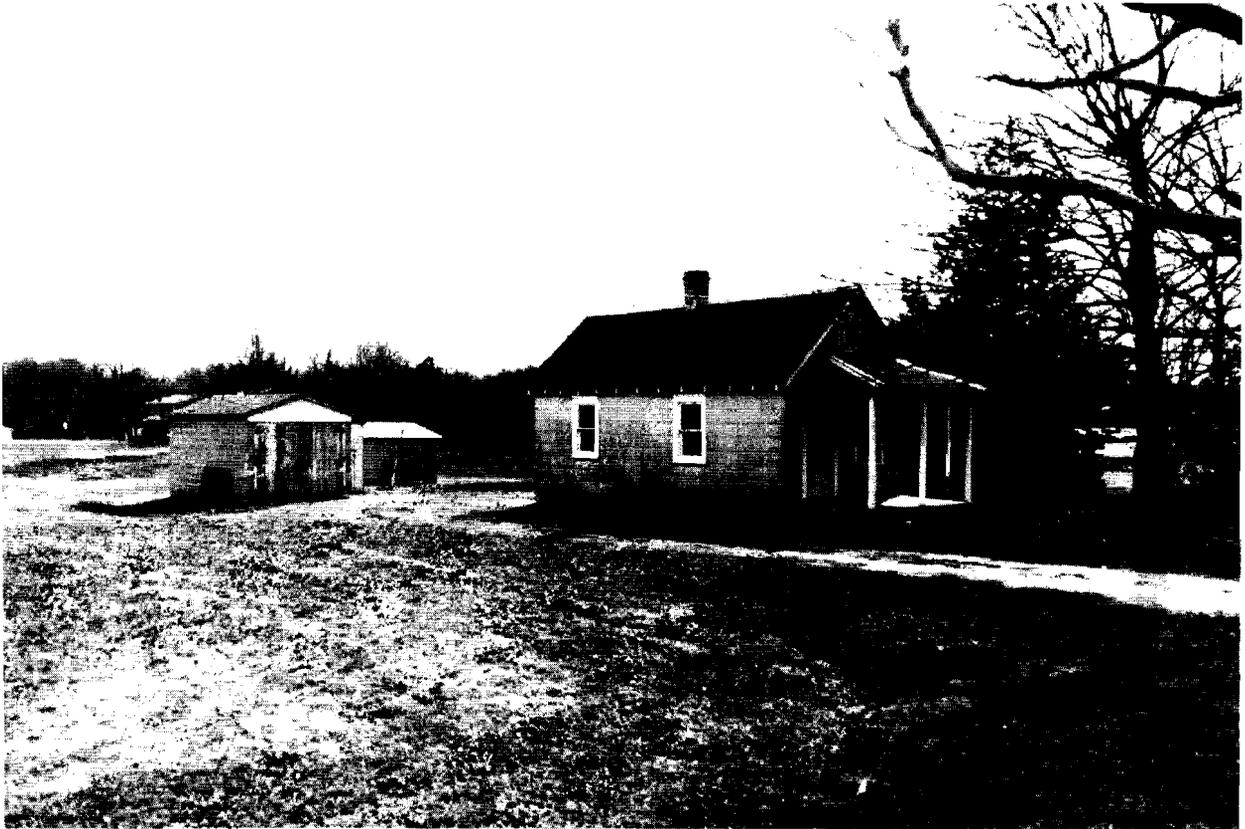
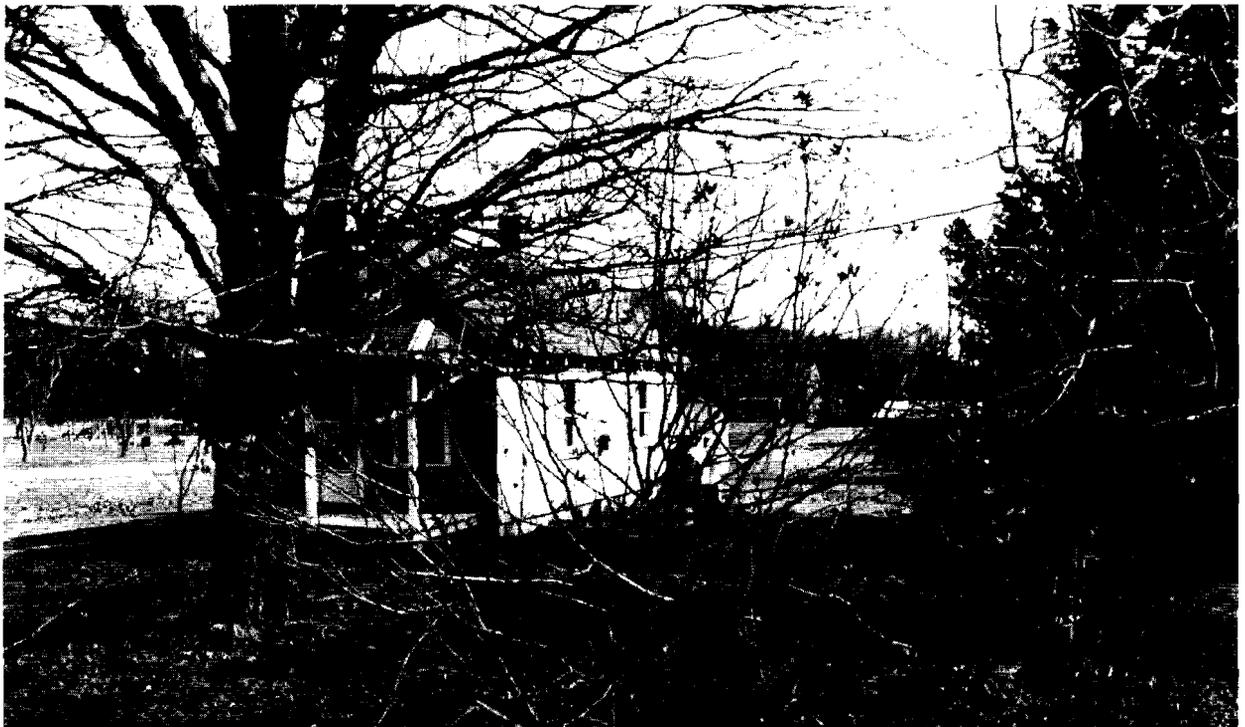
WORKERS HOUSE # 3 - N-11167

- a) Overall shape **rectangular**  
 stories **1 1/2**  
 bays **2**  
 wings **none**
- b) Structural system **frame**
- c) Foundation  
 materials **cmu**  
 basement **none**
- d) Exterior walls  
 materials **asbestos**  
 color(s) **grey**
- e) Roof  
 shape; materials **gable; asphalt with tin flashing**  
 cornice **overhang**  
 dormers **none**  
 chimney location(s) **center of ridge line**
- f) Windows  
 spacing **regular**  
 type **1/1 double hung**  
 trim **lipped lintels**  
 shutters **none**
- g) Door  
 spacing **off center**  
 type **single leaf with glazing**  
 trim **lipped lintel**
- h) Porches  
 location(s) **front**  
 materials **frame**  
 supports **wood posts**  
 trim **none**
- i) Interior details (if accessible)

Top: looking southwest; Bottom: looking southeast

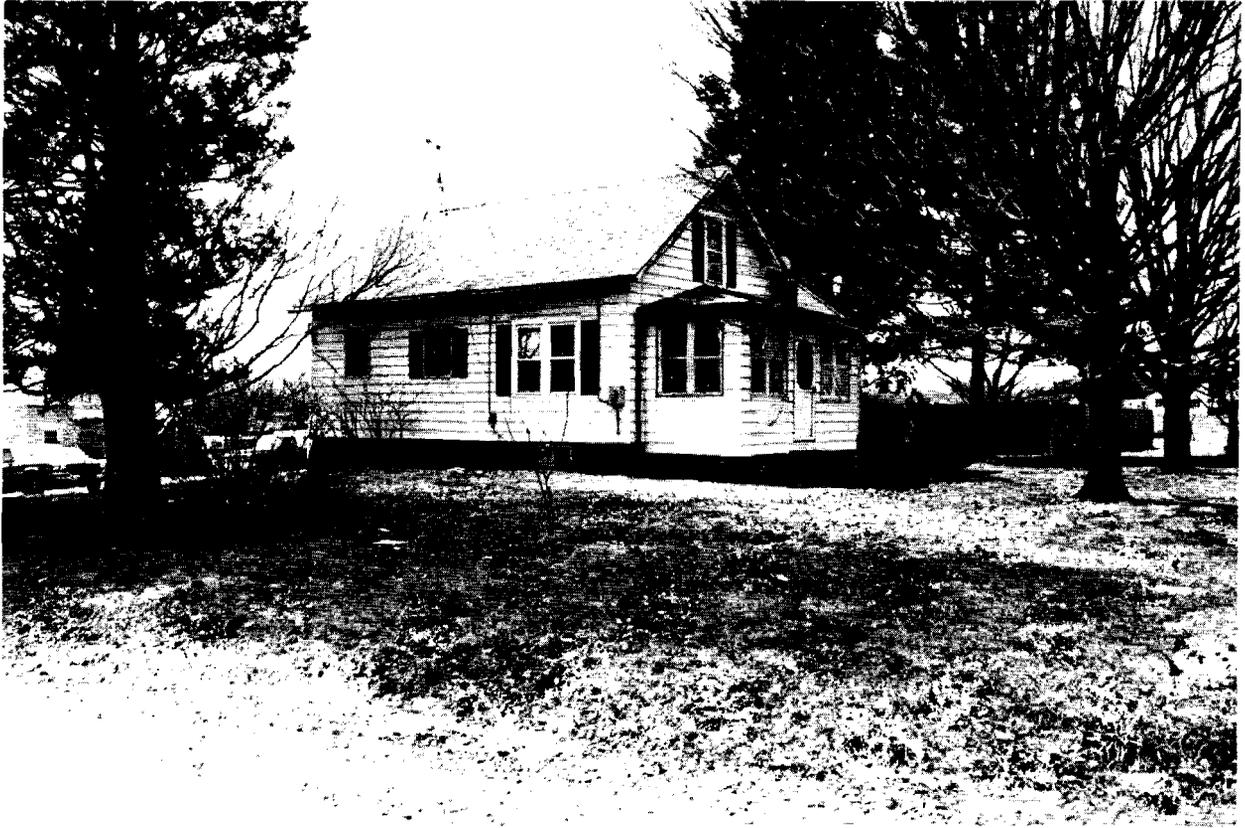
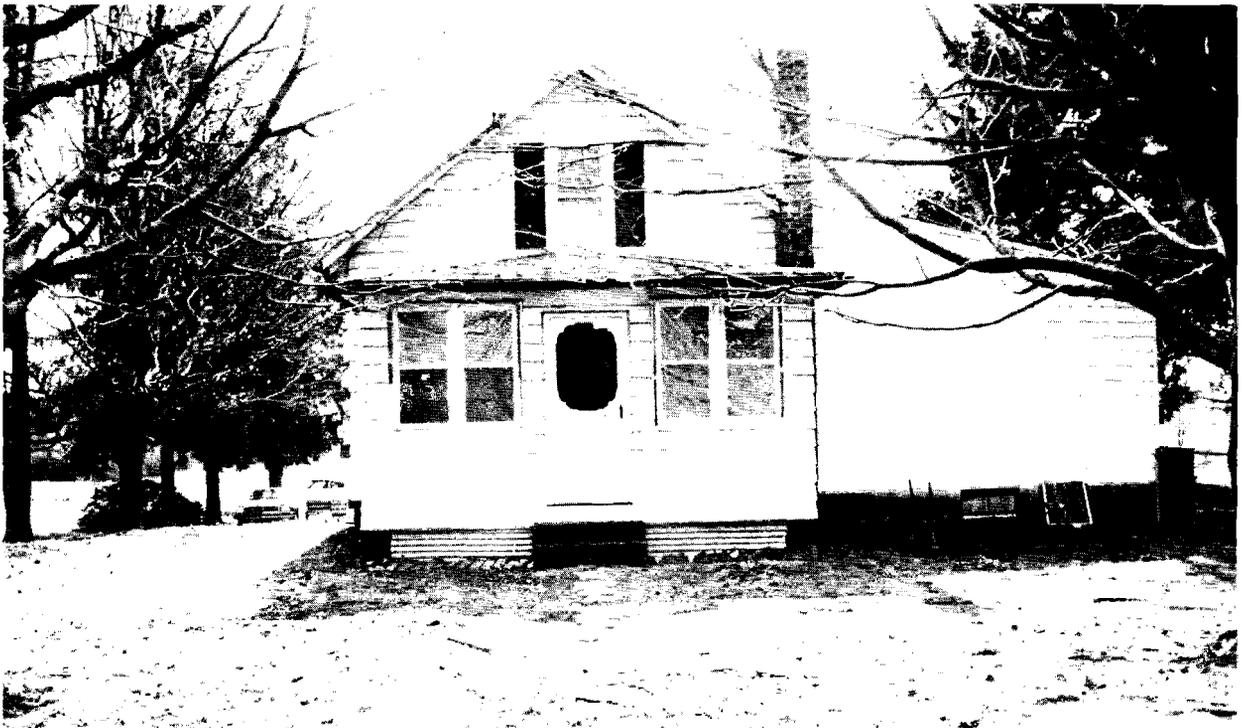
REESE RESIDENCE - N-11166

- g) Door  
   spacing           side  
   type               single leaf, modern glazed  
   trim               simple surround
- h) Porches  
   location(s)        front, enclosed  
   materials         aluminum siding  
   supports          frame construction  
   trim               none

Top: looking southwest; Bottom looking south

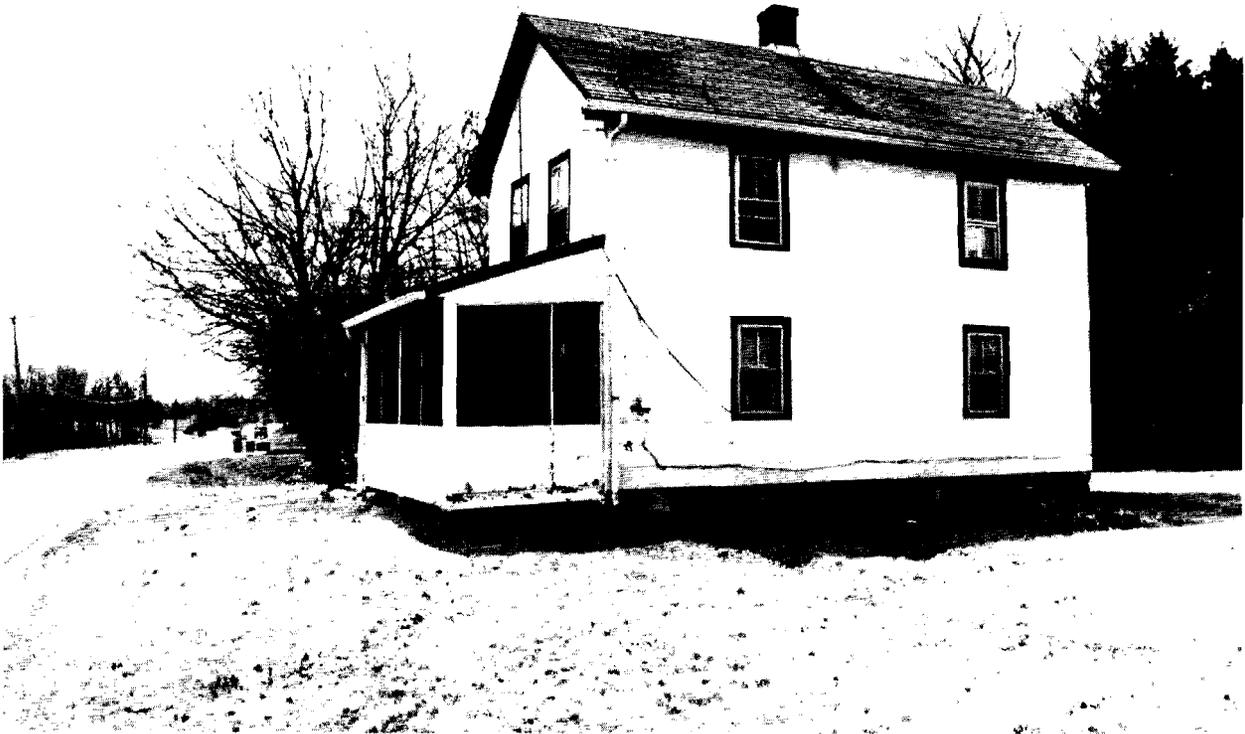
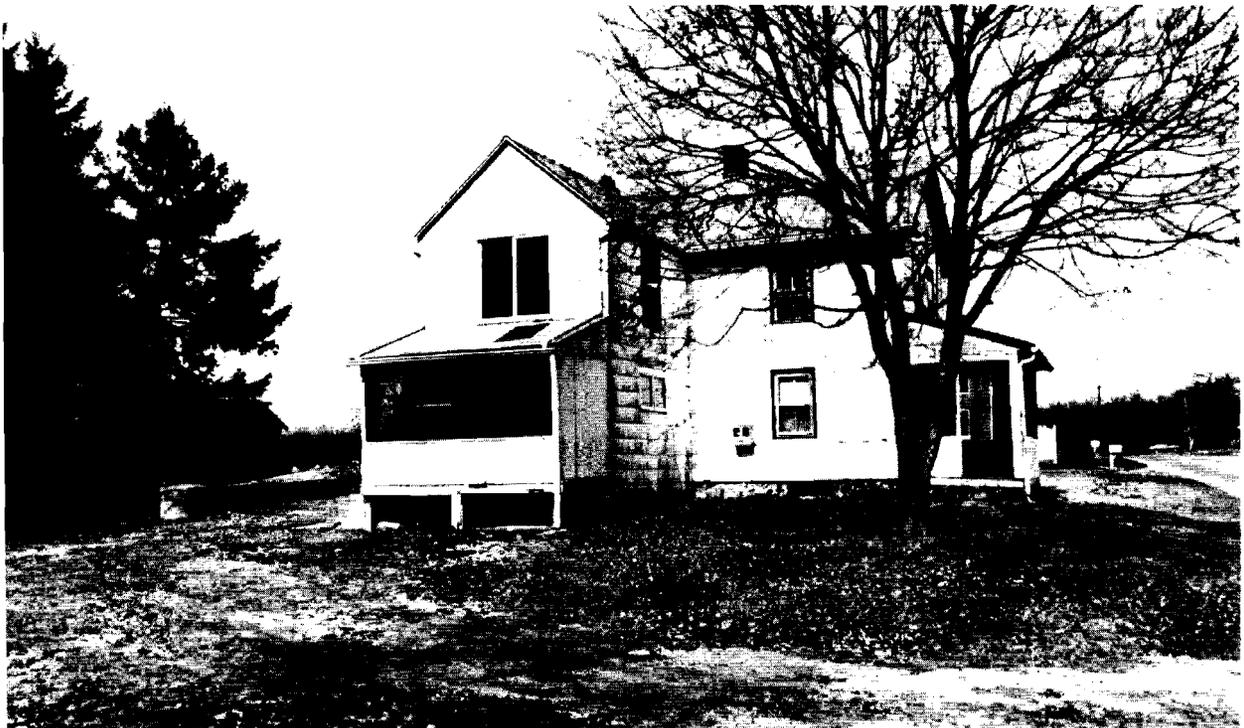
SEXTON'S HOUSE, SALEM M.E. CHURCH N-3994

Top: looking south; Bottom: looking northwest
