APPENDIX VI  
EVALUATION OF STANDING STRUCTURES

**HISTORIC PROPERTY EVALUATION ON OLD BALTIMORE PIKE  
BETWEEN ROUTES 7 AND 896**

Submitted to:  
Delaware Department of Transportation

10 September 1987

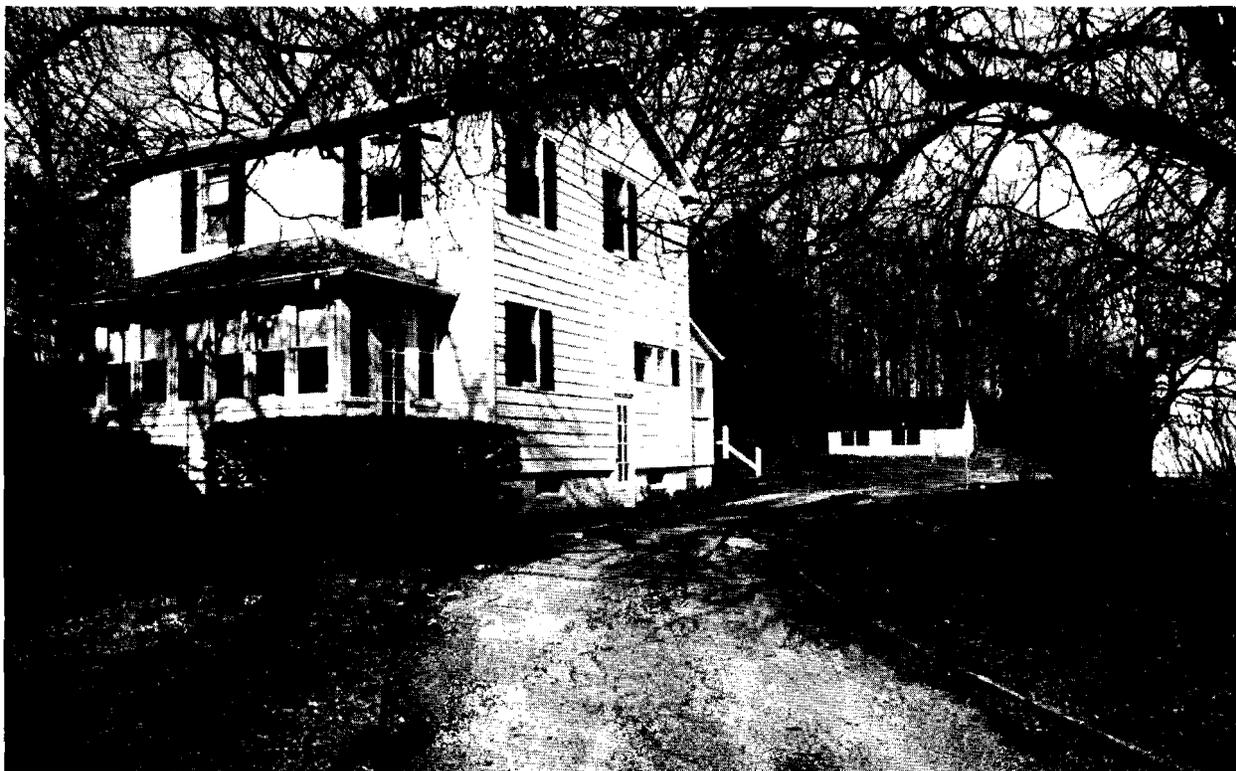
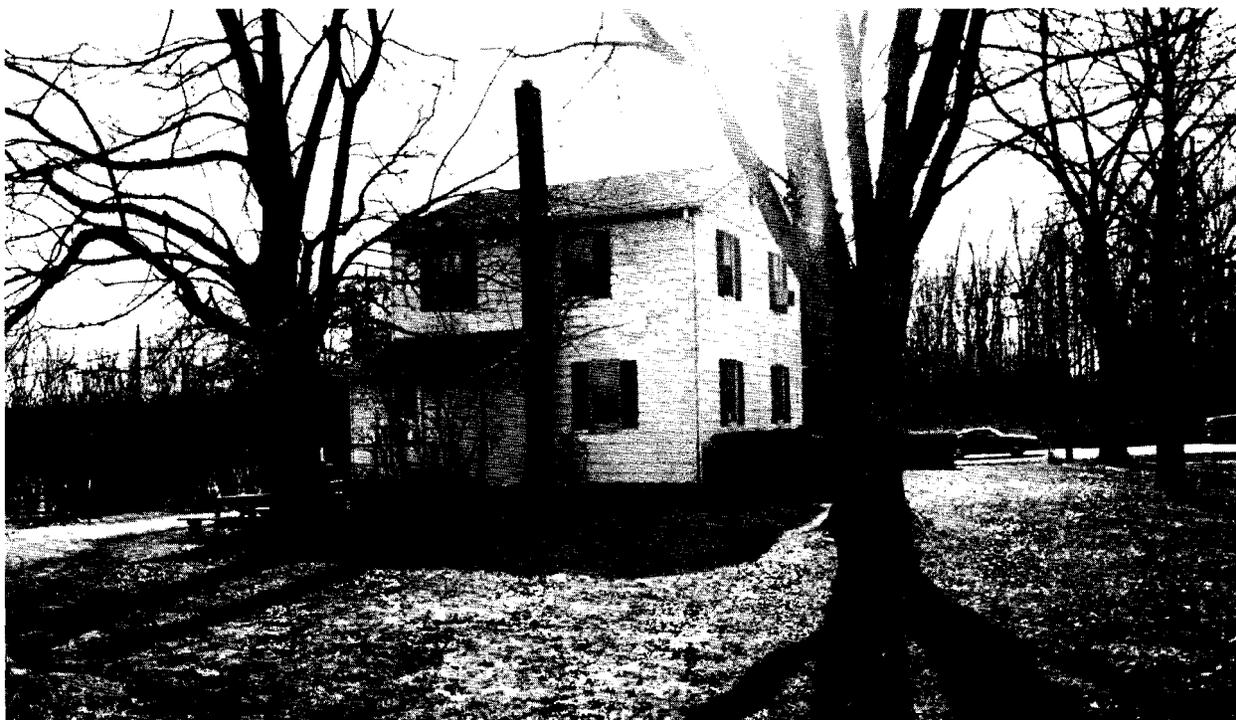
SOUTHGATE/RED ROOF - N-11163

- a) Overall shape rectangular  
stories 2  
bays 2  
wings rear one-story shed room
- b) Structural system frame
- c) Foundation  
materials concrete  
basement yes
- d) Exterior walls  
materials aluminum siding  
color(s) white
- e) Roof  
shape; materials gabled; asphalt  
cornice plain box  
dormers none  
chimney location(s) exterior rear, centered
- f) Windows  
spacing regular  
type 1/1 double hung  
trim panned with aluminum  
shutters plastic louvered, wood-grained
- g) Door  
spacing side  
type single leaf 4-panel  
trim simple
- h) Porches  
location(s) front  
materials wood, enclosed with glass and clapboarding  
supports wood frame  
trim quarter round molding at cornice
- i) Interior details (if accessible)

Top: looking west; Bottom: looking northeast
