# Architectural Investigations of the Route 896 Corridor Summit Bridge to SR 4 New Castle County, Delaware

Martha H. Bowers  
The Cultural Resource Group  
Louis Berger & Associates, Inc.  
East Orange, New Jersey

DELDOT ARCHAEOLOGICAL SERIES 53

In January, 1987, an architectural survey and assessment was conducted along that portion of State Route 896 lying between Summit Bridge and State Route 4 in Pencader Hundred, New Castle County, Delaware. The work was undertaken by the Cultural Resource Group of Louis Berger & Associates, Inc. for the Delaware Department of Transportation (DelDOT), and the Federal Highway Administration (FHWA). The purpose of the survey was to provide information for compliance with Section 106 of the National Historic Preservation Act in consultation with the State Historic Preservation Office (SHPO) and the Bureau of Archaeology and Historic Preservation (BAHP). A program of documentary research and field investigation was employed to inventory eleven properties on Route 896 ranging in date from the late 18th to early 20th centuries, most of which were once associated with agricultural activities. Of these properties, six have been evaluated as meeting

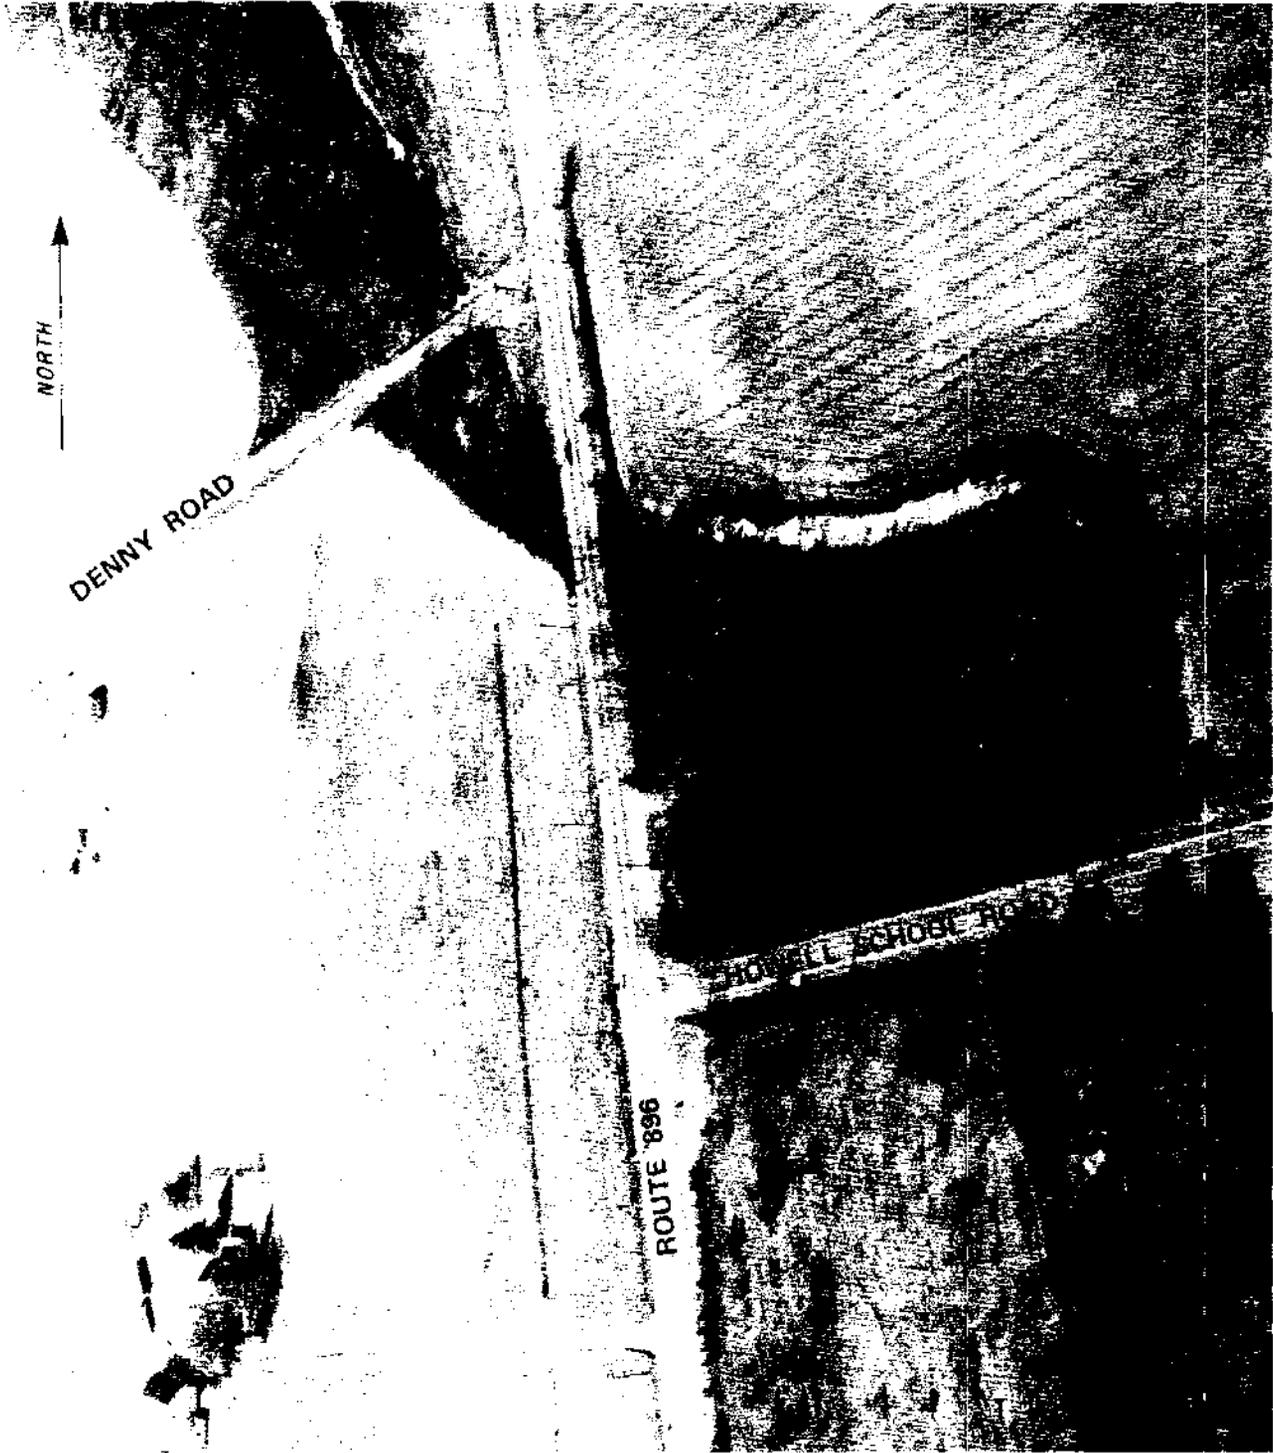
Description: The property known as Bellvue is located on the west side of Route 896, approximately 600 feet south of the 896-Howell School Road intersection. The property consists of the remains of an agricultural complex in which all buildings except a mobile home are uninhabited and unused, although in relatively good condition. The complex is sited on slightly elevated ground with a setback of over 600 feet from the highway, at the end of a rutted lane running between fallow and cultivated fields. The seven structures in the complex are a farmhouse, dairy barn, granary, storage shed, barn converted to machine shed, and house trailer (Plate 1).

PLATE 1: Bellvue Farmstead SOURCE: DELDOT

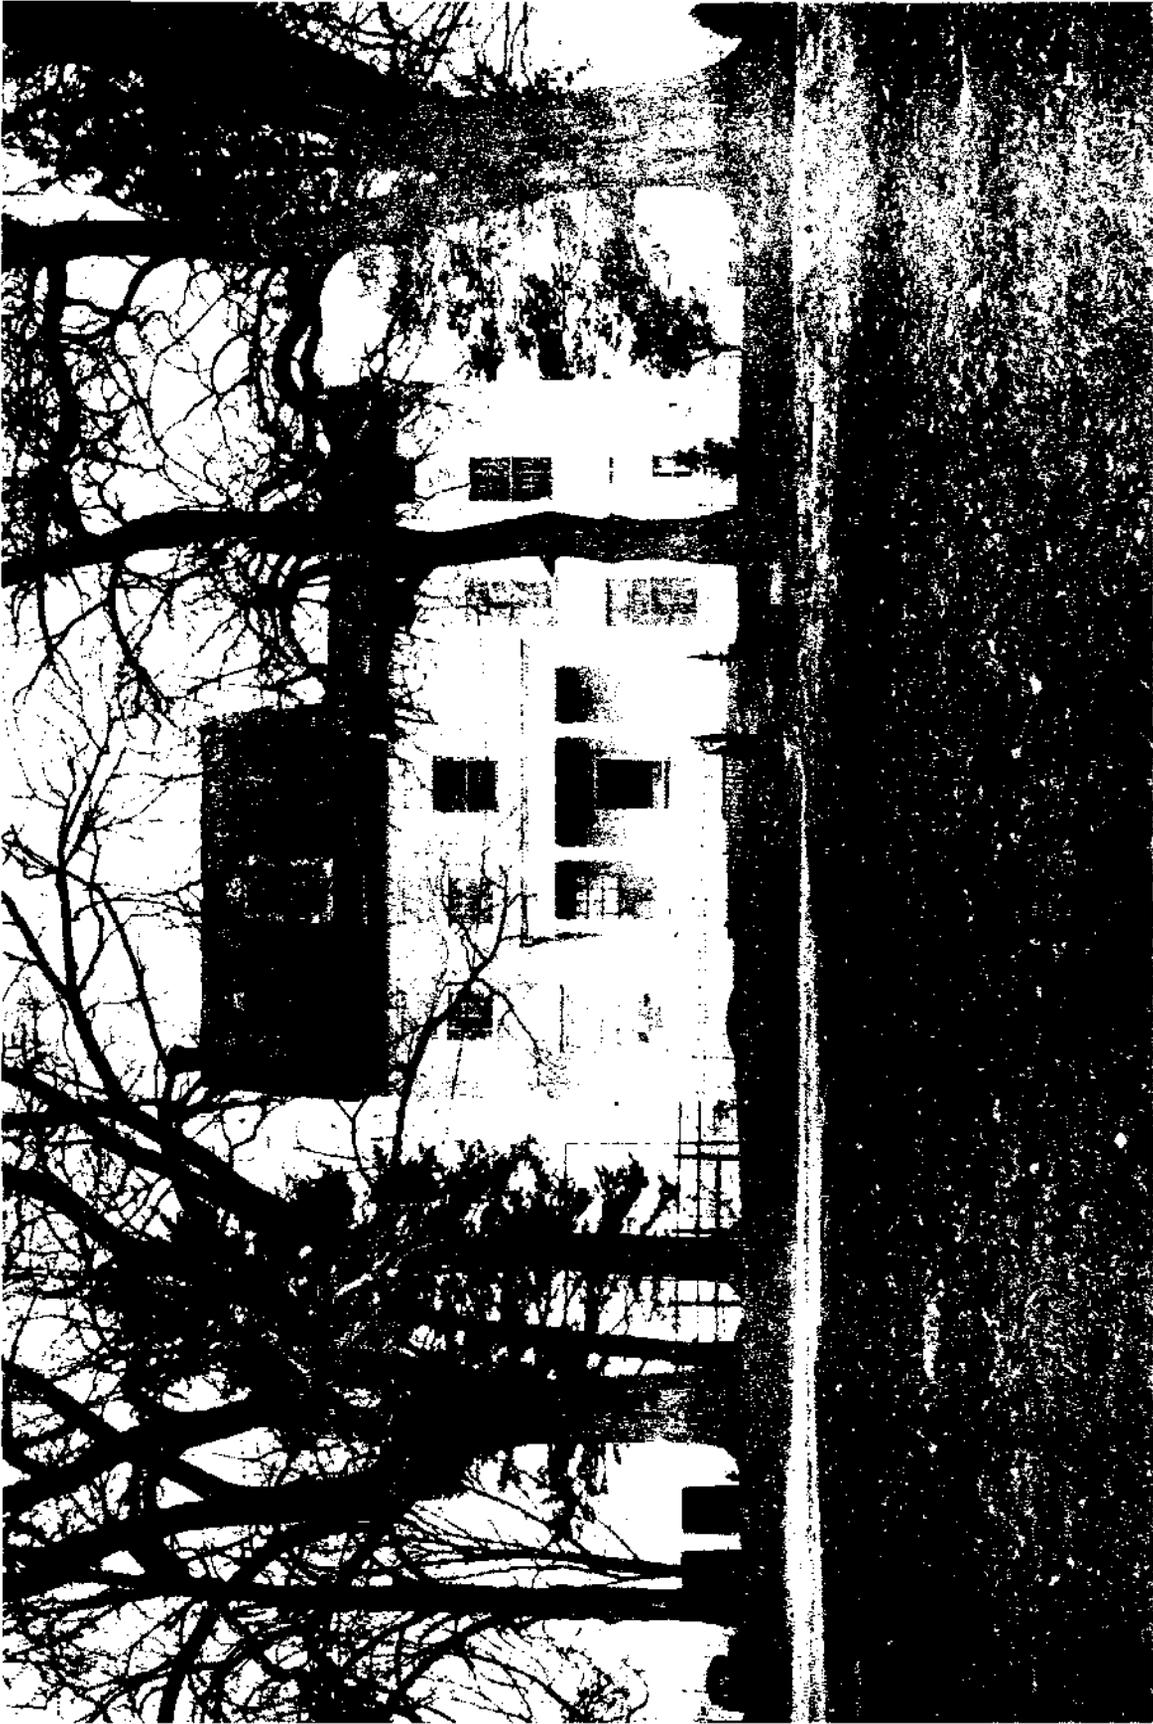
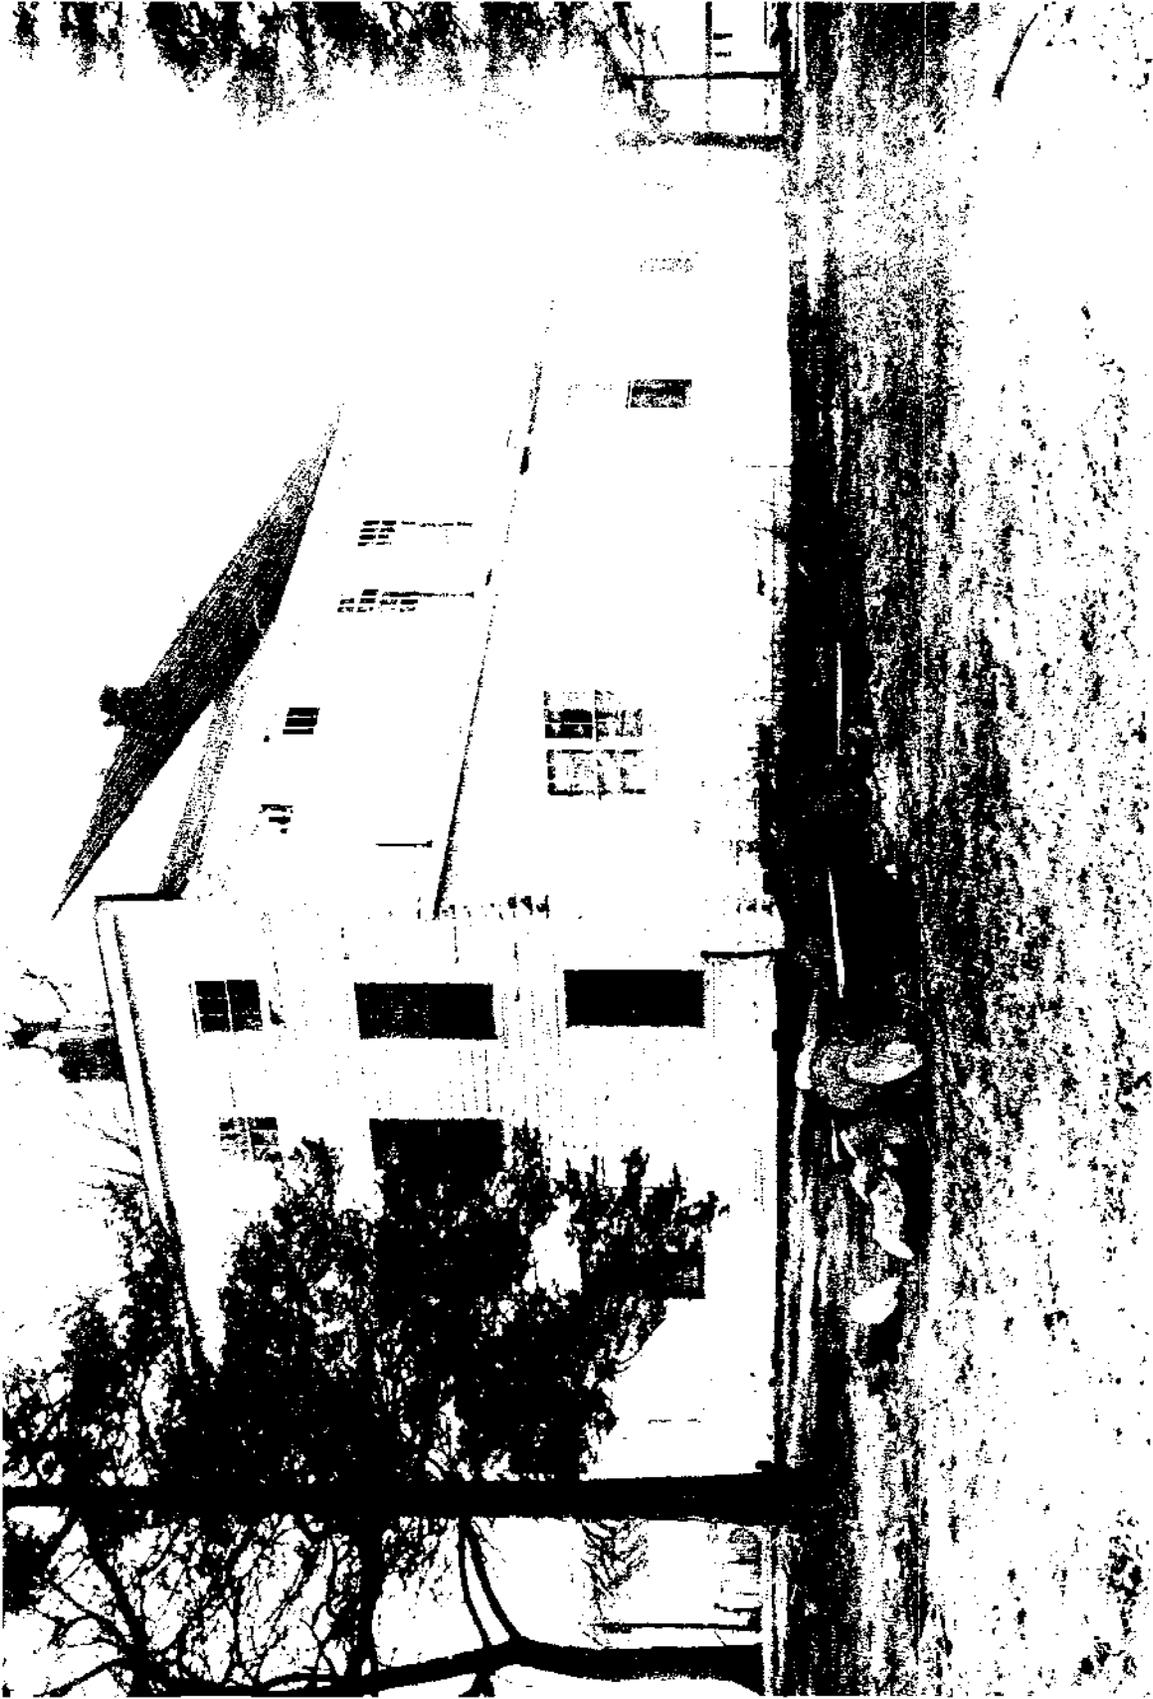
The farmhouse (Plates 2 and 3) oriented perpendicular to Route 896 and facing south, exhibits three major construction phases. Earliest (prior to 1792) is a 2-1/2 story, side-gable side-hall unit of painted Flemish bond brick on a high brick basement. The three-bay facade features 12/12 double hung sash in molded surrounds above thick timber sills. On the west side the

PLATE 2: Bellevue Farmstead, View of Farmhouse Looking North

PLATE 3: Bellvue Farmstead, View of Farmhouse Looking Southwest

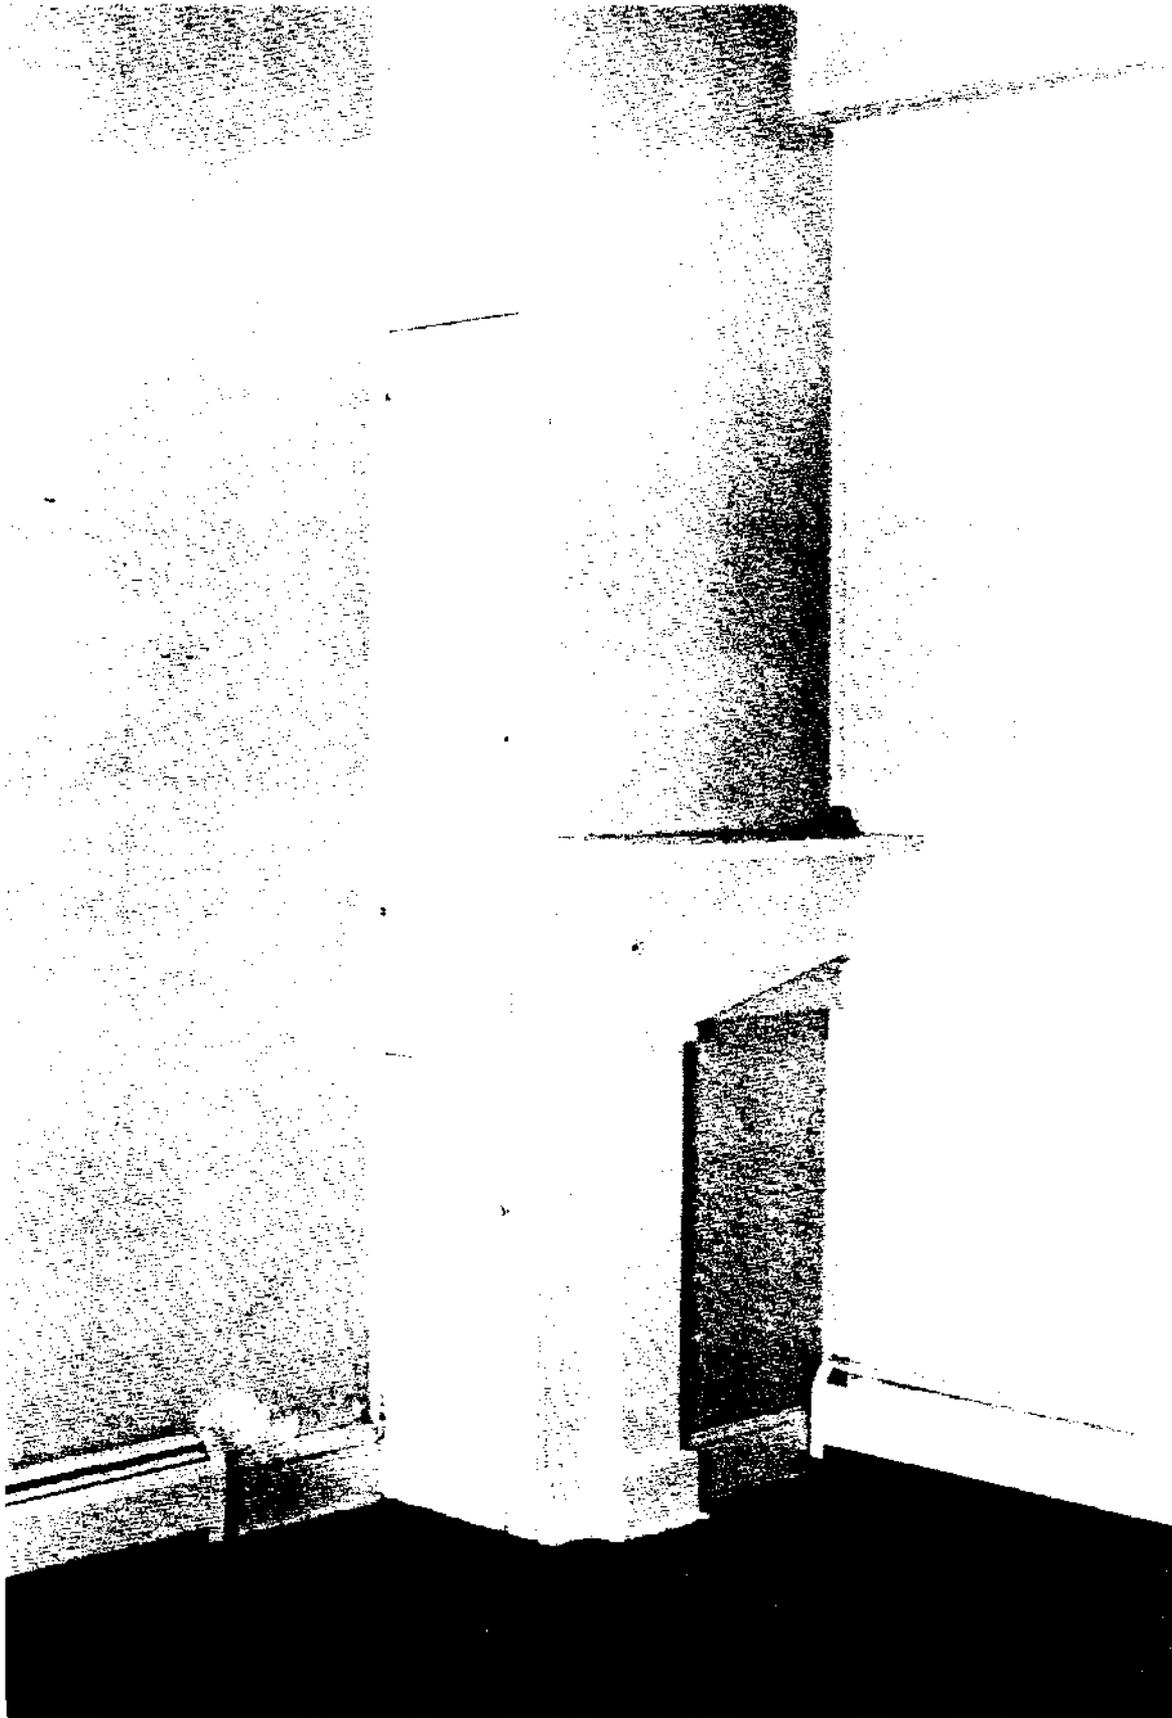
PLATE 4: Bellvue Farmstead, Partitioned Mantel on First Floor of Brick Section

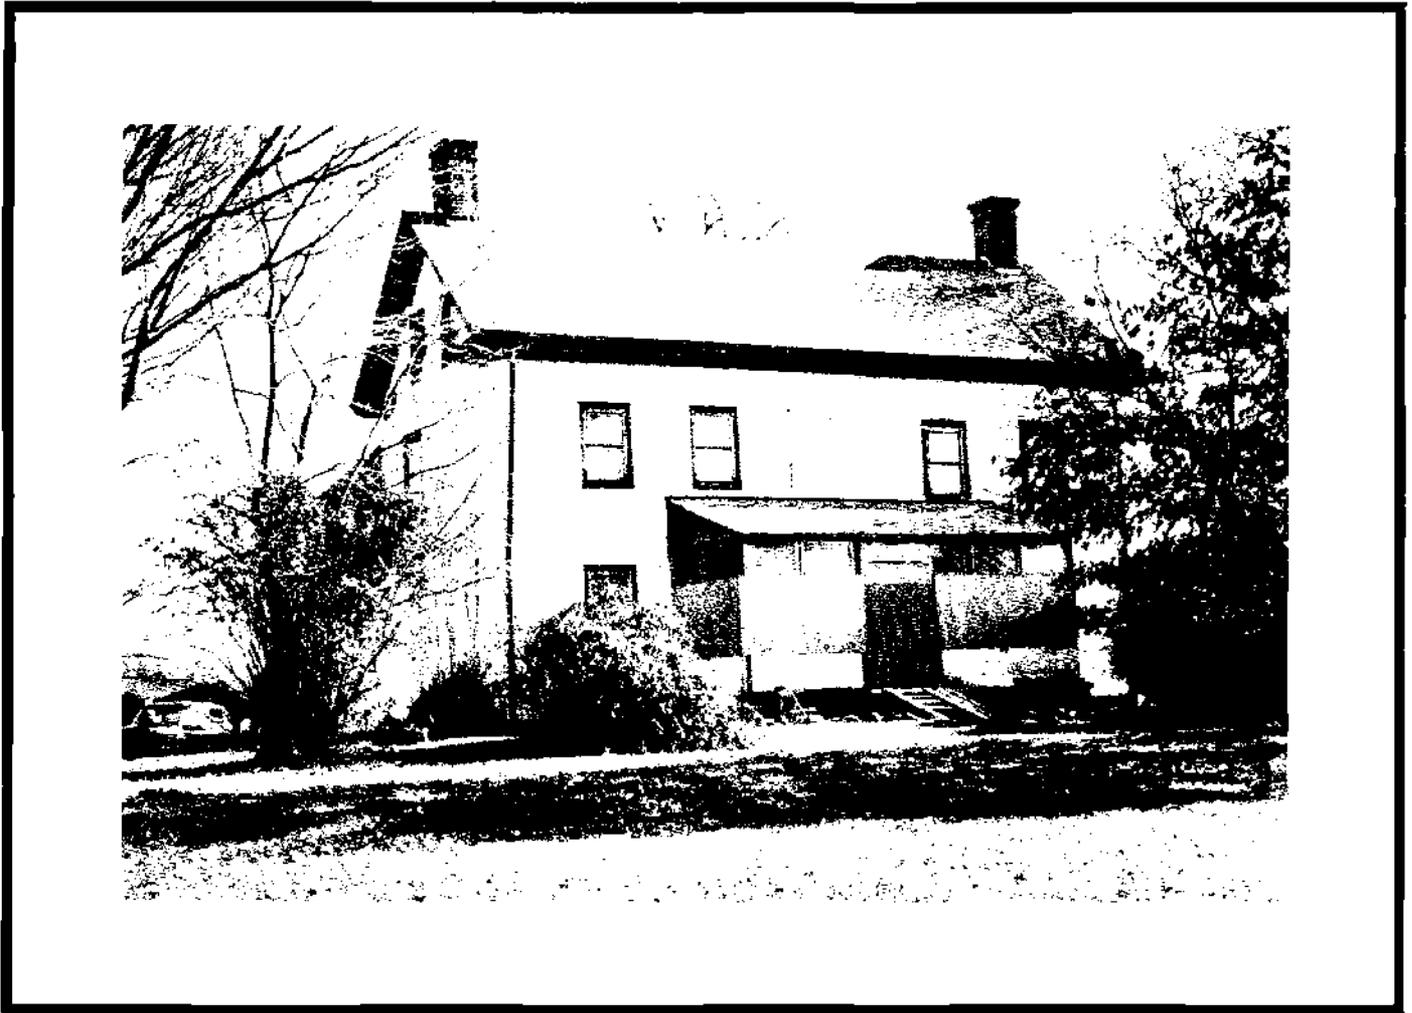
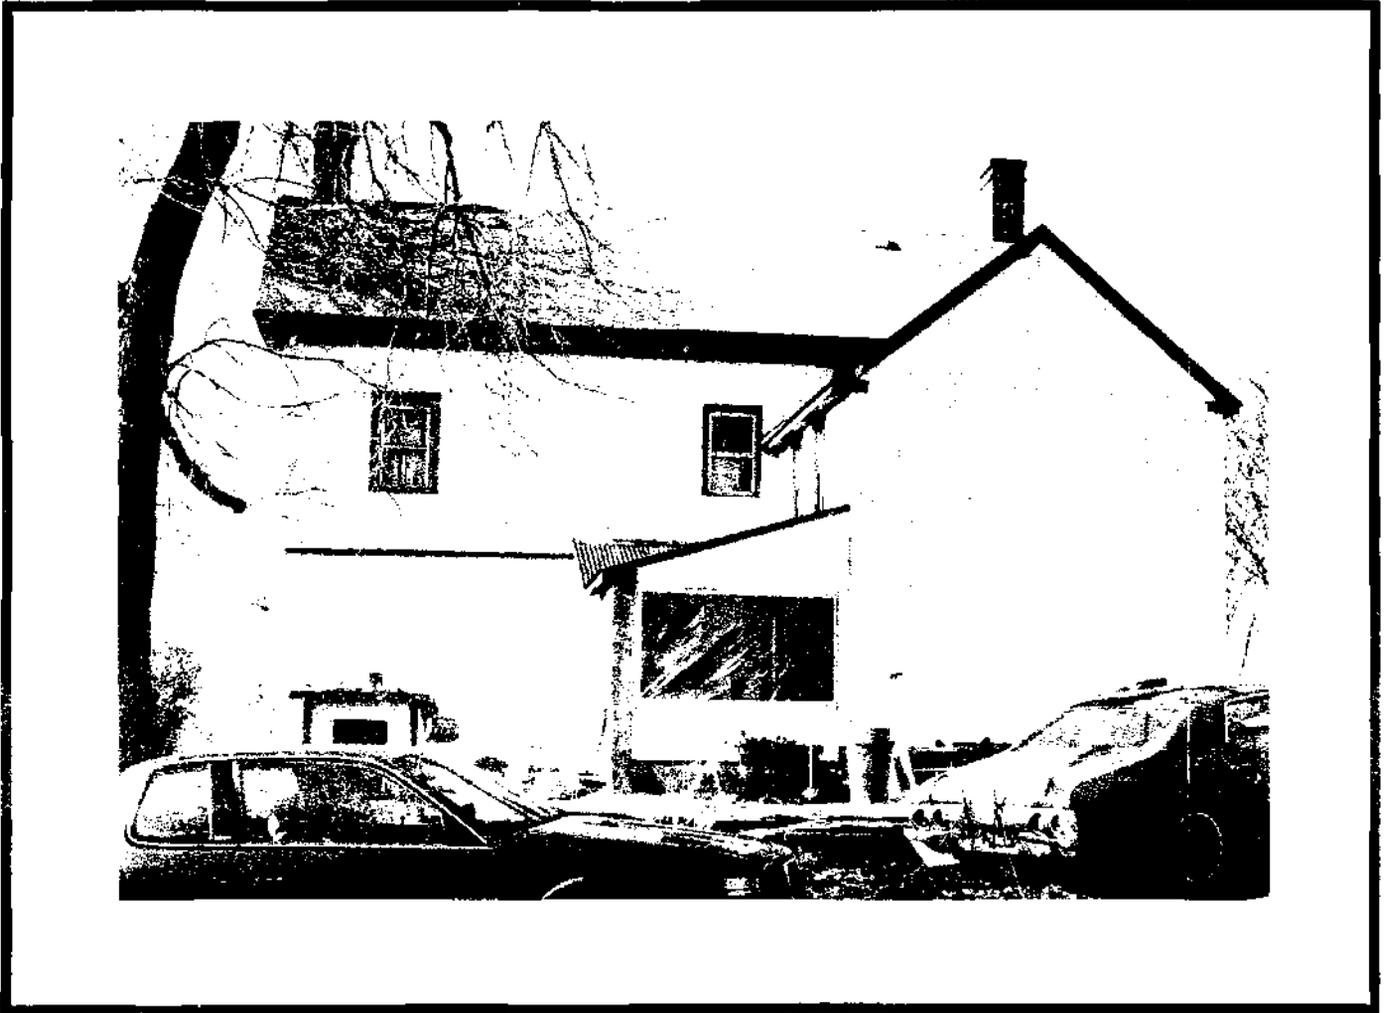
The house consists of a 2-1/2 story side-gable single-pile main block with a two story rear ell (Plates 9 and 10). The house

PLATE 9: DeShane – Paxton House, View Looking Southeast

PLATE 10: DeShane – Paxon House, View Looking West

is of wood frame construction, clad in gray-tan artificial shingling, on a raised masonry foundation coated with concrete. Tall brick chimneys with corbelled caps are located within the gable ends of the main block. The roof is covered with composition shingles, and on the main block has molded cornices with partial returns.

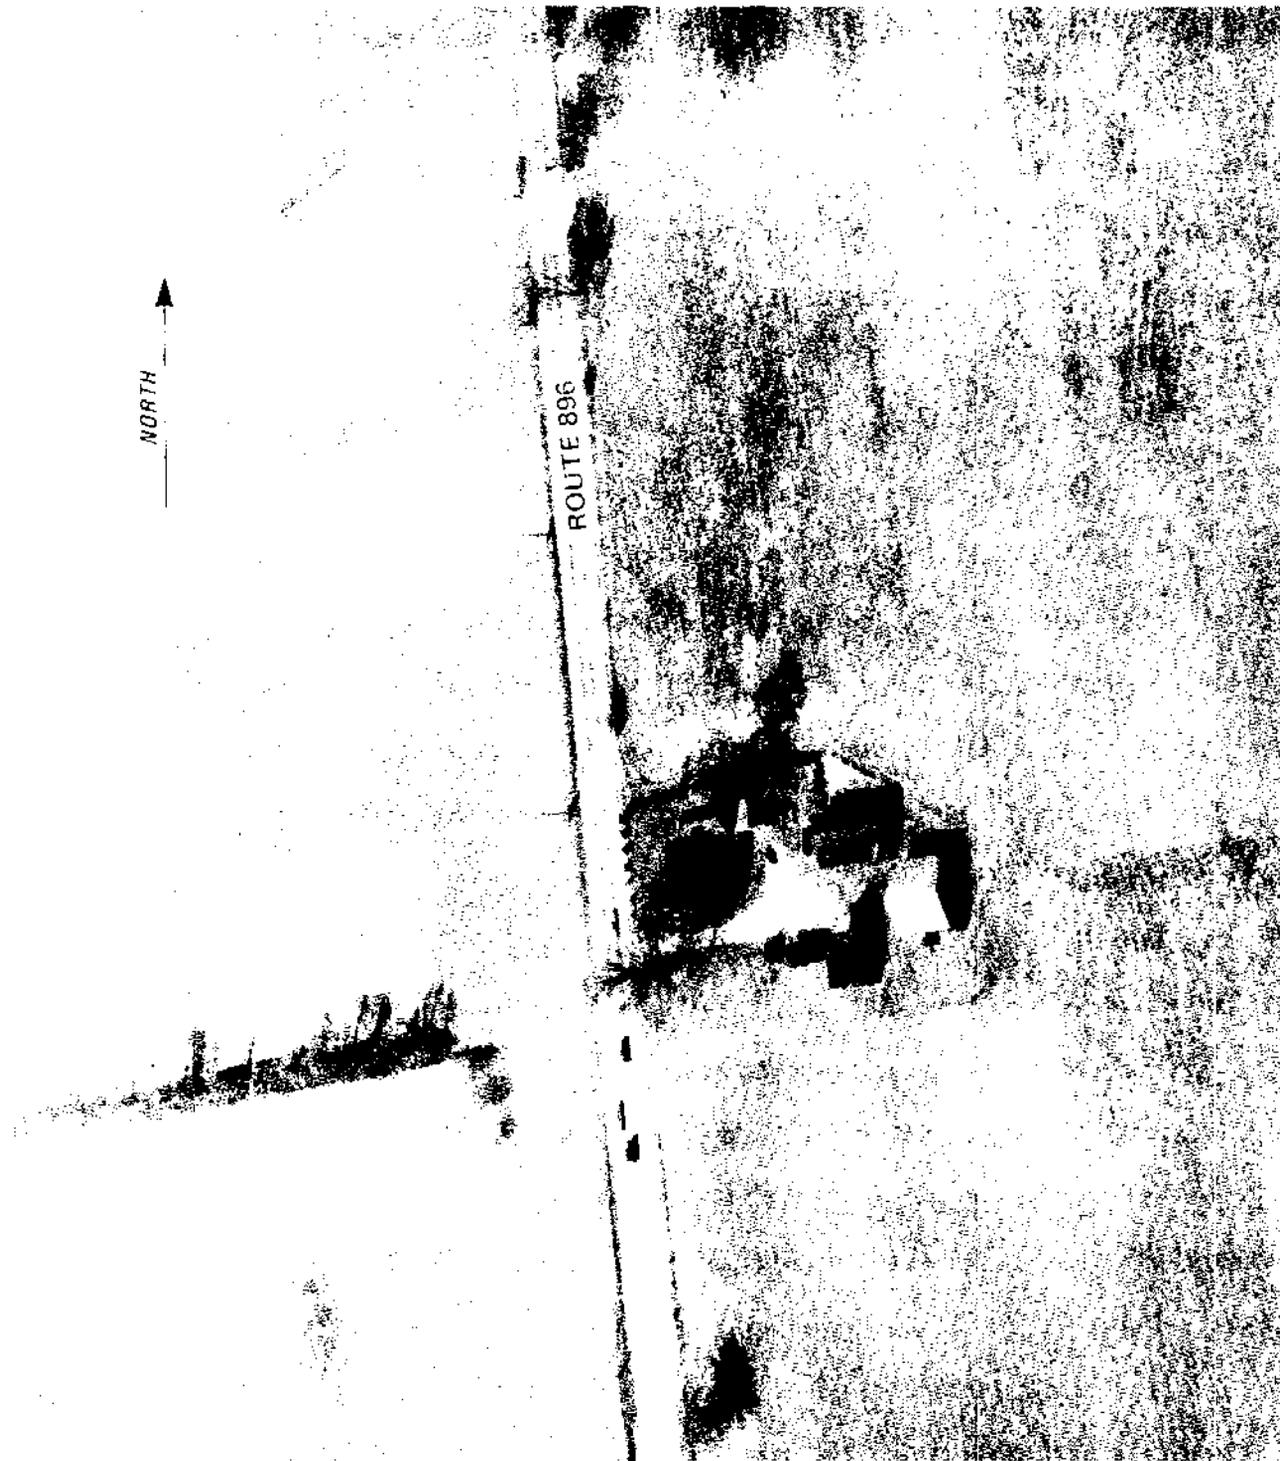
PLATE 12: Roger Williams (C Boulden) House, View to Northwest

The house is a two-story side-gable single-pile structure built of seven course common bond brick on a low brick foundation (Plates 12 and 13). One brick chimney is extant within the wall of the west gable end; a similar chimney at the east gable end has been removed. The roof is covered with composition shingling, with gable-end eaves flush with the exterior wall planes. On the north and south elevations, a narrow line of corbelling constitutes a modest frieze.

The south (main) elevation is irregularly fenestrated with four bays (the main entry and three 9/6 double hung sash windows) on the first story and three bays (with 6/6 double hung sash windows) symmetrically arranged at the second story. The fenestration on the north elevation appears to have originally been symmetrical with three openings at each story. However, the center openings on both stories have been filled in and replaced with a rear entry (not used) and a small single-sash window, both set slightly to the east of the original openings. The west gable end features two windows on the first story, one on the second,

and two square fitted sash windows at attic level. Similar attic windows are present in the east gable, below which is a shadow remaining from a gable-roofed unit removed and replaced with a shed-roofed aluminum clad kitchen wing on a concrete block foundation (however, an earlier exterior bulkhead entrance to the cellar below this wing has been retained).

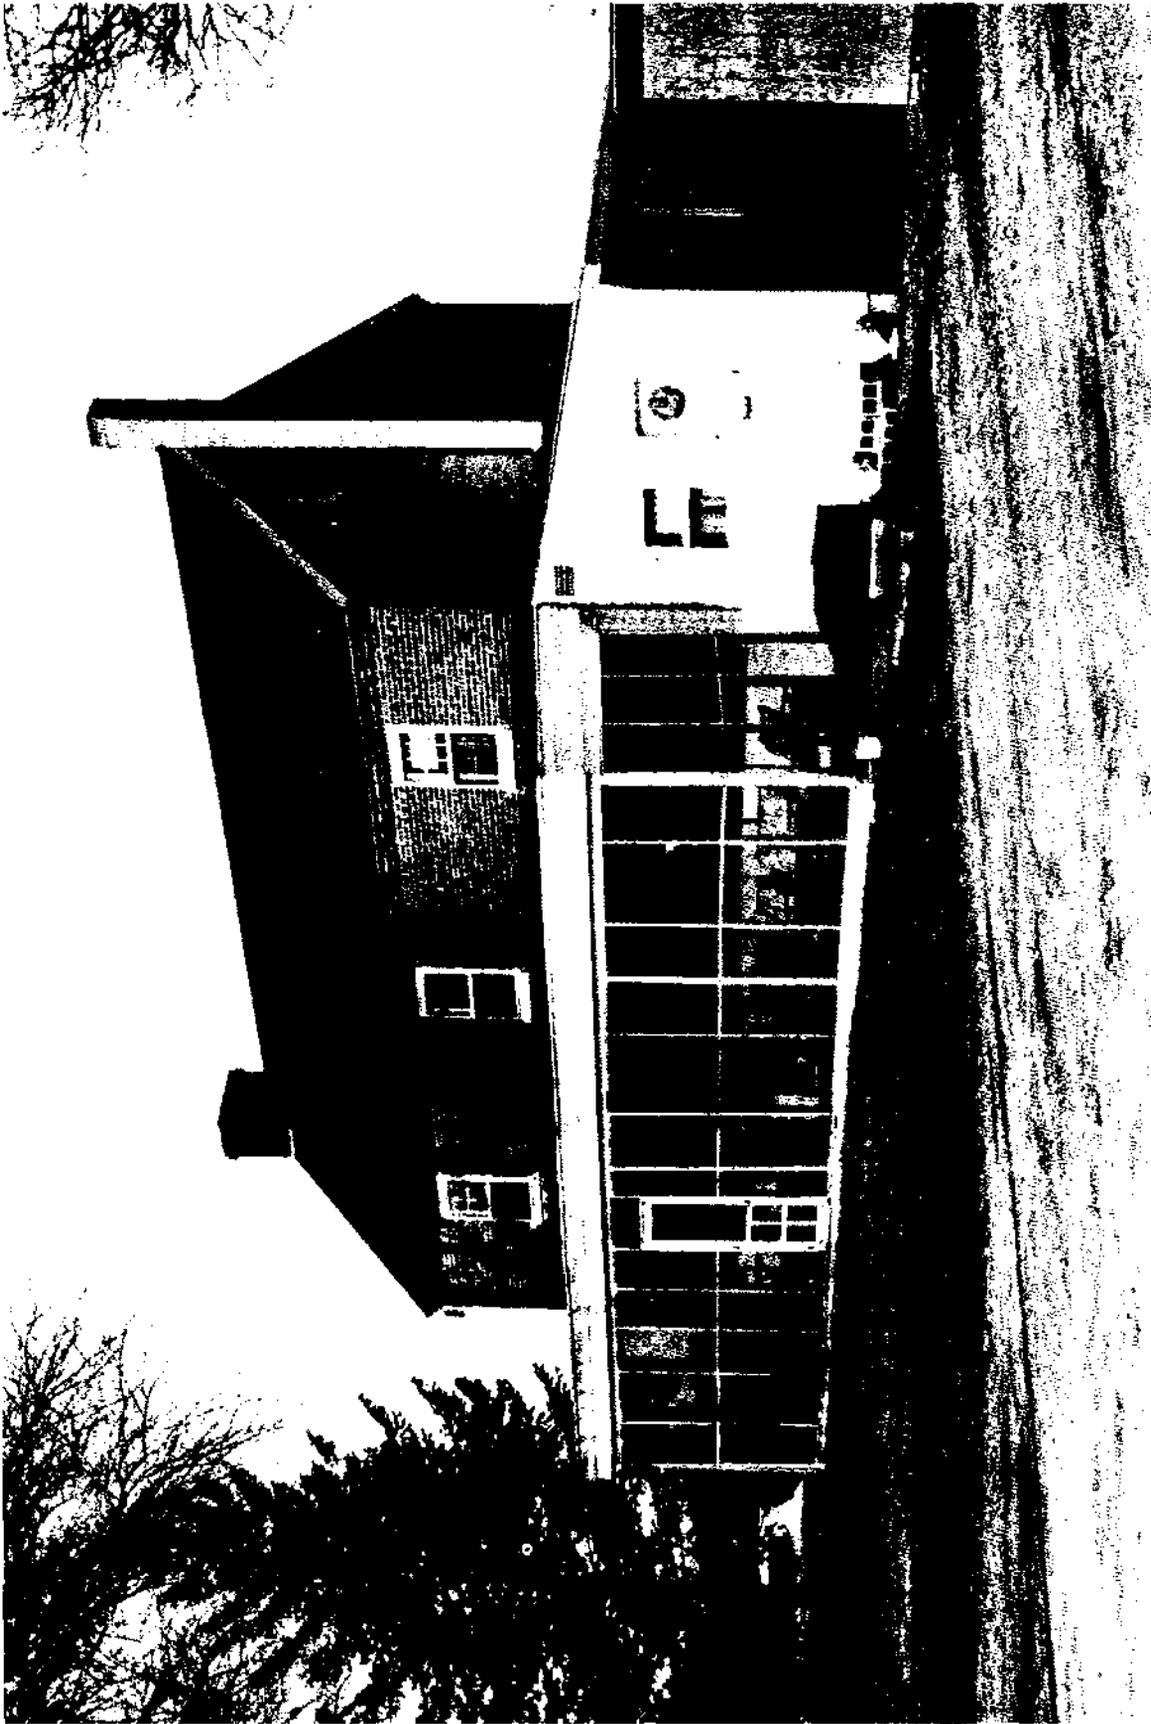
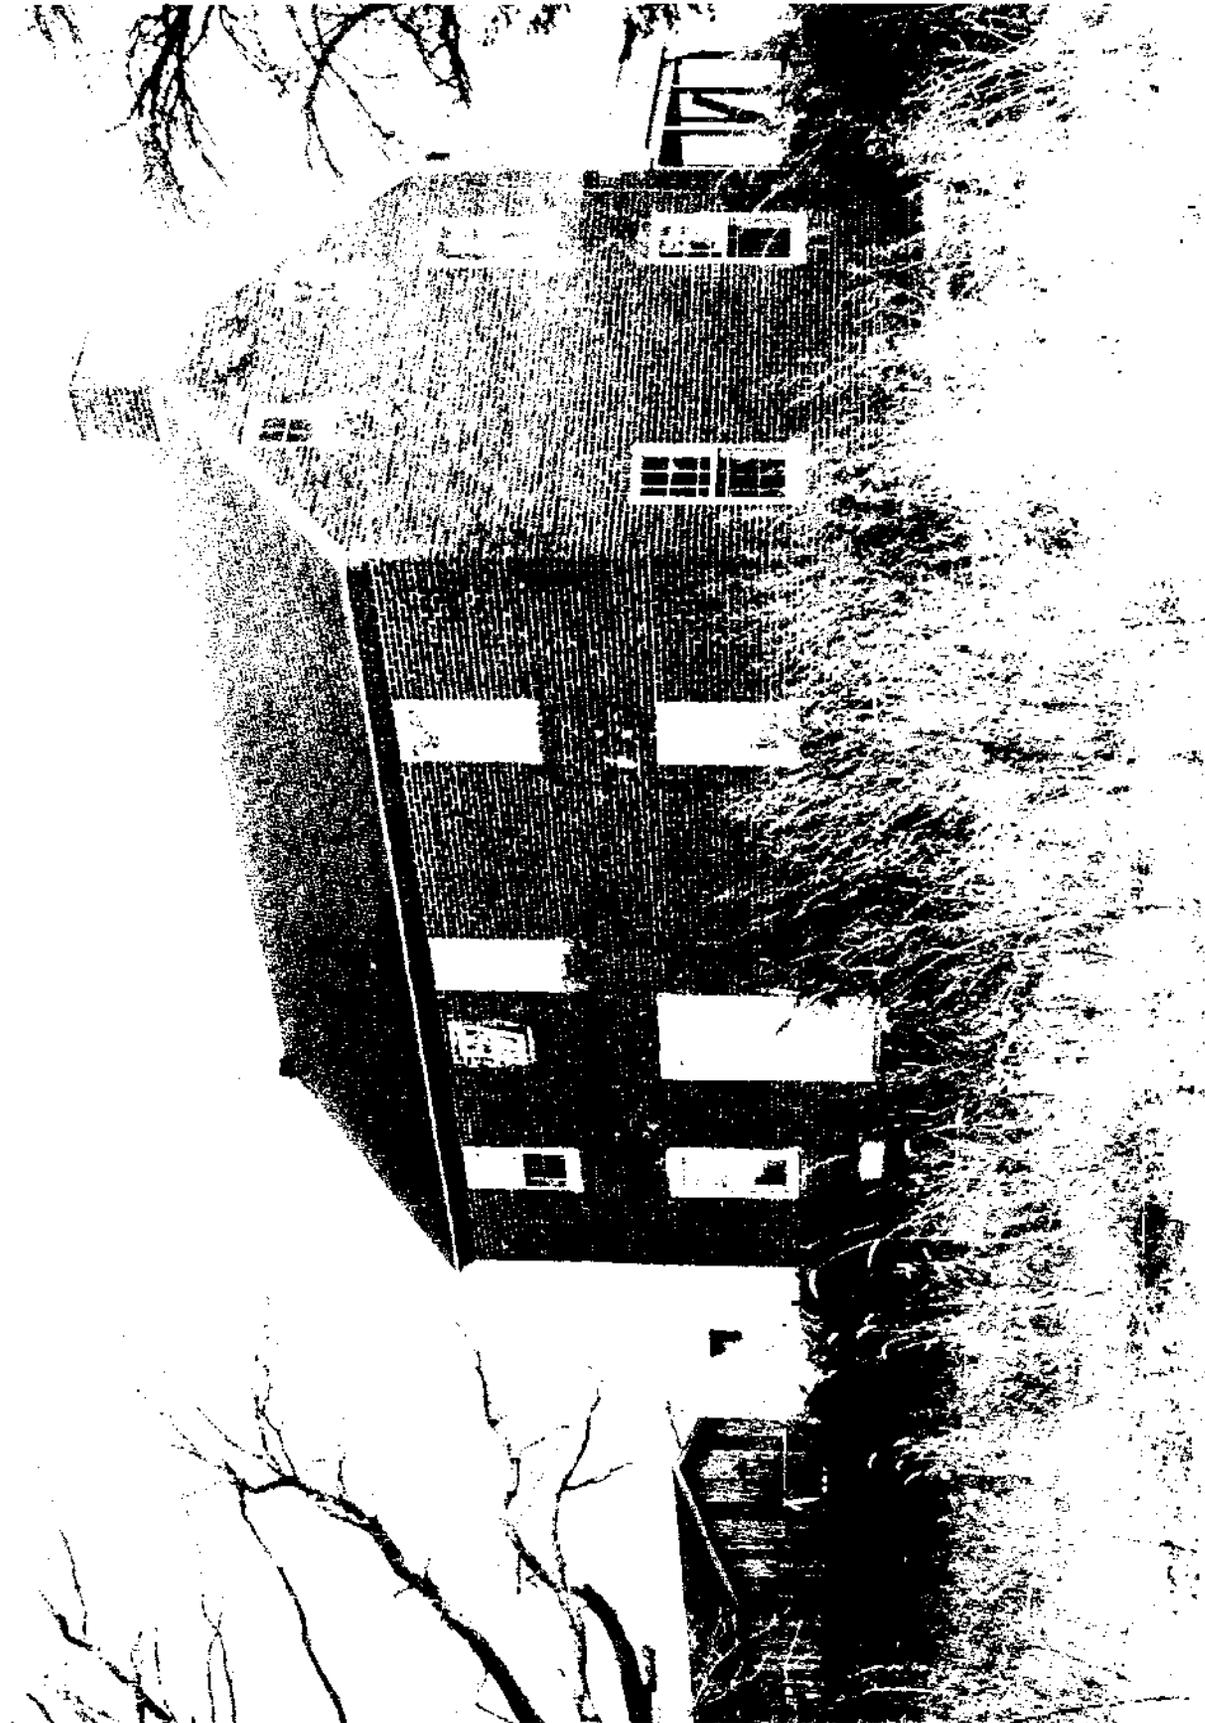
PLATE 13: Roger Williams (C. Boulden) House, View to Southeast

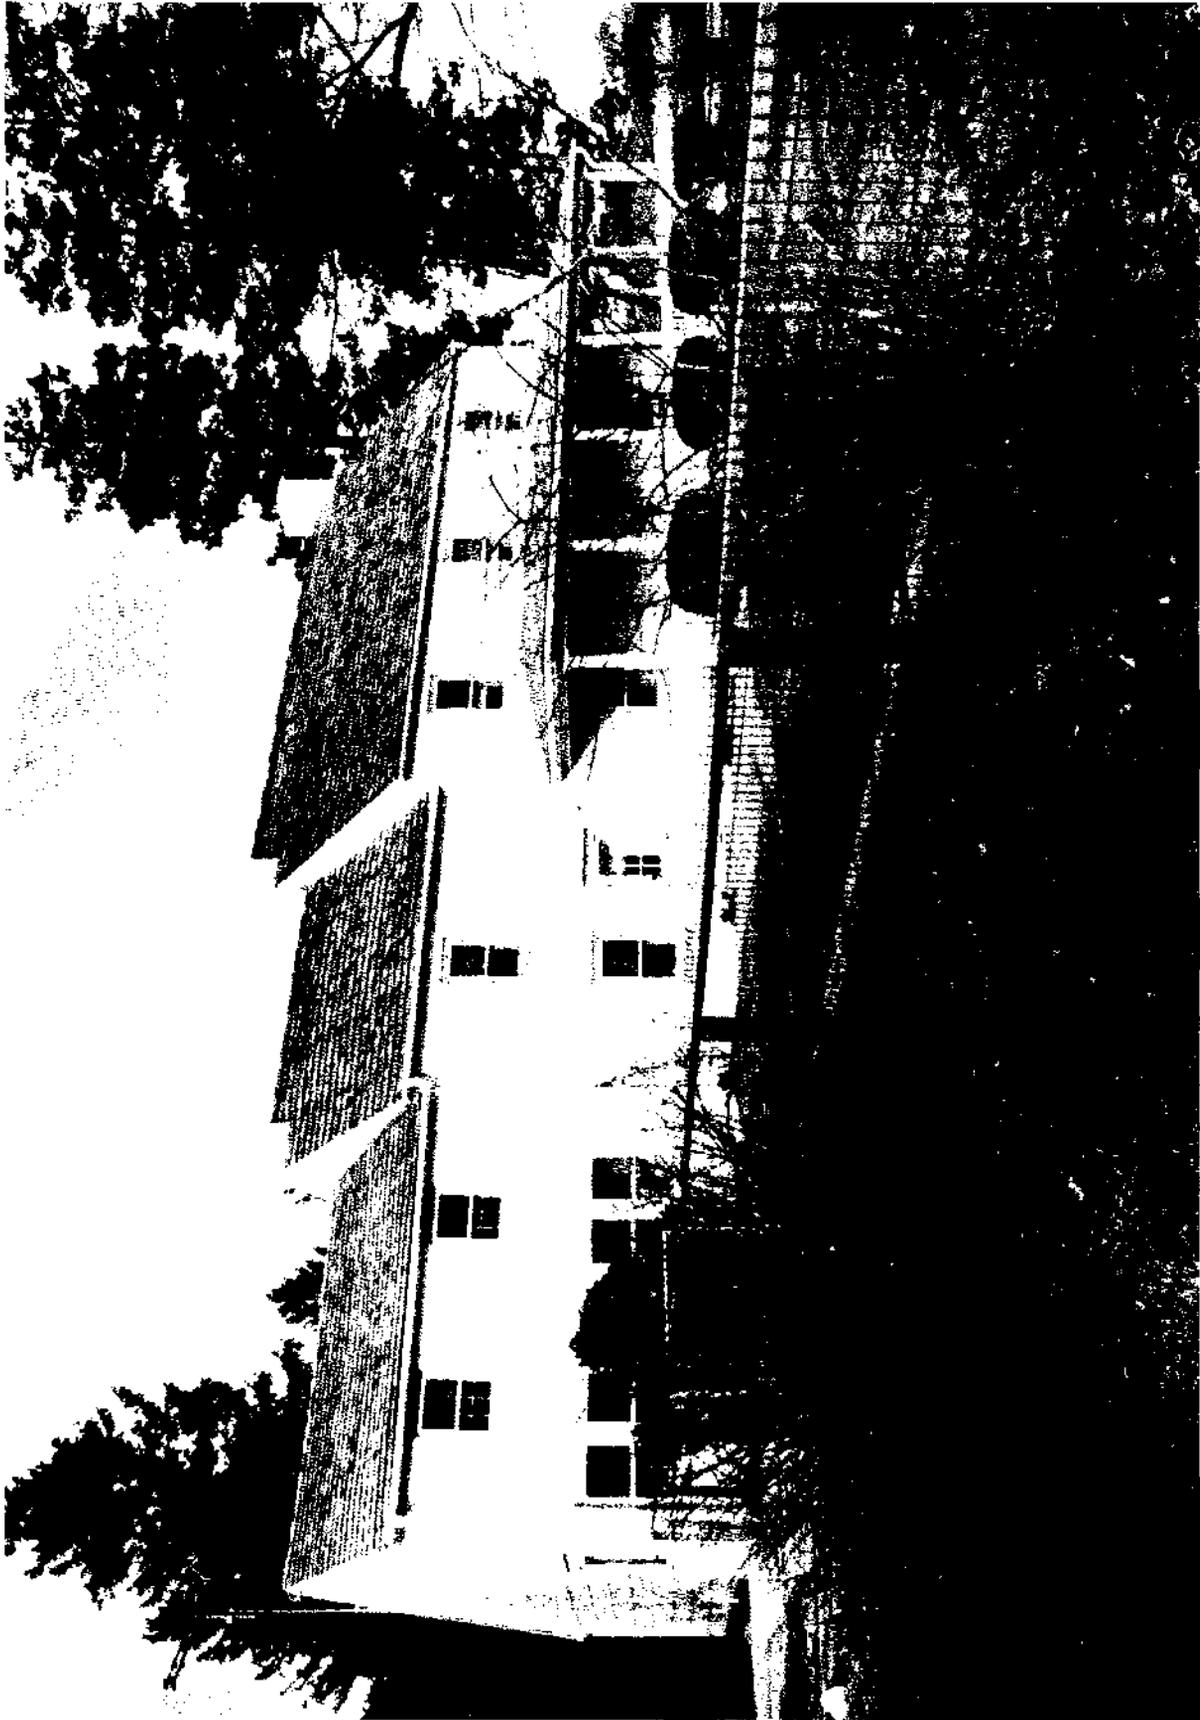
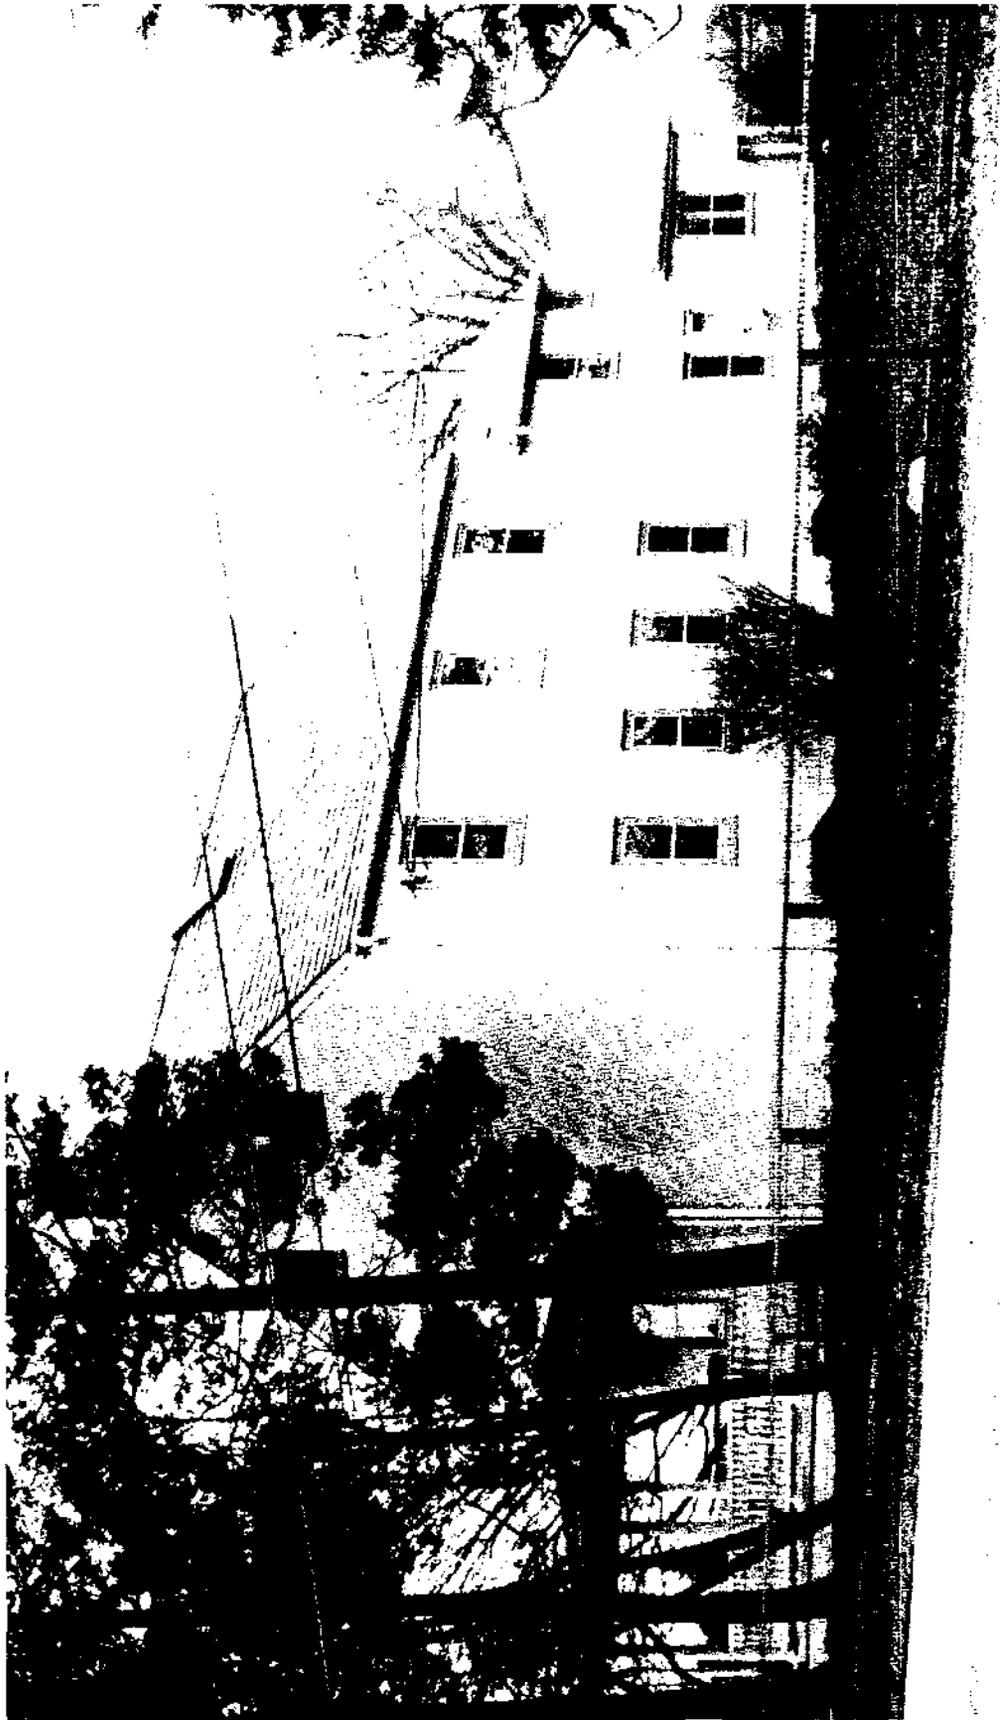
The farmhouse, which was largely completed prior to 1835, is composed of three side-gable single-pile units arranged in linear fashion and oriented to face south (Plates 16 and 17). The largest unit, on the east end, is a two-story stuccoed brick block with hall-parlor plan and rectangular brick chimneys rising out of each gable end wall. The front and rear elevations are irregularly fenestrated, with four symmetrically arranged openings on the first story and three on the second. In the two center bays of the facade are entrances framed with paneled reveals and beaded surrounds, opening directly into the "hall" and "parlor". At the southwest corner is an exterior bulkhead entry to the

PLATE 16: Cann Farmstead, View of Farmhouse Looking Northeast

PLATE 17: Cann Farmstead, View of Farmhouse Looking Southwest
