# Architectural Investigations of the Route 896 Corridor Summit Bridge to SR 4 New Castle County, Delaware

Martha H. Bowers  
The Cultural Resource Group  
Louis Berger & Associates, Inc.  
East Orange, New Jersey

DELDOT ARCHAEOLOGICAL SERIES 53

In January, 1987, an architectural survey and assessment was conducted along that portion of State Route 896 lying between Summit Bridge and State Route 4 in Pencader Hundred, New Castle County, Delaware. The work was undertaken by the Cultural Resource Group of Louis Berger & Associates, Inc. for the Delaware Department of Transportation (DelDOT), and the Federal Highway Administration (FHWA). The purpose of the survey was to provide information for compliance with Section 106 of the National Historic Preservation Act in consultation with the State Historic Preservation Office (SHPO) and the Bureau of Archaeology and Historic Preservation (BAHP). A program of documentary research and field investigation was employed to inventory eleven properties on Route 896 ranging in date from the late 18th to early 20th centuries, most of which were once associated with agricultural activities. Of these properties, six have been evaluated as meeting

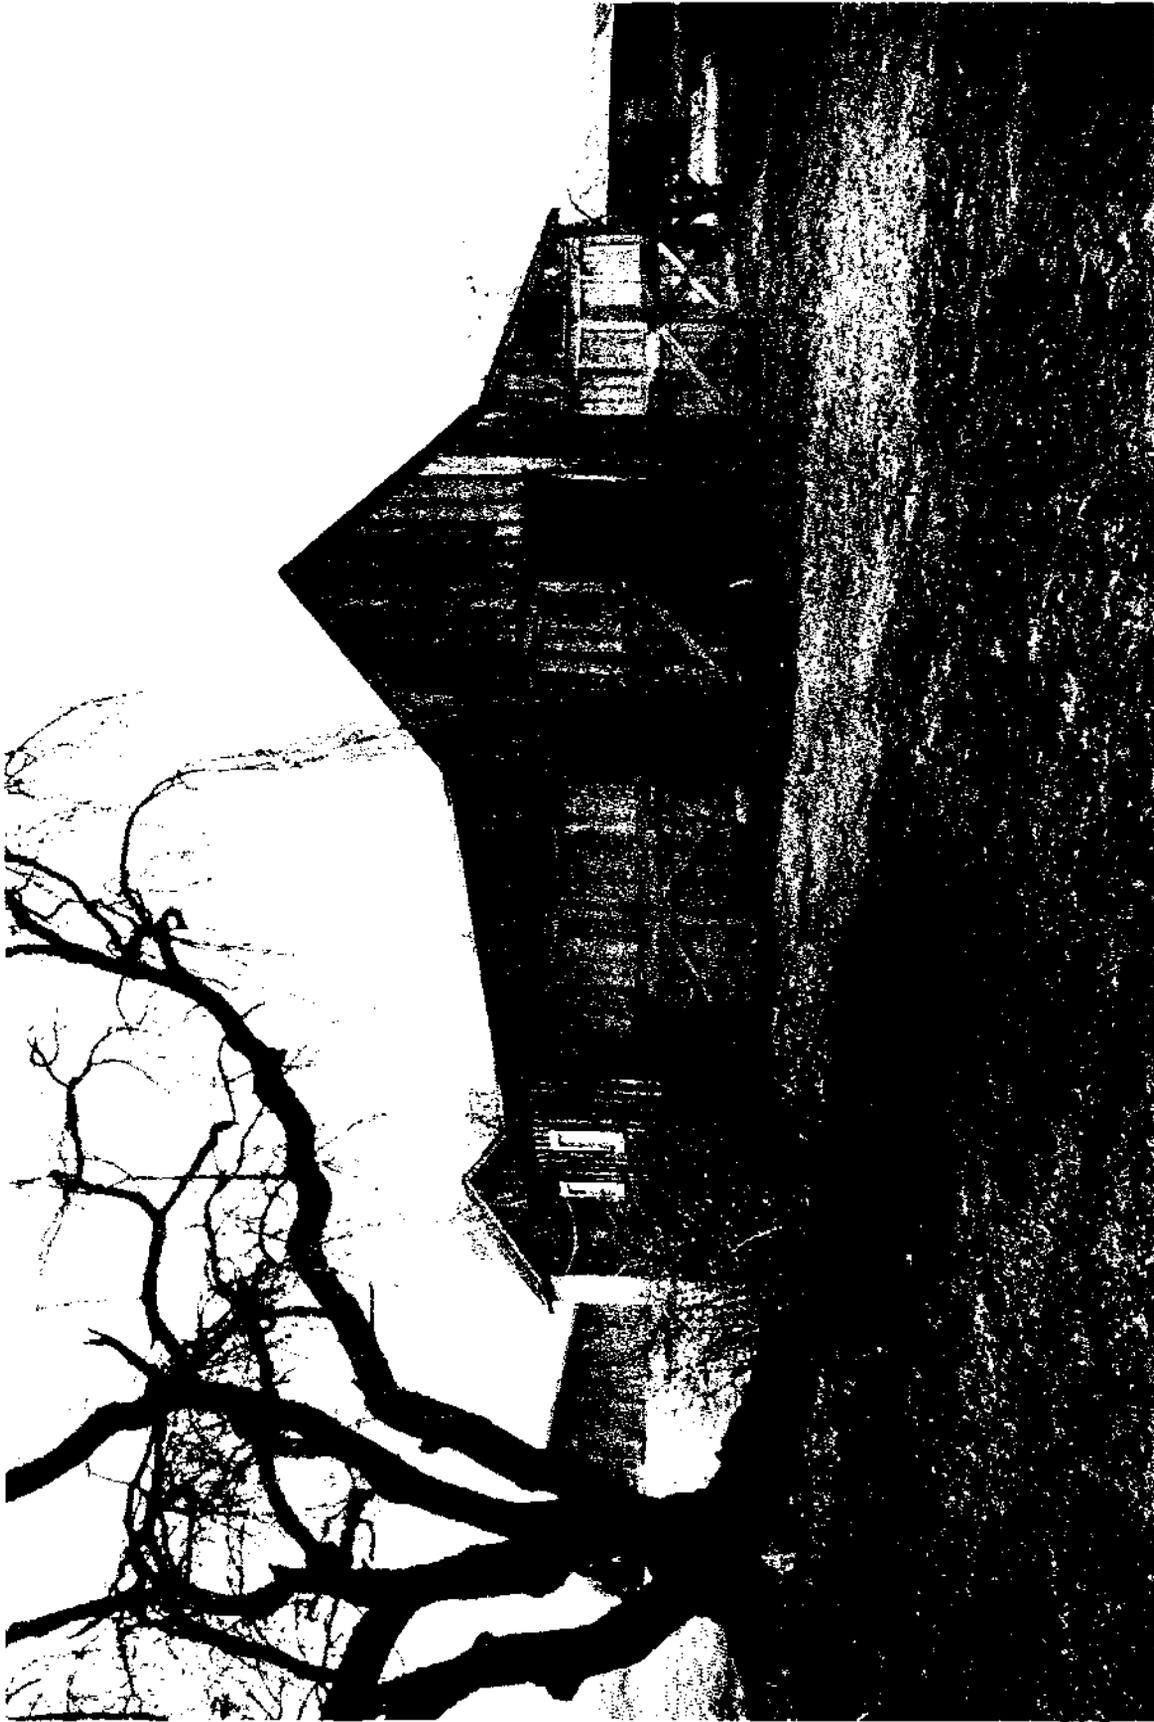
PLATE 20: Cann Farmstead, Garage/Machine Shed, View to West

The outbuildings of the Cann farmstead are arranged in rectilinear fashion extending north and west of the house. Many of these wood frame structures appear to date from the last quarter of the 19th century, in several instances with early 20th century alterations consistent with the property's evolution as a dairy farm. Located directly northwest of the house are a garage with lean-to side extensions, a privy, poultry house and a large gable-roofed crib barn with a very low earthen ramp leading to a gable-end entrance (Plates 20 and 21). North of the farm lane running west from the road to the fields are a hog house, several small corncribs, a six-bay machine shed and another poultry shed (Plate 22). Northernmost in the complex are two large barns set perpendicular to one another and connected by a corrugated metal shed in a L-shaped arrangement (Plates 23 and 24). Both appear to have been originally built as all-timber structures, altered in the 20th century through reconstruction of the ground levels in concrete block for dairy purposes. One barn has been clad in asbestos shingling on three sides, while the other retains vertical plank siding on the upper levels of all four walls. The former barn has a concrete floor and pipe stanchions for milking. The ground level of the latter barn is divided into a series of animal pens.

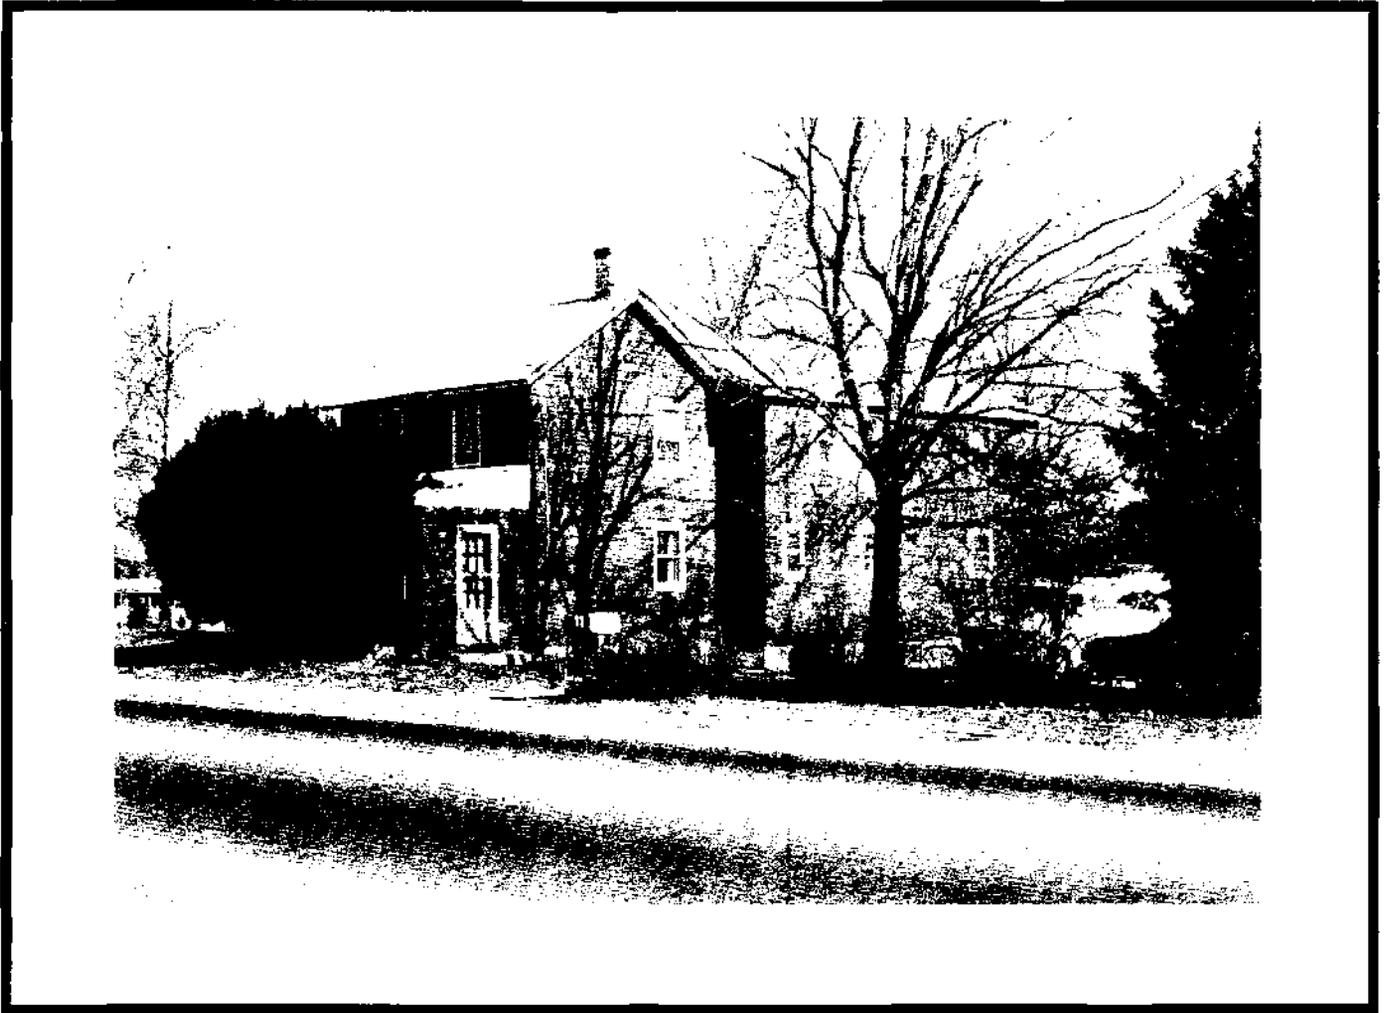
The house is a wood frame structure clad in red aluminum siding (Plate 25). The original block is a two-story, side-gable single-pile I-house on a rubble fieldstone foundation, to which has been added a noticeably large, two-story gable-roofed rear unit with slightly raised concrete basement. A shed-roofed one-

PLATE 25: Early 20th Century Frame House on Route 896, View Looking Northeast

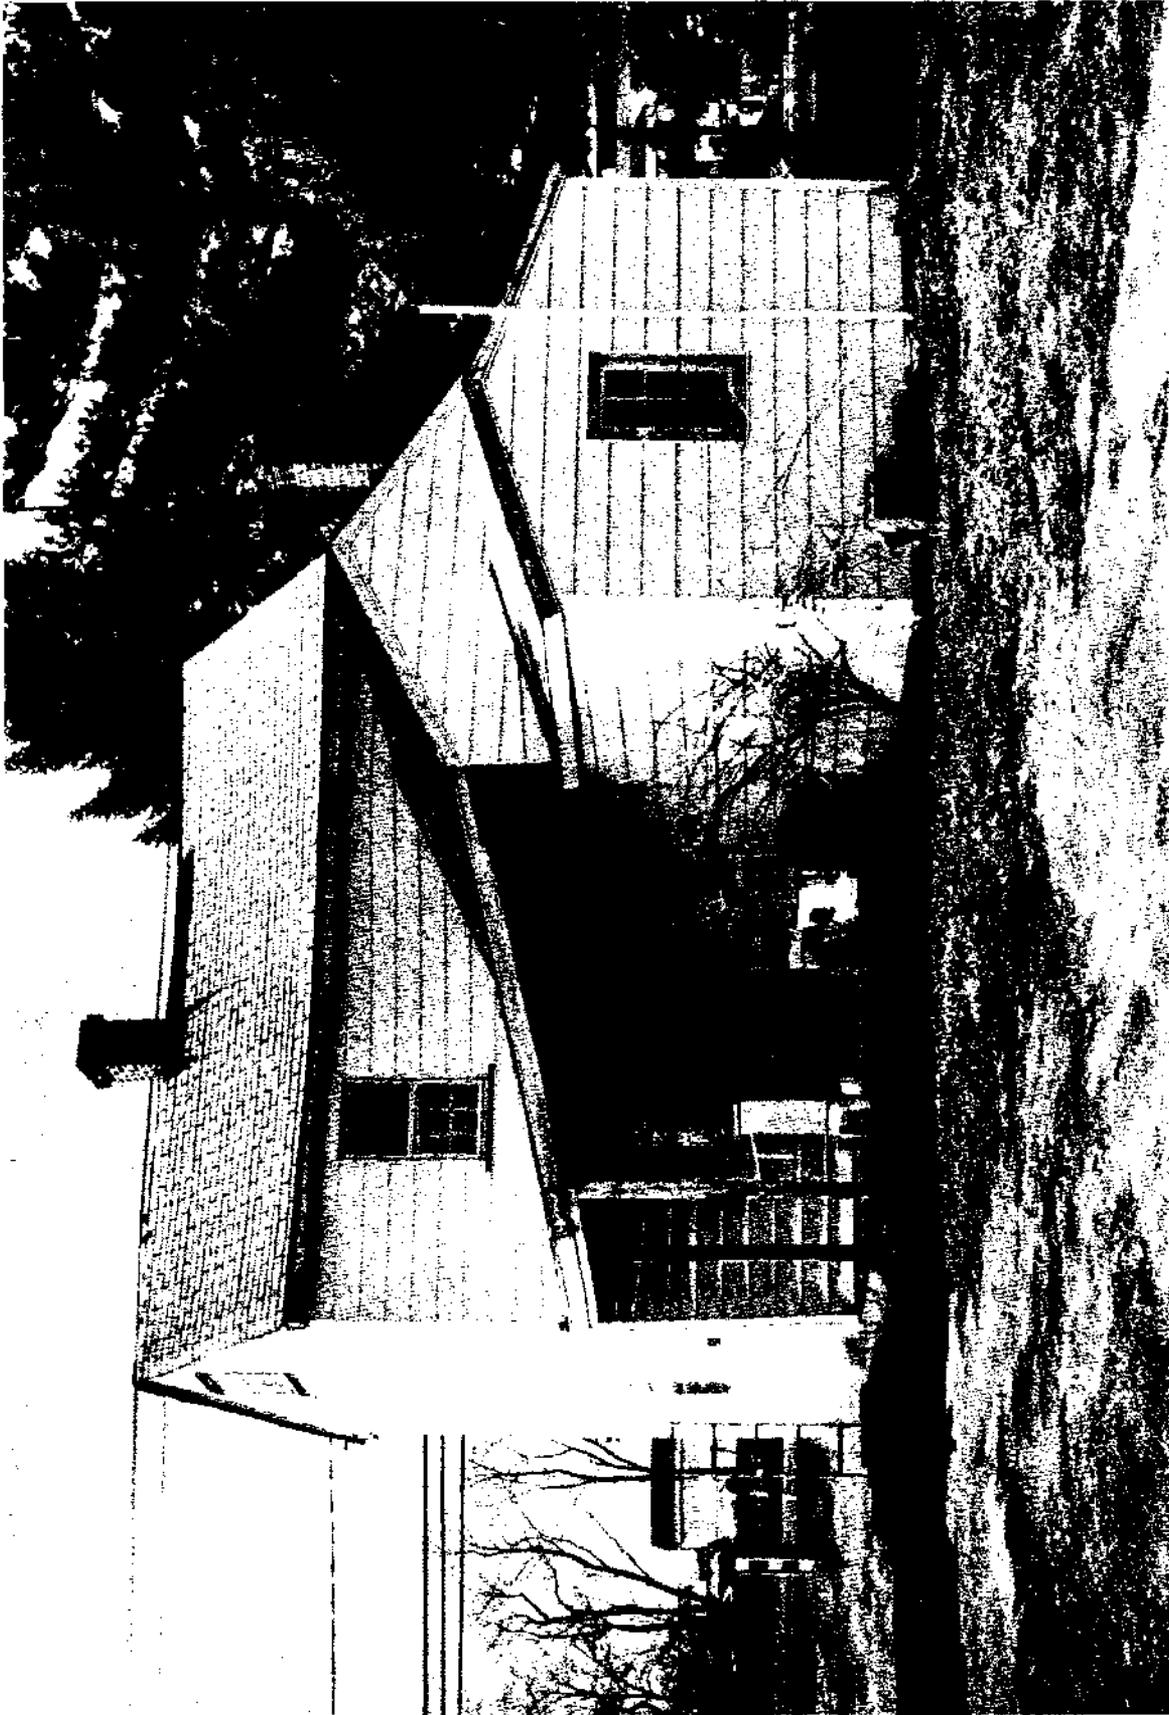
PLATE 27: Evan Lynch House, View to Northwest

The house is a wood frame structure, clad with wide aluminum siding over asbestos shingling (Plates 26 and 27). It is set nearly at-grade without a basement, supported on concrete block footings along the north side and rear. The massing consists of a two-story side-gable single-pile main block with a one-story gabled rear ell which has been expanded with a second one-room unit on the east end. The roof of the main block is clad in composition shingling, while that of the ell retains wood shingles. Both have narrow eaves which at the gables are flush with the wall plane.

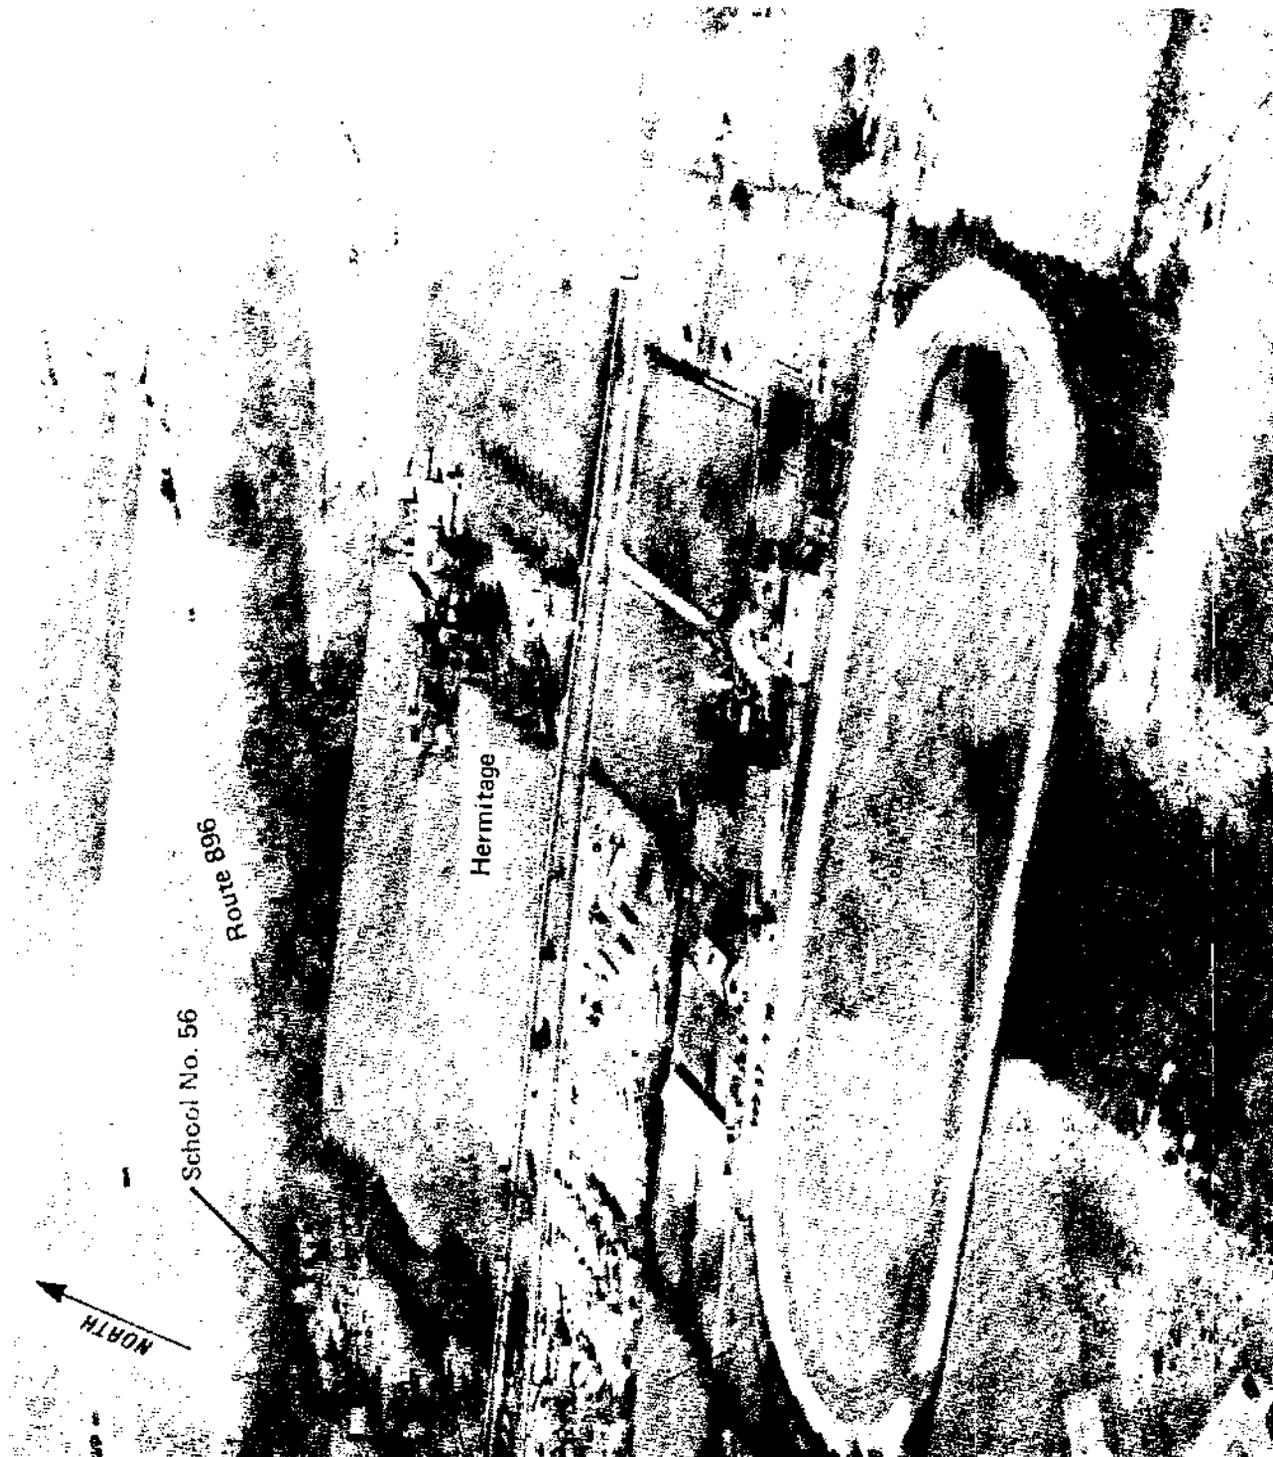
PLATE 28: Hermitage and School No 56

Description: The property known as the Hermitage is an agricultural complex of over 40 buildings situated on the north side of U.S. Route 40 east of Pencader Cemetery in Glasgow (Plate 28). Cultivated fields lie adjacent to the farmstead on the east and west. Some 250 feet to the north of the farmstead is a large office complex associated with the DuPont Glasgow Plant, which corporation has since 1966 been the owner and operator of the farmstead.

The core of the farmstead is sited approximately 450 feet back from the highway, approached by a long unpaved drive lined with mature coniferous and deciduous trees. The drive forks directly in front of the farmhouse, and the fork is marked with a pair of mature holly trees.

The farmhouse, built in the second quarter of the 19th century, is the oldest structure in the complex. Directly west of this house are two tenant houses appearing to date from the late 19th and early 20th centuries. The principal agricultural out-buildings are located in two ranges consisting chiefly of dairy barns and associated structures lying north and northeast of the farmhouse. Northwest of the farmhouse, are two parallel ranges of machine sheds and other structures, many of which have been erected under DuPont or moved by the corporation from other properties in its possession. The current function of the complex as a whole is to farm the undeveloped tracts owned by Dupont and to provide maintenance for the expansive grounds of the corporation's Glasgow Plant.

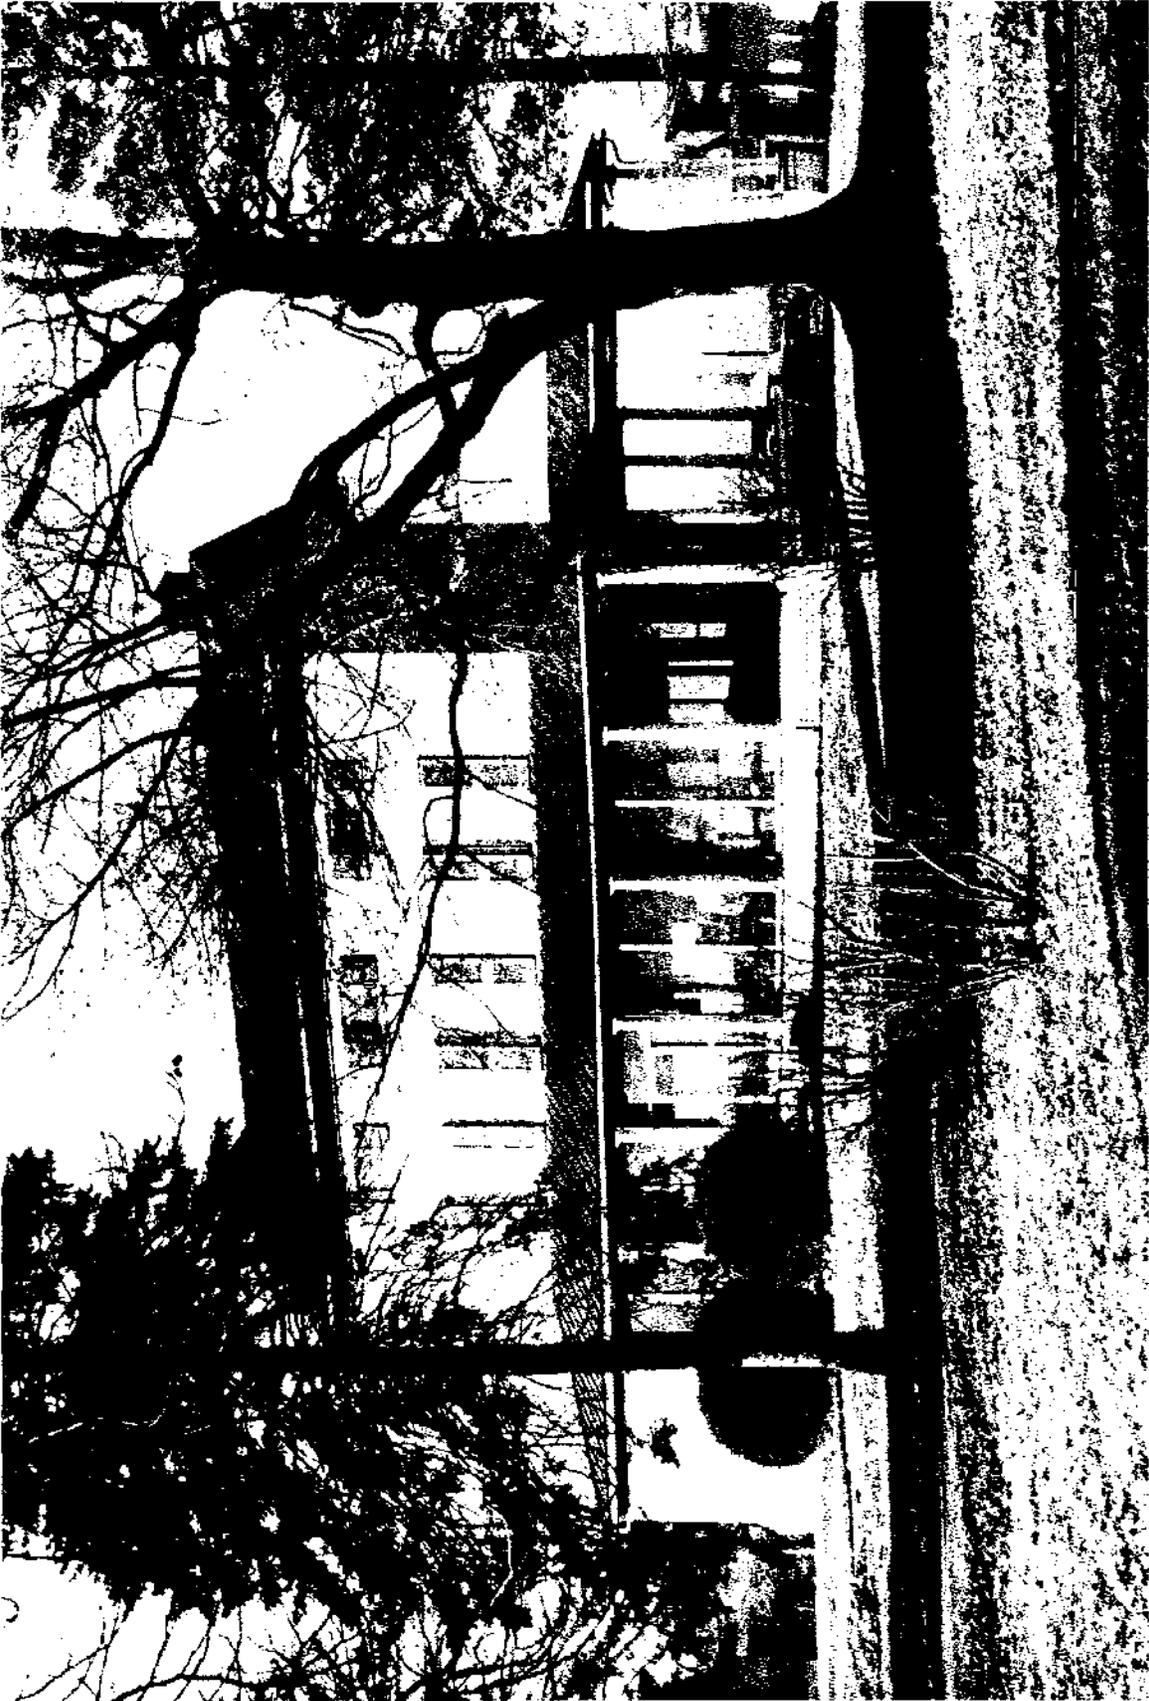
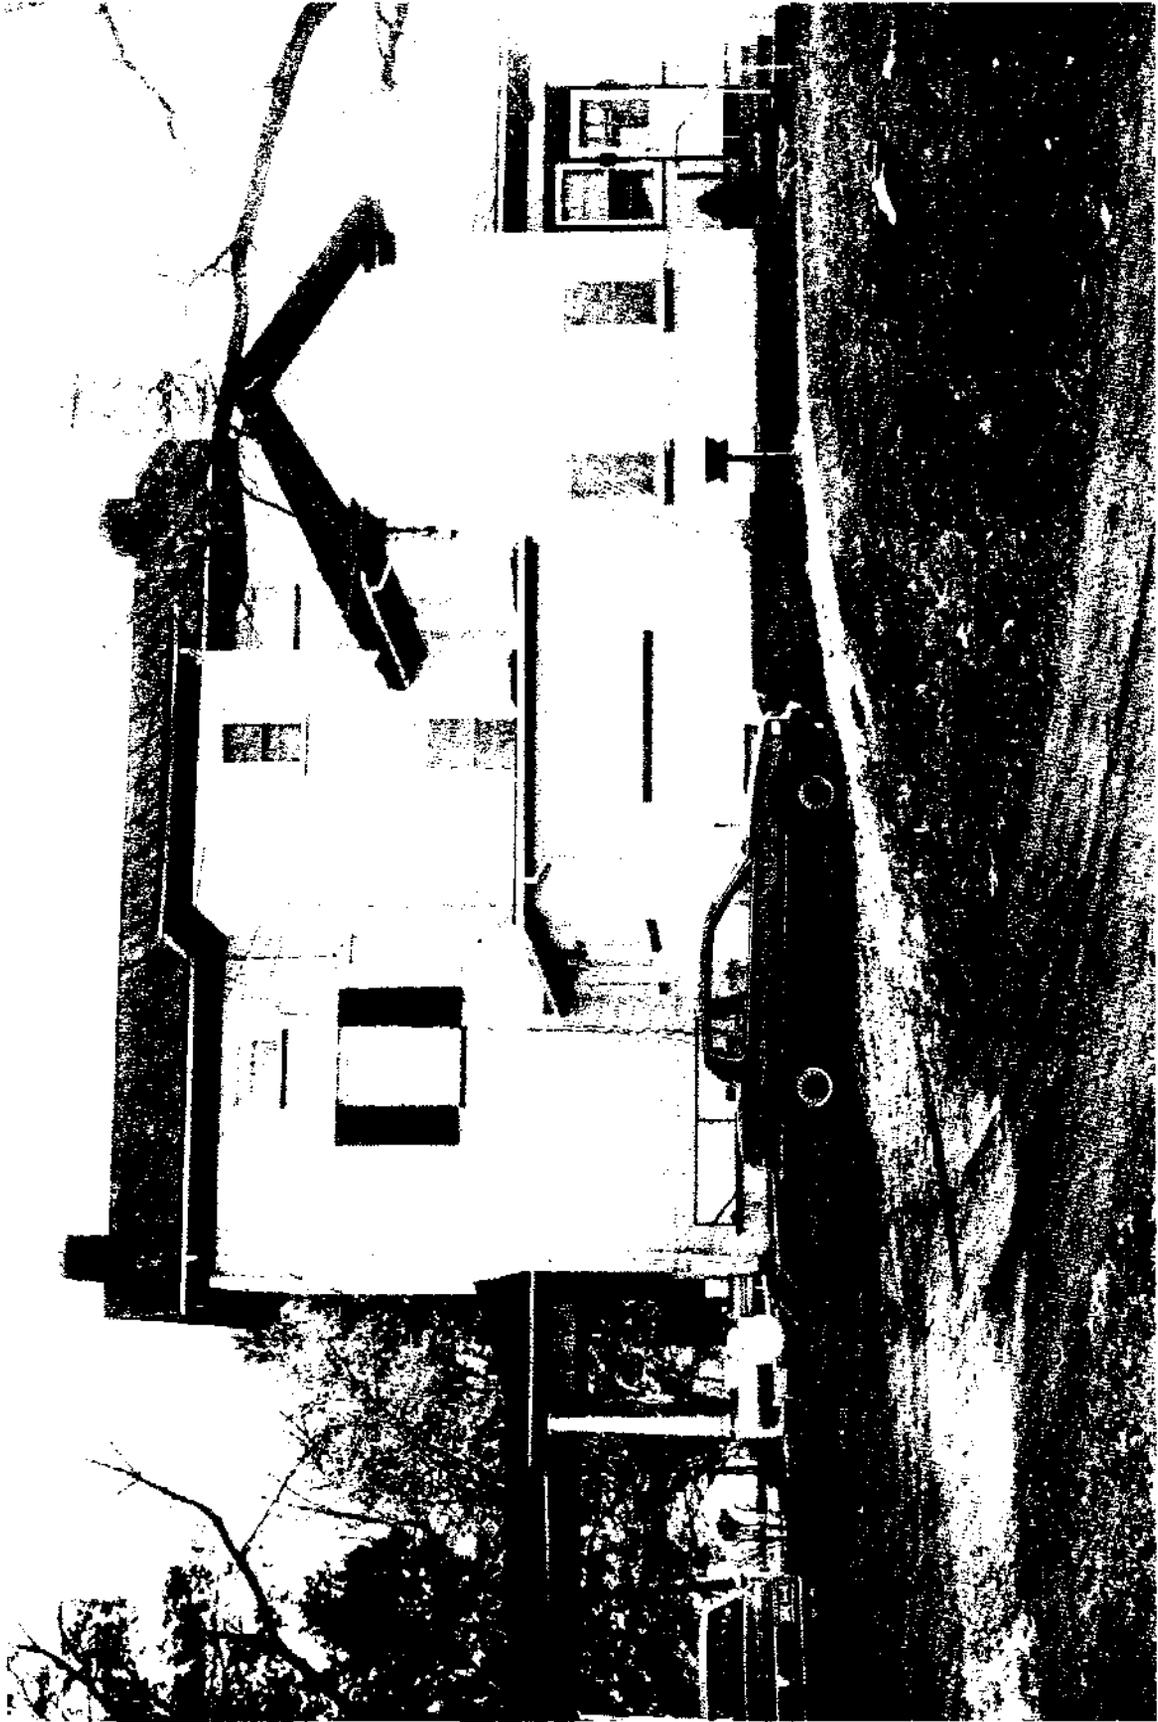
The interior of the main block is arranged according to the Georgian I-house plan, with a single room to either side of a wide stairhall. On the main floor, however, the east wall of the stairhall has been completely removed, and the brick bearing wall

PLATE 29: The Hermitage, John Frazer House, View to Northwest

PLATE 30: The Hermitage, John Frazer House, View to South

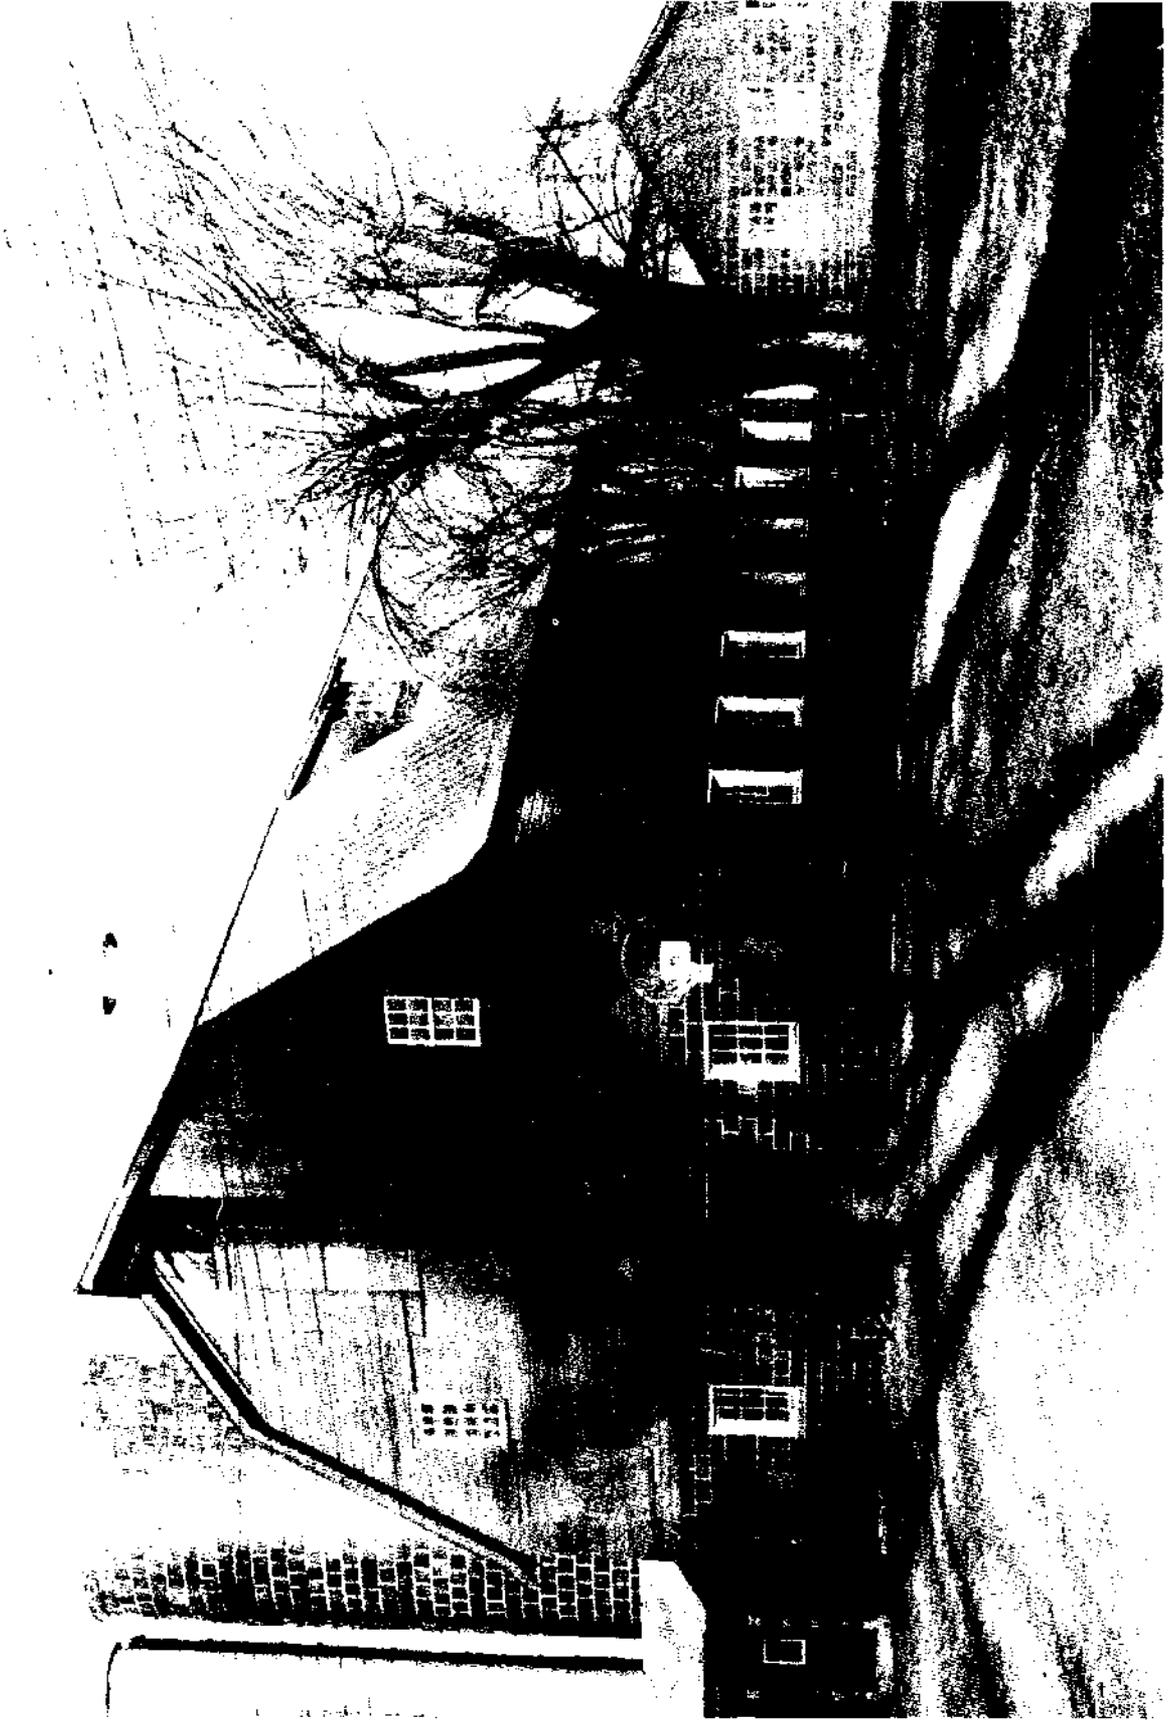
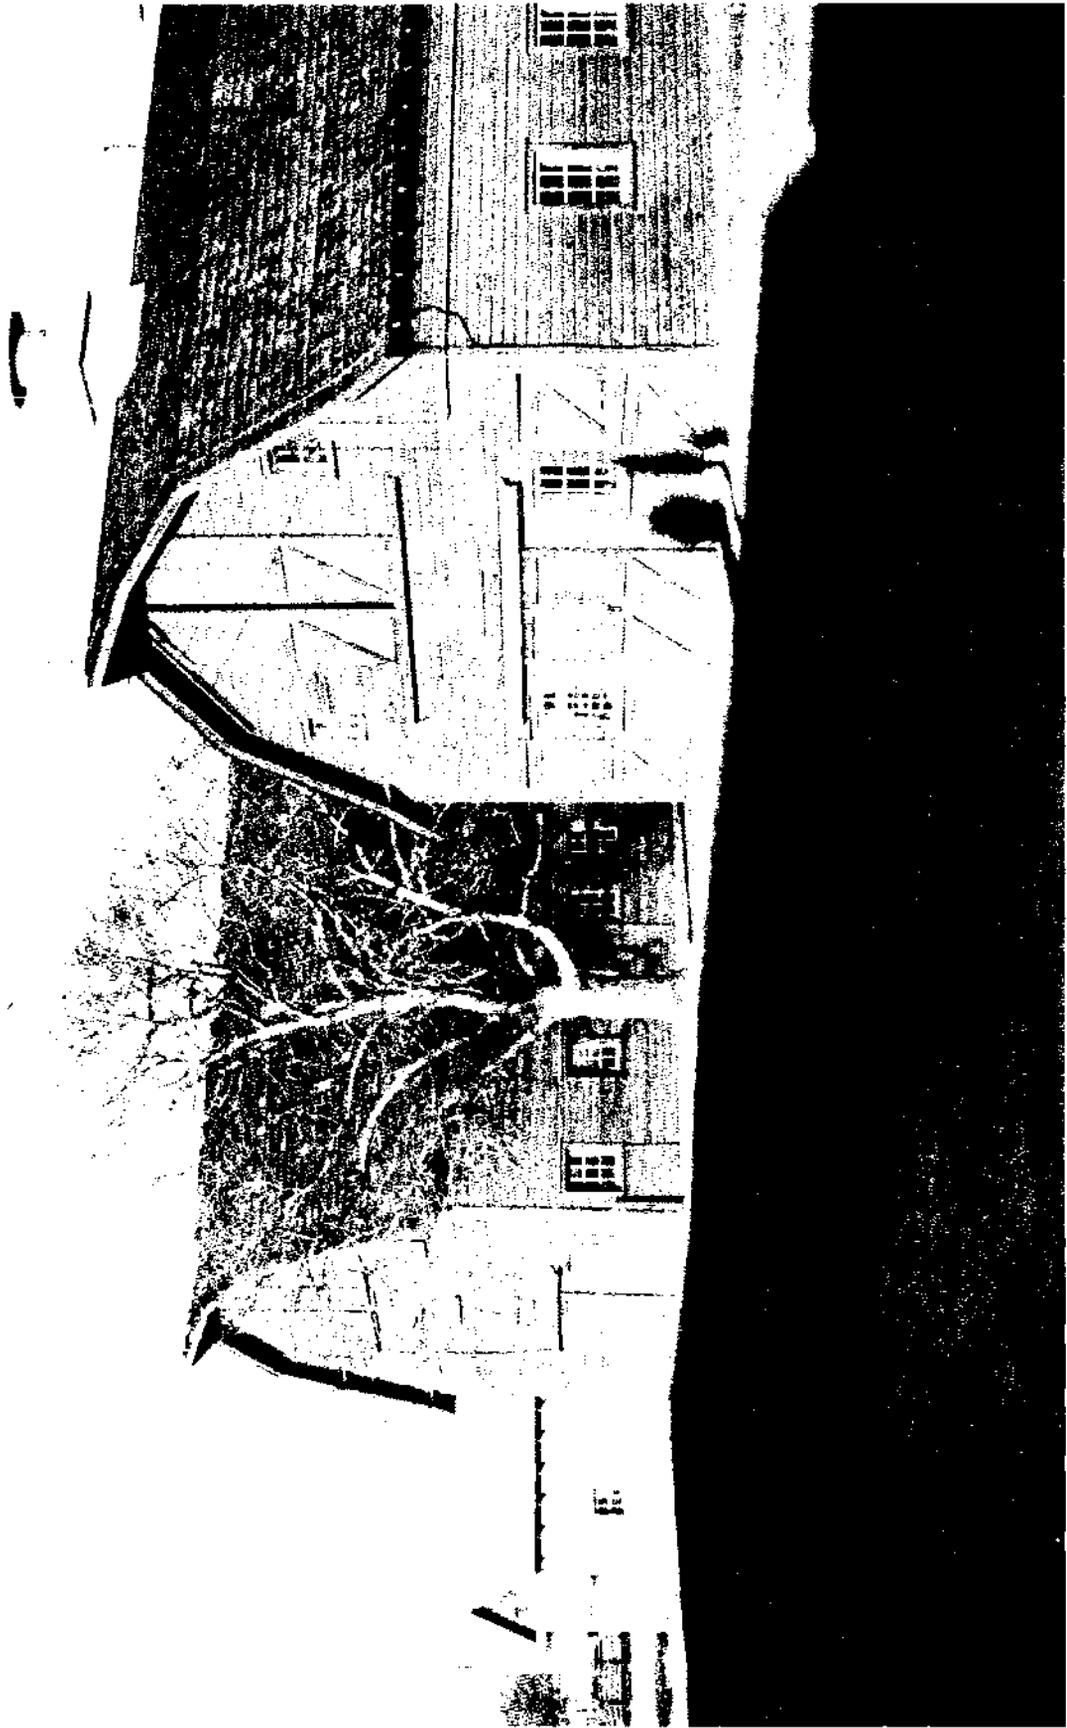
maintenance and repair shop. On the east side of the lane are three gambrel-roofed dairy barns from the first quarter of this century (Plates 34 and 35). The northernmost two have wood shingle roofs, drop siding, 9-light single sash hinged at the bottom, double-leaf sliding ground floor and hayloft doors, and concrete milking floor with pipe stanchions and rows of metal columns which support I-beams carrying the lofts. The third, by far largest, dairy barn is 20 bays long, with a standing-seam gambrel roof, shed dormers, timber-framed loft level clad in drop siding, and ground level of cast concrete block, the textured outer face of which has a red-brown glaze. The same material is utilized in the two tall silos and small gable-roofed structures attached to either side of the main barn structure, the ground floor of which features a concrete floor, metal columns and I-beams, and pipe stanchions.

PLATE 34: The Hermitage, Main Dairy Barn, View to Northeast

PLATE 35: The Hermitage, Dairy Barns, View to Northeast

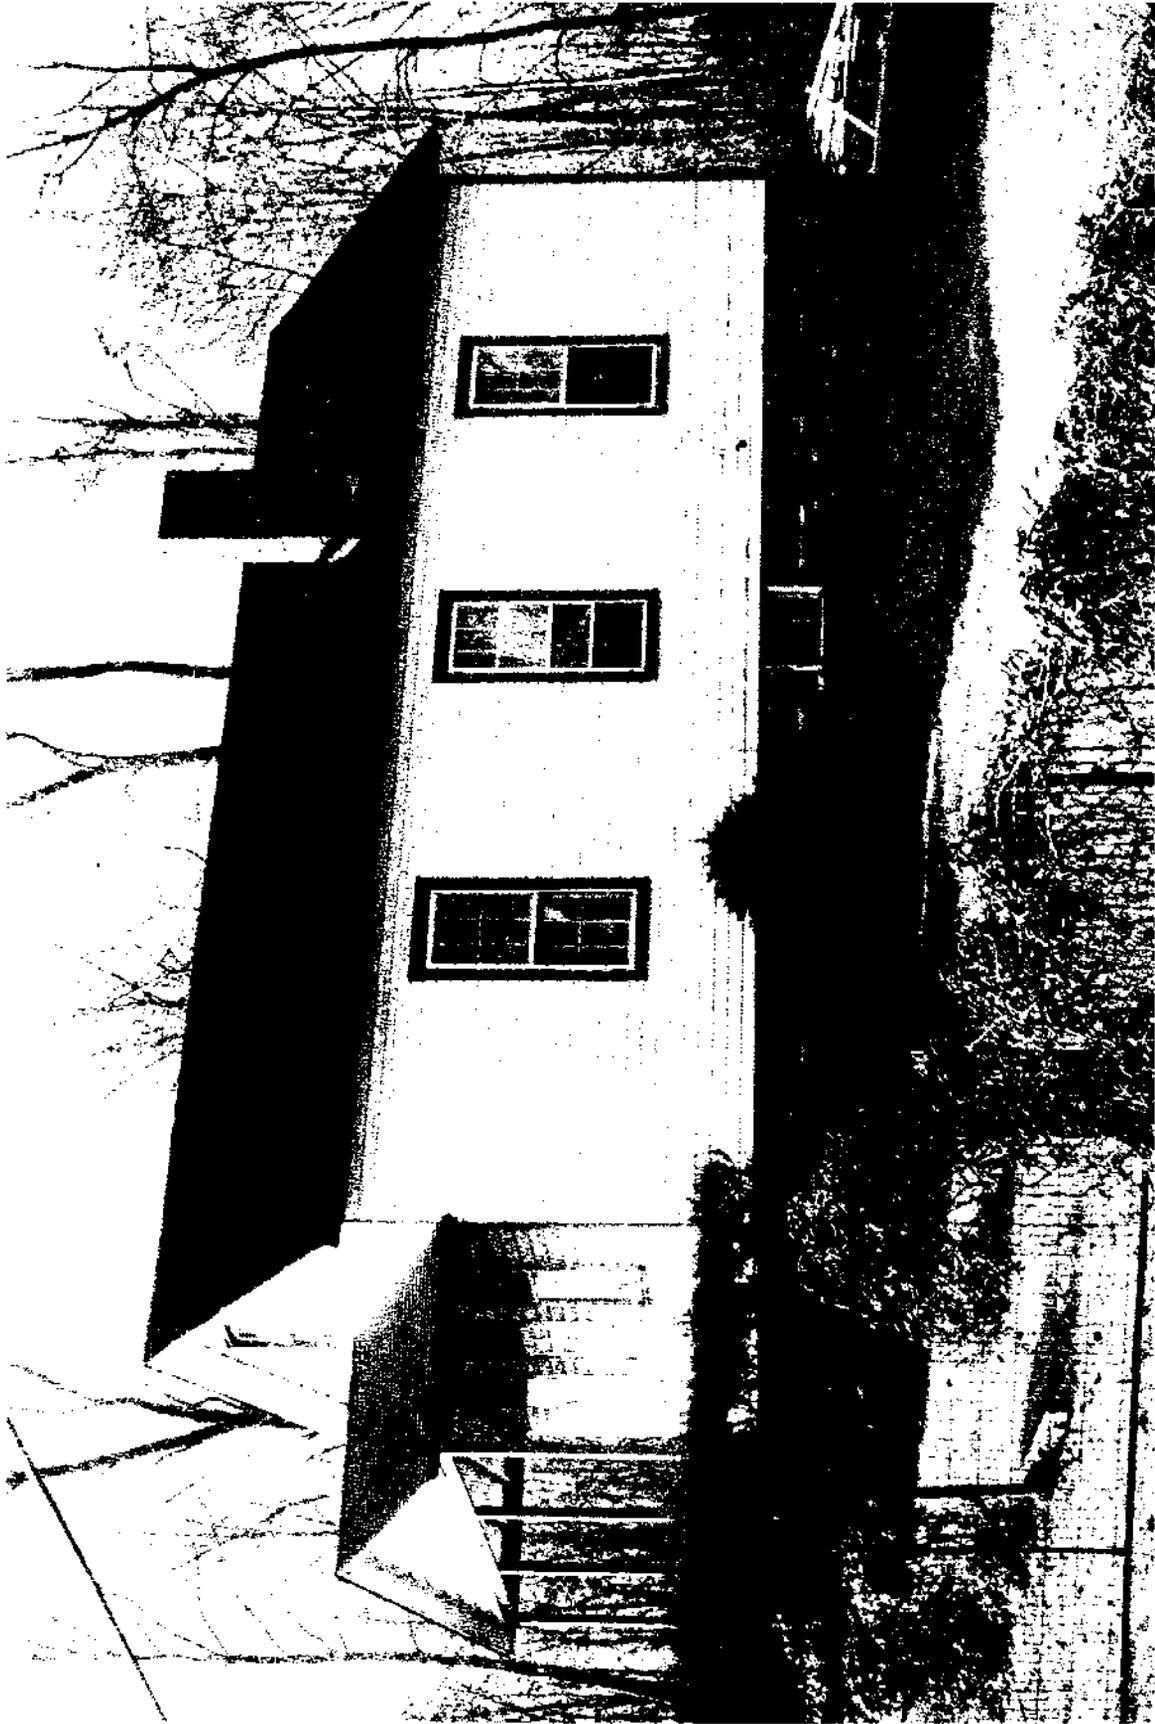
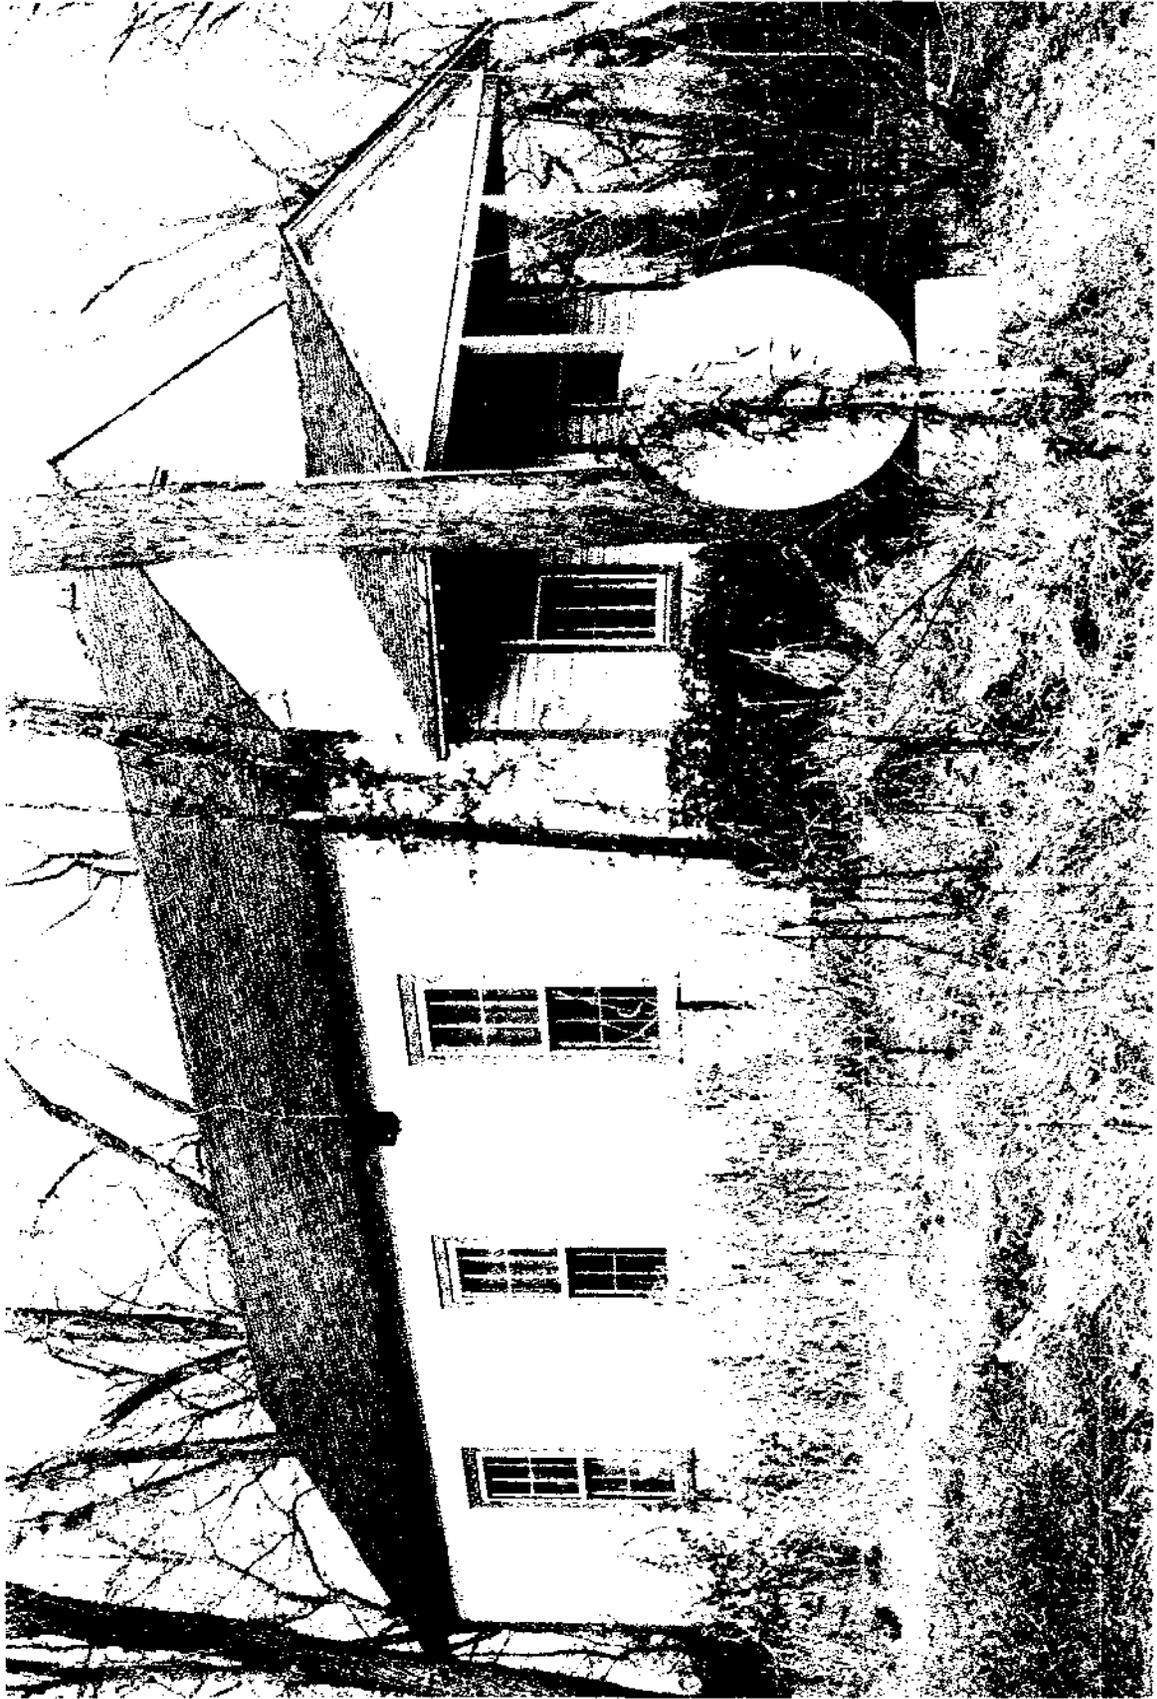
School #56 is a one-story, front-gable rectangular building of wood frame construction on a raised brick foundation encompassing a full basement (Plates 37 and 38). The exterior is clad with drop siding; the roof is covered with composition shingling and has narrow boxed eaves. The side and front elevations are each divided into three bays. Windows have flat plank surrounds with drip shelves and tall 6/6 wooden double-hung sash. The centered entrance features a six-panel wooden door above which is a large two-light transom panel. A gable-roofed porch with square posts is set on a high wood plank floor, reached by a set of concrete steps. On the north side, toward the rear, a brick chimney rises from the roof near the eave.

PLATE 37: School No. 56, View to Southwest

PLATE 38: School No. 56, View to North
