# Architectural Investigations of the Route 896 Corridor Summit Bridge to SR 4 New Castle County, Delaware

Martha H. Bowers  
The Cultural Resource Group  
Louis Berger & Associates, Inc.  
East Orange, New Jersey

DELDOT ARCHAEOLOGICAL SERIES 53

In January, 1987, an architectural survey and assessment was conducted along that portion of State Route 896 lying between Summit Bridge and State Route 4 in Pencader Hundred, New Castle County, Delaware. The work was undertaken by the Cultural Resource Group of Louis Berger & Associates, Inc. for the Delaware Department of Transportation (DelDOT), and the Federal Highway Administration (FHWA). The purpose of the survey was to provide information for compliance with Section 106 of the National Historic Preservation Act in consultation with the State Historic Preservation Office (SHPO) and the Bureau of Archaeology and Historic Preservation (BAHP). A program of documentary research and field investigation was employed to inventory eleven properties on Route 896 ranging in date from the late 18th to early 20th centuries, most of which were once associated with agricultural activities. Of these properties, six have been evaluated as meeting

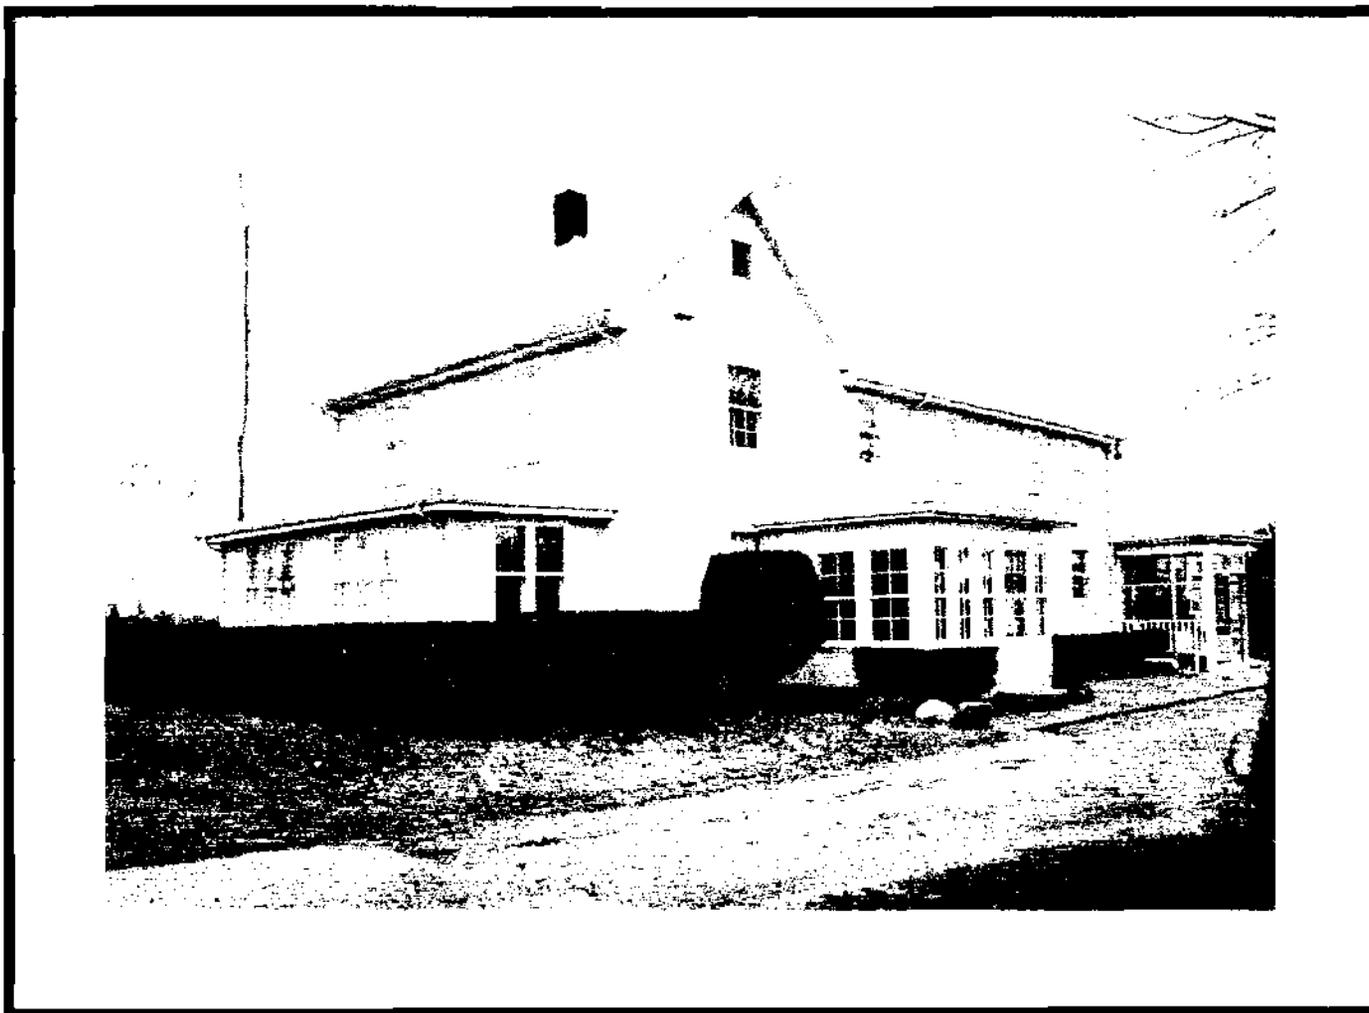
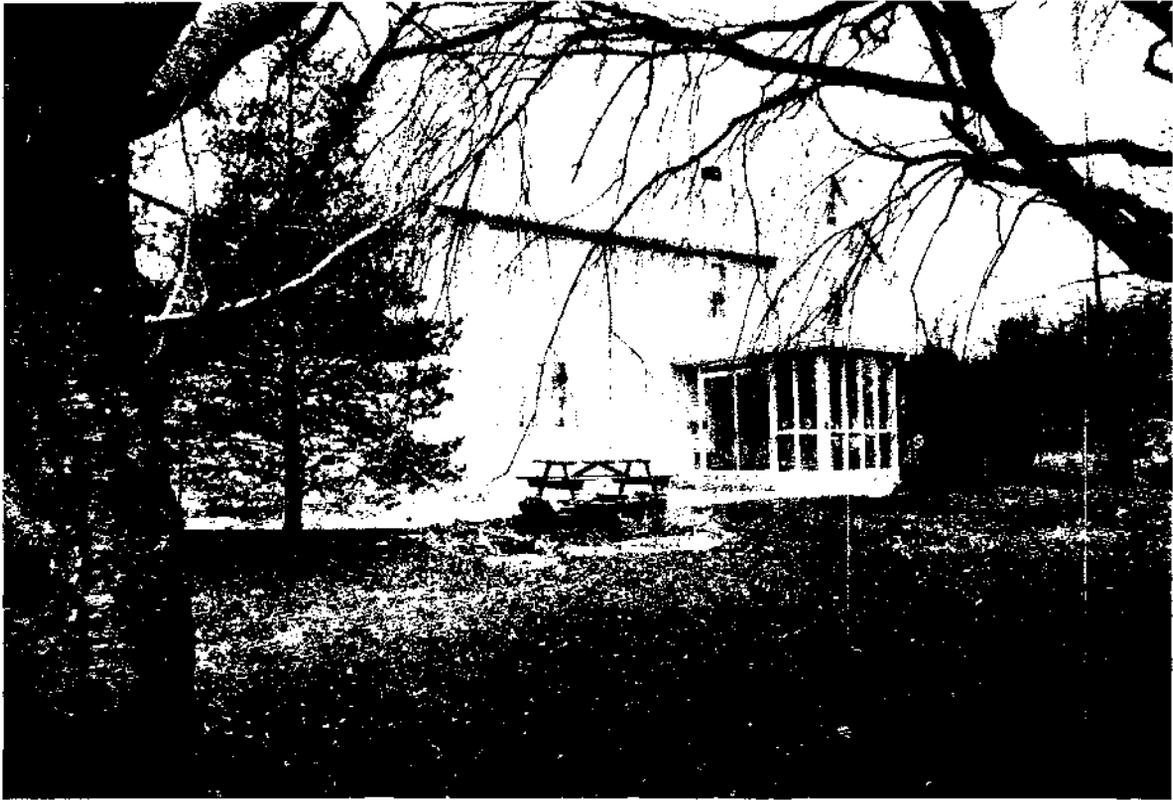
Tenant House #2 (N-10616): This dwelling is situated on the east side of Route 896 adjacent to the DuPont Corporation's Glasgow plant. The dwelling is of wood frame construction, with a full basement of fieldstone beneath the front section, and is clad in blue synthetic shingling (Plates 39 and 40). According to an undated historic photo in the owners' possession, the house was originally massed as a two-story three-bay, center hall, single-pile side-gable main block with a one-story rear kitchen ell. Under the present owners, a portion of the front wall was removed, a full-length porch replaced with a fully-enclosed addition, the rear ell substantially expanded, and most of the original interior spaces rearranged. Among the few features remaining from the period prior to remodelling are several 6/6 double hung sash windows in flat surrounds with narrow drip shelves, and the brick chimney stack centered on the roof ridge.

PLATE 39: Clarksdale Tenant House No 2, View Looking Northeast

PLATE 40: Clarksdale Tenant House No 2, View Looking Southwest

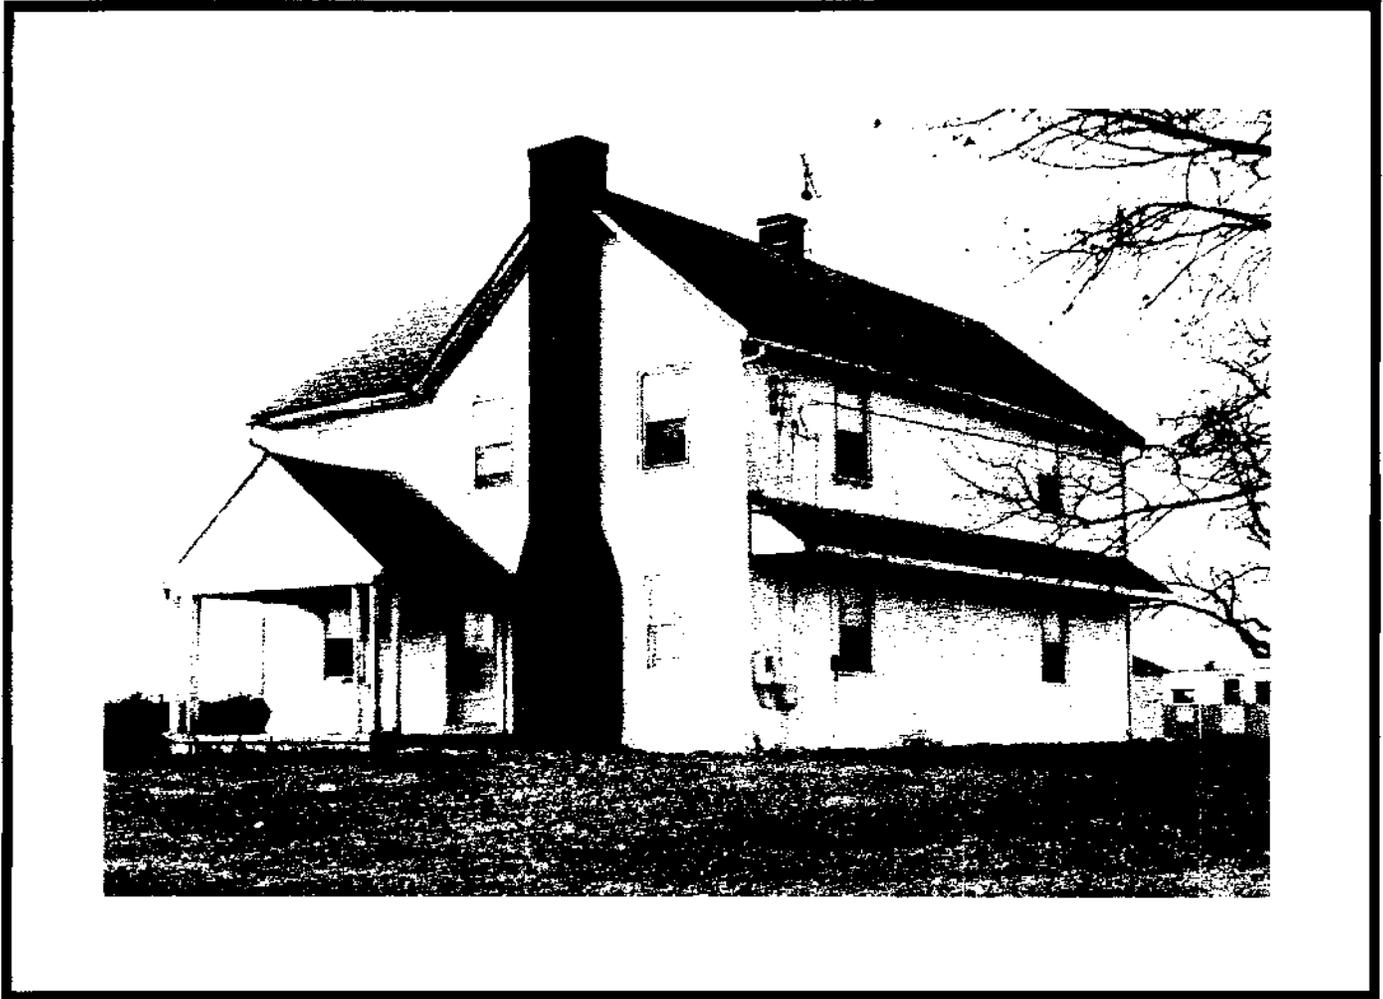
PLATE 41: Clarksdale Tenant House No 3, View Looking Southwest

The house consists of a two-story side gable main block of stuccoed brick, with a two-story gable-roofed wood frame ell off the south side (Plates 41 and 42). The north elevation features two widely-spaced windows at each story, and a narrow pentroof extending the length of the wall between the floors. The west side has two windows on the first floor and one centered above them on the second story. A relatively new exterior brick chimney separates the two bays into which the east gable end is divided. The only exterior entrance to the brick section is located in this wall, sheltered by a modern gable-roofed porch on a concrete slab. The frame ell, clad in synthetic shingling, is one bay long and two bays wide. On the west side, in the re-entrant angle formed by the two sections of the house, is a partially screened slant-roofed porch within which is the entry to the kitchen area.

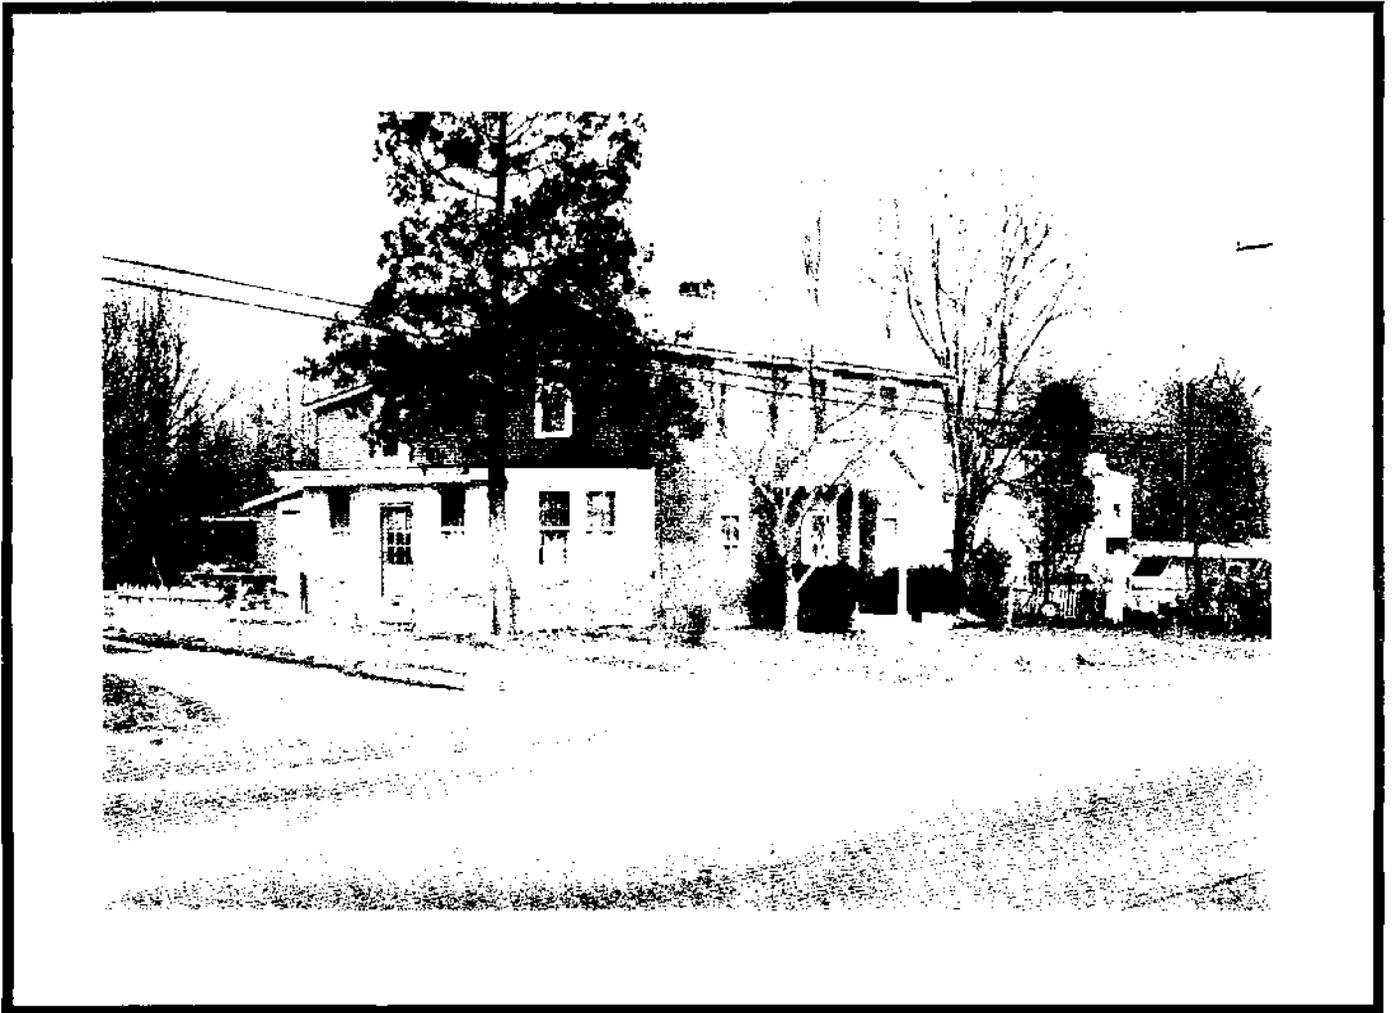
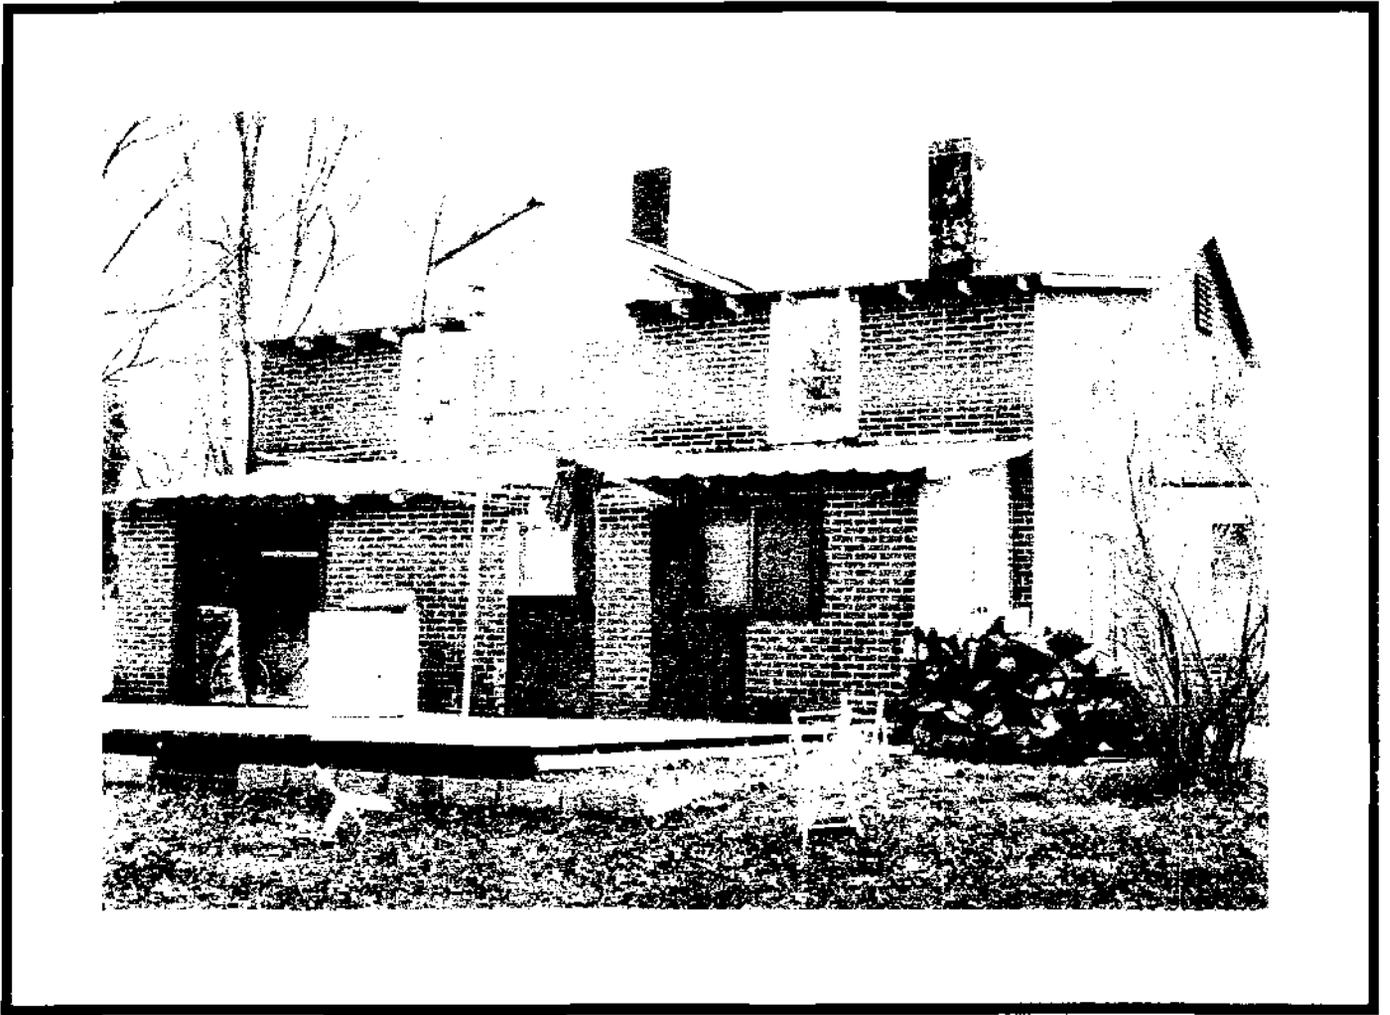
main block to which have been added two slant-roofed units, one of two stories, the other of one story, across the rear (Plates 43 and 44). The entire building, which is of wood frame construction, was covered with red facebrick in 1955, thereby completely obliterating its original exterior wall surfaces. Off the south gable end is a one-room addition on a raised brick foundation. The original main block retains most of its 6/6 double hung sash windows in flat, unmolded surrounds with narrow cornices. The eaves of the low, corrugated metal-clad roof are embellished along with the east side and gable ends with a narrow scalloped fascia board. Two tall brick interior chimneys are symmetrically located on the rear roof slope. A one-bay porch with standing-steam metal clad gable roof and thin Tuscan Doric style columns shelters the main entrance.

PLATE 43: Clarksdale Tenant House No 4, View Looking Northwest

PLATE 44: Clarksdale Tenant House No 4, View to East
