## 7.0 VISUALIZATION STUDY

The superstructure of the new Indian River Inlet Bridge would rise some 319 feet above the water (Figure 41). At this height the structure would be visible from miles around, particularly across the great expanse of Indian River Bay. Consequently, the study area was defined to include a five-mile radius from the proposed bridge site.

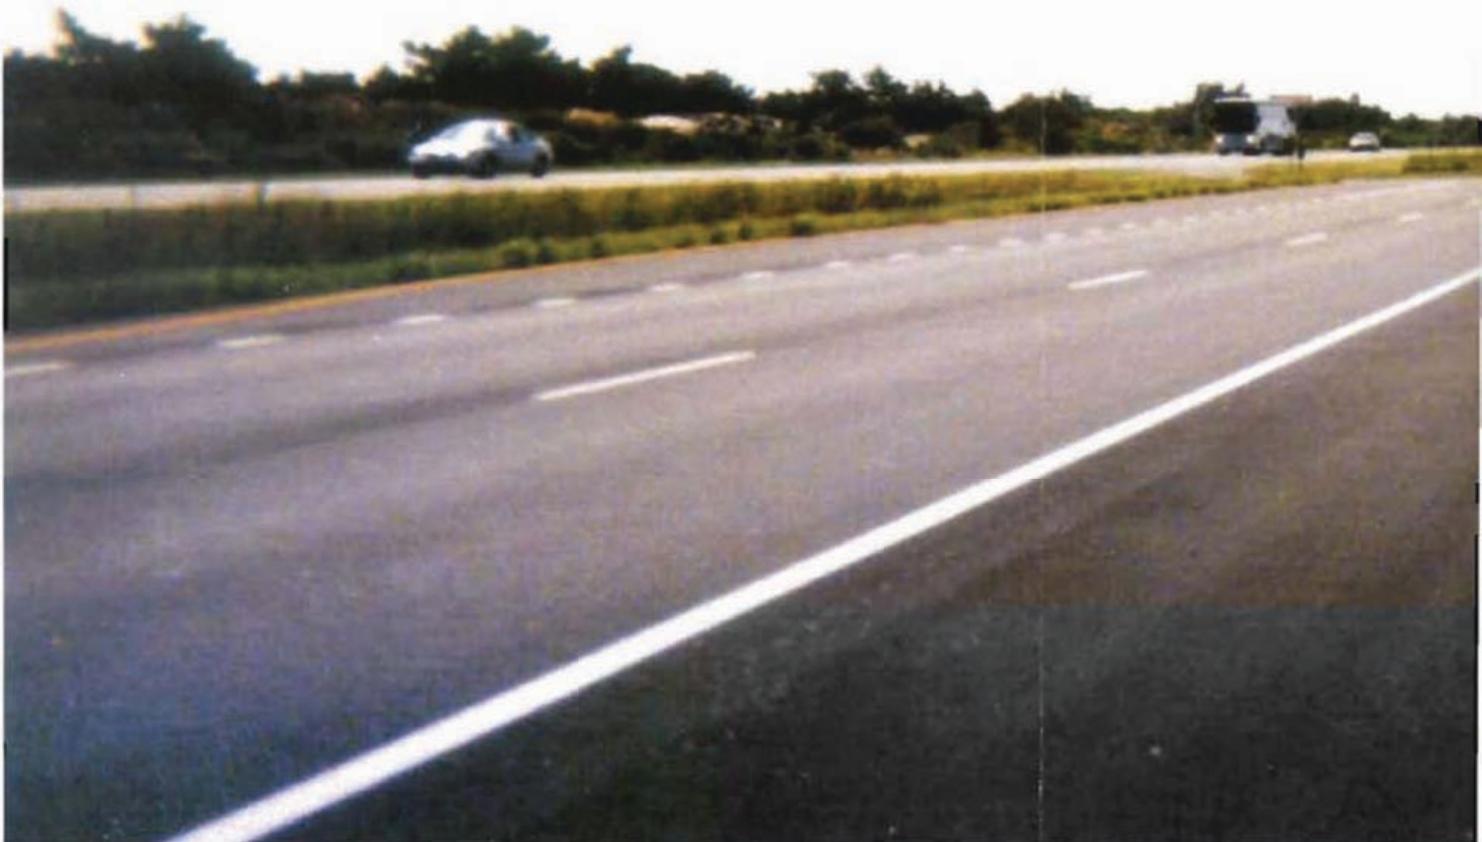
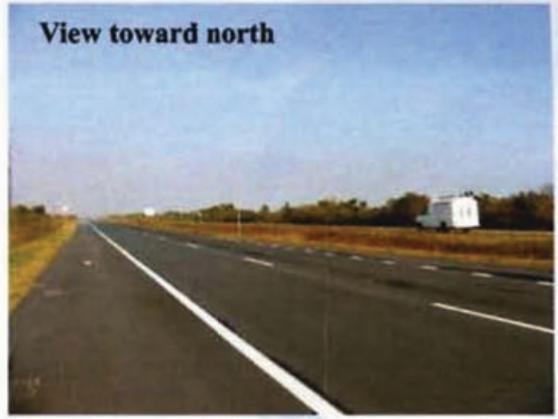
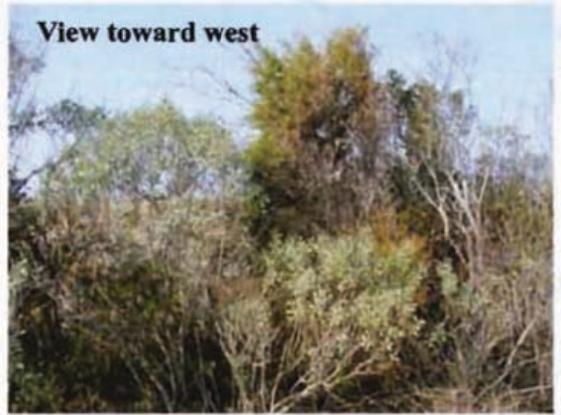
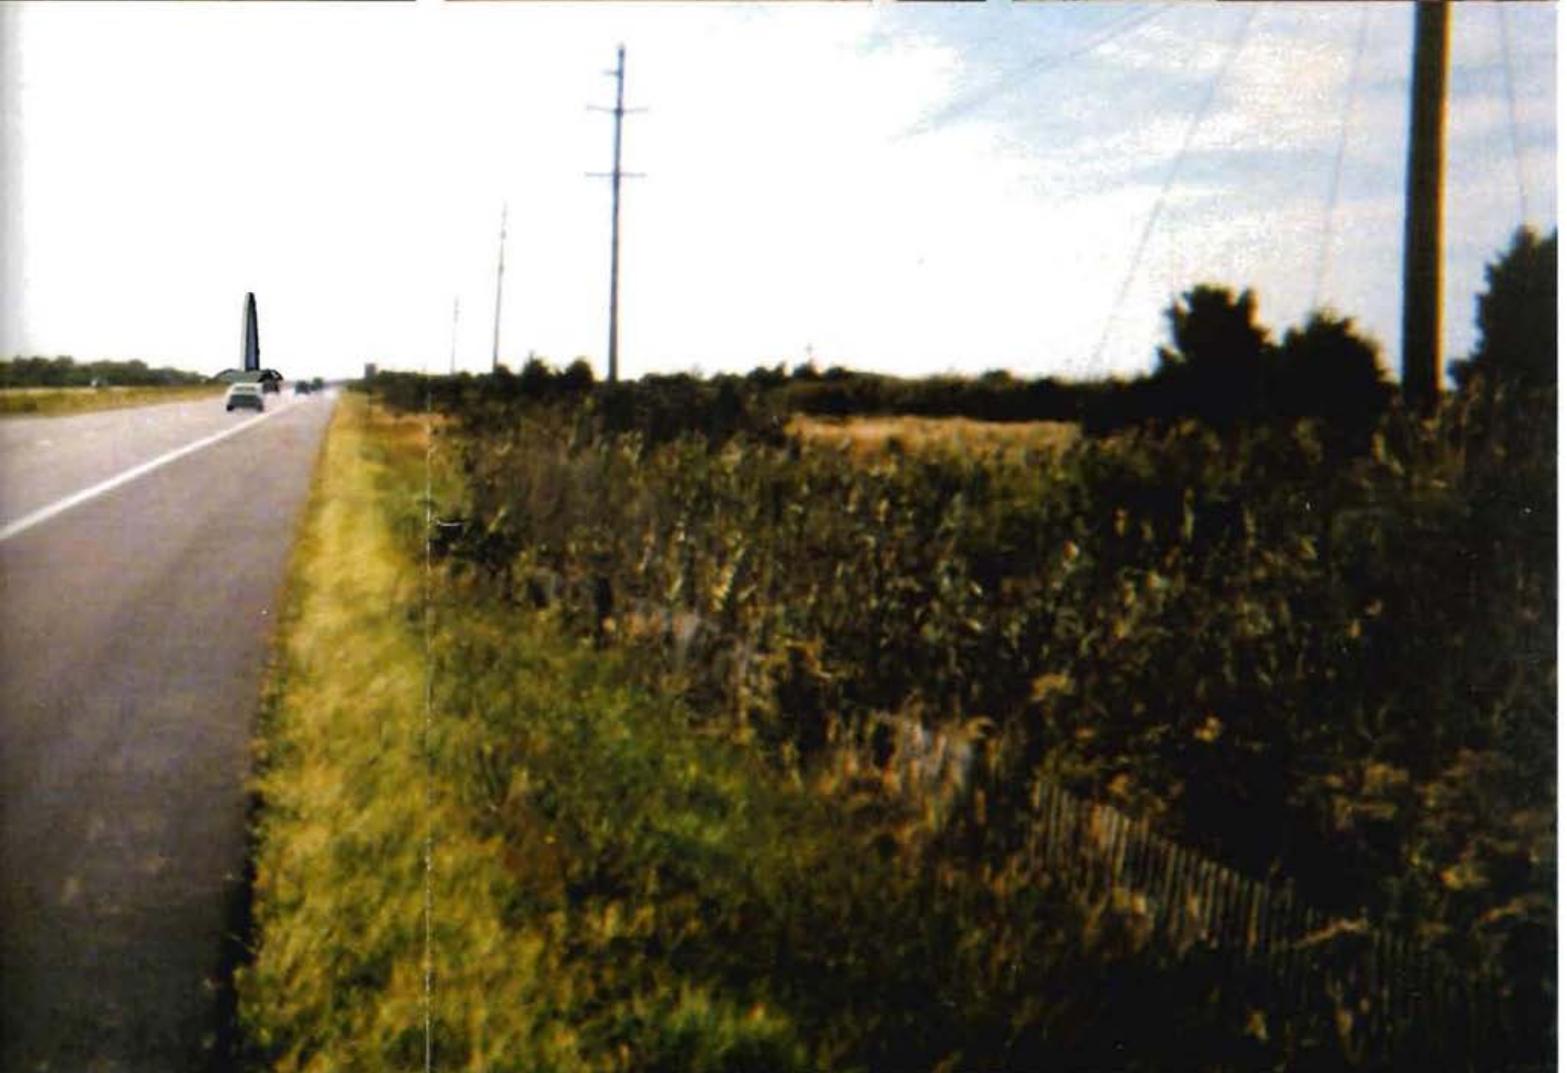
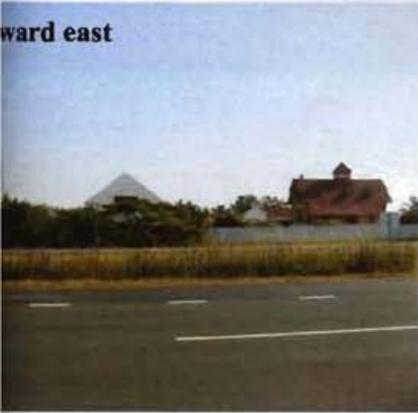
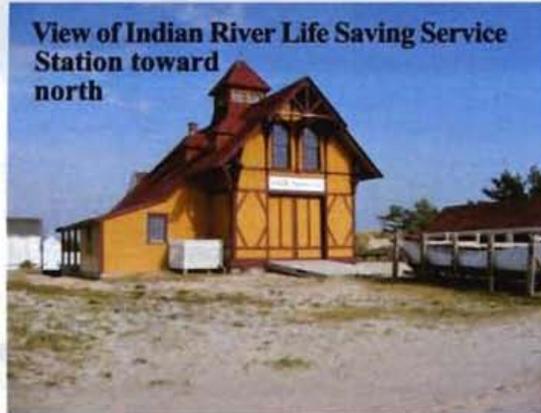
Figure 42. Visualization from camera location 1 (Figg Engineering Group 2003).

Camera location 1 is situated on the west side of southbound SR 1, approximately 1.8 miles north of the midpoint of the new bridge (Figure 42). From this location the new bridge would be visible along the SR 1 corridor to the south, but would appear small due to its relatively great distance from

camera location 1 and the angle of view relative to this location. The new bridge would appear more as a short obelisk-like object, rising near the horizon, than a visually intrusive arched structure. Only a very small portion of the arched elevation would be visible from this location.

There is only one historic property in the vicinity of camera location 1, the NRHP-listed Indian River Life Saving Service Station (S-453) (Figure 42:insets). This property presently functions as a museum. The NRHP boundary is 164 feet east of camera location 1, and the station building is 358 feet southeast of this location. The distance between the historic property and the new bridge would be approximately same as the distance between camera location 1 and the new bridge. The angle of view, however, would change. While a very small portion of the arched elevation would be visible from camera location 1, little, if any, of the arched elevation is likely to be visible from the historic property.

Since the property functioned historically as a facility from which to observe vessels in distress, an unobstructed view from the property is a significant characteristic of it. The view toward the bridge would change, based on one's level of view (Figure 42:insets). From the ground level, the new bridge would not be visible due to the presence of intervening vegetation. From the second-story level of the station building, the same is likely to be true, although here the north end of the bridge superstructure may be partially visible through the tops of adjacent trees. In any event, the museum visitor is not likely to notice the bridge. From the tower level of the station building, the north end of the bridge superstructure would be visible above adjacent trees. However, the view is not likely to be noticed since the tower room is inaccessible to museum visitors.

While the view toward the historic property is an important aspect of one's enjoyment and appreciation of it (Figure 42:insets), the new bridge would be so far removed from it that it is very unlikely to obstruct views toward the property. Therefore, no aesthetic or obstructive effects are anticipated.

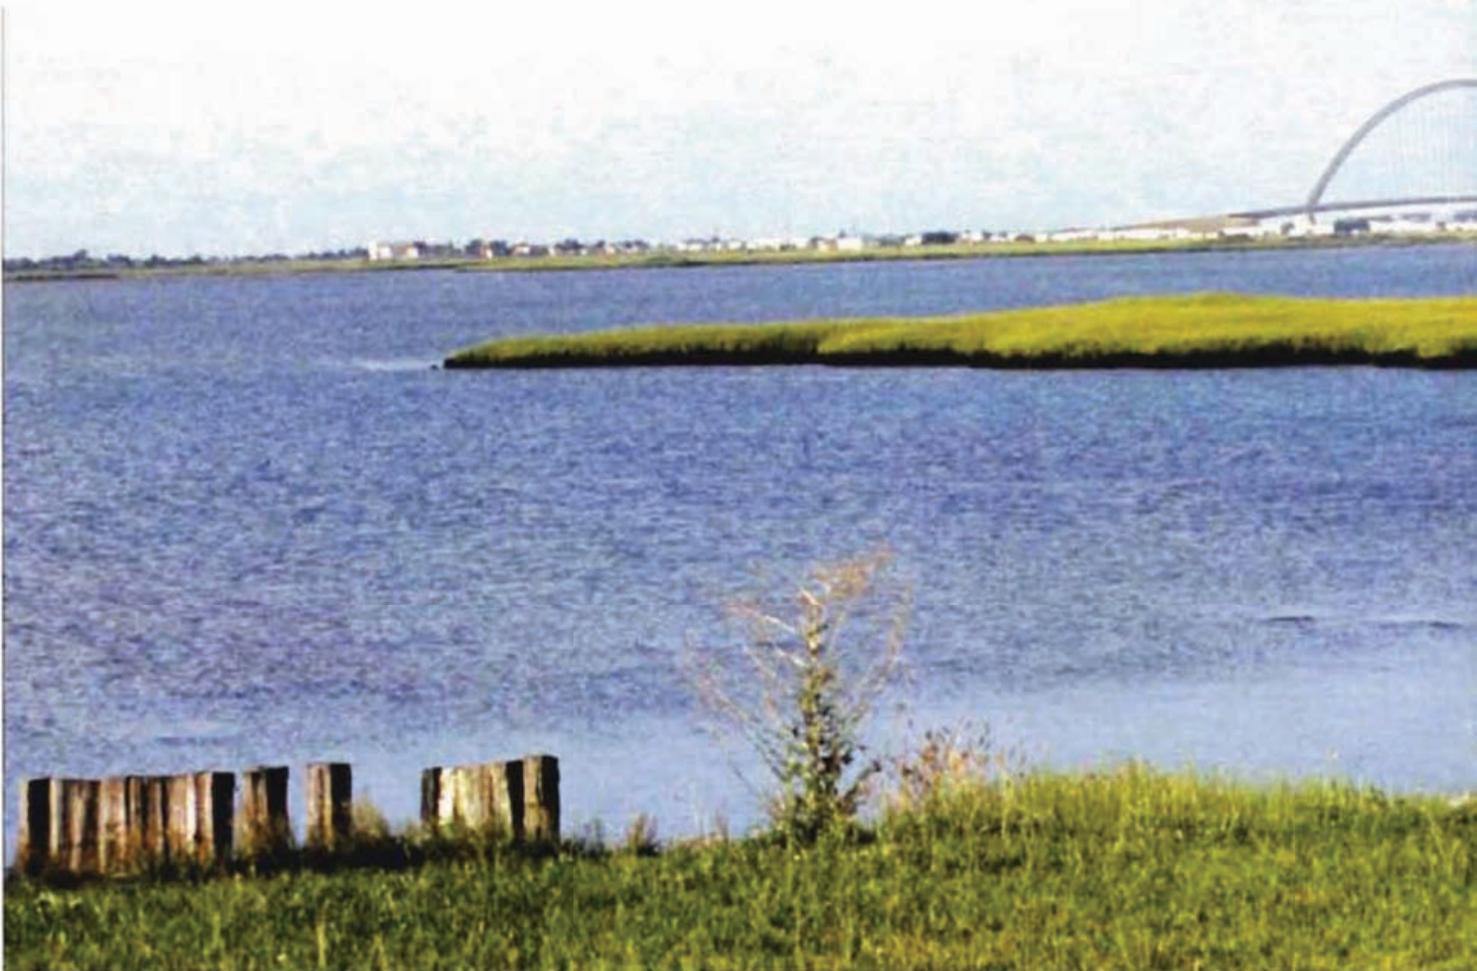
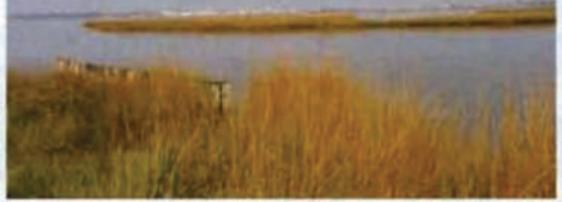
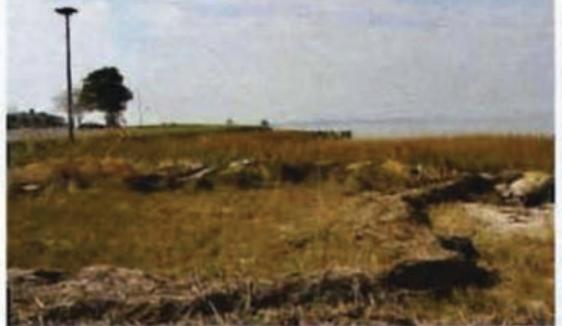
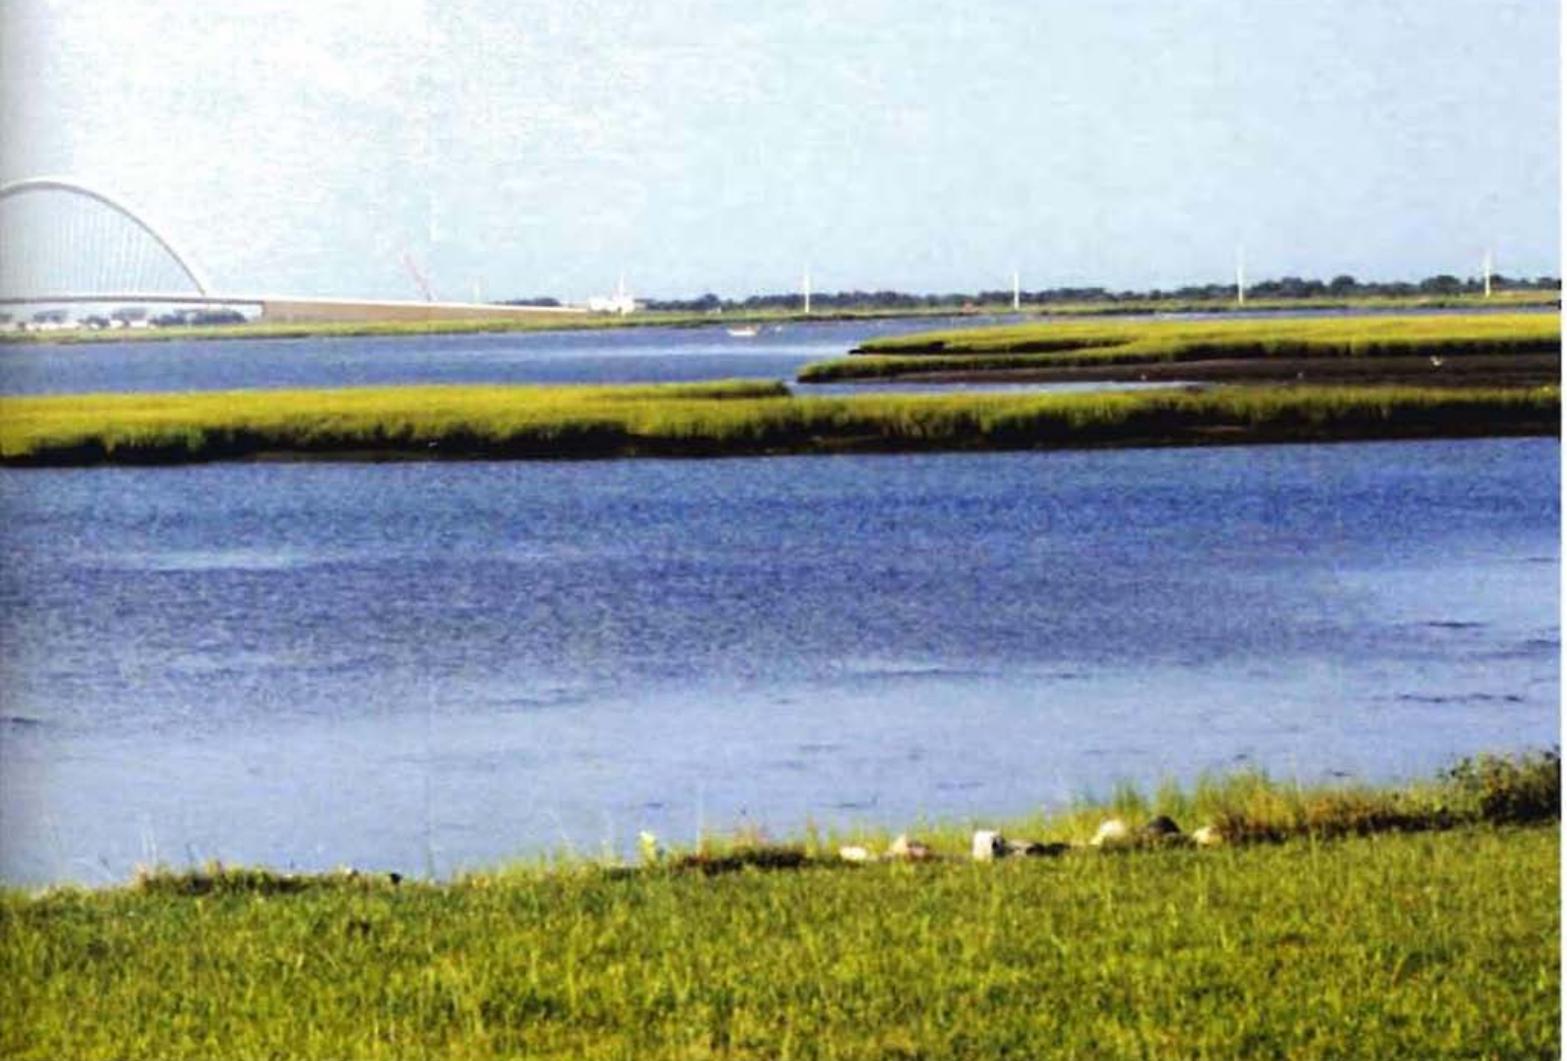
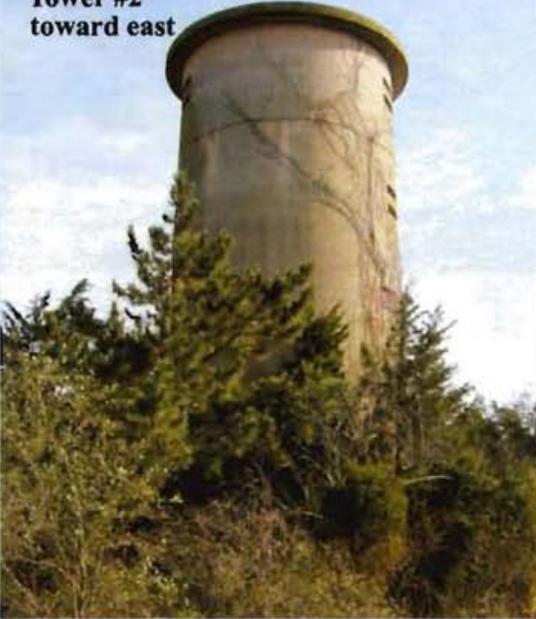
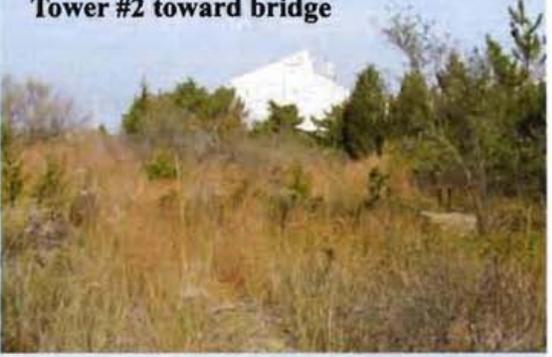
Figure 43. Visualization from camera location 2 (Figg Engineering Group 2003).

Camera location 2 is situated near the Quillens Point boat ramp at the north end of Cedar Neck, approximately 1.5 miles south-southwest of the midpoint of the new bridge (Figure 43). The new bridge would be visible from this location due to its relatively close proximity. The full expanse of the arched superstructure would be suggested, albeit rather obliquely, due to the angle of view from this location.

There are no historic properties in the vicinity (Figure 43:insets). The nearest previously identified architectural resources (S-2564 and S-2569) are located some 0.3 mile to the south. Due to intervening vegetation, the new bridge would not be visible from these locations. However, the NRHP-eligible Fire Station Control Tower #2 (S-6049.2), located approximately 0.7 miles to the east, would be approximately the same distance from the new bridge as camera location 2. This historic property, situated between SR 1 and the ocean, is heavily overgrown with vegetation and inaccessible to the public.

Since the property functioned historically as an observation tower, the view from the property is a significant characteristic of it. Conversely, the view toward the property contributes to one's appreciation and enjoyment of it (Figure 43:insets). However, due to the presence of intervening

residential development and vegetation, the new bridge is not likely to be visible from the historic property (Figure 43:insets), and the new bridge would be so far removed from the historic property that it is unlikely to obstruct views toward the property. Therefore, no aesthetic or obstructive effects are anticipated.

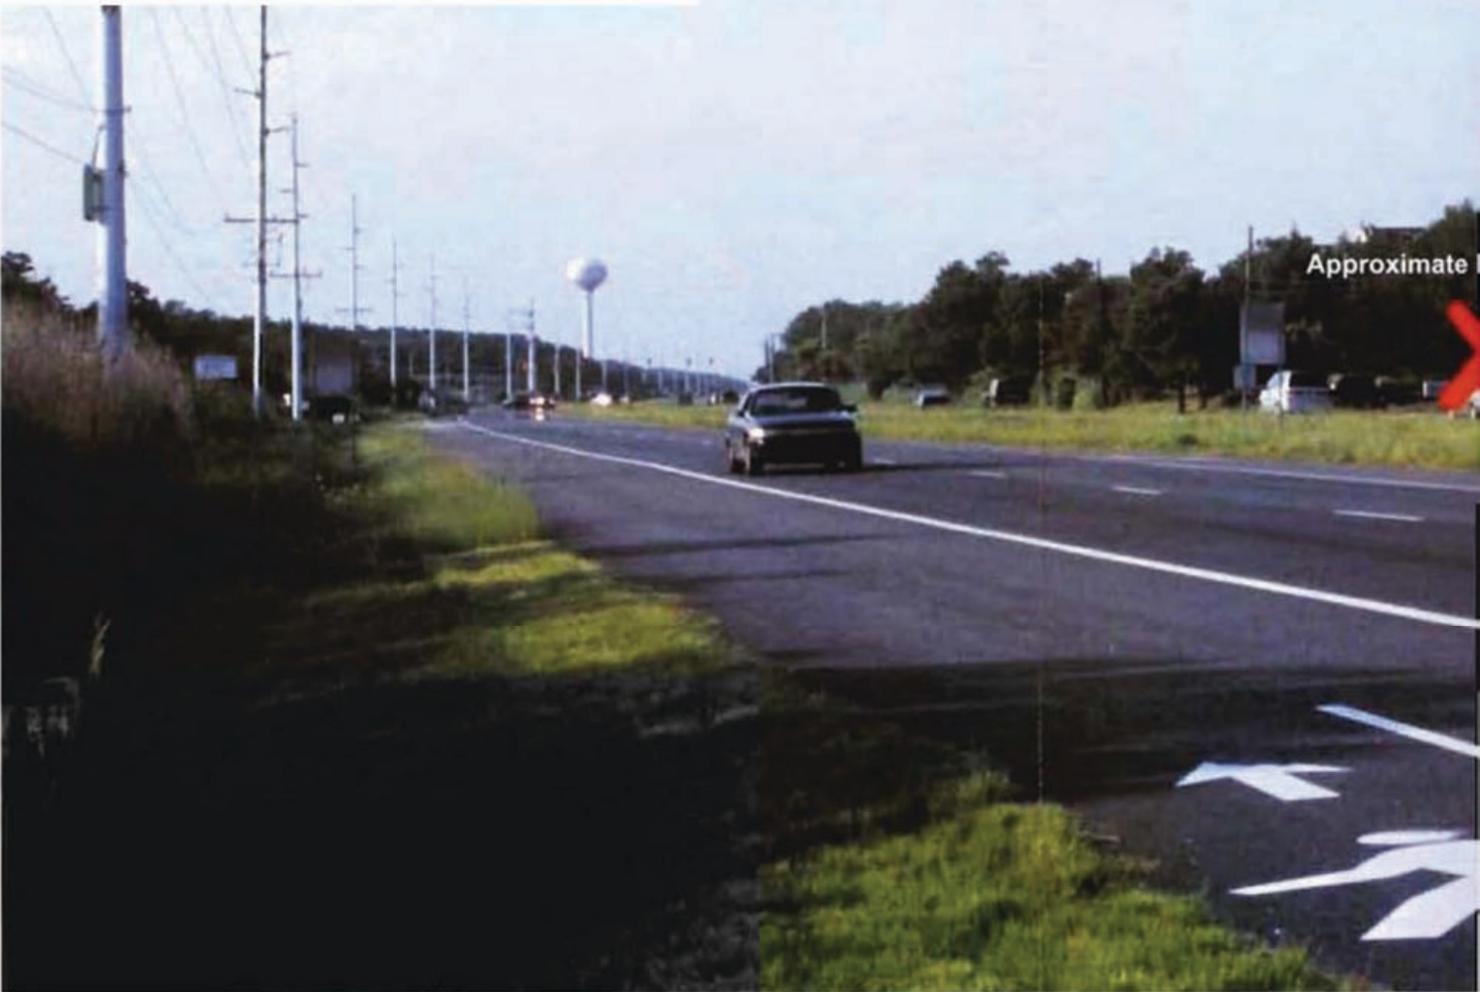
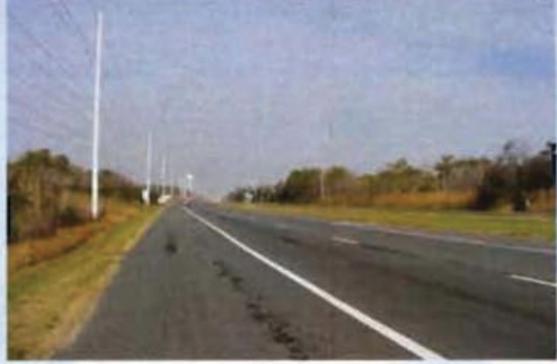
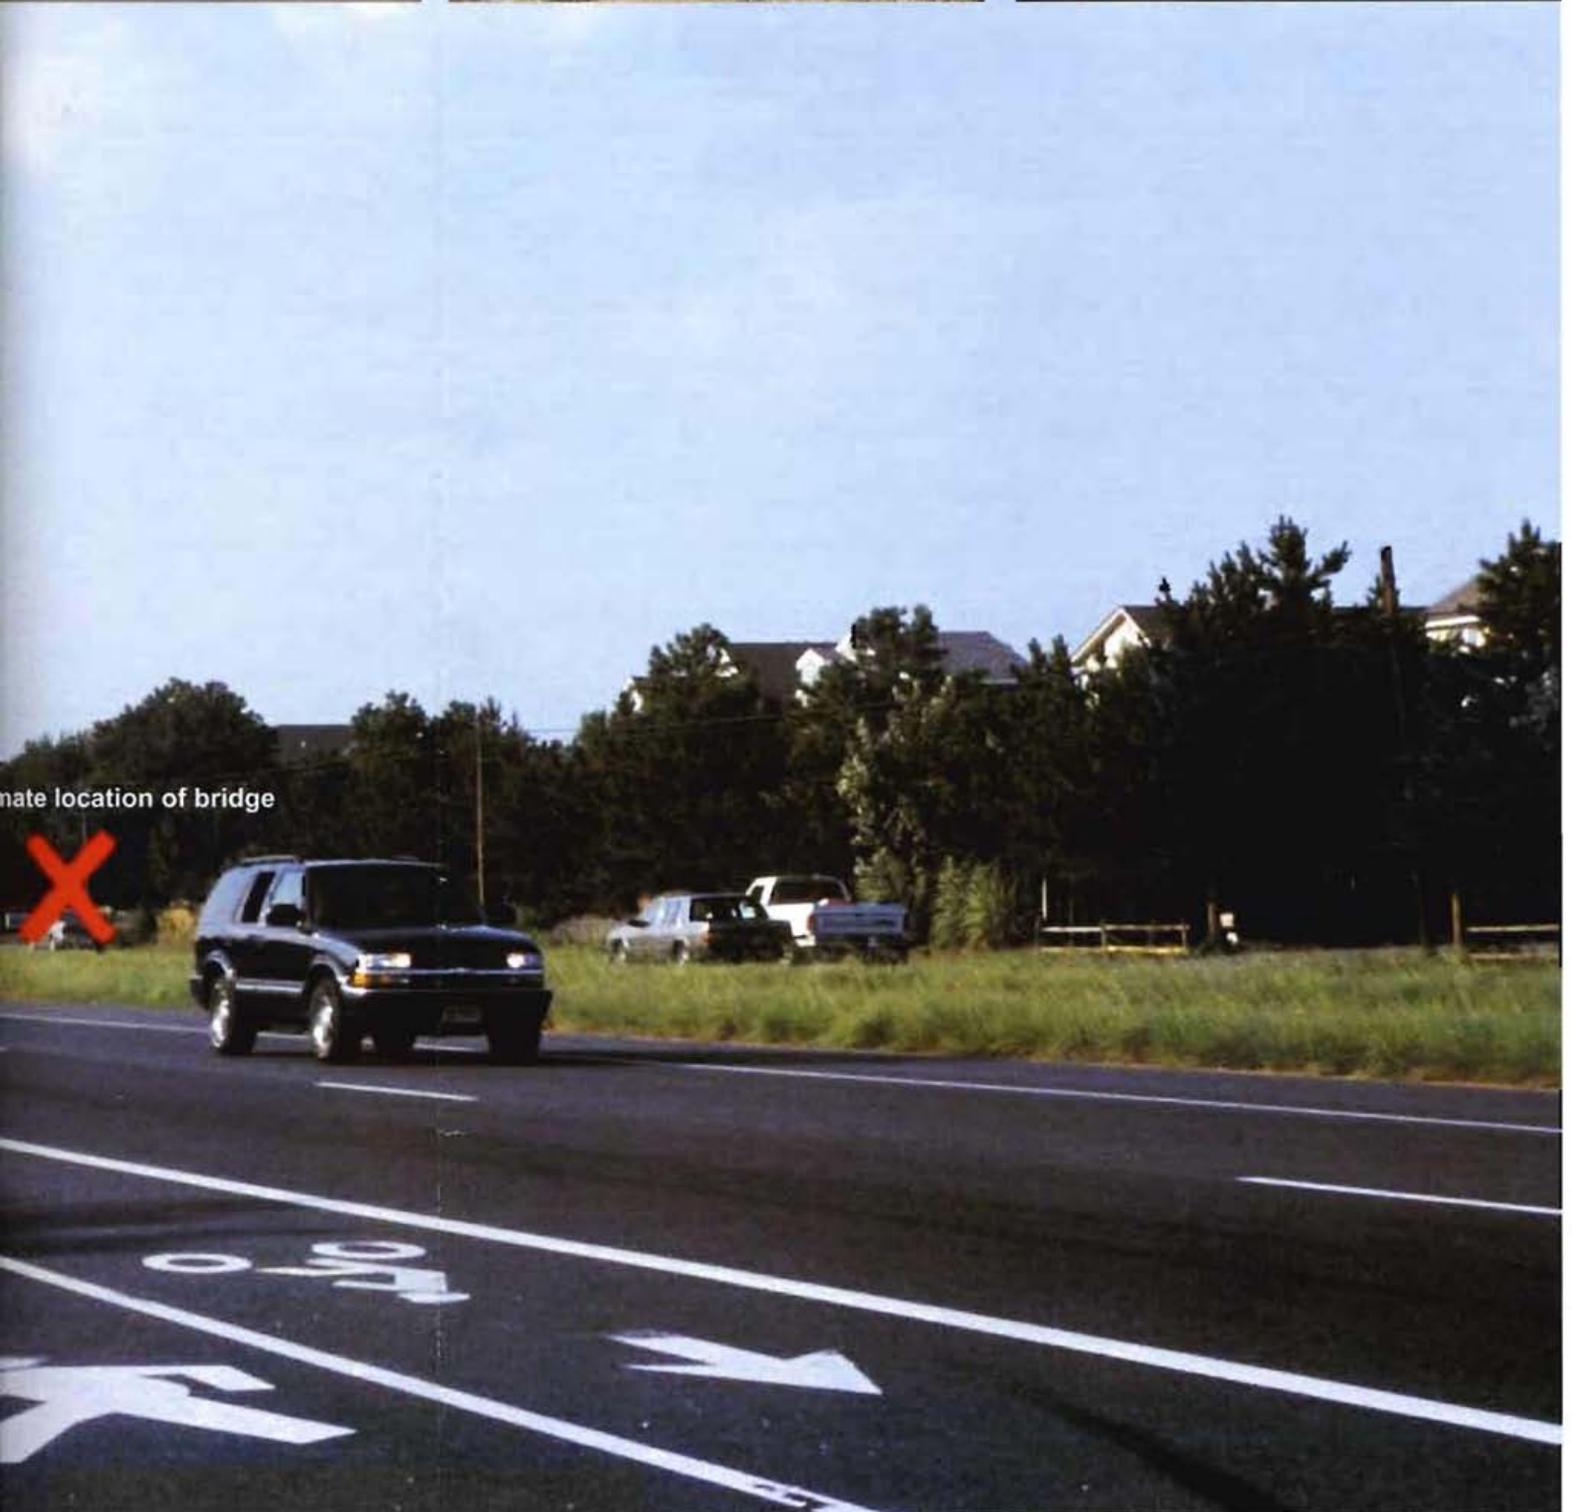
Figure 44. Visualization from camera location 3 (Figg Engineering Group 2003).

Camera location 3 is situated along the west side of southbound SR 1, approximately 4.0 miles south of the midpoint of the new bridge (Figure 44). Views from location 3 to the east and west are heavily obstructed by vegetation, while views to the north and south are dominated by the highway. The view toward the new bridge from camera location 3 would be totally obscured by intervening vegetation and residential development. There are no architectural resources specifically at camera location 3. However the nearest previously identified resource, the NRHP-eligible Bethany Beach Training Site (S-9142) is situated approximately 0.25 miles southwest of the camera location, and the northernmost resources associated with the community of Bethany Beach (S-9923 and S-9925) are situated approximately 0.3 miles to the south (Figure 44:insets). In both cases, visual impact of the proposed new bridge will be even less than depicted at camera location 3.

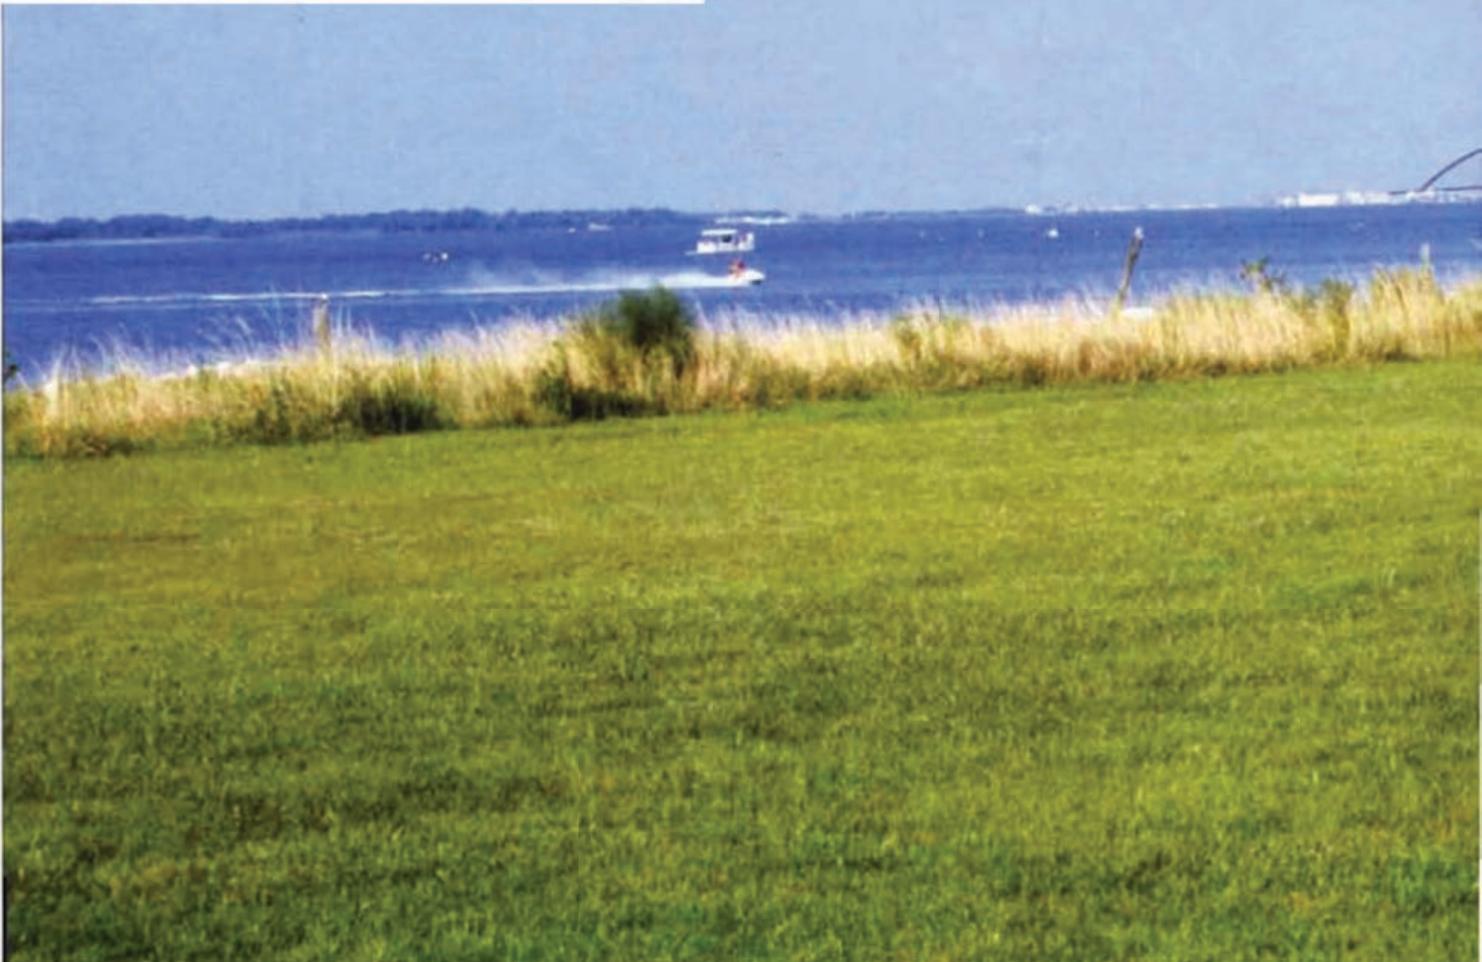
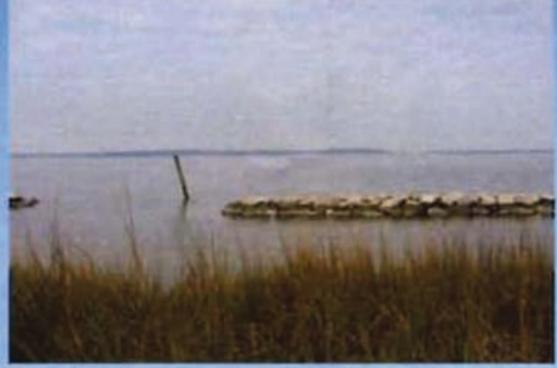
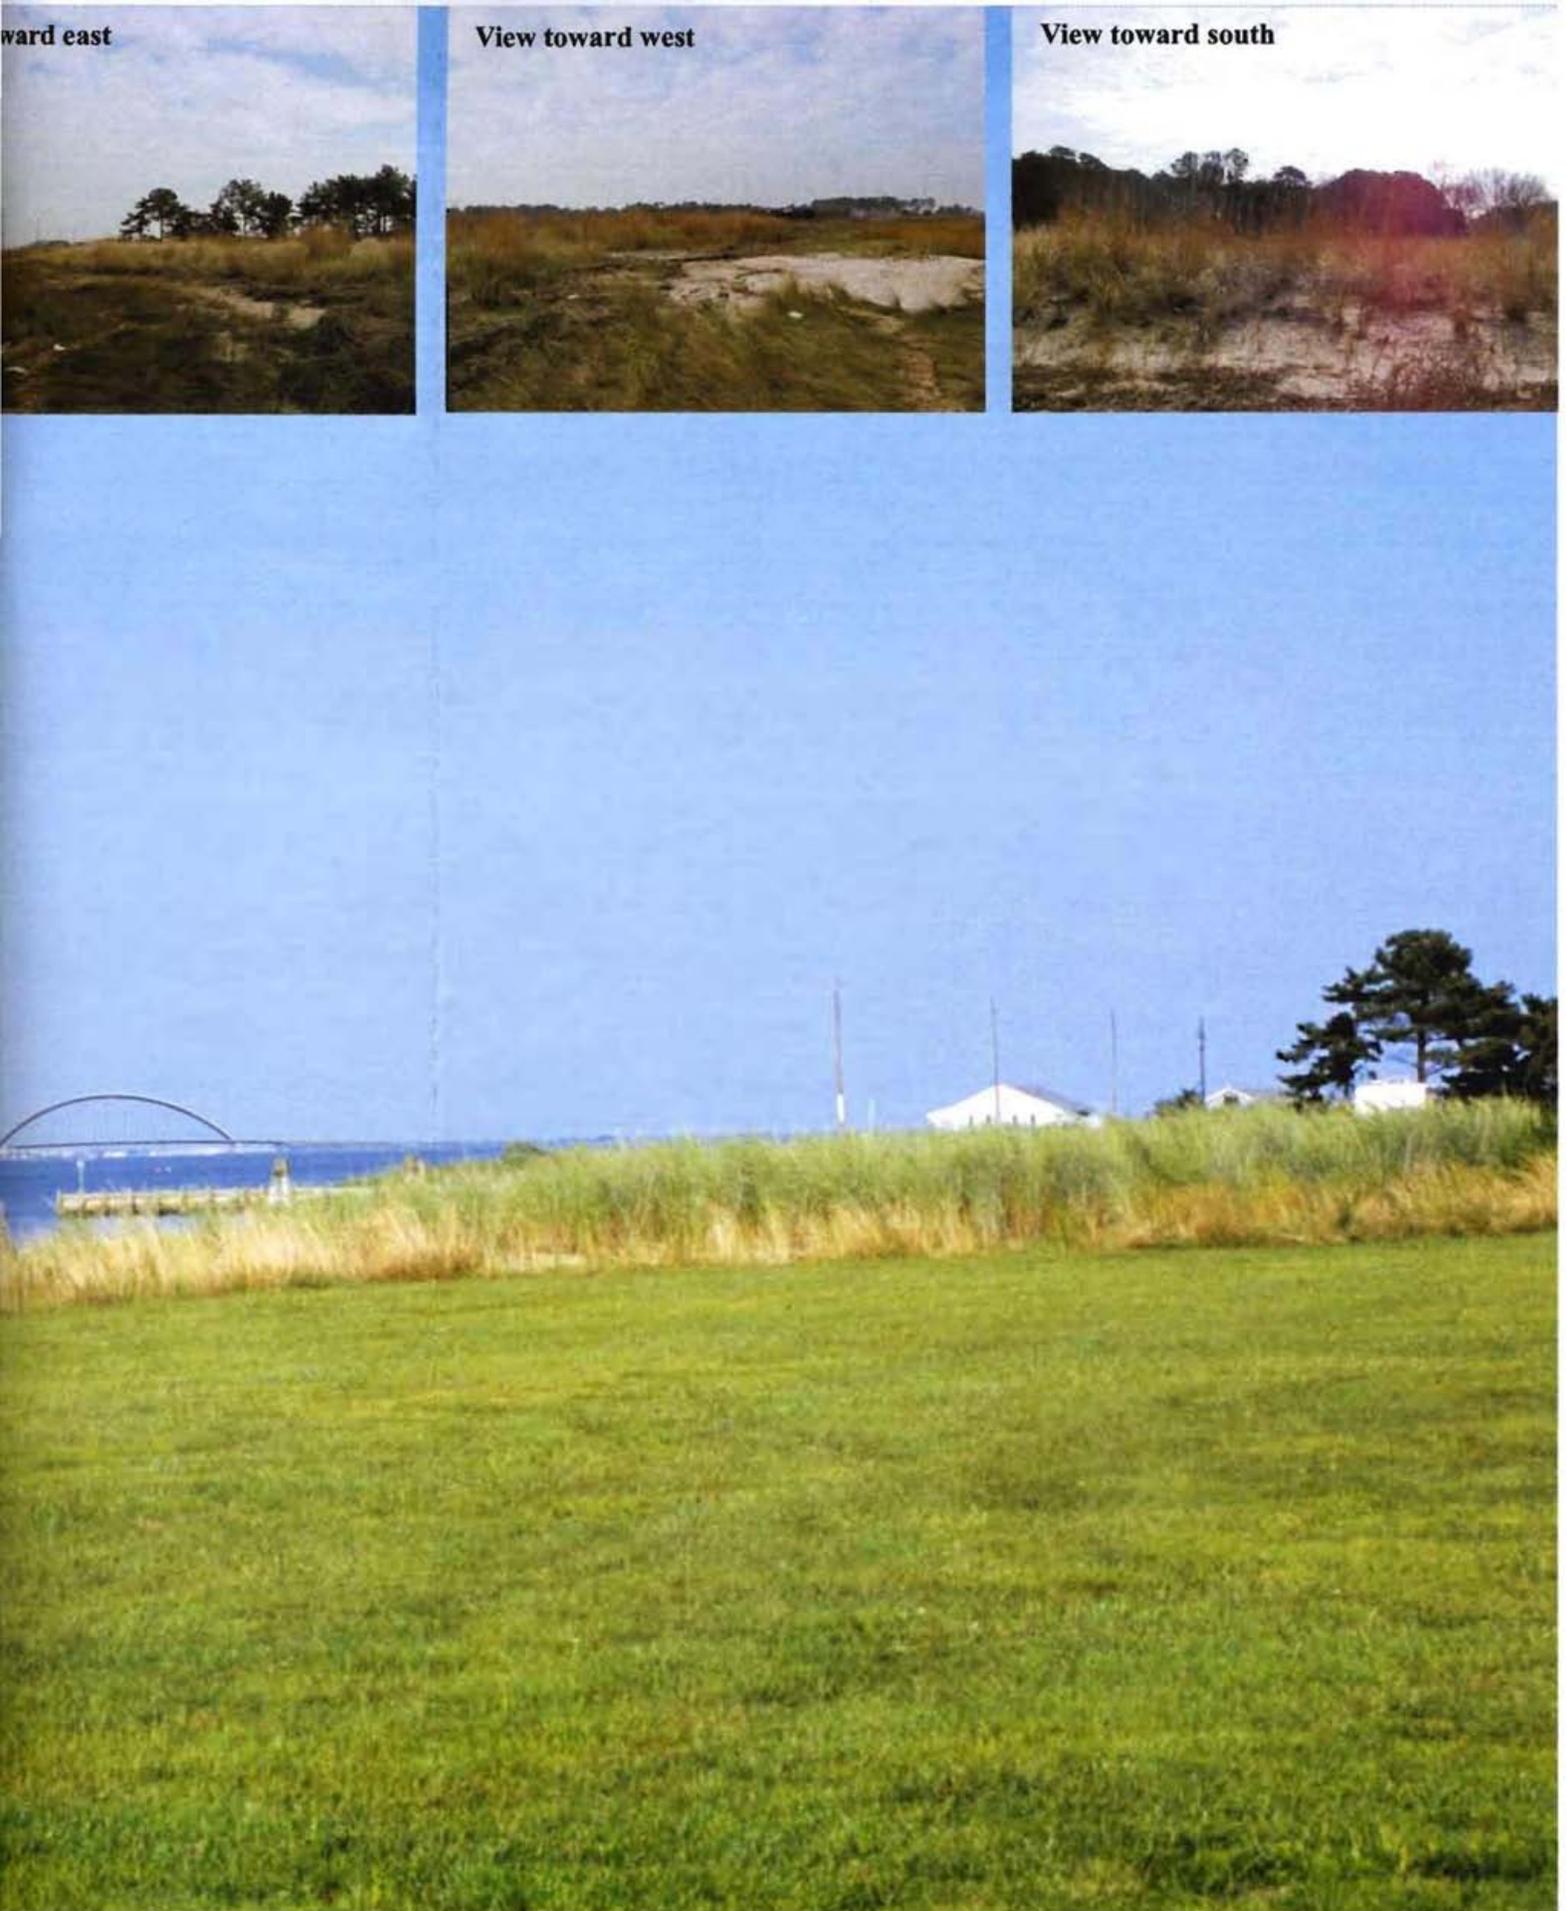
Figure 45. Visualization from camera location 4 (Figg Engineering Group 2003).

Camera location 4 is situated on the south shore of Indian River Bay, approximately 185 feet east-southeast of the boat ramp in Holts Landing State Park and approximately 3.6 miles west-southwest of the midpoint of the new bridge (Figure 45). In general the view from location 4 looking north and east provides a vista across Indian River Bay, with the low fringing marsh and tree lines visible to the east. Looking west and south the view depicts State Park land. The view from camera location 4 would be unobstructed, revealing the full arch of the bridge superstructure in elevation. However, its visual impact would be relatively small due to its distance from camera location 4. There are no previously recorded architectural resources in the vicinity (Figure 45:insets). There is however a previously recorded archeological site (7S-G-8) at the camera location. Previously recorded cultural resources are situated further south and west from this camera location, but these are approximately 1 mile further inland and are separated from the Bay by woodlands.

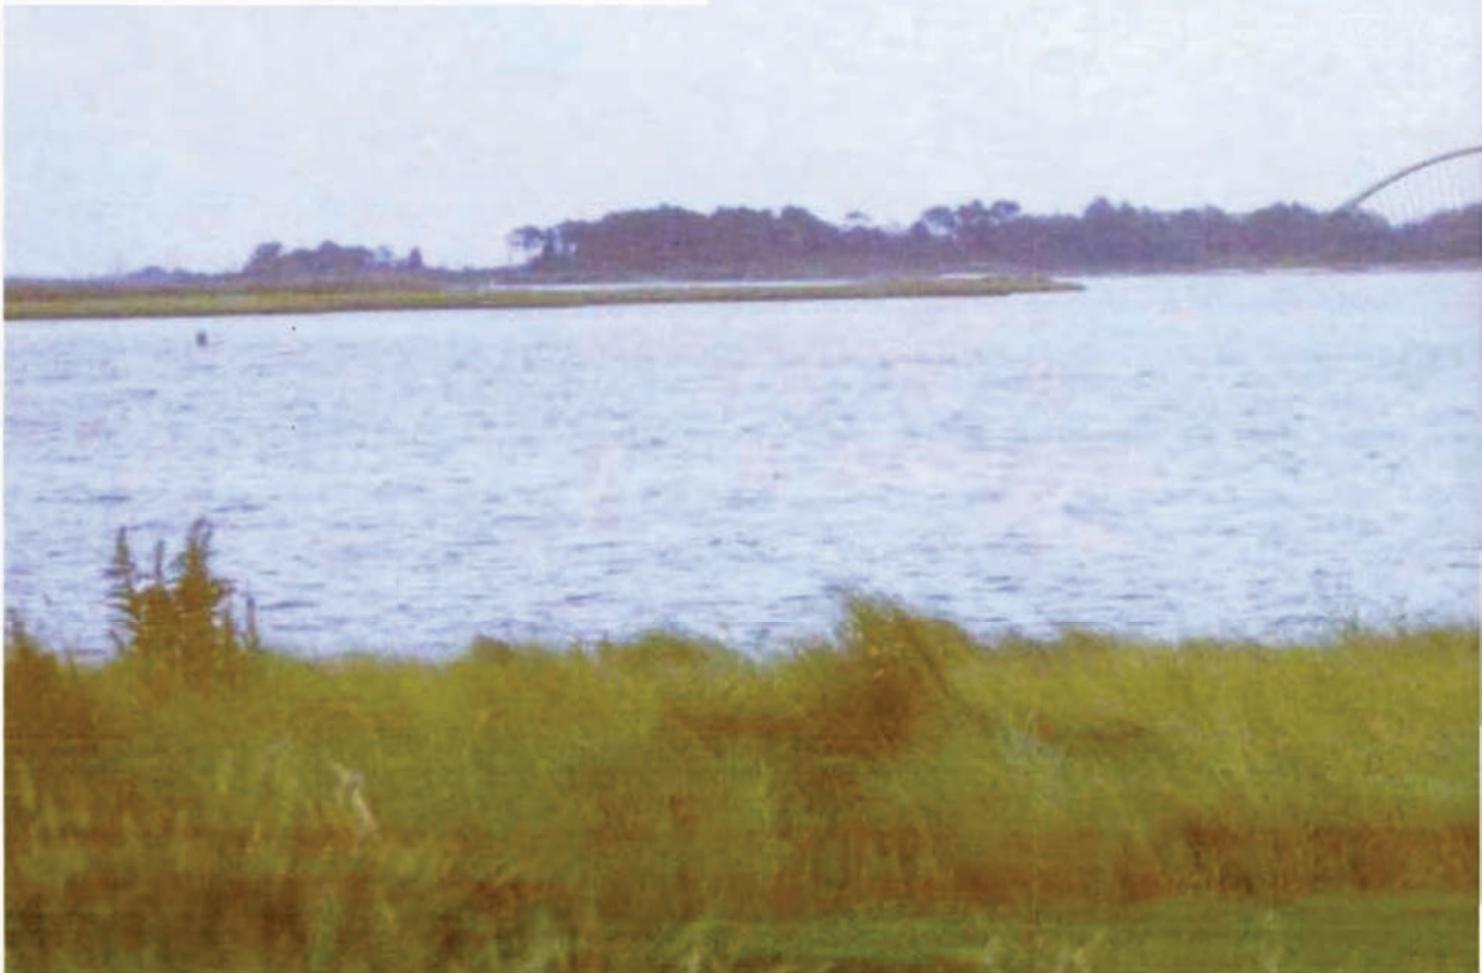
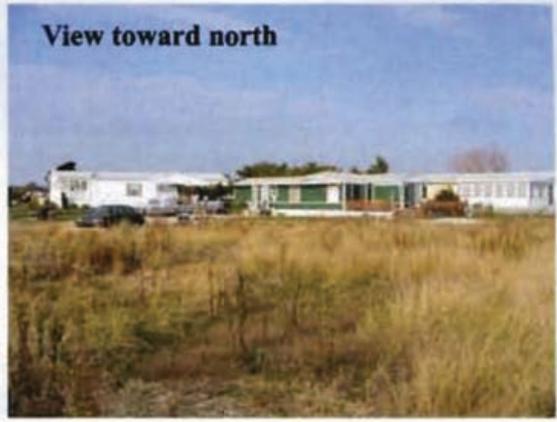
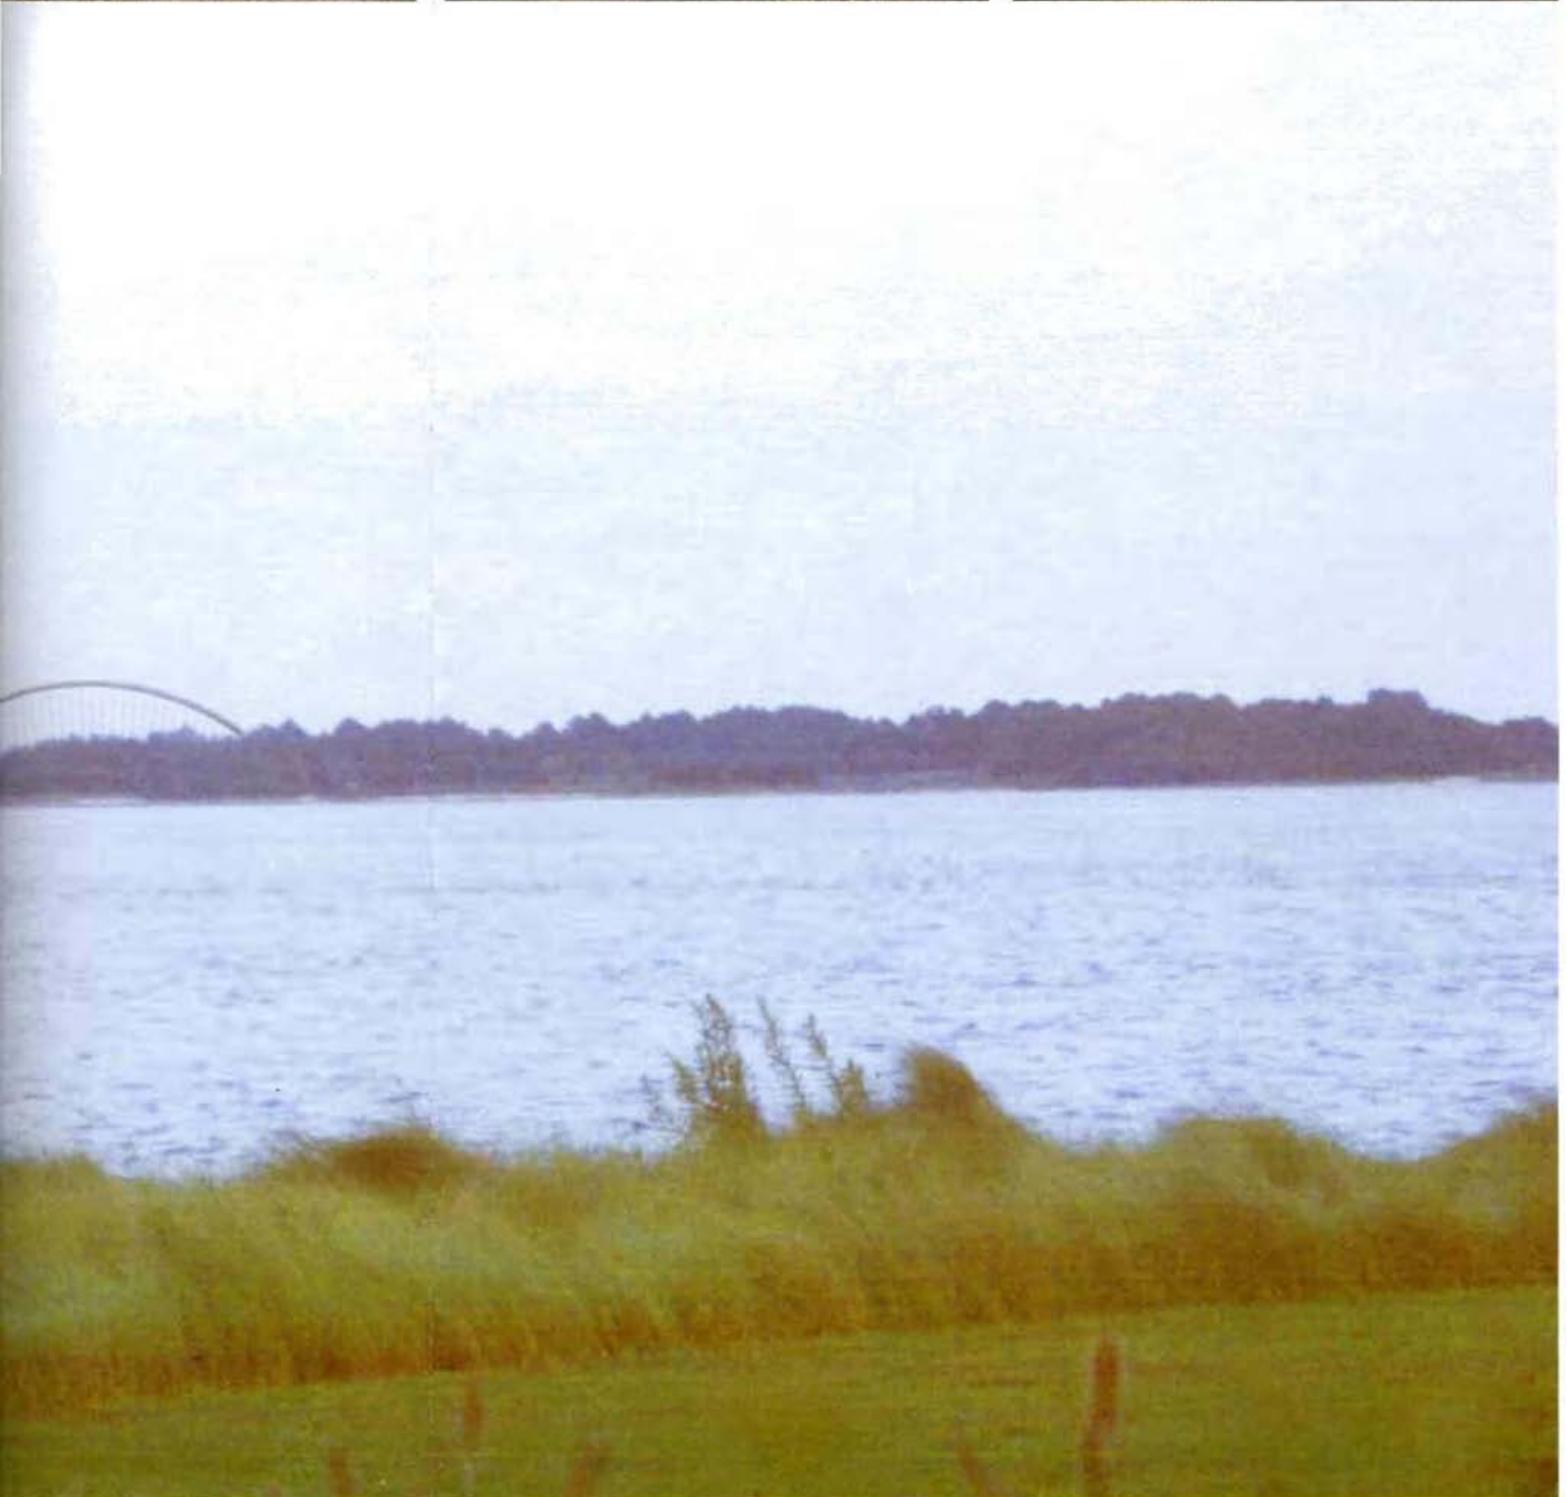
Figure 46. Visualization from camera location 5 (Figg Engineering Group 2003).

Camera location 5 is situated on Long Neck at the north side of the Indian Landing marina inlet, approximately 2.1 miles northwest of the midpoint of the new bridge (Figure 46). Views east, west, and south from this location provide vistas of Indian River Bay, with Burton's Island intervening between the inlet and the camera location. The view to the north depicts a mobile home park. The view from camera location 5 would be somewhat obstructed by vegetation on Burton Island. However, from this oblique viewpoint, the top portion of the bridge superstructure would be visible above the trees. There are no previously recorded architectural resources in the vicinity (Figure 46:insets). A previously recorded prehistoric archeological site (7S-G-1, the Massey Landing site) is located a short distance northwest of the camera location. Previously recorded cultural resources situated further inland are unlikely to be visually impacted by the proposed bridge.
