## 7.0 VISUALIZATION STUDY

The superstructure of the new Indian River Inlet Bridge would rise some 319 feet above the water (Figure 41). At this height the structure would be visible from miles around, particularly across the great expanse of Indian River Bay. Consequently, the study area was defined to include a five-mile radius from the proposed bridge site.

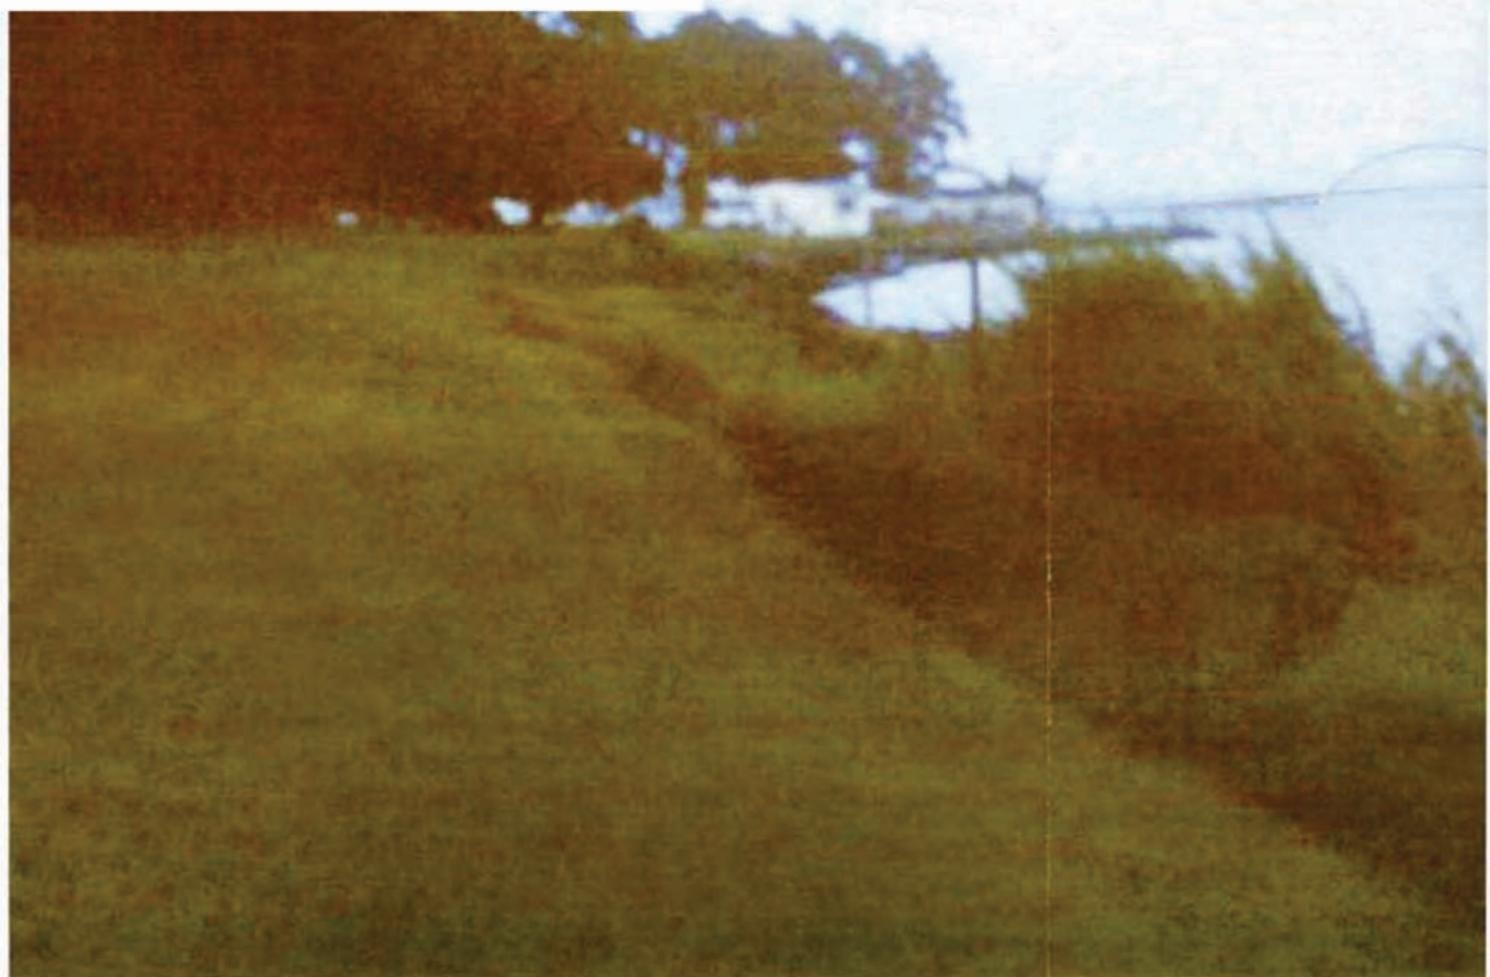
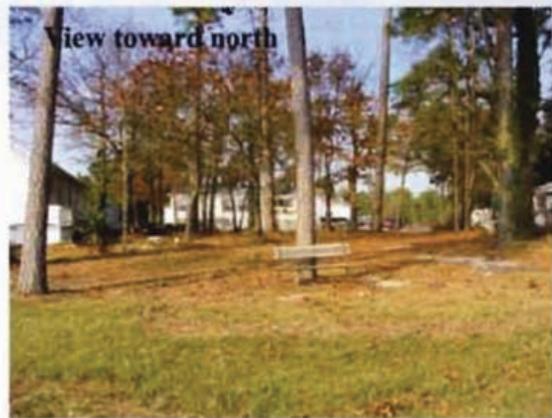
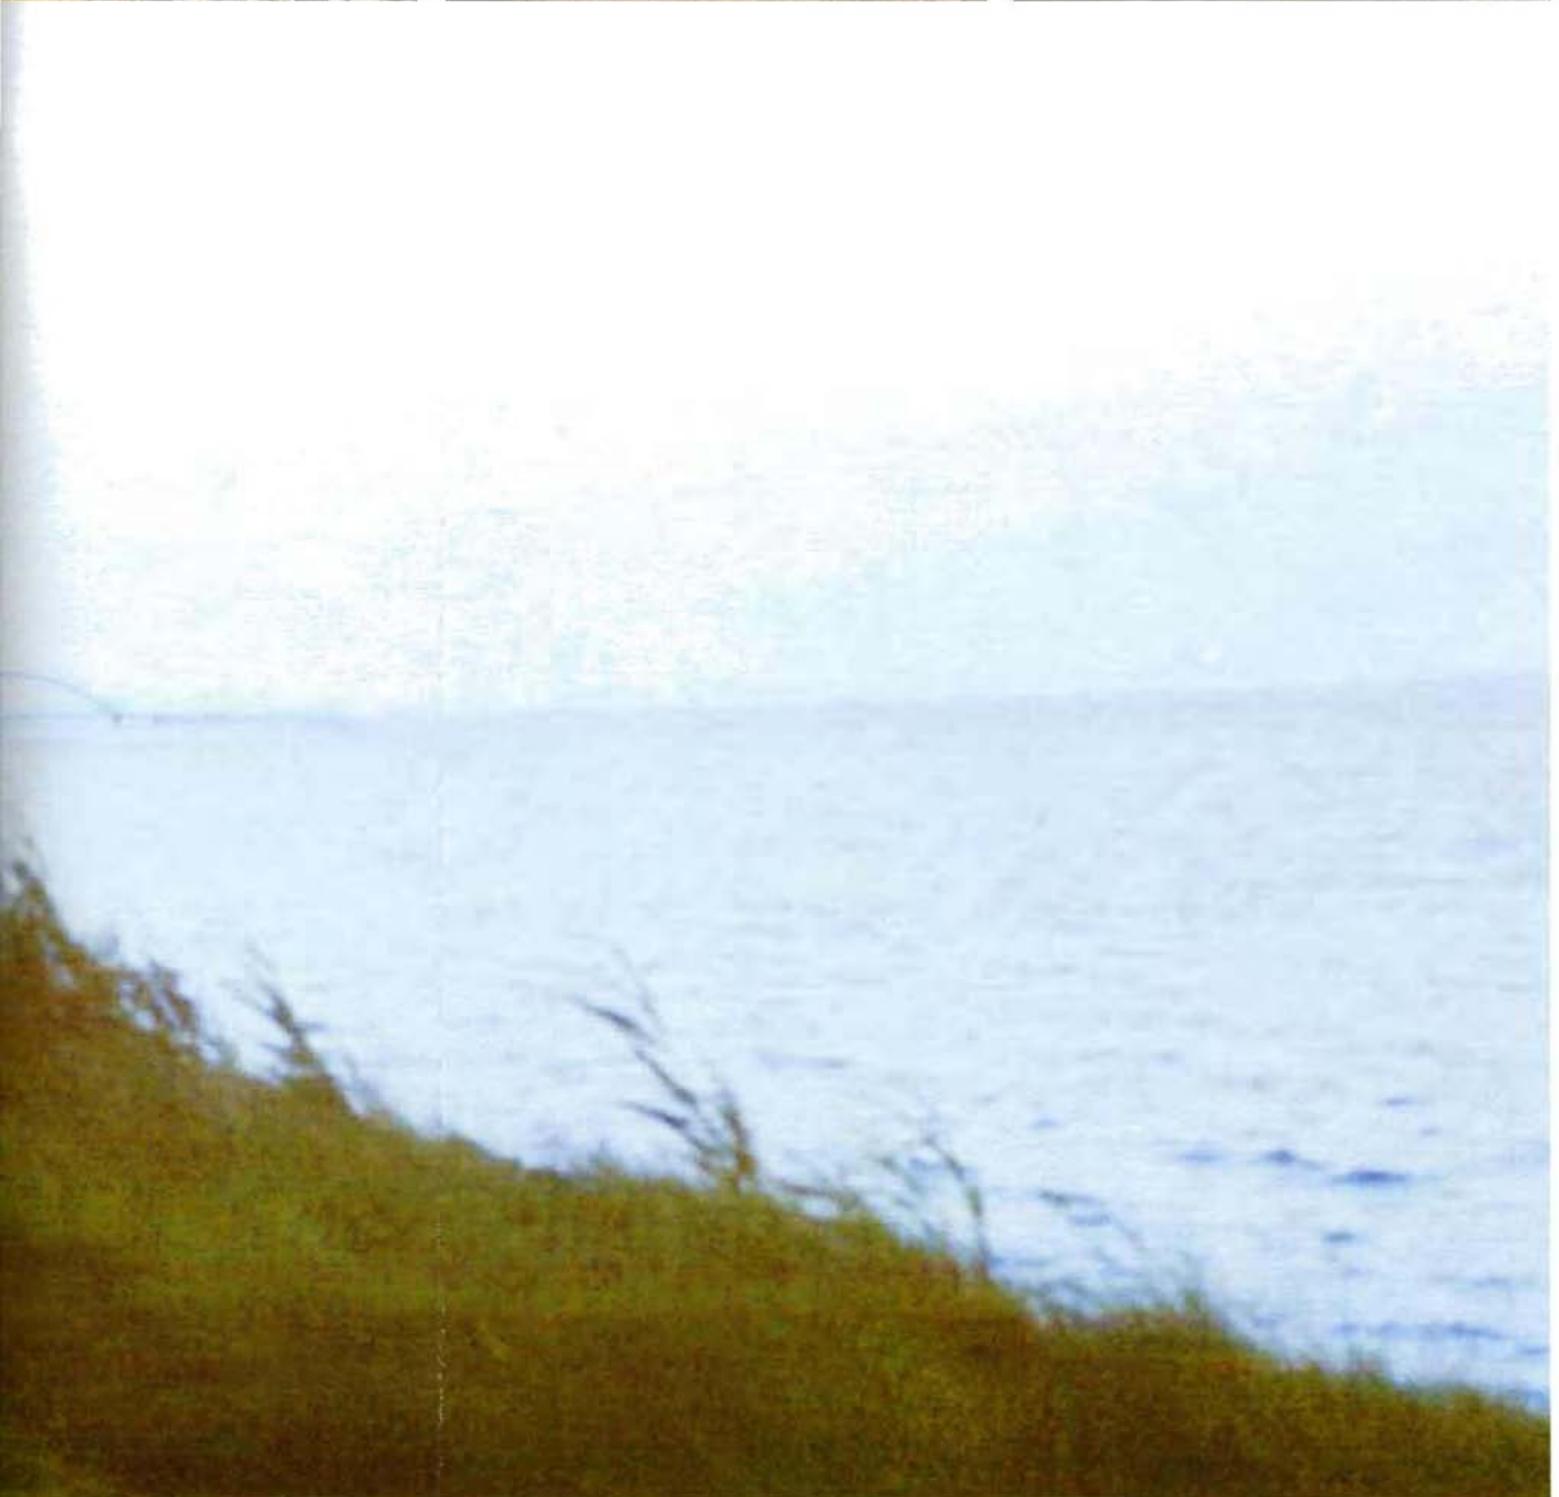
Figure 47. Visualization from camera location 6 (Figg Engineering Group 2003).

Camera location 6 faces Indian River Bay from the south side of Long Neck at Pot Nets Cove, approximately 4.2 miles west-northwest of the midpoint of the new bridge (Figure 47). Views from this location to the south and east provide unobstructed vistas of the Indian River Bay and shoreline. Westward the view includes residential and seasonal housing along the bay front. To the north the view looks inland towards residential housing and woodland. The full elevation of the bridge superstructure would be visible from camera location 6. However, its visual impact would be relatively small due to its distance from the location. There are no architectural resources at the immediate point of camera location 6, however, White House Farm (S-202) is situated approximately 0.4 miles east of the location (Figure 47:insets). While not recorded as such in the SHPO site files, the White House Farm is considered NRHP eligible by the staff of the Delaware SHPO (Gwen Davis, personal communication, January 2004). It is likely that the visual impact on White House Farm would be similar to the view depicted from camera location 6.
