Carpenter Family Farmstead mid 19th-early 20th c.
Route 268 (tax map #3-34-6-64)
Figures 34, 39; Plates 43-48
CRS #S-1041

Thompson Family House c. 1922
Route 1 (tax map 3-34-12-93)
Figures 34, 40; Plates 49-50
CRS #S-8016

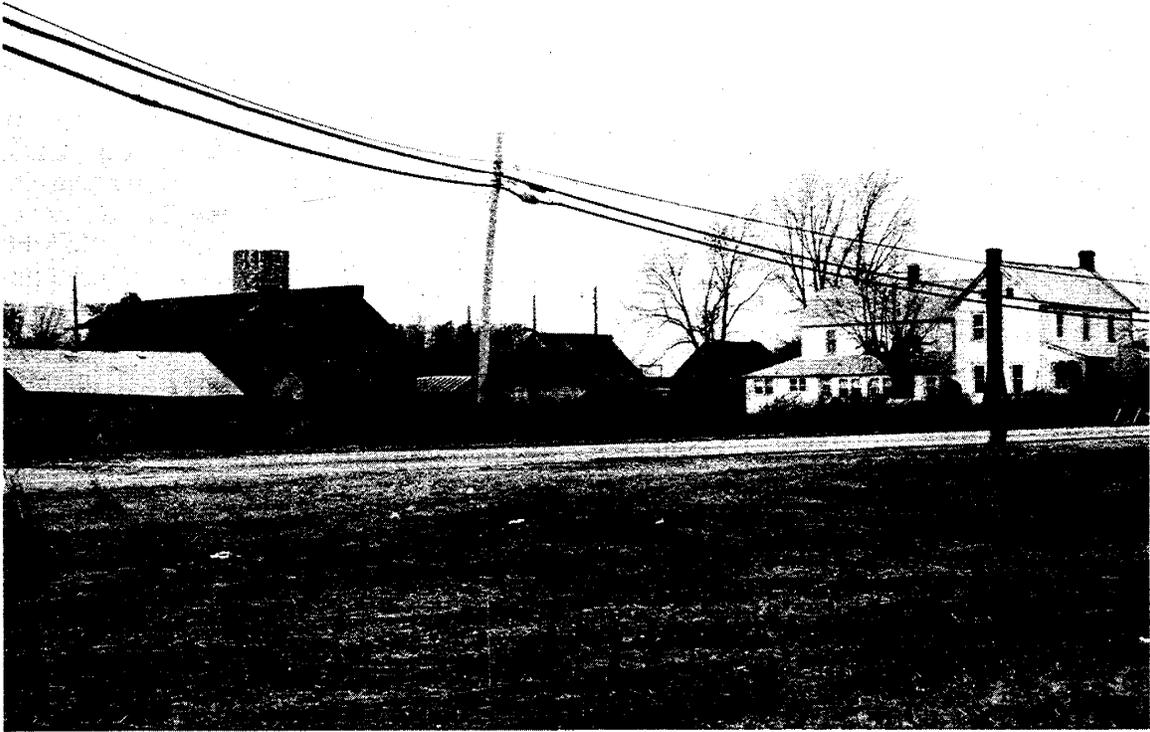
Plate 43. Carpenter Family Farmstead (3-34-6-64), Site, From the East.

coops. The outbuildings are arranged informally around an east-west axis defined by the house.

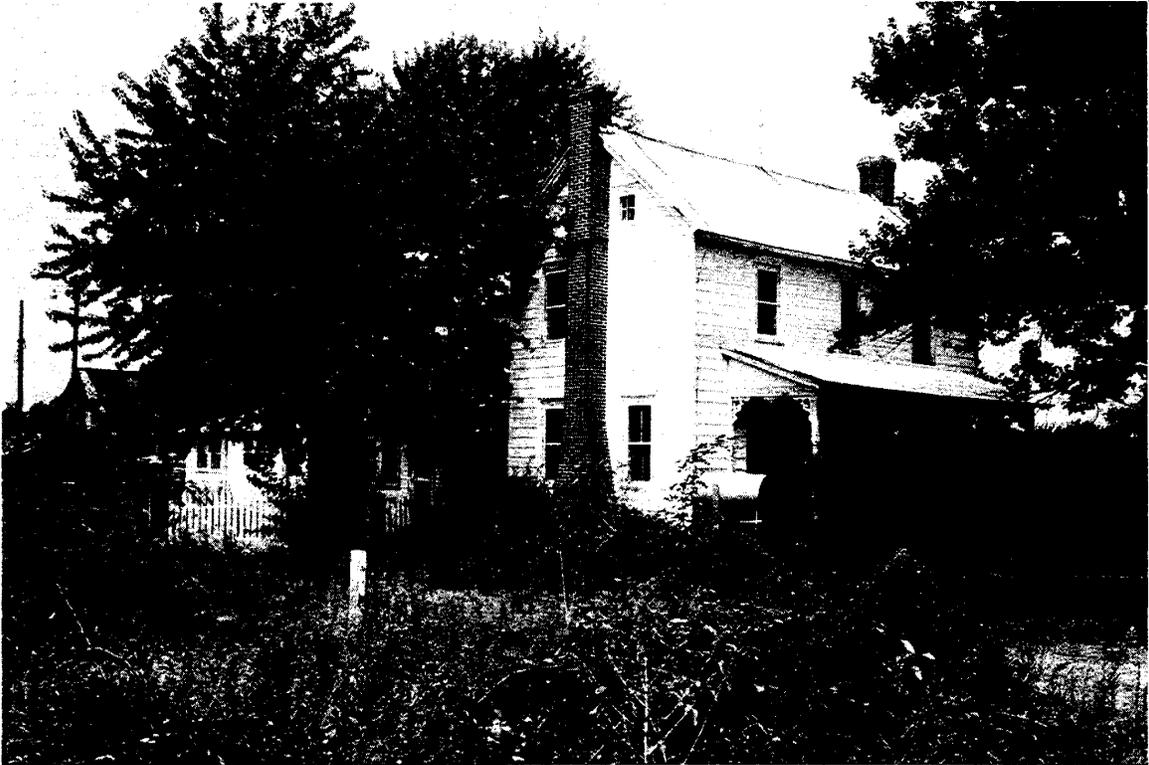
Plate 44. Carpenter Family Farmstead (3-34-6-64), House, From the Southeast.

The house is a two and a half story wood framed farmhouse. An ell plan is created by a two and a half story rear addition extending from the northernmost half of the western elevation. Above a brick foundation the exterior walls are covered with composite siding, and the overhanging gable roof is covered with composite shingles. There are three chimneys: a brick exterior chimney centered on the southern gable ended elevation, a stuccoed corbeled chimney rising from the ridge at the northern end of the main block, and a third chimney centered on the ridge of the rear addition. A shed roofed addition covers the first story of the southern and western elevations of the rear addition. A one story shed roofed porch shelters the three bays of the eastern elevation or facade, with four turned wooden posts supporting the porch roof and bandsawn detailing ornamenting the juncture of the porch posts and beams. The axial sash entrance door and transom are flanked by paired 1/1 sash windows, beneath three symmetrically arranged 2/2 sash windows on the second story of the facade. Door and window openings are trimmed with plain surrounds with molded detailing. The gable ended side elevations of the main block have two casement windows with four lights on the attic story, and one 2/2 sash window on the second story. On the first story there are two 2/2 sash windows in the southern elevation of the main block and one 2/2 sash window in the northern elevation. The rear addition includes four 2/2 sash windows on the second story of the north and south elevations and four 2/2 sash windows on the first story of the north elevation. The one story addition to the rear ell contains paired 2/2 and 1/1 sash windows.

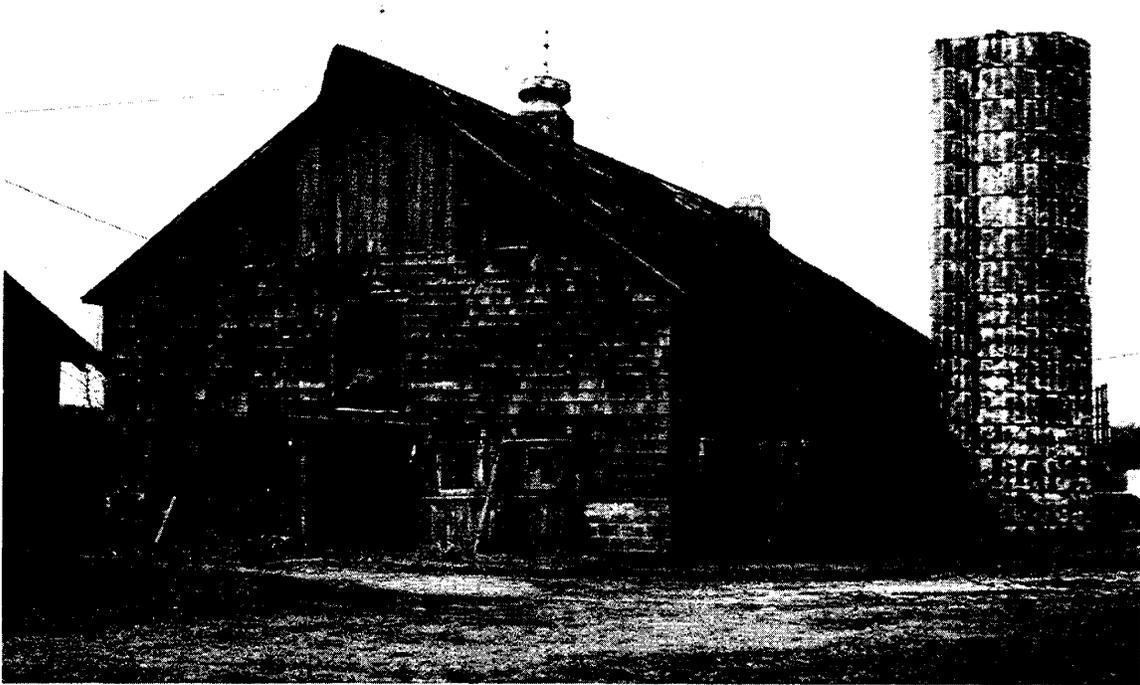
Plate 45. Carpenter Family Farmstead (3-34-6-64), Barn 1, From the Northeast.

Barn 1 is a large three story wood framed and gable roofed rectangular block, set on a concrete block foundation. The exterior walls are covered with cedar shingles, the roof covered with corrugated metal. From the ridge of the roof rise two ventilation hoods, and the eastern gable end of the roof projects to shelter the pulley attached to the ridge pole extension. Below the pulley on the eastern elevation the sliding door to the hayloft is flanked by two eight light windows, above a vertical plank door on the second story and double sliding doors on the first story. On the northern elevation, a small shed roofed addition is centered next to a cylindrical silo. Another silo is positioned at the northwestern corner of the barn. There are eleven nine light

sash windows on the northern elevation, one 6/6 sash window, and a four light sash. The southern elevation of the barn contains 14 six light windows.

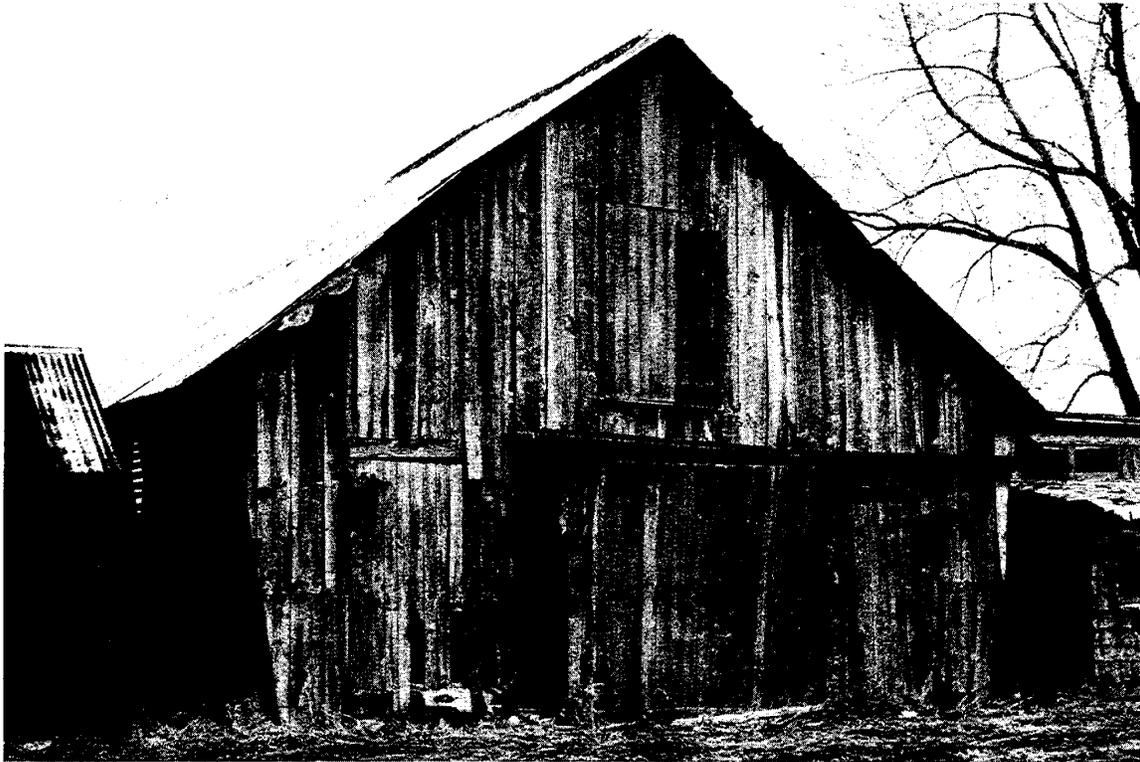
Plate 46. Carpenter Family Farmstead (3-34-6-64), Barn 3, From the Southeast.

Barn 3 is a one and a half story wood framed corn crib, with vertical boards covering the southern elevation or facade, and widely spaced horizontal slats making up the canted side elevations. Corrugated metal covers the gabled roof. On the facade, a vertical board door is centered in the gable and an axial sliding door is flanked by vertical board doors.

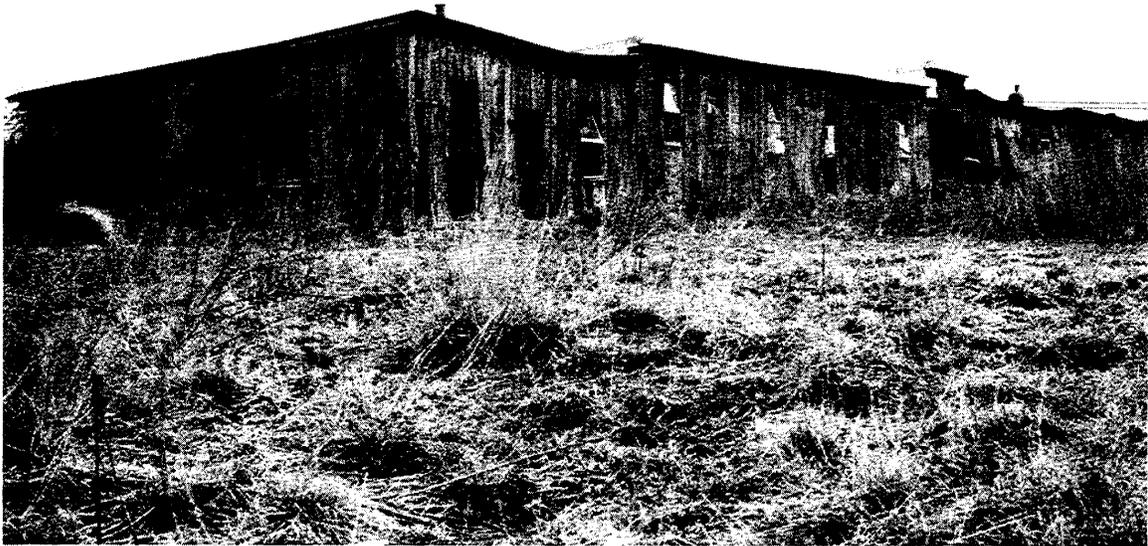
Plate 47. Carpenter Family Farmstead (3-34-6-64), Chicken Coop
2, From the Southwest.

Chicken Coop 2 is a long rectangular one story block, composed of four main sections with varying roof pitches. The exterior walls are covered with vertical boards and the shed roof slopes are covered with corrugated metal and composite shingles. The 20 window openings in the southern elevation and the two on the end elevations held 6/6 sash windows, many now missing. Six vertical board doors are located in the southern elevation.
