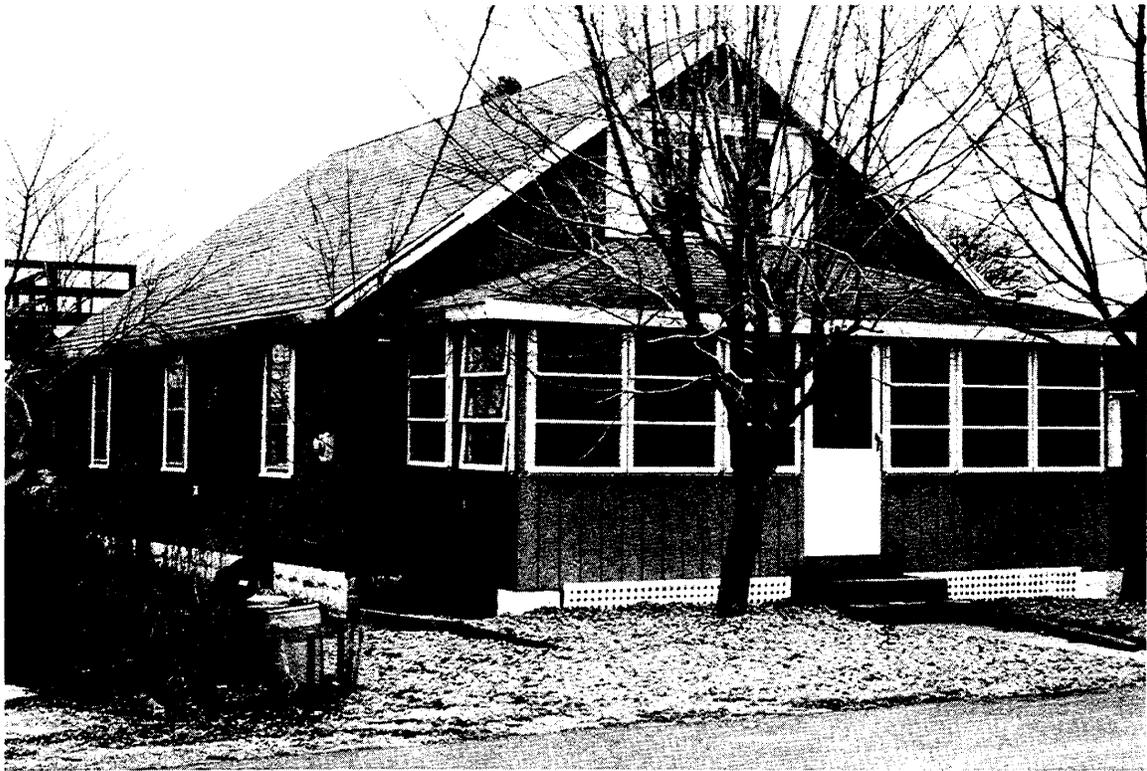
Plate 94. Philip A. Pacheco House (3-34-13.20-72), From the Northwest.

Description: The Philip A. Pacheco House is a rectangular one and a half story wood framed dwelling, three bays wide and four bays deep. Set on a foundation of rock-faced CMU, the exterior walls are covered with vertical board cladding beneath the boxed-in overhanging eaves of a composite shingled gabled roof. The gable end facade is the northwestern elevation, across which extends a one story hip roofed enclosed porch with two louvered windows on each side of the axial entrance door. The porch foundation is composed of rock-faced CMU piers and wood lattice,

indicating that the porch was part of the original building. Above the facade porch a paired window is centered in the peak of the gable. On the northeast elevation are four 4/1 sash windows. On the southwest elevation are two paired 4/1 sash windows at the western end and two smaller single windows at the southern end. A brick chimney rises from the southwestern slope of the roof near the southern end, close to the one story flat roofed addition which extends from the southeastern gable end of the dwelling. One outbuilding stands on this property, a rectangular one story concrete block shed with a shed roof clad in composite shingles. It is located to the southeast of the dwelling at the end of a driveway which parallels the southwest elevation of the house. The entrance door is positioned at the northern end of the northwestern side which faces the street.

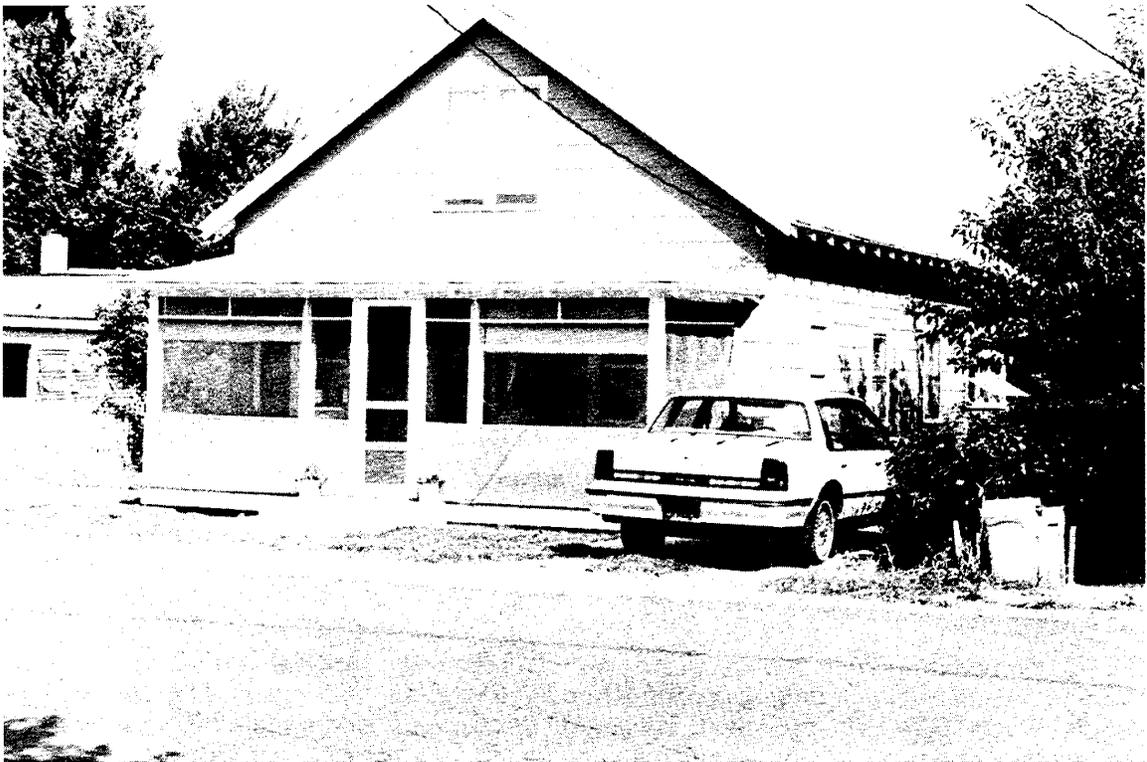
Plate 95. Walter H. Slockett House (3-34-13.20-73), From the West.

Description: The Walter H. Slockett House is a one and a half story rectangular wood framed dwelling on a concrete foundation, covered on exterior walls and gabled roof with composite shingles. The overhanging edges of the roof are supported on exposed rafter ends above the side elevations. The northwestern elevation, a gable end, faces Atlantic Street and forms the three bay facade. Across the first story of the facade is a one story wood framed screened porch with a hipped roof supported on wood posts. The porch features an overhang and exposed rafter ends on all three sides. A central screened door leads onto the porch from street level, and the entrance door into the main block is a sash door in a plain surround set between 1/1 sash windows. Above the porch a paired window centered in the peak of the gable consists of two 1/1 sash windows in plain surrounds. Similar windows occur in the northeastern elevation, two paired and one single 1/1 sash windows. On the southwestern elevation are three single 1/1 sash windows and a set of louvered windows at the southern end. A brick chimney rises from the northeast slope of the roof near the eastern end.

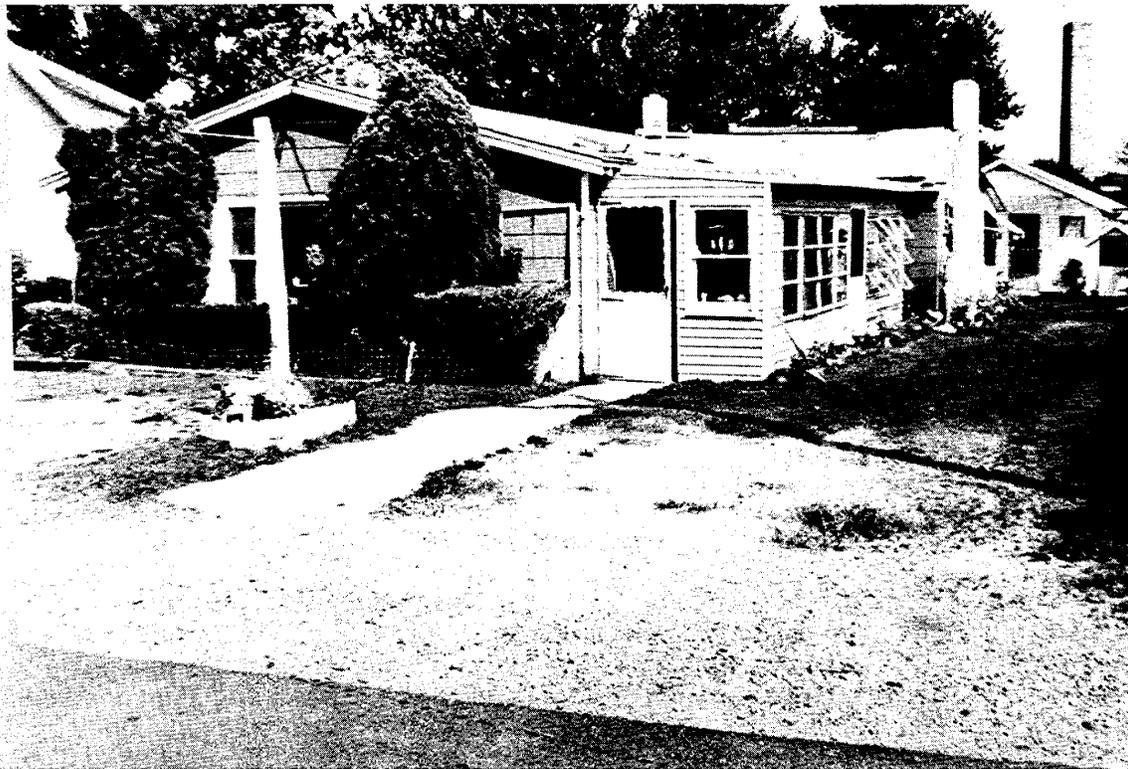
Plate 96. Charlotte B. McDaniel House (3-34-13.20-74), From the West.

Description: The Charlotte B. McDaniel House is a one story wood framed dwelling composed of a gable roofed ell plan main block with one story shed roofed enclosed porches filling in the ell and extending the southeastern or rear elevation. Composite shingles cover the foundation and exterior walls of the main block and also cover the slopes of the overhanging gable roof

and shed roofs. Two chimneys are visible: an exterior concrete block chimney centered on the southwestern gable end of the rear section of the ell and an interior concrete block chimney rising from the northeastern end of the southeastern roof slope of the same rear section. The northwestern gable ended elevation of the main block faces Atlantic Avenue and forms a one bay facade. This facade contains a large fixed light, flanked by 1/1 sash windows. The northwestern elevation of the enclosed porch contains a sash entrance door and a 1/1 sash window. On the northwestern elevation of the enclosed porch a sash entrance door is centered between louvered windows. Flanking the chimney on the southwestern gable end of the main block are 1/1 sash windows. The enclosed porch on the rear elevation has window openings swathed in plastic sheeting.

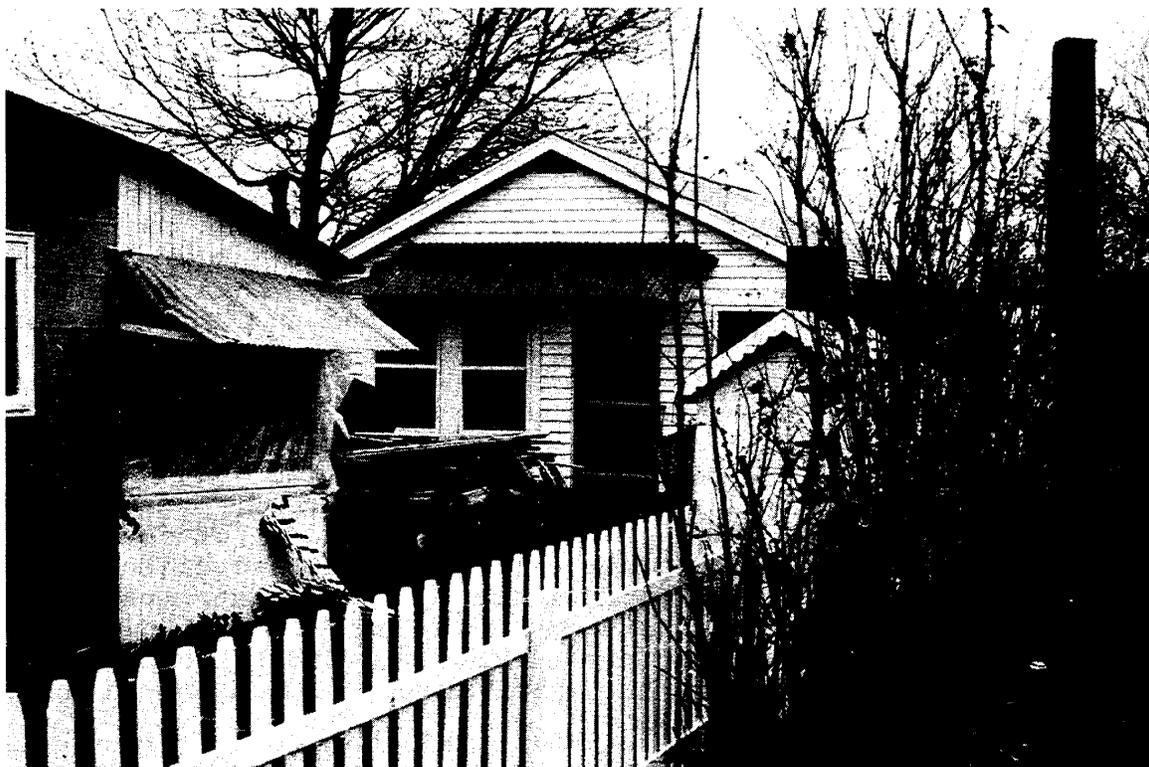
Plate 97. Charlotte B. McDaniel Cottage (3-34-13.20-74), From the Northwest.

The Charlotte B. McDaniel Cottage is located southeast of the house at the end of a driveway which parallels its southwestern elevation. The exterior walls of the rectangular one story wood framed cottage are clad in metal siding. The roof is covered in composite shingles. The northwest gable ended elevation forms a three bay facade, the sash entrance door set off-center in plain surrounds between a single light casement window and a paired 1/1 sash window. No chimney is visible.

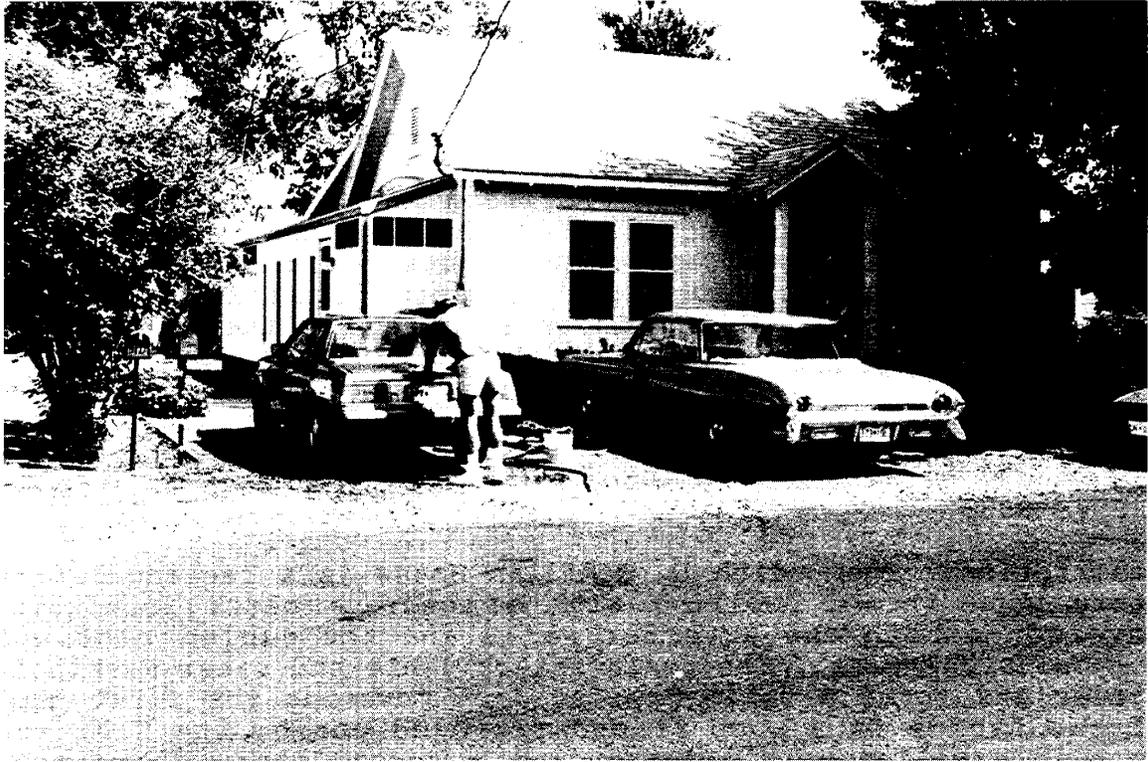
Plate 98. Stephen R. Leaderman House (3-34-13.20-75), From the Northwest.

Description: The Stephen R. Leaderman House is a rectangular one story dwelling set on a rock faced CMU foundation and covered by a gabled roof with overhanging eaves and exposed rafter ends. Stucco coats the exterior walls, and the roof is covered with composite shingles. Facing Atlantic Street, the northwestern elevation presents a three bay facade, with an axial sash entrance door set between paired 6/1 sash windows. In front of the entrance door is a one bay porch sheltered by a gabled roof with exposed rafter ends. Wooden posts with molded trim support the porch roof. The window and door openings are set in plain surrounds, a molding atop the lintels forming small hood molds. A shed roofed addition covers the first story of the northeastern elevation and extends beyond the southeastern elevation of the dwelling. A sash entrance door and four narrow single light windows occupy the center of this elevation. A rank of three small four light windows are at the northernmost end of this elevation. Another one story shed roofed addition extends across the southeastern or rear elevation. Two 6/1 sash windows occupy the first story of the southwestern elevation on either side of the axial brick chimney.

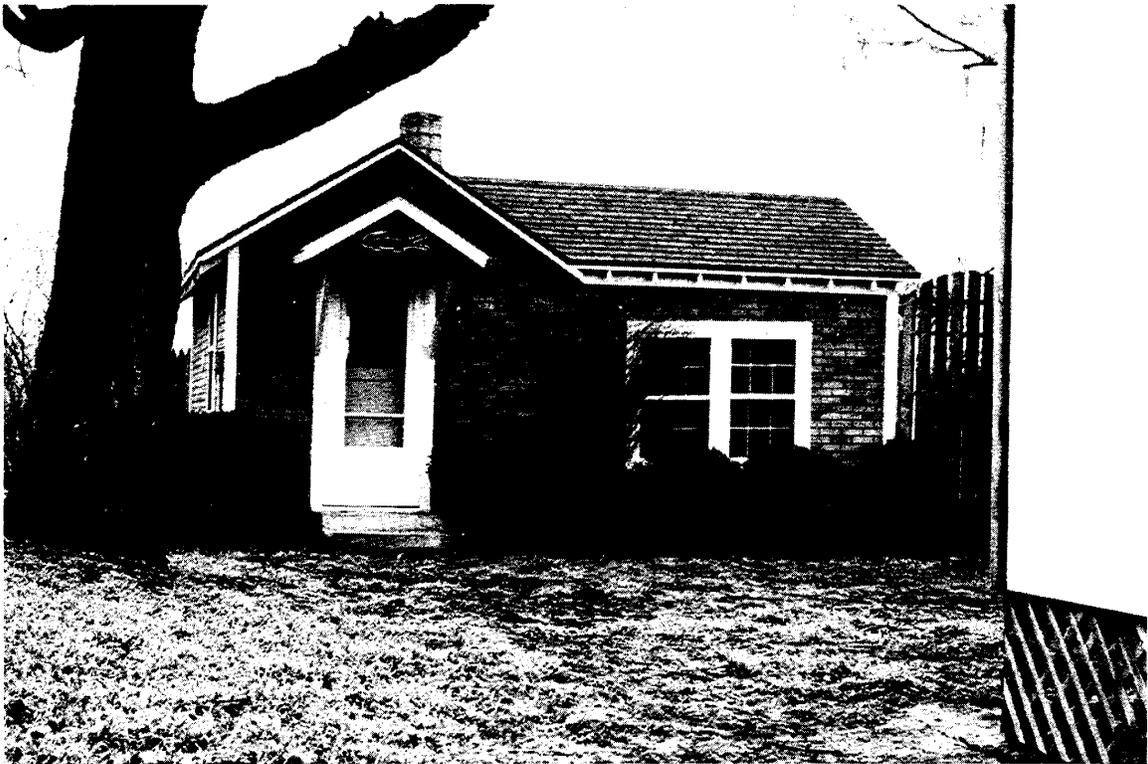
Plate 99. Stephen R. Leaderman Cottage (3-34-13.20-75), From the Northwest.

The Stephen R. Leaderman Cottage, located northeast of the dwelling, is a one story wood framed rectangular cottage,

supported on concrete block piers. Composite shingles cover both the exterior walls and the overhanging gable roof with exposed rafter ends. At the northern end of the northwestern elevation the sash entrance door in plain surrounds is sheltered by a doorhood supported on wooden struts. 6/6 sash windows in plain surrounds occur as a paired window in the northwestern elevation and as a single window centered in the northeastern elevation. No chimney is visible.

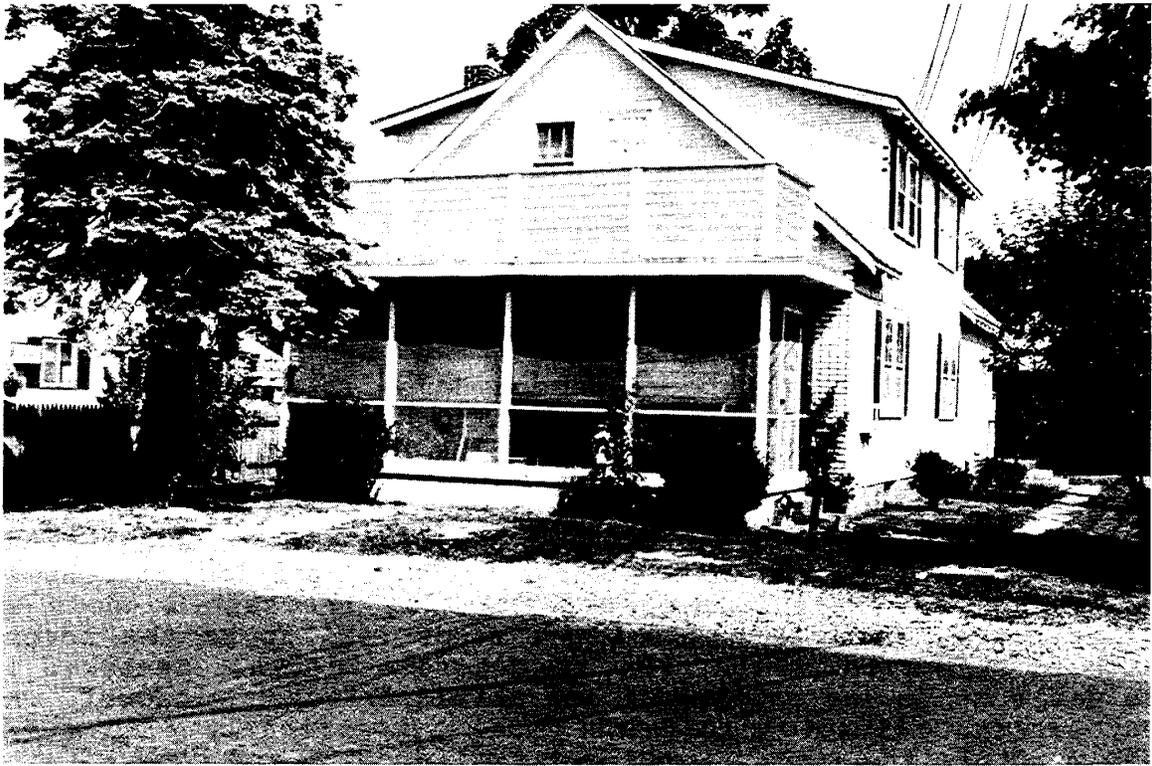
Plate 100. Judith E. McMillan House (3-34-13.20-76), From the Northwest.

Description: The Judith E. McMillan House is a rectangular two story wood framed dwelling with a concrete block foundation, covered on both the exterior walls and the gabled roof with composite shingles. The northwestern gable end faces Washington Street and forms a three bay facade. Covering the first story of the facade is a wood framed screened porch, its flat roof forming a walled deck entered from a second story door in the gable end. The entrance door is centered on the facade, reached by a screen door on the southwest side of the screened porch. On the northeastern and southwestern elevations large shed roofed dormers raise the roof line to enclose two paired second story window openings, each window containing 1/1 sash. Similar paired windows are positioned below the dormer windows on the southwest elevation, while on the northeast elevation single windows appear on the first story. On these side elevations the overhanging roof edges are supported on exposed rafter ends, and the windows are flanked by shutters. A brick exterior chimney stack rises at the center of the northeastern elevation.

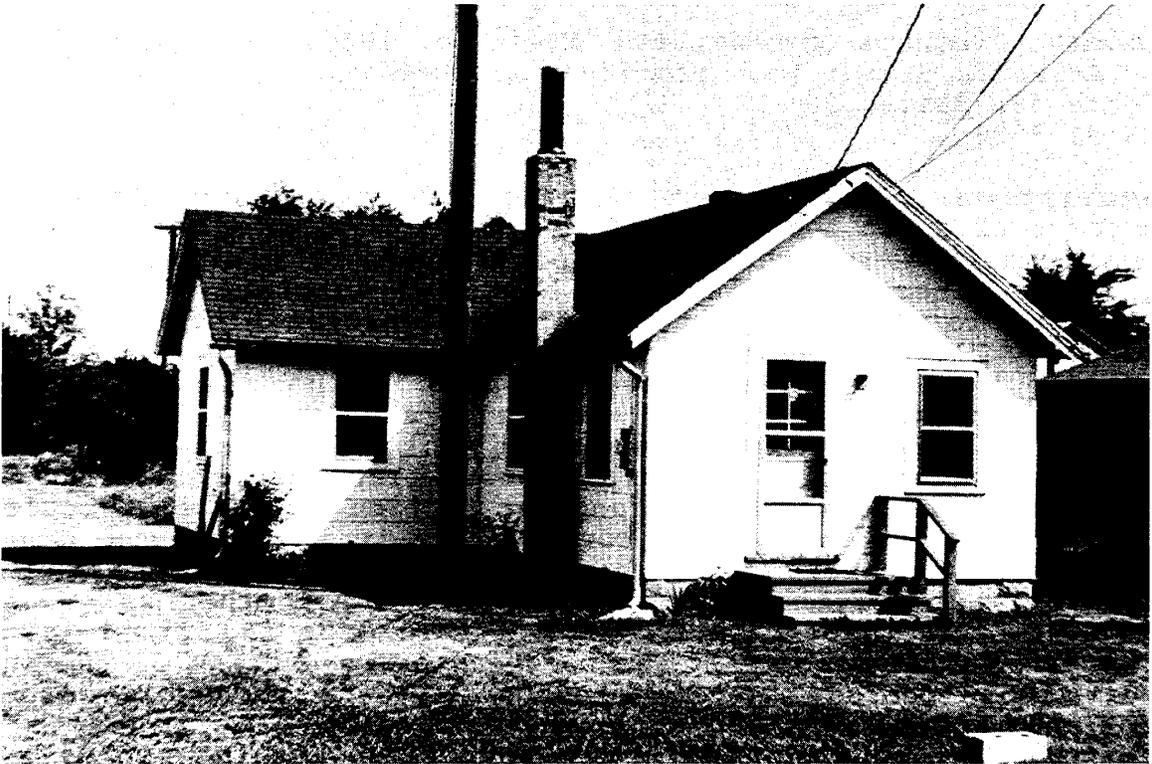
Plate 101. Charles D. Joseph House (3-34-13.20-78), From the North.

Description: The Charles D. Joseph House is a one story wood framed ell-plan house with a rock-faced CMU foundation and an overhanging gable roof with exposed rafter ends. Both the exterior walls and the roof are covered with composite shingles. The northwest gable end of the main block faces Atlantic Street, forming a facade with both an entrance sash door and a 1/1 sash window in plain surrounds, symmetrically placed. Three steps and a handrail give access to the entrance door which is to the north of the window on the facade. Three similar windows are symmetrically arranged on the southwest elevation. On the northeast elevation of the main block are two 1/1 sash windows, and on each of the northeast and northwest elevations of the wing is one 1/1 sash window. A brick exterior chimney stack,

now cement covered and topped with a length of pipe, is centered on the northeast wall of the main block between the windows.

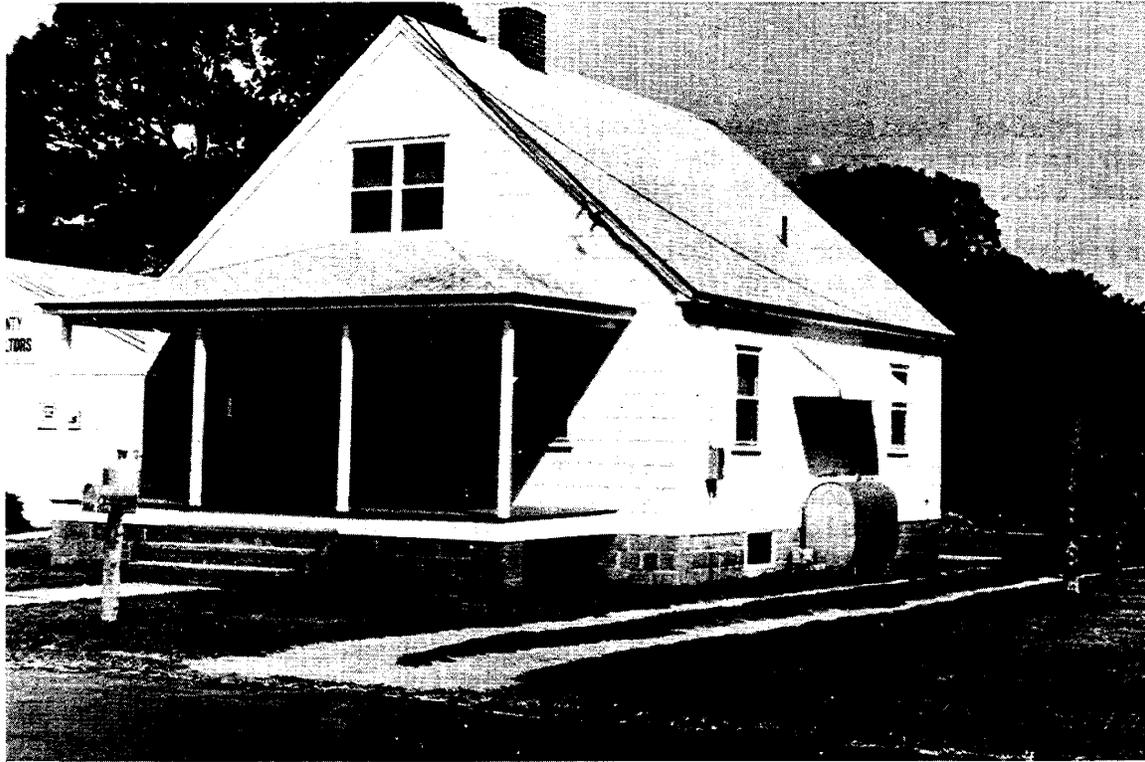
Plate 102. J. Theodore Joseph House (3-34-13.20-79), From the West.

Description: The J. Theodore Joseph House is a one and a half story rectangular wood framed dwelling with a concrete block foundation and a gabled roof. Both the exterior walls and the roof are covered with composite shingles. On the facade or northwestern elevation, which is a gable end facing Atlantic Street, four wooden posts support the hipped roof of a one story porch. The three bays of the first story of the facade consist of the central entrance door and flanking 1/1 sash windows in molded trim. Three concrete block steps lead up to the porch, which is supported at the front on concrete blocks. Centered in the gable above the porch roof are paired 1/1 sash windows. The southwestern elevation contains three symmetrically placed 1/1 sash windows, the center window of smaller size and covered with a metal awning. On the northeastern elevation are two 1/1 sash windows and, in the easternmost bay, a three-sided bay window. A brick chimney rises from the ridge of the roof to the northwest of the center point.

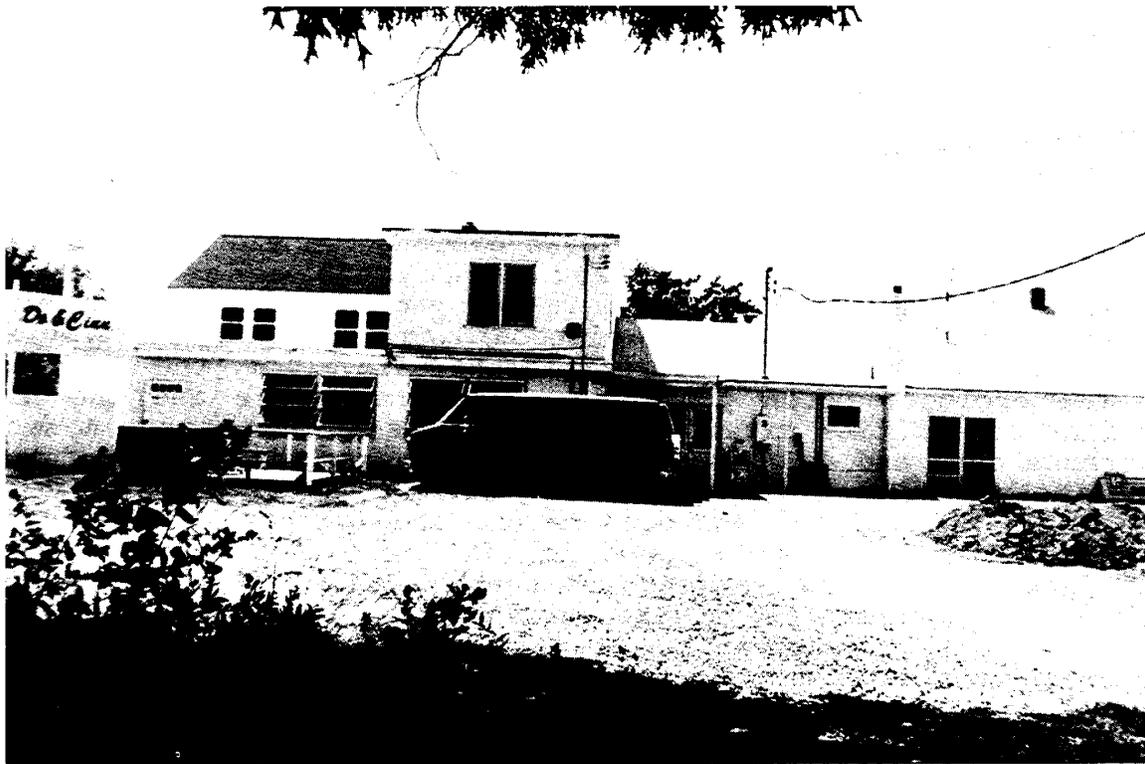
Plate 103. Rehoboth Products Company, Inc. House (3-34-13.20-80), From the Northeast.

Description: The Rehoboth Products Company, Inc. House is composed of a two and a half story wood framed main block, sited toward the rear of the lot. The northwestern gable end faces Atlantic Street. The building has been enlarged with three additions to the northwestern and northeastern elevations. A two story flat roofed rectangular addition covers the facade of the main block and extends beyond it to the northeast, forming an ell plan which has been filled in by a one story flat roofed addition. Extending toward Atlantic Street from the northwestern elevation of the two story flat roofed addition is a one story gable roofed rectangular section with a flat roofed porch filling in the eastern corner where it joins the two story addition. Composite shingles cover the gabled roofs and the exterior walls of the two story addition. All other walls are stuccoed. On the facade a sash entrance door and fixed light window fill the two bays. The northeastern elevation of the one story gable roofed section contains two sets of double leafed sash entrance doors and an exterior brick chimney near the center. The two story flat roofed addition contains paired 1/1 sash windows on the second story and paired louvered windows on the first story on the northeastern elevation. The one story

flat roofed addition has paired louvered windows and a paneled sash entrance door on the northeastern elevation. The main block second story above shows the paired 1/1 sash windows.

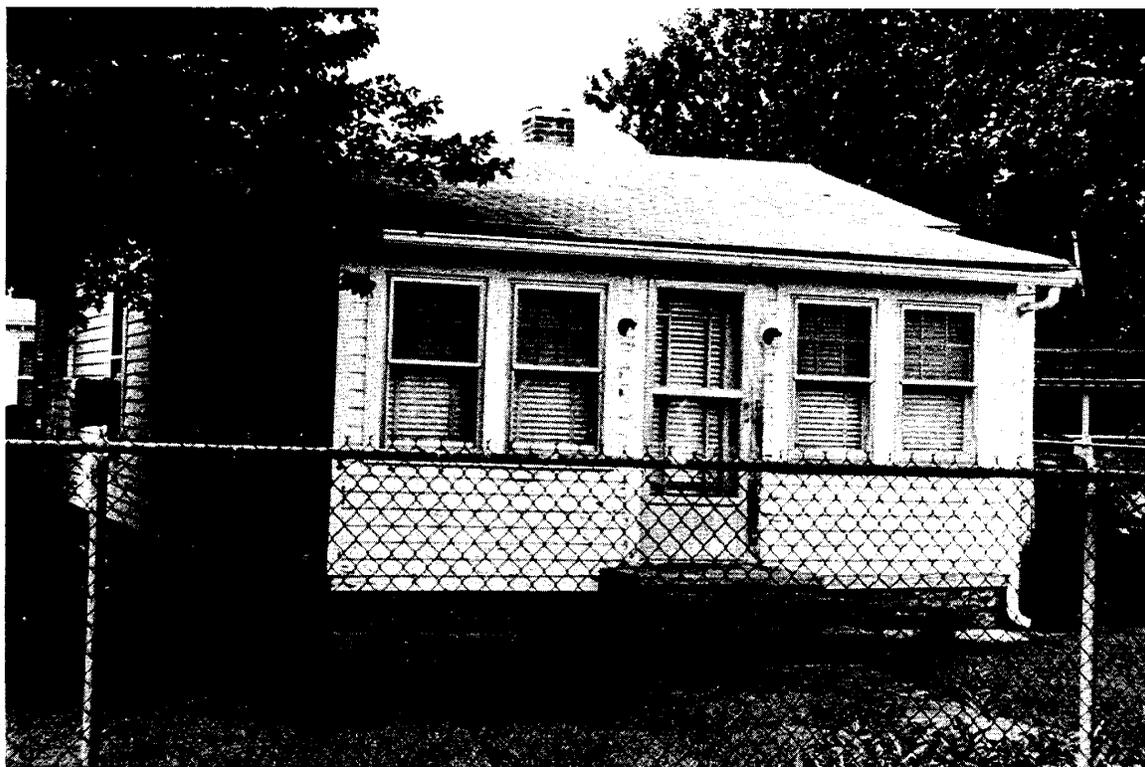
Plate 104. Mary Wardencki House (3-34-13.20-81), From the Northeast.

The house is a one story gable roofed wood framed rectangular block, set on a rockfaced CMU foundation. Wooden clapboards cover the walls, and composite shingles cover the roof. On the northeastern elevation of facade a shed roofed enclosed porch presents a five bay facade, with an axial sash entrance door flanked by two 6/1 sash windows on each side. On the southeastern side elevation two 6/1 sash windows occupy the enclosed porch, two 6/1 sash and one 1/1 sash the main block. The northwestern elevation contains two 6/1 sash windows on the enclosed porch, two single 6/1 sash windows near the rear of the main block, and three 6/1 sash windows on a one story gable roofed addition at the northern half of the main block. A brick chimney rises from the rear slope of the roof, to the northwest of center.

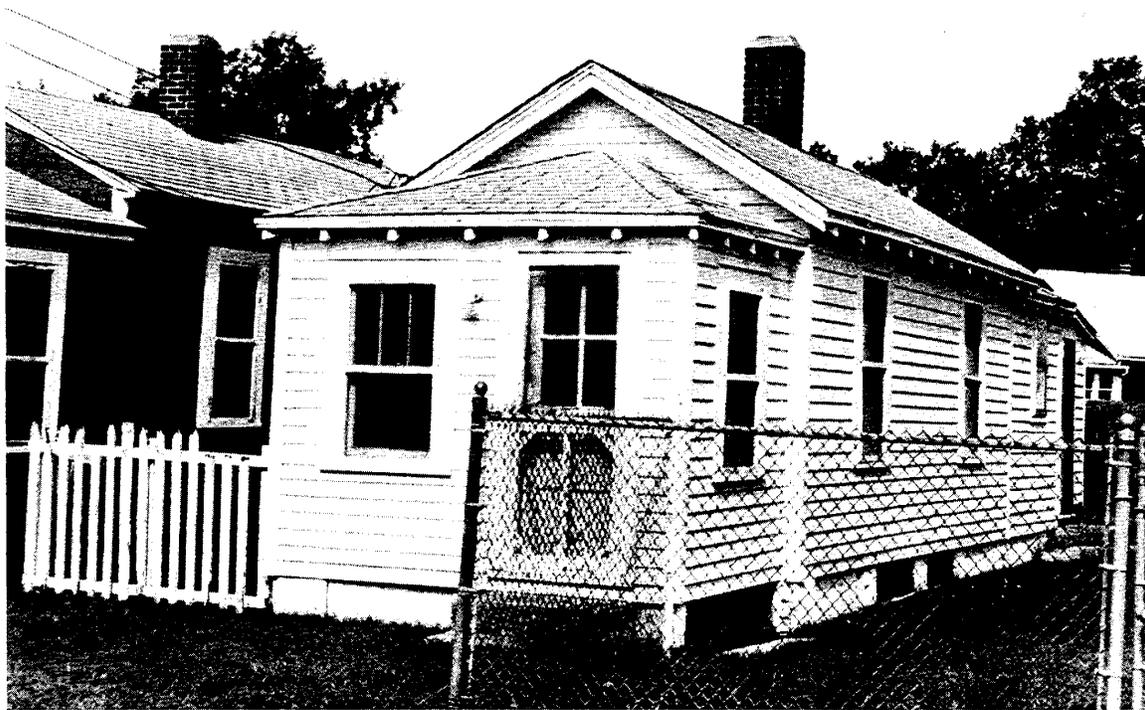
Plate 105. Mary Wardencki Cottage 1 (3-34-13.20-81), From the Southeast.

Cottage 1 stands at the northeastern end of the row of three cottages sited with their southeast gable ended elevations close to and facing Atlantic Street. Set on a concrete block foundation, the one story wood framed gable roofed cottage has exterior walls covered with clapboarding. Composite shingles cover the overhanging gable roof on the main block, the hip roof on the enclosed porch projecting from the facade and the hip roof on an addition extending for two bays at the rear. A sash entrance door and a 3/1 sash window occupy the two bay facade of the enclosed porch. One 3/1 sash window is centered on each side elevation of the enclosed porch, and two 3/1 sash windows are placed on each side elevation of the main block. On the rear addition a sash entrance door and a small 3/1 sash window occupy the northeastern elevation, and three 6 light windows are found on the southwestern elevation. The door and window openings are set in plain surrounds with a small molded trim above the lintels. Rafter ends are exposed on both the main block and the hip roofed additions, and a brick chimney rises from the center of the ridge.

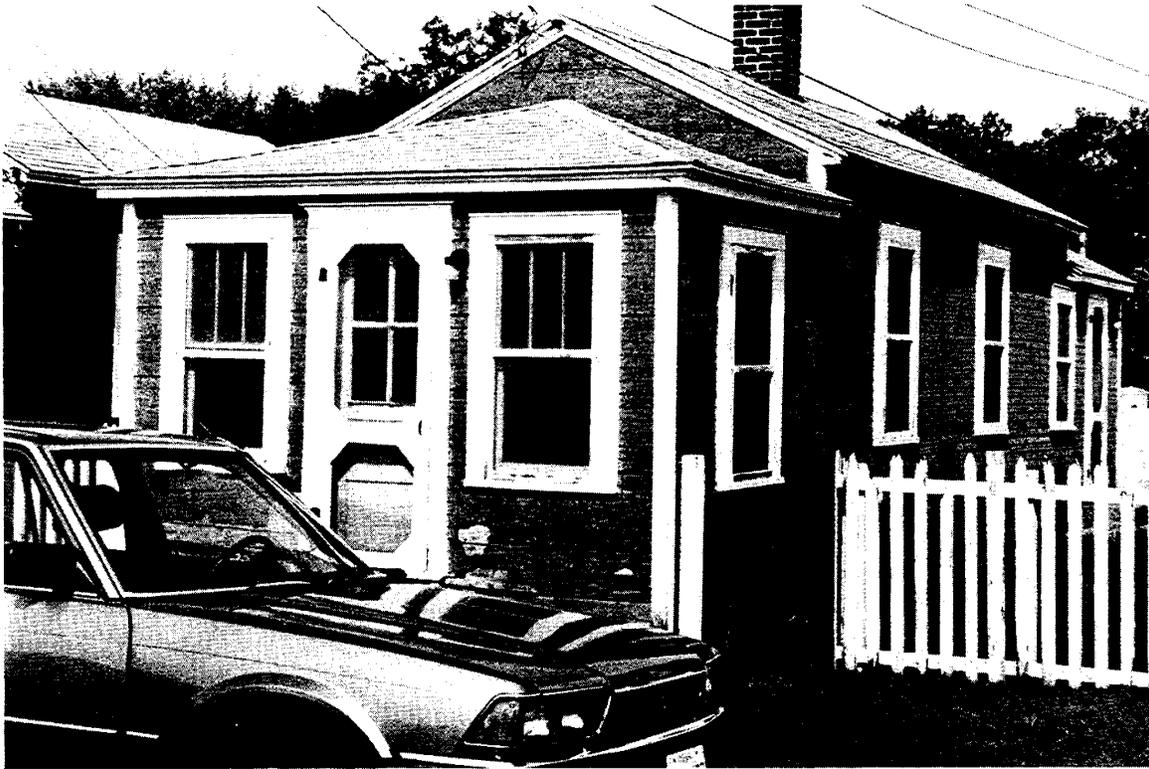
Plate 106. Mary Wardencki Cottage 2 (3-34-13.20-81), From the Southeast.

Cottage 2 stands between Cottage 1 and Cottage 3. Identical to Cottage 1 in most respects, Cottage 2 differs in the following details: 1) the rear addition has a gabled roof; 2) the walls are covered in brick patterned sheathing paper; 3) the roof lacks the overhang and exposed rafter details; and 4) the facade of the enclosed porch has three bays, a sash entrance door flanked by 3/1 sash windows.

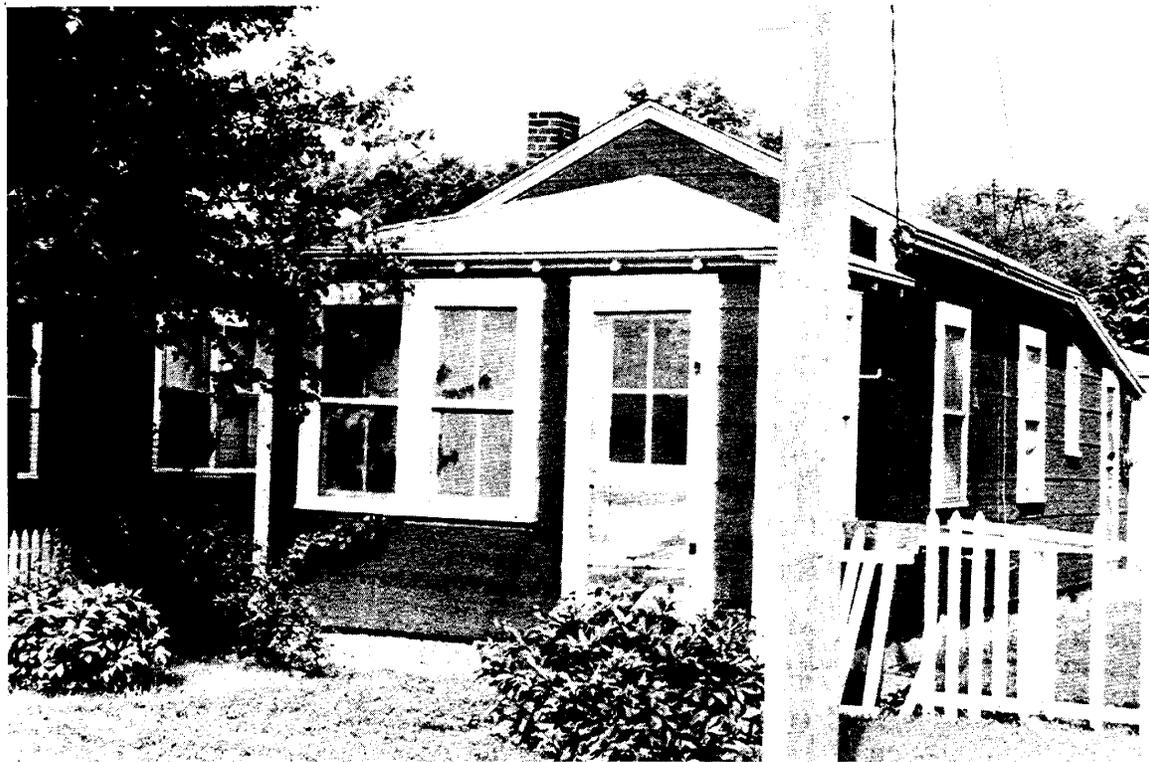
Plate 107. Mary Wardencki Cottage 3 (3-34.13.20-81), From the Southeast.

Cottage 3 stands at the southwestern end of the row of three cottages. It is identical to Cottage 1 in most respects, but differs in the following details: 1) the rear addition has a shed roof; 2) the walls are covered with brick patterned sheathing paper; 3) only the enclosed porch roof has the overhang and exposed rafter detail; 4) on the two bay facade of the enclosed porch, the window in the southern bay is a paired 2/2 sash window; 5) the chimney is on the exterior, centered on the southwestern elevation; and 6) the other windows are 2/2 sash.

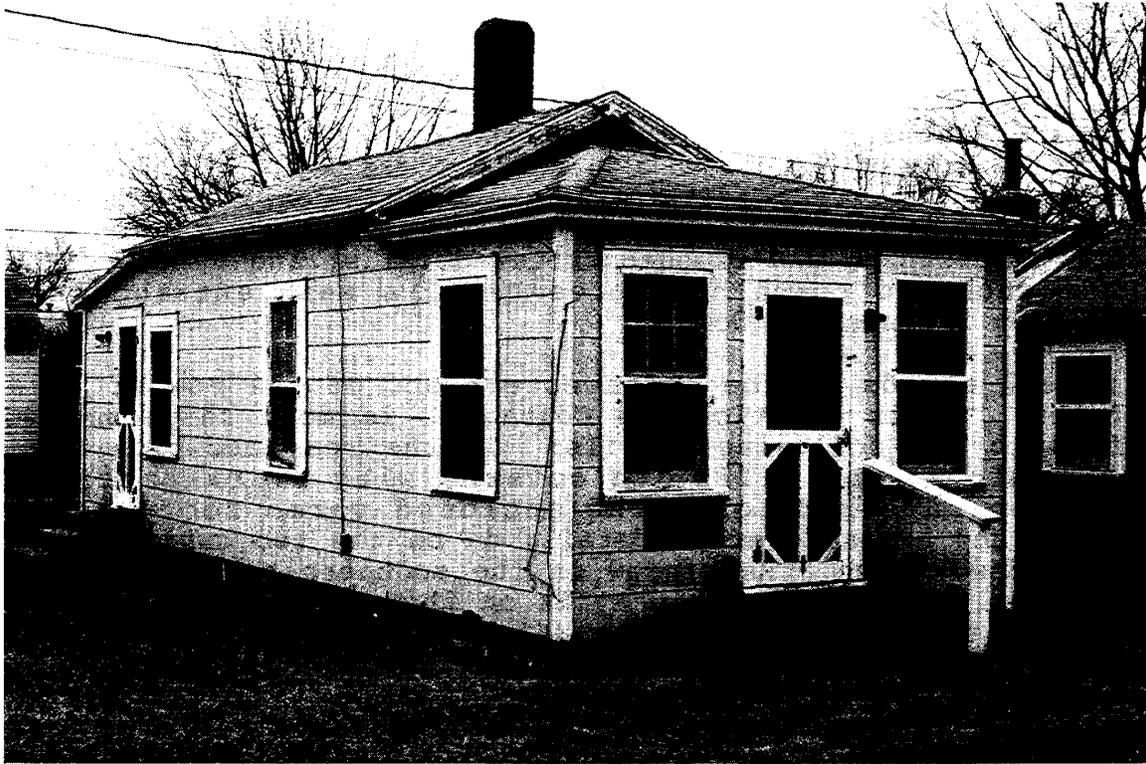
Plate 108. Mary Wardencki Cottage 4 (3-34-13.20-81), From the East.

Cottage 4 stands back from Atlantic Street to the rear of Cottage 3, the northeastern elevation forming the facade. It is identical to Cottage 1 with the following exceptions: 1) the rear addition has a shed roof; 2) the walls are covered with composite siding; 3) the roofs lack the overhang and exposed rafter details; 4) the chimney is coated with asphalt; and 5) the enclosed porch has a three bay facade, a sash entrance door flanked by 6/1 sash windows. The other windows are 6/1 sash as well; and 6) the side entrance is on the southwestern elevation of the rear addition.

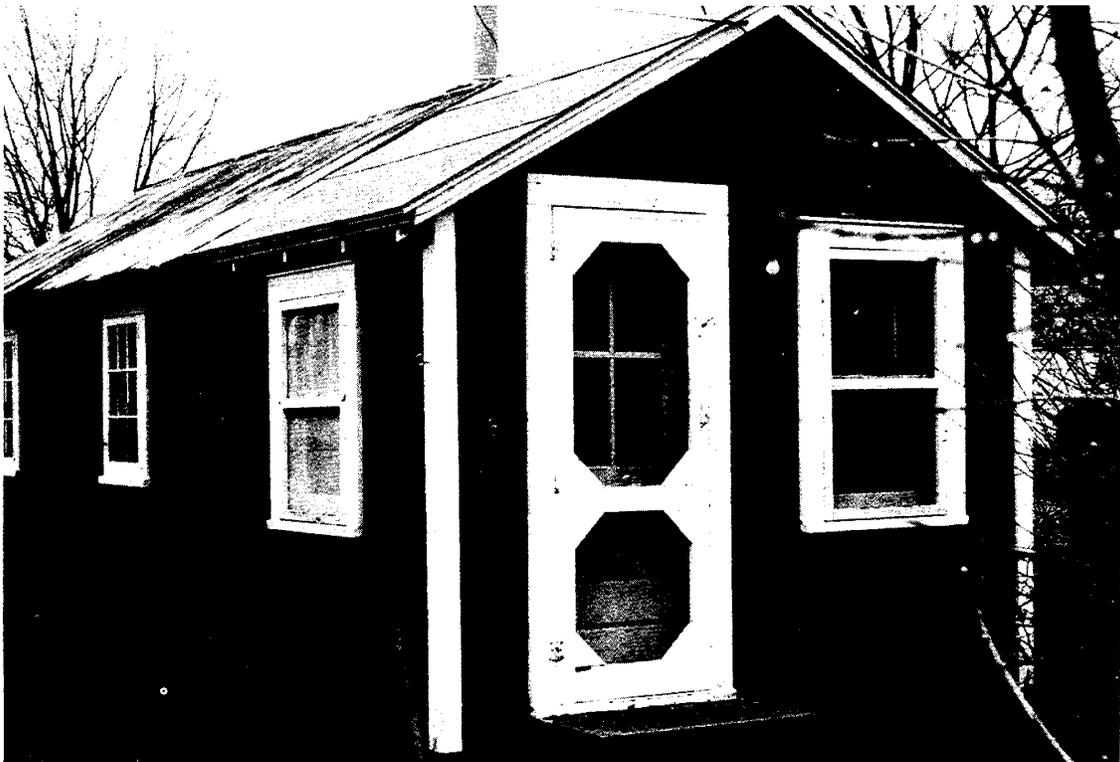
Plate 109. Mary Wardencki Cottage 5 (3-34-13.20-81), From the East.

Cottage 5 stands parallel to Cottage 4 on the northwest side. It is identical to Cottage 1 with the following exceptions: 1) the enclosed front porch has a corrugated metal covered gable roof continuous with the gable porch of the main block; 2) the foundation consists of concrete block piers; 3) the exterior walls are covered with brick patterned sheathing paper; 4) the entrance door and the 3/1 sash window occupy reversed positions on the two bay facade; 5) fenestration on the side elevations of the main block consists of nine light casement windows; and 6) the chimney is centered on the northwestern slope of the roof.
