CULTURAL RESOURCE SURVEY  
PROPERTY IDENTIFICATION FORM

1. HISTORIC NAME/FUNCTION: Sikh Center of Delaware
2. ADDRESS/LOCATION: 1107 S Dupont Highway, New Castle, Delaware, 19720
3. TOWN/NEAREST TOWN: Bear vicinity?
4. MAIN TYPE OF RESOURCE: building  structure  site  object   
landscape  district
5. MAIN FUNCTION OF PROPERTY: Religious
6. PROJECT TITLE/ REASON FOR SURVEY (if applicable):  
SR 1 Road Widening

CRS # N08824.001

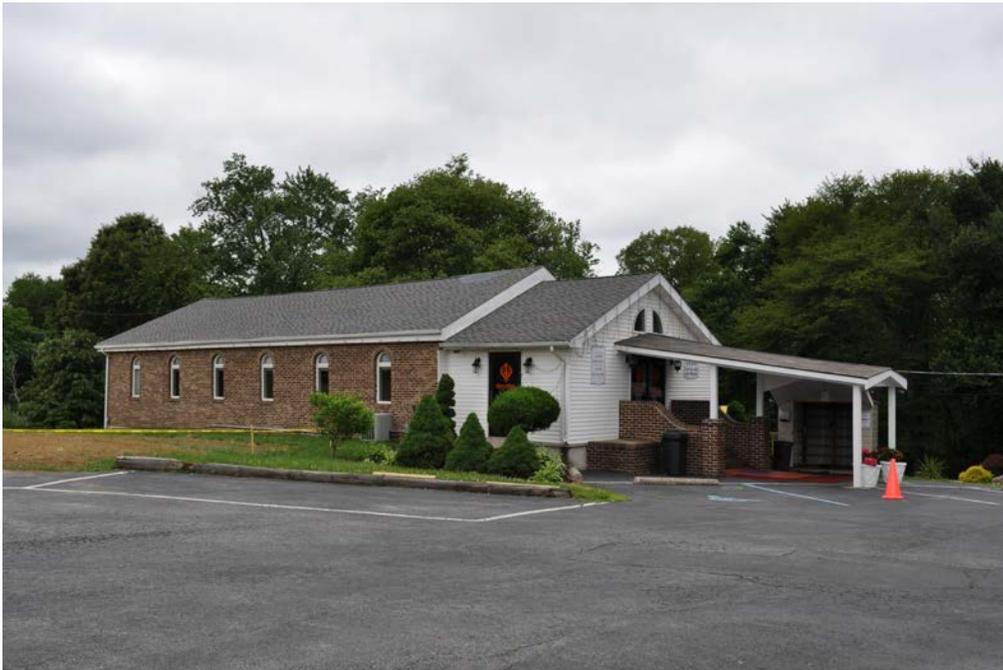
CRS # N08824      Date 5/22/2012      Photo Roll # n/a      Surveyor S Groesbeck & P Kuhn

Description Northeast corner of main building looking southwest
