4.0 RESULTS

DELAWARE DEPARTMENT OF TRANSPORTATION	
S.R. 54 IMPROVEMENTS SOUND CHURCH ROAD TO KEENWICK ROAD BALTIMORE HUNDRED SUSSEX COUNTY	
SOIL PROFILES SHOVEL TEST PITS A-3 AND D-1	
FIGURE - 3	SKELLY AND LOY, INC. CONSULTANTS IN ENVIRONMENT - ENERGY ENGINEERING - PLANNING

S.R. 54 IMPROVEMENTS
SOUND CHURCH ROAD TO KEENWICK ROAD
BALTIMORE HUNDRED
SUSSEX COUNTY

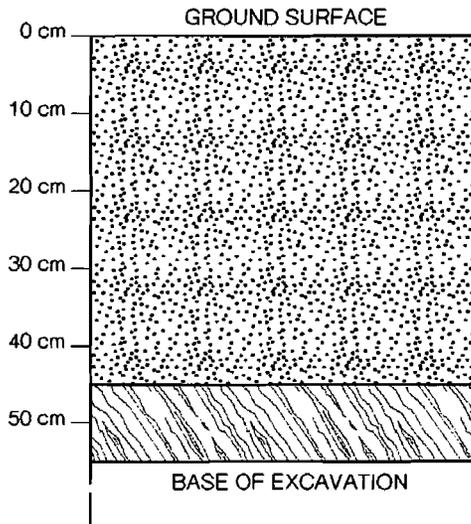
SOIL PROFILE SHOVEL TEST PIT A-3

Ap 10YR 4/2 Dark grayish brown sandy loam.

Btg 2.5Y 5/1 Gray sandy clay loam.

The soil profiles within five STP excavations, from five different test areas across the project APE, were examined and described according to the methods and nomenclature prescribed by the United States Department of Agriculture-Natural Resources Conservation Service (Figures 3, 4, and 5; Appendix C). These soil profiles were typical and representative of profiles encountered

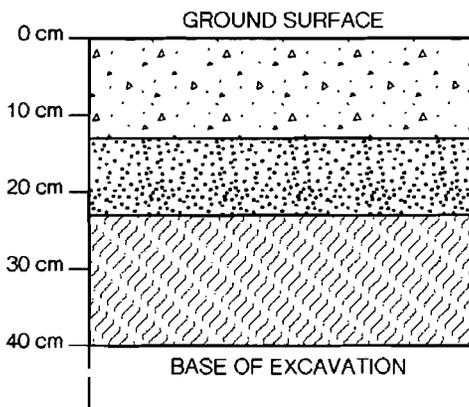
SOIL PROFILE SHOVEL TEST PIT D-1

Fill Sandy loam.

A 10YR 3/2 Very dark grayish brown sandy loam.

Bt 10YR 5/4 Yellowish brown sandy clay loam.

Soil profiles from STPs D-1, H-4, J-3, and N-5 are typical of the well developed, well drained soils found within the majority of the undisturbed portions of the project APE. These soils have been deeply weathered. A 13.0 cm (5.1 in) layer of fill was found overlying an undisturbed soil profile in STP D-1, a material most likely spread over the area for lawn enhancement. The profile from STP A-3 is typical of the well developed but somewhat poorly drained profiles found in depressions of the project area. These areas have a shallow water table and are wet during a large portion of the year.

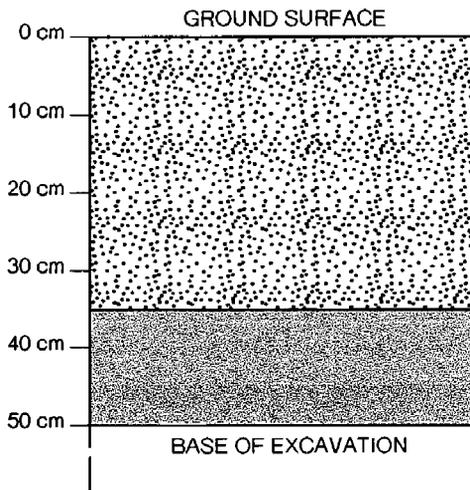
SOIL PROFILE SHOVEL TEST PIT H-4

Ap 10YR 3/2 Very dark grayish brown sandy loam.

Bt 2.5Y 5/4 Light olive brown sandy clay loam.

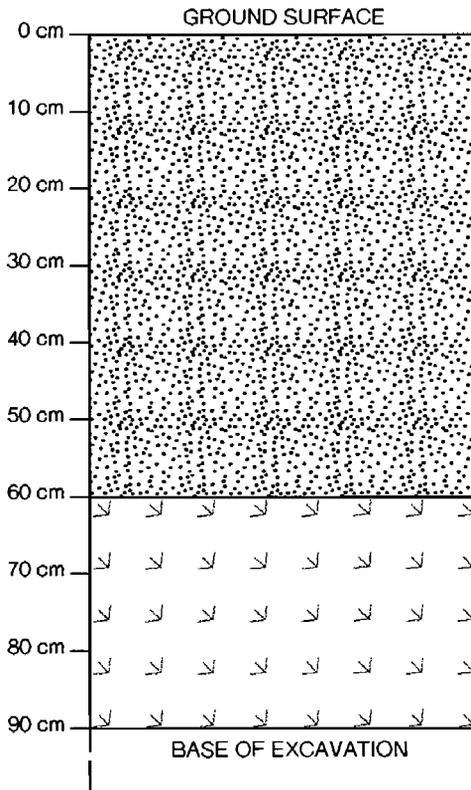
SOIL PROFILE SHOVEL TEST PIT J-3

Ap 10YR 3/2 Very dark grayish brown sandy loam.

Bt 2.5Y 6/3 Light yellowish brown sandy clay loam.

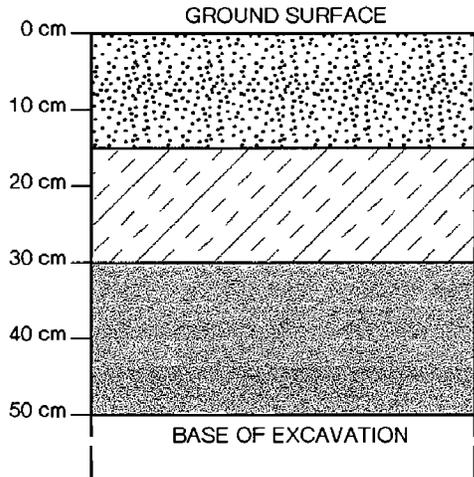
SOIL PROFILE SHOVEL TEST PIT N-5

Ap 10YR 3/2 Very dark grayish brown sandy loam.

BA 10YR 5/2 Grayish brown sandy loam.

Bt 2.5Y 5/4 Light olive brown sandy loam, with
10YR 5/4 Yellowish brown mottles.

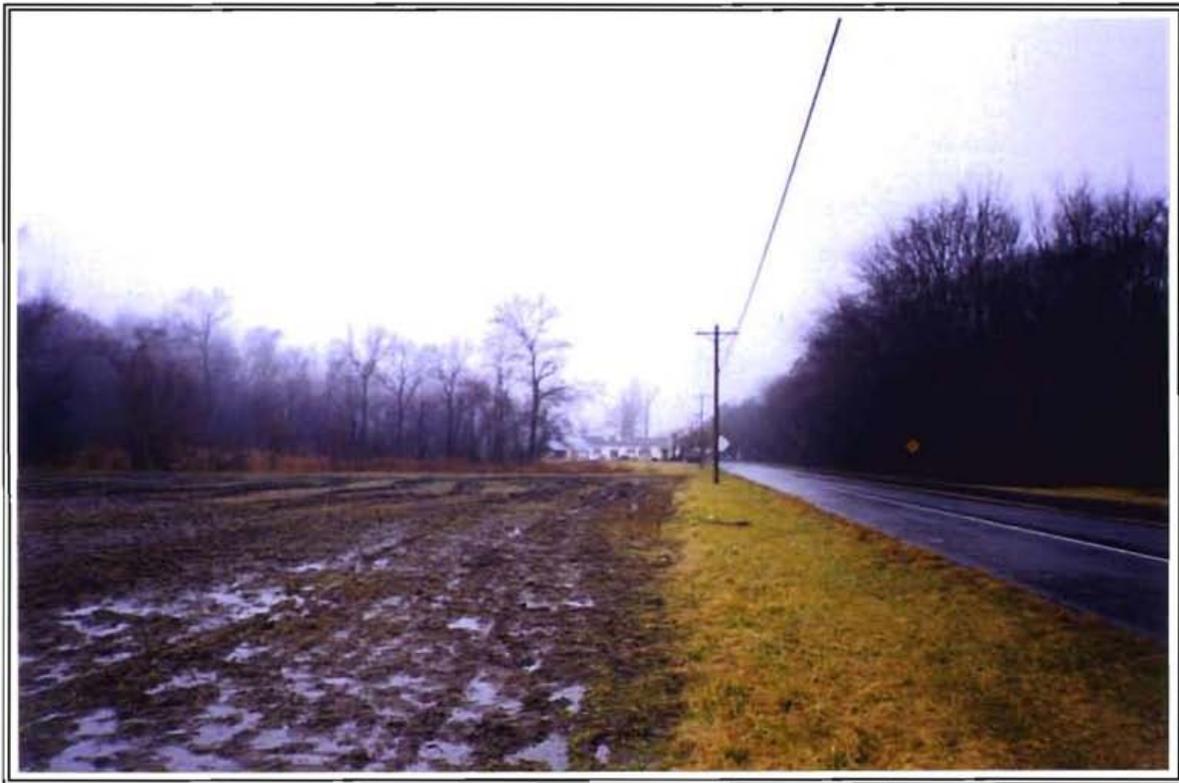
Photograph 1. View of Test Area A, facing west.

Test Area A is located near the western terminus of the S.R. 54 Improvements project APE along the southern side of the roadway (see Figure 2). The test area begins immediately east of a condemned house and continues east for approximately 195.0 m (639.8 ft) to the proposed realigned intersection of Zion Church Road and S.R. 54. The test area is comprised of grassy portions and fallow soybean fields (Photograph 1). Disturbances to the test area include past agricultural activities and excavation and maintenance of a drainage ditch, utilities, and the roadway.

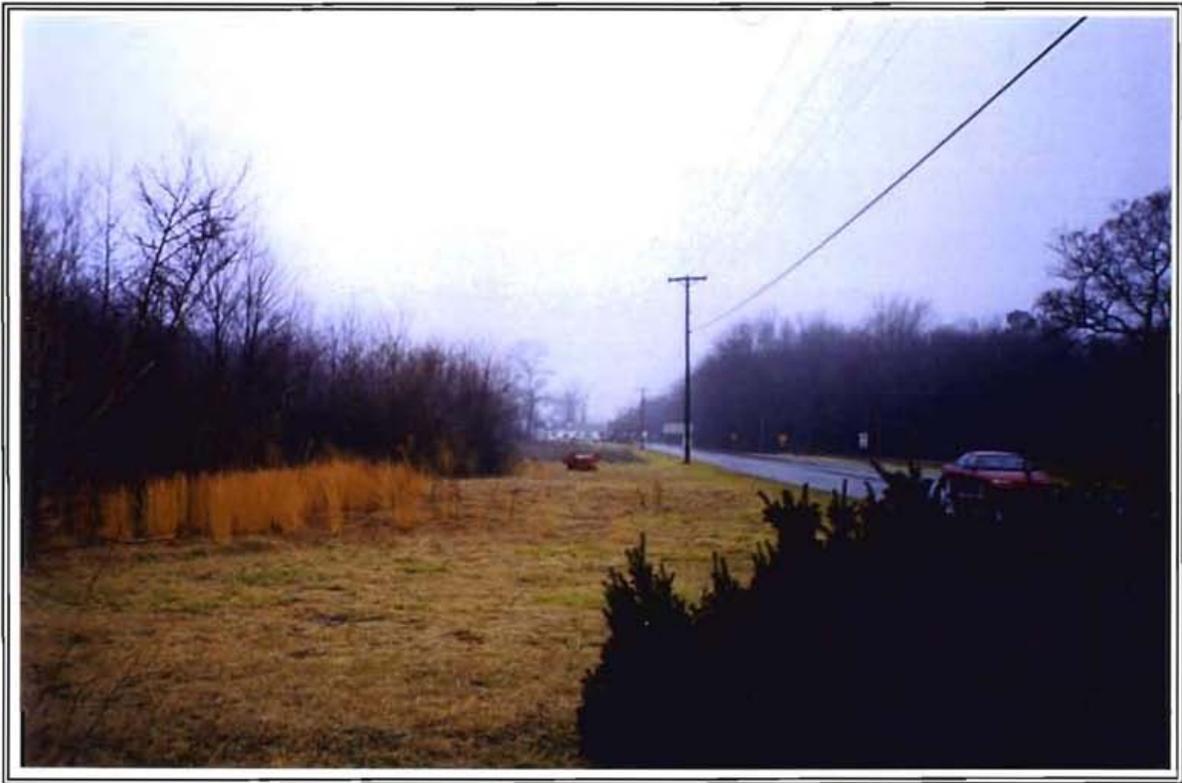
Photograph 2. View of Test Area B, facing west.

Test Area B is located near the western terminus of the S.R. 54 Improvements project APE along the southern side of the roadway (see Figure 2). The test area begins at the proposed realigned intersection of Zion Church Road and S.R. 54 and continues east to the existing intersection of Zion Church Road and S.R. 54, a distance of approximately 96.0 m (315.0 ft). The test area is comprised of grassy areas (Photograph 2). Disturbances to the test area include excavation and maintenance of utilities, and the roadway.

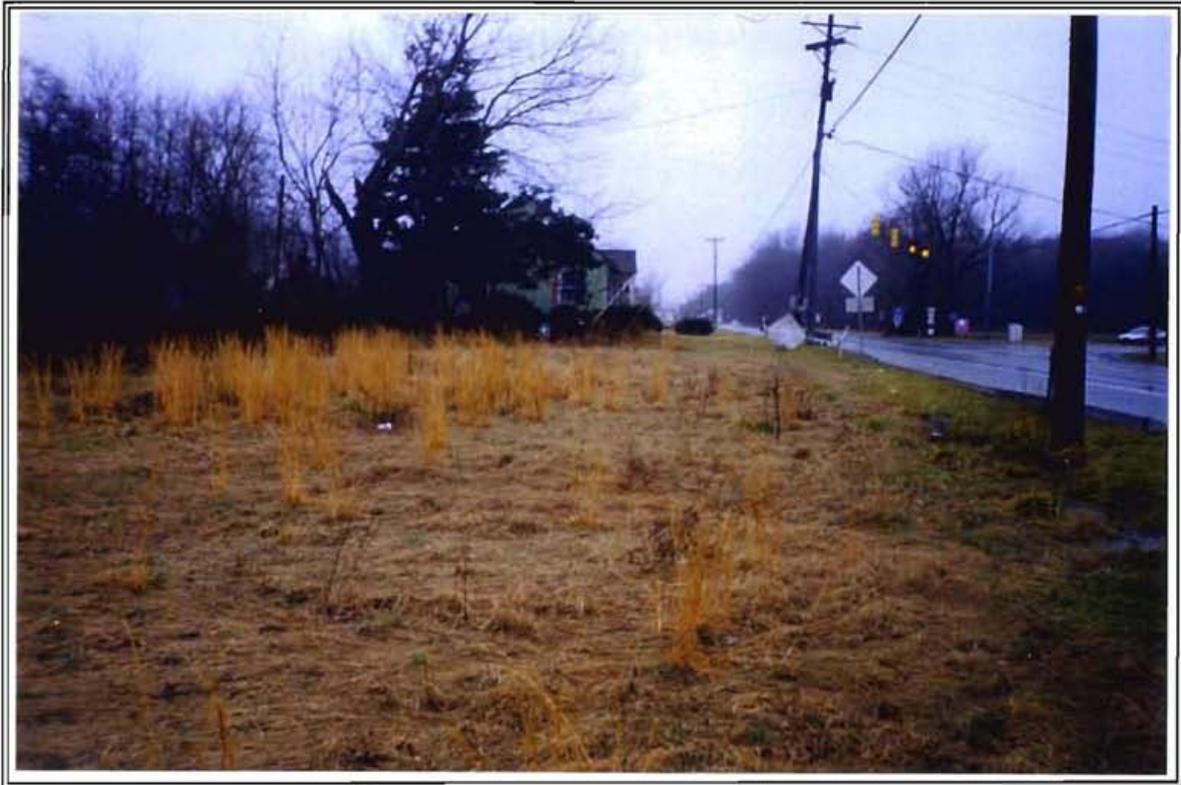
Photograph 3. View of Test Area C, facing west.

comprised of grassy areas (Photograph 3). Disturbances to the test area include past excavation and maintenance of utilities, and the roadway.

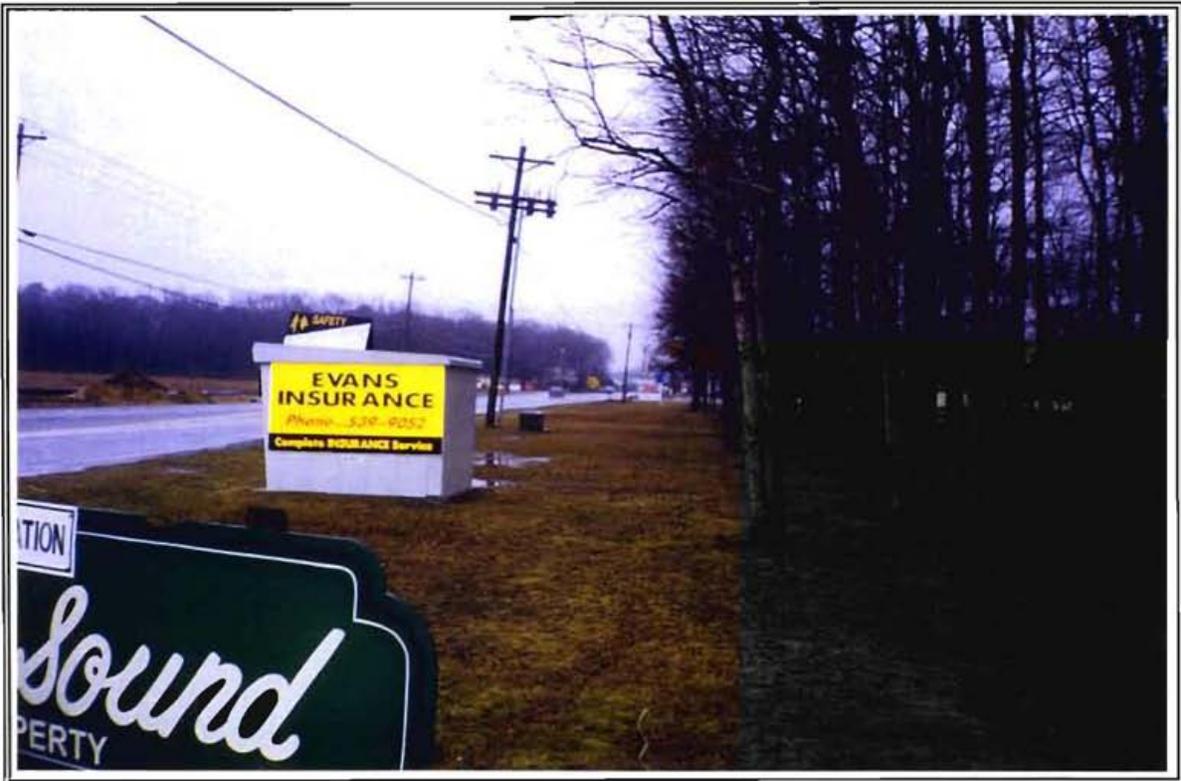
Photograph 4. View of Test Area D, facing east.

Test Area D is located in the central portion of the S.R. 54 Improvements project APE along the southern side of the roadway (see Figure 2). The test area begins immediately east of the intersection of River Run Road and S.R. 54 and continues east for approximately 169.0 m (554.5 ft). The test area is comprised of grassy portions with scattered trees (Photograph 4). Disturbances to the test area include construction of a bus shelter and a driveway, as well as excavation and maintenance of utilities and the roadway.

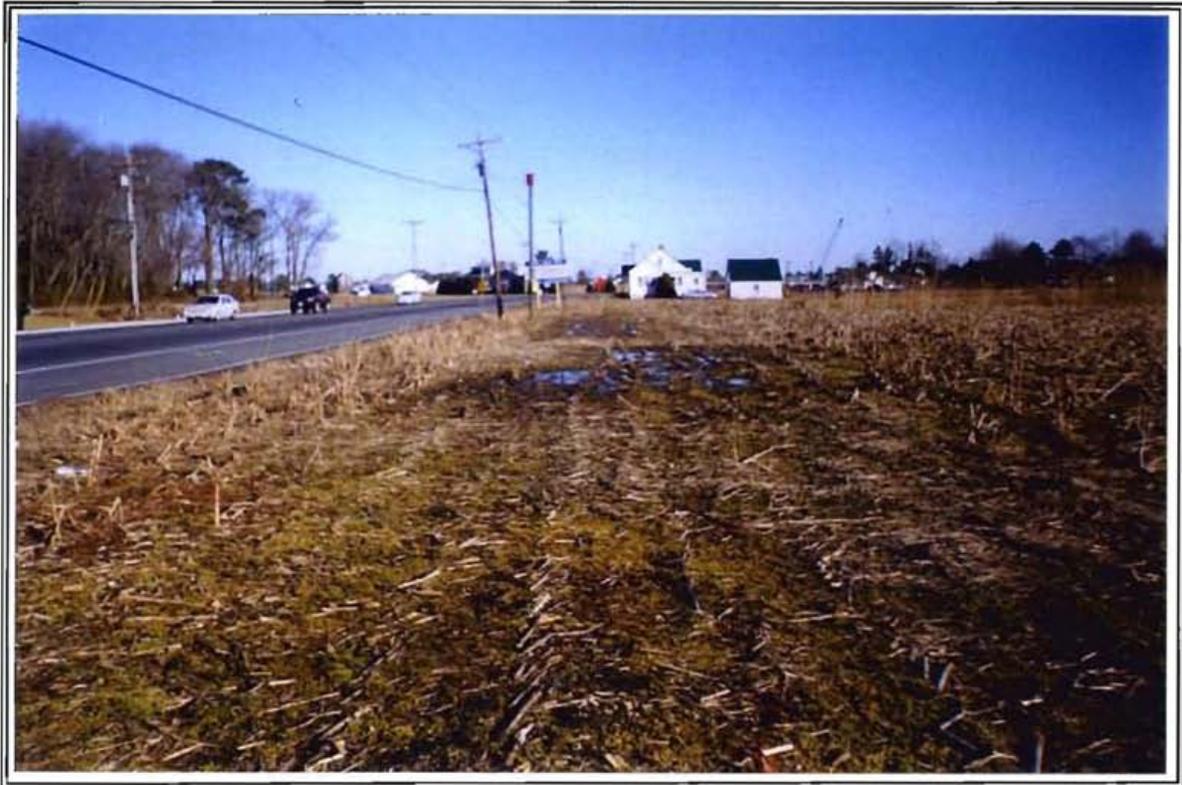
Photograph 5. View of Test Area E, facing east.

and wooded portions, as well as yards and agricultural fields (Photograph 5). Disturbances to the test area include past agricultural activities; excavation and maintenance of drainage ditches, underground utilities, and the roadway; and house construction and landscaping.

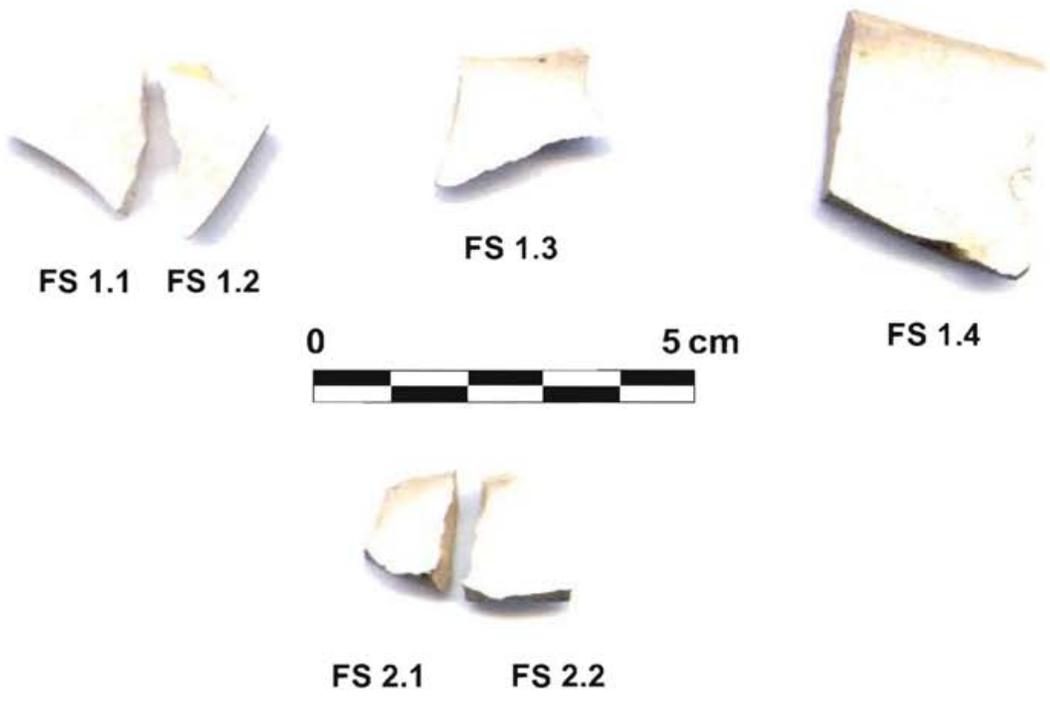
were recovered from Stratum 5; however, all of the sherds appear to originate from the same undecorated, clear glazed plate. All six sherds are plain, without decoration or maker's marks, but do exhibit crazing (Photograph 10).

Photograph 10. Ceramic sherds recovered from STP N-5.

These sherds are not specifically temporally diagnostic due to the lengthy manufacturing and use periods associated with whiteware. Whitewares, which were first produced in the United States in the 1830s, are still presently manufactured (Ramsay 1947; Spargo 1926). Without a maker's mark, identifying decorative features, or associations with other datable cultural features or artifacts, these plain whiteware sherds are not useful for revealing new or significant information about the history of the project area. These ceramic sherds are most likely the result of a single discard activity, indicative of the general residential/domestic rural land use of the project area. Due to the limited number of sherds recovered, the small size of the individual sherds, their lack of association with cultural features and/or other artifacts, and their temporally non-diagnostic nature, these sherds are considered an isolated find and are not assigned a site designation. These ceramic sherds do not comprise a historic period archaeological site and can not contribute significant information about the specific land-use history within the project APE; therefore, no additional archaeological research in Test Area N is recommended.
