CULTURAL RESOURCE SURVEY  
SURVEY UPDATE FORM

CRS # S-00210

1. HISTORIC NAME/FUNCTION: Sussex Correctional Institution

Organization: John Milner Associates Inc.                  Date: 06/2006

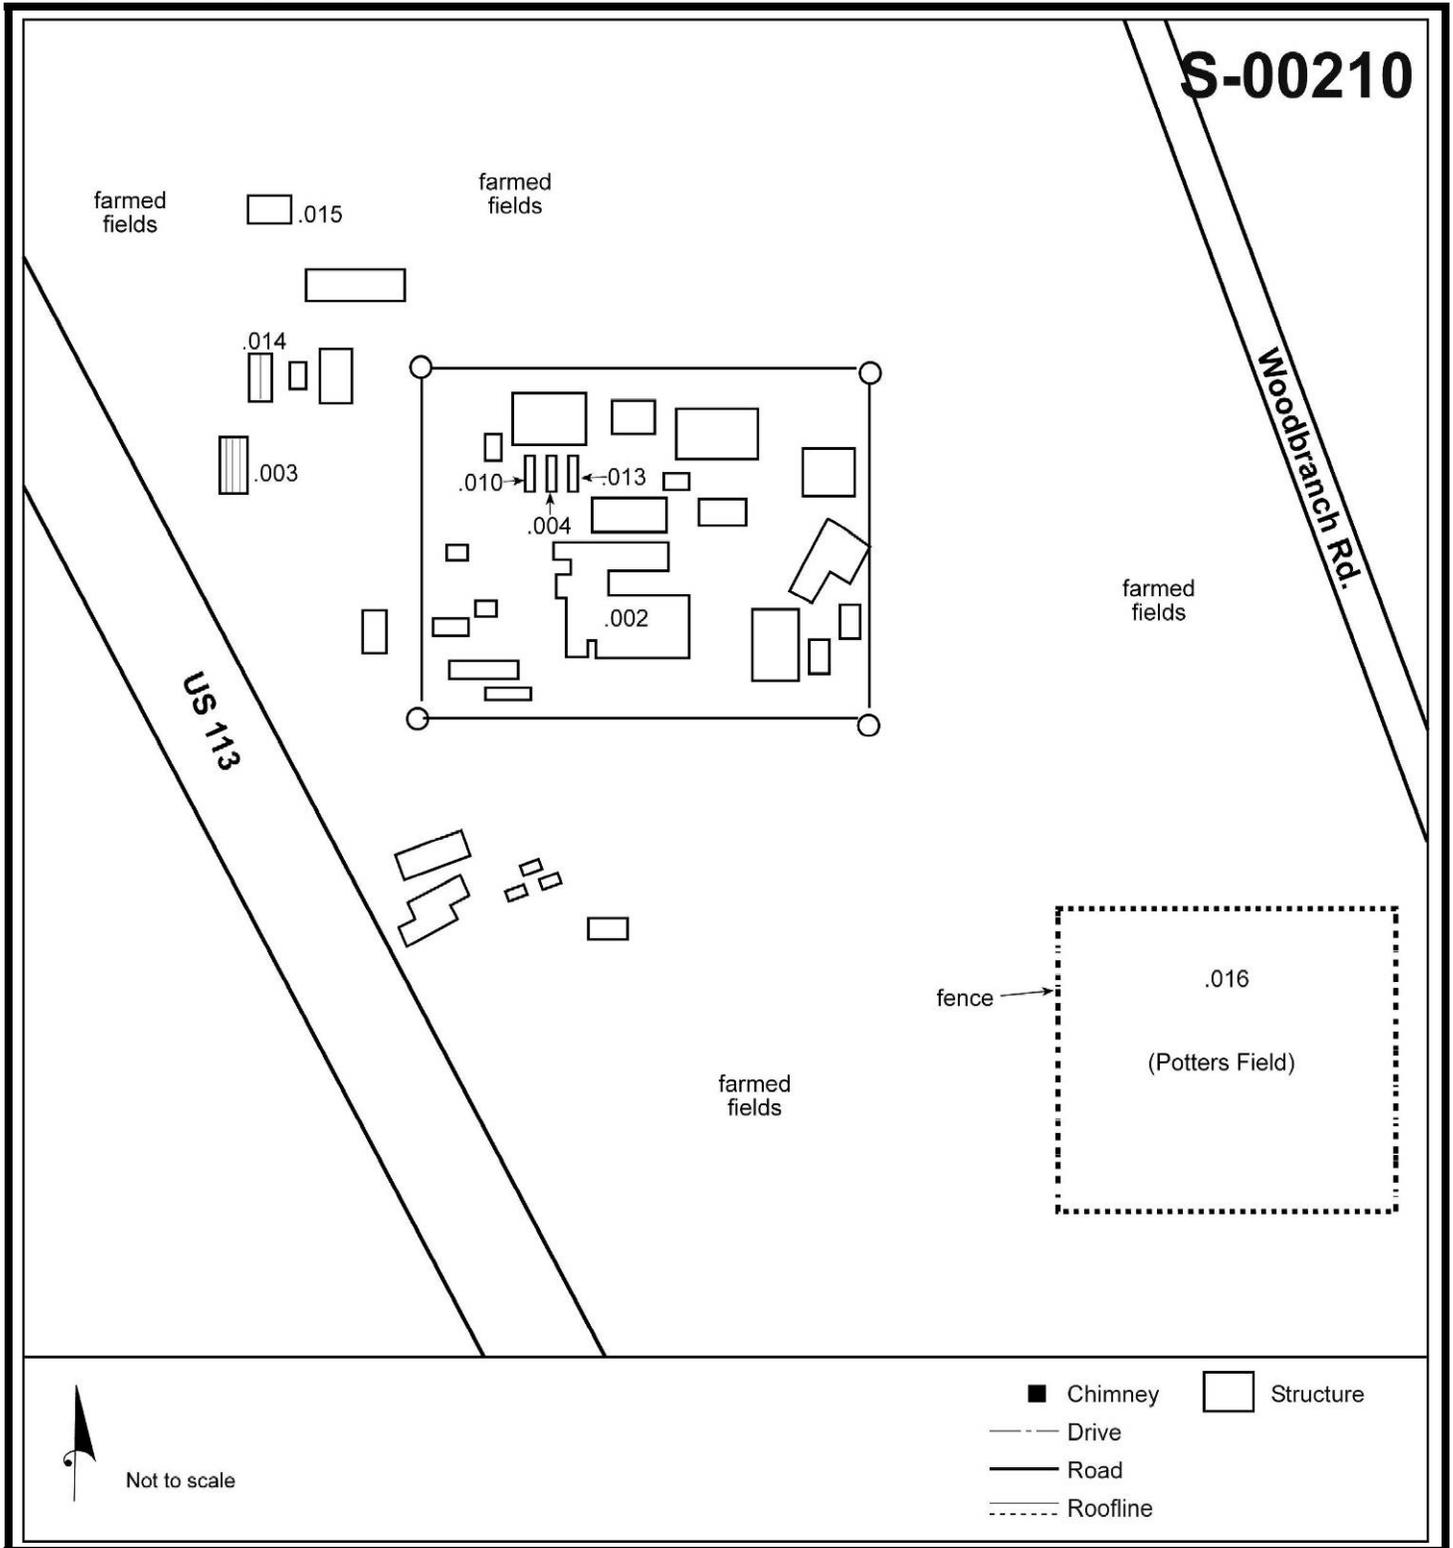
CRS # S-00210

JMA architectural historians walked the property with warden Richard Kenney. Several resources that had been recorded in 1980 and 1998 were no longer extant: Warden's house (.001), feed barn (.005), machine shed (.006), maintenance office (.007), machine shop (.008), print building (.009), armory (.011), and kitchen (.012). Four additional elements were identified that had not previously been recorded: potato shed (.013), swine barn (.014), vehicle equipment shed (.015), and potters' field cemetery (.016).
