SR 273 Pedestrian & Bicycle Road Safety Audit

New Castle County, Delaware

**Prepared for:
Delaware Department of Transportation**

**By
Urban Engineers**

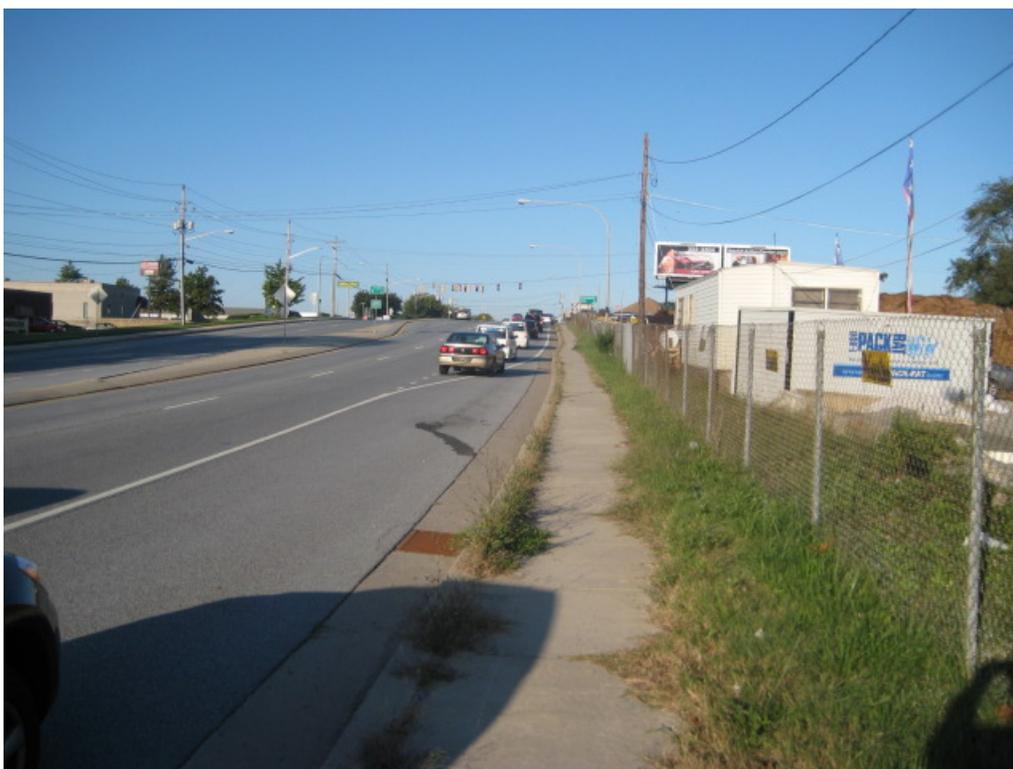
Photo 2 : Typical SR 273 Cross-Section between US 13 and SR 1

This section of SR 273 has two travel lanes per direction, a posted speed of 45 mph and mountable concrete median dividing each direction. The travel lanes are twelve feet wide and the shoulder widths vary from two to twelve feet. Along this section of the corridor, sidewalk is consistent on both sides of SR 273 and there are some pedestrian facilities at the intersections. There are also several mid-block uncontrolled pedestrian facilities. Based on a visual inspection, no signalized intersections in this section of the corridor are equipped with emergency vehicle pre-emption.

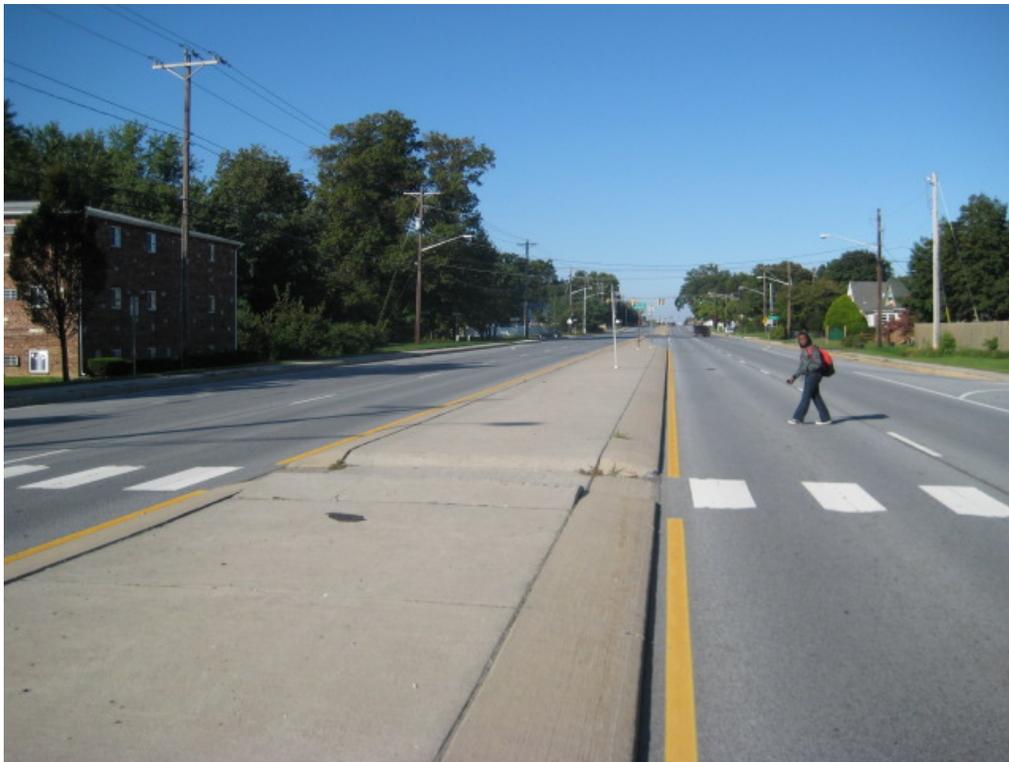
Photo 3: Marked, Unsignalized Crossing near Georgetown Manor Apartments

Between Prangs Lane and Scottie Lane (**Figures 2C** and **2D**), SR 273 includes a number of T-intersections with non-ADA compliant ramps. This section also includes an unsignalized mid-block crossing just west of Rambleton Drive (**Figure 2D**). DART bus stops are located along both sides of SR 273 at this crossing. The pedestrian ramps at this location are not ADA compliant and the signs alerting drivers of a crosswalk are not compliant with current sign standards.

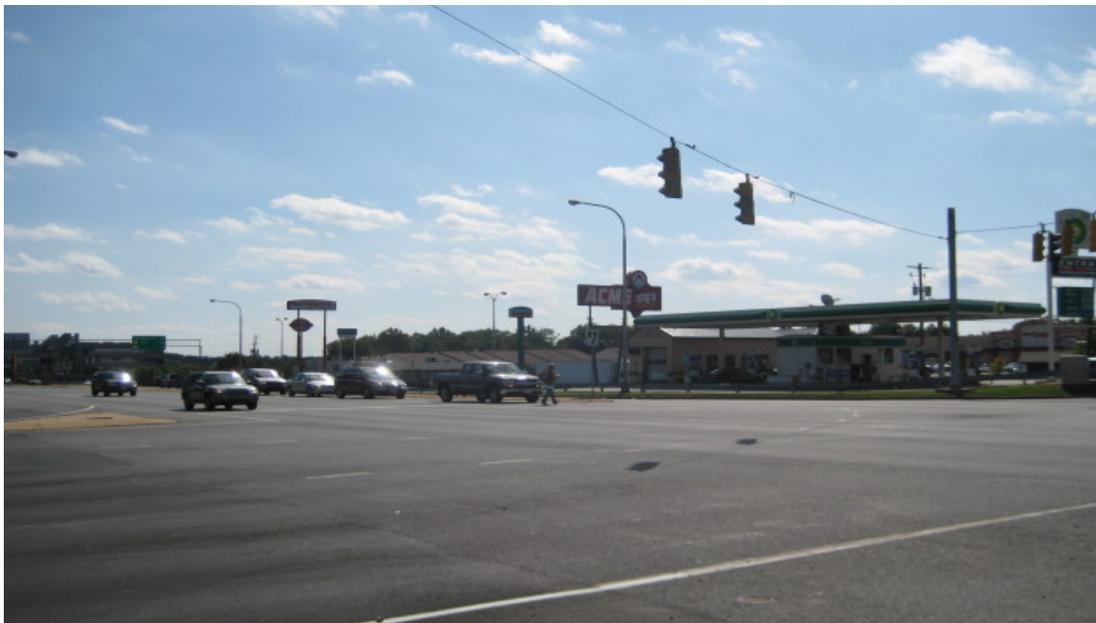
Photo 4: Intersection of SR 273 and Eagle Run Road

At the intersection of SR 273 and Eagle Run Road (**Figure 2L**), double left turn lanes- are located on each approach. Sidewalks and an ADA compliant pedestrian ramp are on the northwest corner, as well as a non-ADA compliant cut-thru in the median of the north leg of the intersection, but no corresponding pedestrian ramp is on the northeast corner of the intersection. West of this intersection, a 4' high concrete barrier divides each direction of traffic on SR 273 and extends across the interchange with I-95 west to the intersection with Harmony Road. The I-95 Interchange is a full interchange with grade separated access to and from both directions of the interstate. There are no pedestrian facilities however, pedestrians were occasionally observed crossing I-95 using the SR 273 shoulder

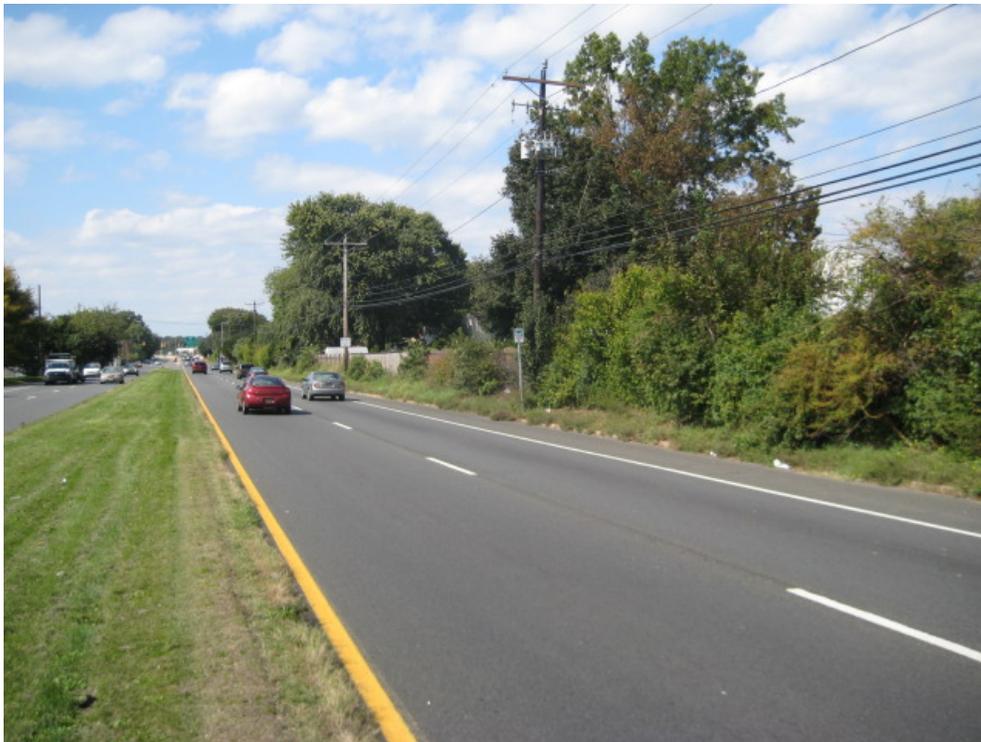
Photo 5 : Typical SR 273 Cross-Section between I-95 and SR 4

No sidewalks are located along SR 273 between Harmony Road and Brownleaf Road (**Figure 2N** and **2O**). DART bus stops are on both sides of SR 273 near the Christiana Skating Center, although the bus stop on the westbound side of SR 273 does not have a pedestrian refuge. The intersection of SR 273 and Brownleaf Road has no pedestrian crosswalks, signal heads or push buttons. Pedestrian ramps are on all corners of the intersection but none are ADA compliant. Bus stop is located on the southwest and northeast corners of the intersection.

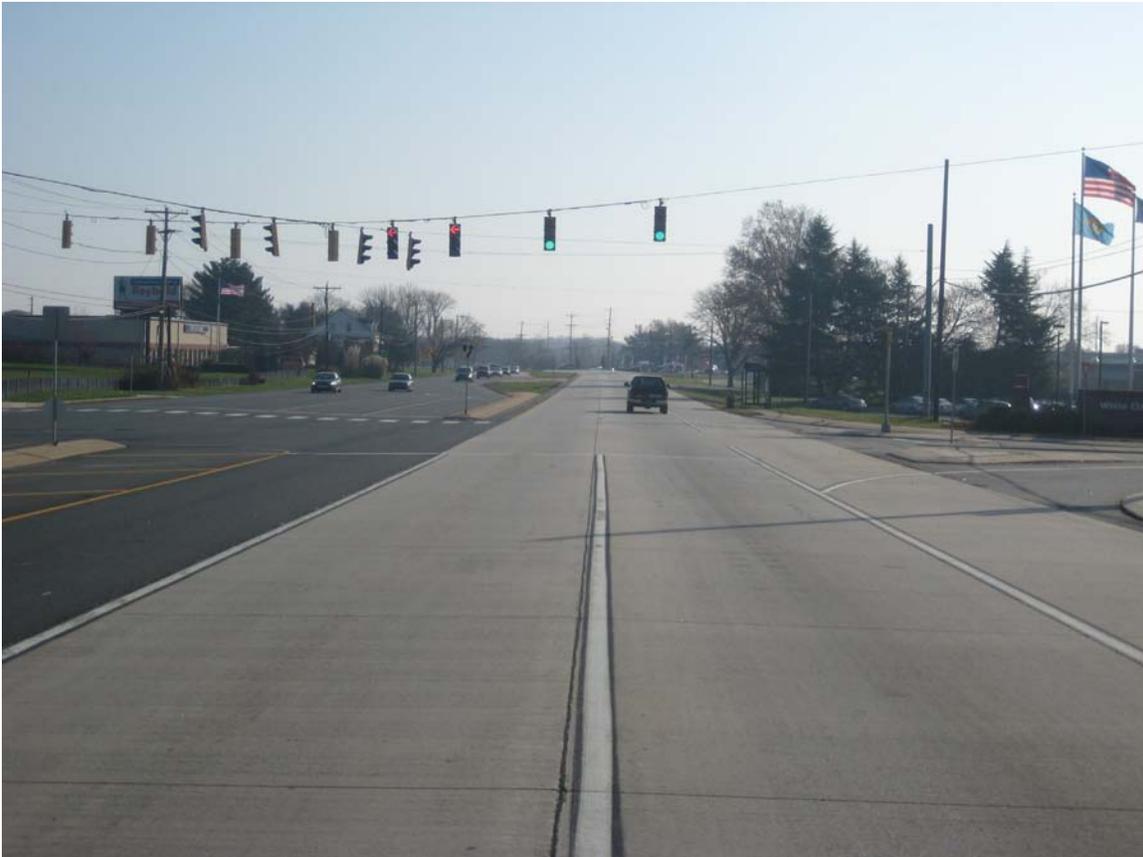
Photo 6: Typical Cross-Section of SR 273 between DE 4 and Marrows Road

This section of SR 273 has two travel lanes per direction, with a variation of grass and concrete median dividing each direction. The posted speed is 45 mph from SR 4 to Ruthar Drive, and 50 mph for the remainder of the section. The travel lanes are typically twelve feet wide and the shoulder widths are also twelve feet. This section of the corridor is mainly commercial and industrial and contains no sidewalks along SR 273. No signalized intersections in this section of the corridor are equipped with emergency vehicle pre-emption except for the intersection with Red Mill Road/ Paradise Lane. The interchange with SR 4 provides full access between the roadways, with ramps to and from SR 273 leading to signalized intersections on SR 4.

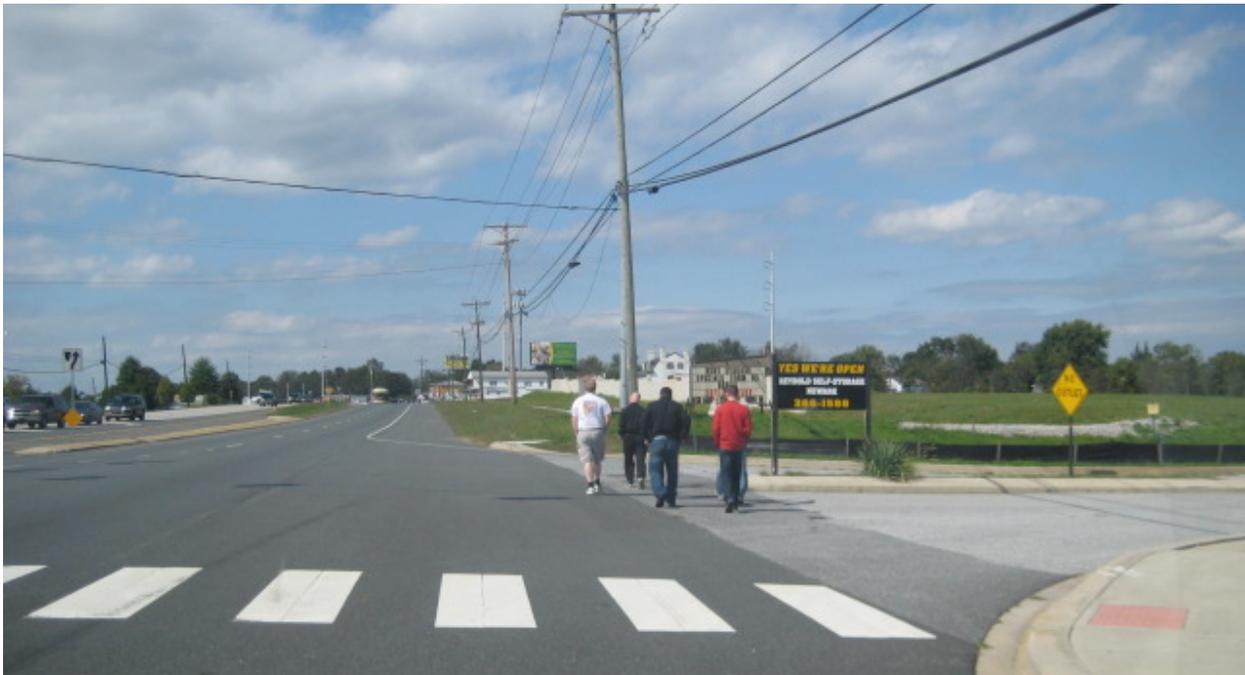
Photo 8: Photo of White Clay Road

Further west is the signalized intersection of SR 273 and White Clay Road (**Figure 2V**), which has a crosswalk on the east leg. This crosswalk is not ADA compliant and consists of two different design styles. There are sidewalks on the northeast and southeast corners of the intersection along with non-ADA compliant pedestrian ramps. These sections of sidewalk lead to bus stops on both sides of SR 273. The bus stop on the southeast corner of the intersection has a shelter and bench. On the northwest corner of the intersection, a concrete sidewalk starts at the corner with no pedestrian ramp and continues west to the commercial parking lot of Jake's Burgers and a barber shop. The pedestrian signal heads at this location are not equipped with countdown displays. The pedestrian push button on the north east corner of the intersection is measured as 50" above the ground, which is 8" above current standards. The

pedestrian push button on the south east corner of the intersection is rotated away from the pedestrian landing area.

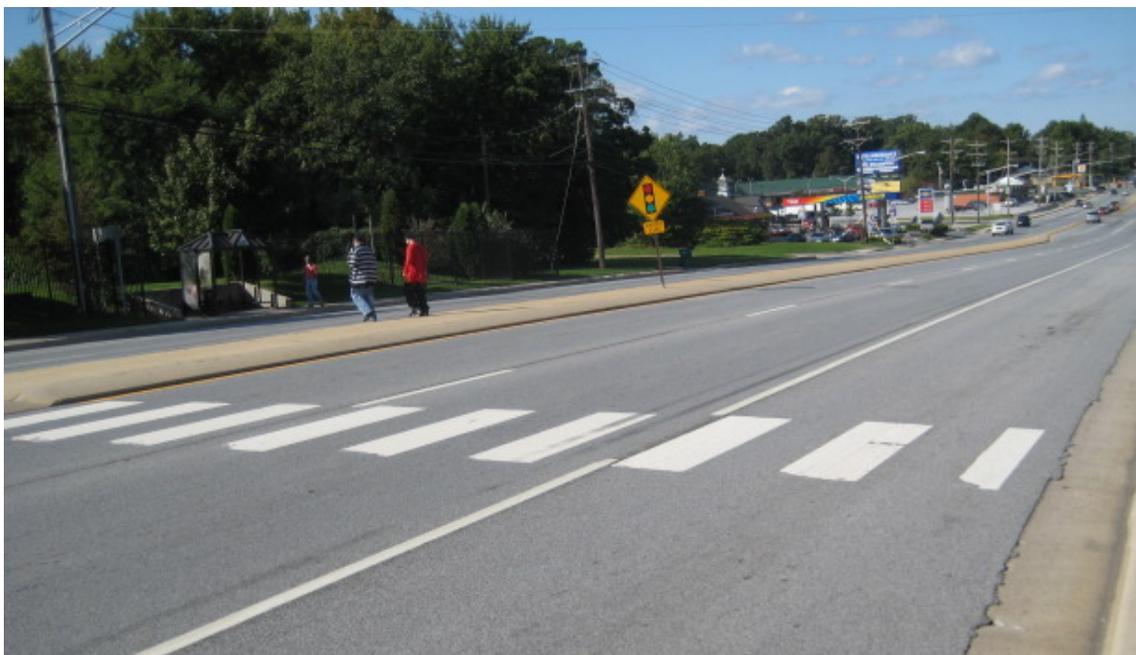
Photo 9: Pedestrians near unsignalized crossing at Georgetown Manor Apts

The area with the highest observed activity in the study area was around the Georgetown Manor Apartments, approximately between Edinburgh Road and Airport Road, particularly near the entrance to the apartment complex and Freedom Trail. The total number of pedestrians observed walking on the SR 273 sidewalk on the south side of the road, crossing the Freedom Trail approach was 97 and 73 pedestrians were observed crossing the Georgetown Manor entrance (**Figure 2F**). A total of 49 pedestrians were observed crossing SR 273 in the vicinity of the apartment complex not using the designated crosswalk. 13 pedestrians used the unsignalized crosswalk. Between the entrance to Georgetown Manor Apartments and Airport Road, 153 pedestrians were observed using the sidewalk on the north side of SR 273, despite the many large trees partially blocking the way, while only 17 used the sidewalk on the south side. Pedestrian volumes in the area are shown in **Figures 2E** and **2F**. A common destination on the north side of the road was the Laundromat east of Airport Road. Bus stops are also located on both sides of SR 273 at Airport Road and at the unsignalized crosswalks in the area.

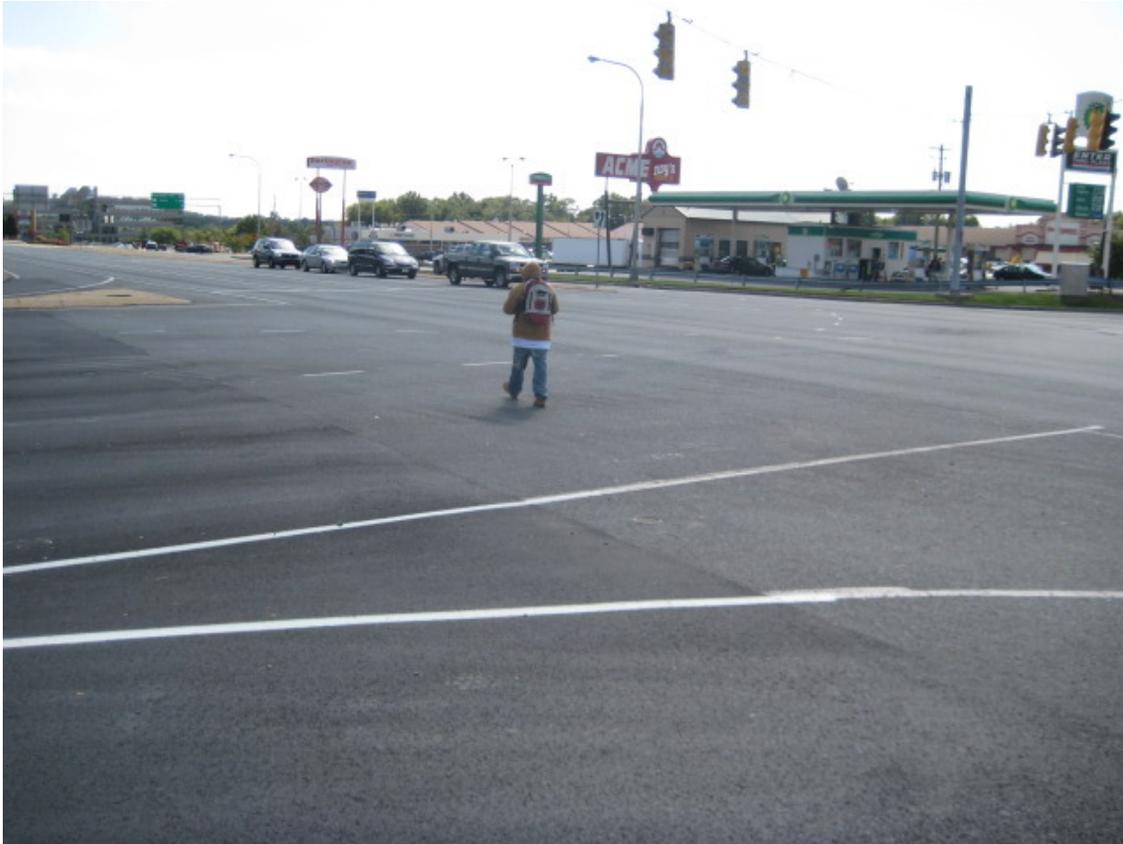
Photo 10: Pedestrian crossing Eagle Run Road

At SR 273 and Eagle Run Road (**Figure 2L**), significant pedestrian activity was recorded at the intersection during an average weekday. Volumes were fairly evenly spread out, with slightly more (34) crossing SR 273. One pedestrian crossing of SR 273 was recorded west of Eagle Run Road. This intersection has no existing pedestrian crossing facilities.

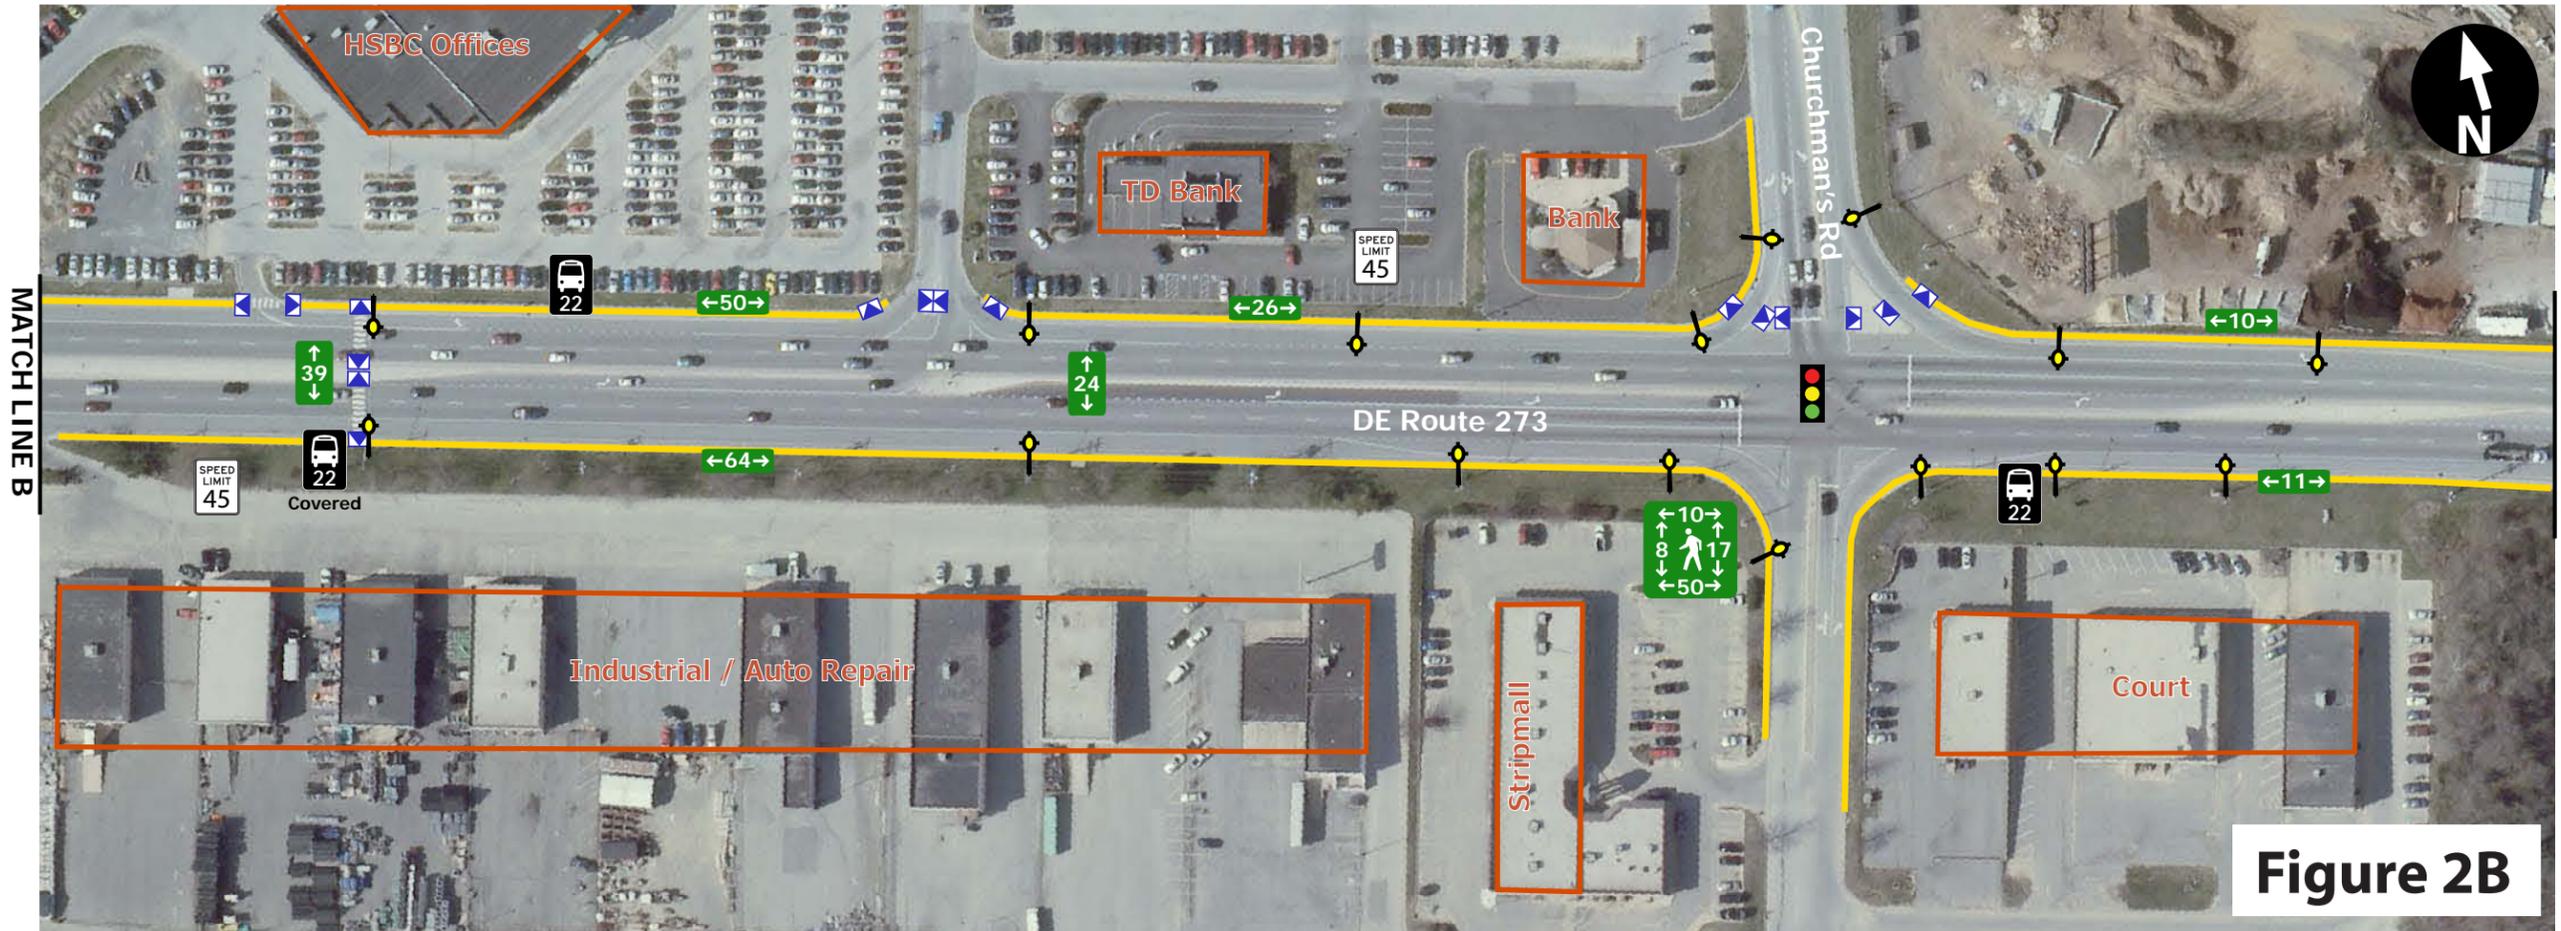
Figure 2B

At the signalized intersection of SR 273 and Churchman's Road, there was a significant number of pedestrian counted, as shown in **Figure 2B**. The majority of these pedestrians were crossing Churchman's Road with 50 pedestrians crossing the south leg and 37 pedestrians were crossing the north leg. To the east of this intersection, the highest number of pedestrians were observed on Saturday, with 10 pedestrians using the sidewalk on the north side of SR 273 and 11 pedestrians using the sidewalk on the south side.

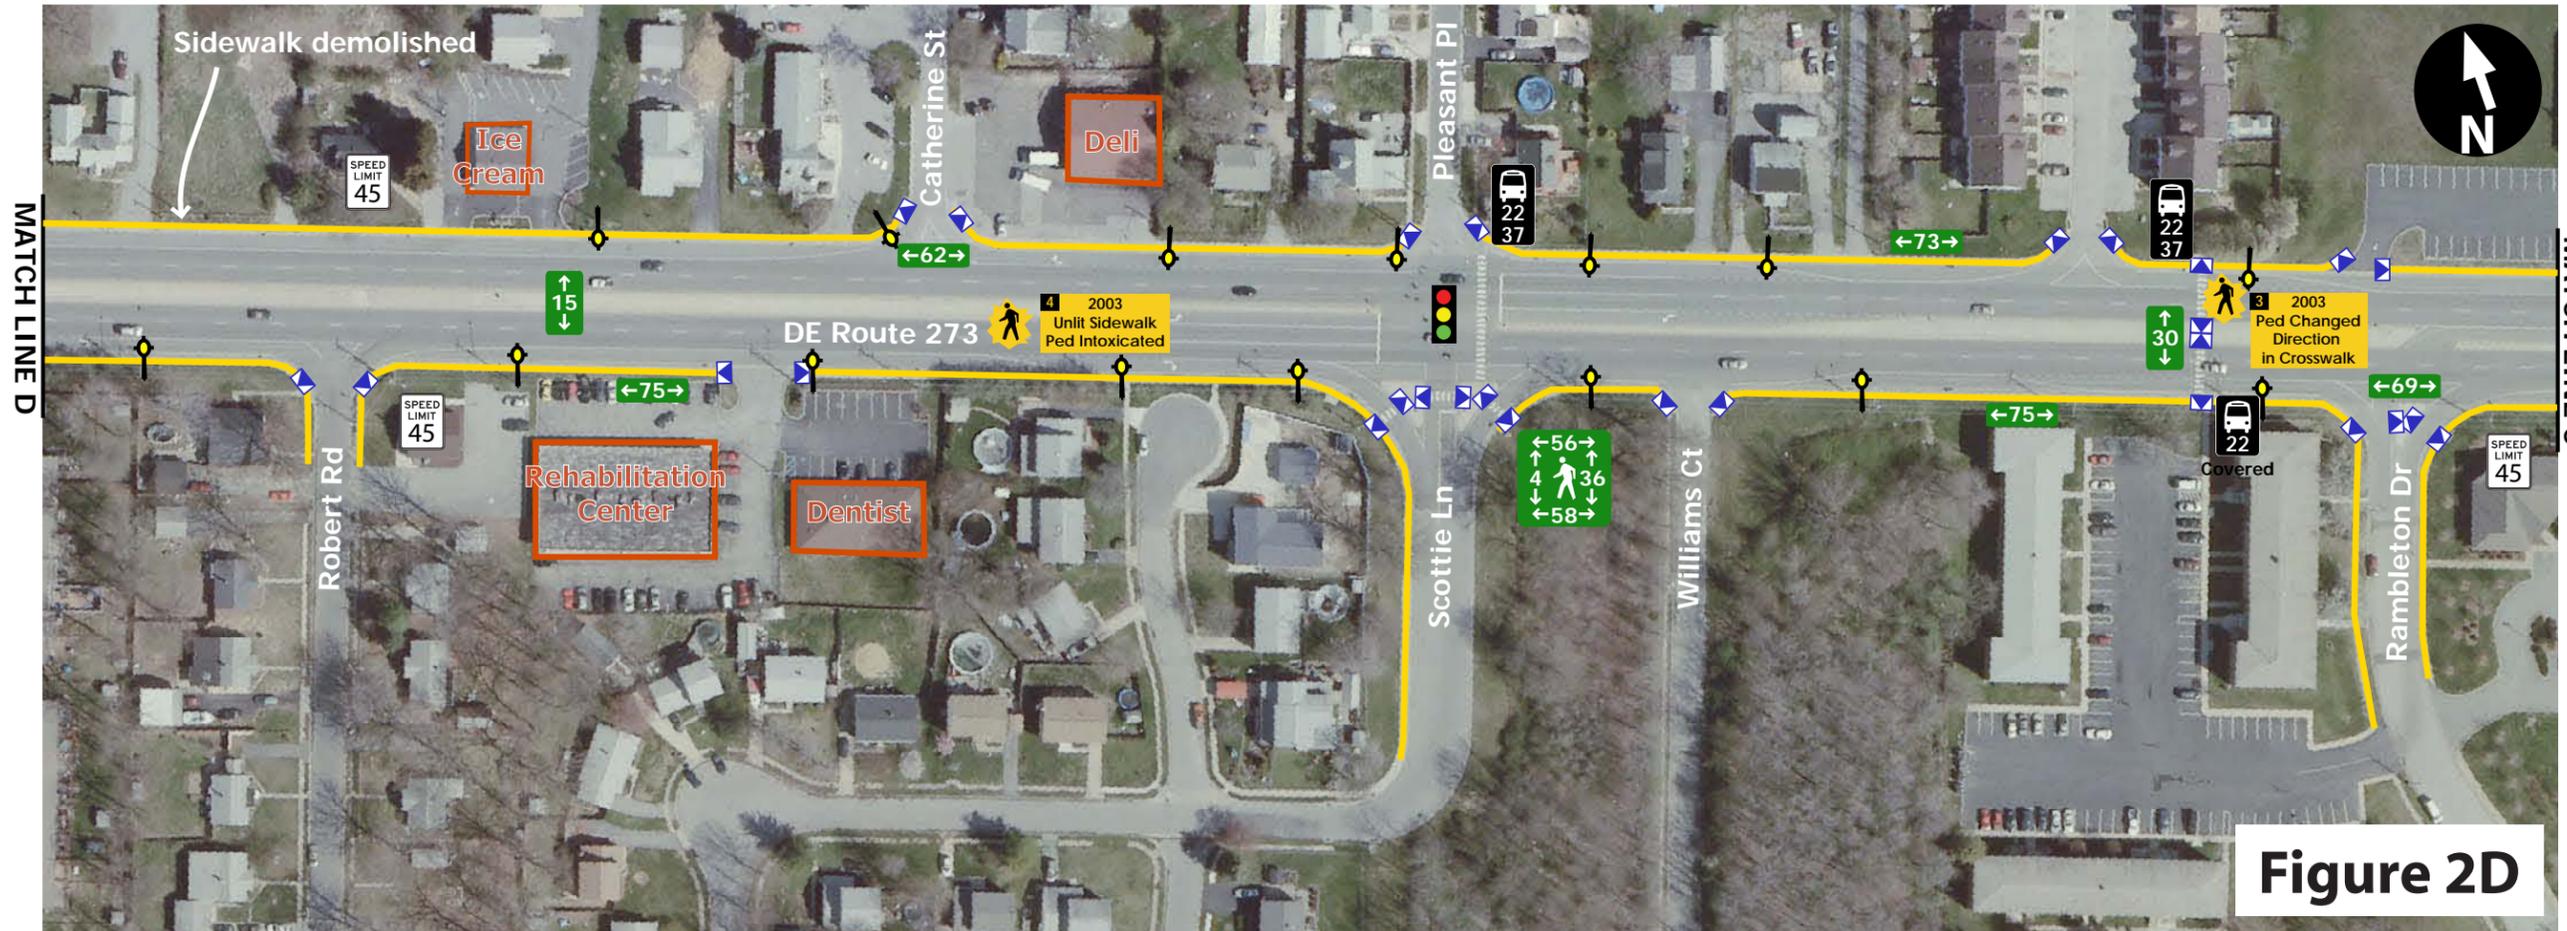
Figure 2D

At the intersection of SR 273 and Scottie Lane/Pleasant (**Figure 2D**), the majority of pedestrians were crossing Scottie Lane/Pleasant Place, with 58 crossing the south leg and 56 crossing the north leg. A large number of pedestrians (36) used the crosswalk on the east leg to cross SR 273. In the morning a school crossing guard was stationed at the intersection, most likely for the Pleasantville Elementary School located north of SR 273 on Pleasant Place.

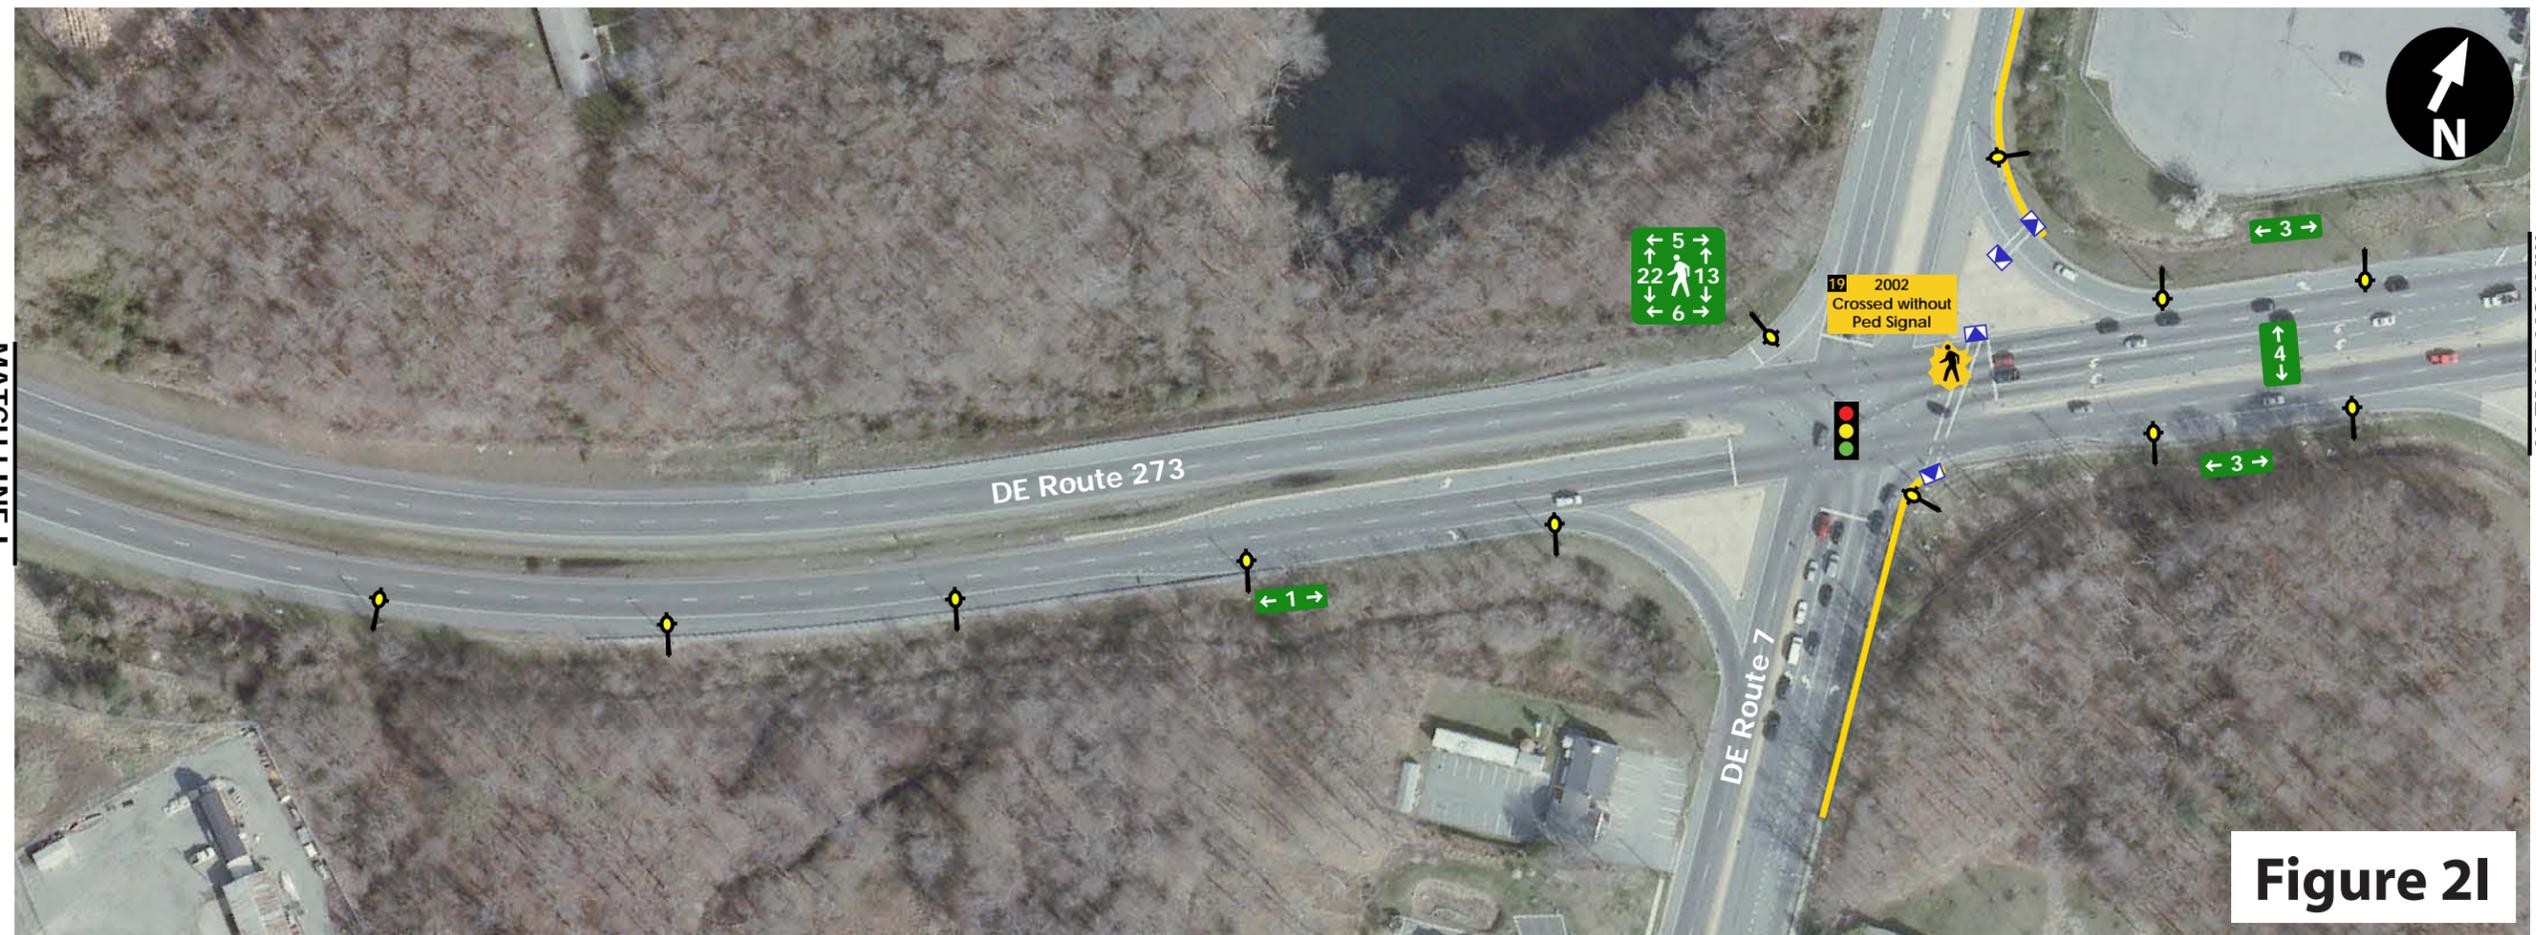
Figure 2I

At the intersection of SR 273 and DE 7, a total of 46 pedestrian crossings took place, with 21 during the peak hour (**Figure 2 I**). Of the 46 daily crossings, most of them (35) were pedestrians crossing US 273. The east leg has a marked pedestrian crossing with pedestrian signal heads, although most of the crossings (22) were on the west side of the intersection, which does not have these facilities. Few pedestrians, however, were observed walking along SR 273, with only one pedestrian walking along the south side of the road west of the intersection and a total of six (6) east of the intersection. Many of the pedestrian crossing SR 273 from the south appeared to be headed to a park and ride lot located on the northeast corner of the intersection.

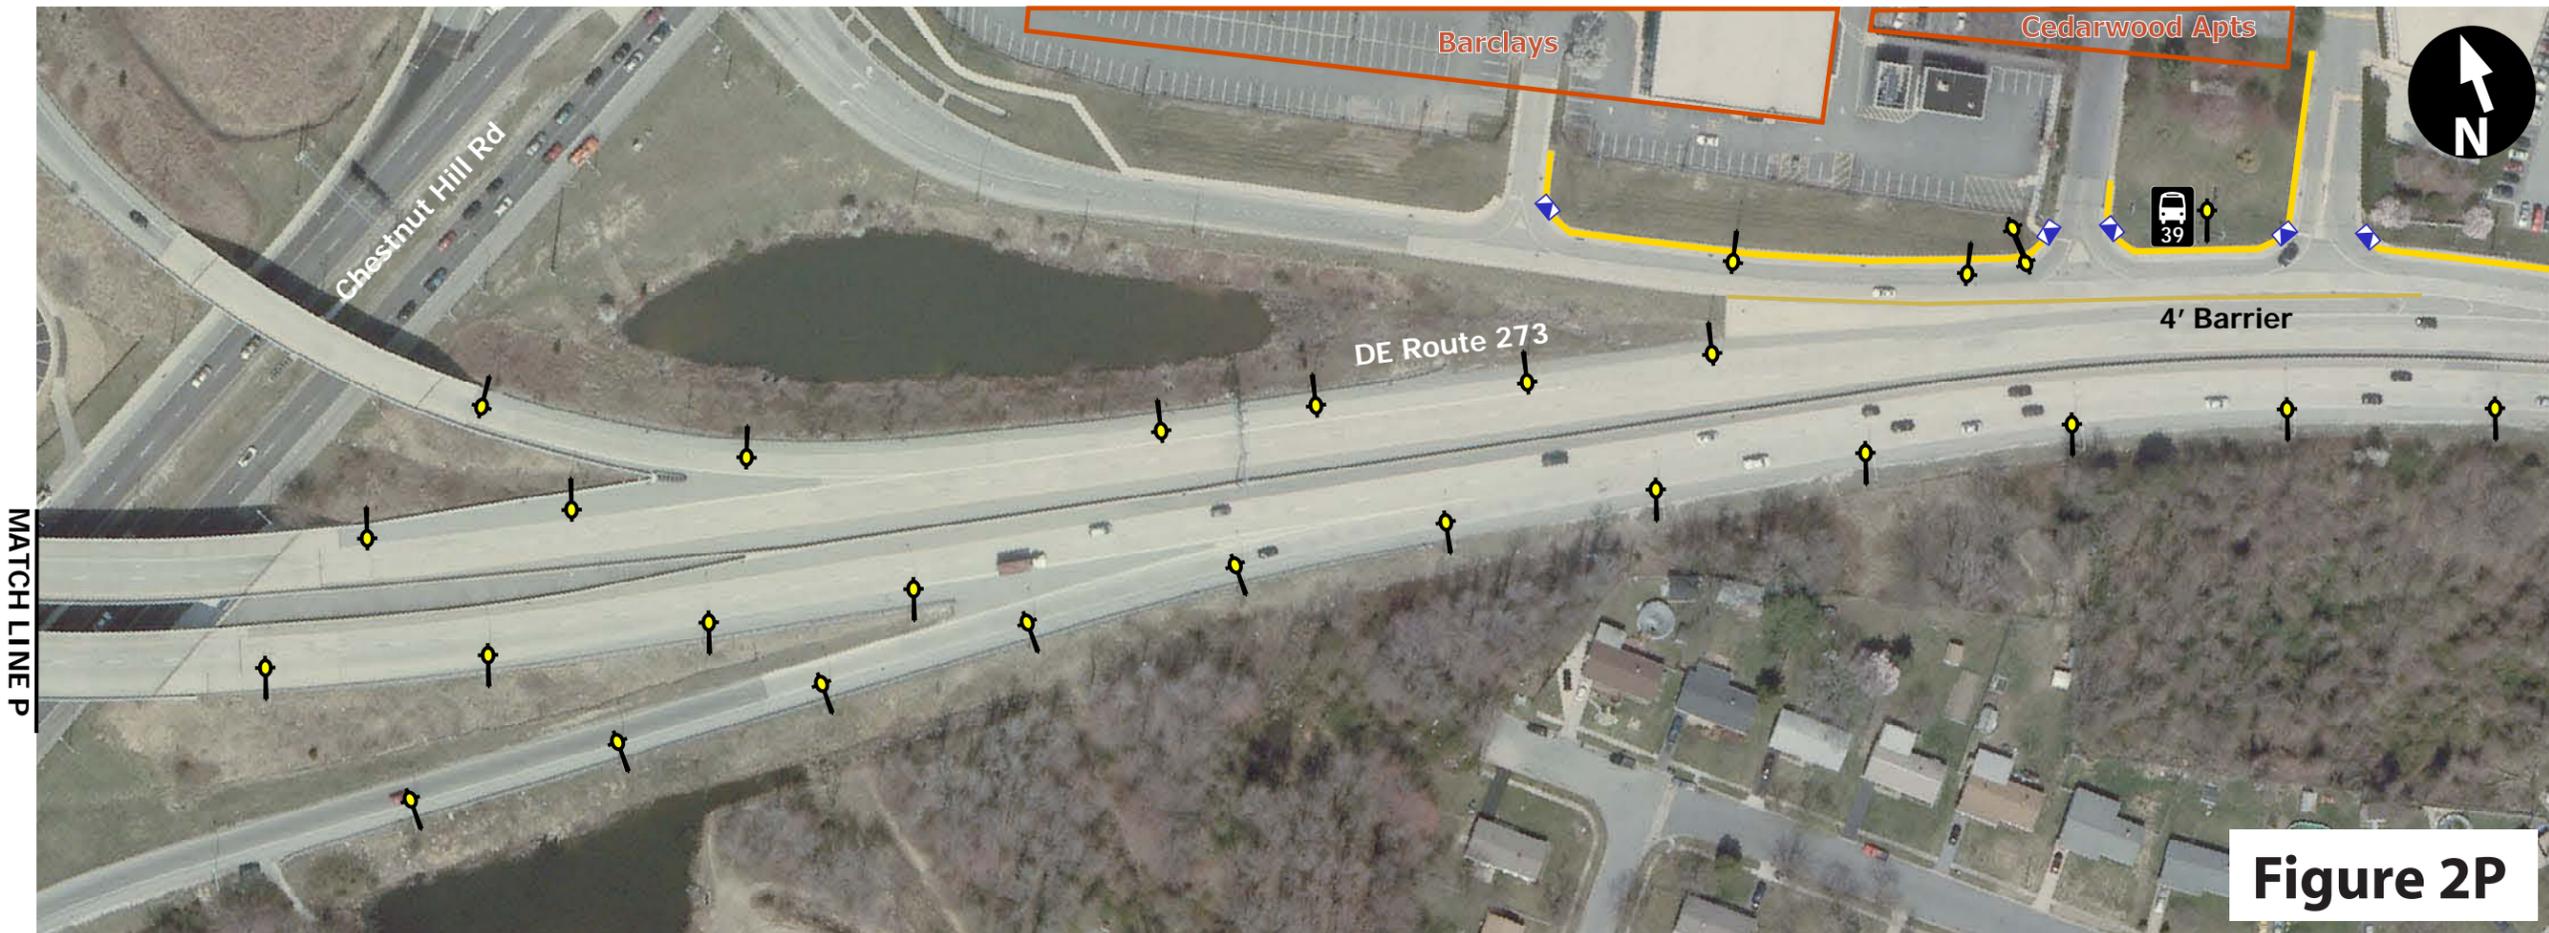
Figure 2P

To the west of Harmony Road, six (6) pedestrians were observed walking in the shoulders between Harmony Road and Brownleaf Road. At the intersection of SR 273 and Brownleaf Road (**Figure 2P**), there were 27 pedestrians observed crossing on the west leg of the intersection during weekday peak hours and nine (9) pedestrian crossing east of Brownleaf Road. A number of these pedestrians were school children on bikes.

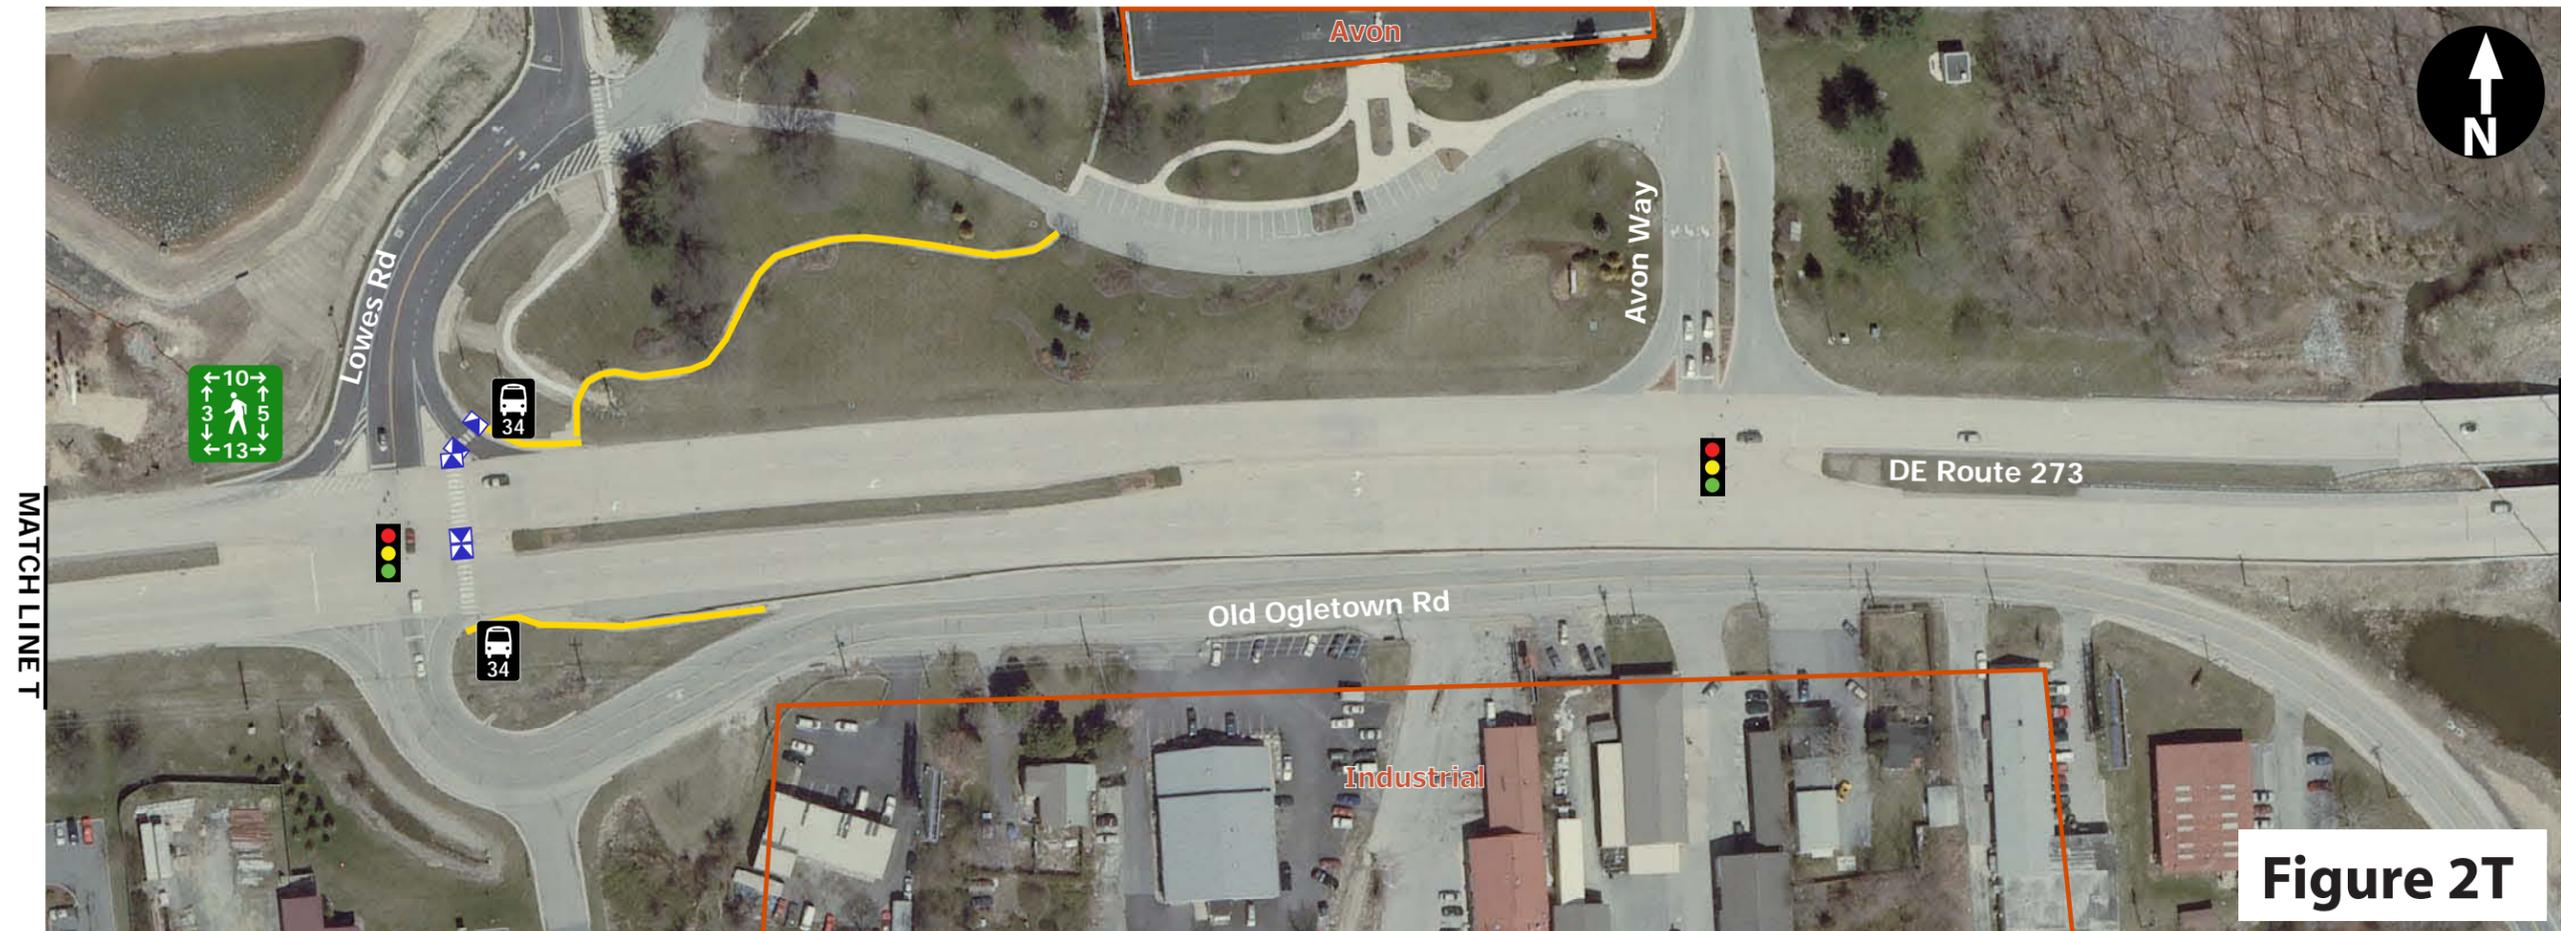
Figure 2T

At the signalized intersection of SR 273 and Old Ogletown Road/Lowes Road (**Figure 2T**), a crosswalk is located on the east leg of the intersection with non-ADA compliant pedestrian ramps. Small sections of sidewalk are on the northeast and southeast corners. The sidewalk on the northeast corner of the intersection connects to walkways that extend to the Avon campus. Pedestrian signal heads are provided, but they are not equipped with countdown displays. One of the pedestrian pole assemblies is in the median, which is not compliant with current standards.
